# METALLIZING AND COATING OF THE STICKNEY POINT DRAW BRIDGE

FRANK D. REA, PCS, GREENMAN-PEDERSEN, INC.

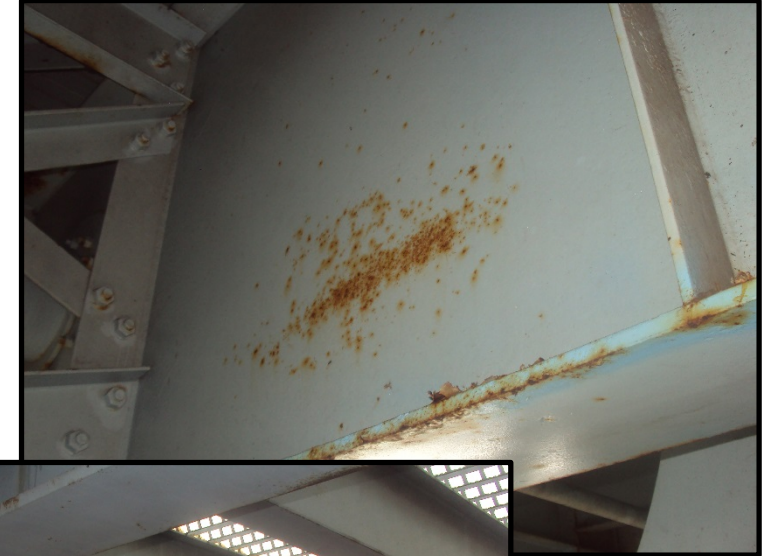
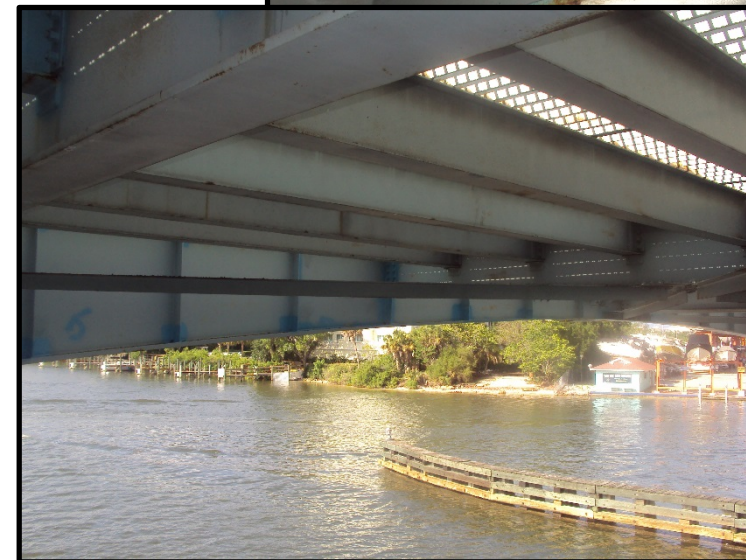
- Bridge No. 170052 – Eastbound (EB)
- Visible Corrosion 5-8%
- Average DFT 6.2 – 8.6 mils
- Two Coats
- ASTM D 3359 Adhesion 0A – 5A
- Significant Chalking

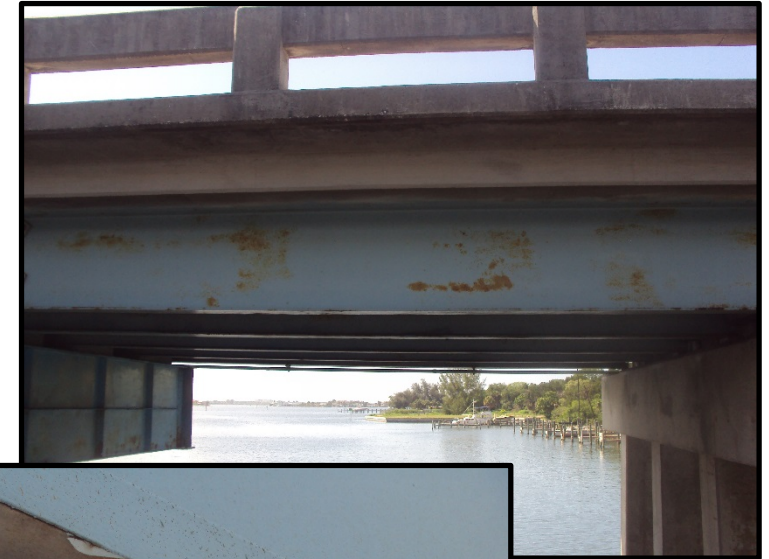
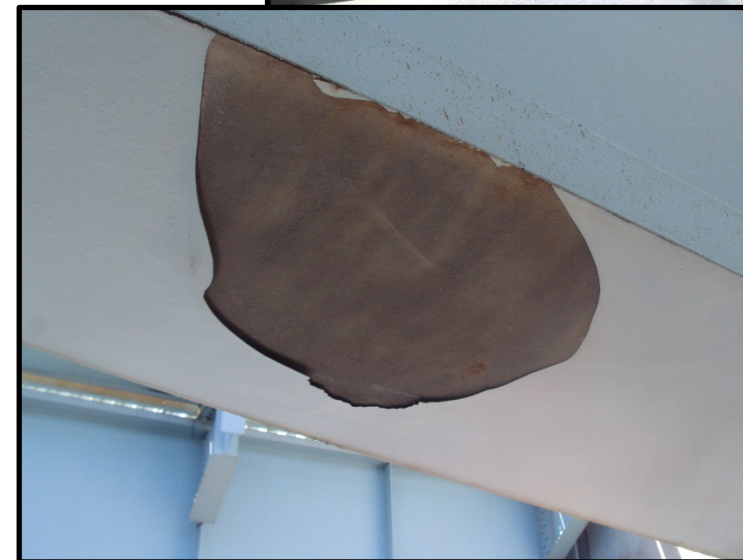
- Bridge No. 170065 – Westbound (WB)
- Visible Corrosion 3- 5%
- Average DFT 12.1 – 21.9 mils
- Three Coats
- ASTM D 3359 Adhesion 0A – 5A
- Peeling of Top Coat
- Significant Chalking

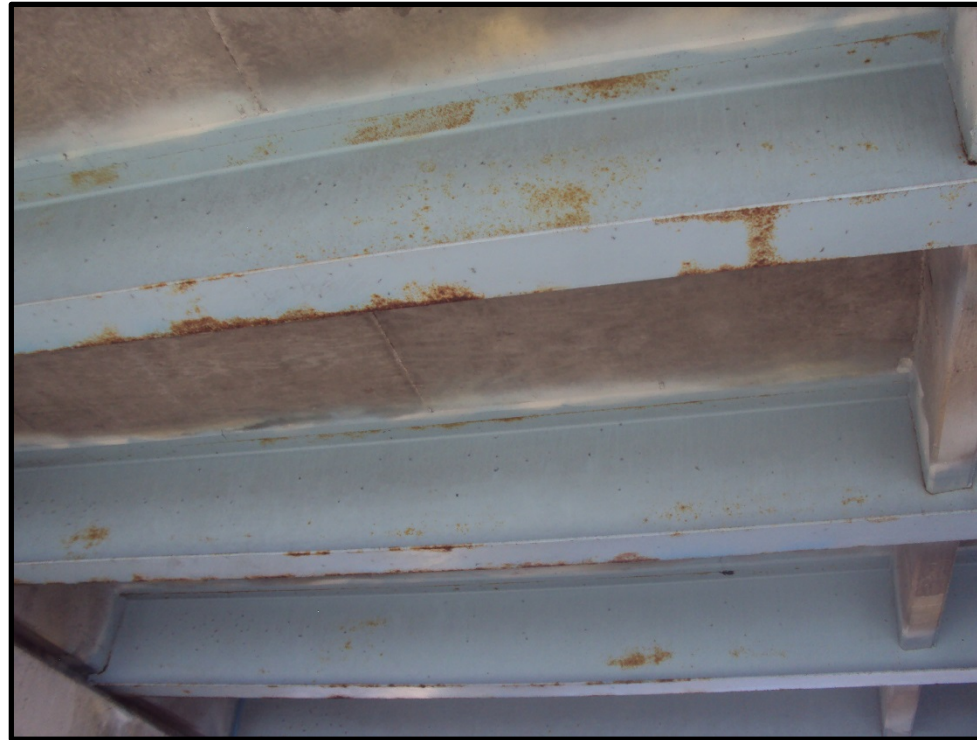
- Flame Hardened Edges

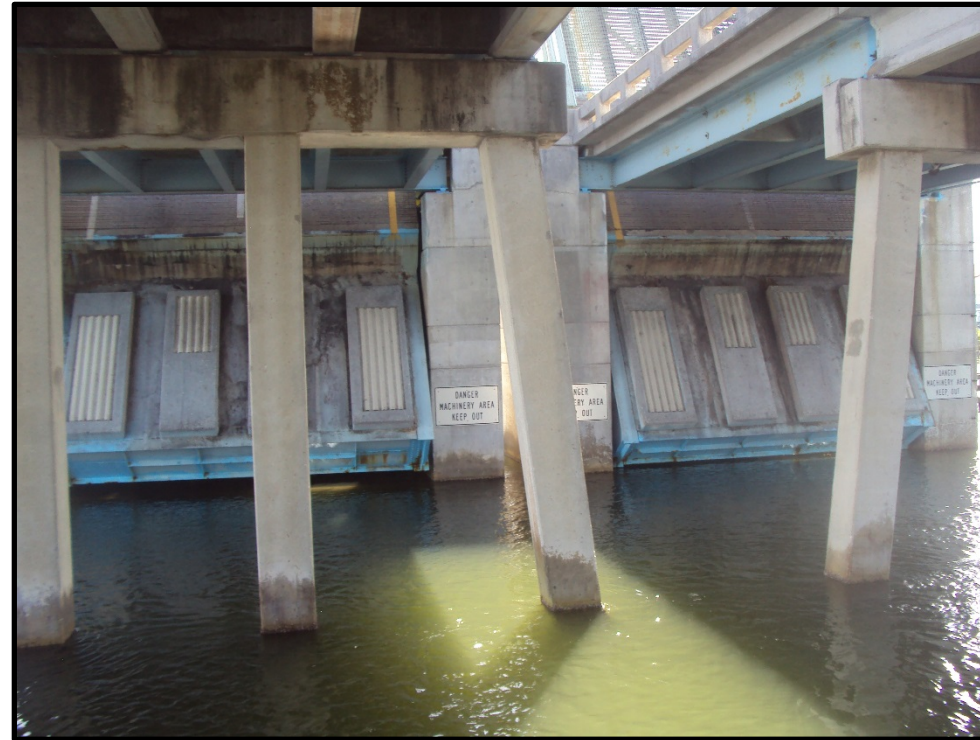
- Counterweights Dipping Into Water

- Counterweights Dipping Into Water
  - Coal Tar Epoxy Originally Specified
    - Possible Odor Problems
    - Undesirable Finish Color
  - Contractor Offered to Metallize at No Extra Cost
  - Holiday Testing was Required

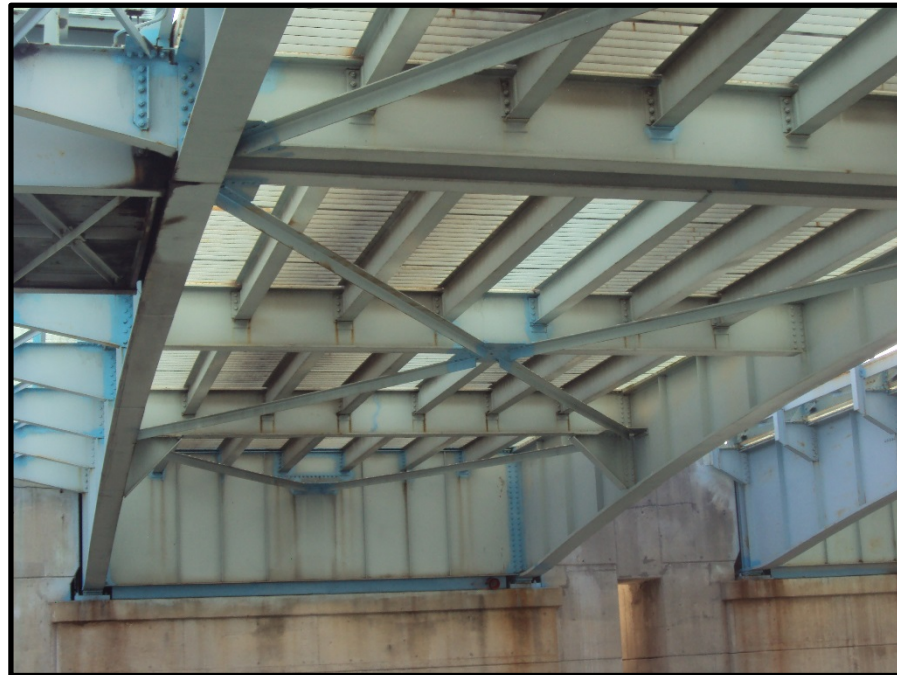
- Deck Grating – Tops of Floor Beams
  - Restrictive Lane Closures Prevented Metallizing

- Deck Grating – Tops of Floor Beams
  - Specified Sequence
    - Blast the Top of Floor Beams While Deck was Removed
    - Replace Deck
    - Power Tool Touch Up Surface Preparation
    - Apply Two Coats of Aluminum Epoxy Mastic
  - Too much Time was Allowed to Elapse Before Application of the Coatings

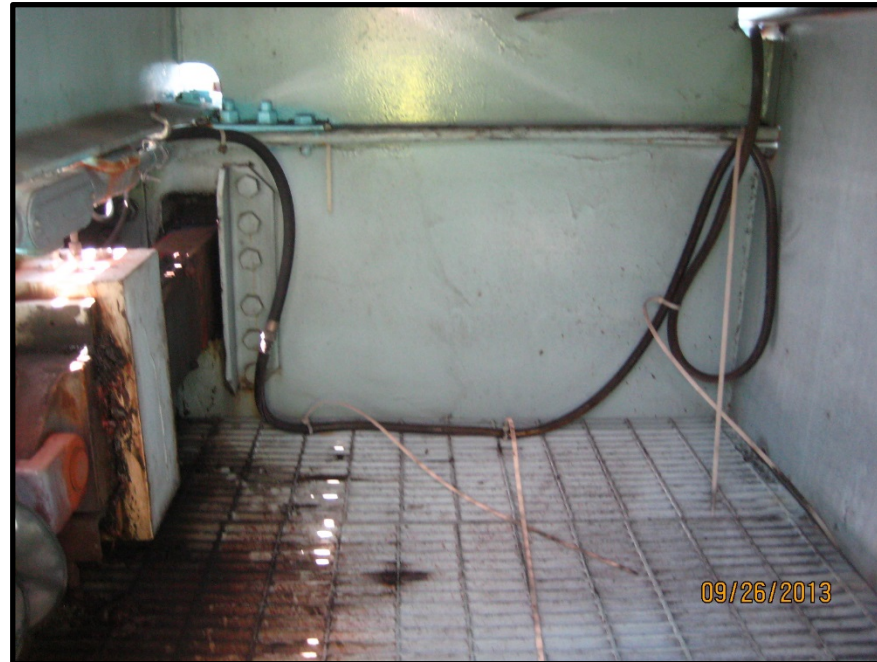
- Difficult to Access Areas
