2017 SEBPP ANNUAL MEETING

# Preserving the New River Gorge Bridge

Chad Robinson, PE – WVDOT

Matt Lewellyn, PE – B&N

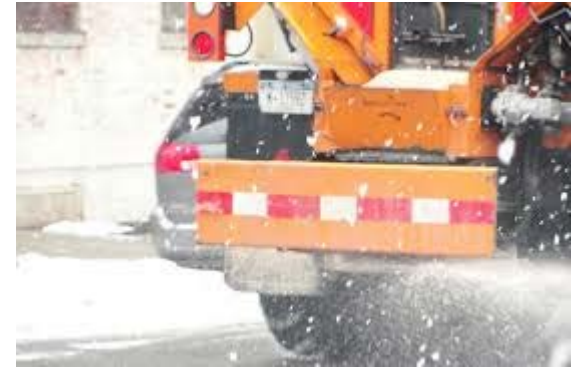
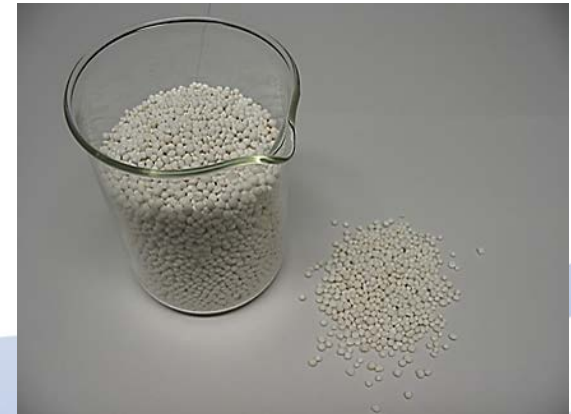
- Salt Spray from 1977 to 1998
  - Corrosion Initiated
  - Leaking into Box Members
- 1998 Maintenance
  - Washing to Remove Salt
  - Replaced Deteriorated Bolts
  - Caulked Box Members
- Current De-icing Plan
  - Calcium Magnesium Acetate
  - Salt stops on approaches

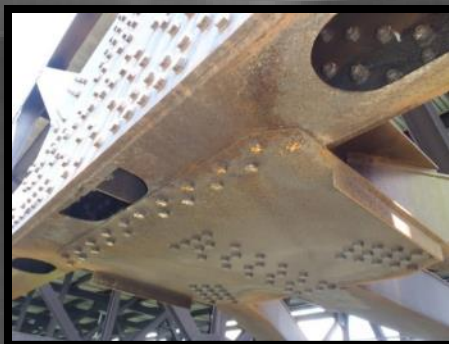
**Nut Loss**

- ❖ Weathering Steel
- ❖ Prolonged Wetting
- ❖ Poor Bolt Sealing

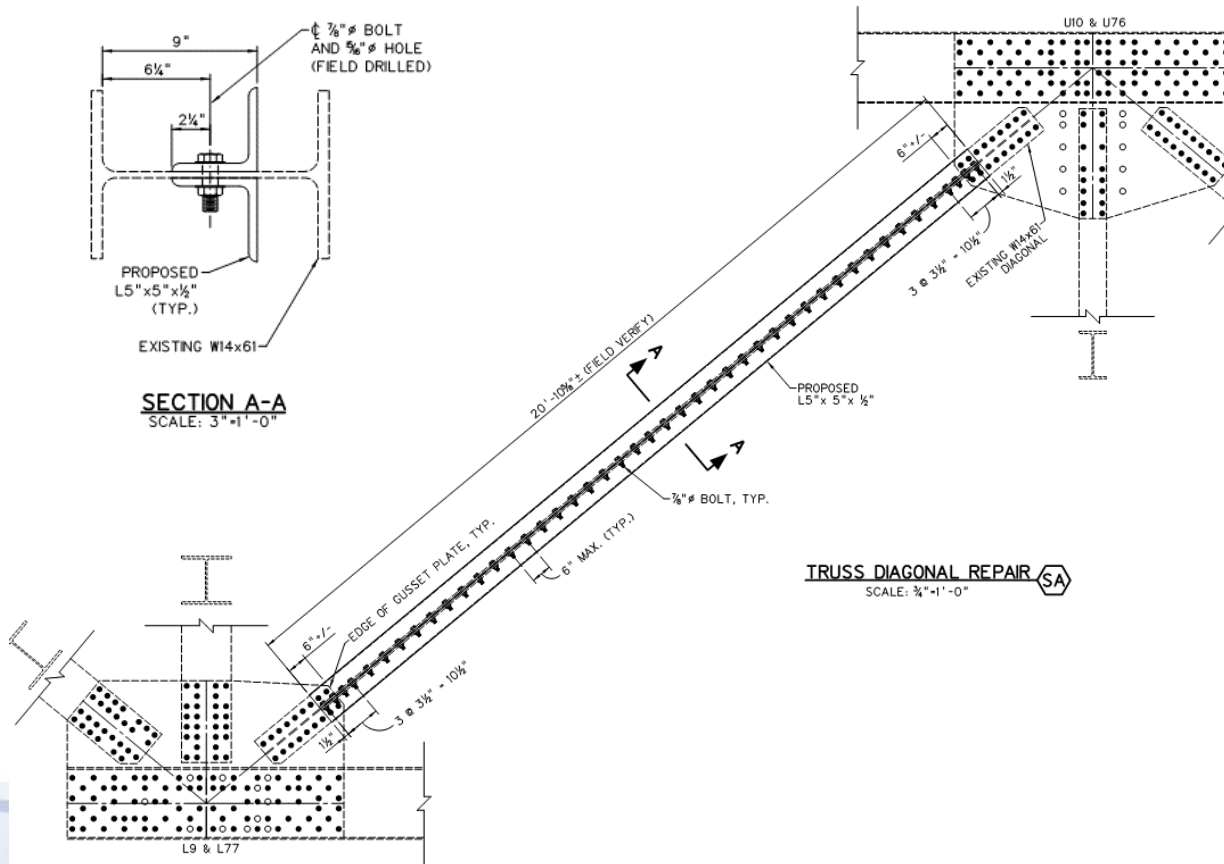
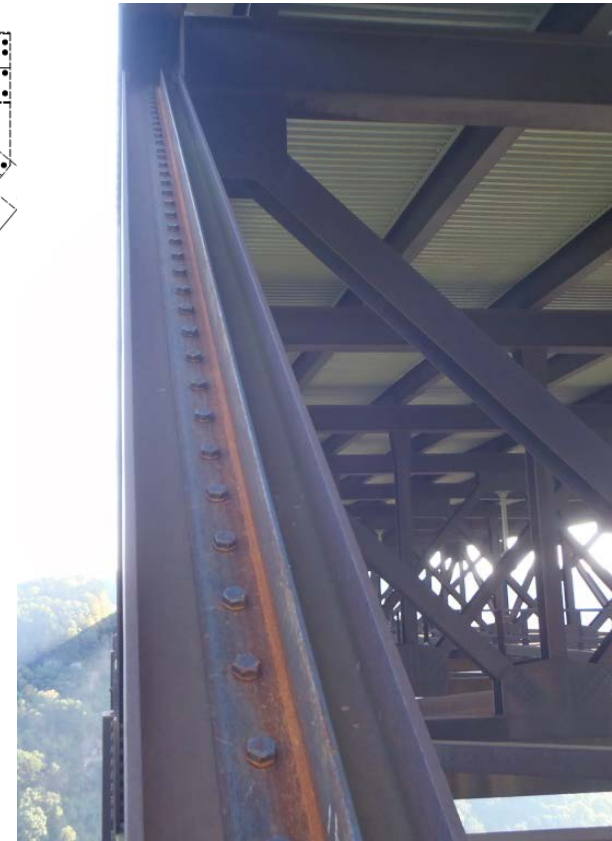
- 8 deck truss diagonals need strengthened
- All rated members have HS20 operating ratings > 1.0
- All gusset plates and connections have HS20 inventory and operating ratings > 1.0

- Weak axis bending strength will be increased by addition of bolted angles.

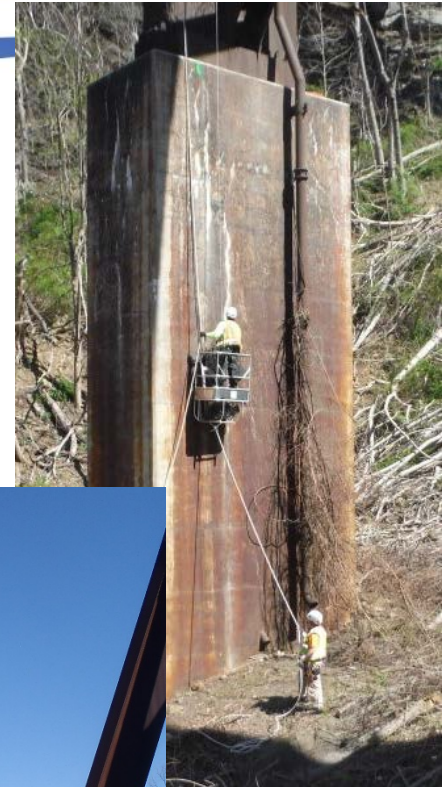
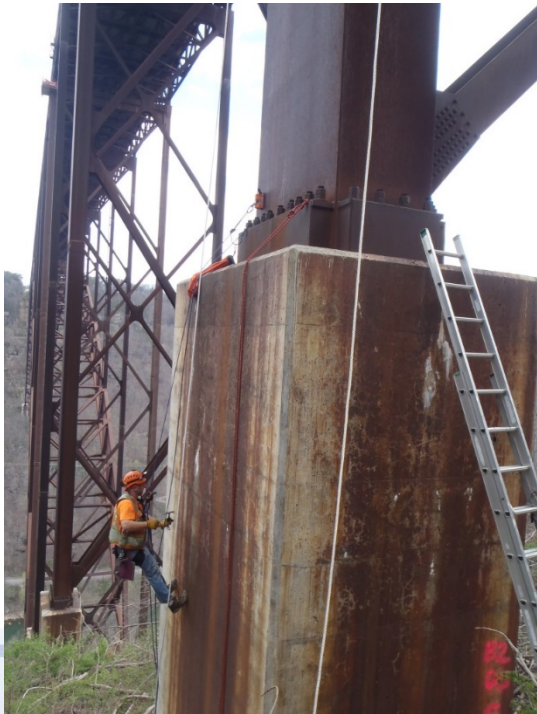
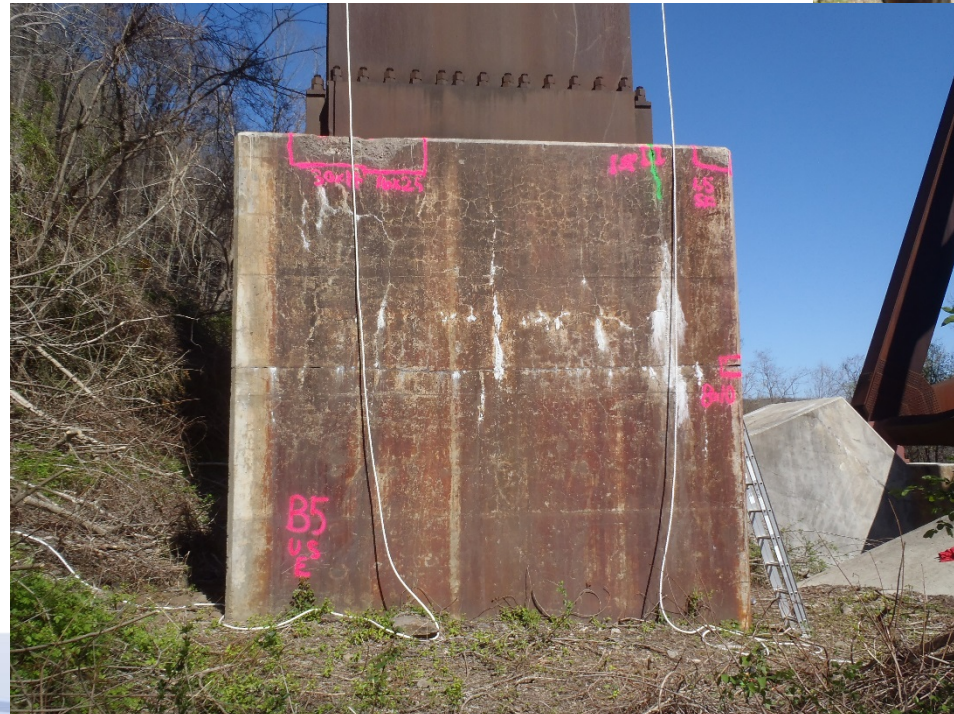
- 100% Sounding
- Baskets/Rappelling
- Mark w/Paint
- Photograph/Document/Quantify

Green = Crack Seal  
Orange = Patching

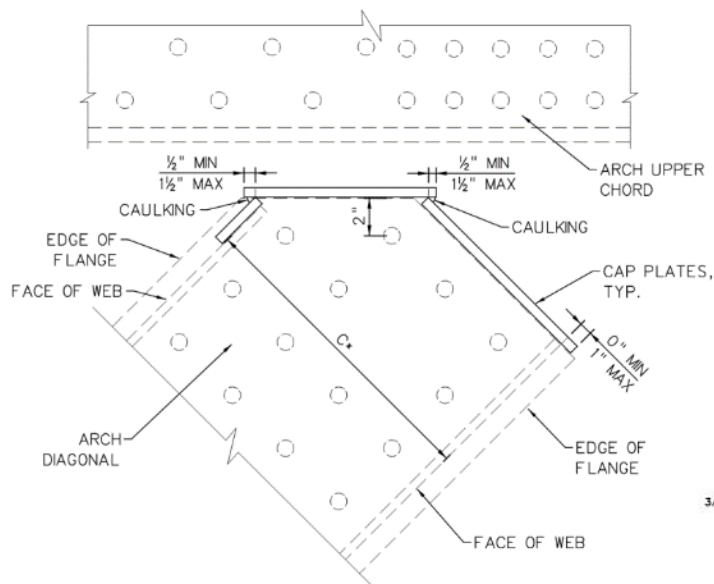
- **Problem:** Water/Birds Entering Top of Arch Members
- **Solution:** Install HDPE Cap Plates

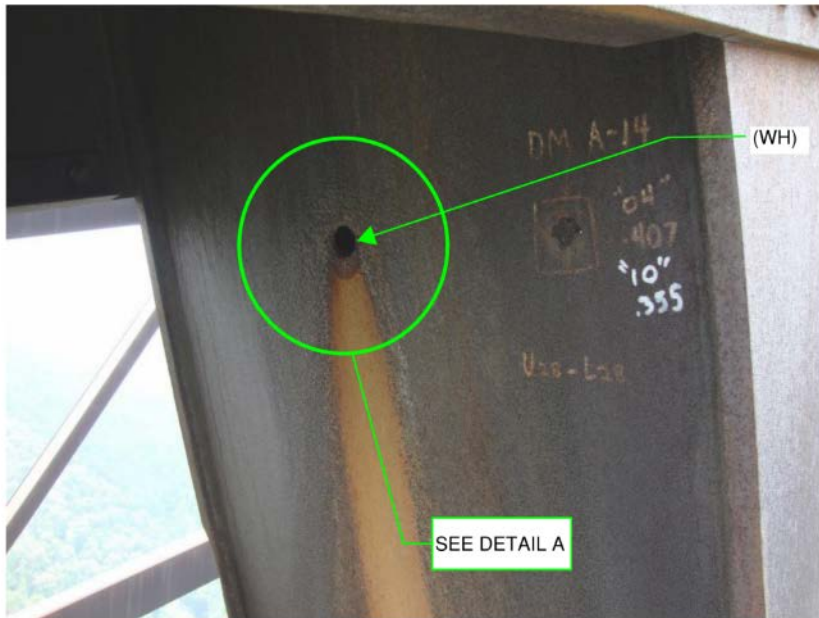
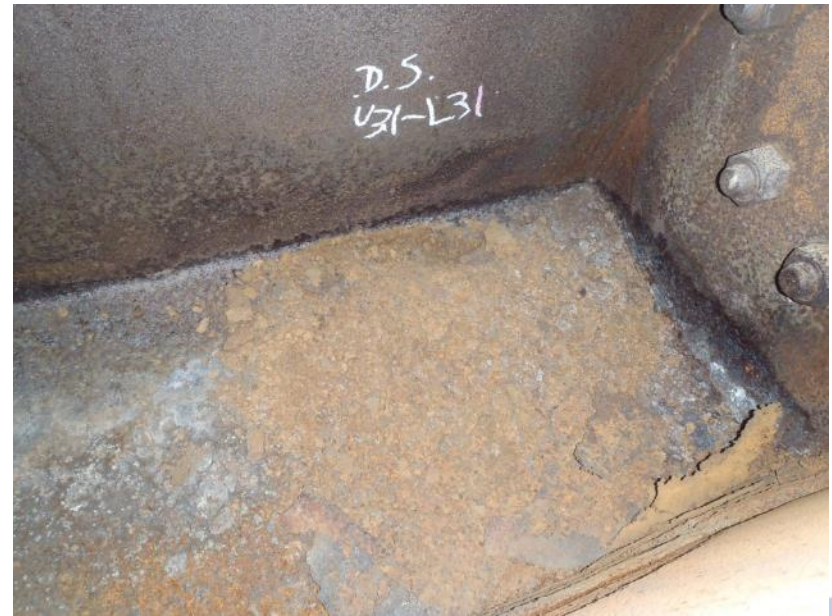
TYPICAL UPPER ARCH WEEPHOLE

- **Problem:** Members Not Draining, Weep Holes too High

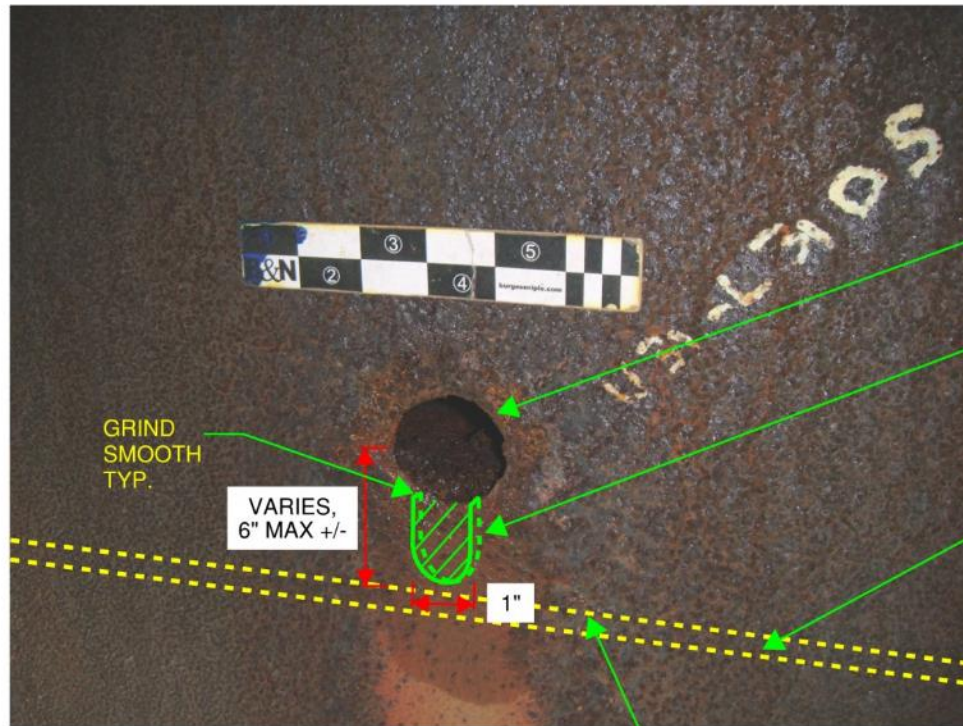
DETAIL A

- **Problem:** Members Not Draining, Weep Holes too High
- **Solution:** Extend Weep Holes

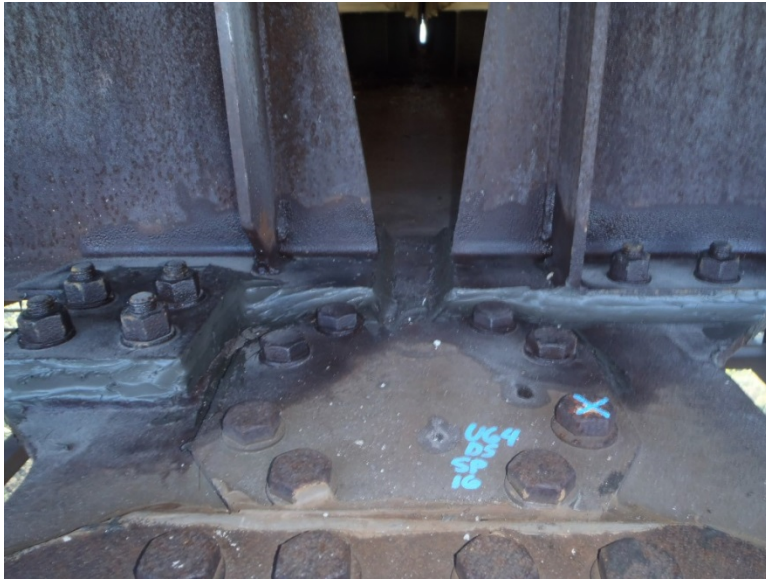
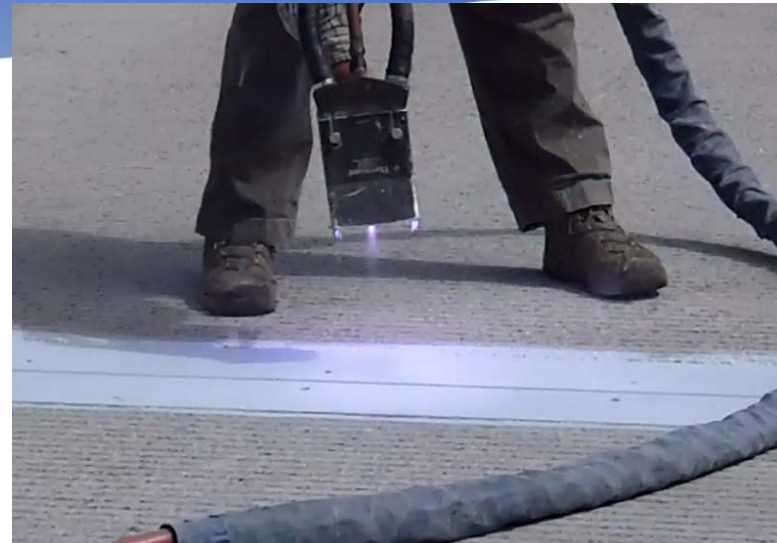
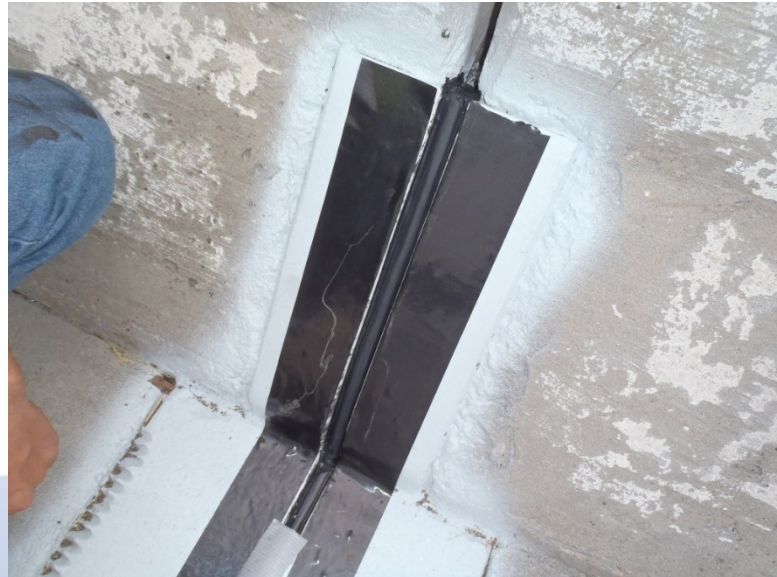
# Leaking Joints causing Pack Rust at Bearings

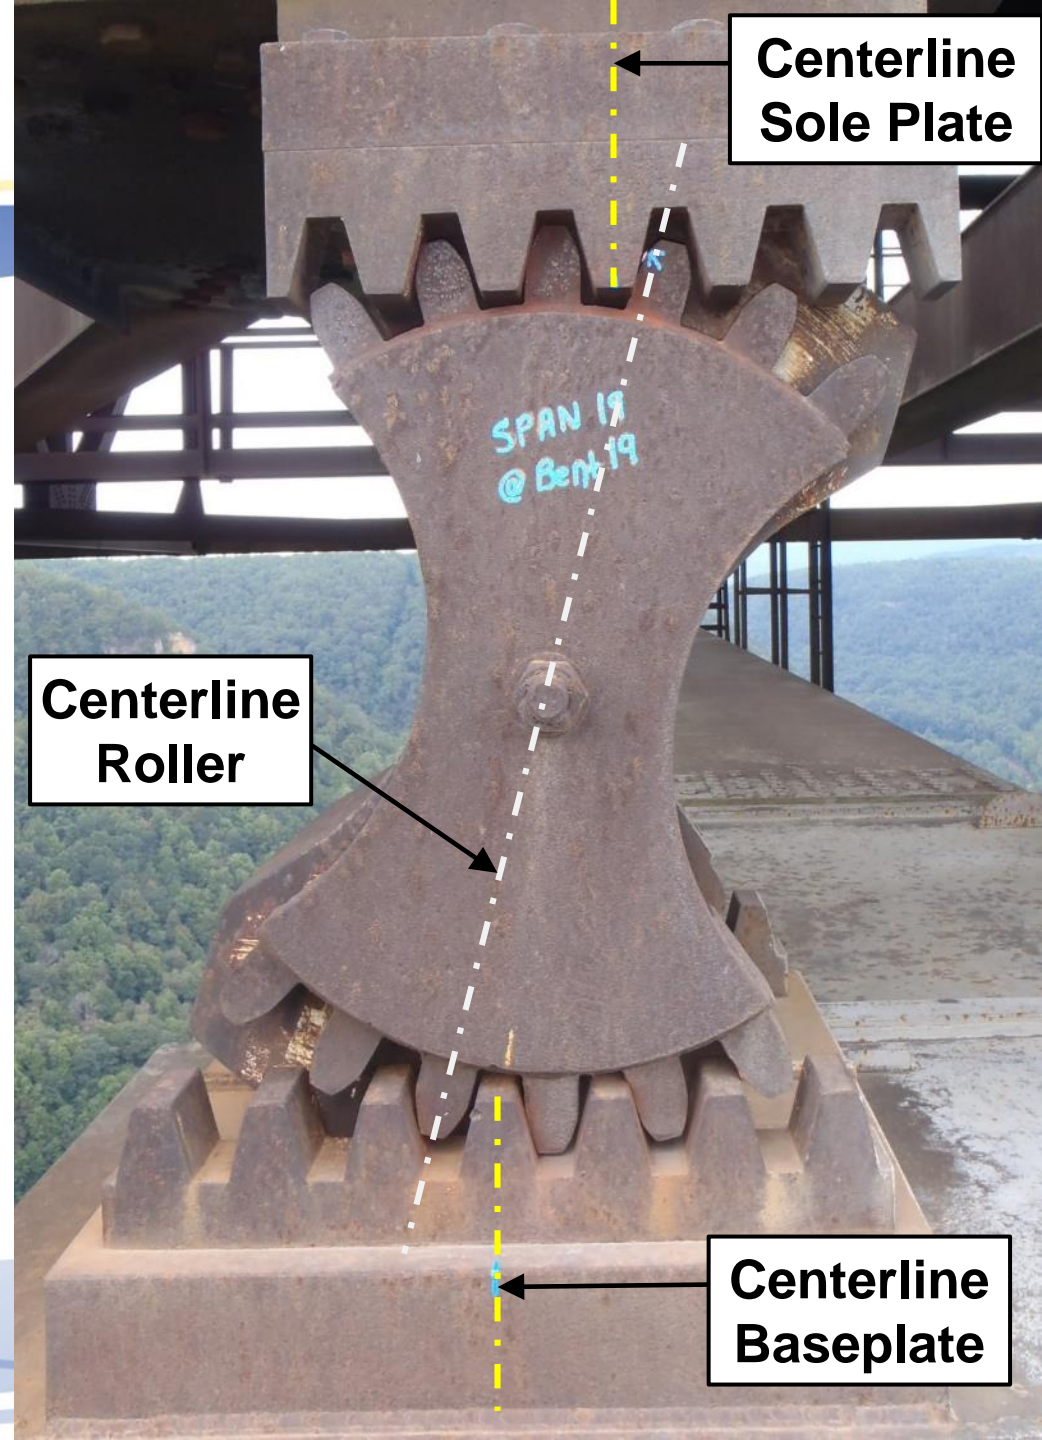
- Excessive tilt.
- Plates were misaligned at mean temperatures.
- Roller had slipped.
- Retainer plates should prevent slippage, but they were not functioning properly.

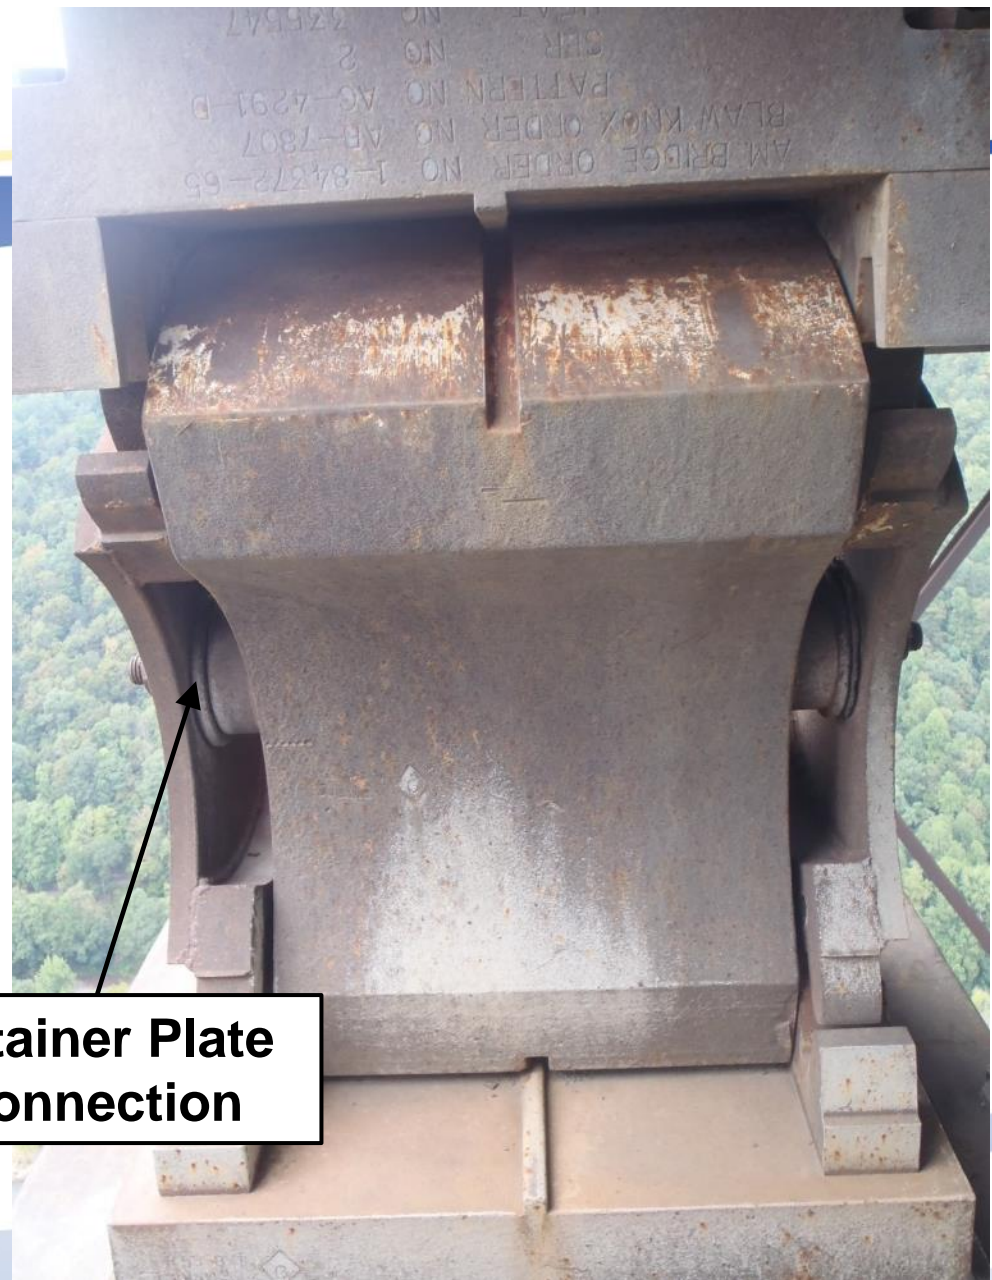
**Retainer Plate Connection**

- Geared retainer plates are intended to keep bearing from slipping relative to the baseplate and sole plate.
- Retainer plates are connected to the roller only at the center of the roller.
- This connection allows the plates to rotate relative to the roller, making the retainer plates ineffective.

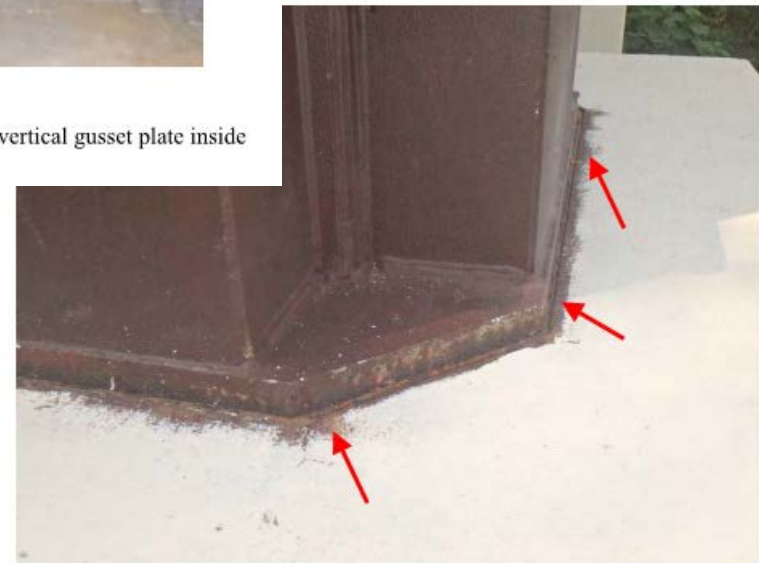
**Photo 16**

Typical area where sealer needs touched up at outside fillet weld channels and at bottom of vertical gusset plate inside spandrel bent bottom cell.
