2018 National Bridge Preservation Partnership Conference

New River Gorge Bridge Rehabilitation

Billy Varney, PE, West Virginia DOT

Matt Lewellyn, PE, Burgess & Niple

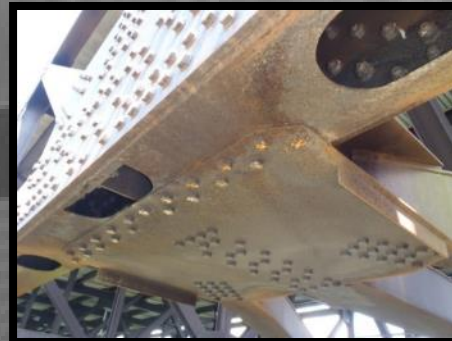
Nut Loss

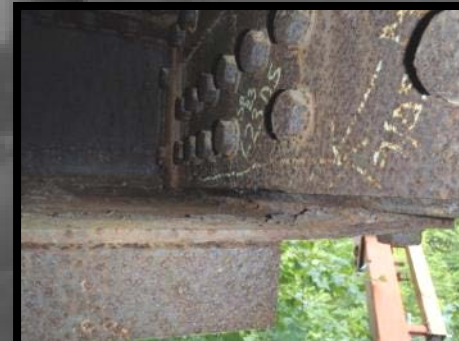
Pack Rust

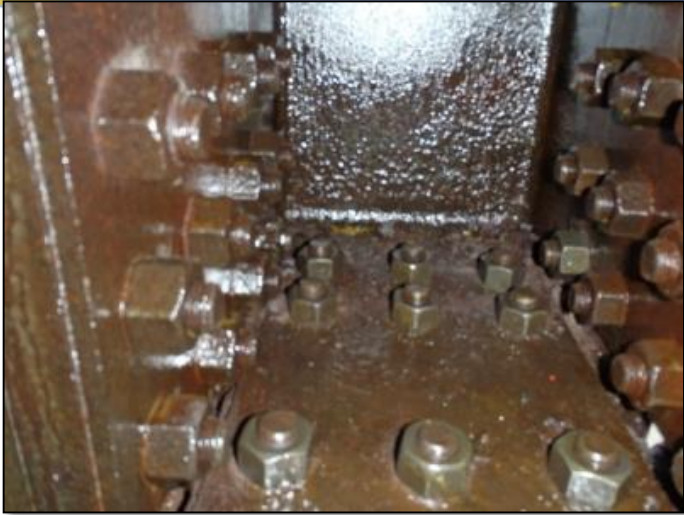
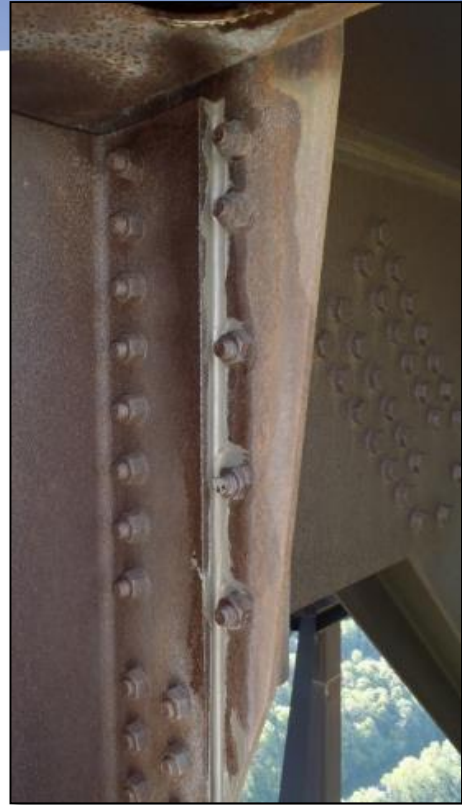
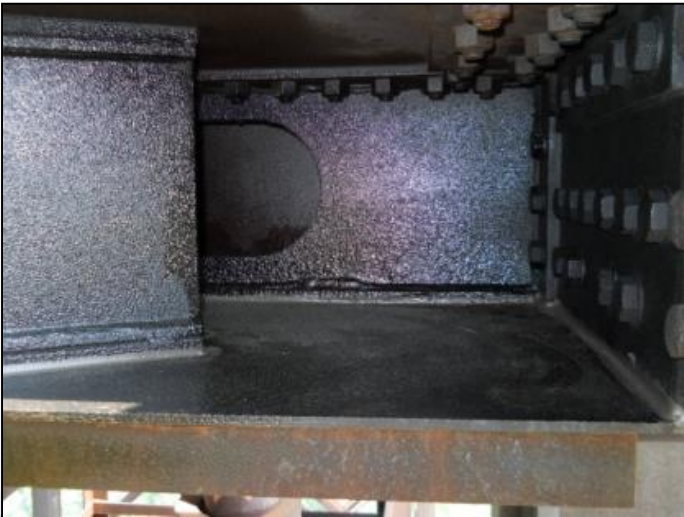
- Weathering Steel
- Prolonged Wetting
- Poor Bolt Sealing

- Vacuum Clean
- Pigeon Waste
- Water Blast
- Caulk Seams
- Apply Penetrant Sealer
 - Inside handholes
 - Areas of corrosion
- Bolt Replacements

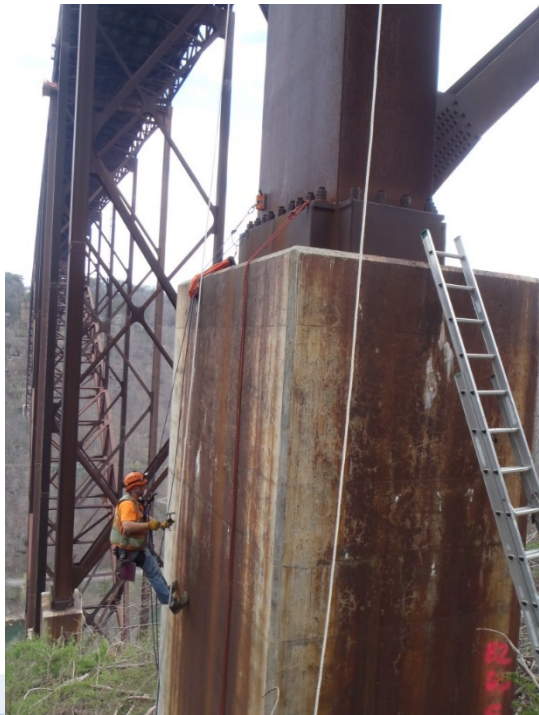
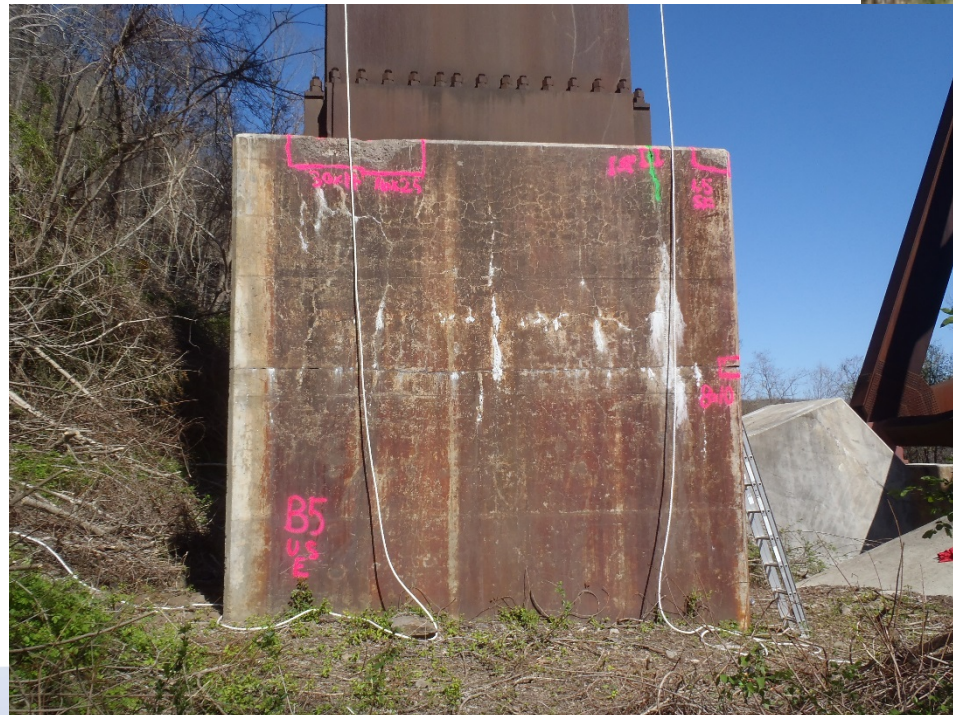
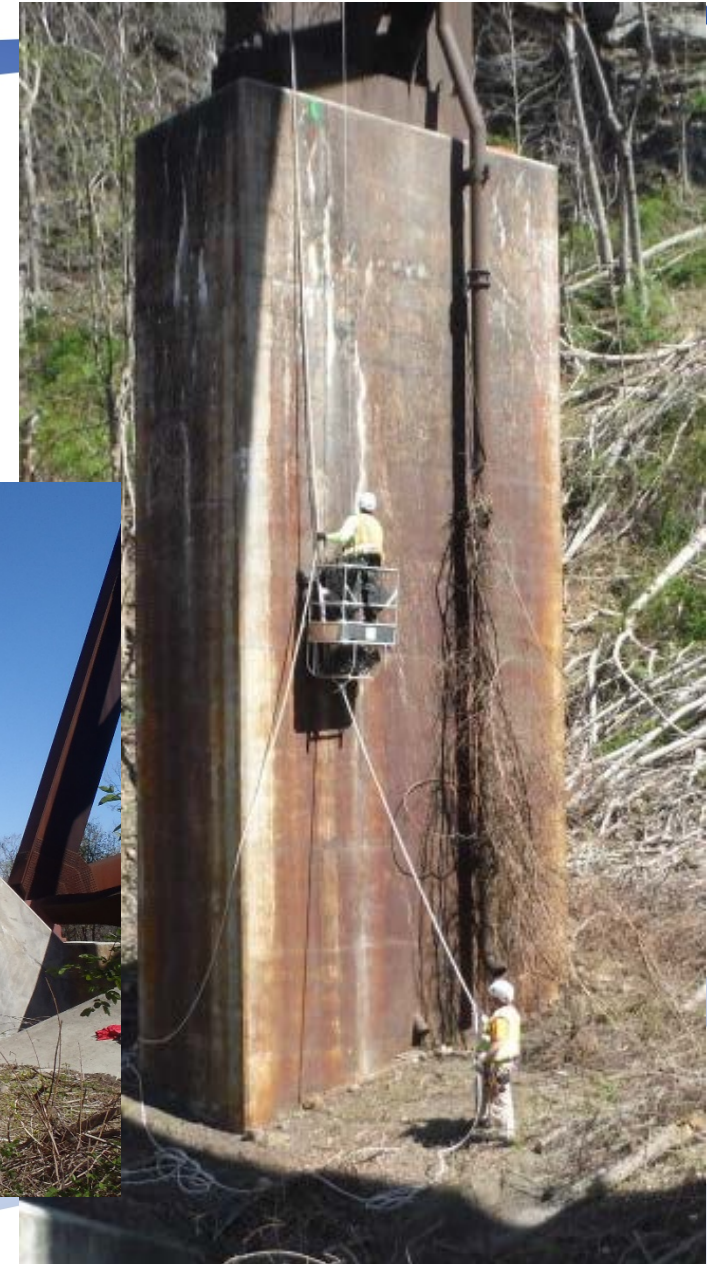
Green = Crack Seal
Orange = Patching

- 100% Sounding
- Baskets/Rappelling
- Mark w/Paint
- Photograph/Document/Quantify

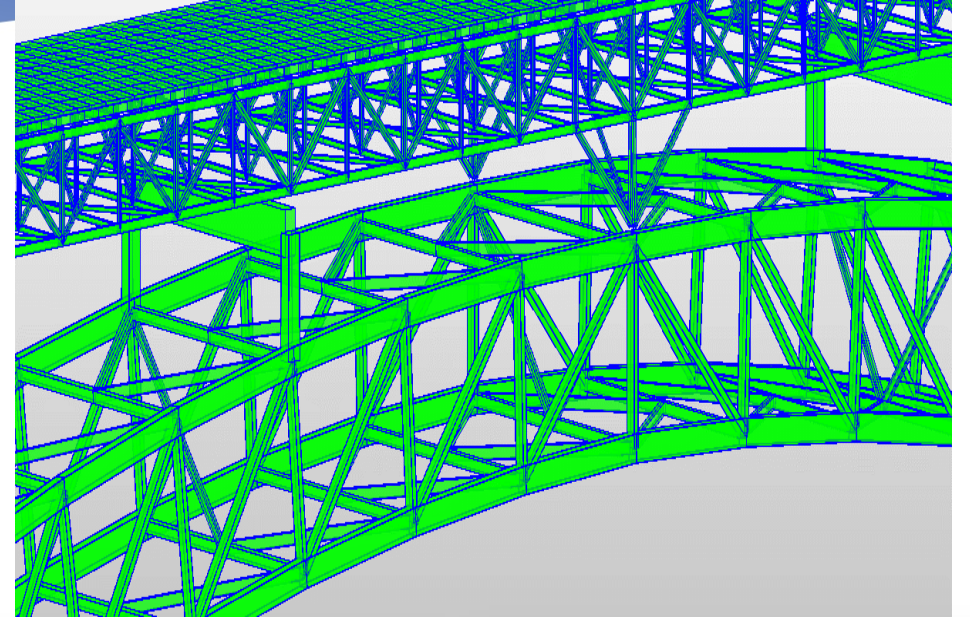
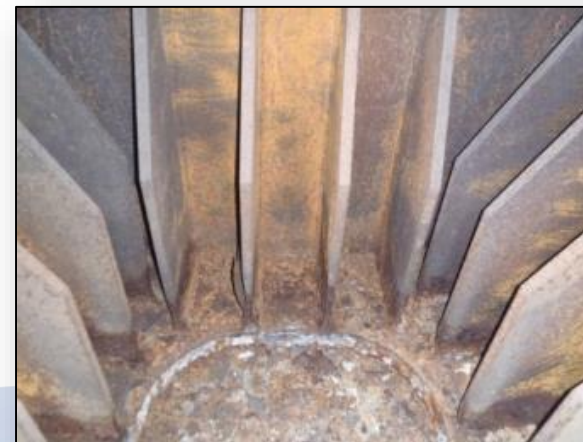
Primary Issue = Corrosion and Section Loss inside Boxes

- Loss in Bents and Arch
- Cleaning and Sealing
- Follow-up with Magnets
- Not Controlling the Load Rating

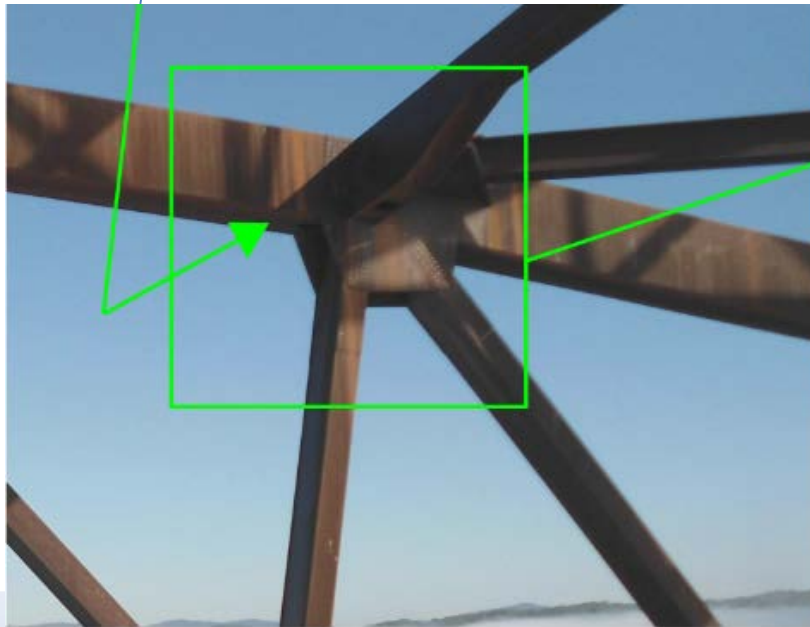
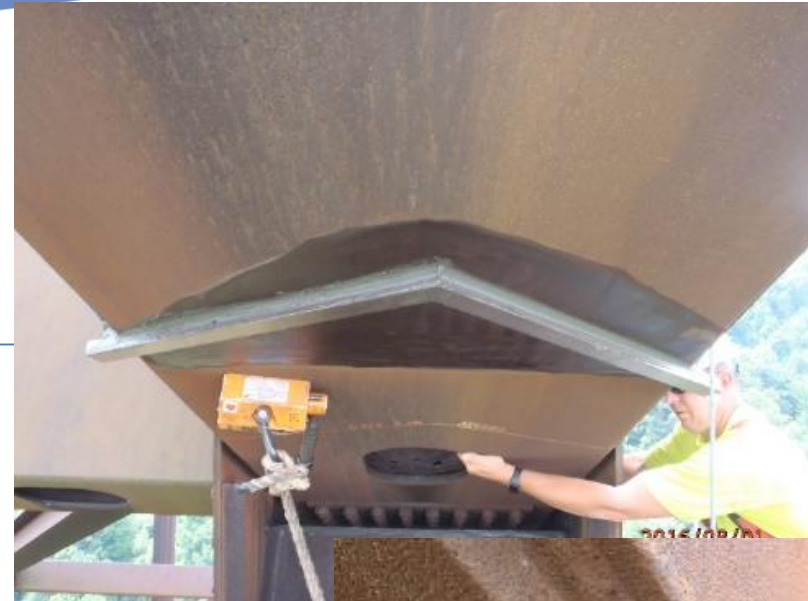
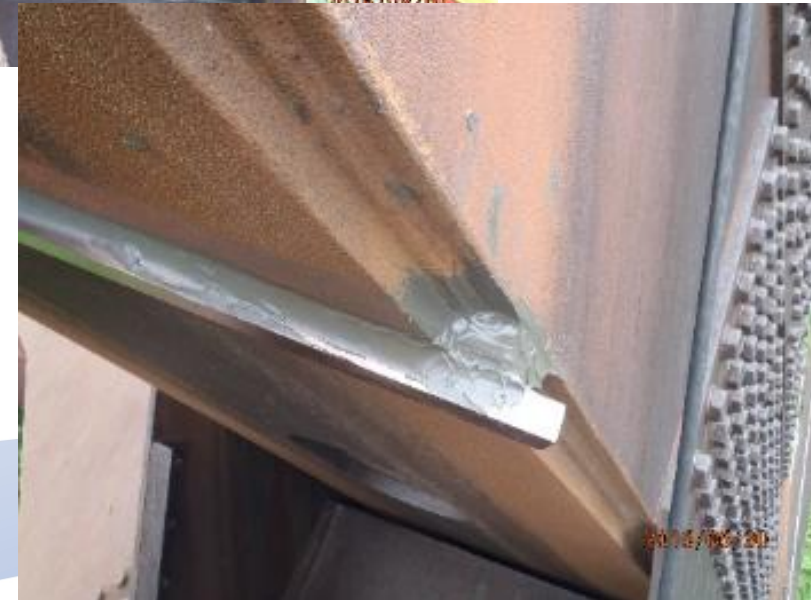
- **Problem:** Water Flowing Under Arch Rib
- **Solution:** Divert Water with Magnetic Drip Bar

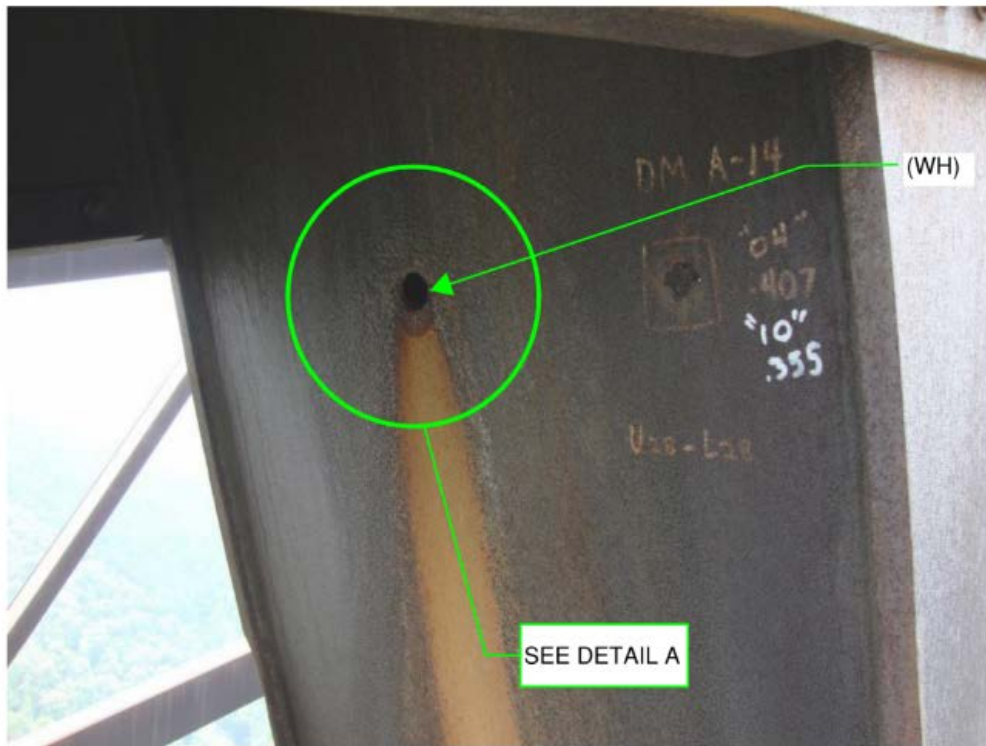
TYPICAL UPPER ARCH WEEPHOLE

- **Problem:** Members Not Draining, Weep Holes too High

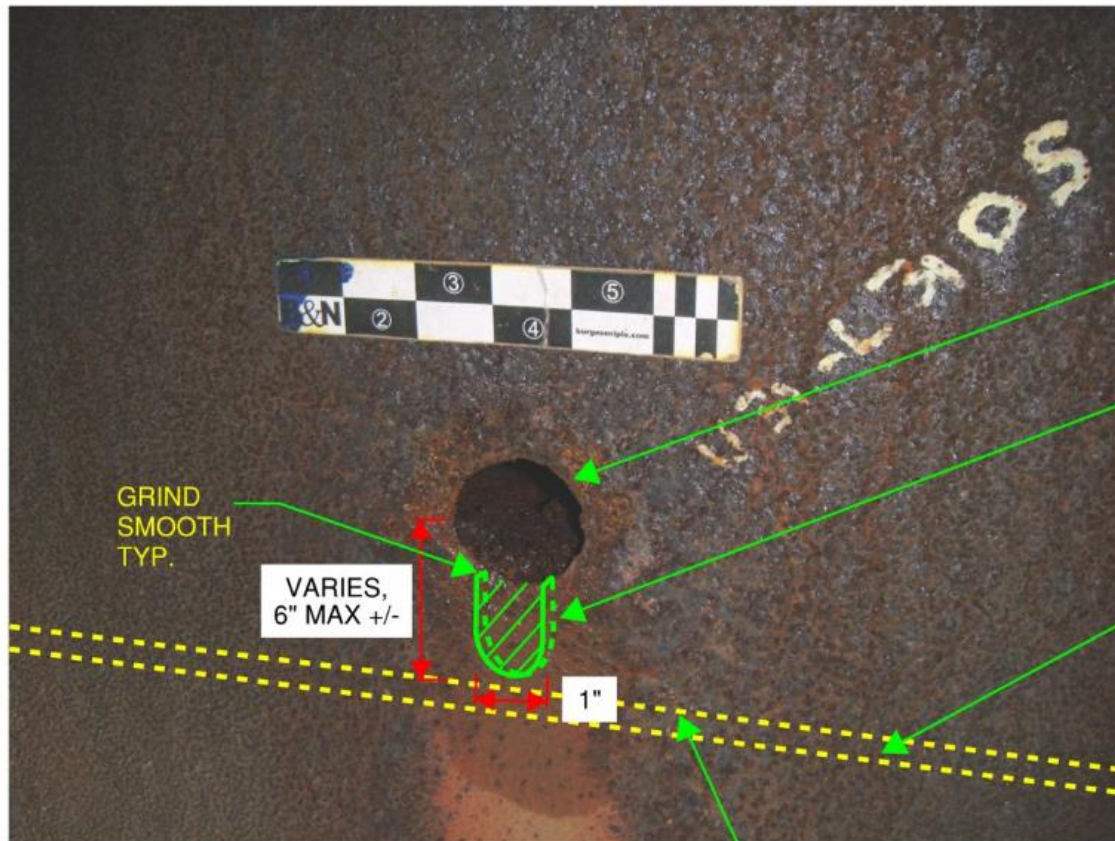
DETAIL A

- Problem: Members Not Draining, Weep Holes too High
- Solution: Extend Weep Holes

DO NOT CUT INTO TOE OF
END DIAPHRAGM WELD

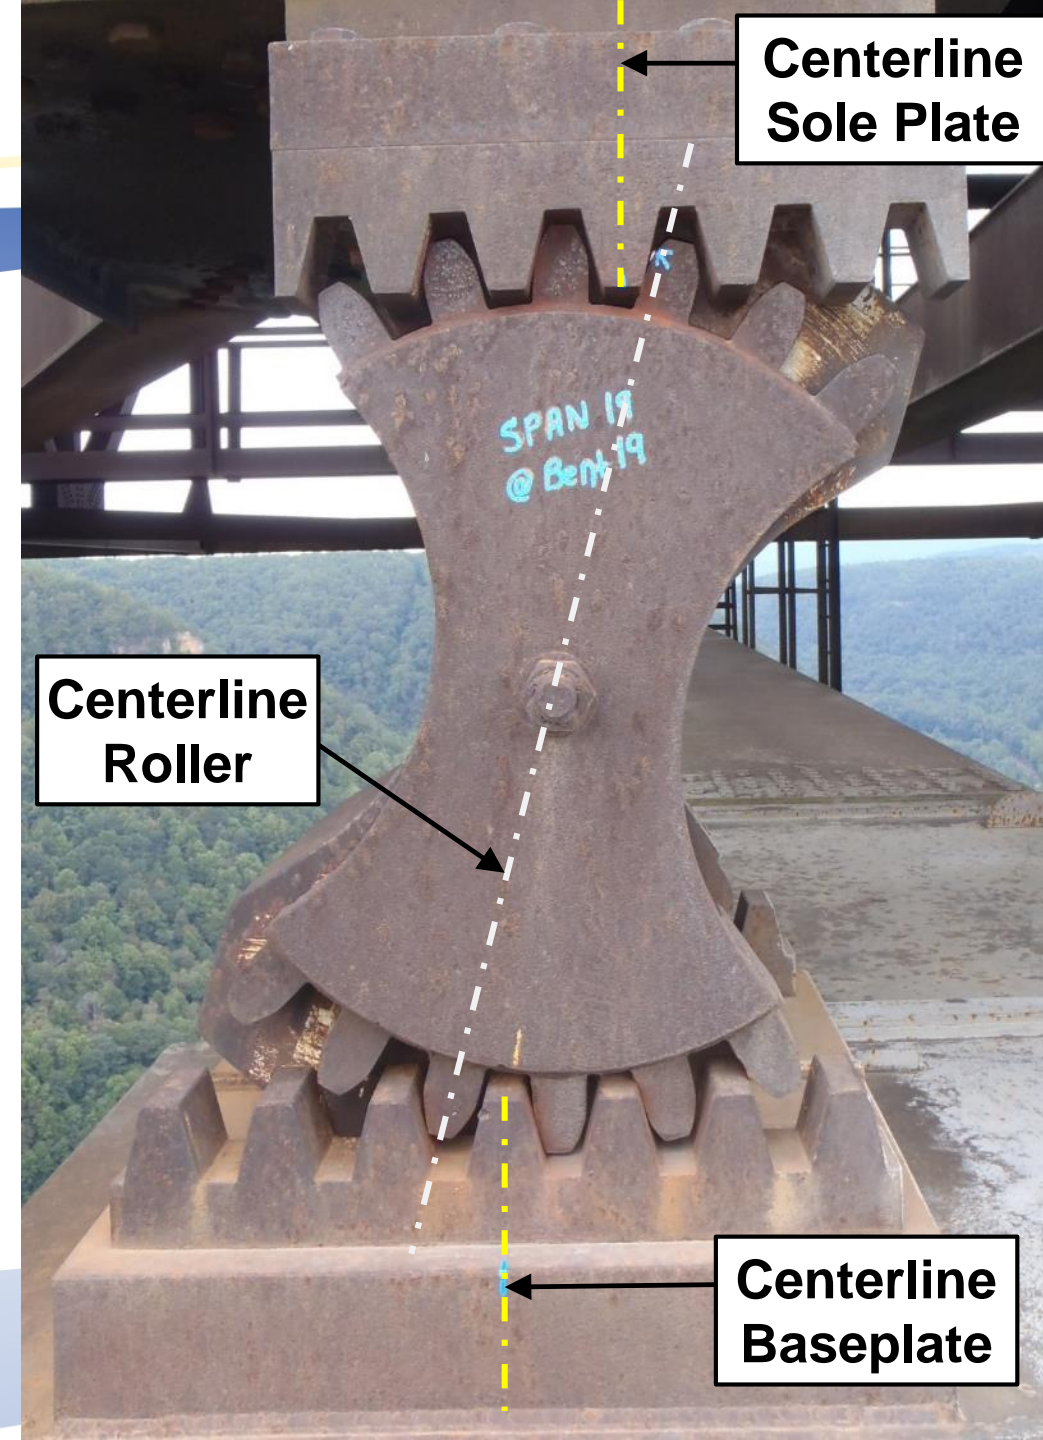
- Excessive tilt.
- Plates were misaligned at mean temperatures.
- Roller had slipped.
- Retainer plates should prevent slippage, but they were not functioning properly.

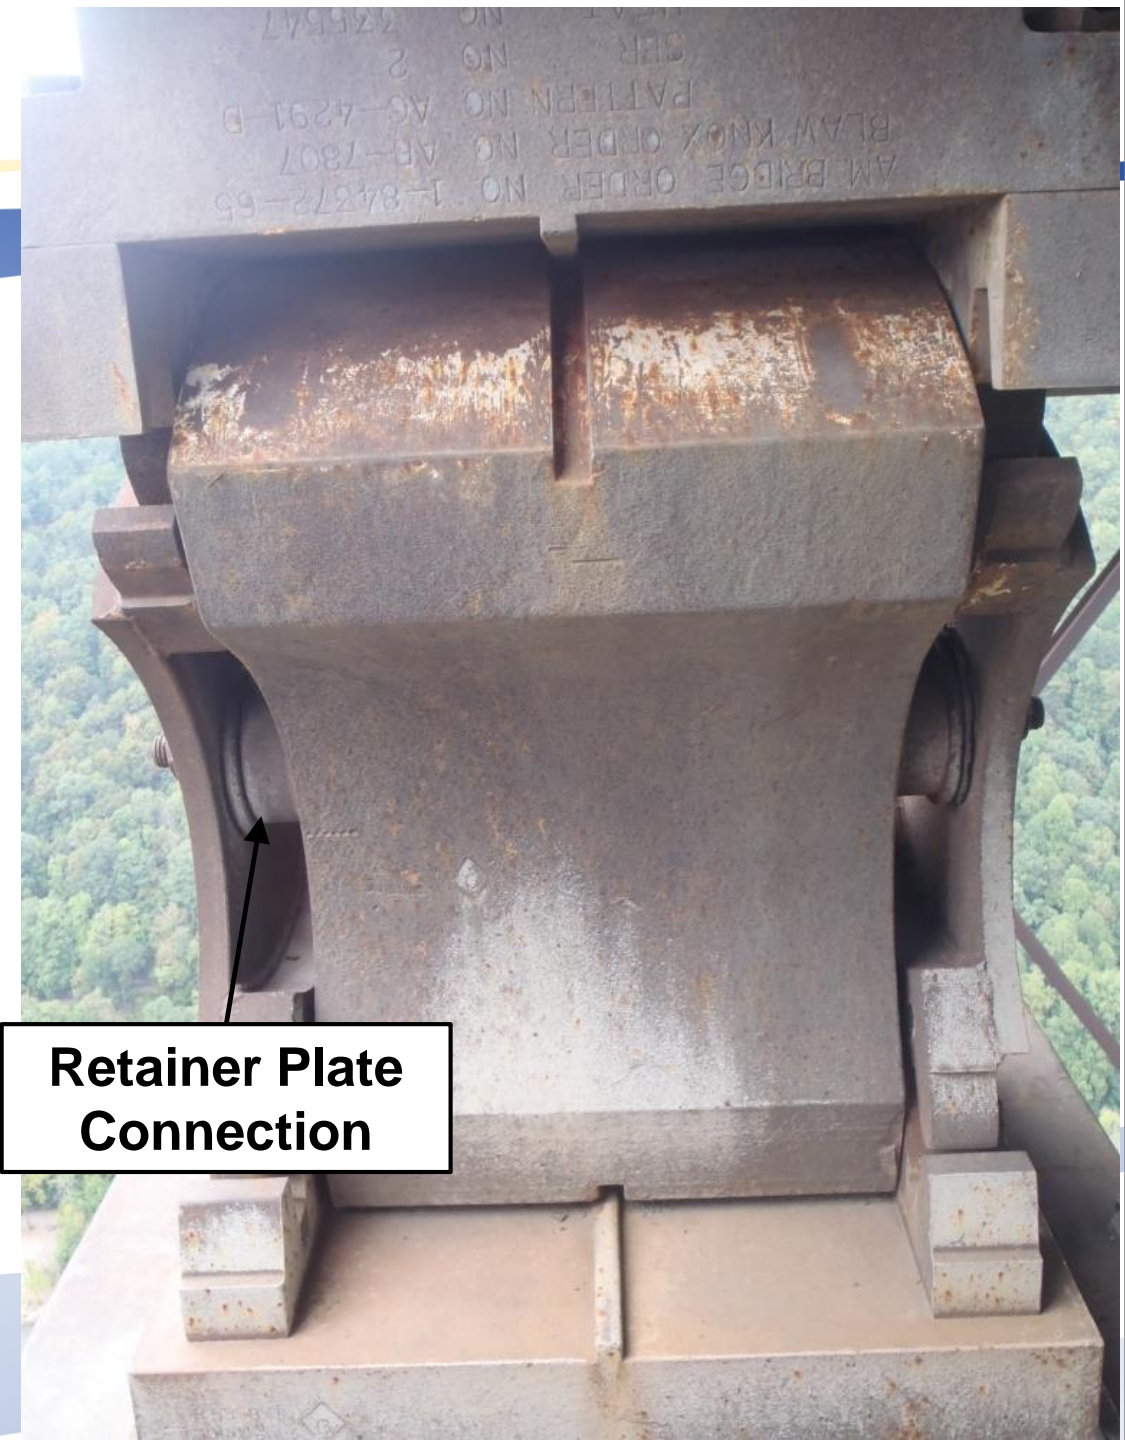
- Geared retainer plates are intended to keep bearing from slipping relative to the baseplate and sole plate.
- Retainer plates are connected to the roller only at the center of the roller.
- This connection allows the plates to rotate relative to the roller, making the retainer plates ineffective.

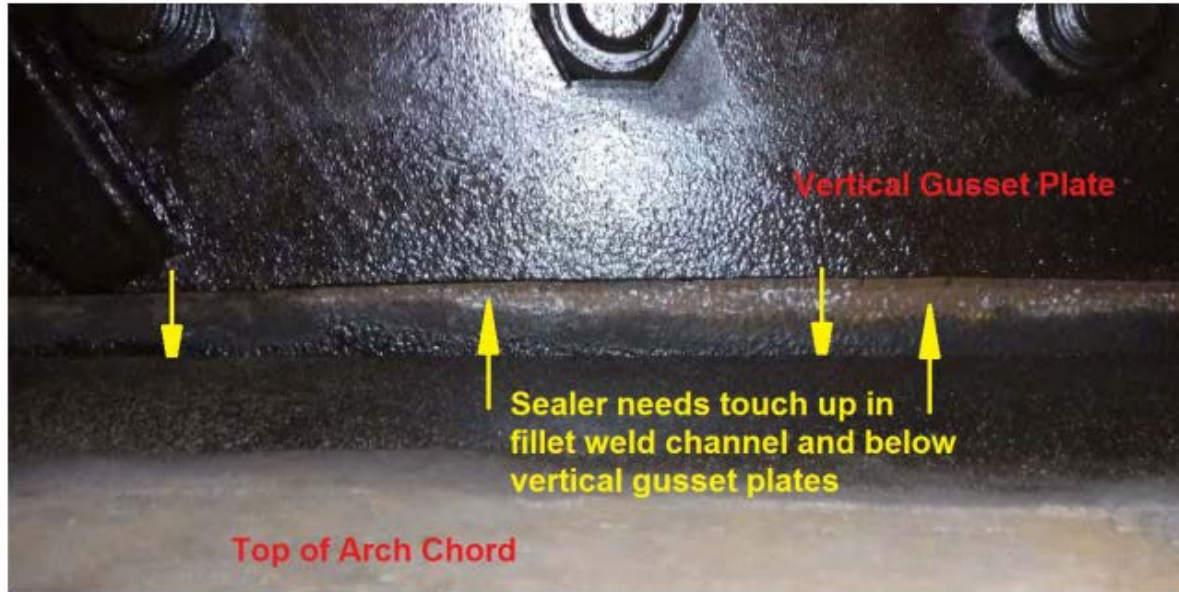
Photo 16

Typical area where sealer needs touched up at outside fillet weld channels and at bottom of vertical gusset plate inside spandrel bent bottom cell.

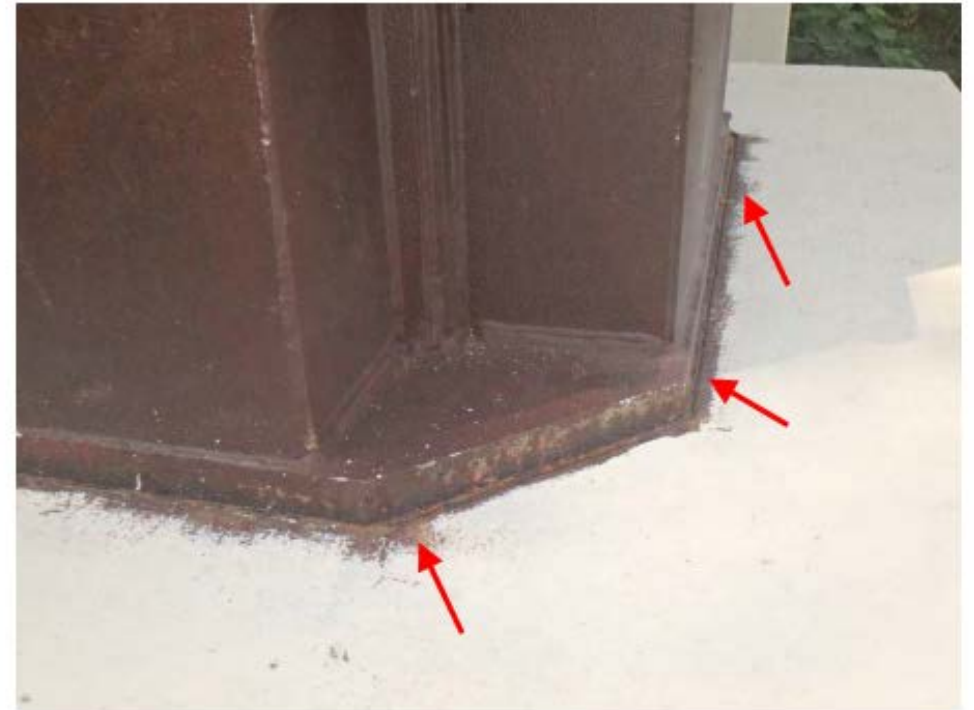
Photo 22

At bases of land bents, touch up the paint on the concrete surface around the steel bases as needed.
