Effective repair of severely deteriorated prestressed beam ends

Paul Pilarski, P.E., S.E.

Repair of Bridge 27568

US Route 169 over Nine Mile Creek

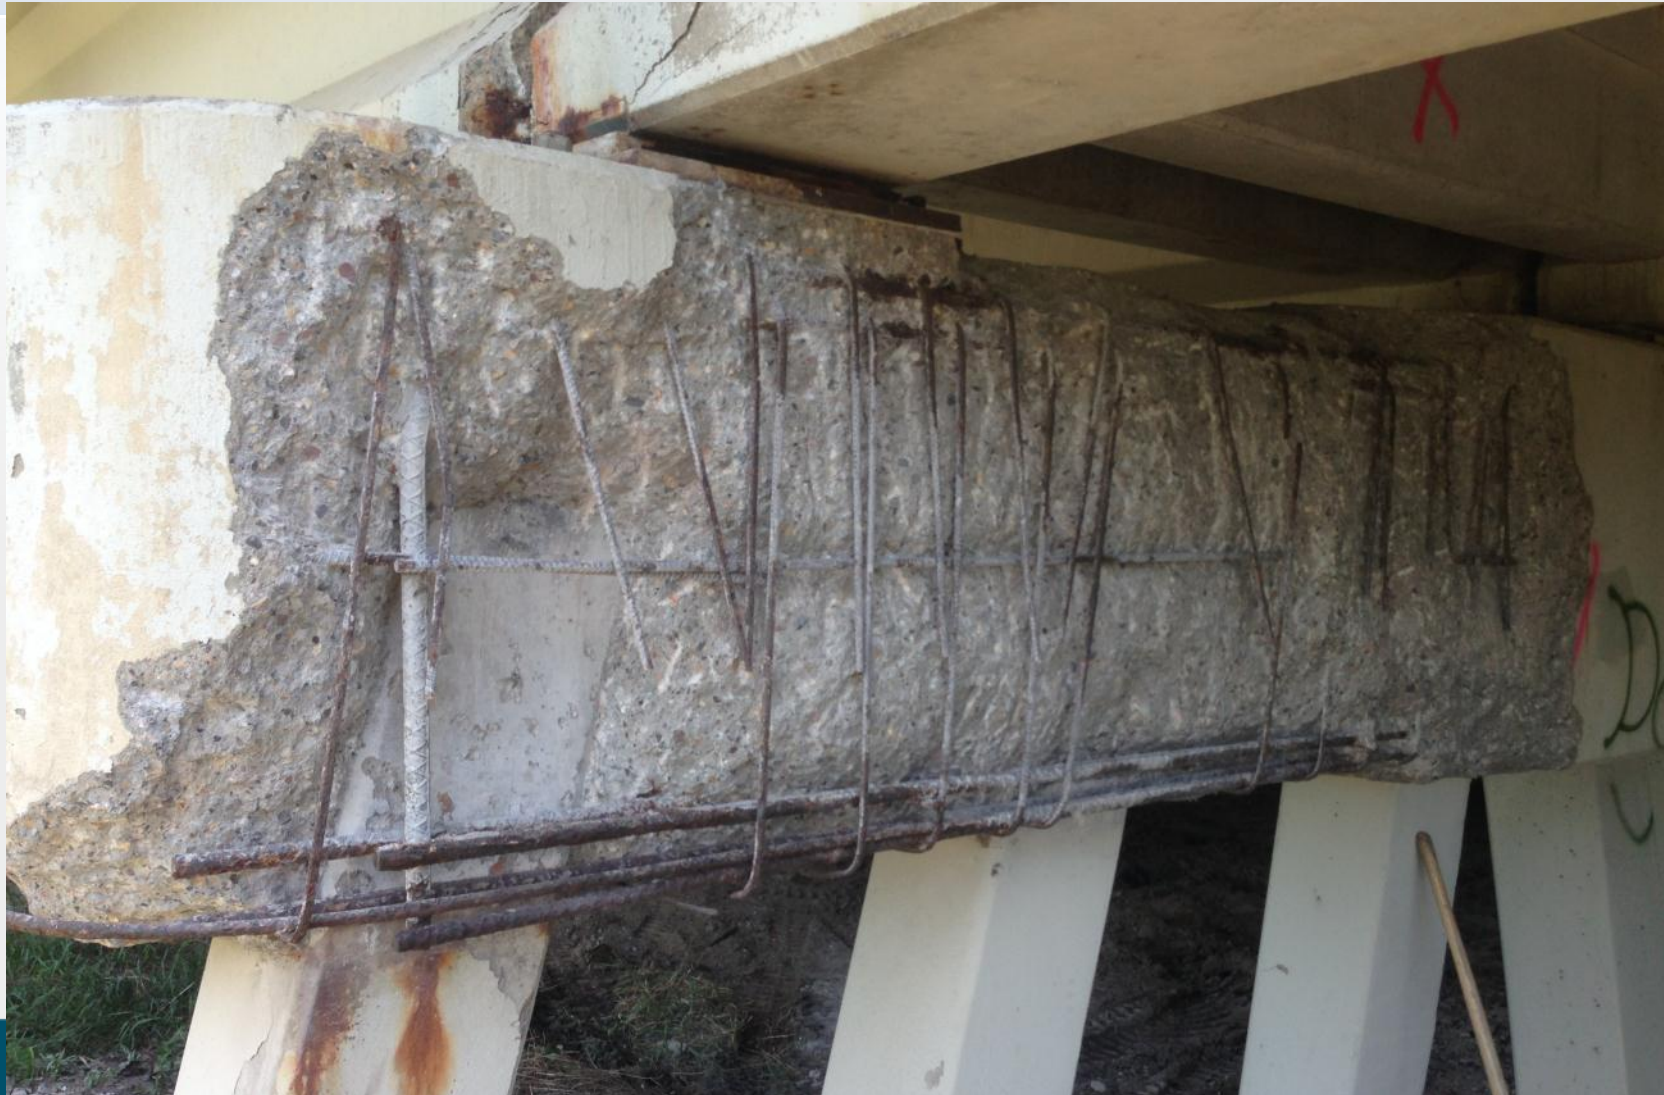
Step 2: Remove delaminated concrete

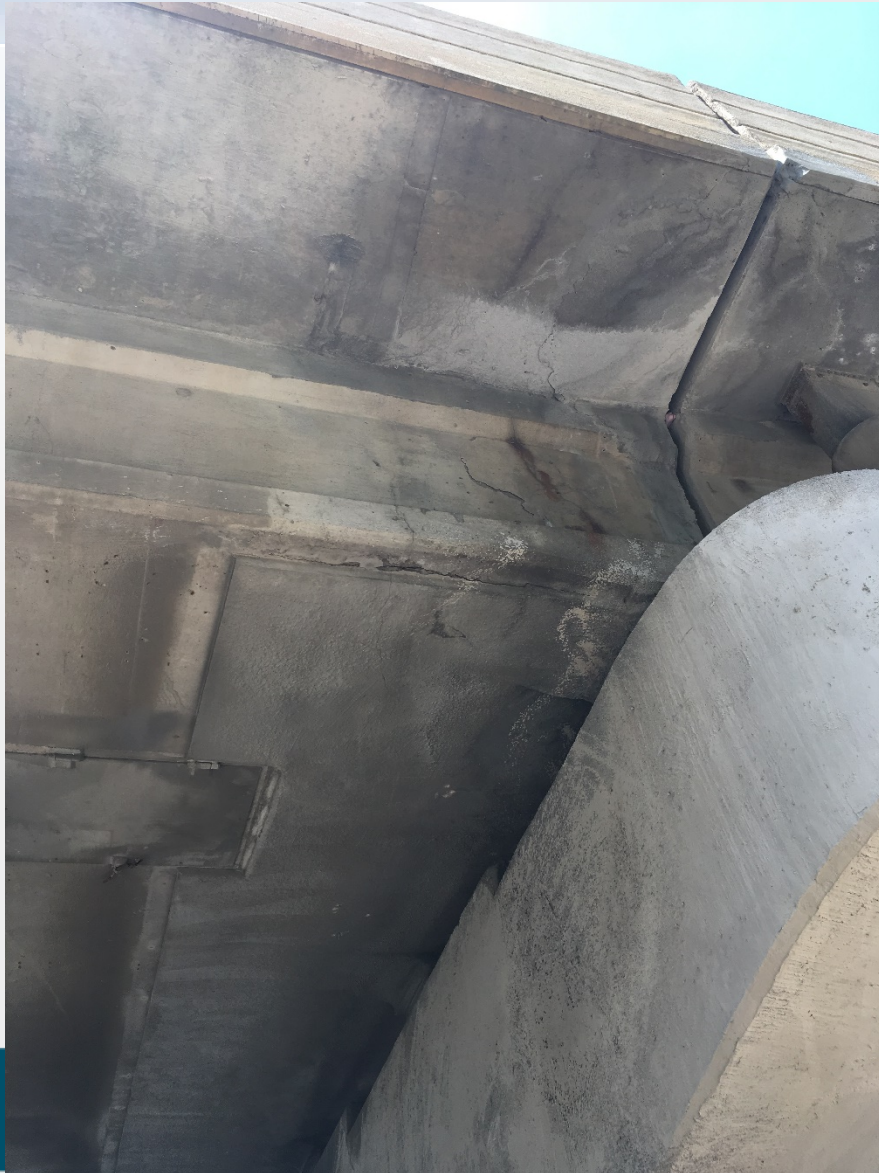
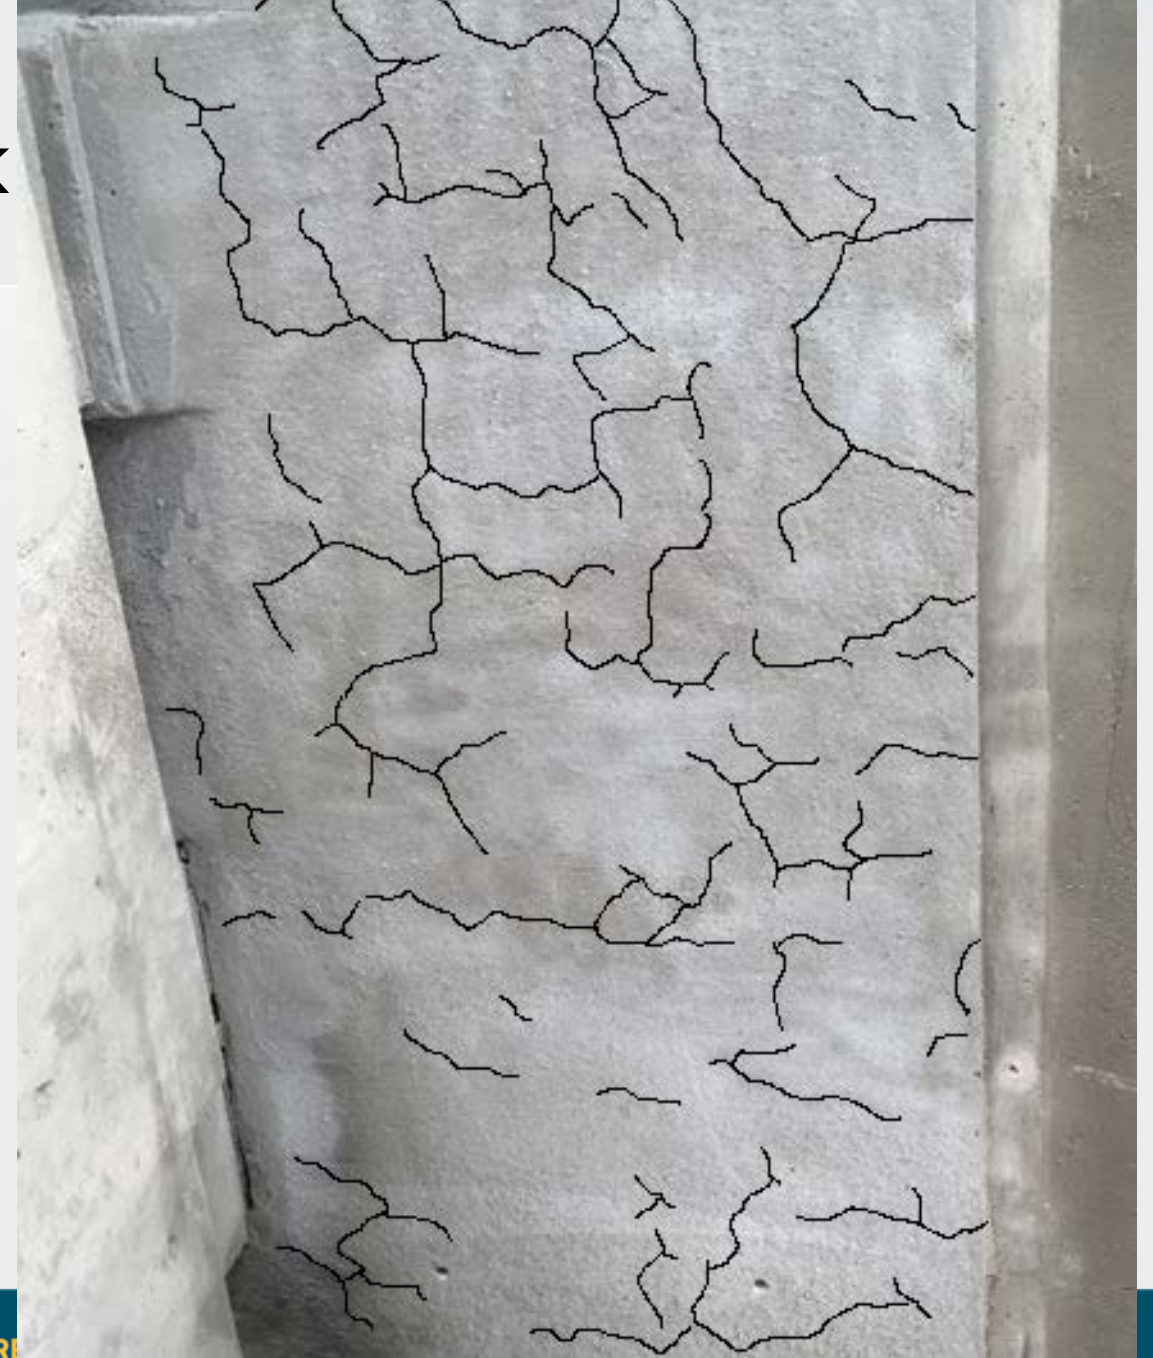
Common shotcrete map-crack

Shotcrete often performed without load relief or temporary support

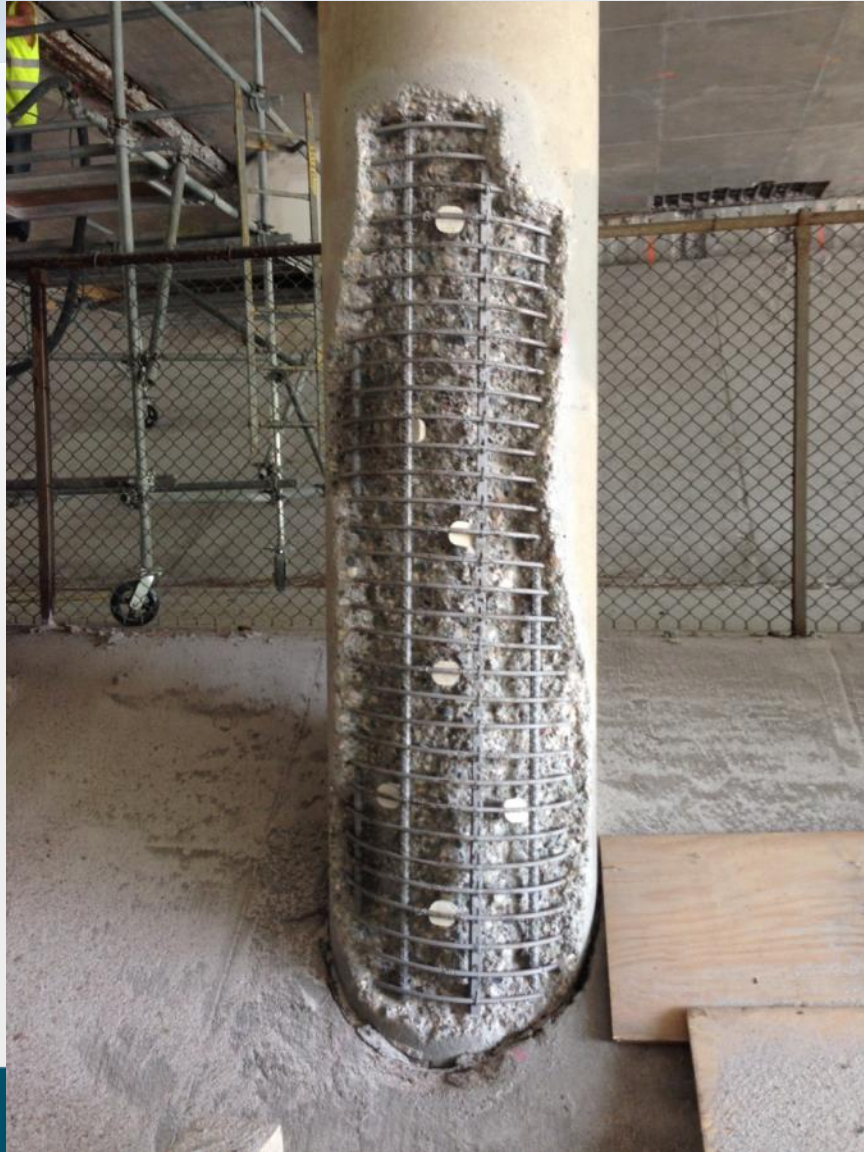
unsound removals

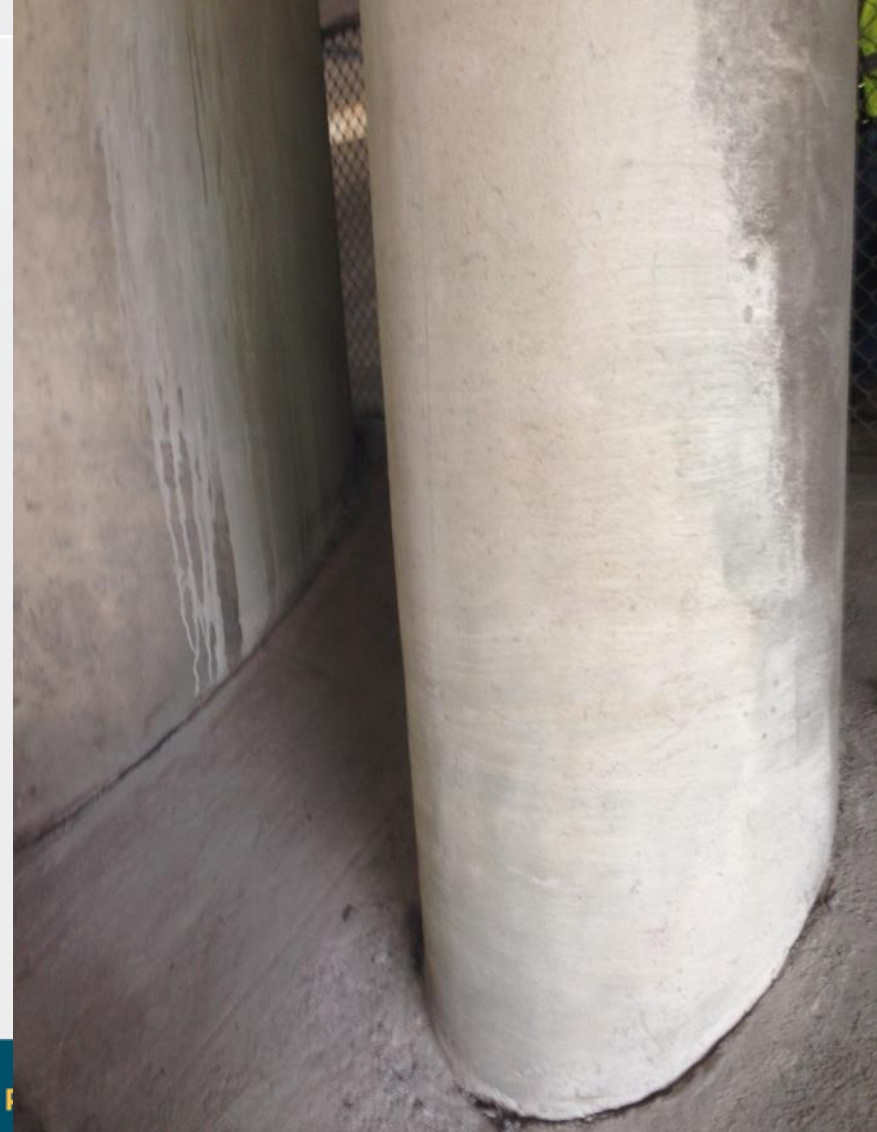
shotcrete repair with curing agent

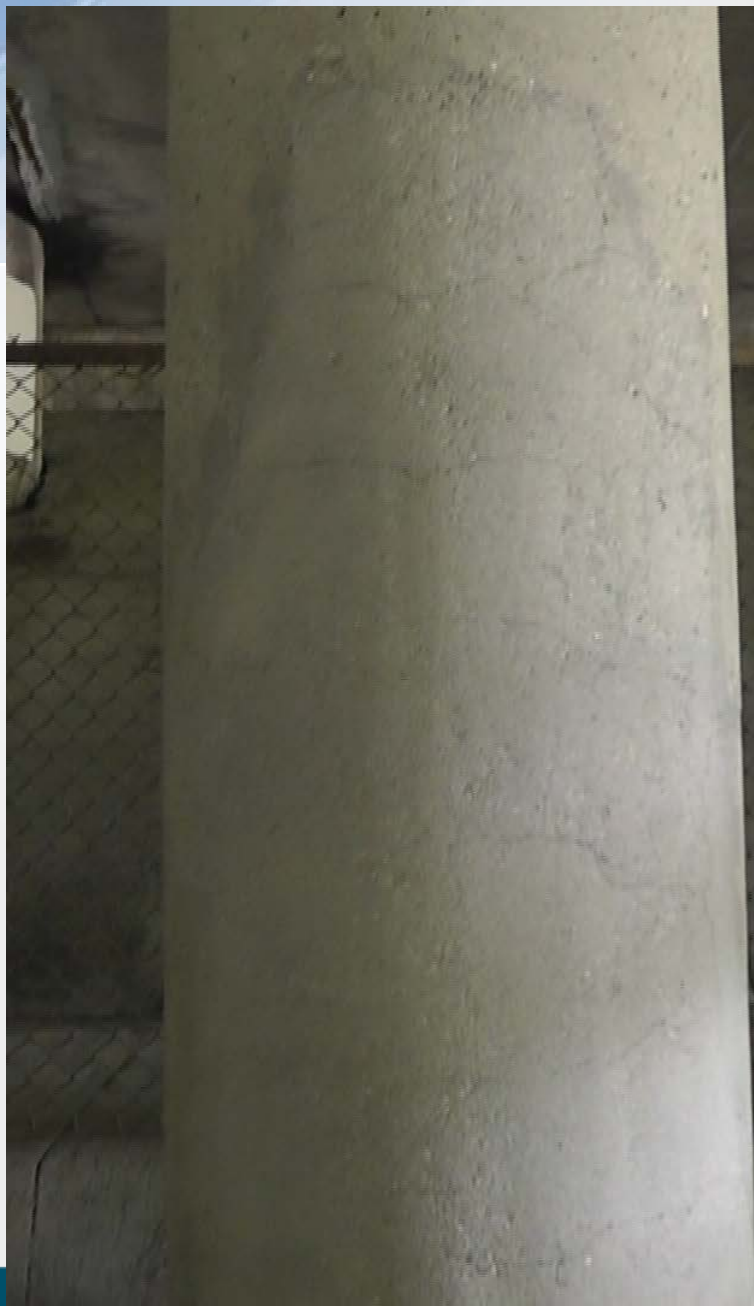
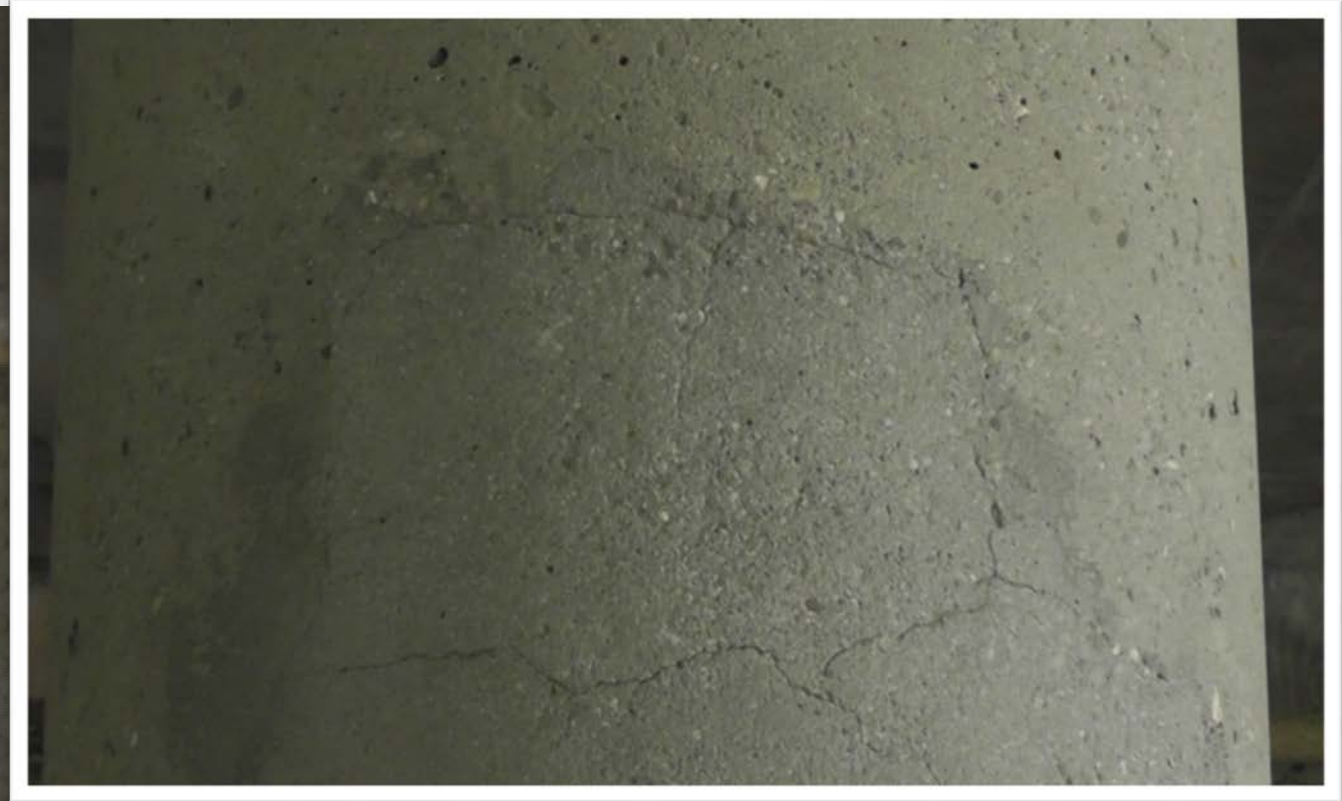
BRIDGE I

Shrinkage
cracks within
year old patch

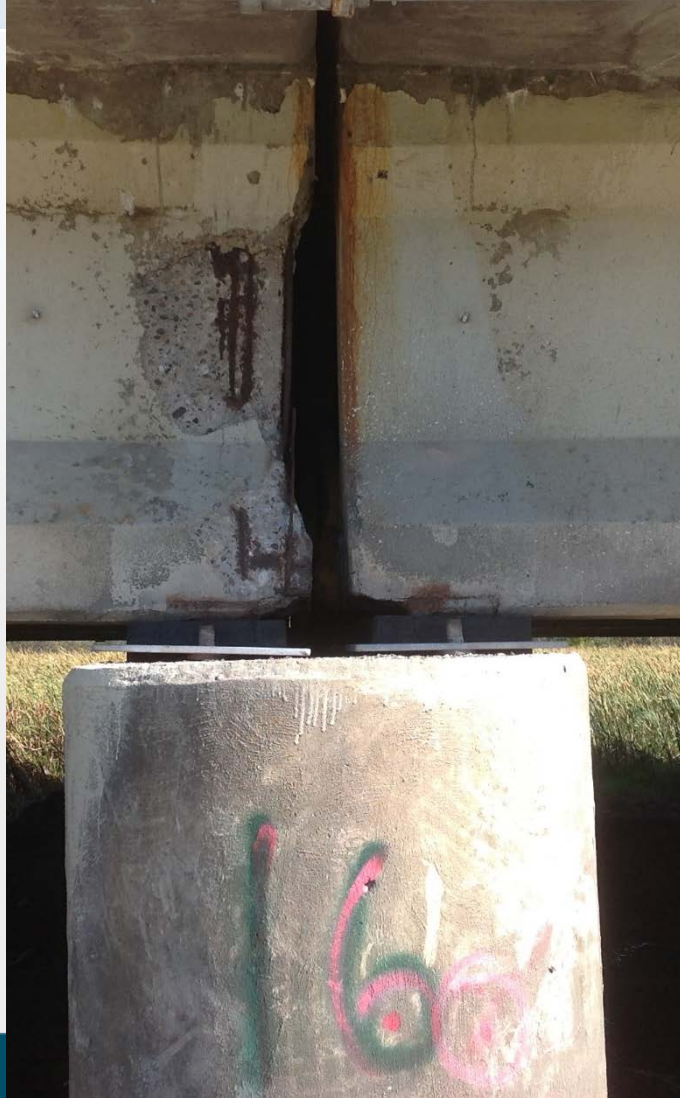
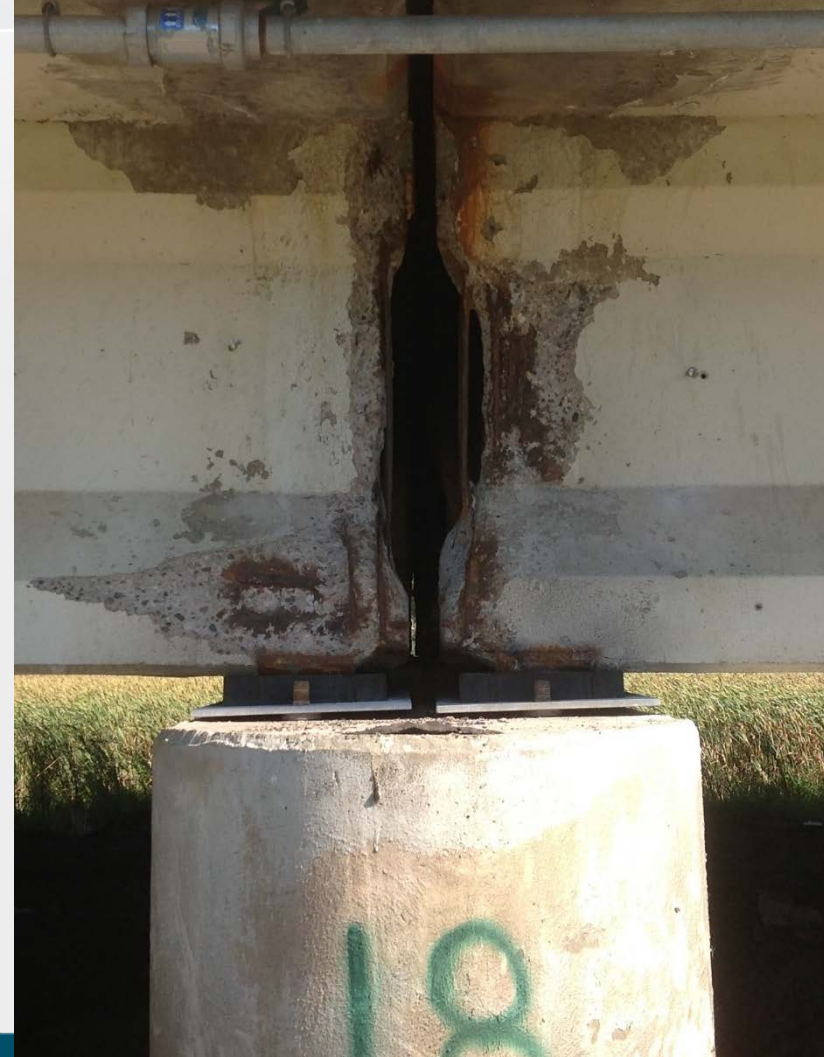
Variety of deterioration levels

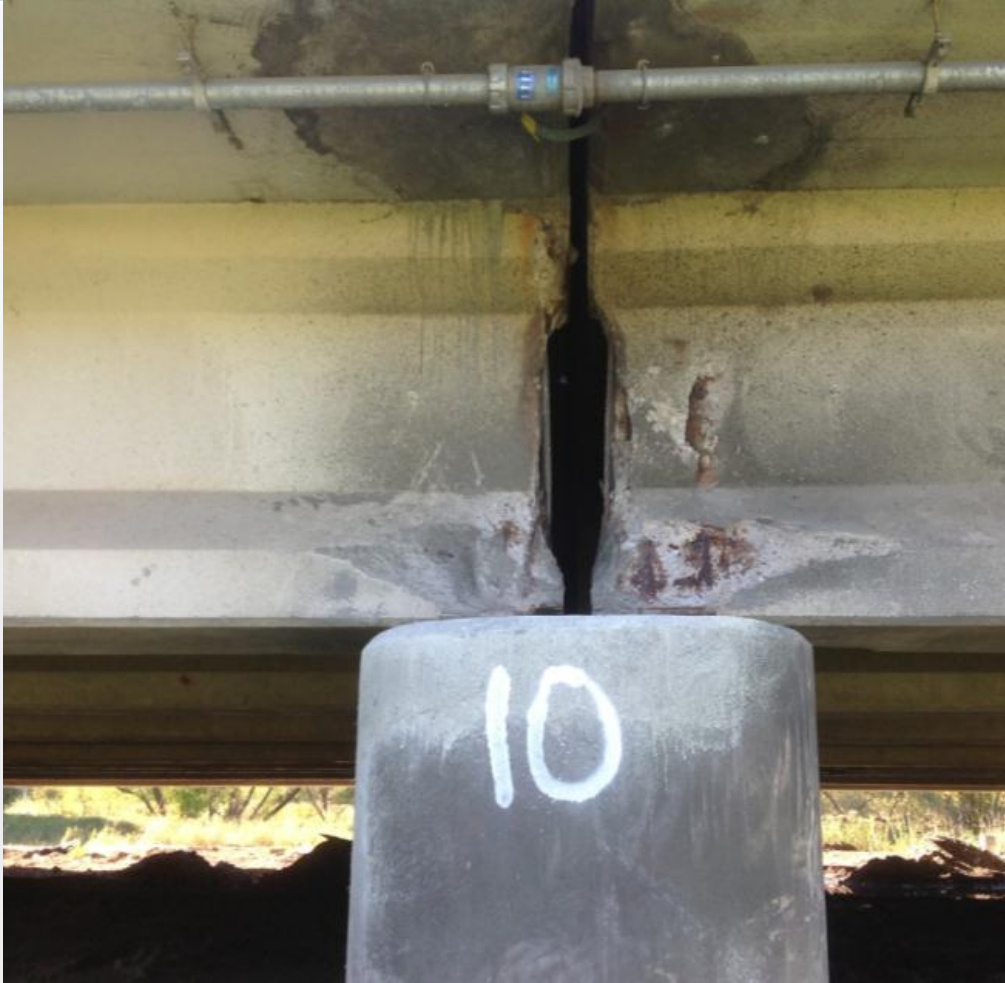
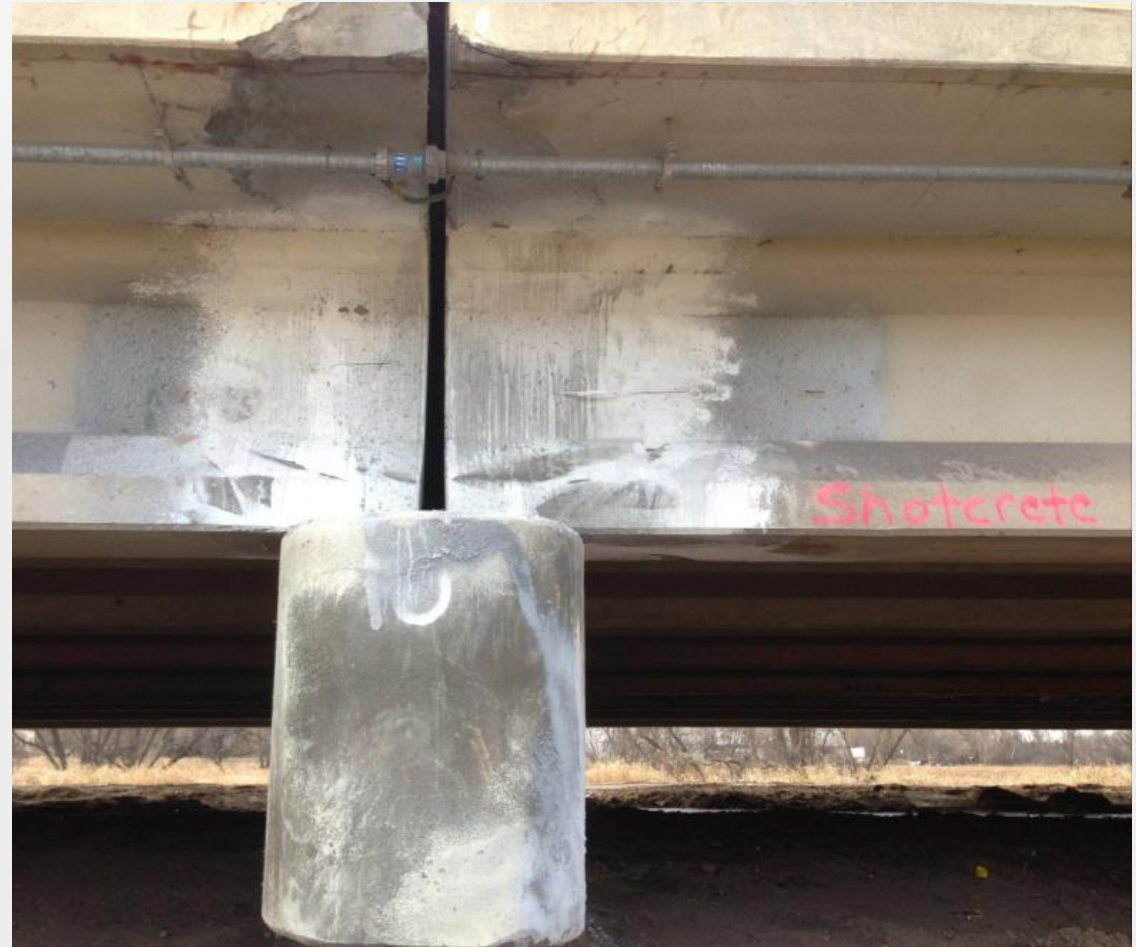
NB Pier 10 Fascia

Beam End Repairs - Small

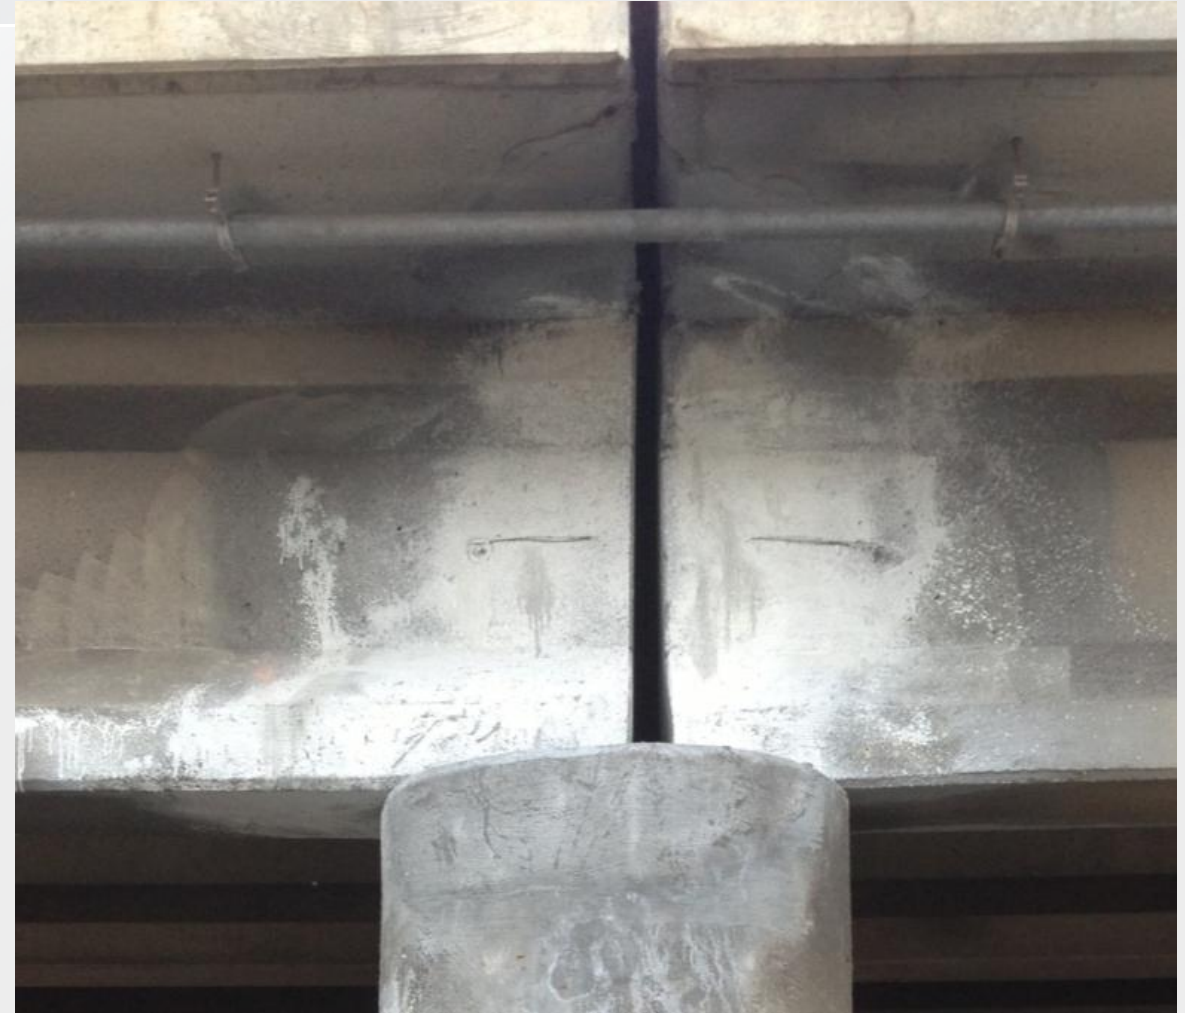
NB Pier 34 East Fascia

Beam End Repairs - Small

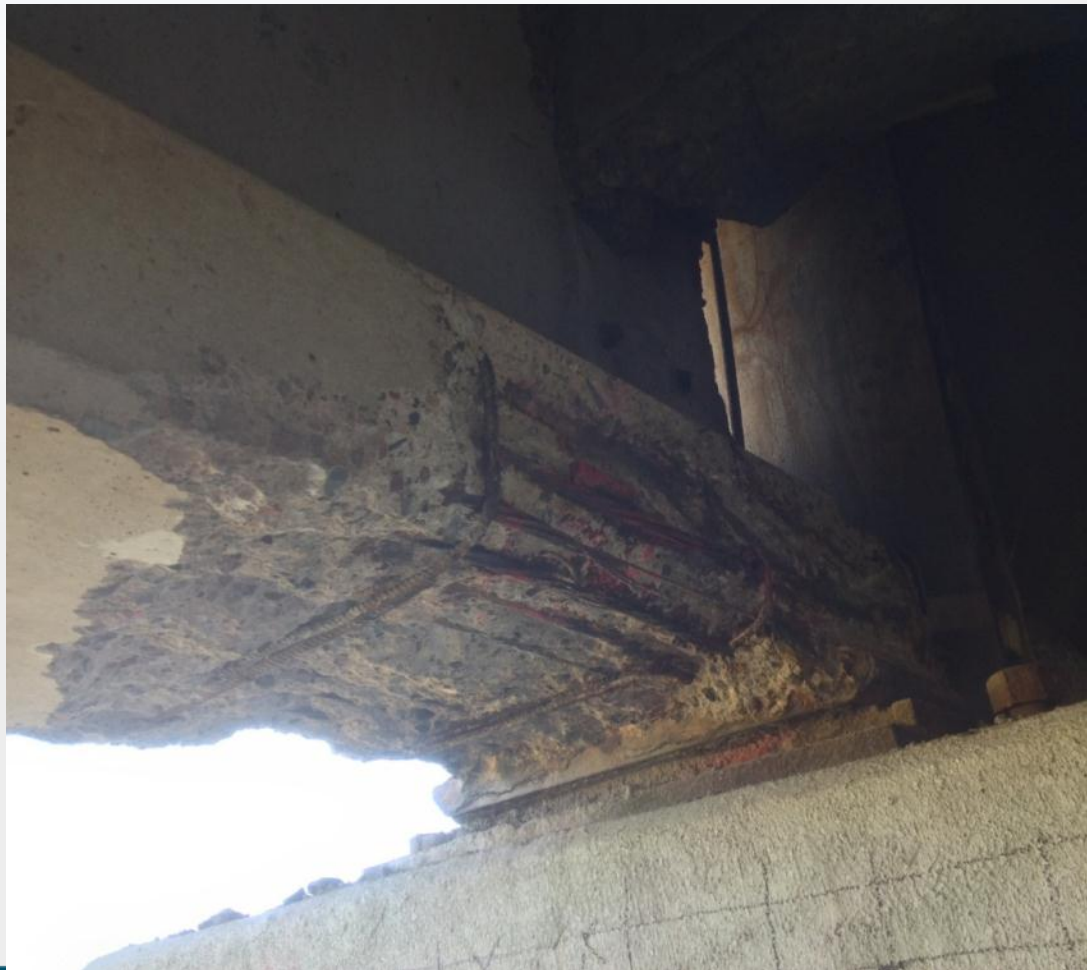
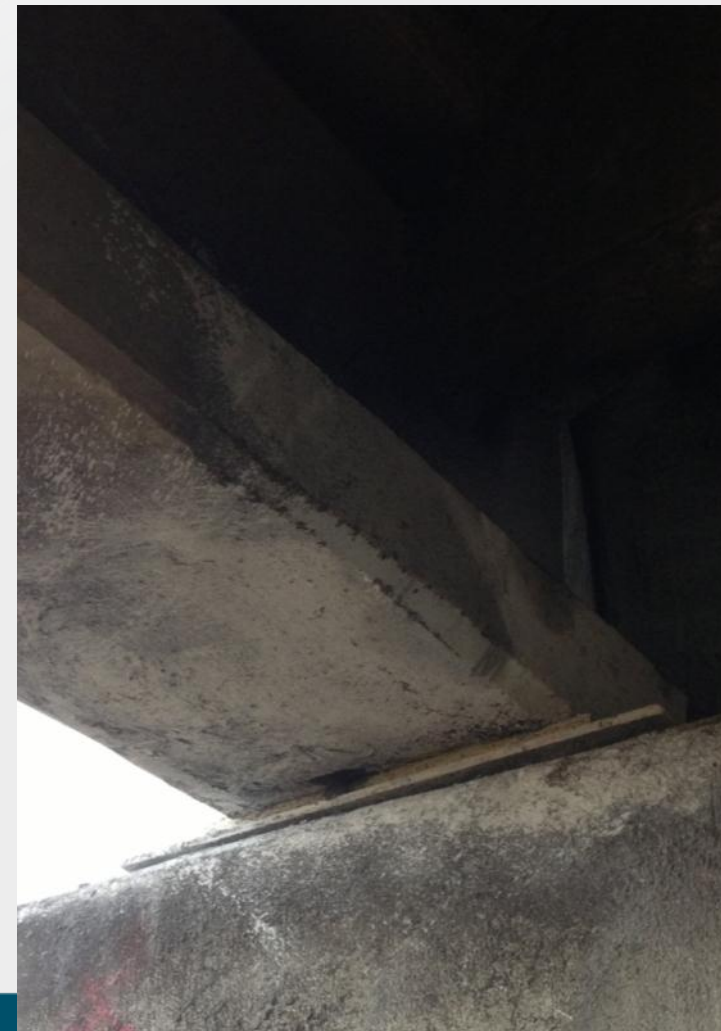
Beam End Repairs - Large

Pier 16: Large repair - Shotcrete repair without support

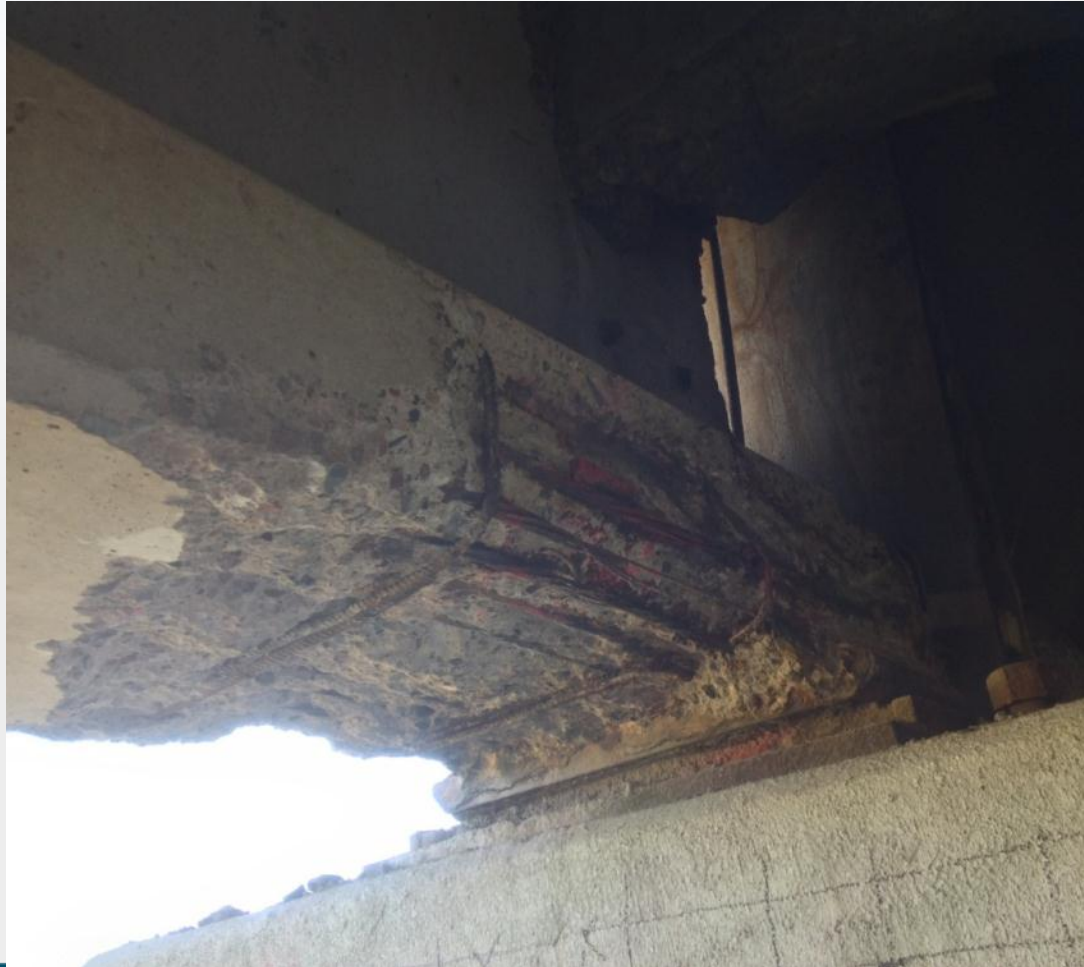
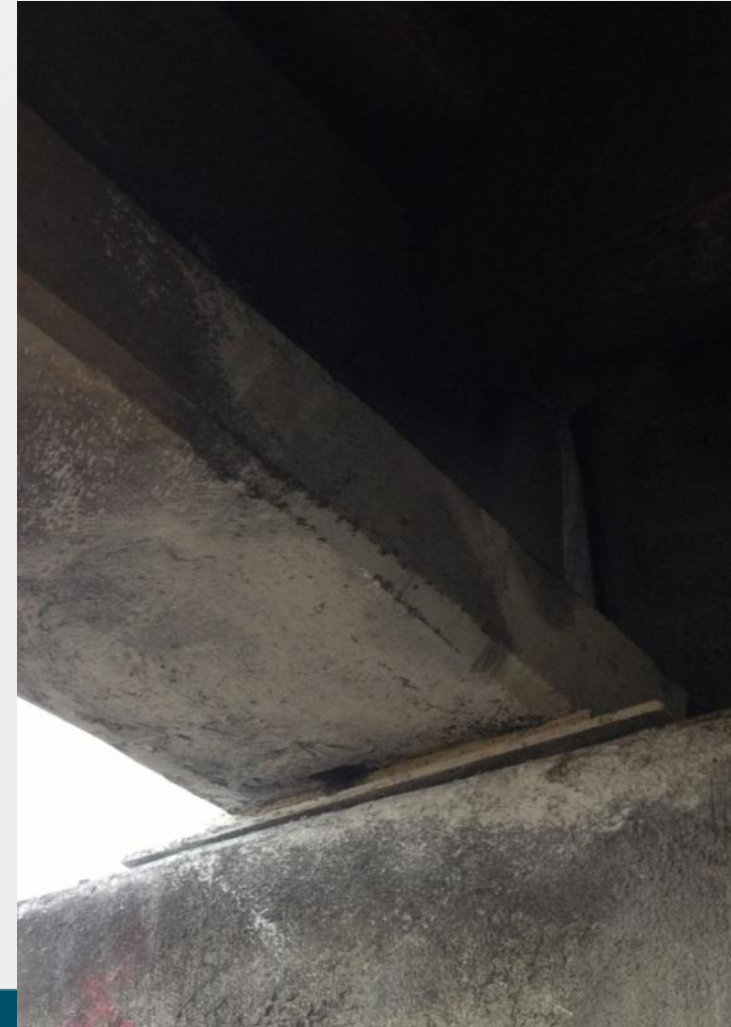
Beam End Repairs - ~~Large~~ ^{Medium}

Pier 16: ~~Large~~ repair - Shotcrete repair without support
Medium

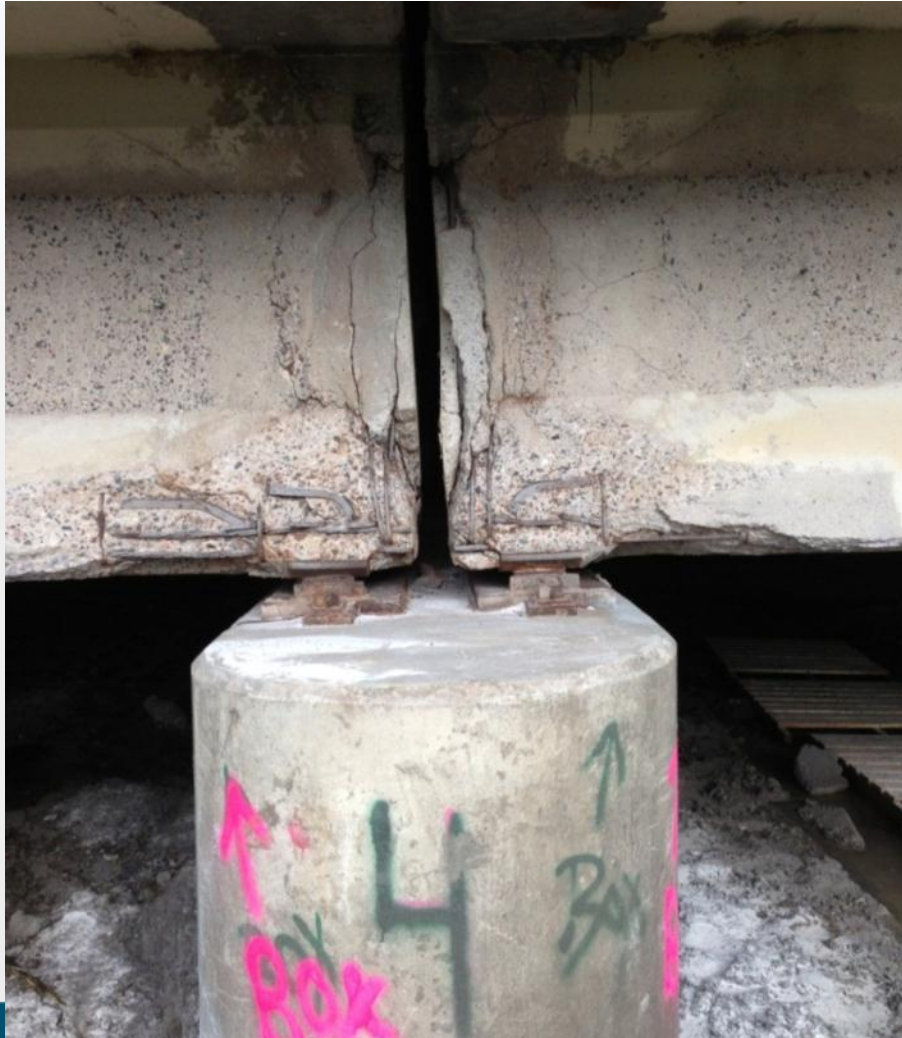
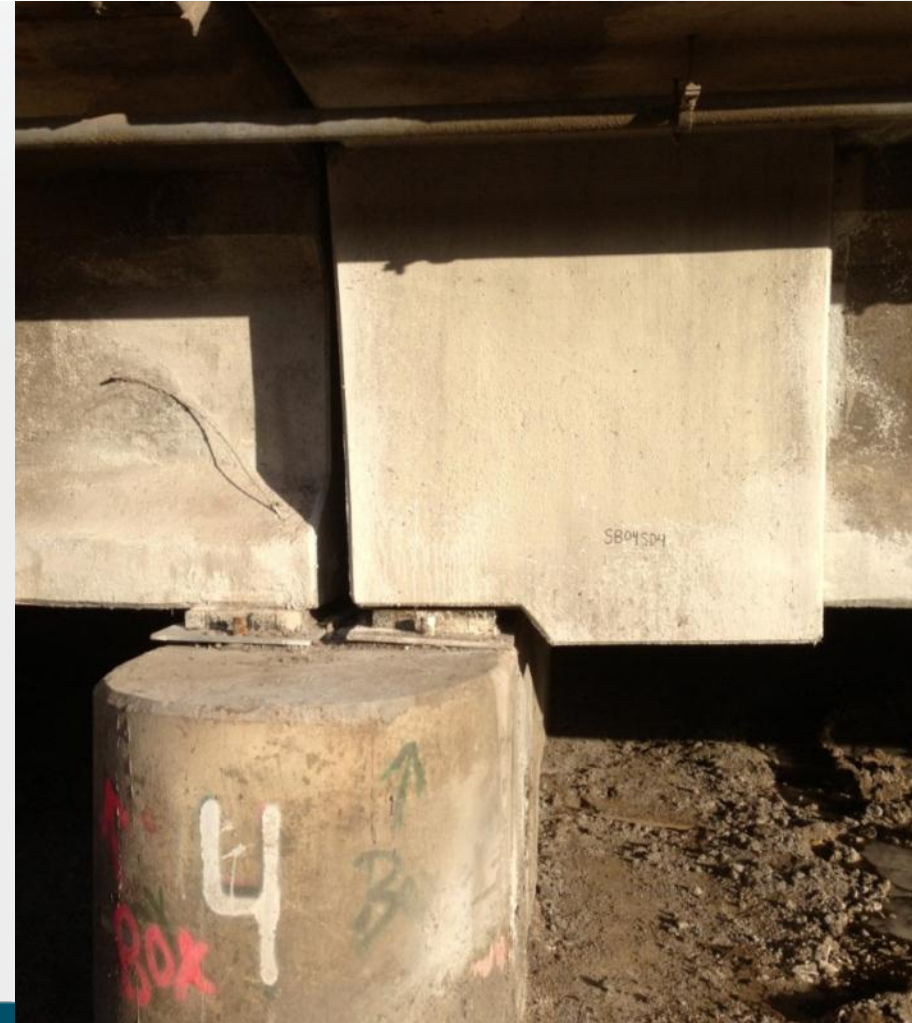
Beam End Repair - Large

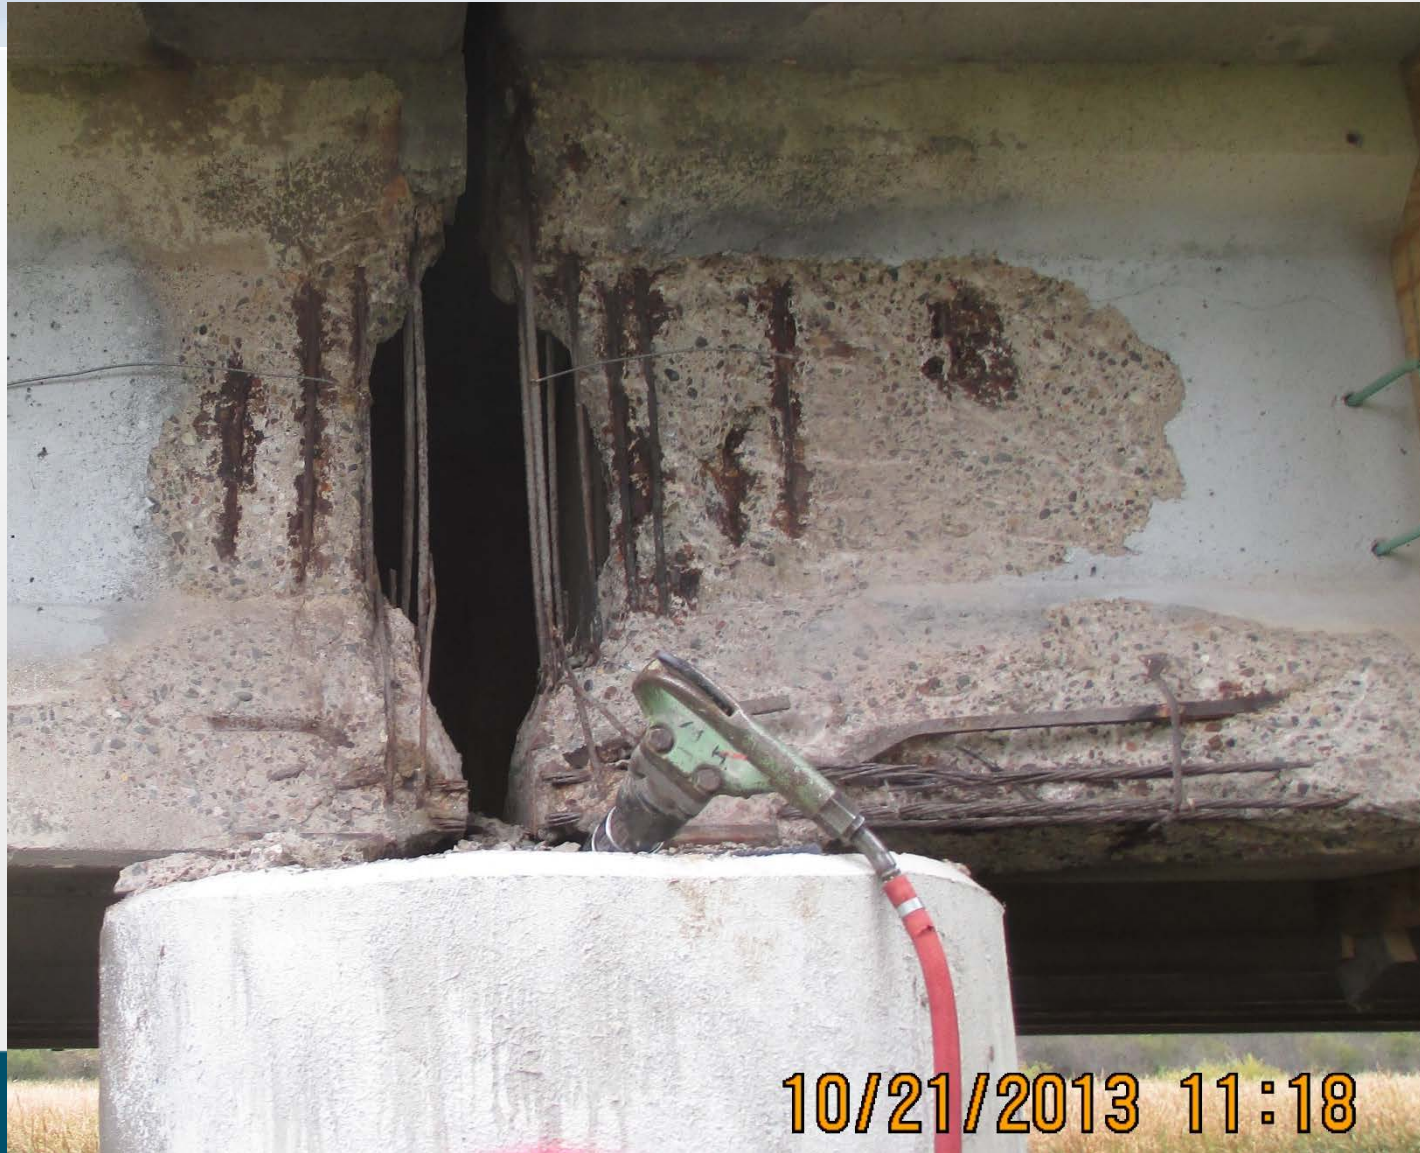
Damage beyond Michigan Conclusions

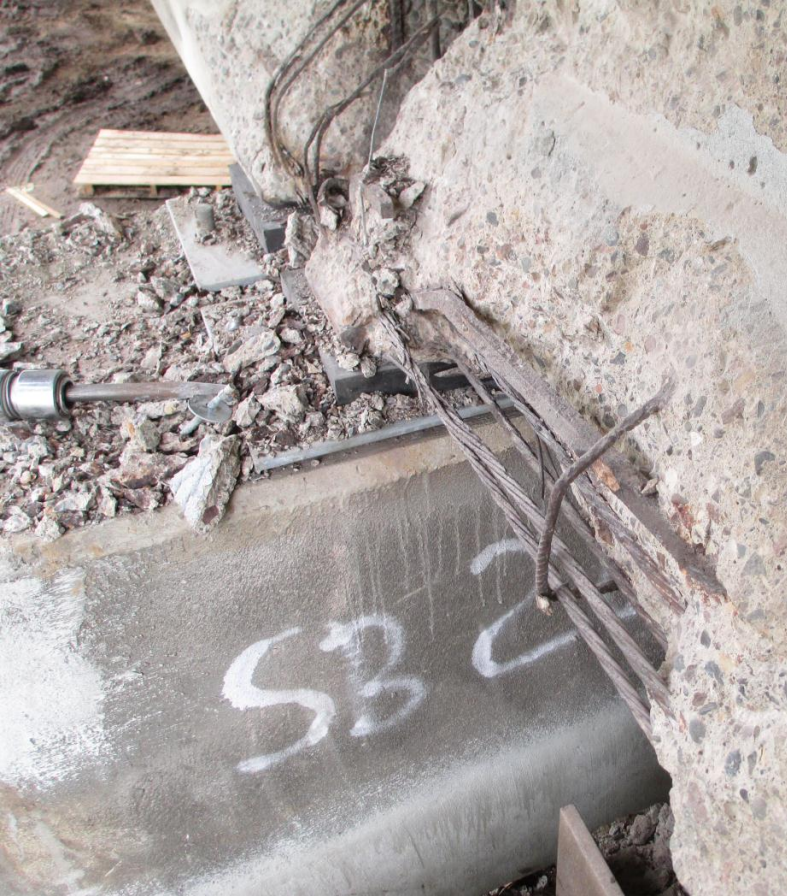
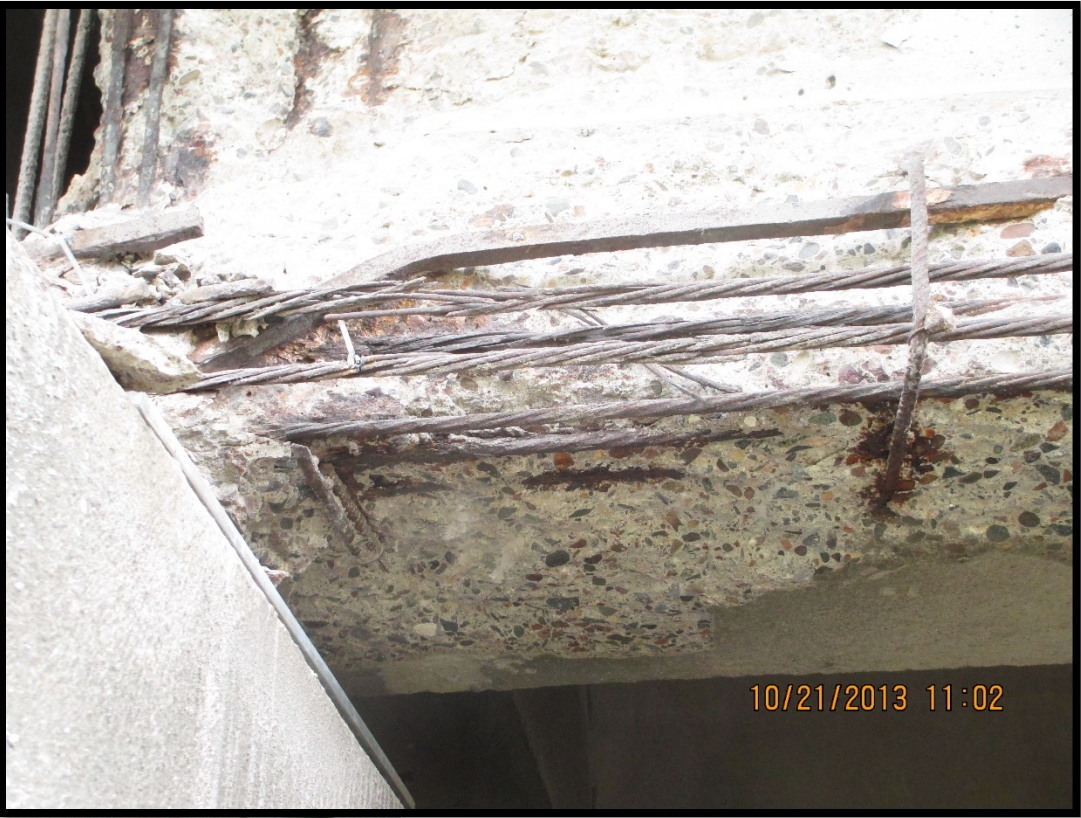
Damage beyond Michigan Conclusions
