Effective repair of severely deteriorated prestressed beam ends

Paul Pilarski, P.E., S.E.

Repair of Bridge 27568

US Route 169 over Nine Mile Creek

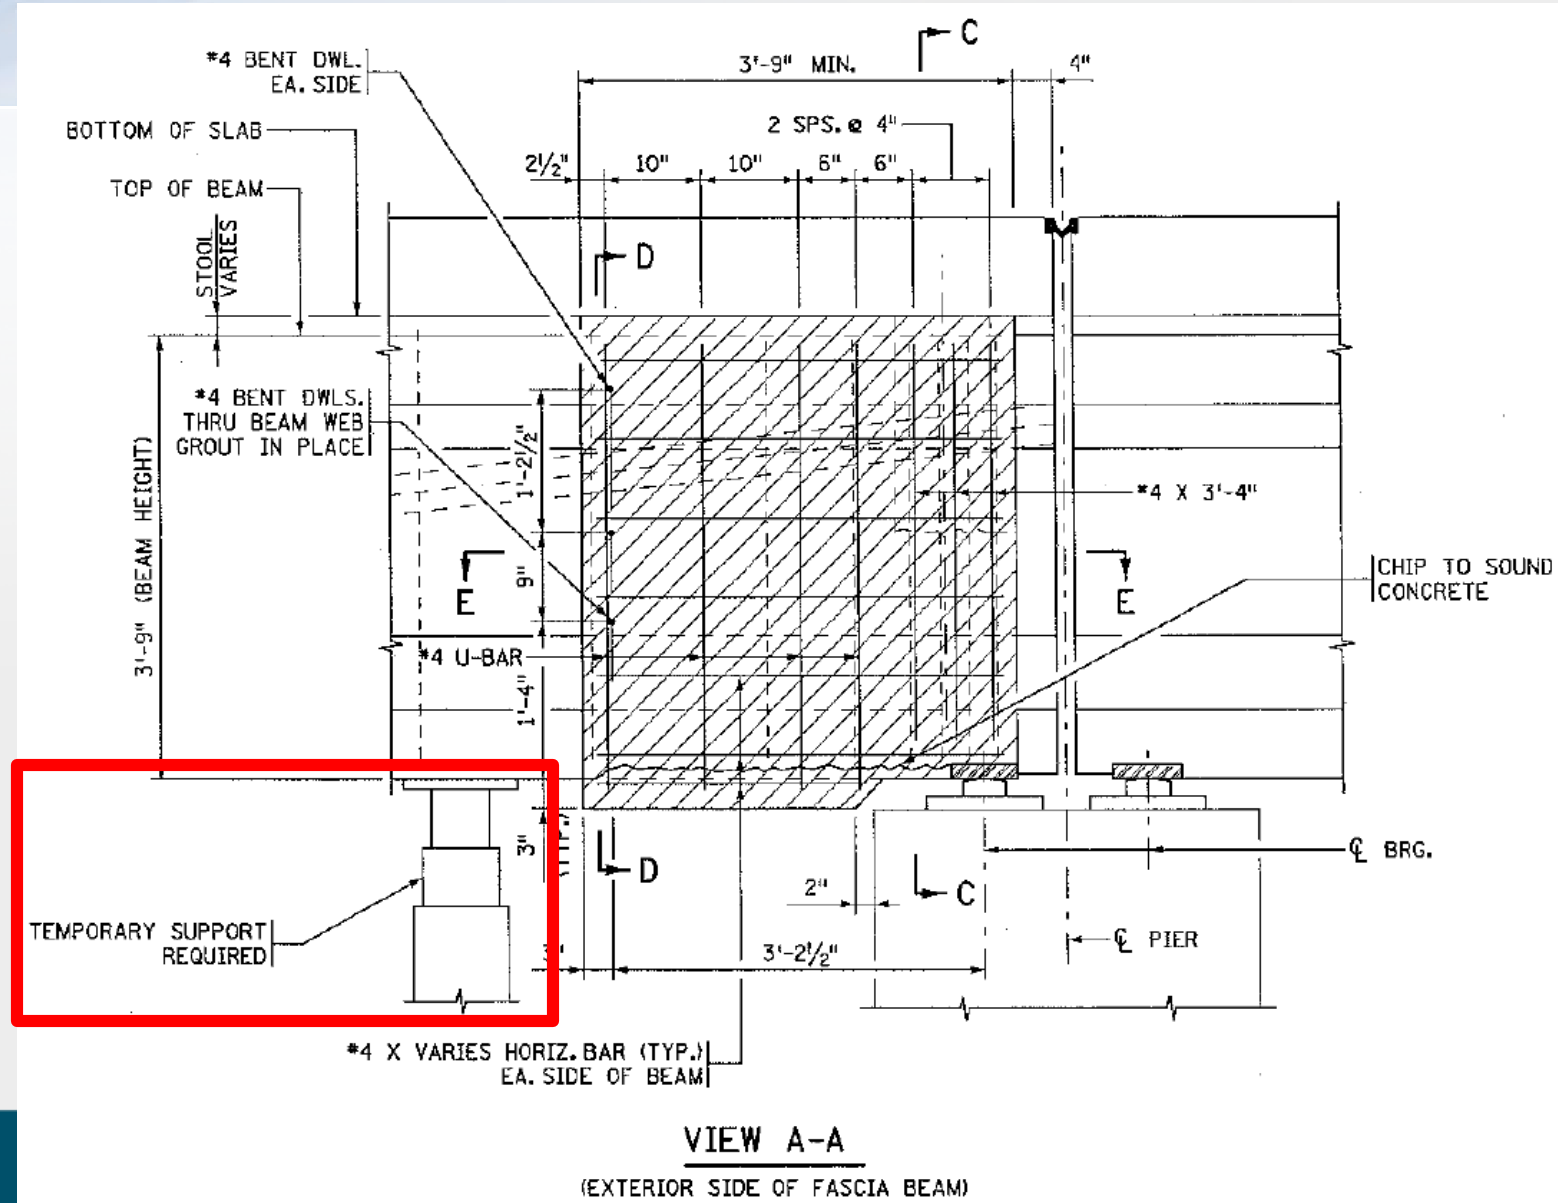
Box Type Repair (Large Repair)

Full DL relief can be detrimental to internal force balance!

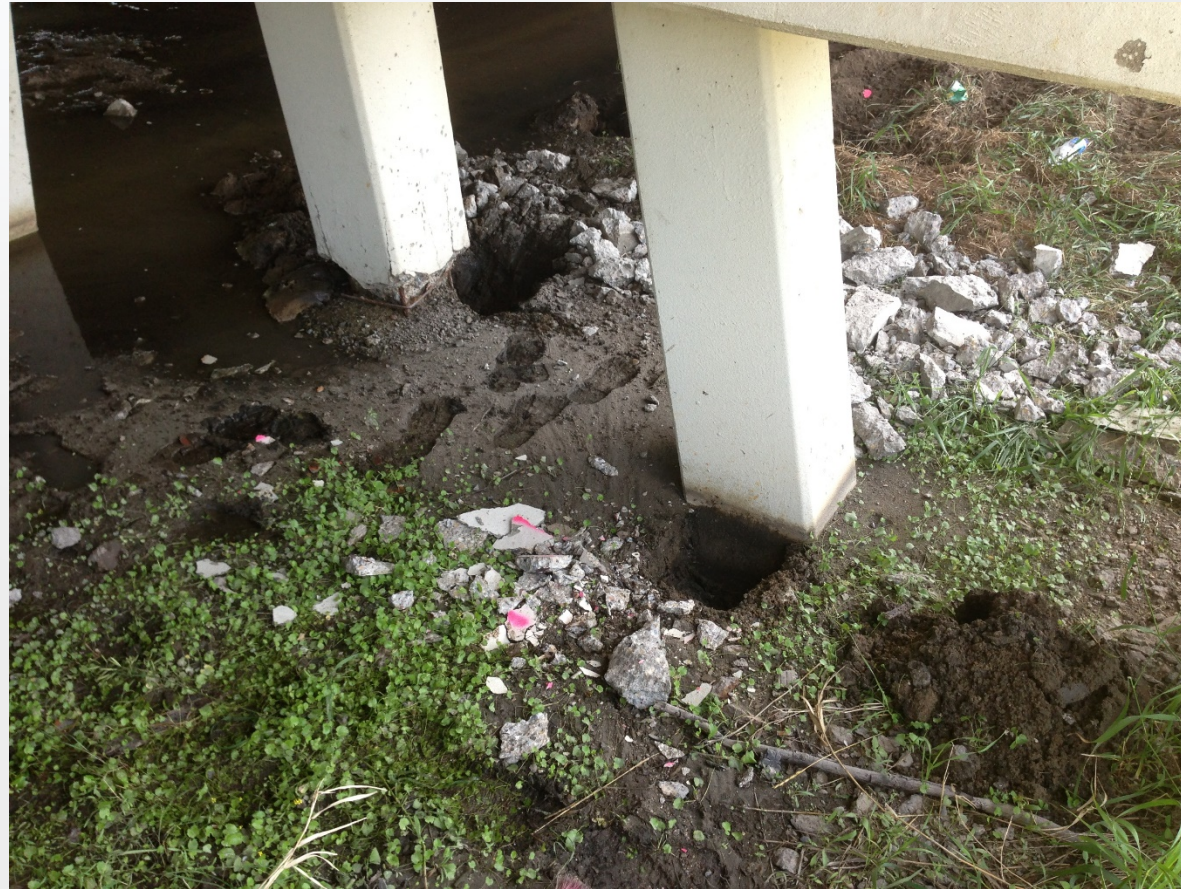
Other deteriorated components

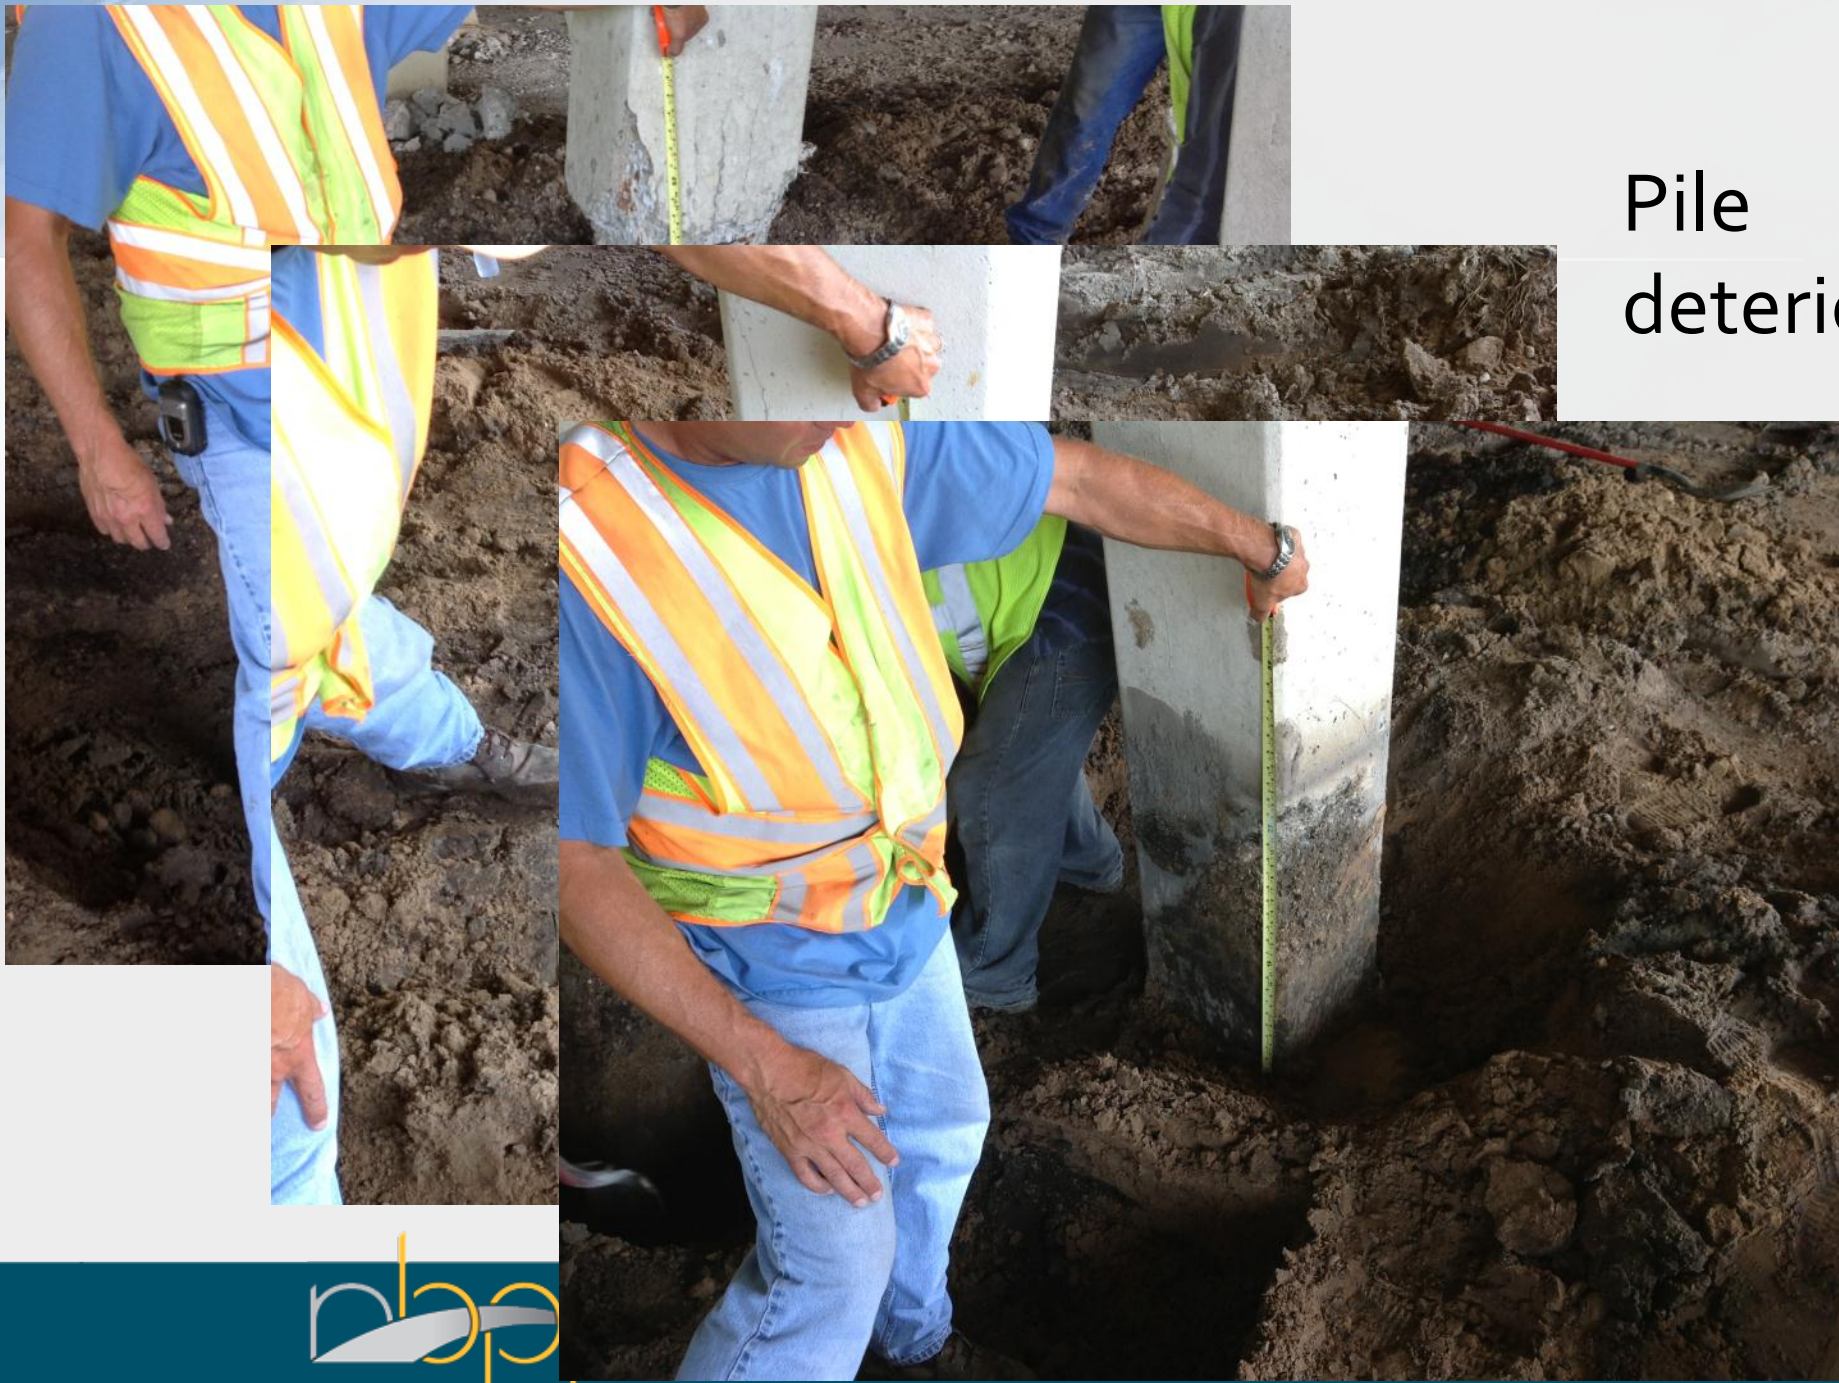
Pile deterioration
