Implementation of Cathodic Protection as a Bridge Preservation Effort at the Sunshine Skyway Bridge in Florida

FDOT – Corrosion Research Laboratory

FDOT - District Seven Structures Maintenance Office

NATIONAL BRIDGE PRESERVATION PARTNERSHIP CONFERENCE 2018

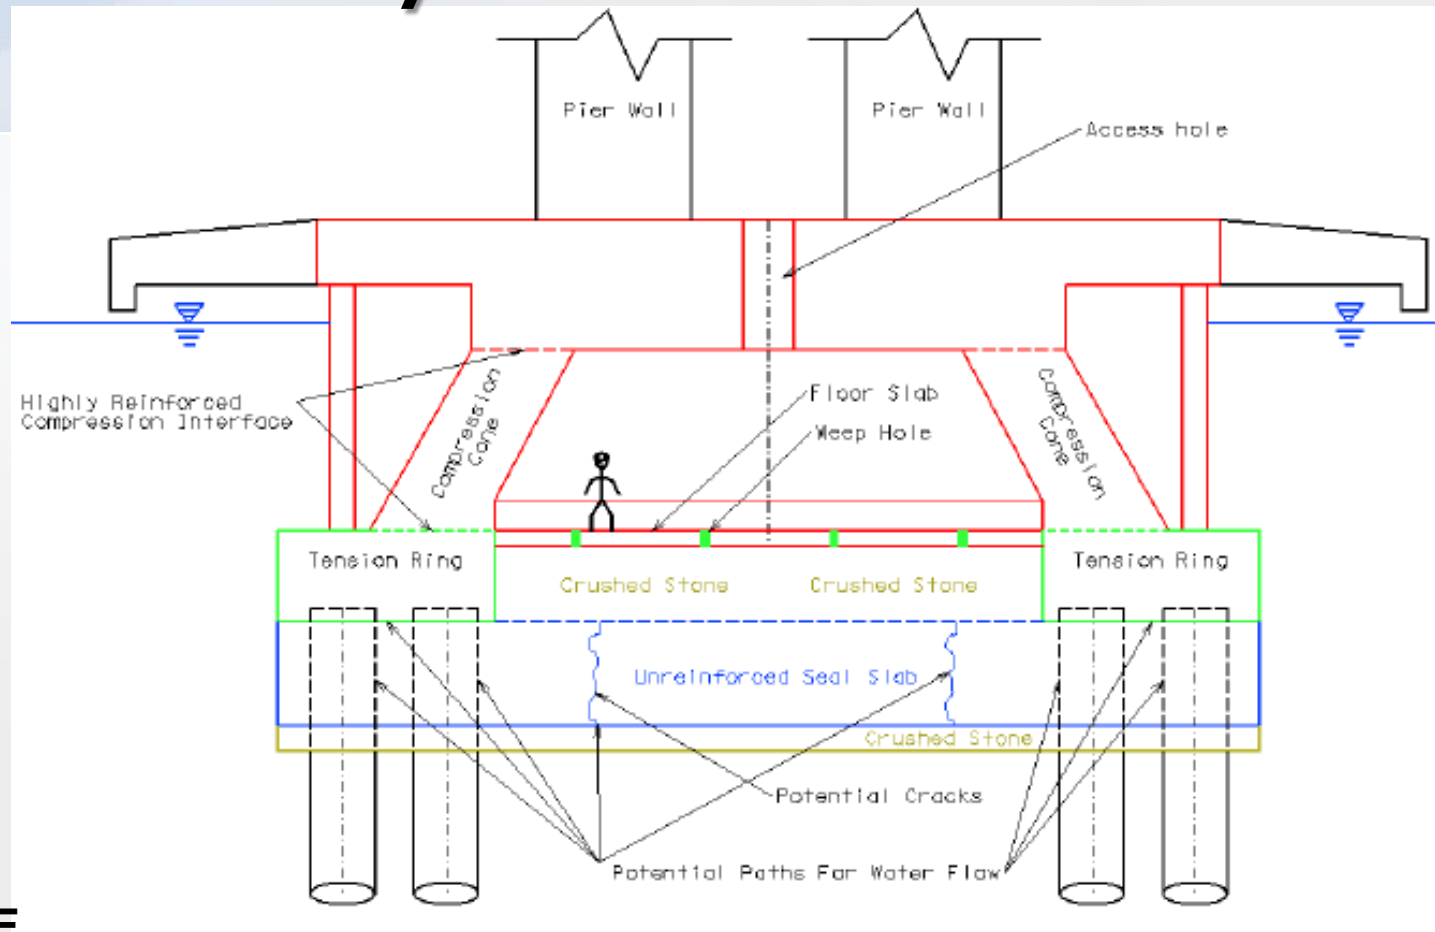
Cross-Section of Pylon Footer

- HOLLOW INSIDE
- CRACKS FOUND ON THE FOOTERS WALL DURING CONSTRUCTION
- INSIDE CHAMBER IS FILLED WITH WATER ON BOTH PYLONS FOOTERS

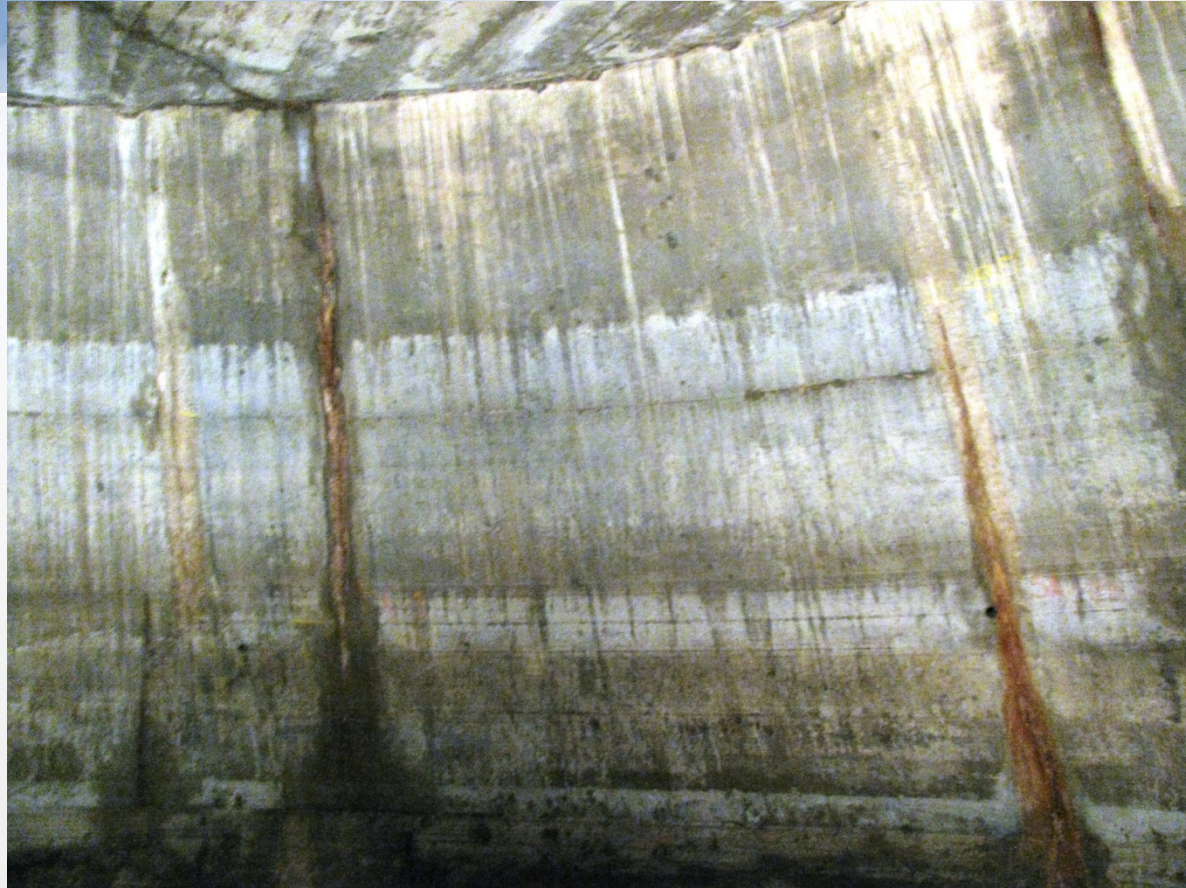
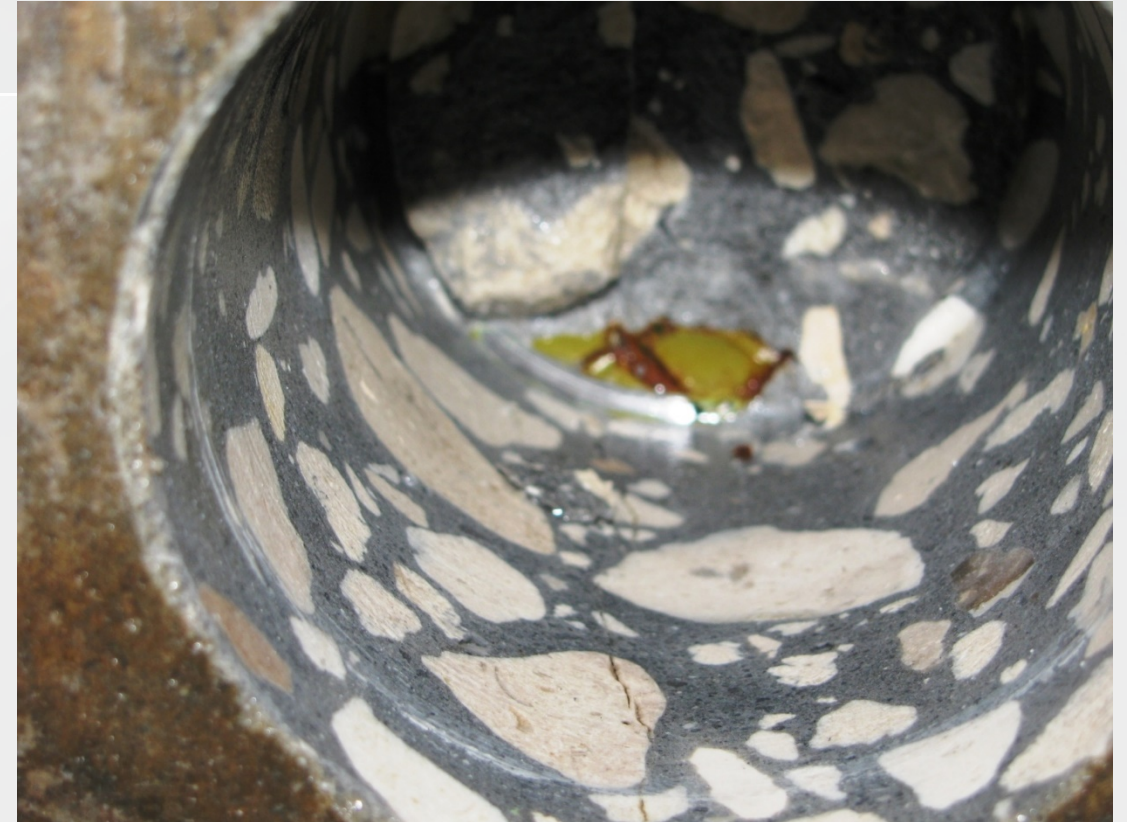
Interior of Pylon

- THE REINFORCEMENT HAS ~ 4 INCHES OF COVER.
- CORROSION OF THE ECR WAS DETECTED BUT, ONLY ON REBARS INTERSECTED BY CRACKS.

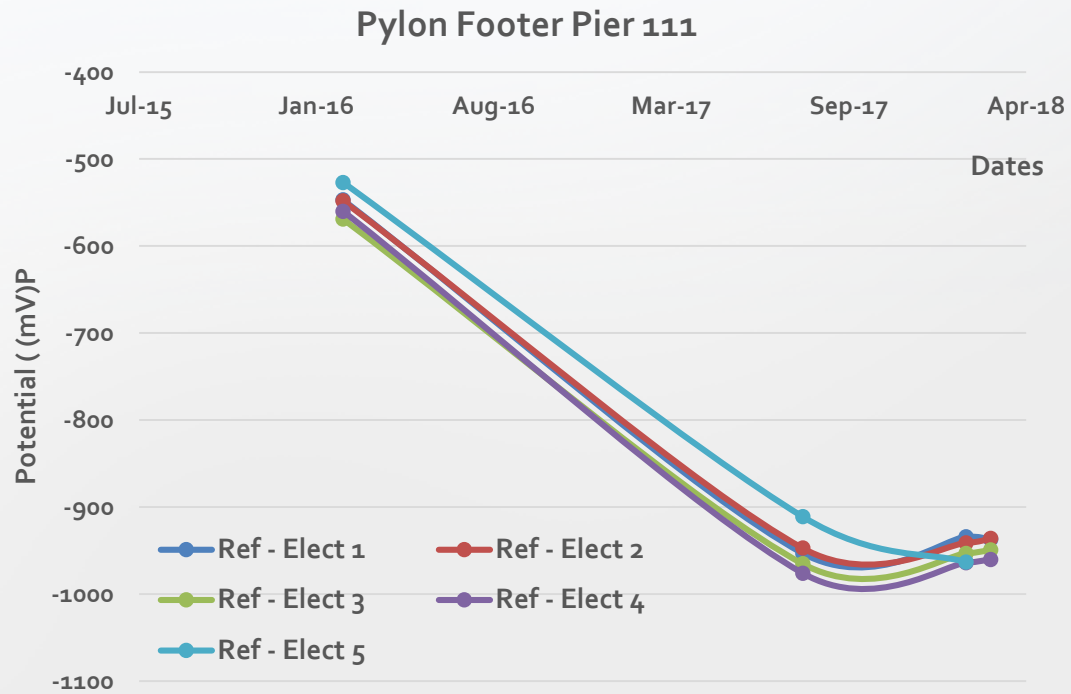
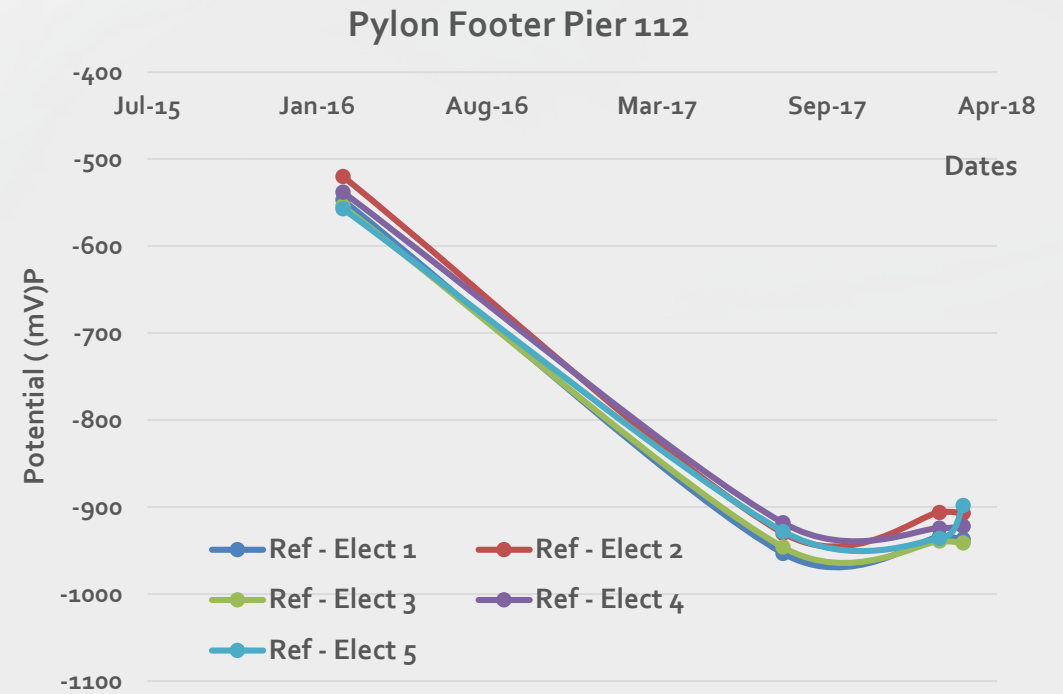
Pylon CP Data

System providing excellent performance

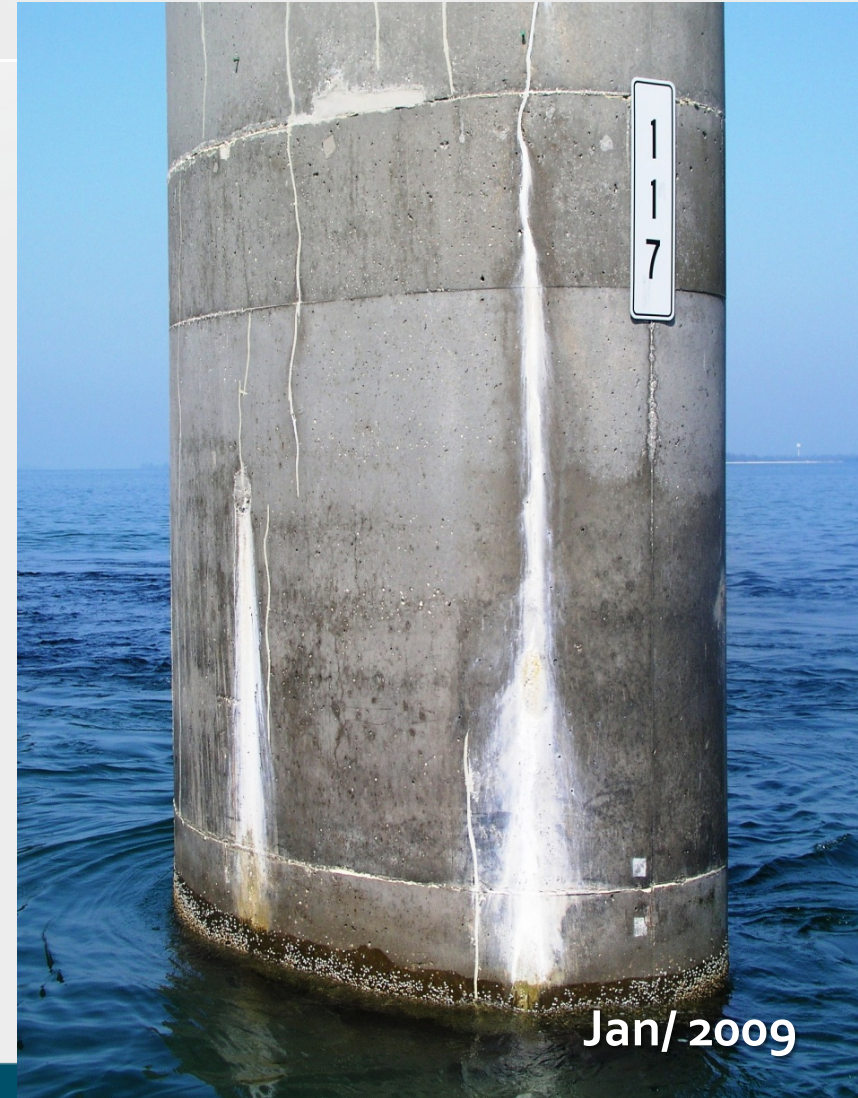
- Many old and new cracks are showing severe amounts of moisture and efflorescence.
- After sealing, water continued to leak out of the crack, suggesting water inside column or on upper portion of the crack.
