Timber Substructure Repairs

Travis Kinney, Oregon DOT

NATIONAL BRIDGE PRESERVATION PARTNERSHIP CONFERENCE 2018

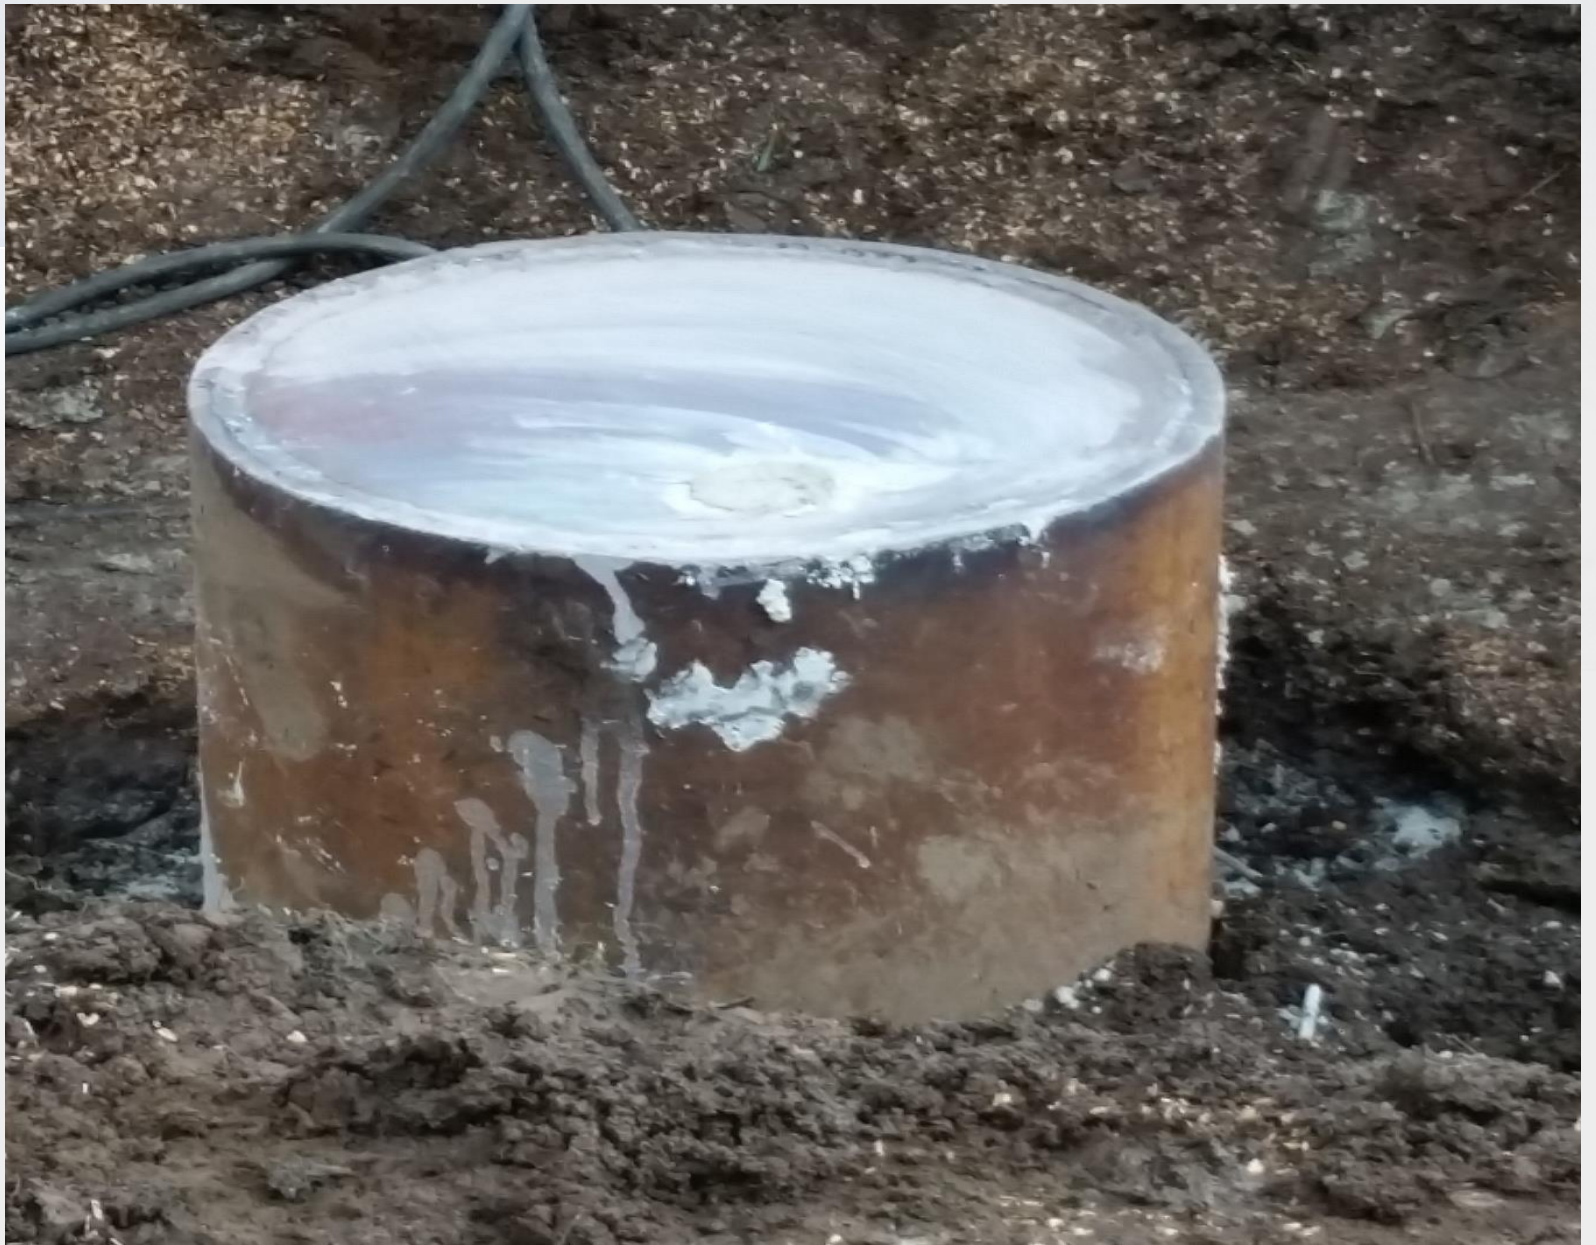
Step 9: Position Steel Pile.

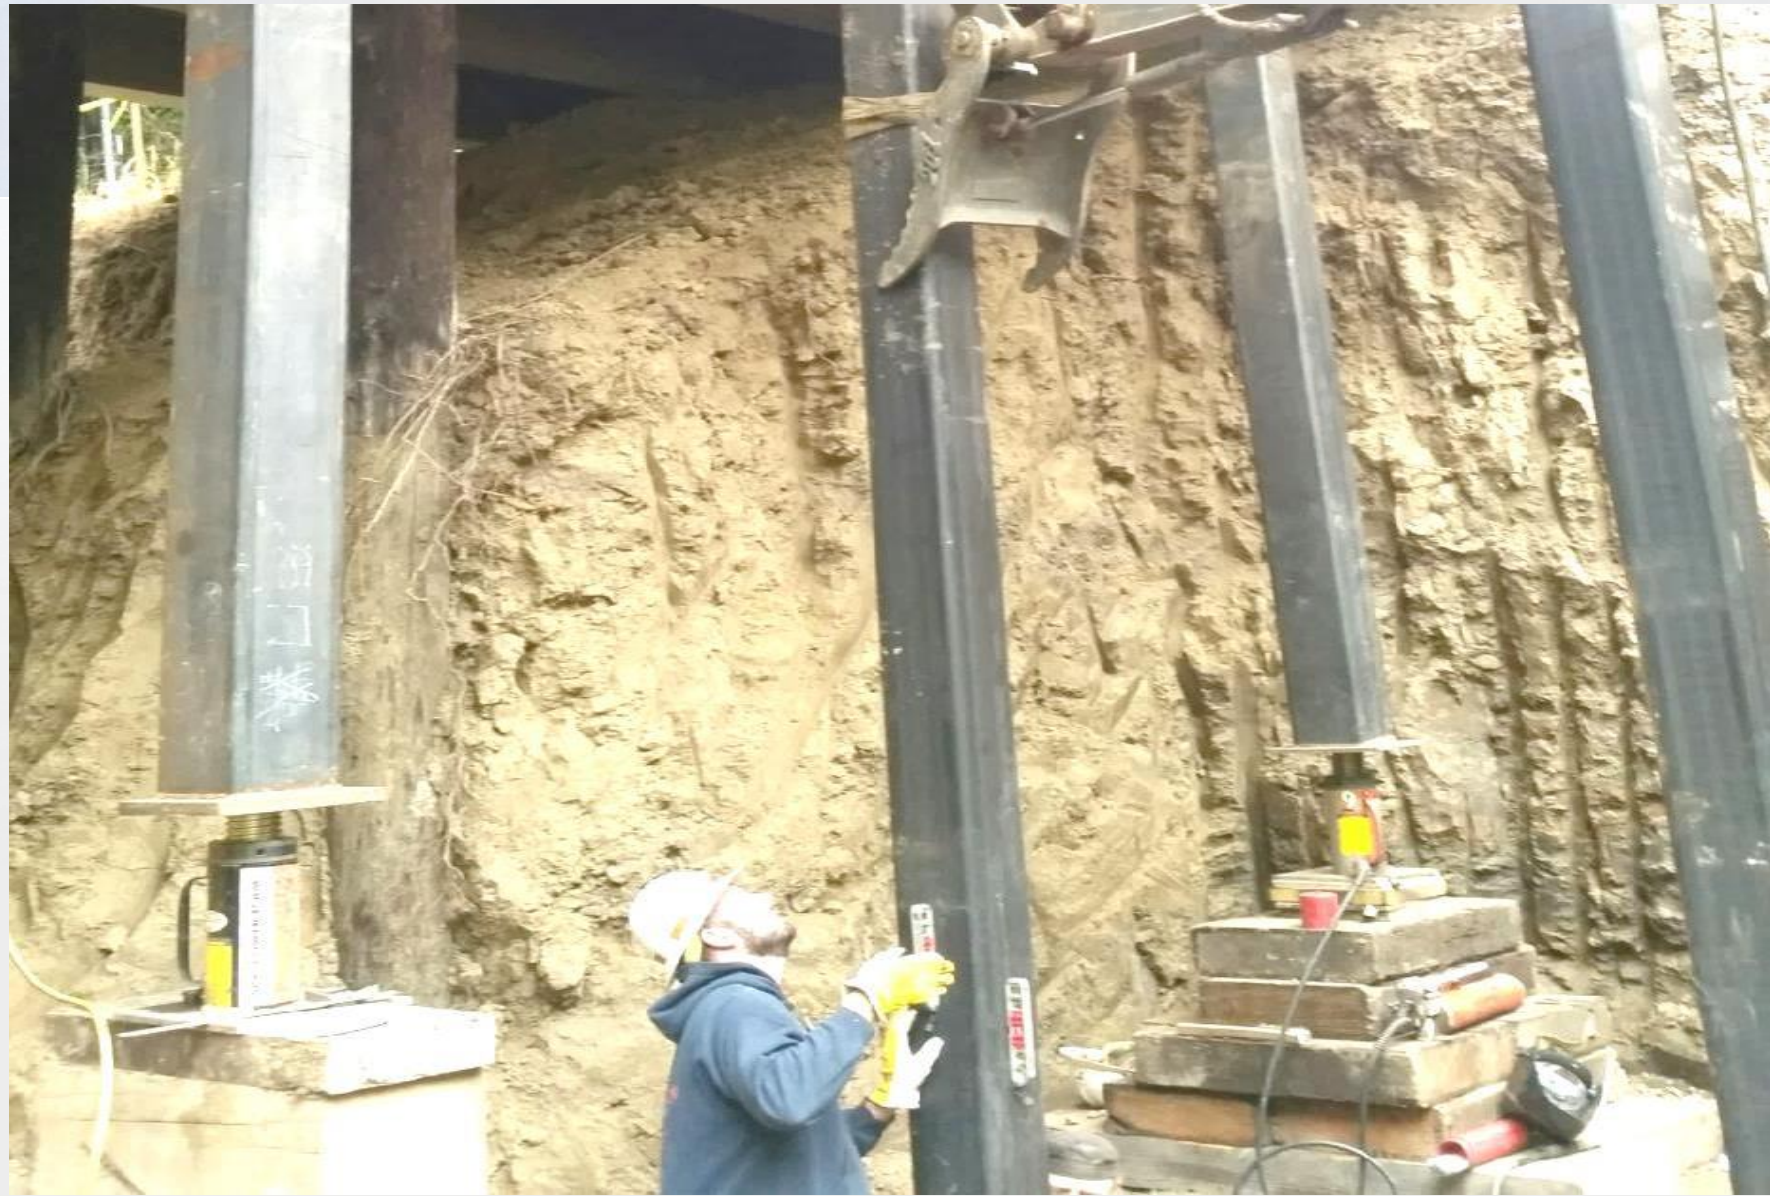
Step 10: Preload with 20 ton hydraulic jack

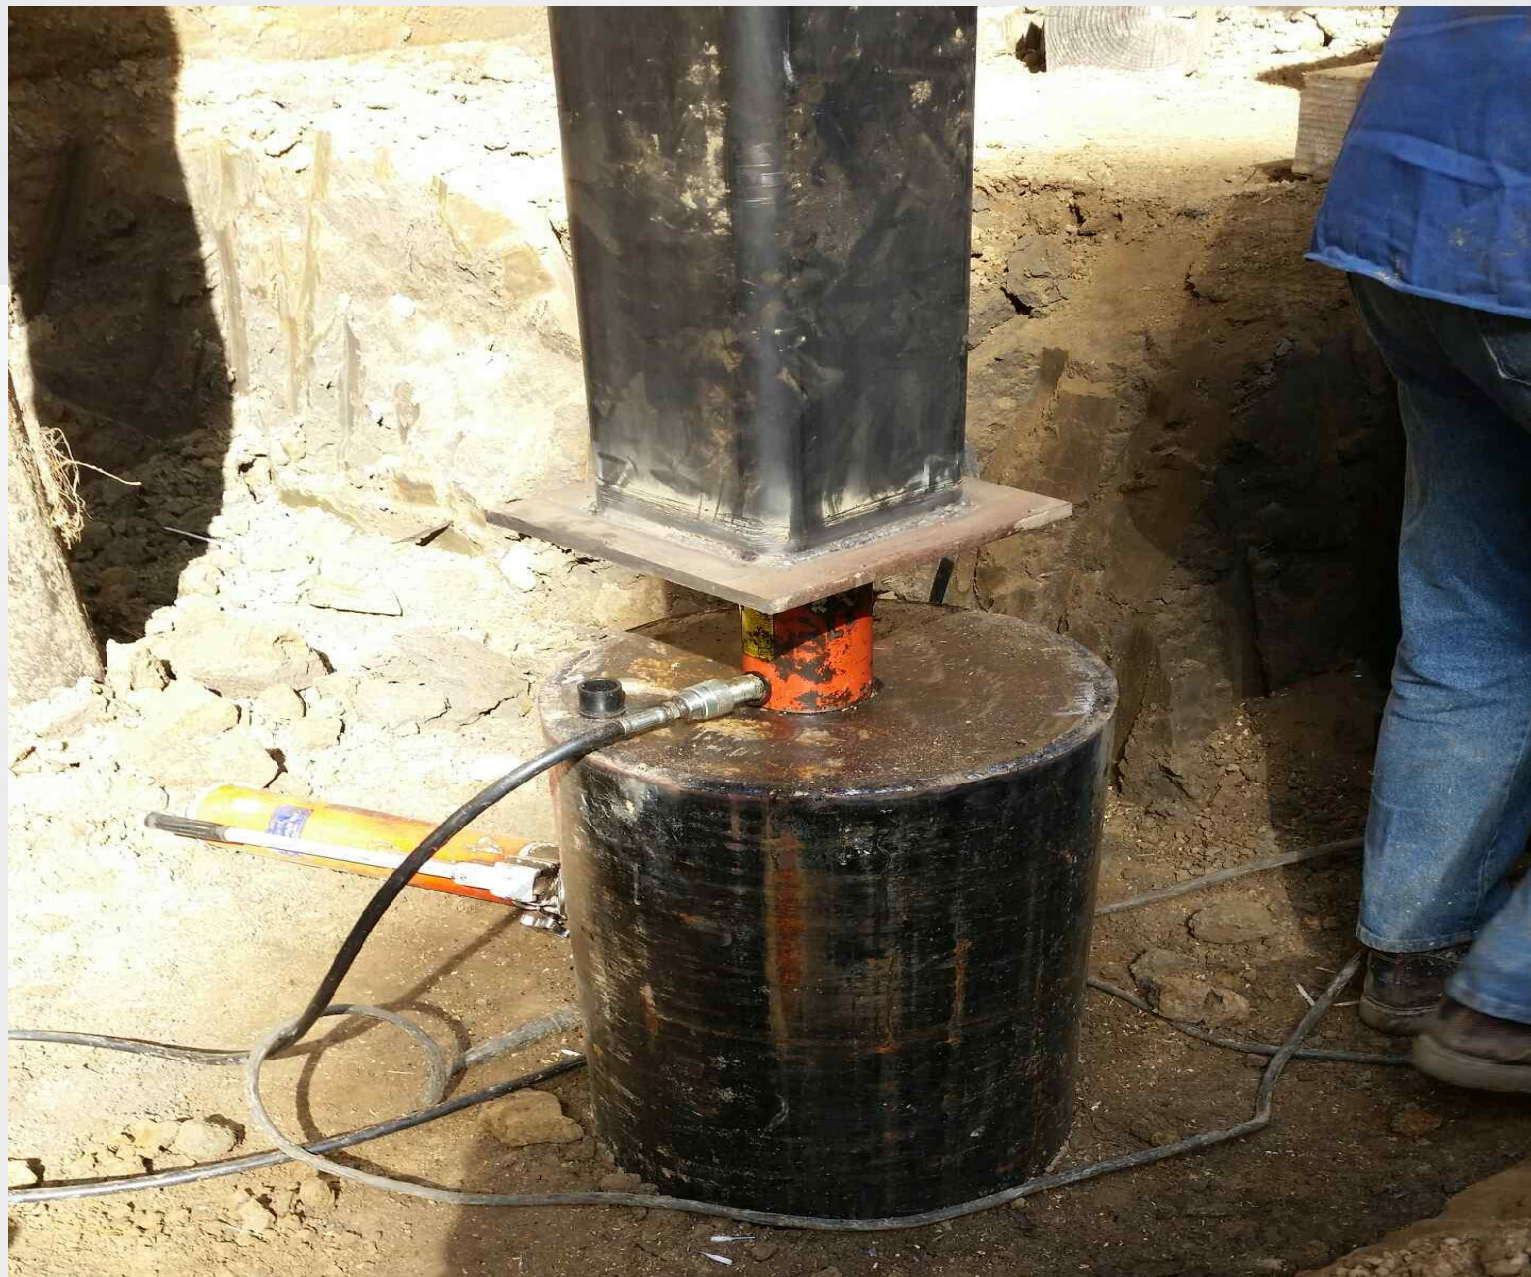
Step 11: Cut
shims to fit and
weld in place

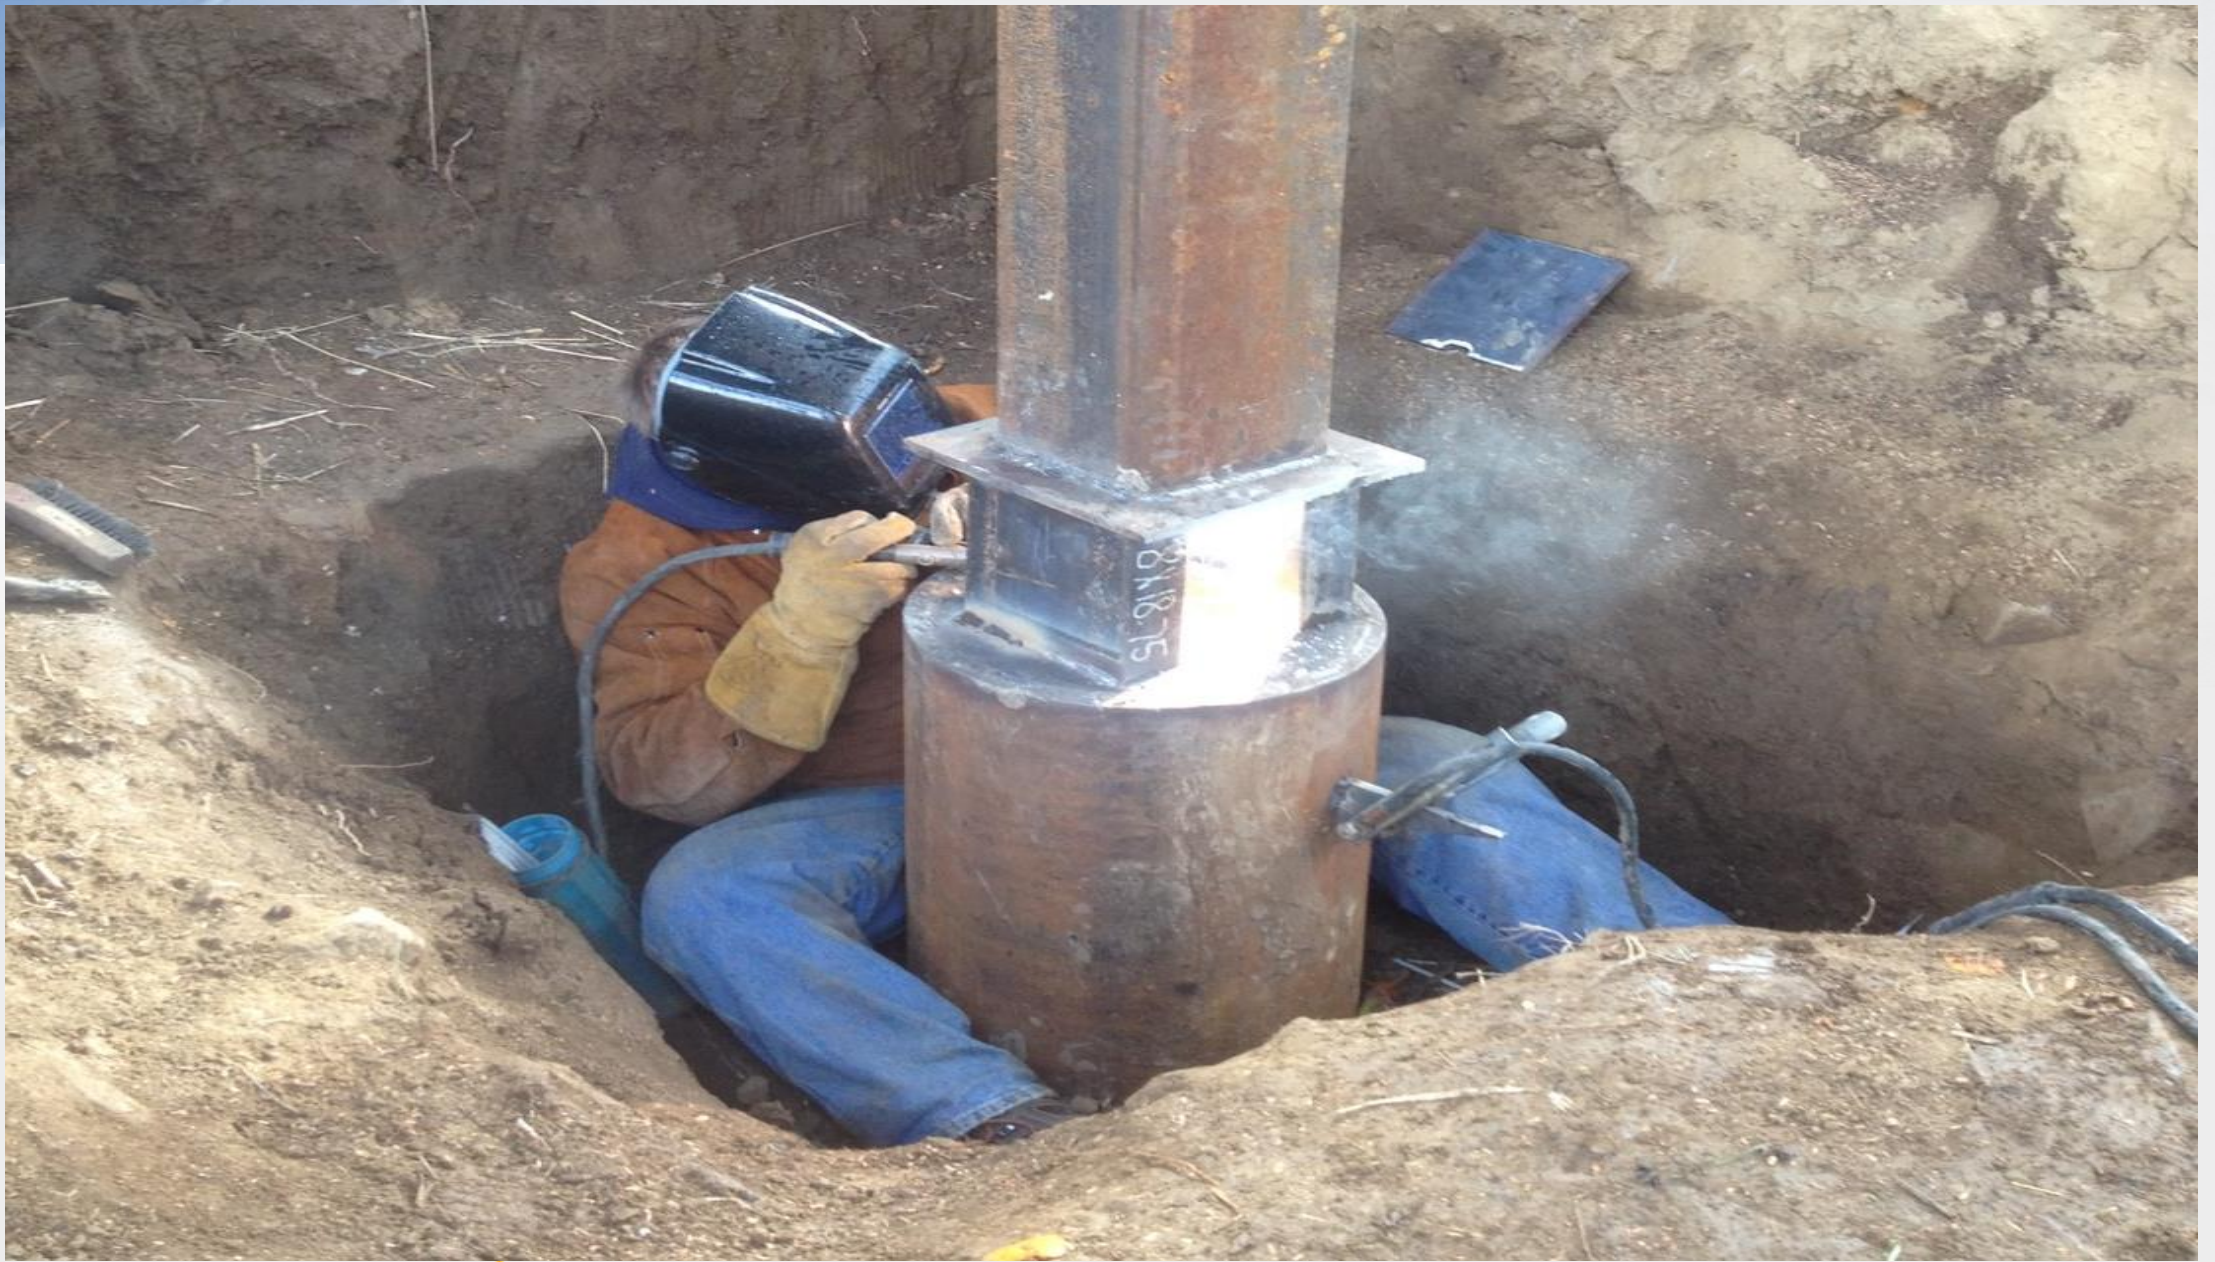
Completed Splice

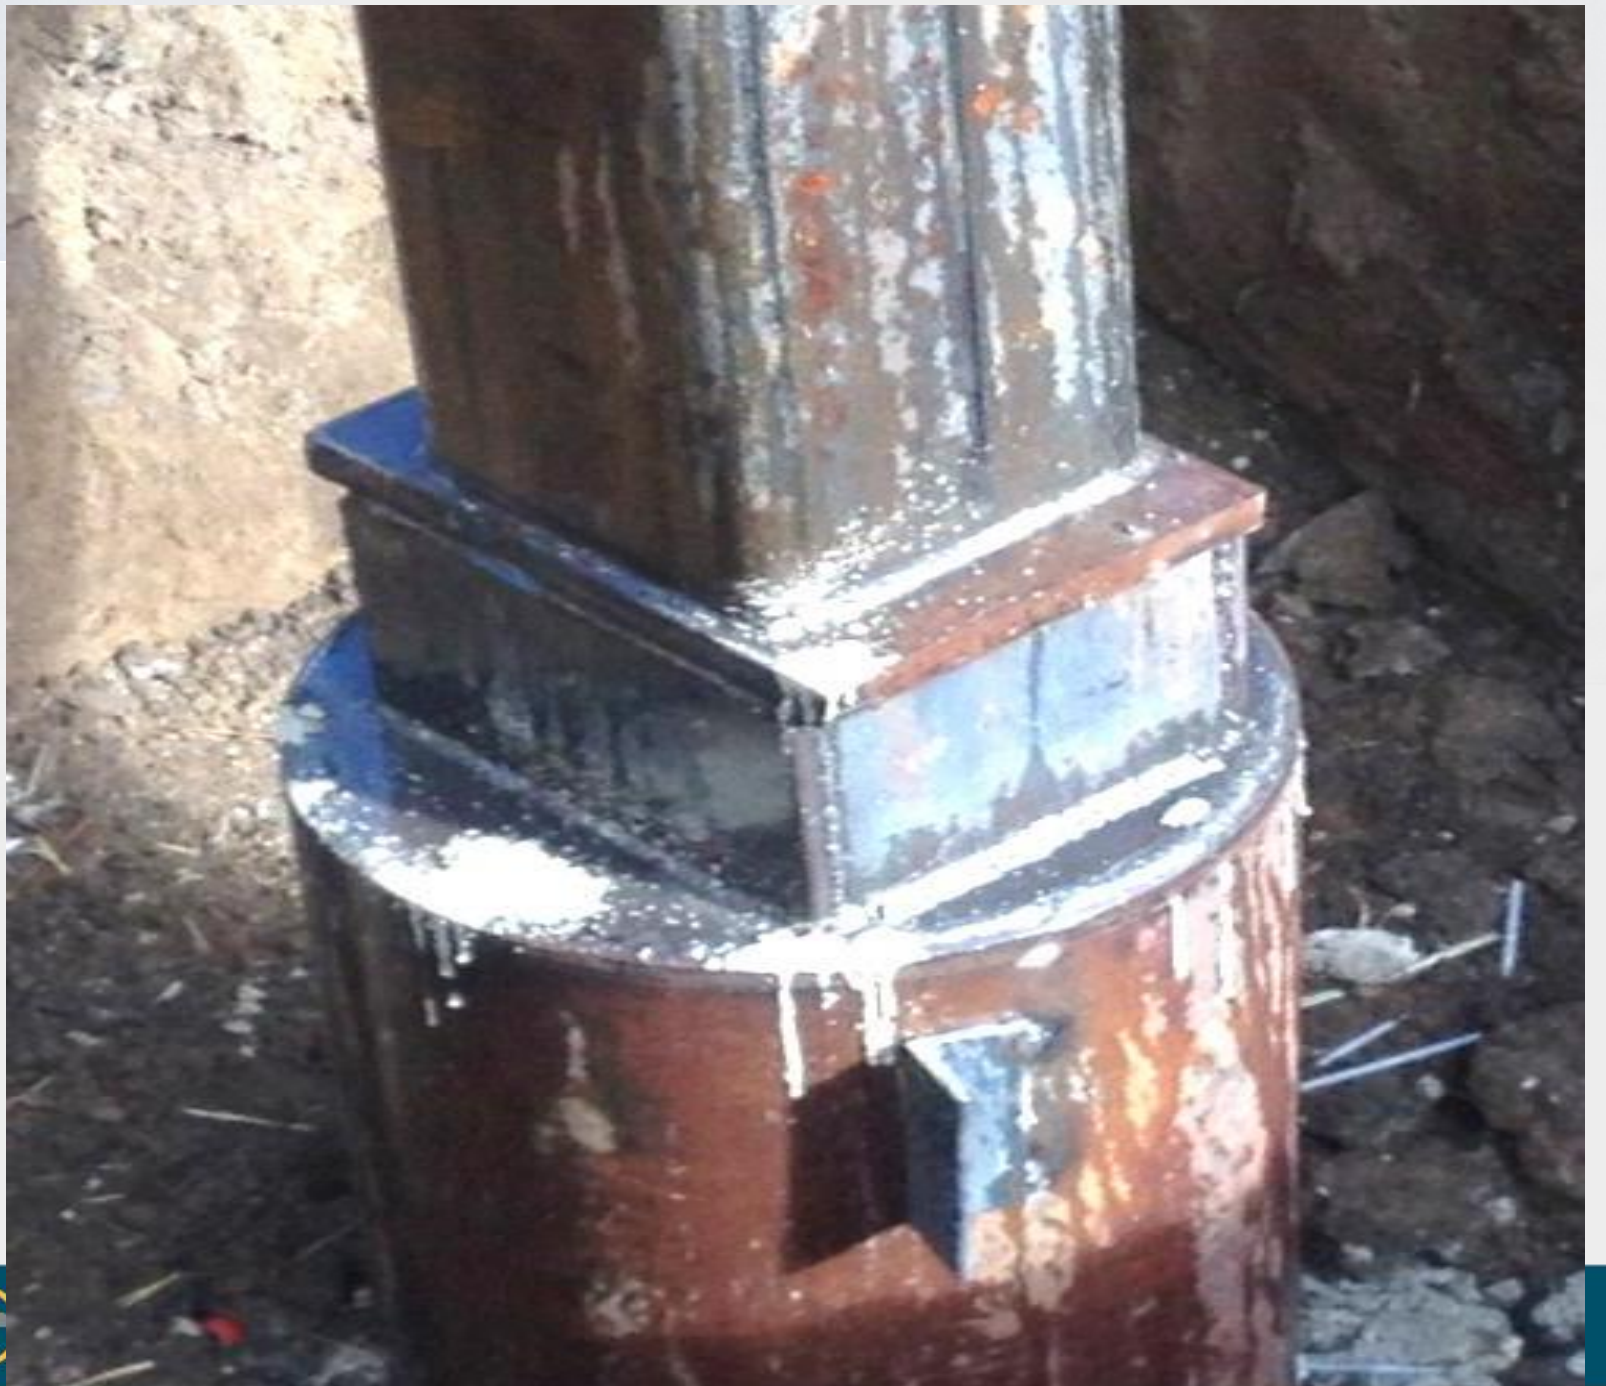
Step 12: Back fill
to existing ground
level

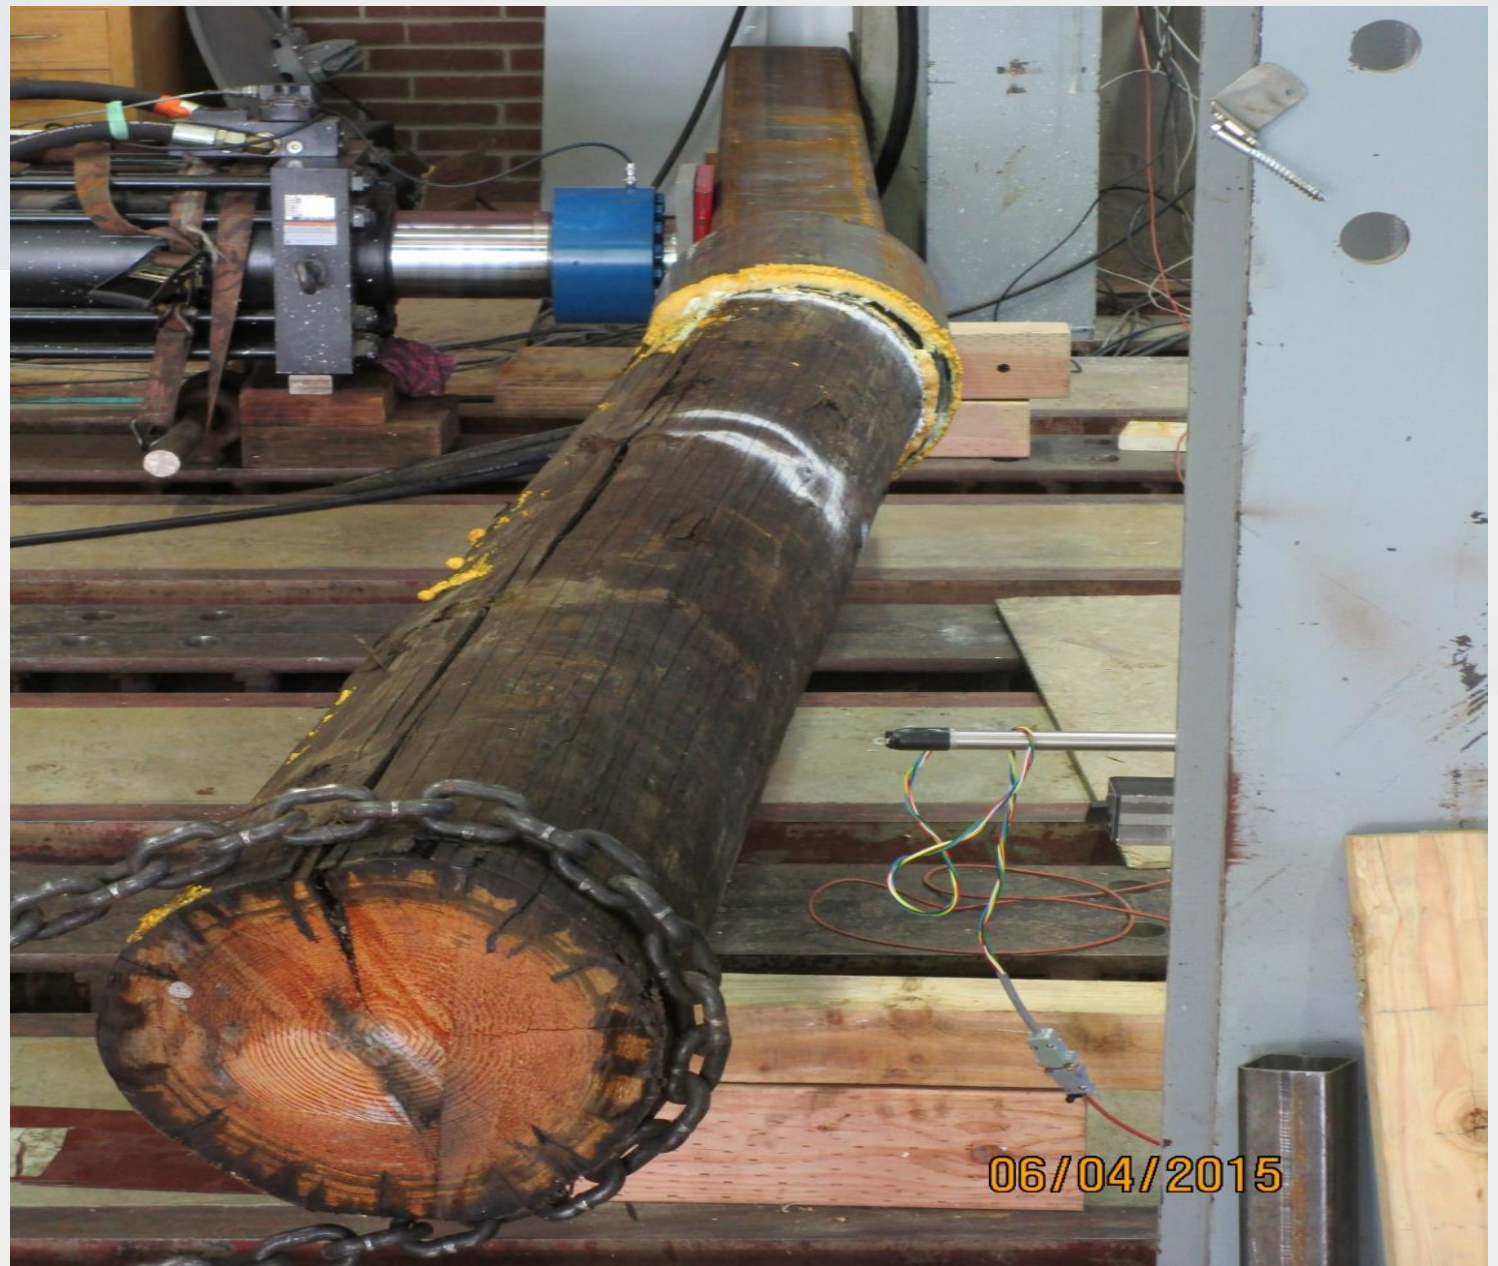
Typical Lateral Test Failure

- All three failed at the base of the splice.
- Loading at failure was about what you'd expect for an unrepaired pile with 2" shell.
- Load remained about constant through 12" – 24 " of deflection

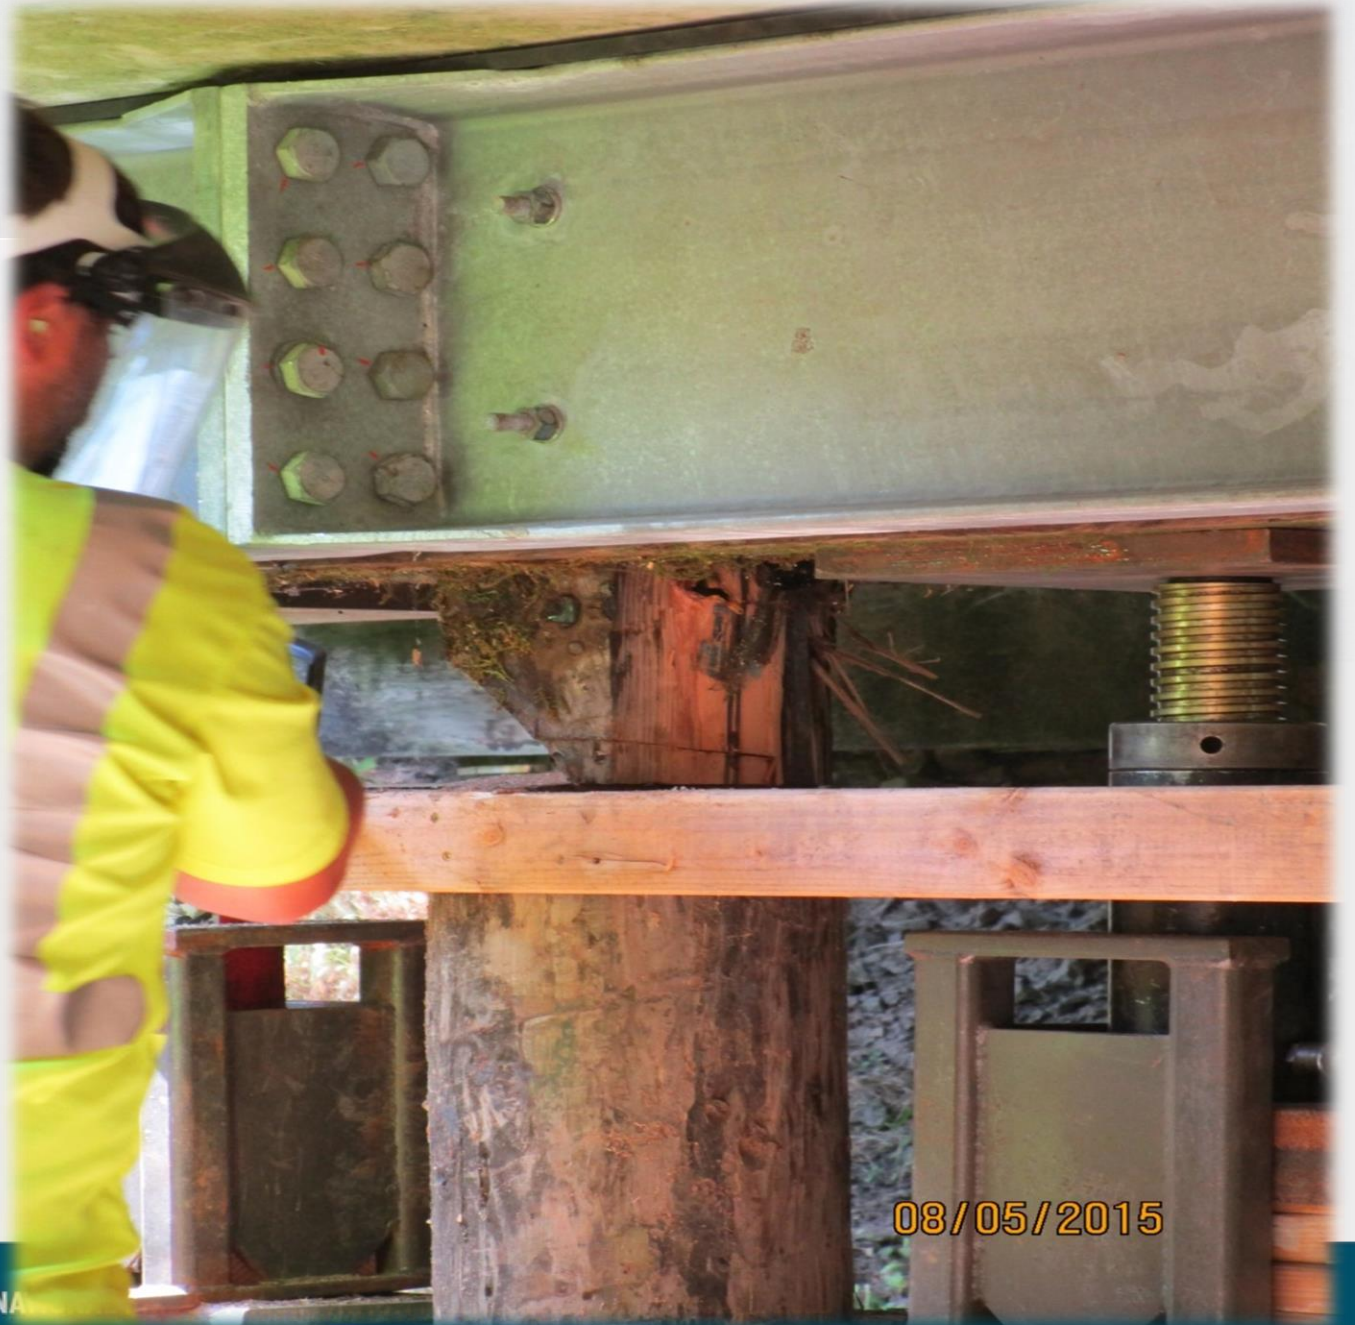
- Cutting Pile Off to install splice.

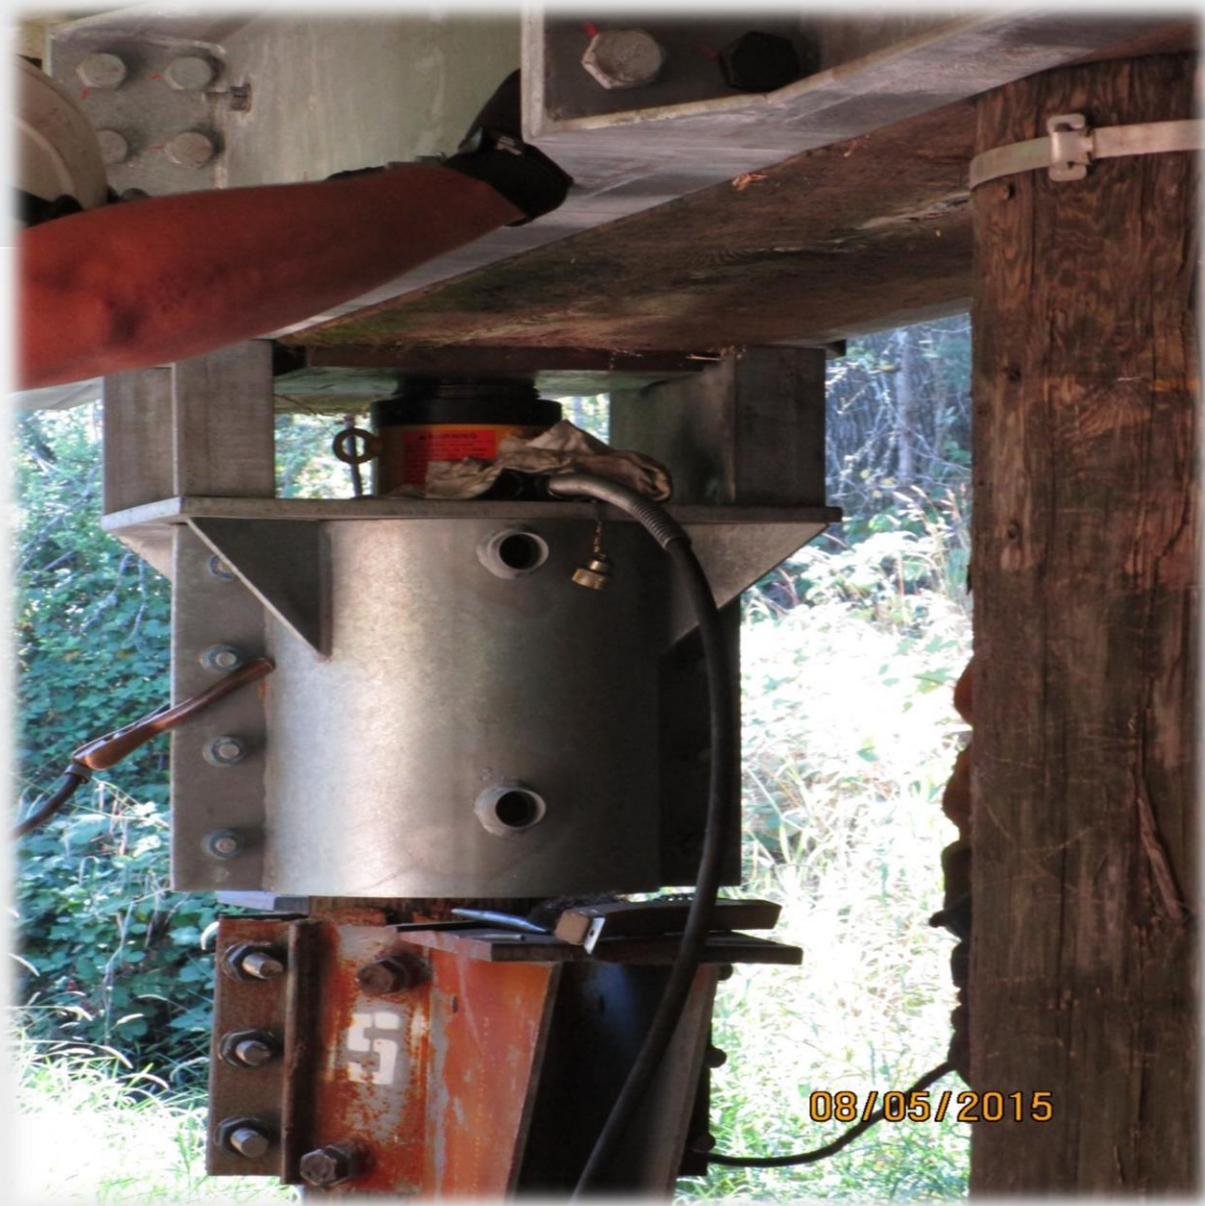
- Installing channel shims to connect steel cap to pile splice.

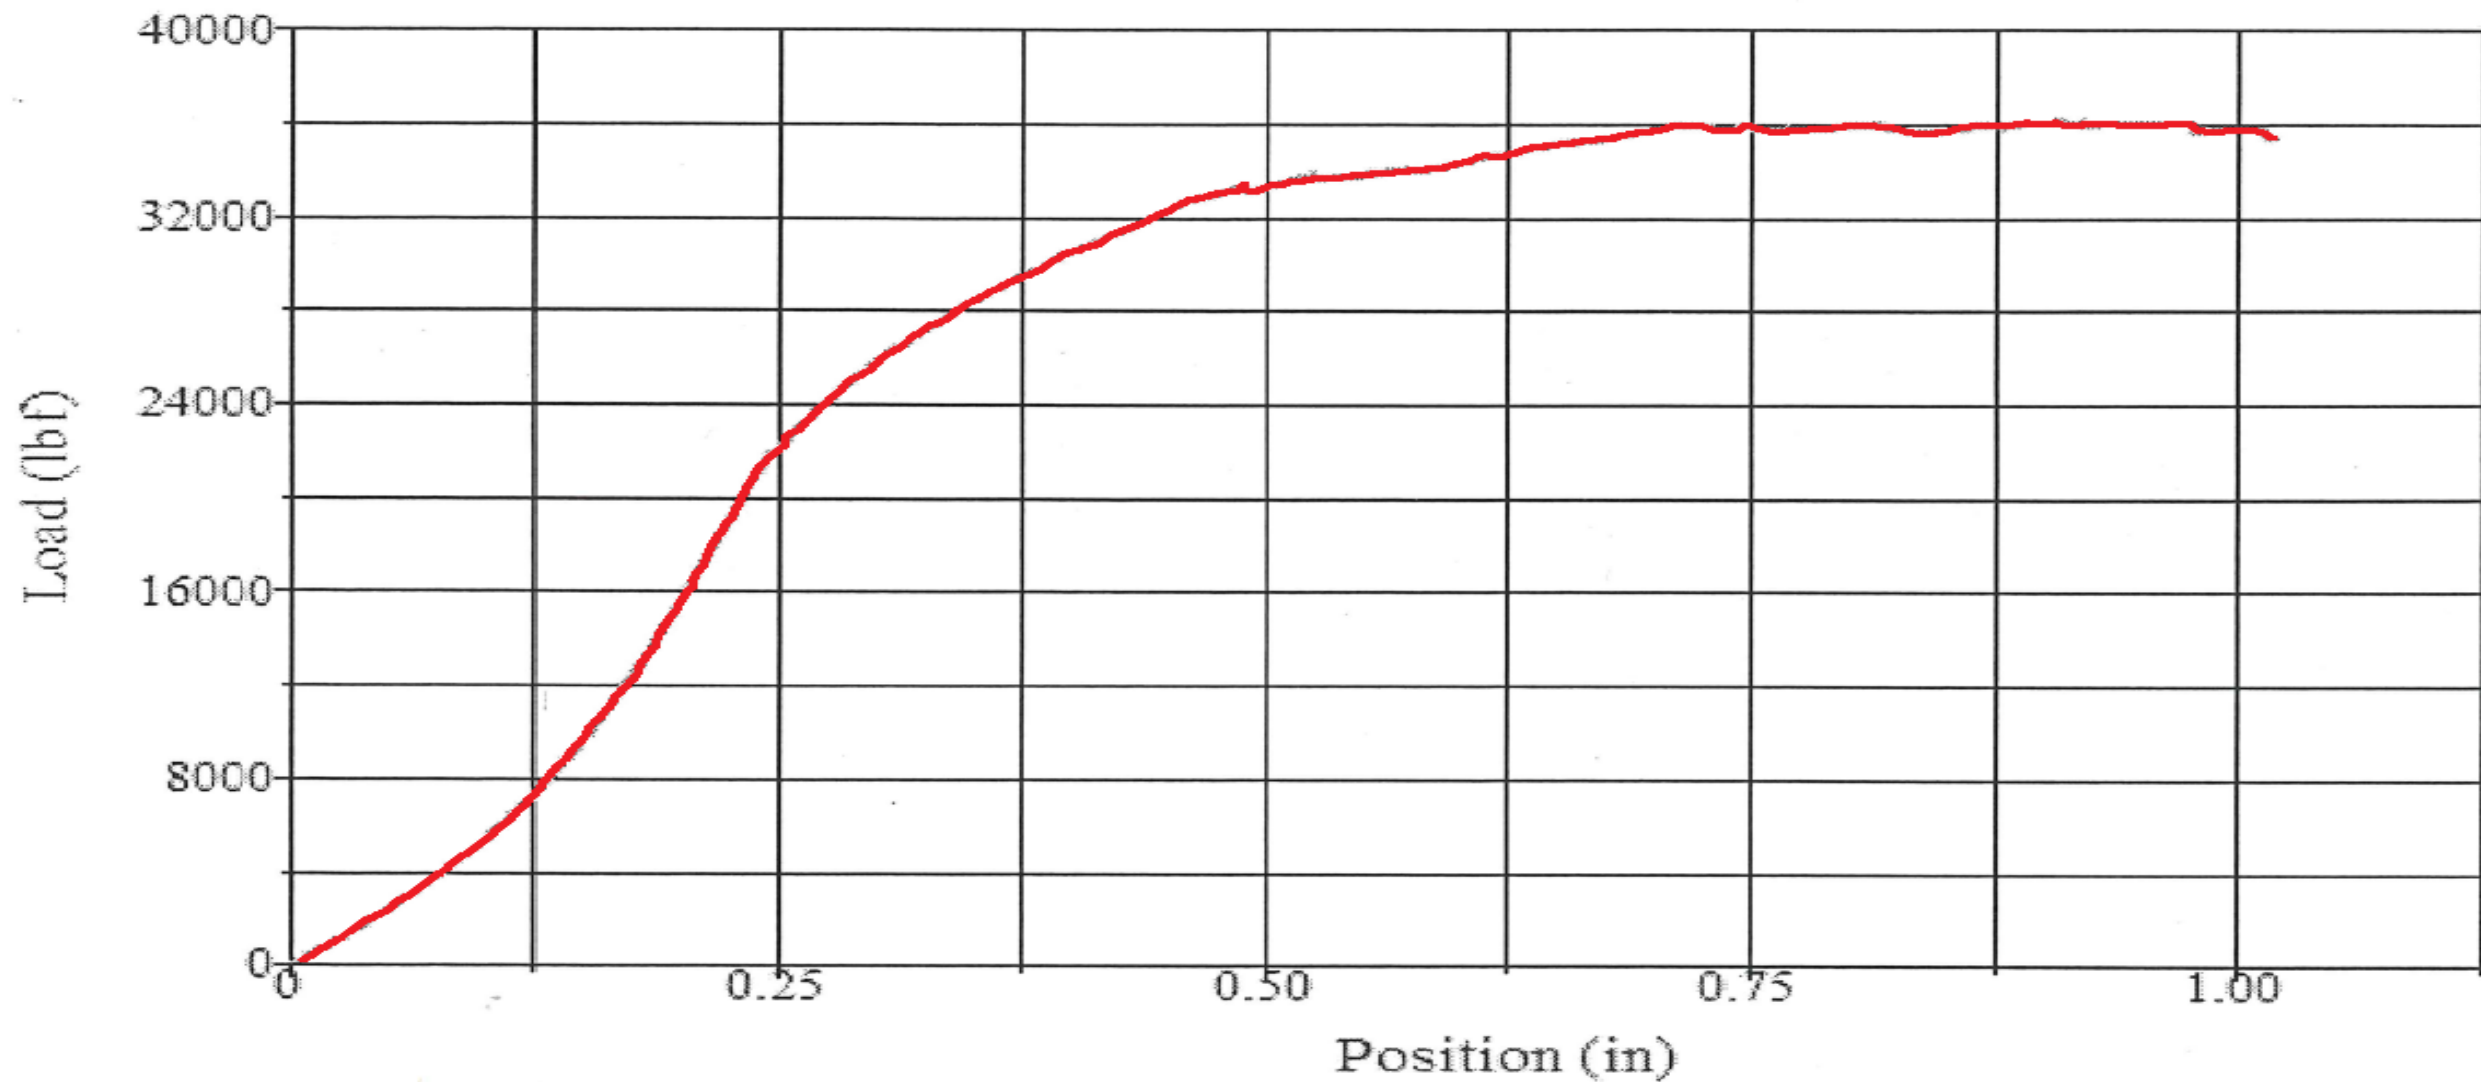
Destructive Testing Results

- Encapsulation:
 - Useful when utilities or shoring constraints make full removal problematic.
 - \$50,000 - \$80,000.
 - Connection to piles can be difficult.
 - Not feasible on abutments.
- Cap Replacement:
 - \$25,000 - \$65,000
 - Shoring dominates design constraints and overall cost.
- Epoxy Injection:
 - Not recommended at this time as a viable cap repair.
