# Successful Implementation of Steel Coating and Bridge Rehab Projects

Rex A. Costley, P.E.  
Director of Maintenance  
Texas Department of Transportation

Queen-Isabella-Causeway

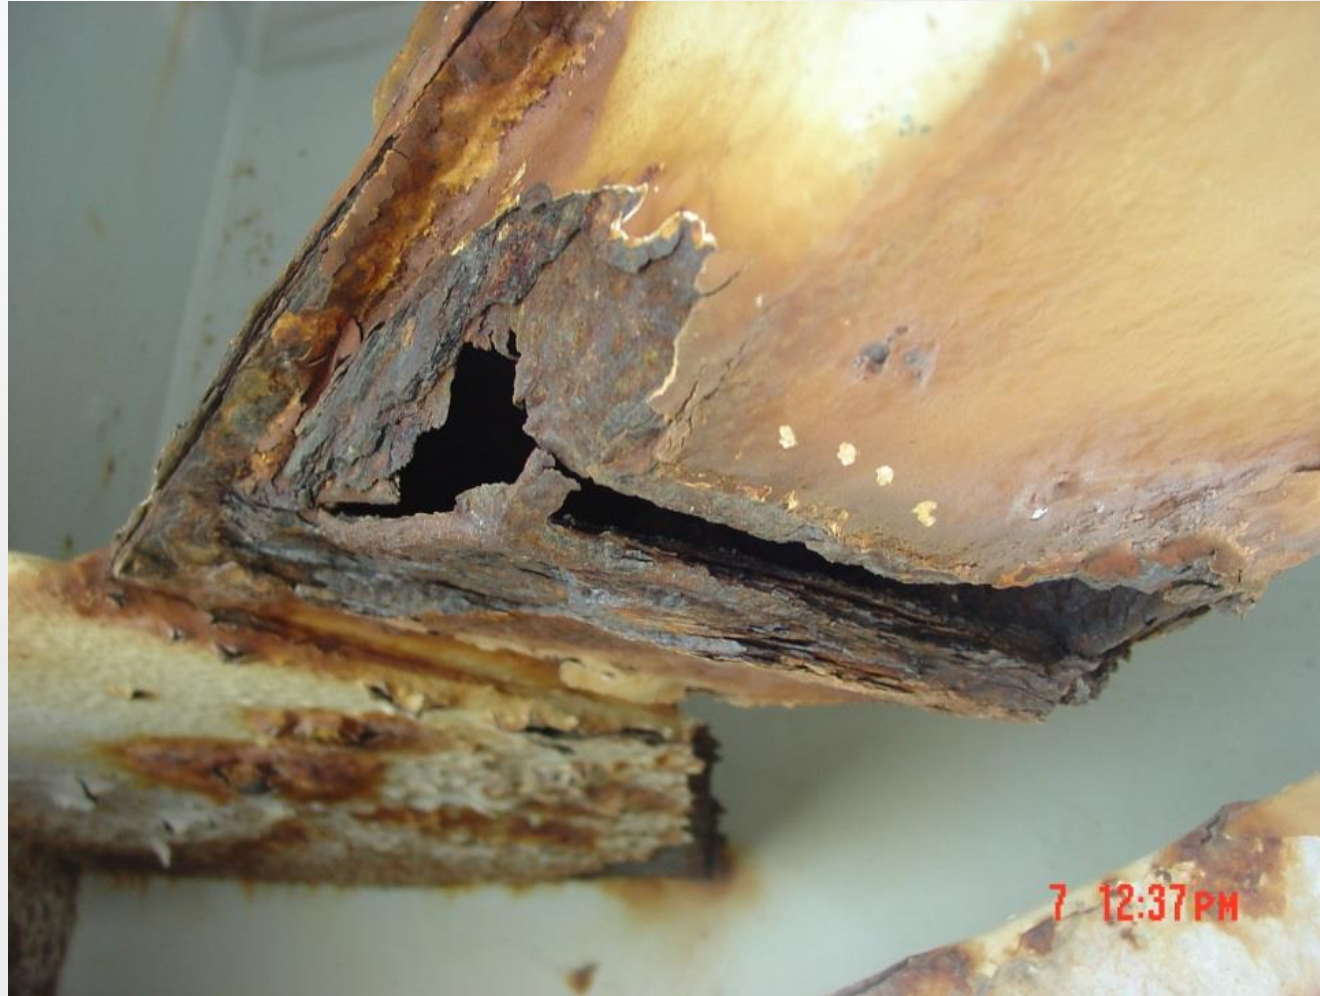
# Existing Conditions

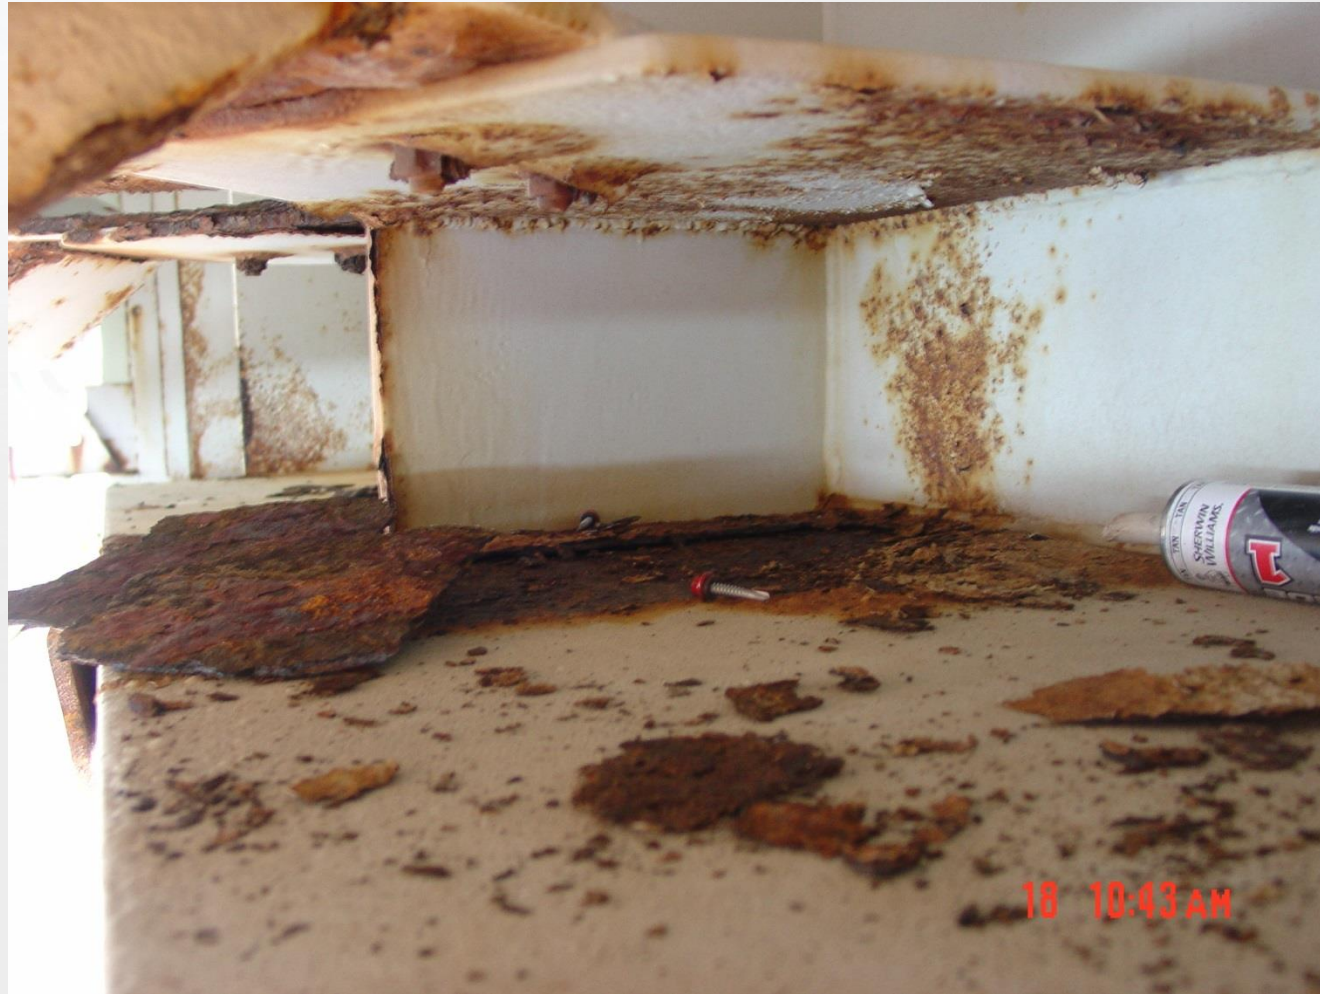
# Existing Conditions

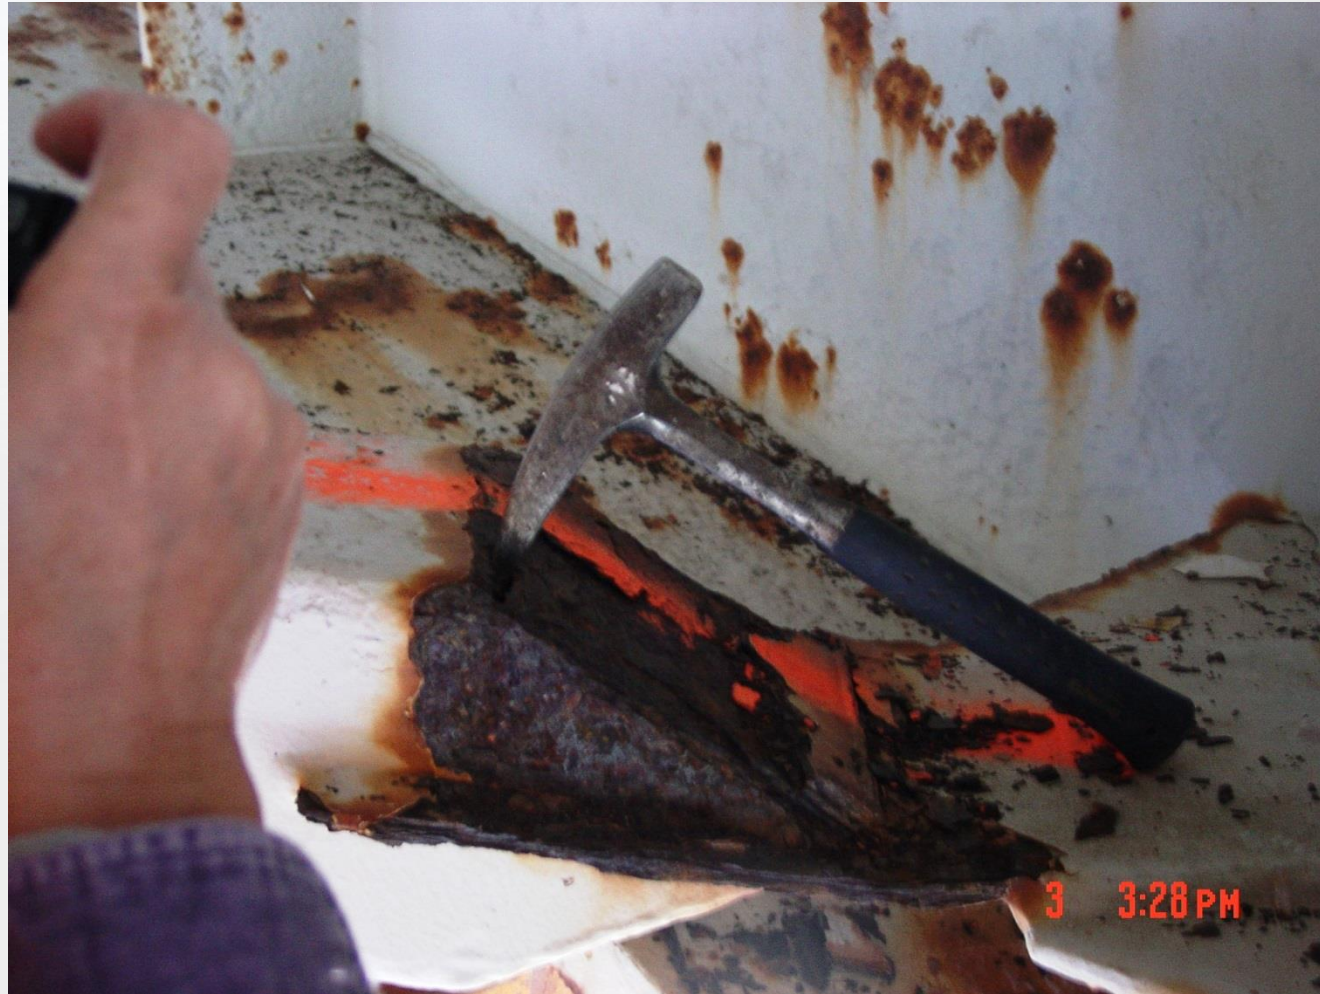
# Existing Conditions

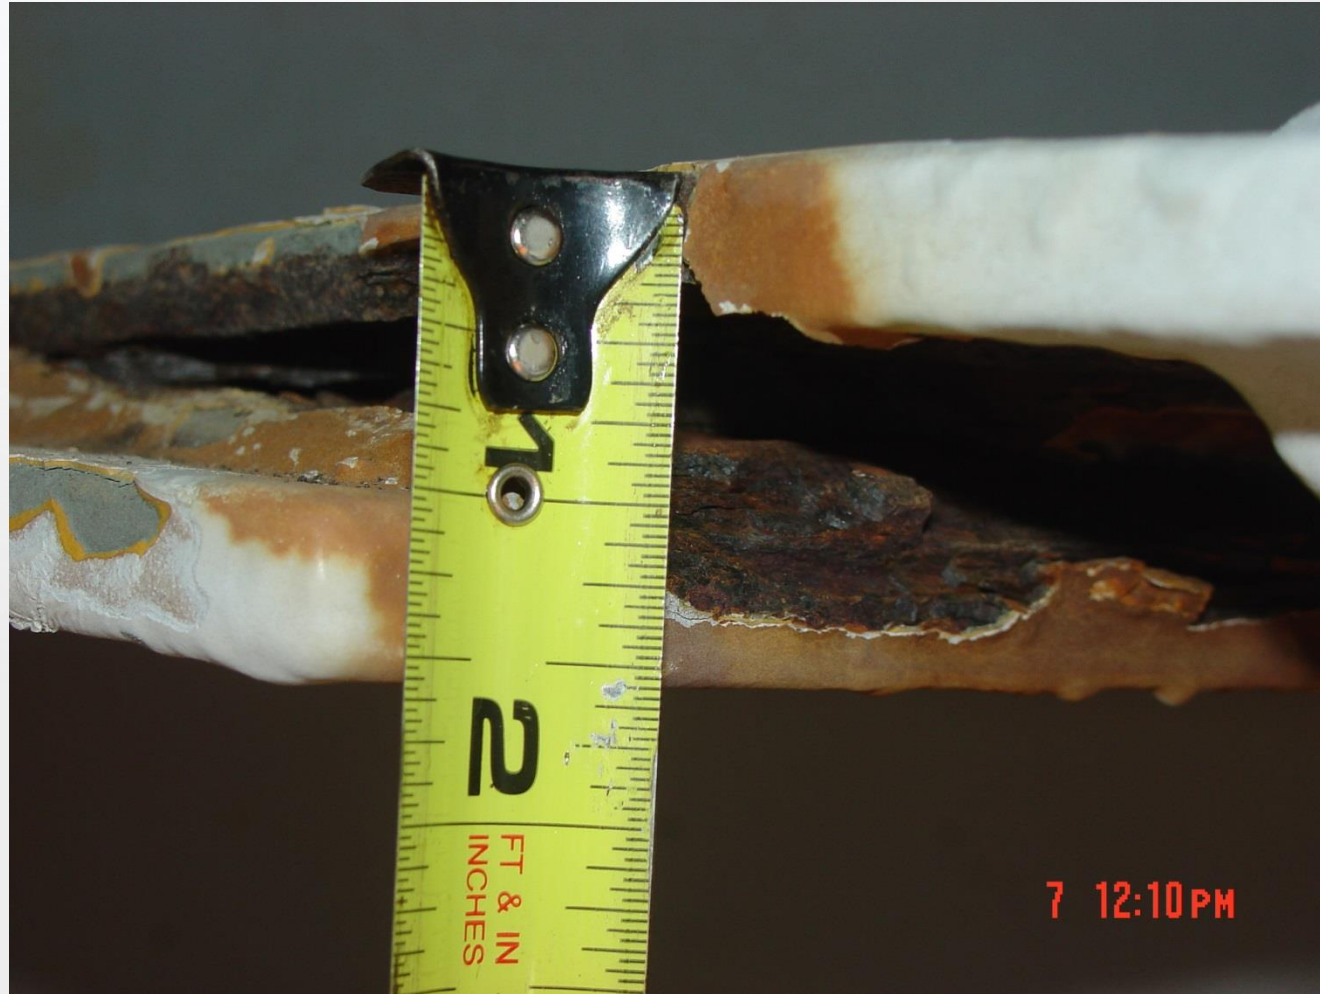
# Existing Conditions

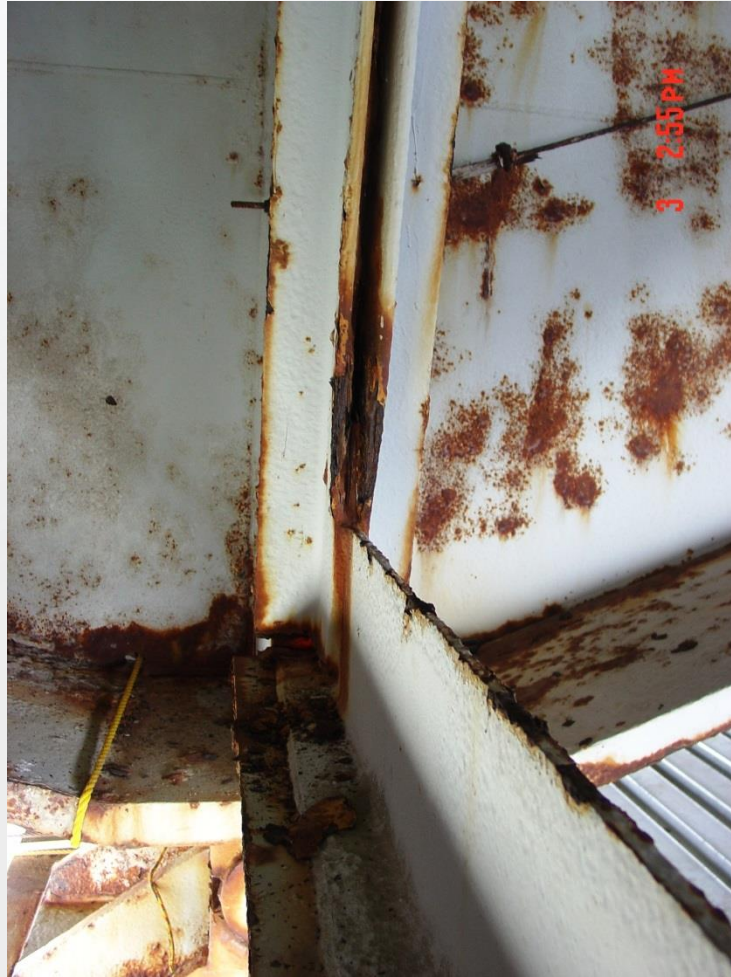
# Existing Conditions

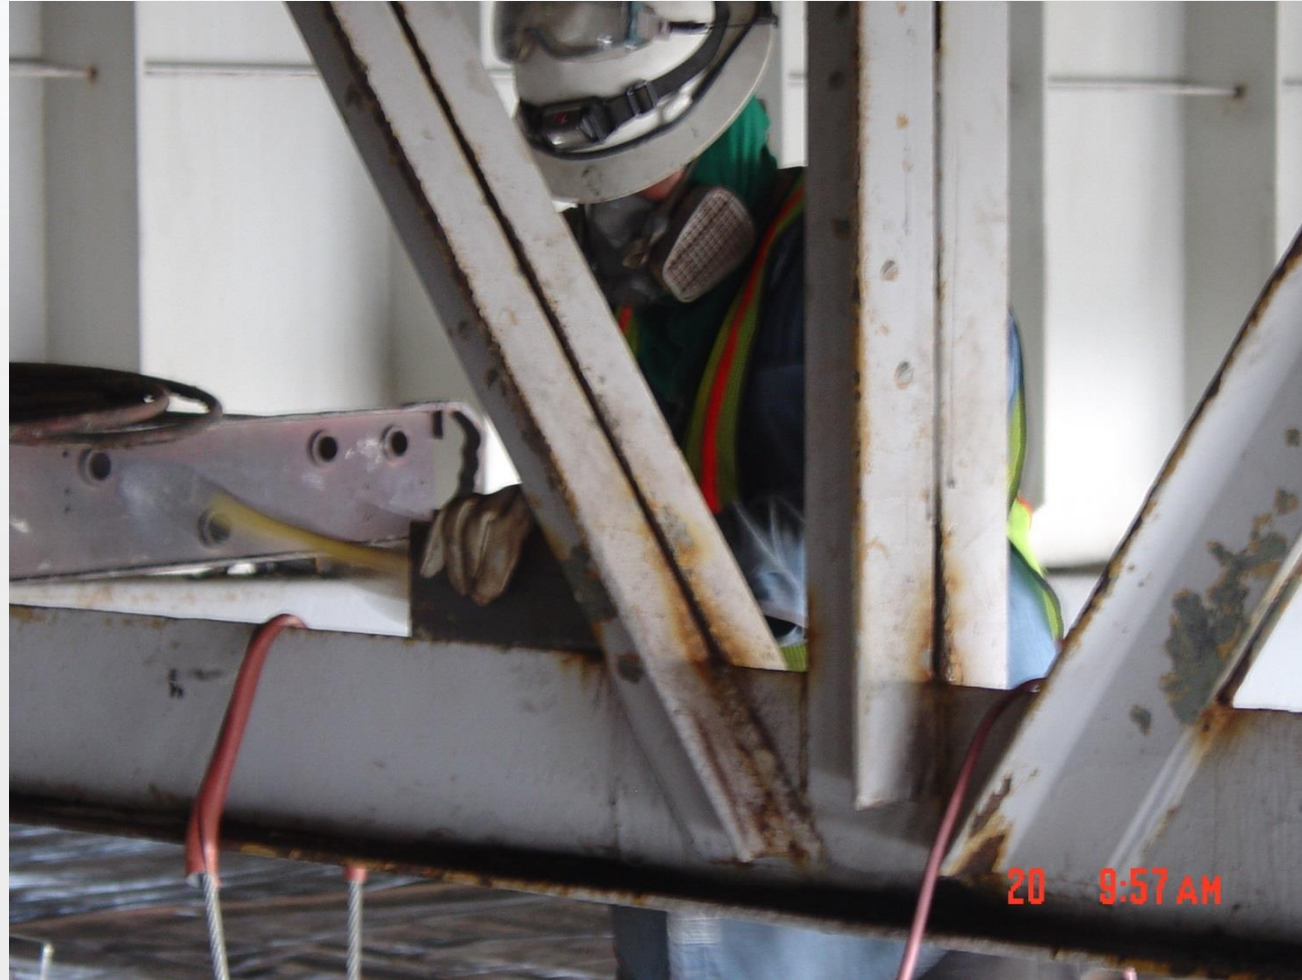
# Paint Removal (Removing Pack Rust)

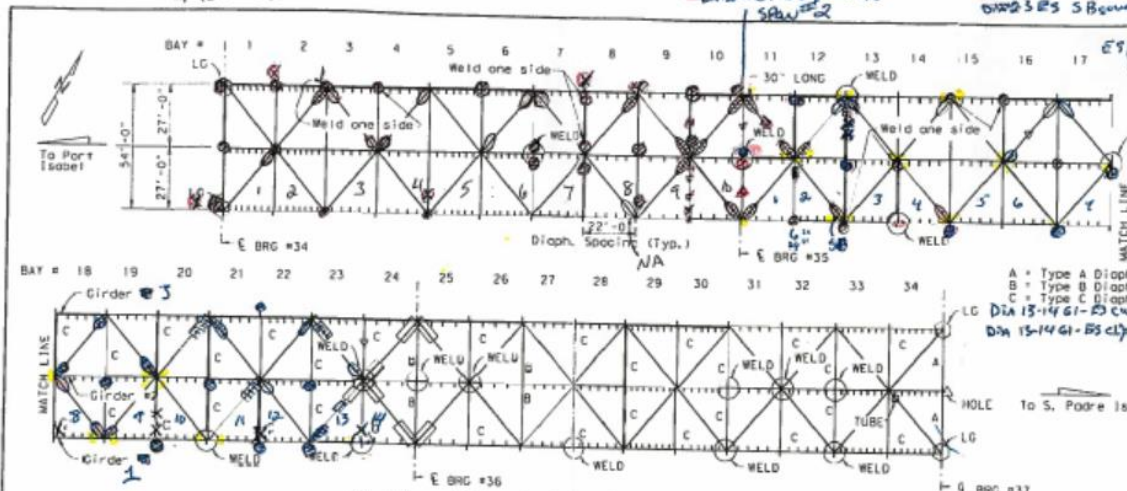
PLAN ~ Steel Repair Location  
CONTINUOUS PLATE GIRDER UNIT

Note: This sheet includes all repairs to date and is subject to change due to post blasting operations and upon further investigation of the preferred repair type by the Engineer.

NOTES:  
Clean and Paint all steel components on bridge (including but not limited to: beams, stiffeners, diaphragms, bracing, and shoe bearings) in accordance with Item 446, "Cleaning and Painting Steel."  
APPROXIMATE TOTAL SURFACE AREA = 150,000 SF

- STEEL REPAIR WORK (as annotated on drawings):
- "LC" - Install 7 lateral guides at this shoe bearing. To be paid under Item 442-2005.
  - "WELD" - Perform weld repair(s) at this node. To be paid under Item 784-2002.

- "TUBE" - Perform steel repair(s) at the end of tube(s) at this node. To be paid under Item 784-2005.
  - "HOLE" - Perform steel repair to holes at this node. To be paid under Item 784-2005.

- "TYPE 1" - Perform steel repair(s) to tubes at this node. To be paid under Item 9000-2004.
  - "TYPE 2" - Perform steel repair(s) to tubes at this node. To be paid under Item 9000-2004.

- "TYPE 1 OR 2 TUBE REPAIR" - Perform steel repair(s) to tubes. To be paid under Item 9000-2005.
  - "CRACKED WELDS" - Perform weld repair(s) at this node. To be paid under Item 9000-2004 or 9000-2005.

- "DIAPHRAGM ENDS" - Perform steel repair(s) to ends of diaphragm. To be paid under Item 9000-2009.
  - "CLIP ENDS" - Perform steel repair(s) to holes at this diaphragm. To be paid under Item 9000-2010.

- "CLIP STIFFENER" - Perform steel repair(s) to stiffener. To be paid under Item 9000-2011.
  - "SMALL HOLES" - Perform steel repair(s) to diagonal tubes. To be paid under Item 9000-2012.

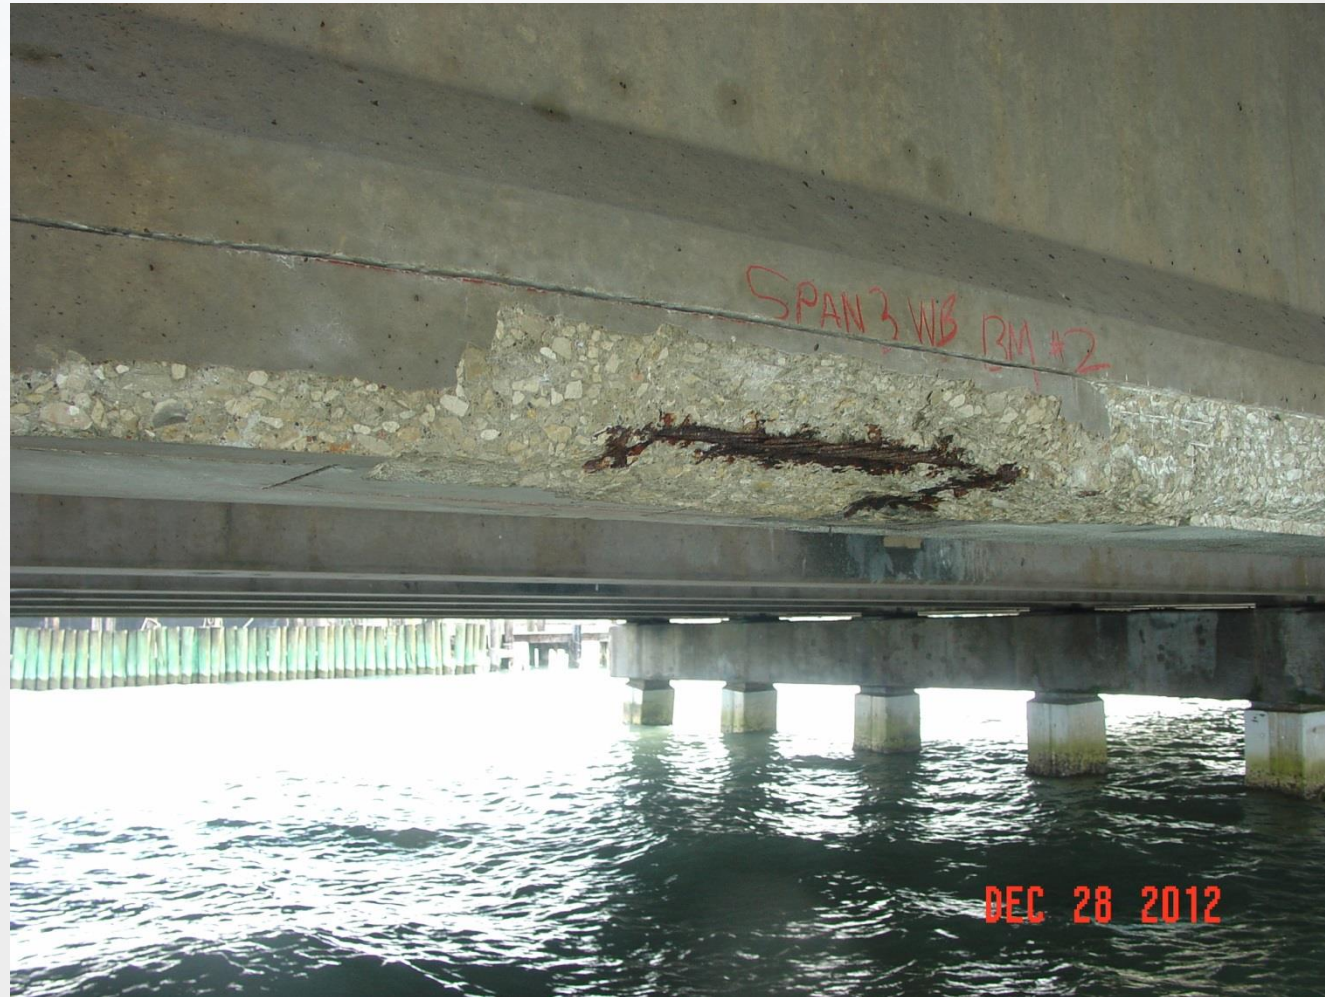
# Exposed Pre-Stressed Strand – Corrosion Propagating

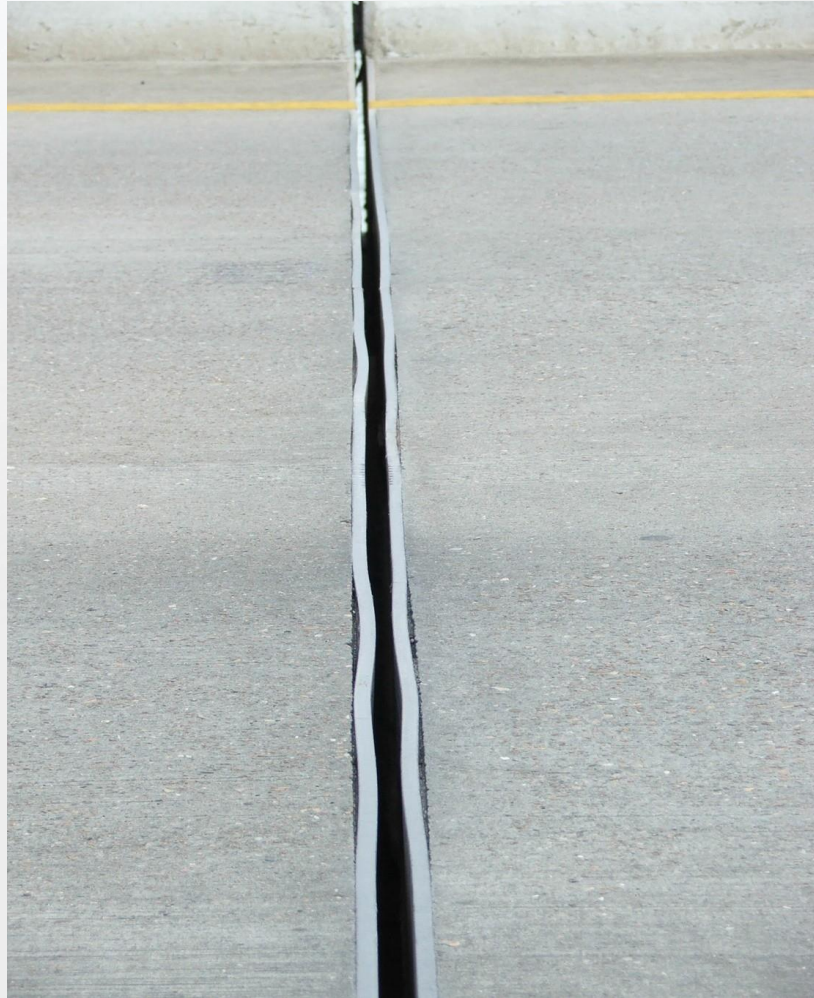
# Armor Joint Plate – Deformation

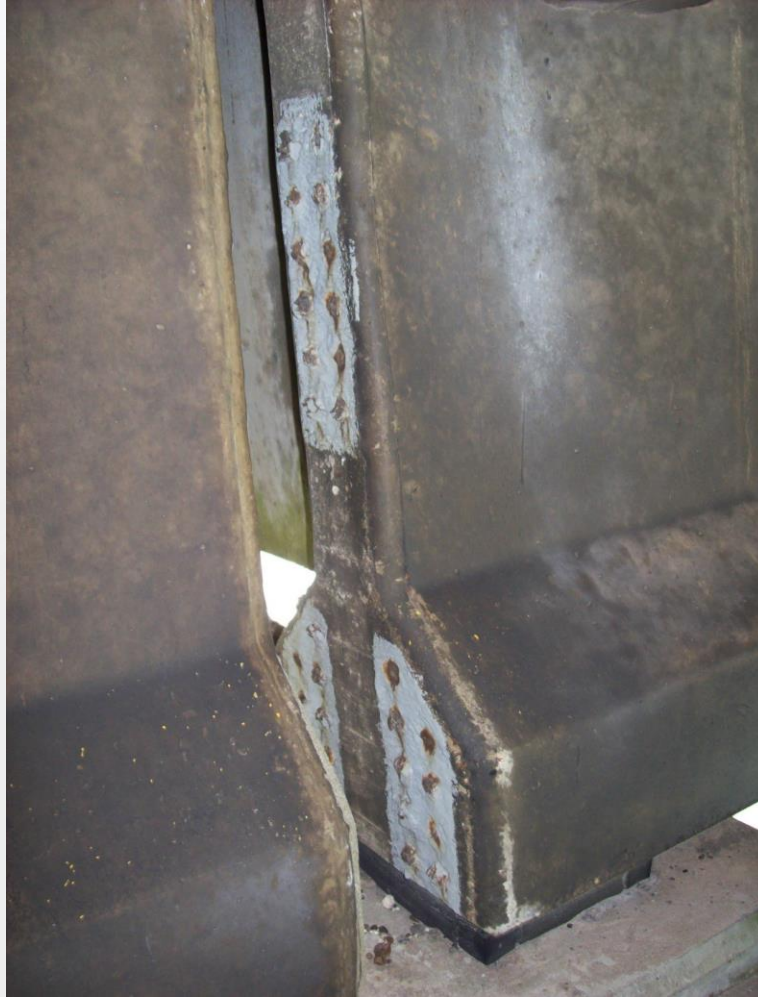
# Beam End at Various Locations Deteriorated Epoxy Coating and Exposed/Corroded Strands

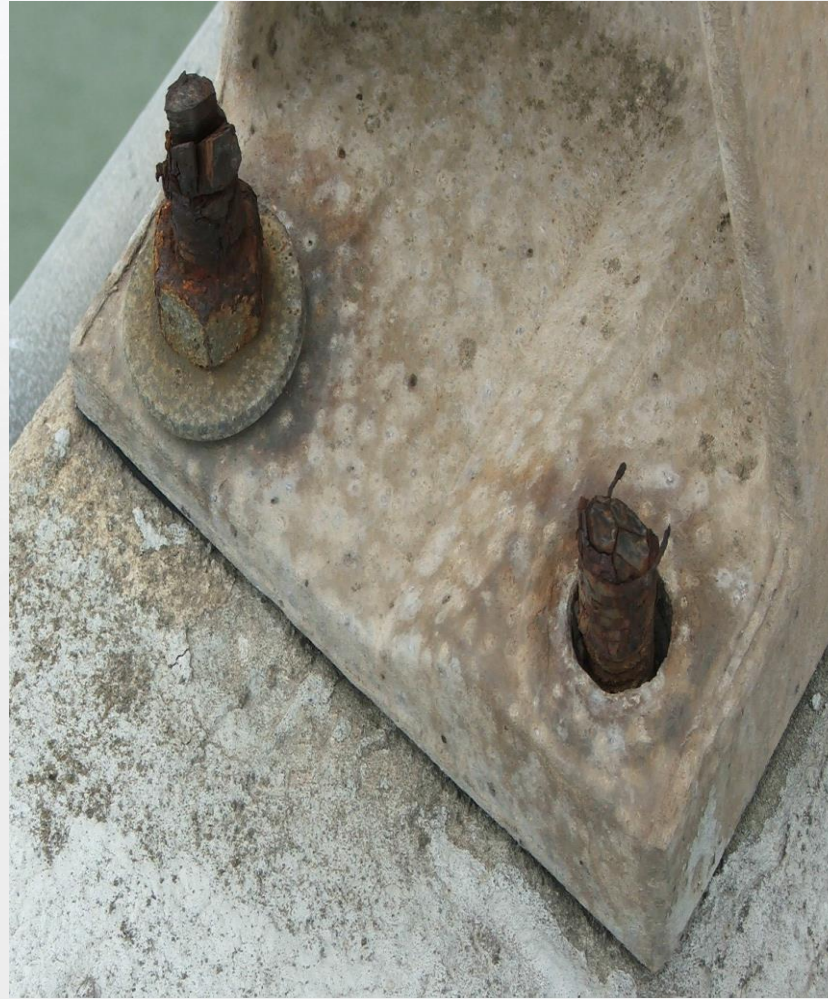
# Existing Rail Connection – Typical Existing Anchor Bolts and Hardware Severely Corroded
