Route 37 EB & WB Bridges over Barnegat Bay *Superstorm Sandy Emergency Repairs to Scour damaged Piers*

Township of Toms River, County of Ocean, New Jersey

PRESENTED APRIL 2018

OWNER: NEW JERSEY DEPARTMENT OF TRANSPORTATION
DESIGNER: WSP USA (FORMERLY PARSONS BRINCKERHOFF)

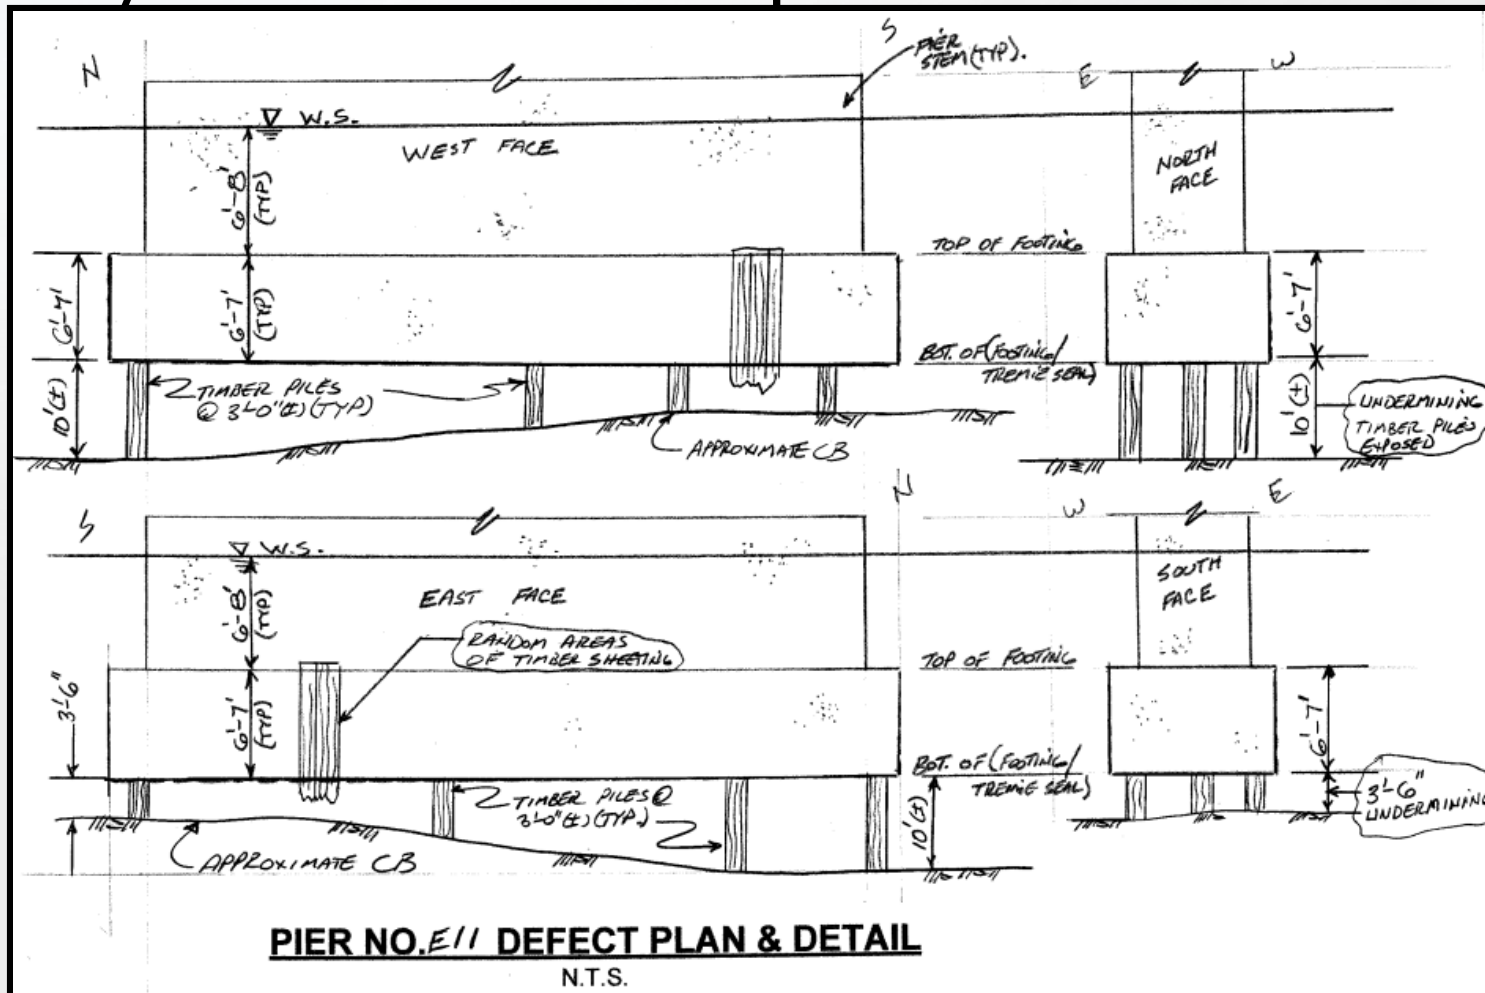
Post-sandy underwater inspection sketches

- Team's Familiarity with Project Site
- As-built Bridge Plans Included Subsurface Information
 - Length of pier timber piles were estimated from as-built quantities
- Analysis Included:
 - Post-Sandy scoured condition – Dec. 2012 inspection data used
 - Post-construction condition with scour repairs installed
 - Determined ultimate geotechnical axial capacity of single pile for critical pier
 - Analyzed pile group for pile cap deflection, axial load, shear, and bending
 - Critical Pier 11– fully undermined, 10' max. pile exposure, 15' scour

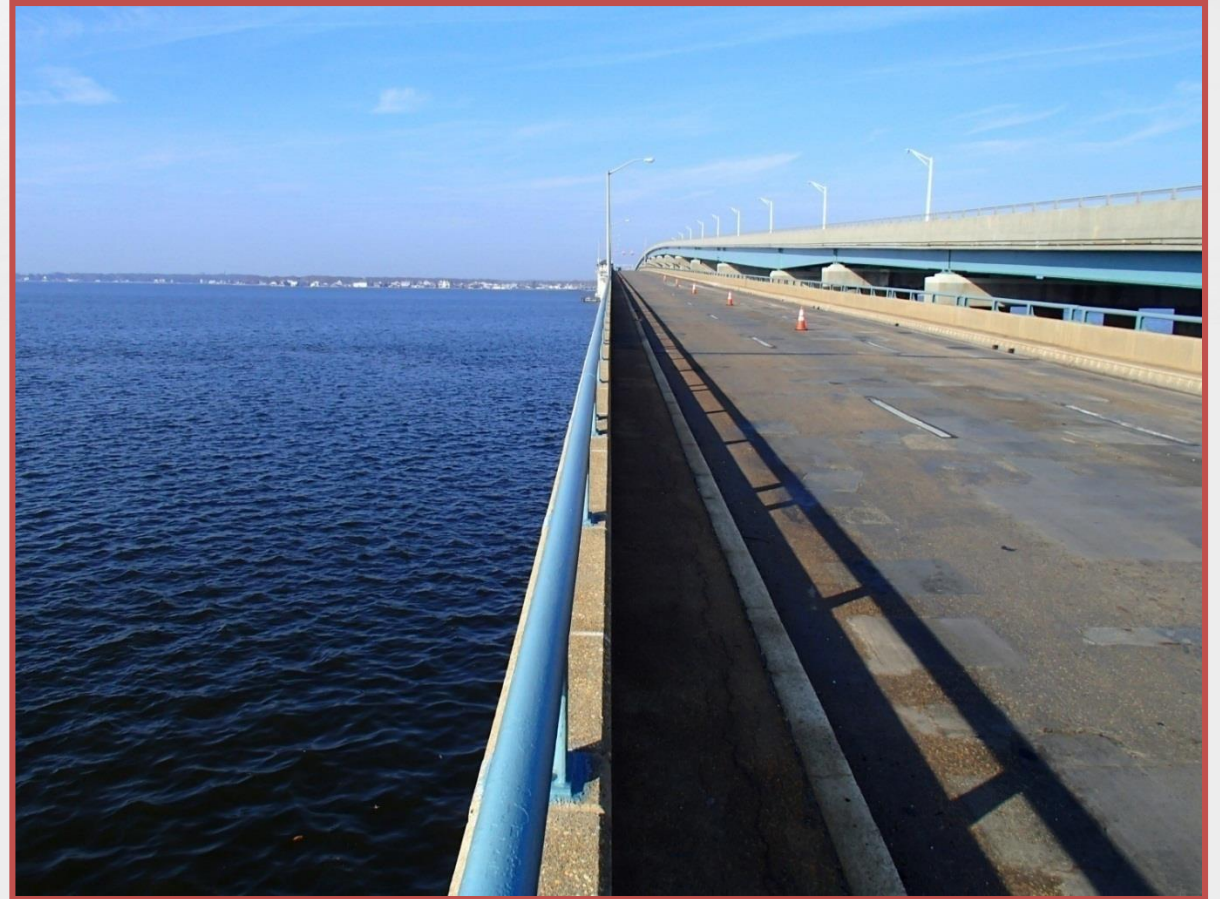
General view of south railing during emergency inspection

No dips or kinks to indicate immediate damage incurred
