# 2019 Midwest Bridge Preservation Partnership Meeting Bismarck, ND

Fouad Jaber, PE

# Damage Inspection Report

**Situation:** On Friday, June 1<sup>st</sup>, 2018, an RV caught fire on the I-80 WB shoulder directly adjacent to the pier of the 10<sup>th</sup> street bridge (S080 45433). The fire caused damage to the I-80 WB pavement, barrier rail, north face of the bridge pier, steel elements of the superstructure, bridge deck, and utilities attached to the bridge. The fire department used 7 fire trucks to put out the fire.

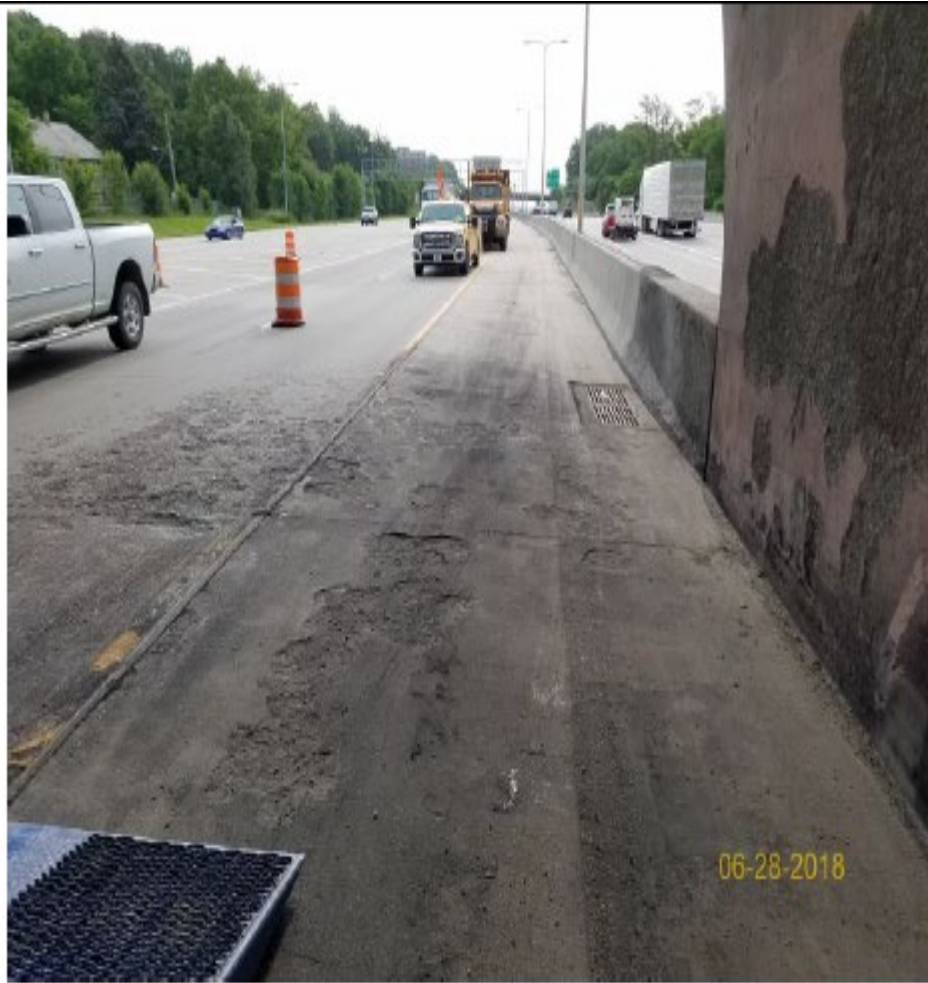
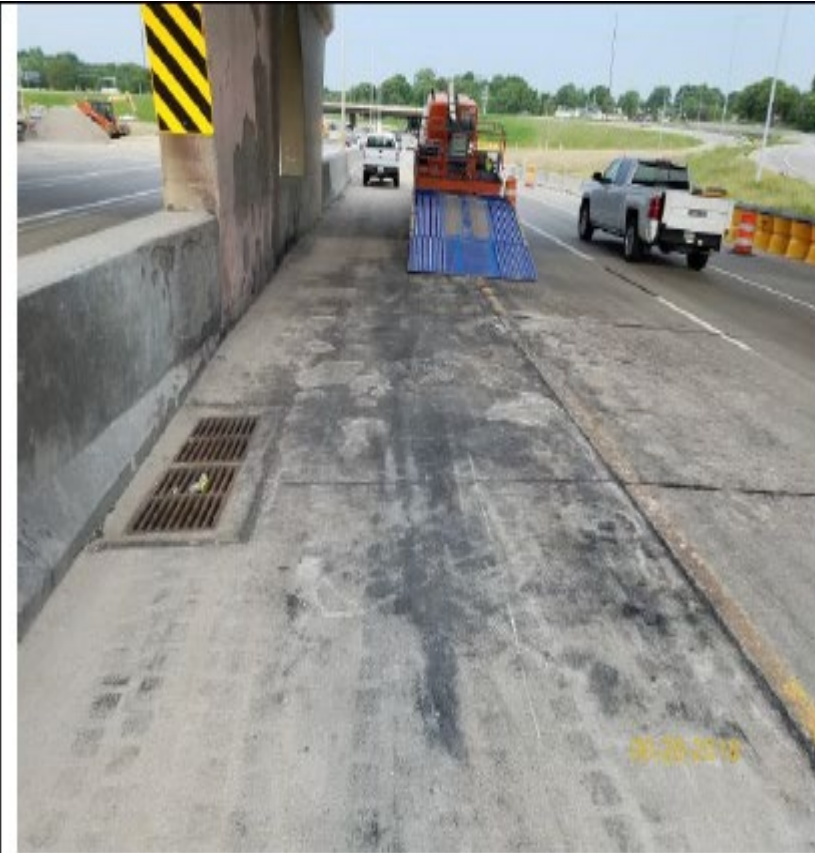
**I-80 Paving:** There are large areas of shallow spalling to the shoulder and left passing lane of I-80 WB. There are localized spalls of the barrier rail near the pier with no exposed rebar. See Appendix B for limits of paving damage.

Shallow spalling to I-80 WB shoulder, left lane, and barrier rail.

- The roadway median barrier and roadway surface may be repaired in a similar manner as the concrete bridge pier. However, it may be more cost effective to fully replace the damaged areas.

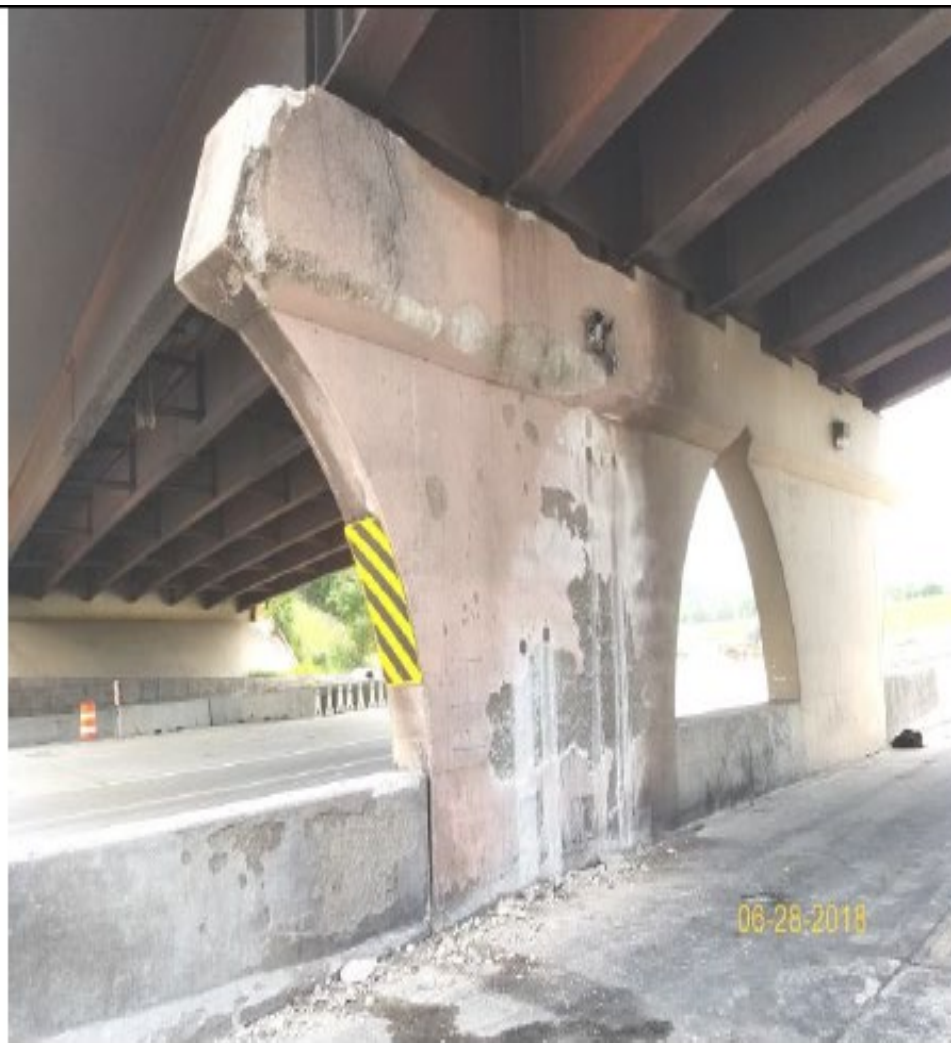
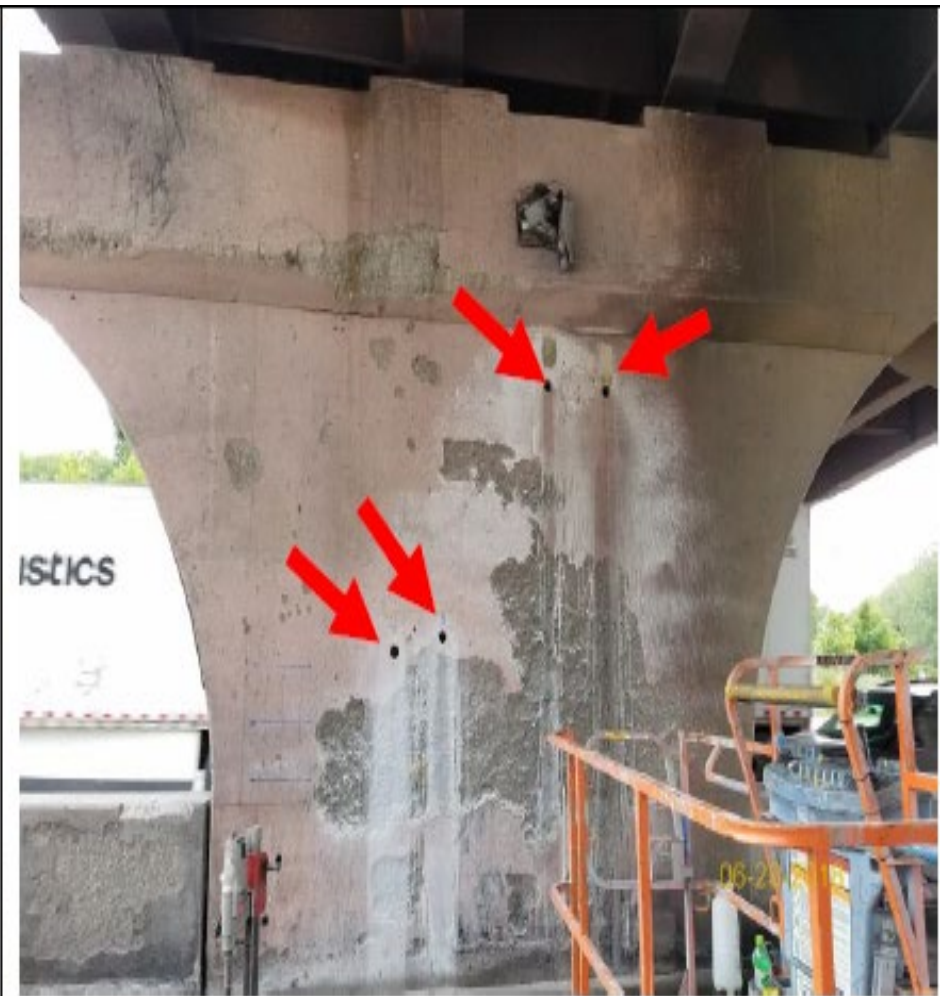
74,73

**Substructure:** Large areas of the north face of the east pier column have shallow spalling. Spalling is occurring at the pedestals near the bearings. Hammer sounding the concrete revealed no areas of delamination.

Widespread fire damage and CS 3 spalls to the north face of the east pier column. 4 cores taken for testing.

Type of Defect: Spall

- The concrete bridge pier may be repaired by removing of concrete on the north face down to the reinforcing. Concrete anchors embedded into the remaining concrete may be necessary to anchor the repair concrete to the existing concrete.

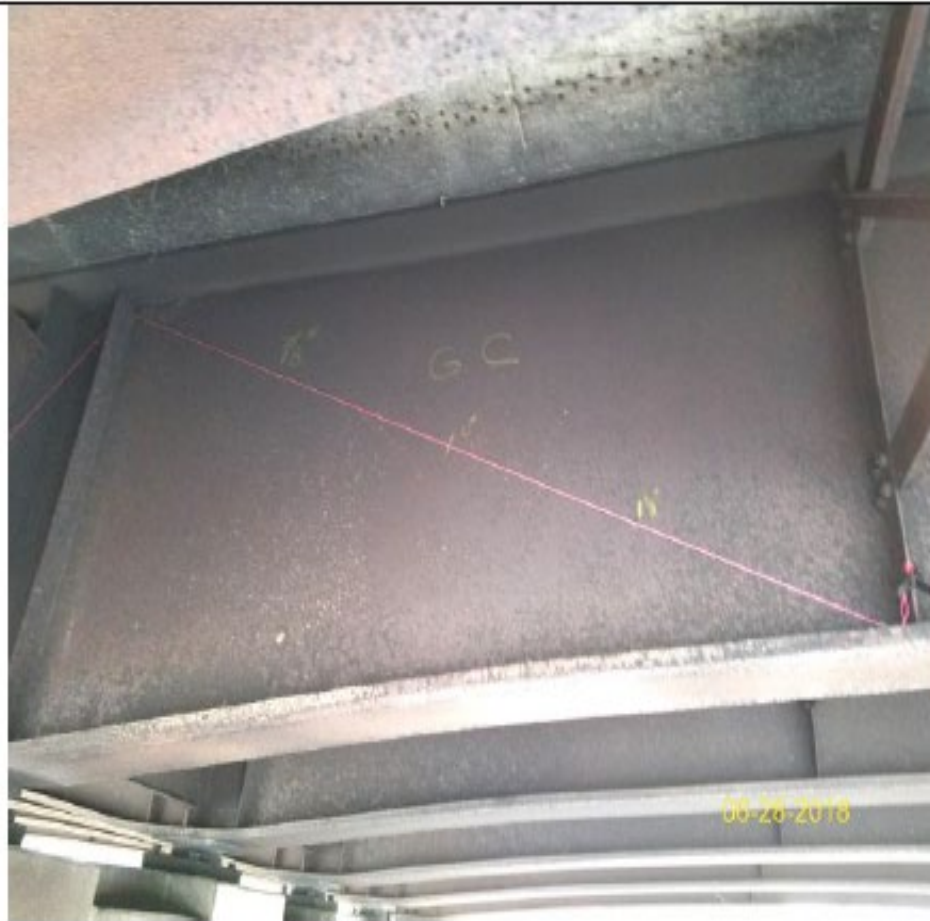
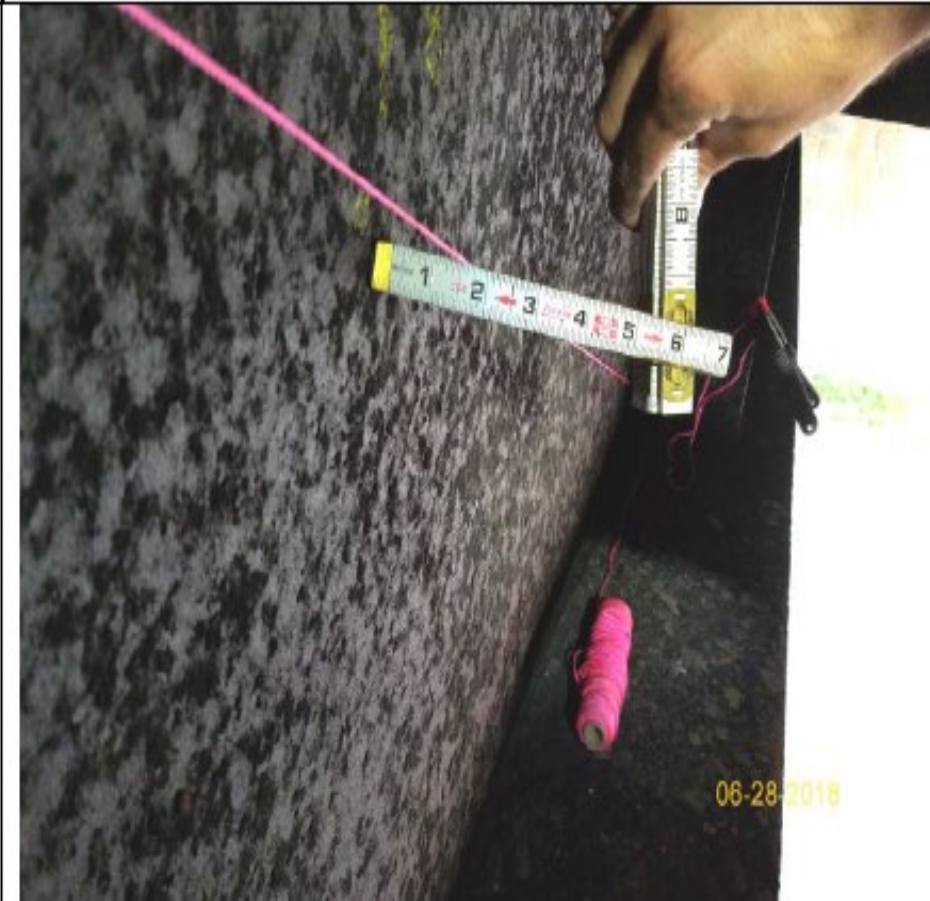
33,11

**Superstructure:** High heat has caused distortion of the webs of Girders A, B, and C with out of plane measurements up to 1 5/8". Cross frames between A-B, and B-C have buckled, and the Pier Diaphragm between A-B has buckled. After power washing, no cracks were detected and no discoloring of the steel was evident. Minor pitting of the steel was observed. See Appendix A for a key plan of the damaged girders, cross frames and pier diaphragm and sketches of the affected girders.

Heat distortion to girder webs with out-of-plane measurements up to  $1 \frac{5}{8}$ ". Evident in Girders A, B, and C. Order of severity: A (worst), B, C

Type of Defect: Girder Web Distortion

- Replacement of the girder field sections affected by the fire.
- To determine the extents of the fire damage, we would recommend LIDAR scanning of girders to further quantify the extent of out-of plane deformation of girder webs. Based on the results of the scanning, determine the extents of girder replacement.
- Replace cross frames and Pier diaphragms identified in the visual inspection. Use LIDAR results to determine if other cross frames were affected.
- Determine repair or replacement recommendations for other fire damaged members identified by the scanning.

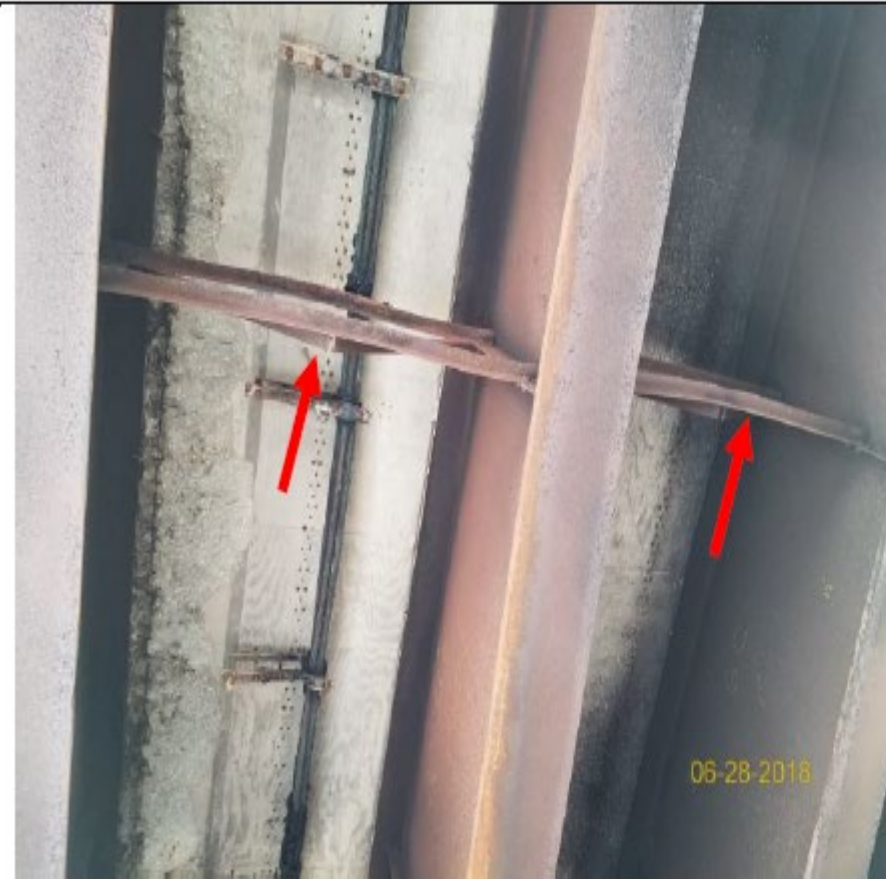
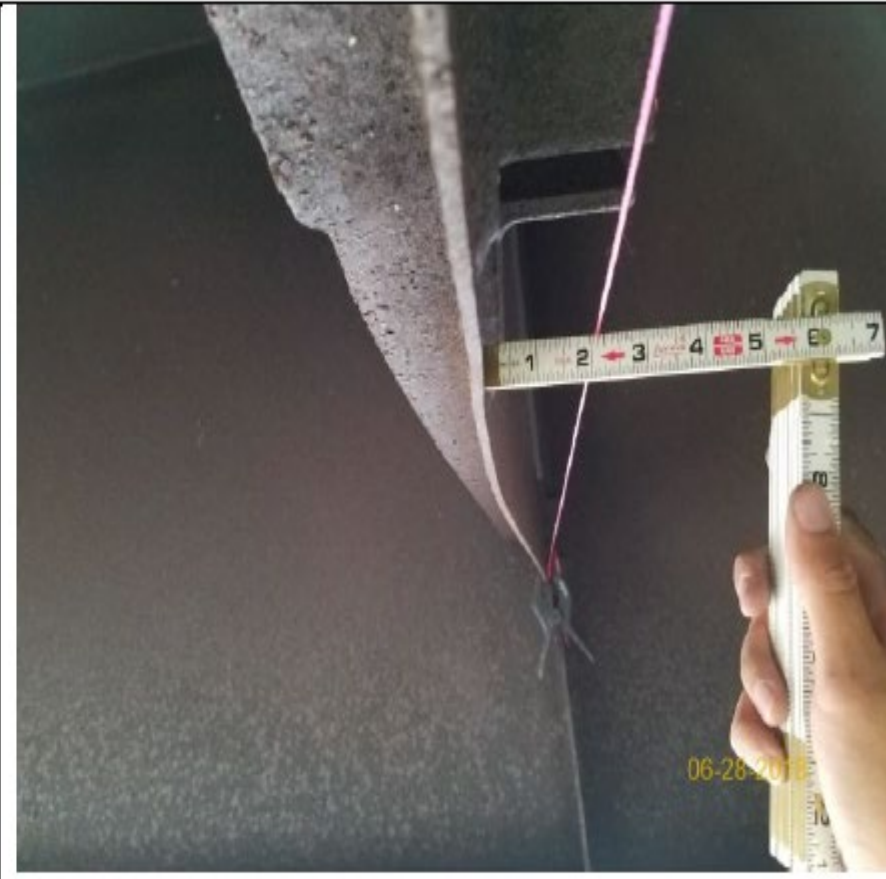
1<sup>st</sup> set of crossframes away from the pier have distortion in bays from A-B, B-C.

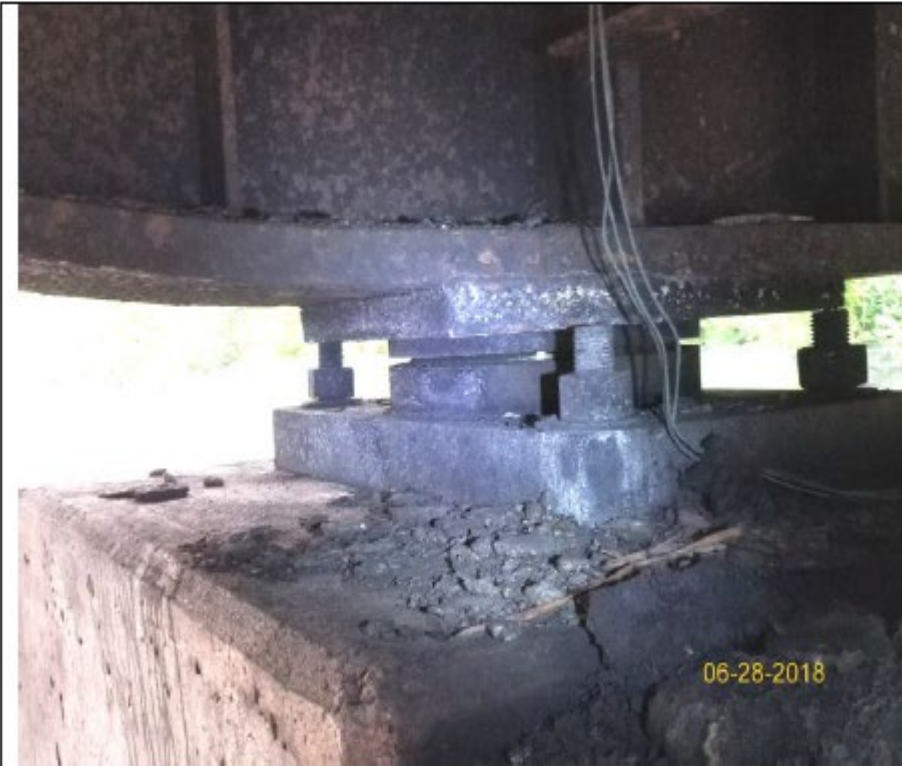
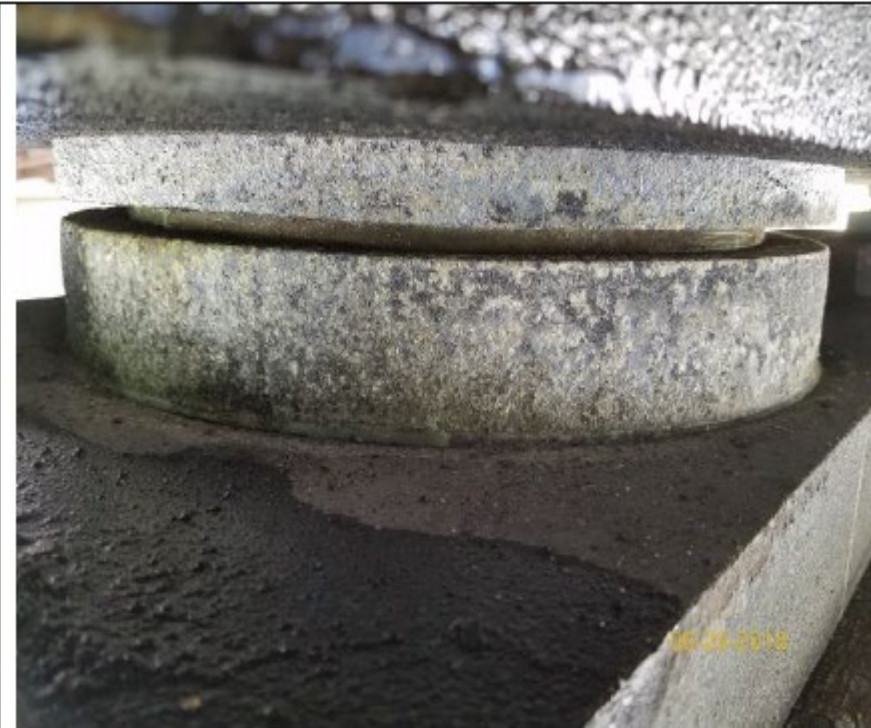
**Bearings:** The exterior of the pot bearings are scorched with the galvanizing coming off at Bearing A. Minor pitting of the steel was observed. No other damage, or extrusion of the inner elastomeric element to the bearings, was observed.

Bearings covered in soot and melted plastics (Typical at A and B). After powerwashing, bearings have minor pitting (Girder B shown).

**Reference Photo/Sketch No.:** 20,85 **Type of Defect:** Bearing Scorched

- Bearings affected by the fire have lost their protective galvanized coating. Although no evidence of damage to the internal elastomer was found, the elastomers are not directly visible. It is recommended to replace the pot bearings with the girder replacement. Additionally, utility conduit will need to be replaced.
- Replace damaged paving panels and median barrier for I-80.

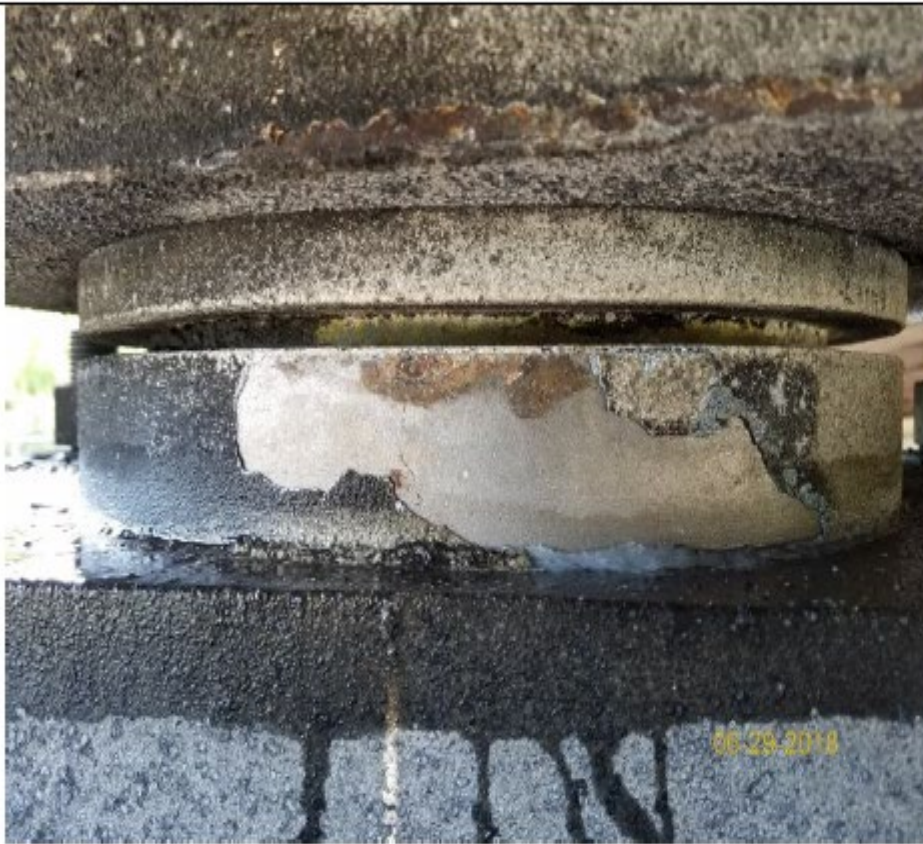
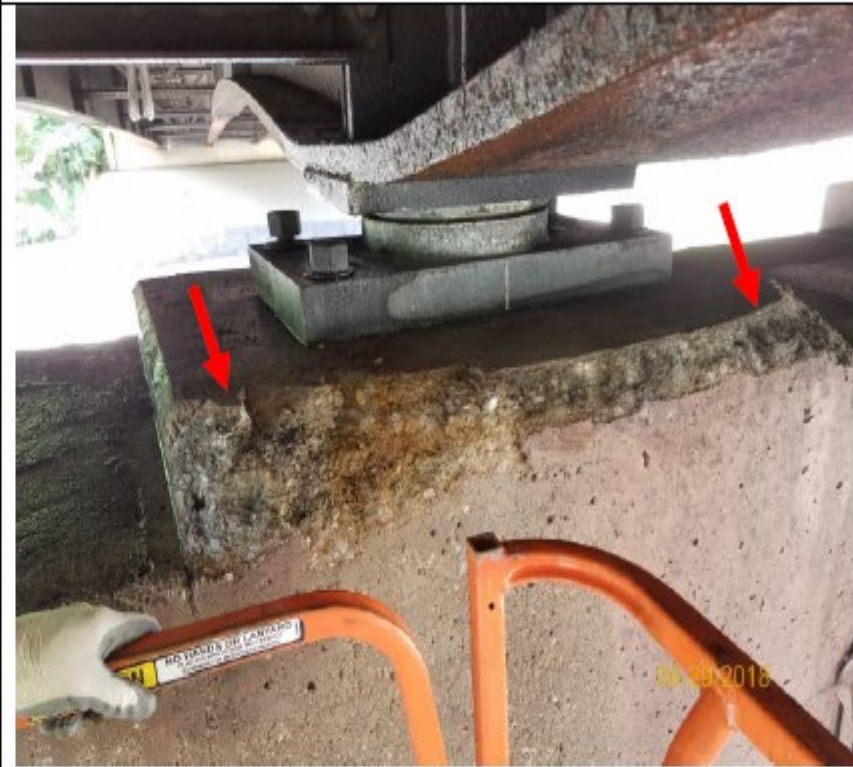
92,82

Girder A Bearing after power washing. Galvanizing coming off. Spalling to pedestals near bearings.

Bearings Scorched / Spall

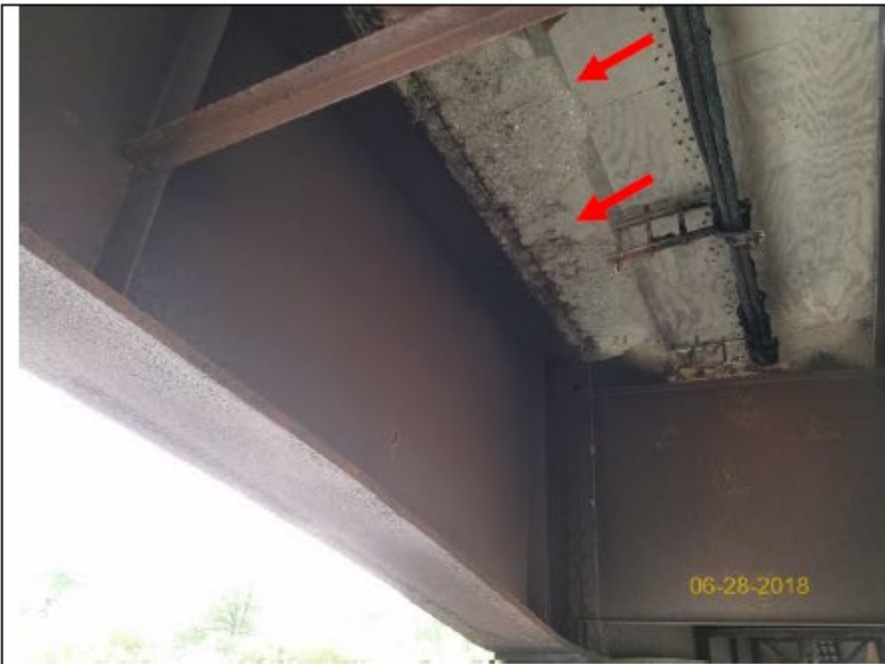
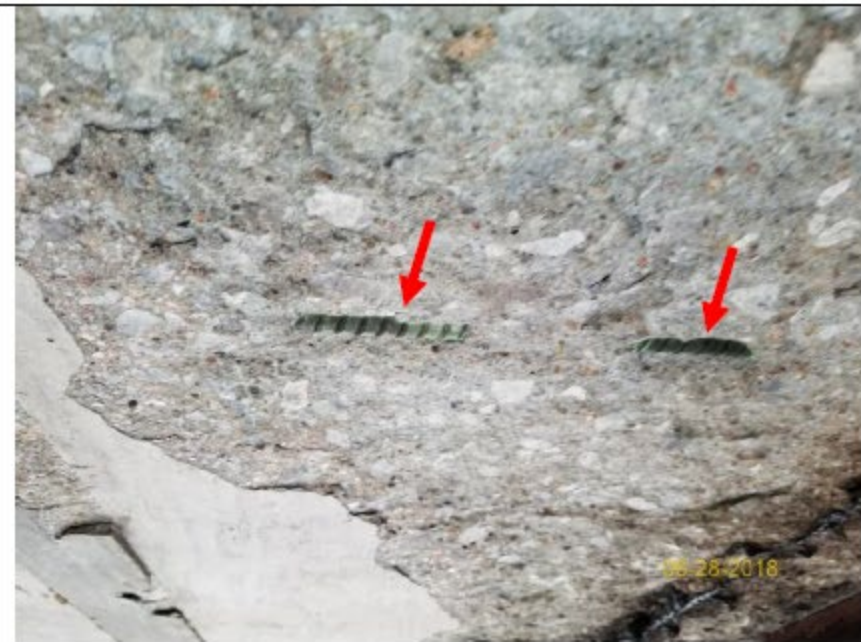
**Deck:** The deck has areas of spalling with exposed rebar next to Girder A (East Girder). Hammer sounding the underside of the deck did not indicate delamination. There is evidence of damage to the epoxy coating of the exposed reinforcing. All utilities on the bridge were consumed.

Deck spall along Girder A near the pier. Reinforcing exposed with damage to epoxy coating.

Reference Photo/Sketch No.: 55,61

Type of Defect: Deck Spall / Exposed Rebar

- The underside of the concrete bridge deck is difficult to repair to a pre-fire damaged condition. Replacement of this area of bridge deck is our recommendation for repairing it to a pre-fire damaged condition. The another option would be recognize the loss of structural life of the bridge deck caused by the fire and take measures such as applying concrete sealers to the bridge deck to preserve the remaining life.

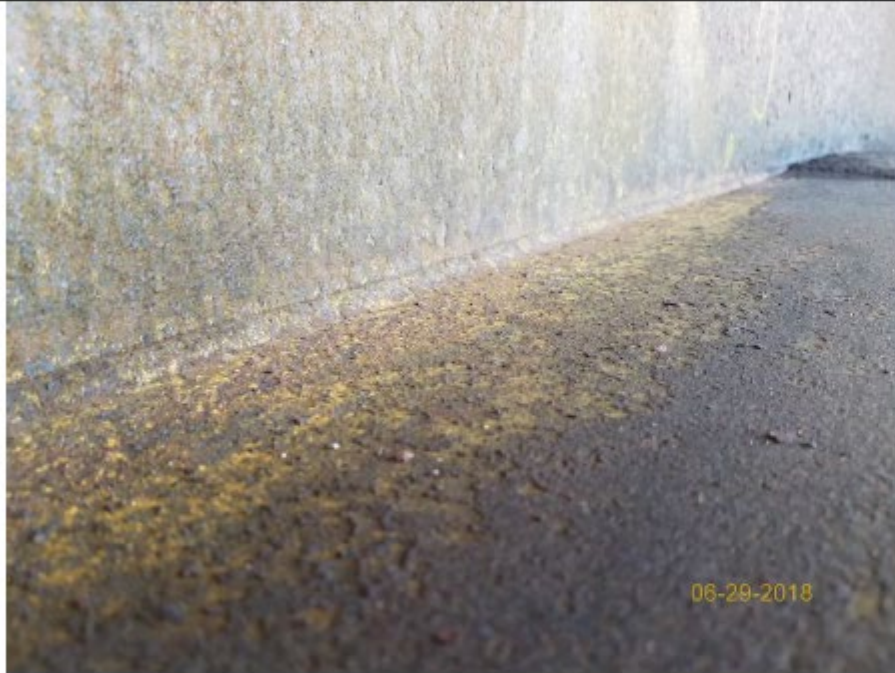
Power washing revealed no dis-coloring of the steel from high heat. No cracks in welds were found.

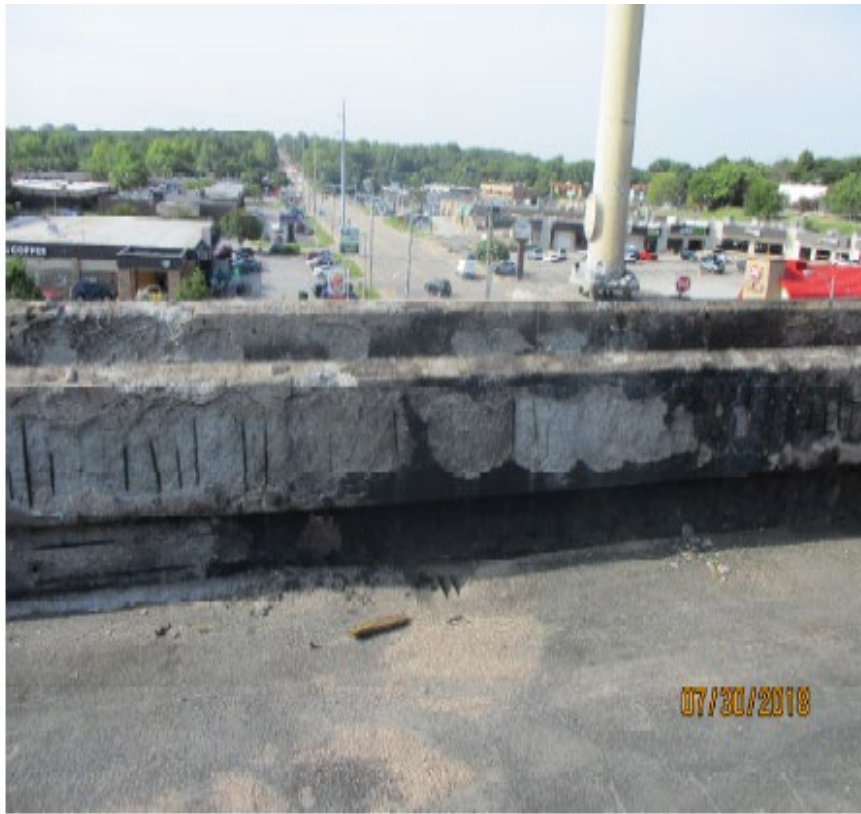
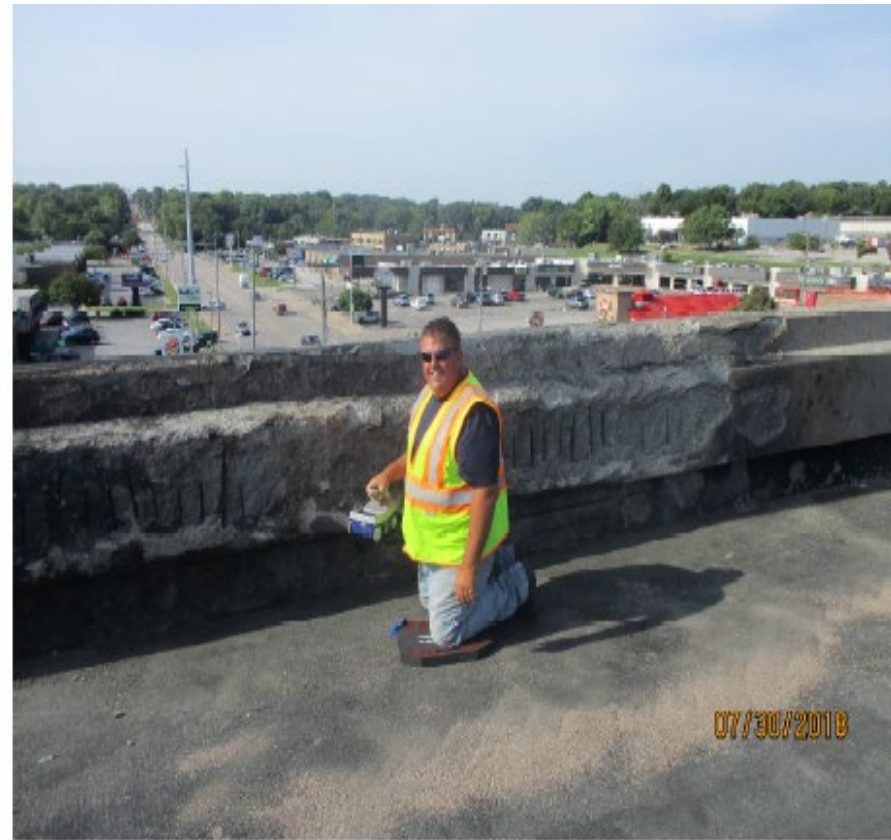
Description:  
South rail scorched

Sequential Photo No.(s): 2,3 Type of Defect: Barrier damage

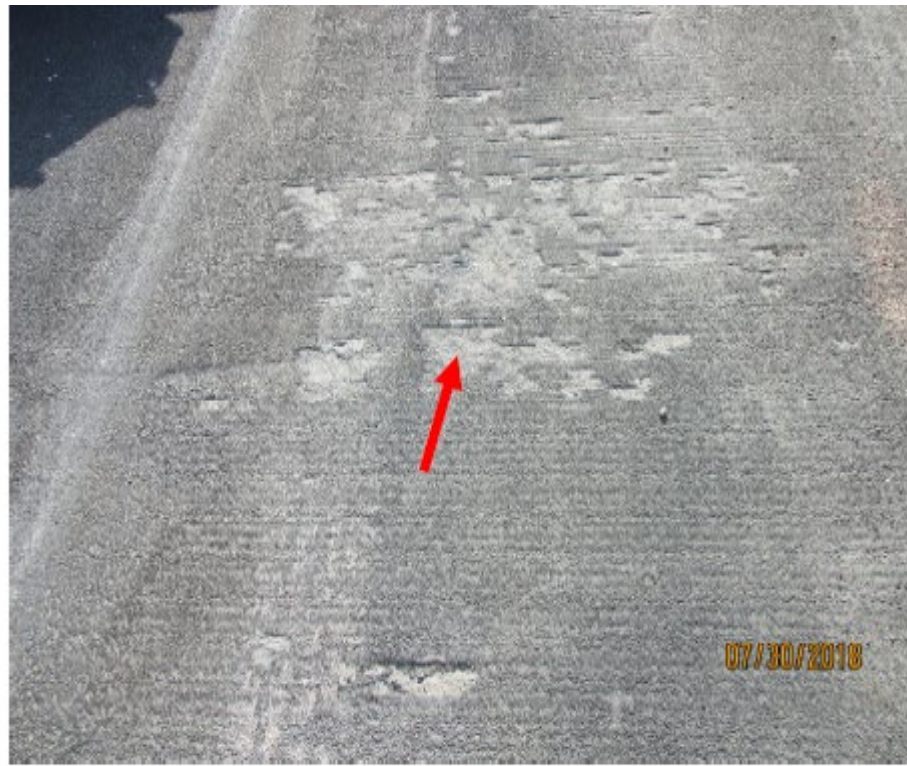
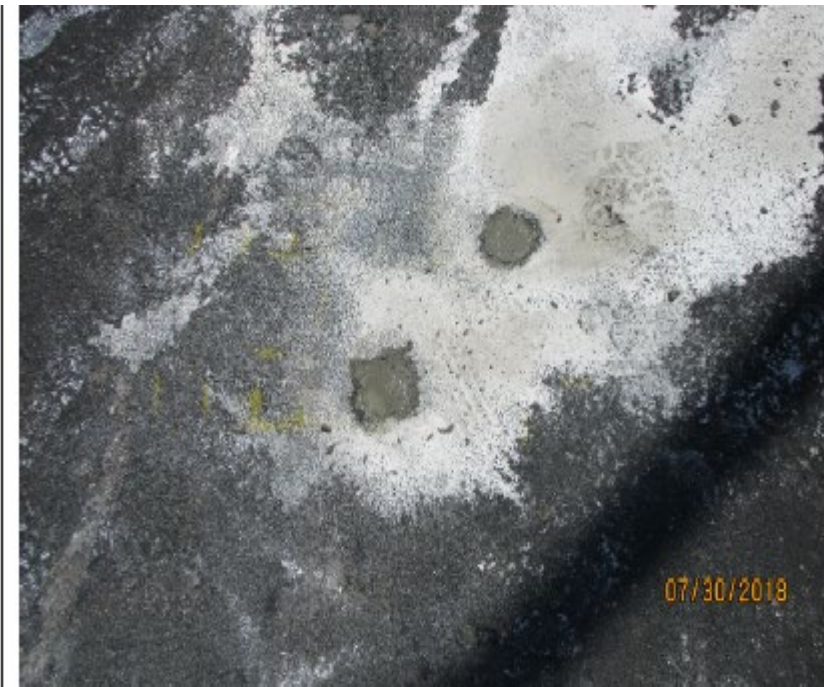
Scarring of the epoxy overlay along the shoulder. Cores taken out of the deck.

Overlay Damage

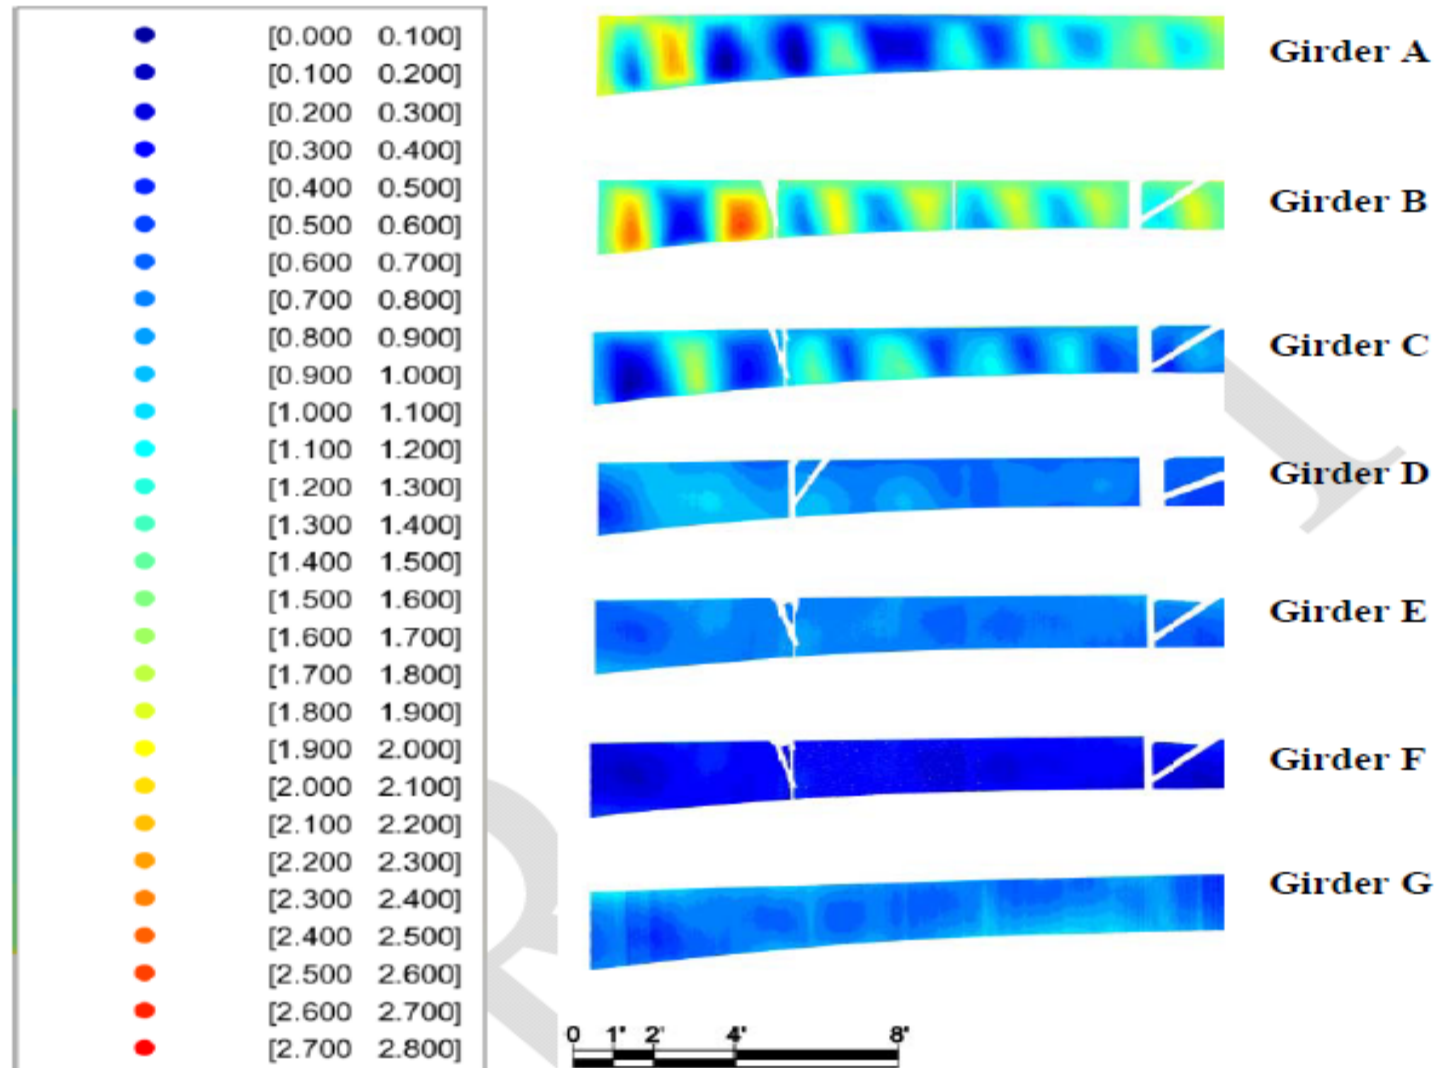
Figure 12. Depth-map analysis results for the girders on the westbound side of the bridge (in inches).

maximum magnitude of 1.63 inches. No significant deformation is measured along the spans of Girders D, E, F, and G.
