Investigations of Fractures in Three Kentucky Transportation Cabinet Steel Bridges

Theodore Hopwood II P.E.
Kentucky Transportation Center
NEBPP Annual Conference
September 9, 2019

I-75 NB Bridge Over Lynn Camp Creek in Whitley County KY

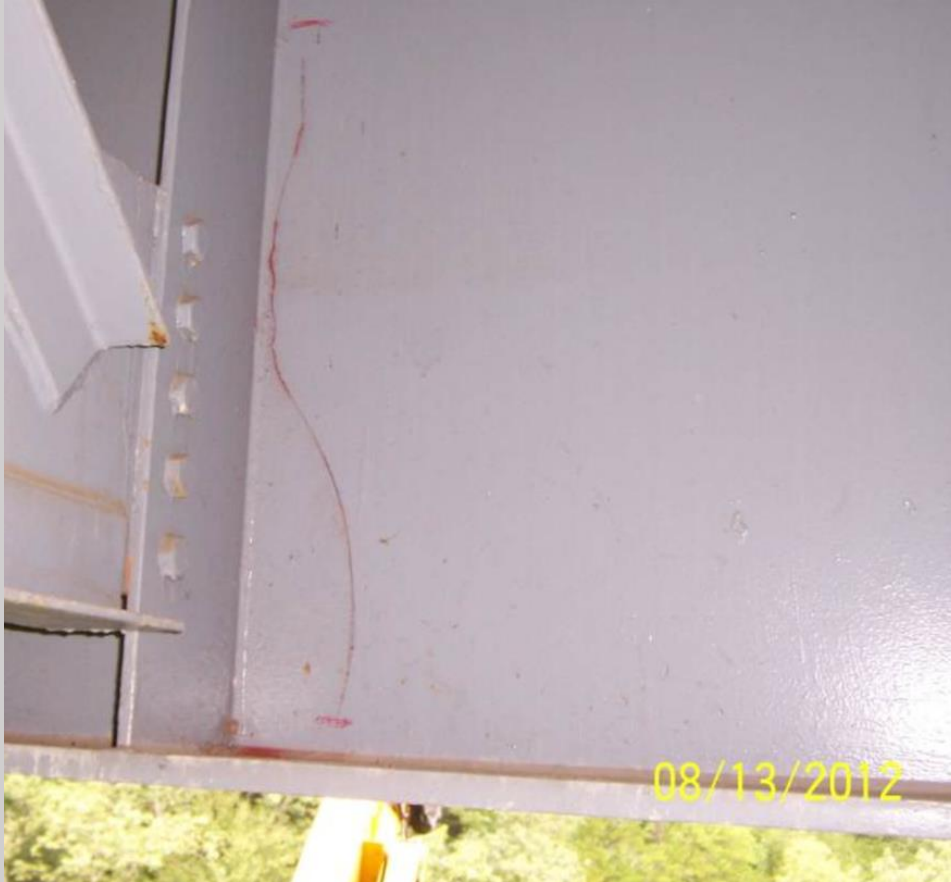
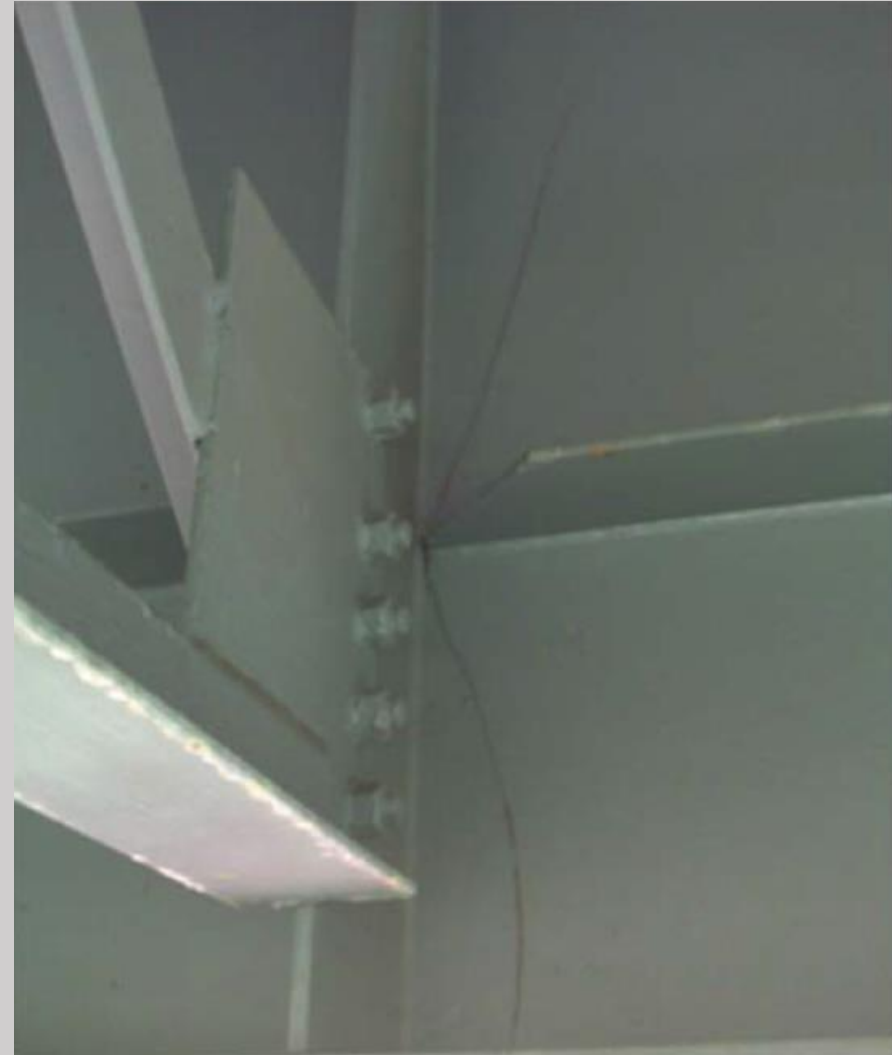
Girder Cracking in NB & SB Bridges in 2012

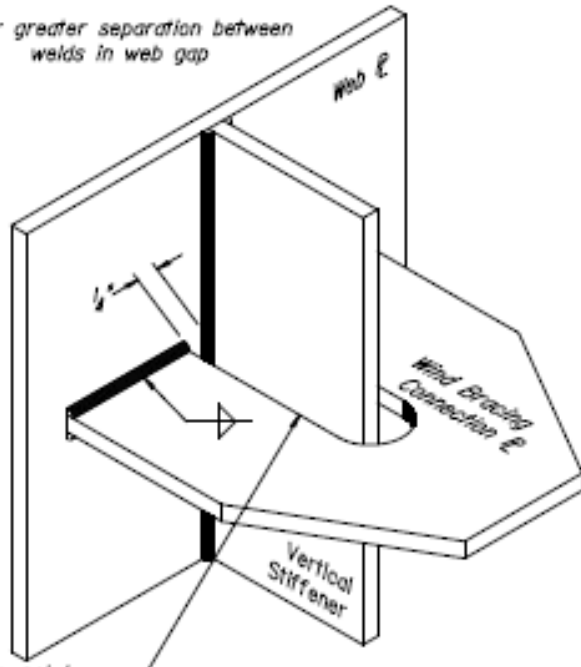
$\frac{1}{4}$ " or greater separation between welds in web gap

There may or may not be a weld present connecting the wind bracing connection R and vertical stiffener

Wind bracing connection R 's with $\frac{1}{4}$ " or greater clear gap between welds has a low risk of constraint-induced fracture.

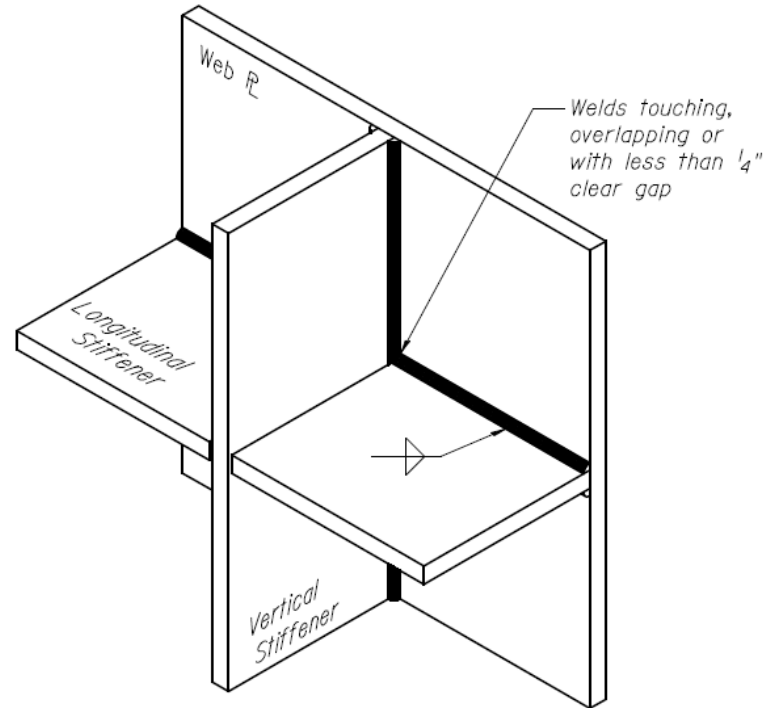
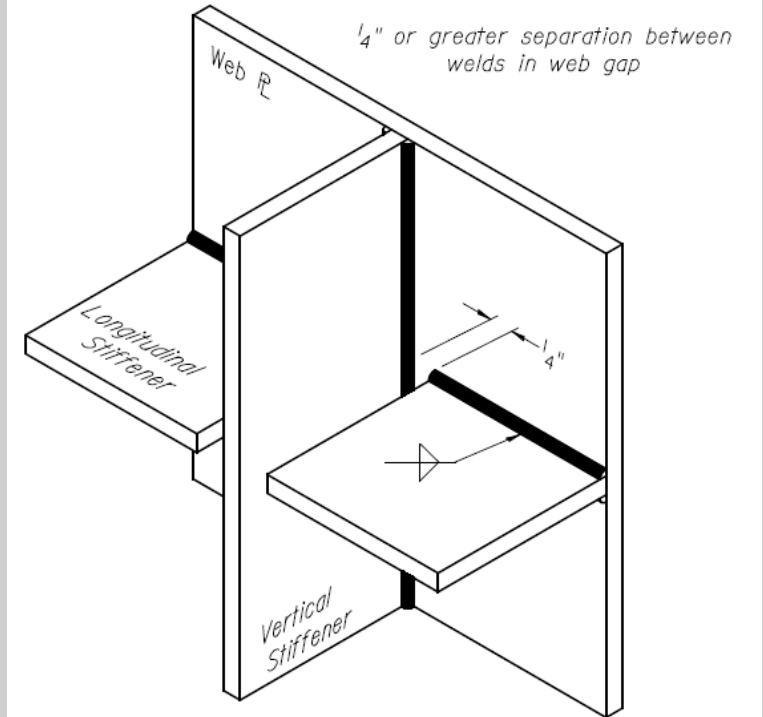
Longitudinal stiffener terminations in areas of the web subject to tension are vulnerable to constraint-induced fracture if there is insufficient weld clearance.

$\frac{1}{4}$ " or greater separation between welds in web gap

Longitudinal stiffener terminations with $\frac{1}{4}$ " or greater clear gap between welds present a low risk for constraint-induced fracture.

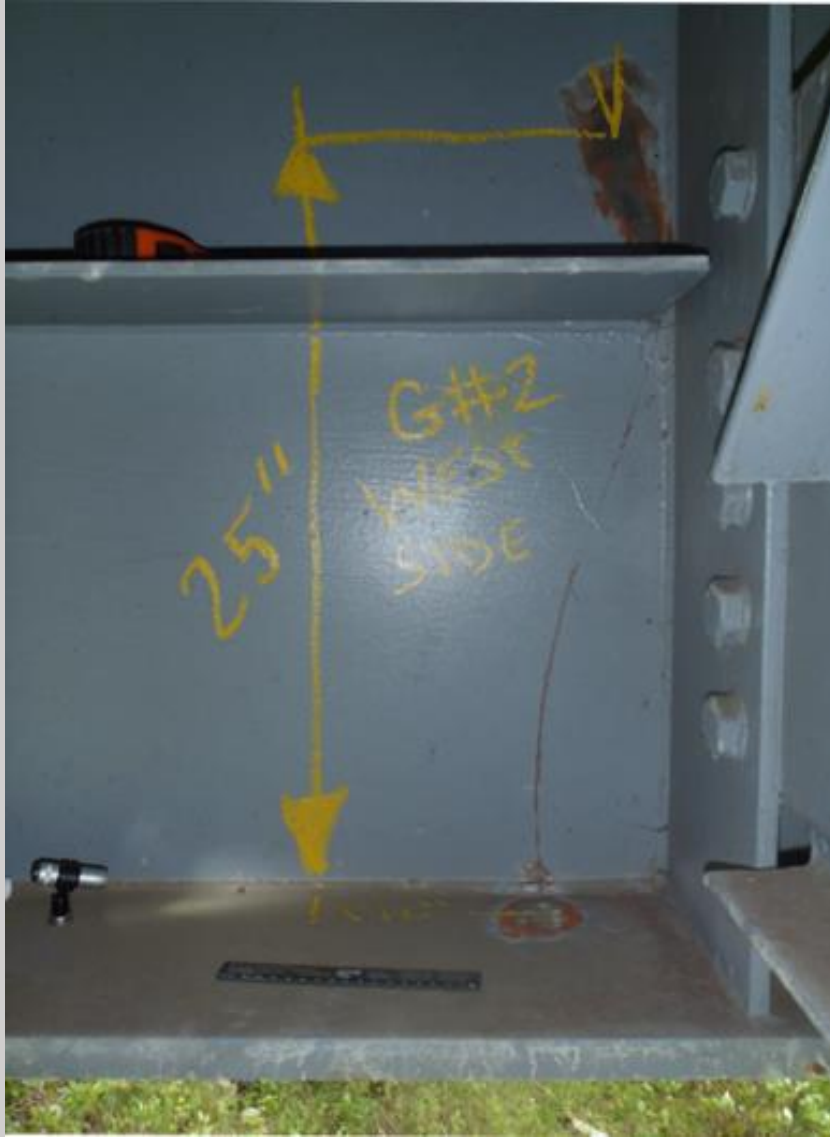
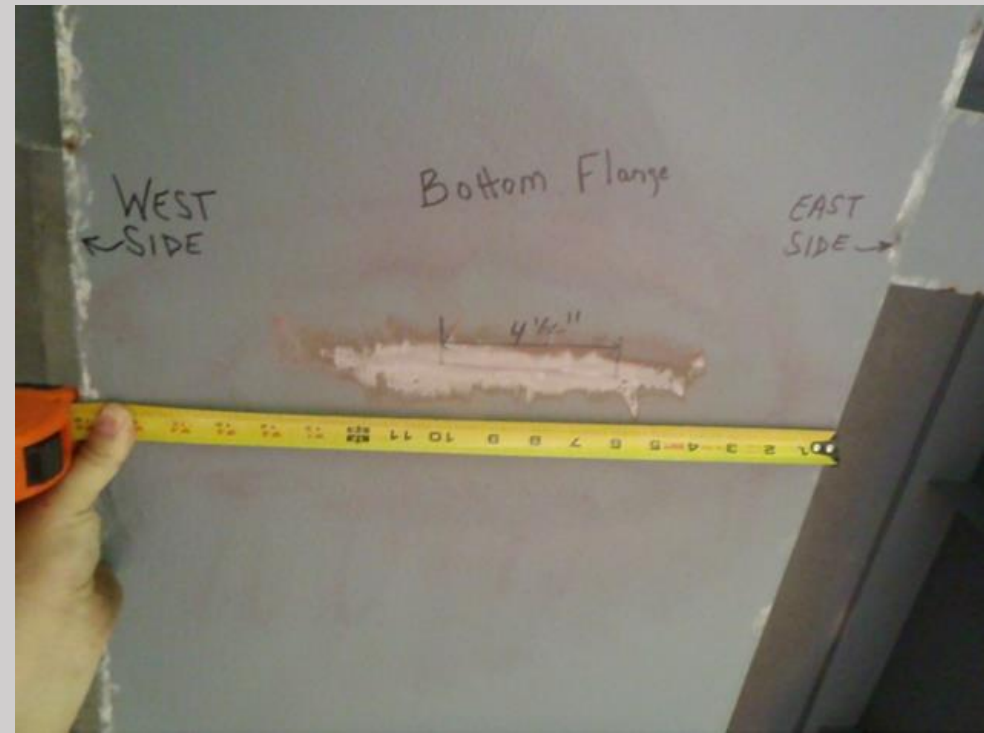
Cracking in N.B. Bridge June 2014

- Girder experienced unstable brittle fracture in the web
 - Unstable fracture initiated by a 5mm x 1 mm fatigue crack
- Web base metal was found to:
 - Meet the physical & mechanical properties met the ASTM A36 “Carbon Structural Steel” Standard
 - Satisfy the requirements for Charpy V-Notch toughness for Zone II (non-fracture critical structures)
 - 15 ft-lb. @ 40° F
- Fracture mechanism - possible CIF/fatigue interaction causing unstable fracture
 - Small fatigue crack at horizontal stiffener termination (Cat E fatigue detail)
 - Interaction with CIF detail (vertical & horizontal fillet welds for lateral bracing attachment in girder webs)
- At time of repair, the crack in the lower flange and was growing by fatigue

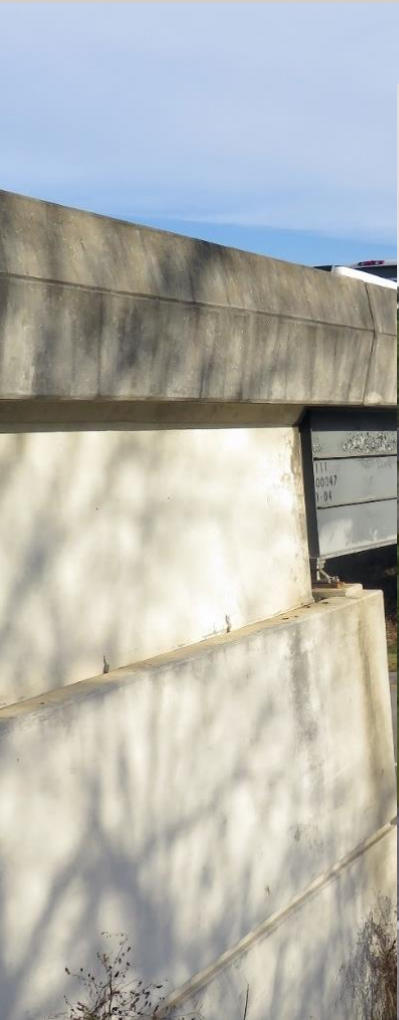
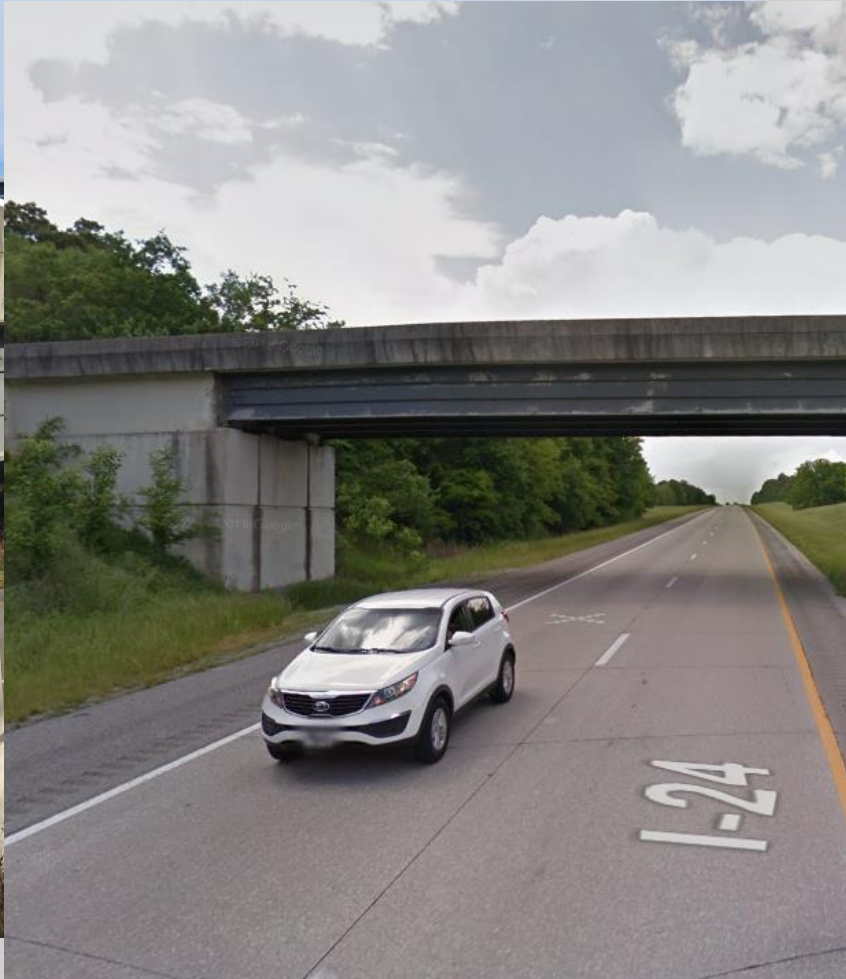
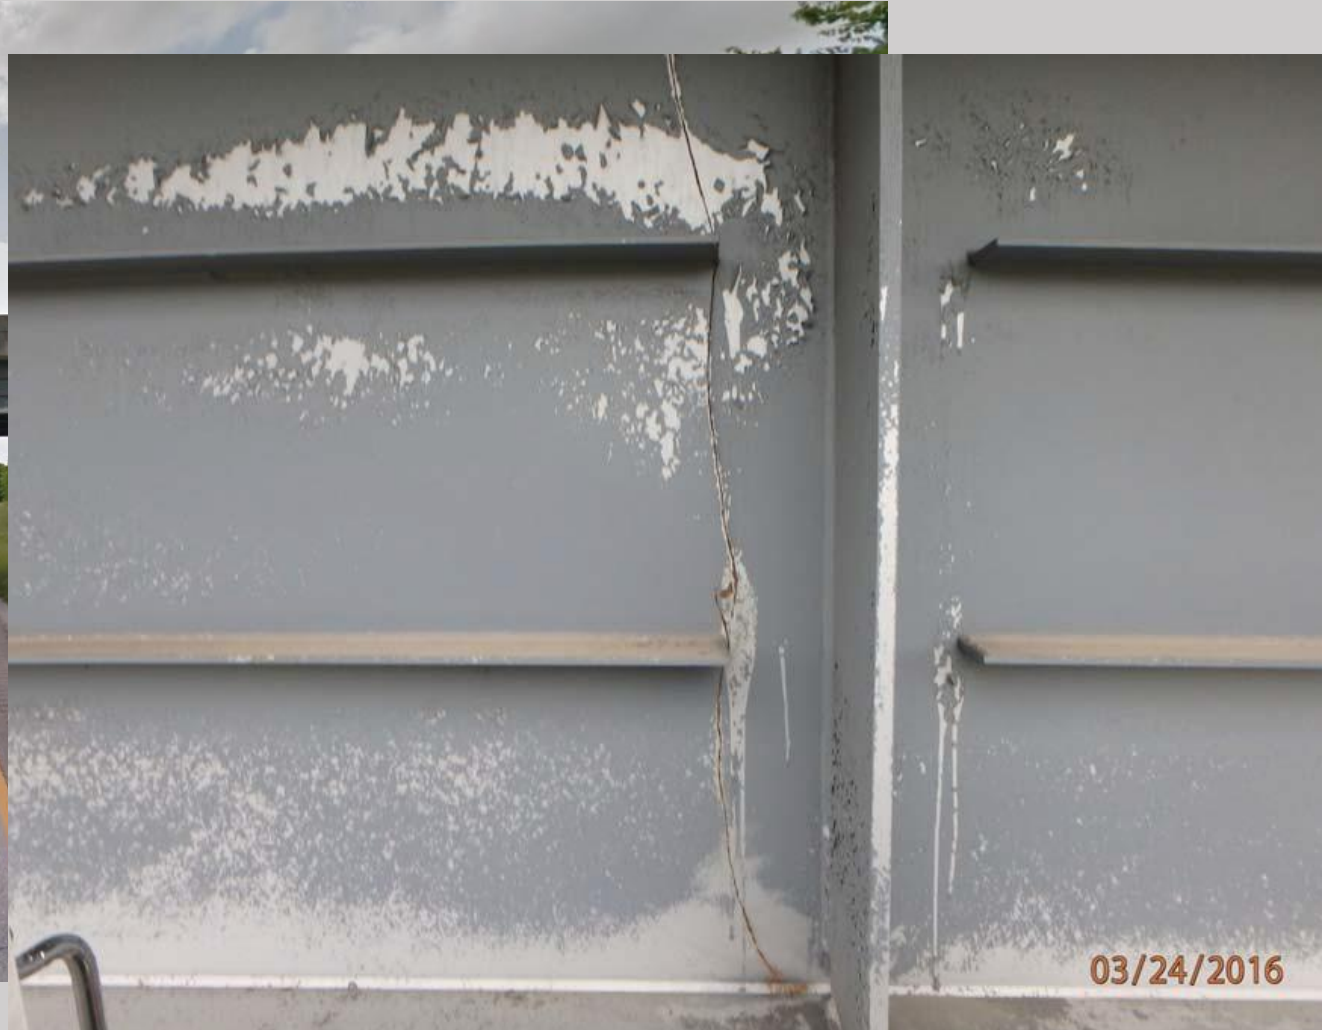
Bush Road Bridge & Fracture Location

- Built in 1978
- Continuous welded steel girder structure with 4 girder lines
 - 97'-121'-97' spans
 - 60" deep girders
- Made from ASTM A36 steel
- Traffic count over bridge ??
- Twin cracks were detected a on fascia girder in 2016
 - Negative moment area at pier

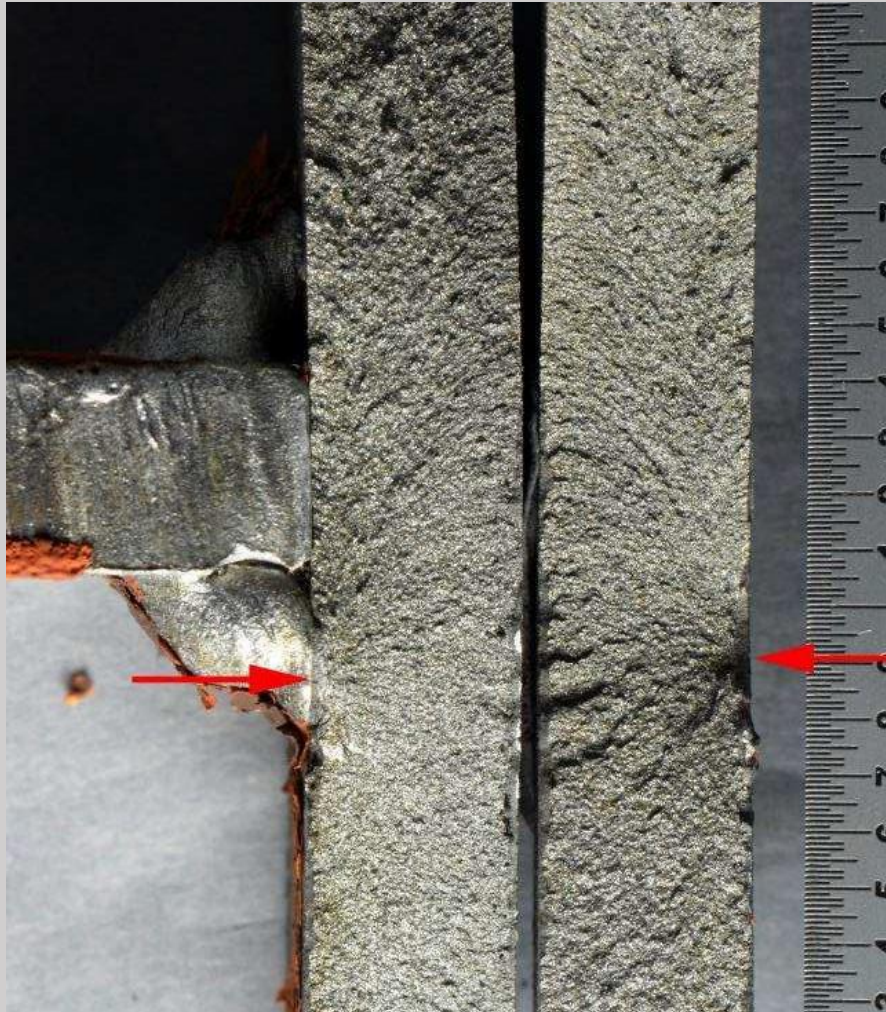
Upper Stiffener

Fractures in Horizontal Stiffener

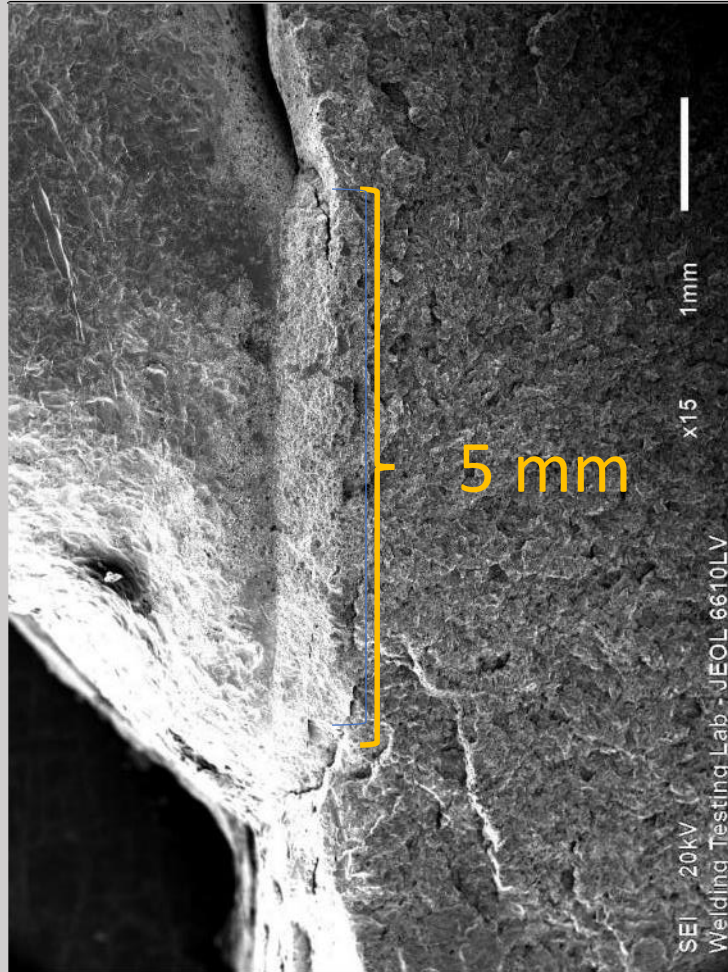
Upper Horizontal Stiffener

SEM Pictures of Fatigue Crack Surfaces

- Girder experienced unstable brittle fractures in the web
 - Fractures were initiated by two 5mm x 1 mm fatigue cracks
- Web base metal was found to:
 - Meet the physical & mechanical properties met the ASTM A36 “Carbon Structural Steel” Standard
 - Satisfy the requirements for Charpy V-Notch toughness for Zone II (non-fracture critical structures)
 - 15 ft-lb. @ 40° F
- Category E fatigue details at horizontal stiffener termini
 - No constraint present
- Fractures caused by low-cycle fatigue
 - Due to periodic heavy farm-to-grain elevator farm loads
 - Girder presumed to be highly stressed at time of failure

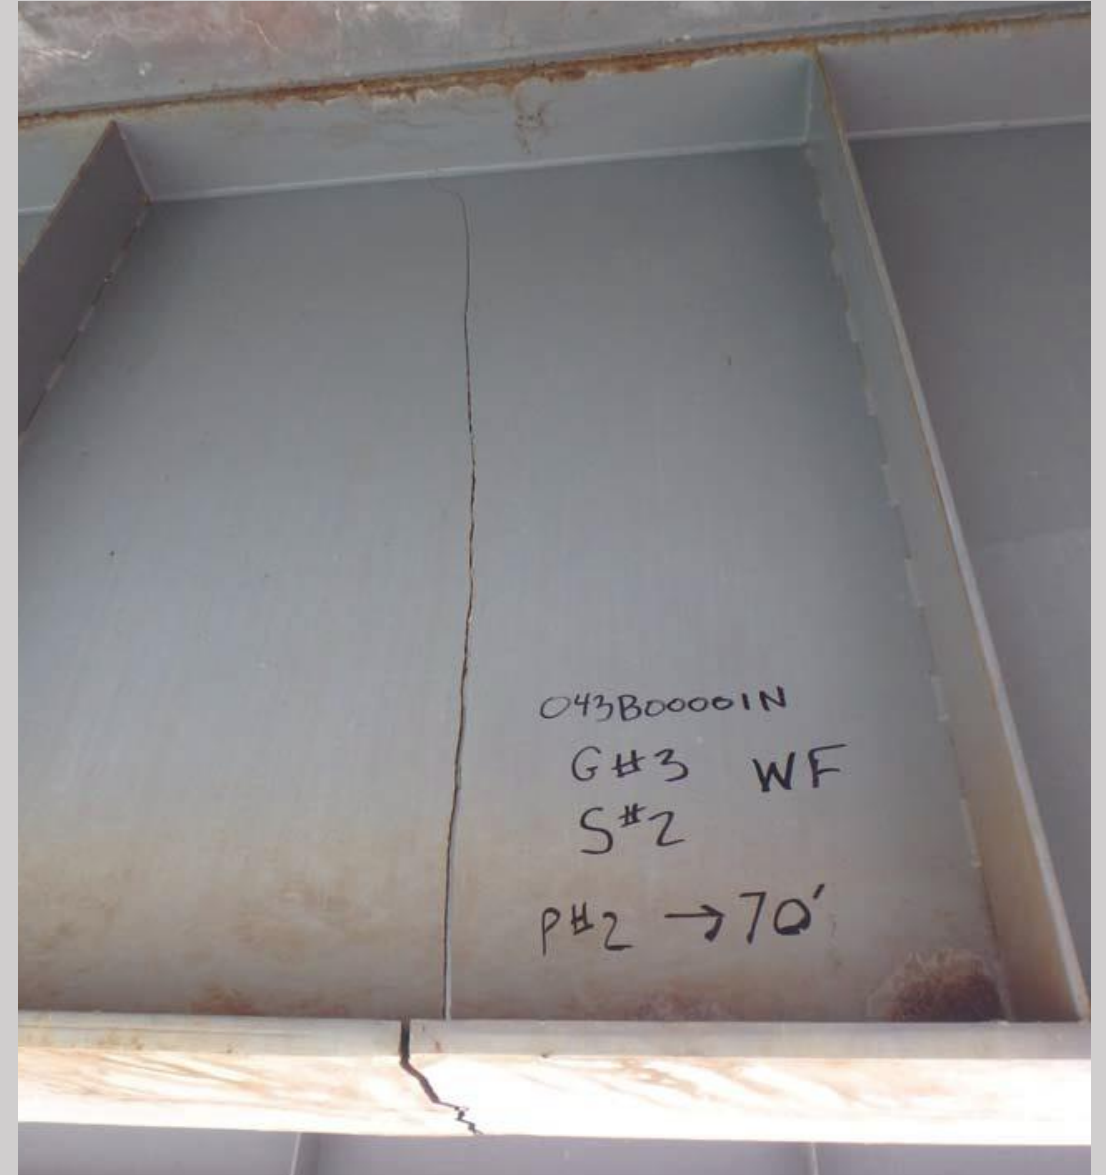
Girder Fracture

- Girder #3
 - 14' from C.L of 170' span
 - Located in lower flange weld
 - 1-1/8" to 1-3/8" thick transition
- Fracture
 - Lower flange 100%
 - Web 100%
 - Upper flange (~ 5% + arrest)

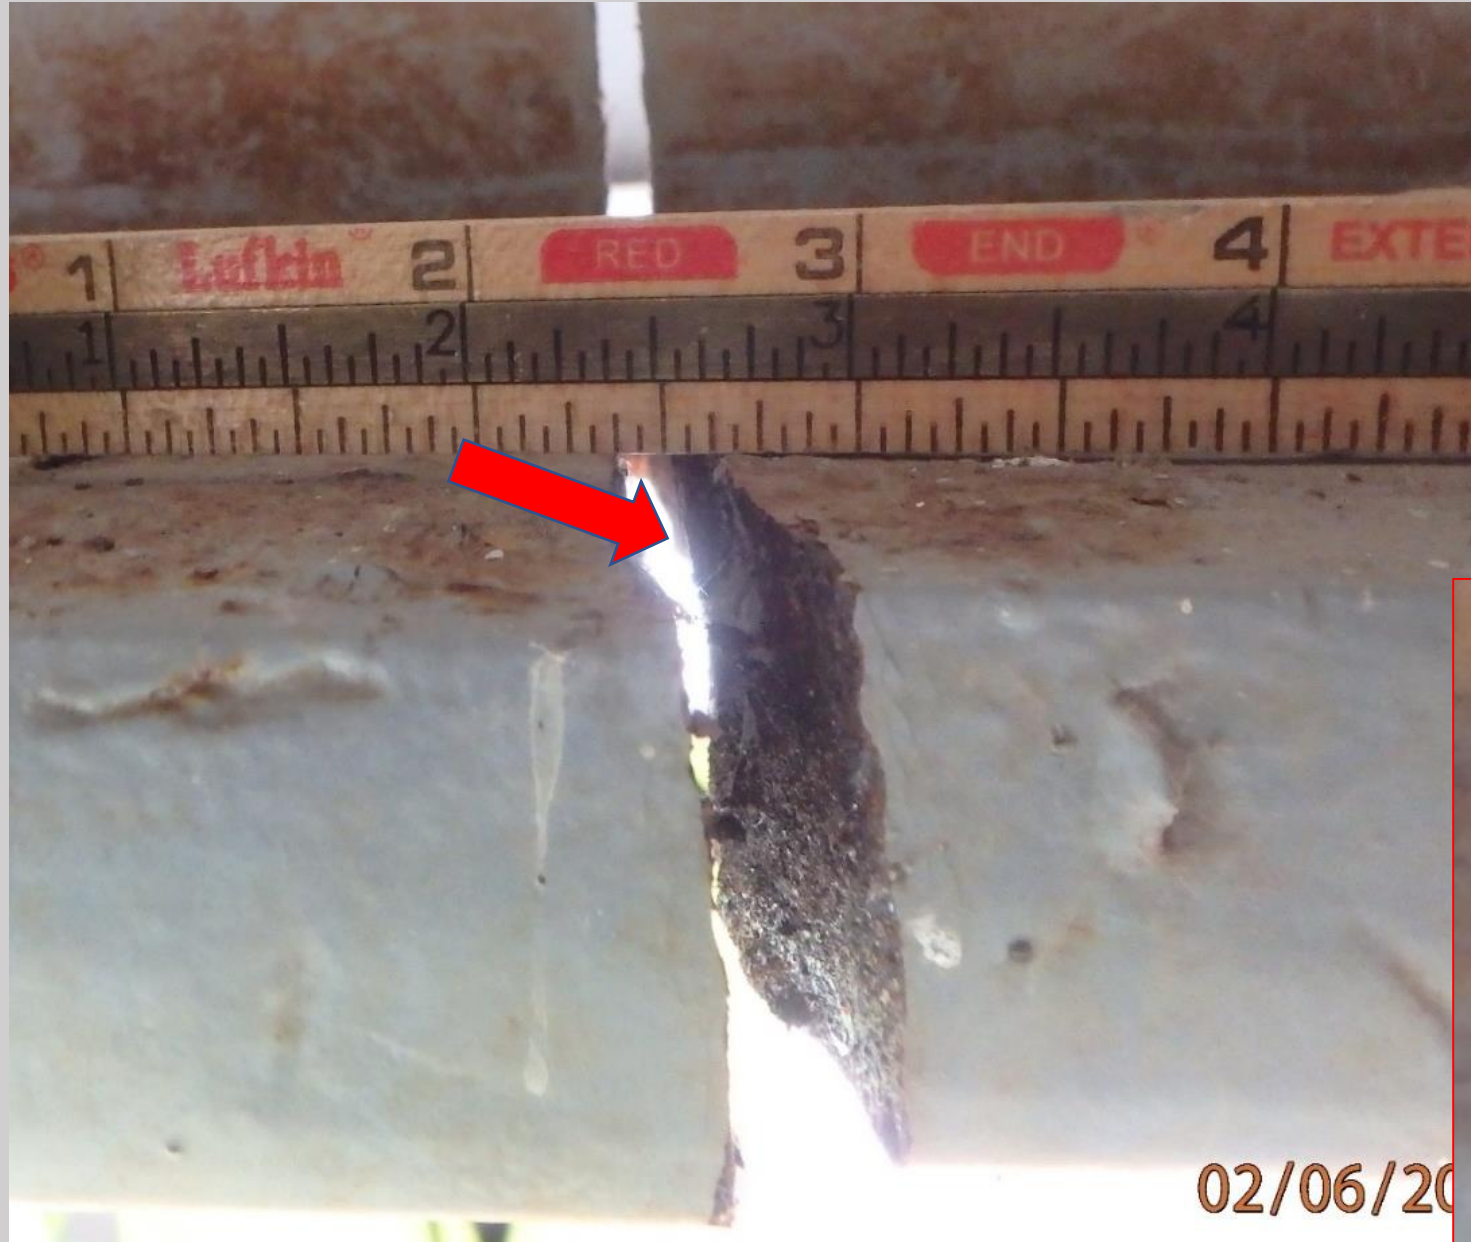
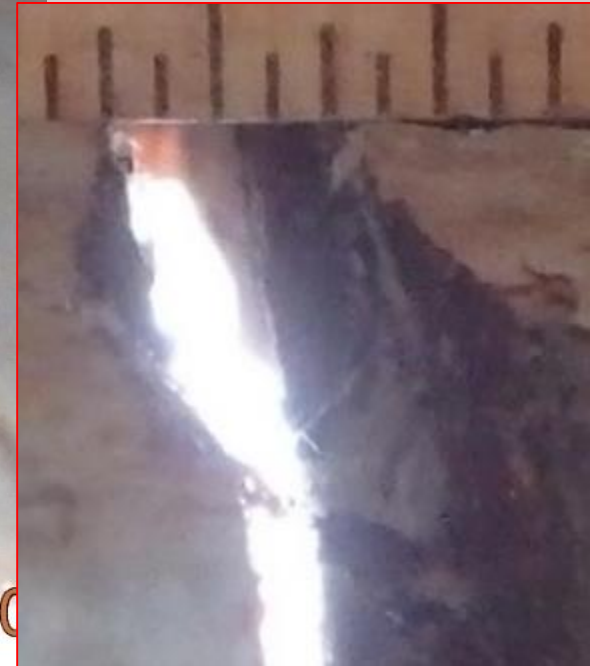
Crack Surface Observation

Thumbnail Crack Feature

- Located at flange transition butt-weld adjacent to web-to-flange welds
- Appears to be semi-circular or elliptical
 - From ruled scale in picture, the feature appears to be $\approx 3/4$ " wide x $\approx 3/8$ " deep
- Surface texture doesn't match balance of the fracture surface
 - Smooth vs. granular & irregular
 - Possible concentric "beach marks" indicating a fatigue crack

- Girder experienced unstable brittle fracture
 - Initiated at a defect in the lower flange butt weld or flange-to-web fillet weld
- Web base metal was found to:
 - Meet the physical & mechanical properties met the ASTM A373 “Structural Steel for Welding” Standard
 - Satisfy the requirements for Charpy V-Notch toughness for Zone II (non-fracture critical structures)
 - 15 ft-lb. @ 40° F
- Number of stress cycles and equivalent stress range too low to cause fatigue initiation at weld details
 - Possible weld defect missed by QC & QA (shop NDE)
 - Gradual crack growth by fatigue to critical size for unstable brittle fracture
