MD 355 Over the Monocacy River Emergency Repairs

Collaboration and Innovation in Emergency Response

December 6, 2017

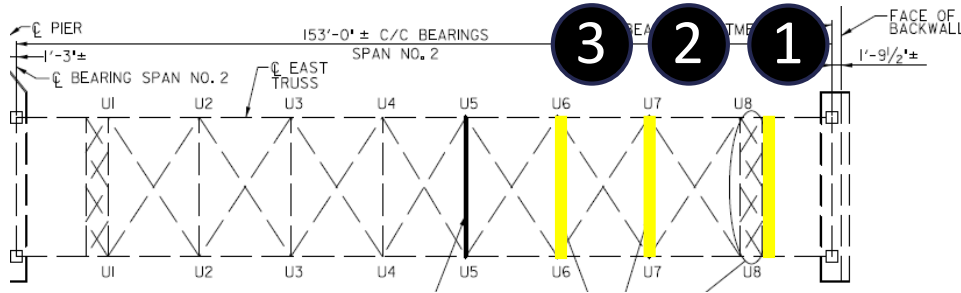
Lateral
Bracing

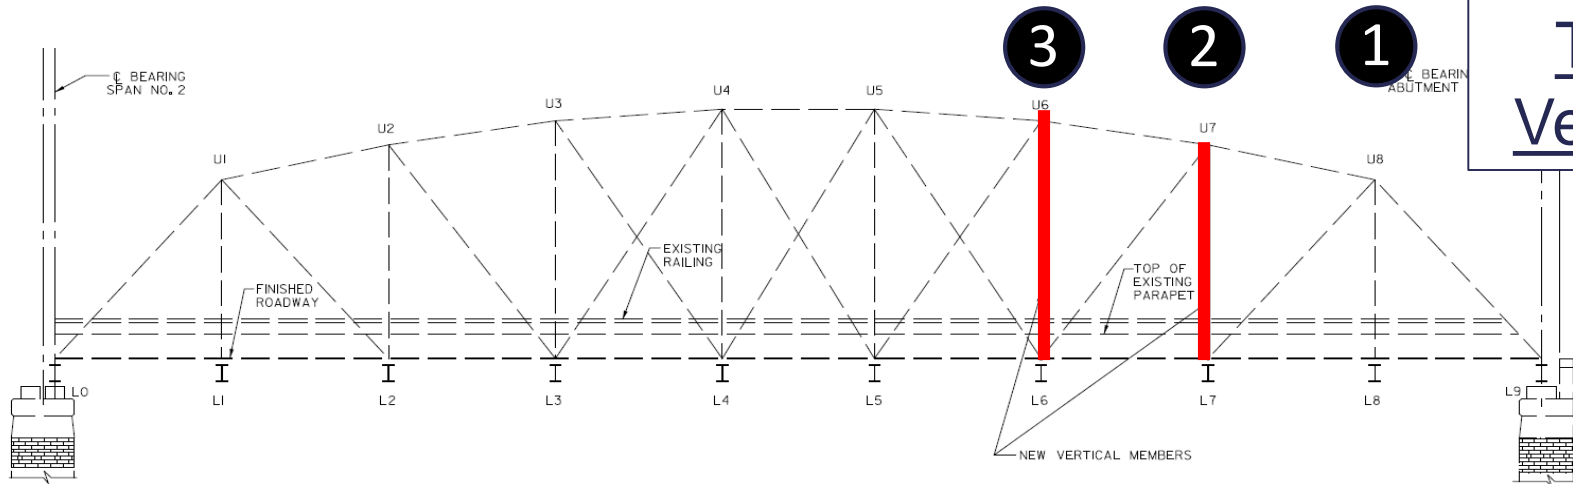
Truss
Verticals

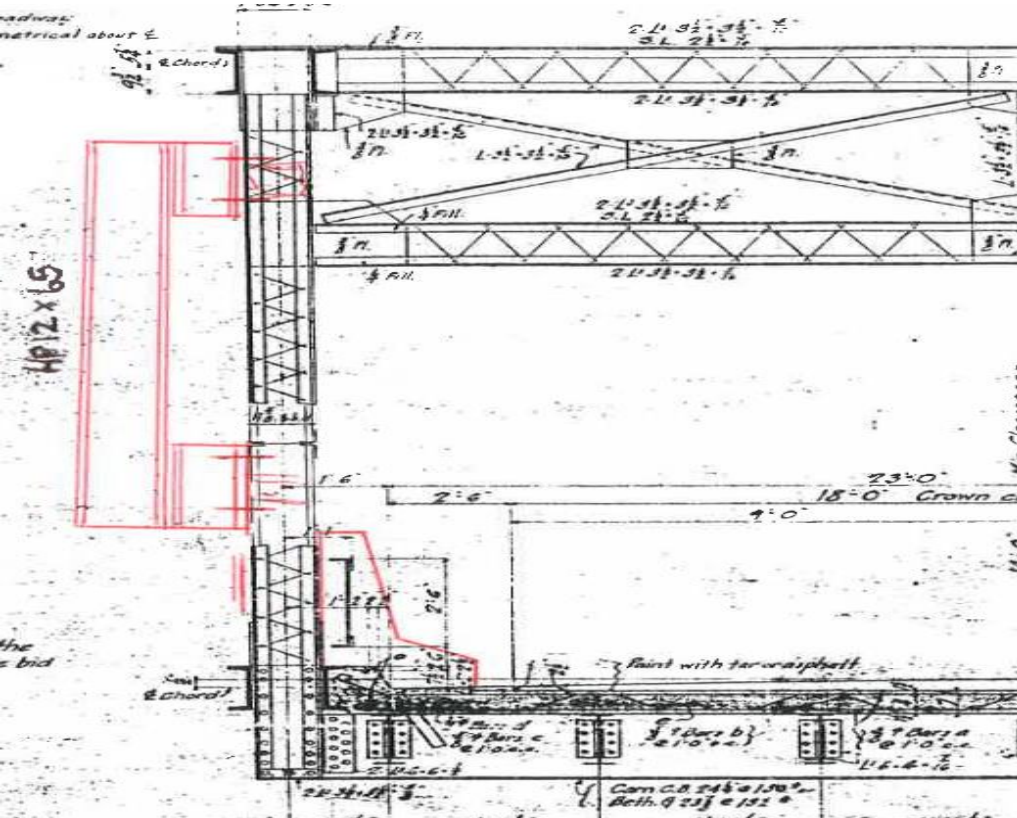
Install stabilization to provide safe access for repairs.

“Sister Beam”

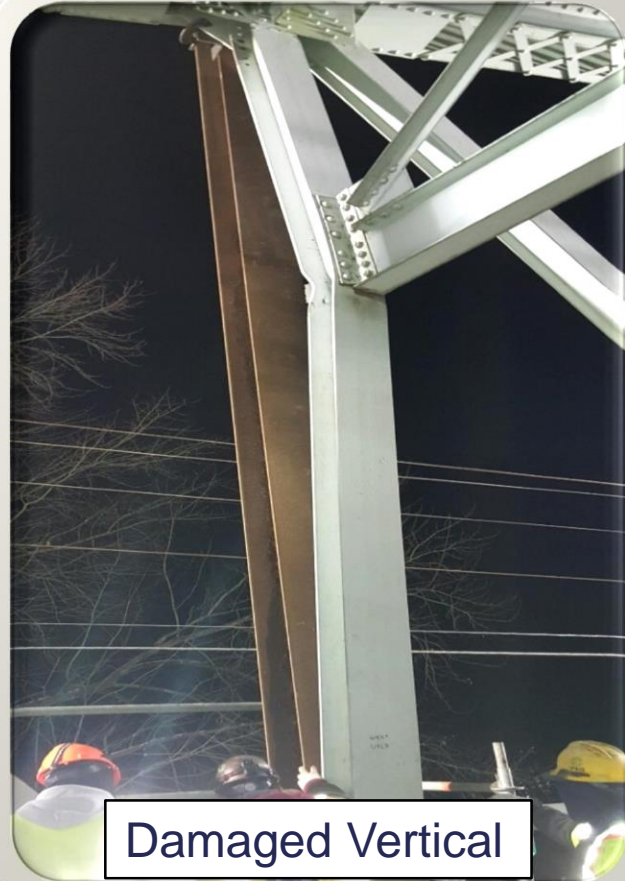
Damaged Vertical

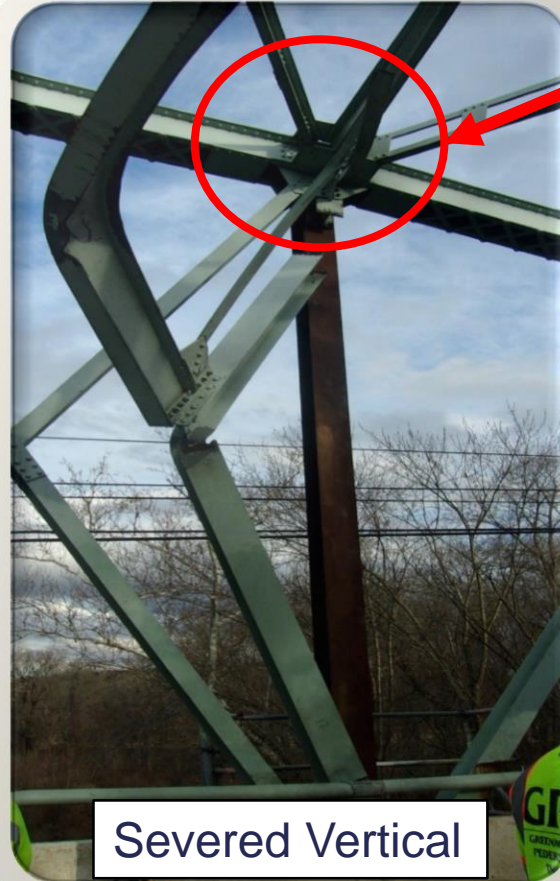
Severed Vertical
