Replacement of Non-Redundant TPG Cover Plates

NHDOT Bridge Maintenance
Andrew Hall, PE

Distance from bearing to bearing = 70'
Width from curb to curb = 24'

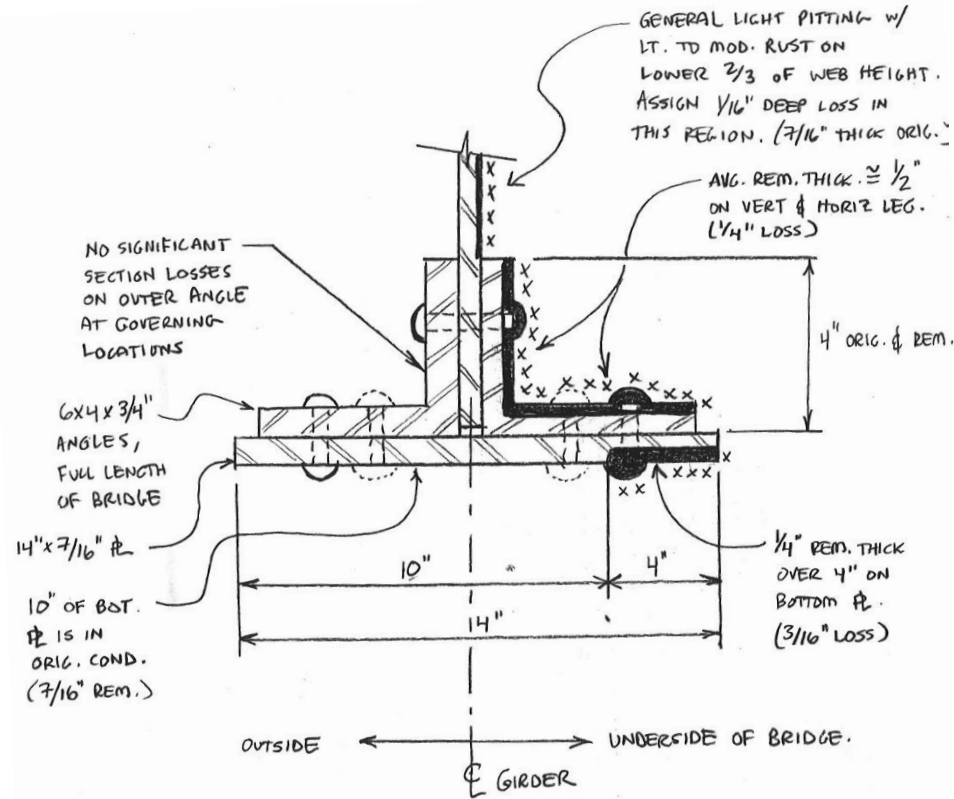
SECTION OF LOWER FLANGE

THIS CONDITION OBSERVED AT LOCATIONS NEAR MIDSPAN, AT FB LOCATIONS,

- Reinforce lower flange by removing 7/16" x 14" x 30' cover plate and replacing 3/4" x 14" x 50' cover plate

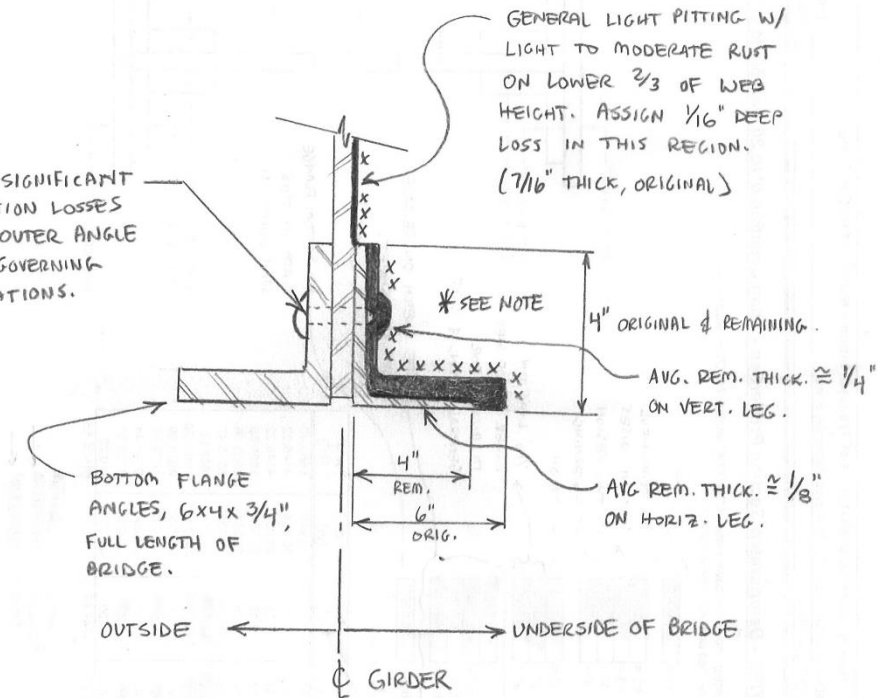
SECTION OF LOWER FLANGE

* THIS CONDITION OBSERVED AT SEVERAL LOCATIONS (SOUTH GIRDER @ FB#4, FB#10, N. GIRDER @ FB#4)

THIS LOCATION GOVERNS, 17.5' OUT FROM ABUT.

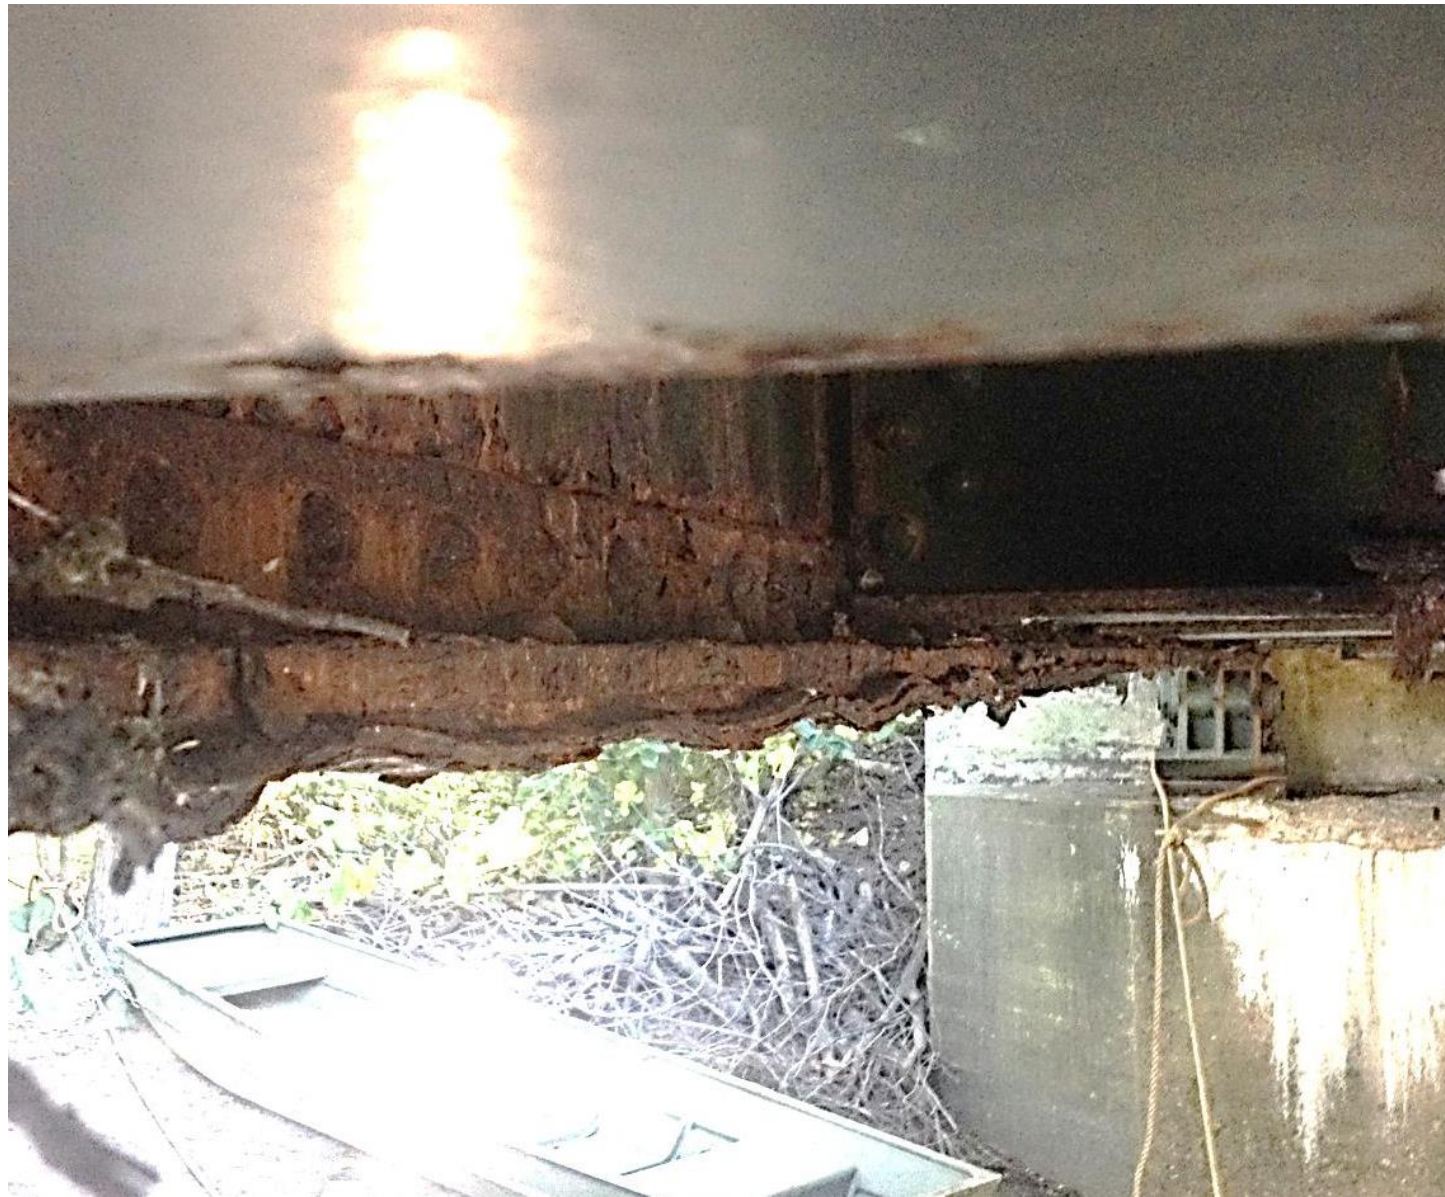
Typical condition of existing cover plate

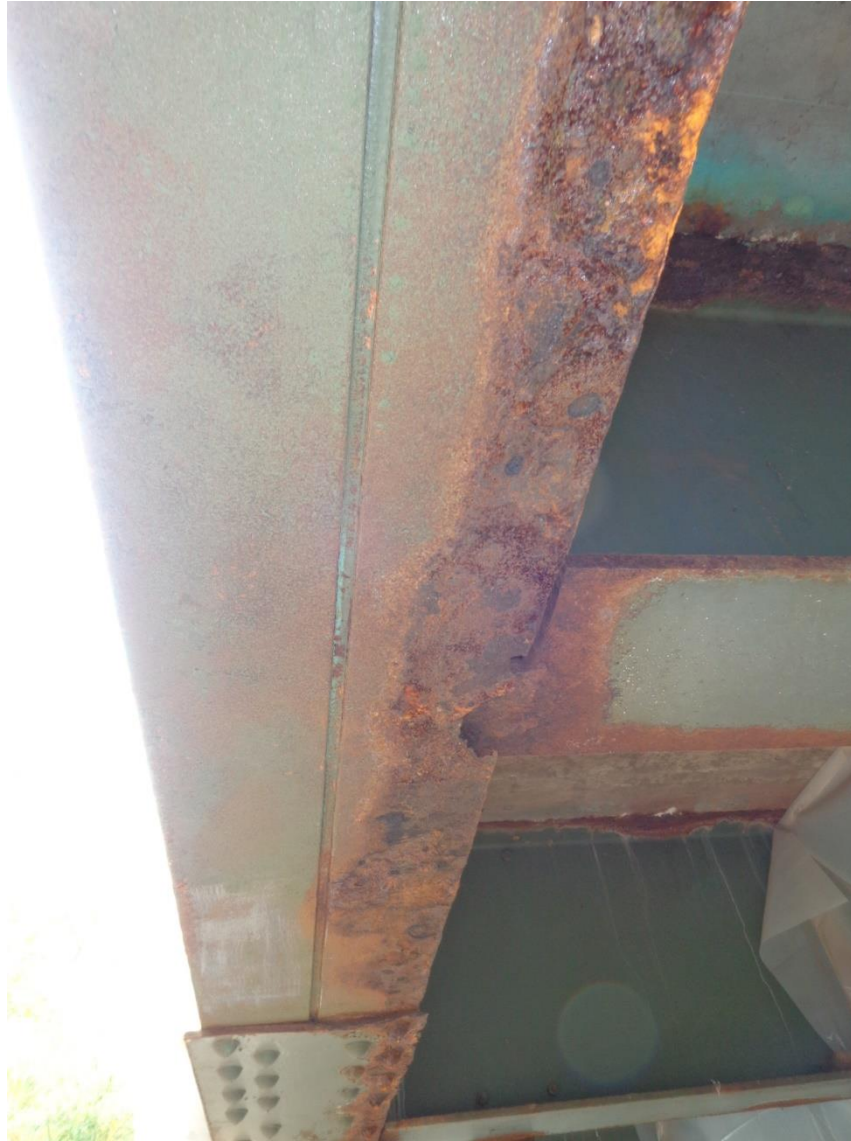
Lower flange section loss in critical area

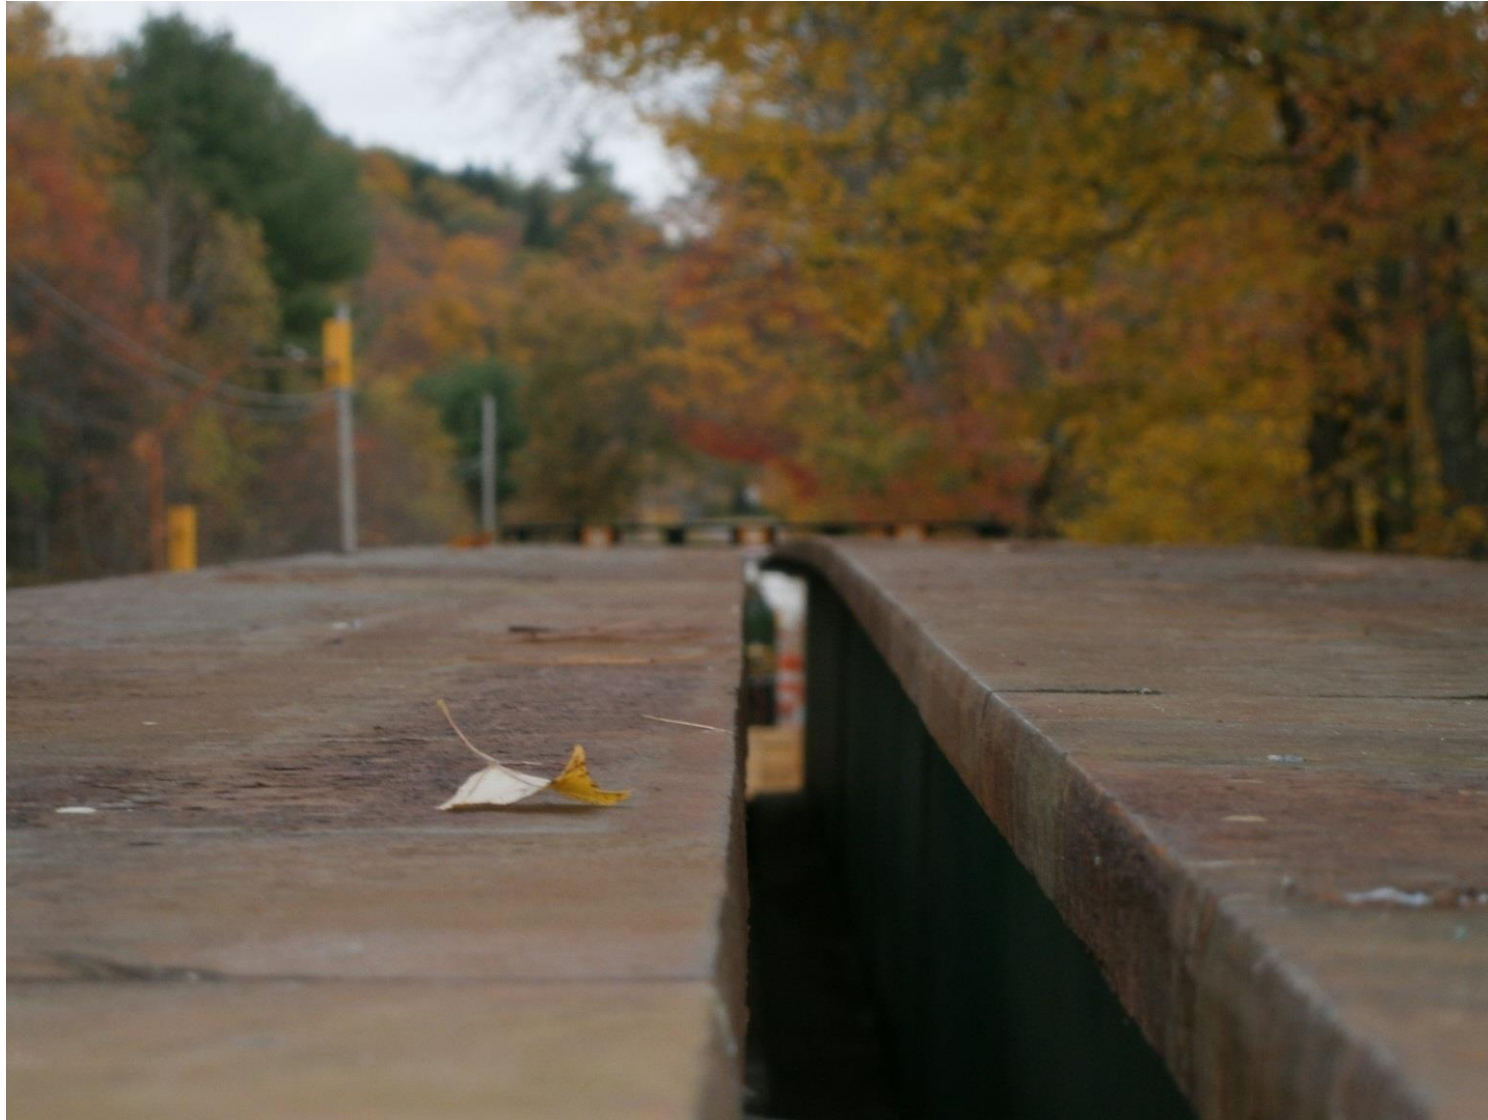
The tops of the support girders did not line up.
