HEAT STRAIGHTENING OF A DAMAGED BOTTOM FLANGE

NBPP 2019 MEETING BURLINGTON, VT Timothy Boodey, P.E. NHDOT

NH 16,Sp Tpk over Long Hill Road

Concord 041/123 US 4 over I-93 (Exit 17 SB)

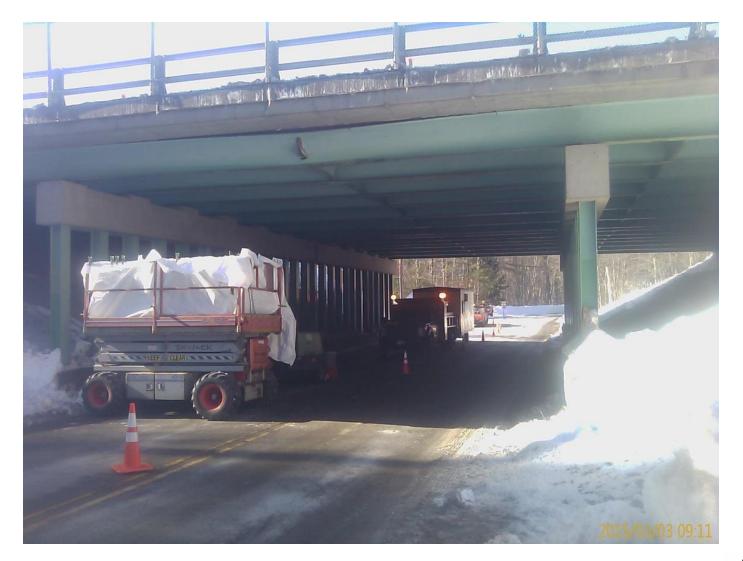
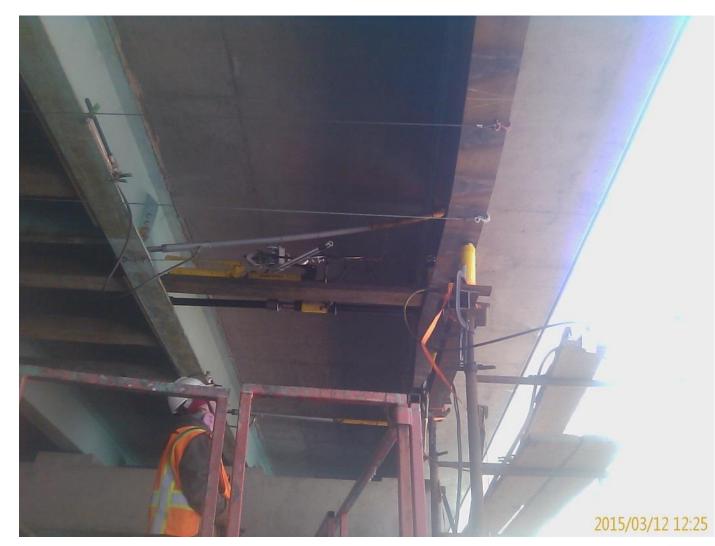
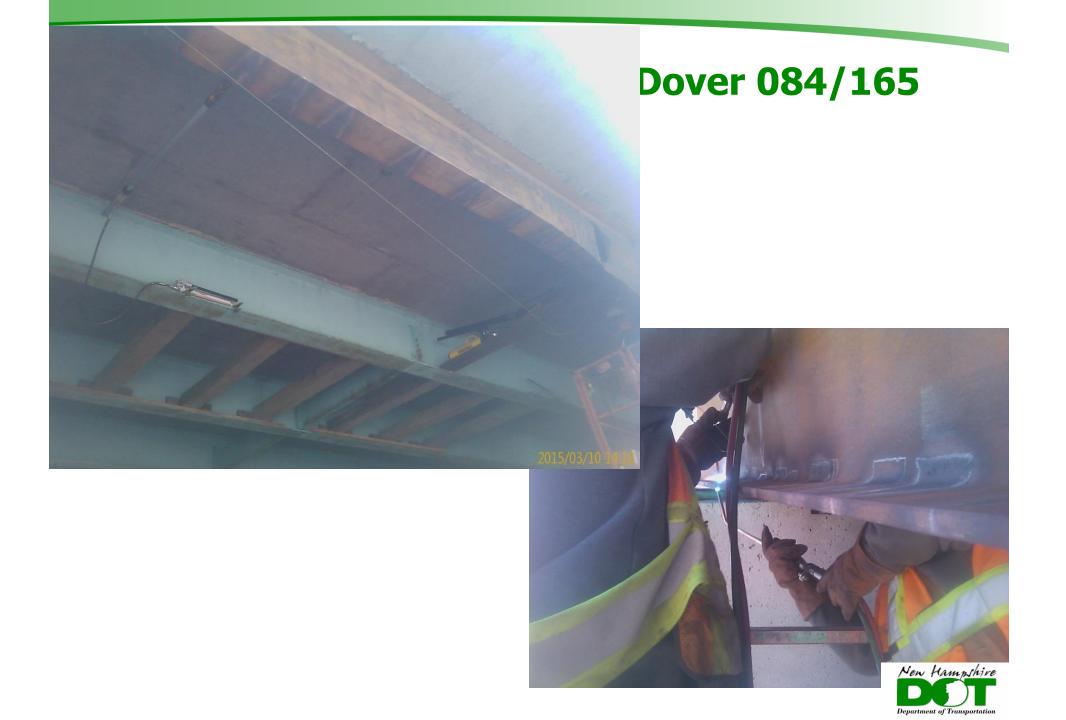
Damage to Girder 14, span 2 (32'), ~18" horizontal displacement, lower flange rotation, puncture

19 working days for all work using daytime road closures (3 days paint removal, 9 days heat straightening)

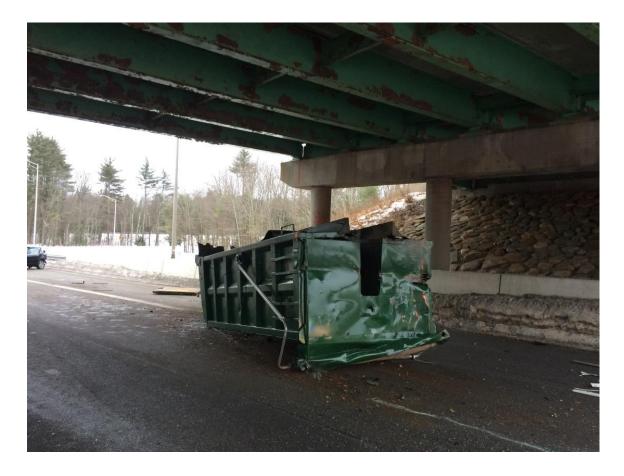
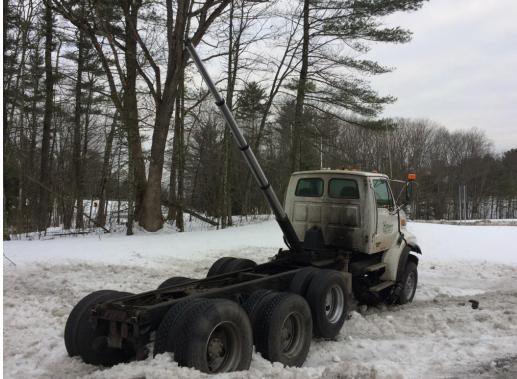
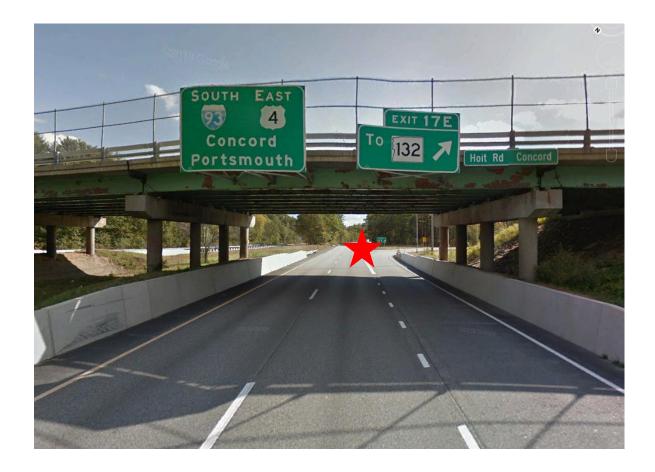
Damage to Girder 8, Span 4, ~11.5" horizontal displacement, puncture

25 working days for all work using daytime road closures (4 days paint removal, 15 days heat straightening)
