CONCRETE METALIZING ON THE QUEEN ISABELLA CAUSEWAY

Steven Austin

Texas Department of Transportation

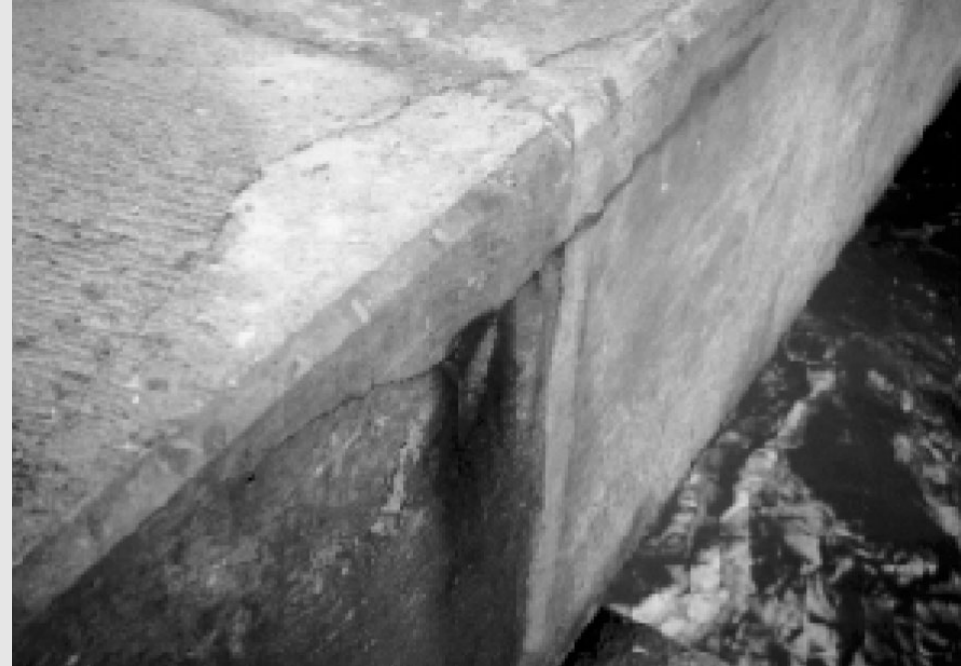
- Cover meter readings indicated cover over 3.5"
- Various crack widths from 0.03" to 0.125".
- No delaminations identified

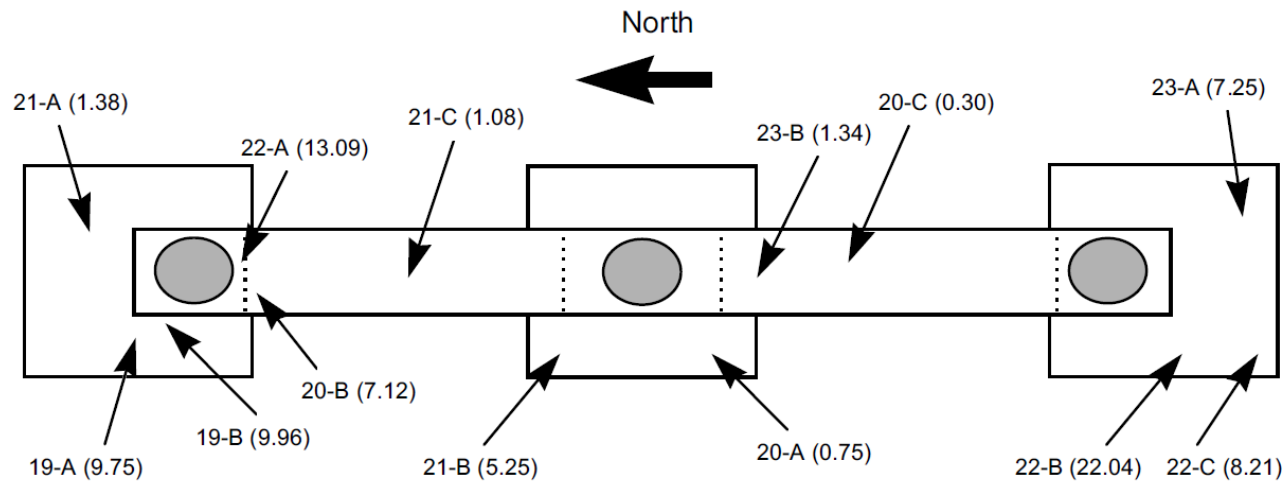
- Half-cell potential readings correlated well with cracks.
- Moderate to very high chloride content at reinforcing level.
- Application of metalizing to splash zone only

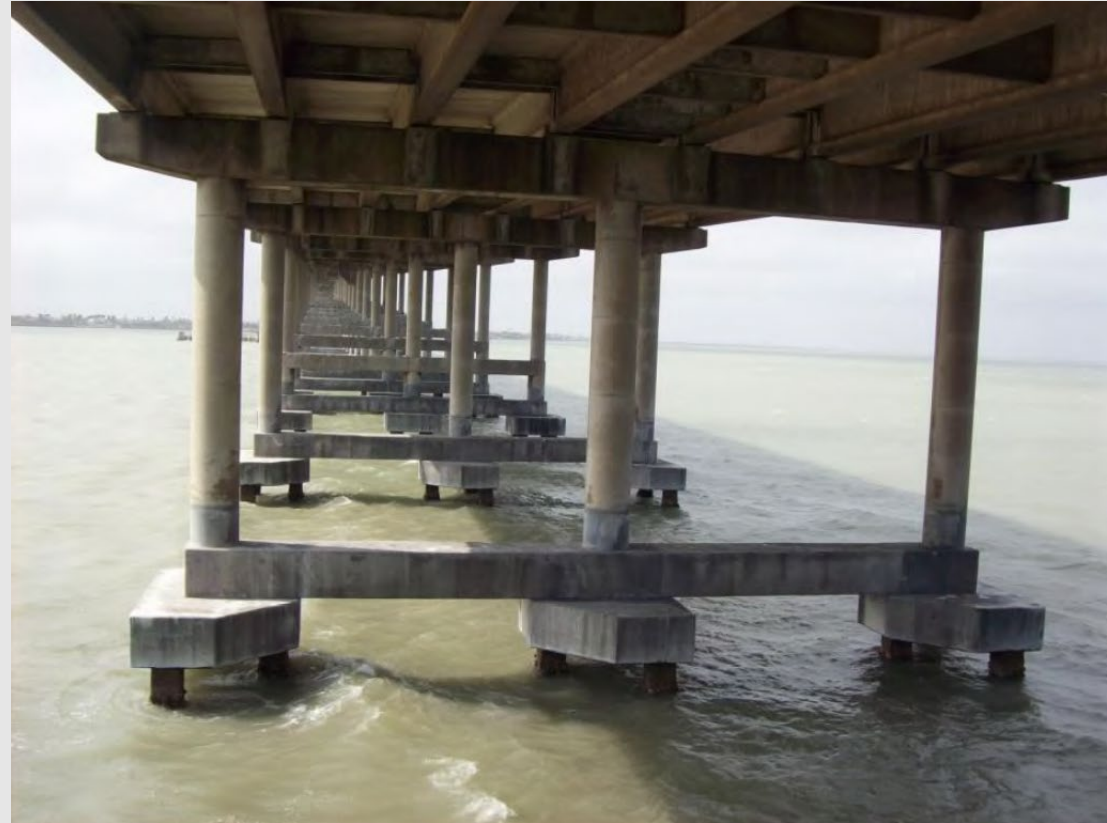
- Assessment to determine effectiveness and remaining life of bridge
- Cathodic protection was effective
- More rapid average consumption of the Al coating compared to the Zn coating
- Recommended re-application to the aluminum-coated bents

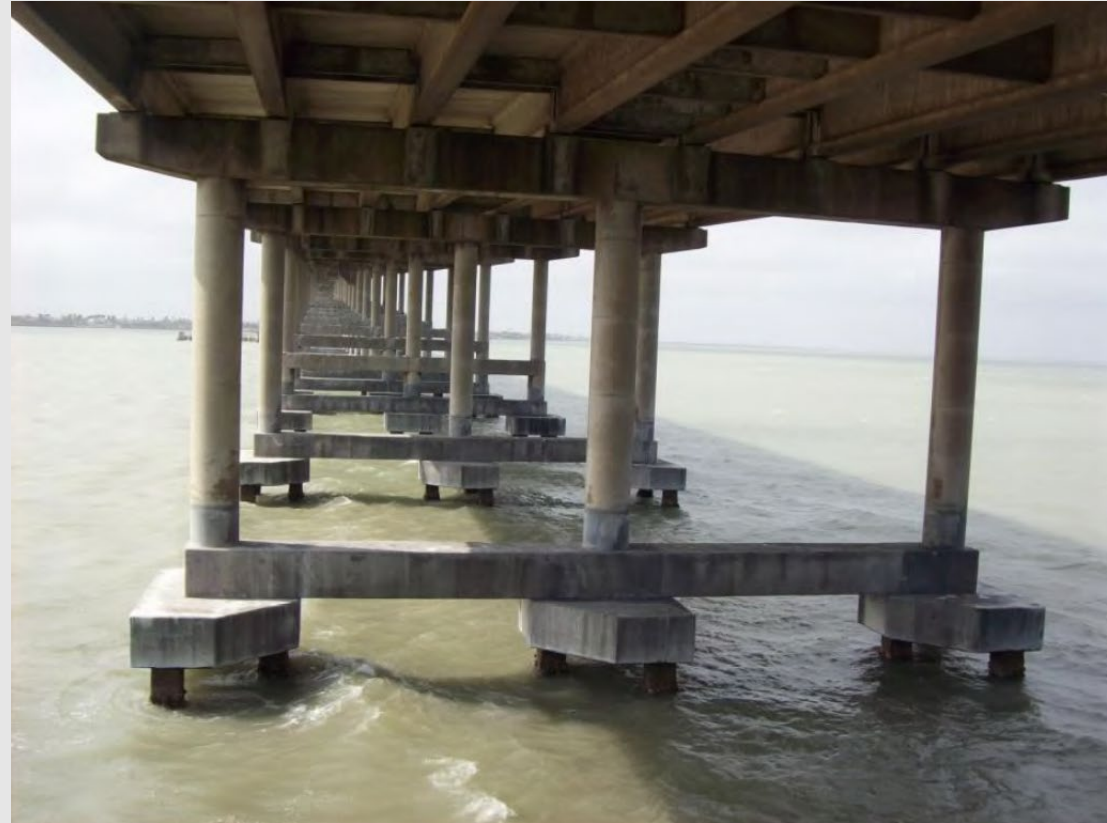
- More rapid consumption of the anode at the connection to reinforcing. Loss of this connection could result in loss of effectiveness
- 5 years after installation assessment estimated service life of metalizing protection of 10 to 15 years of service life.

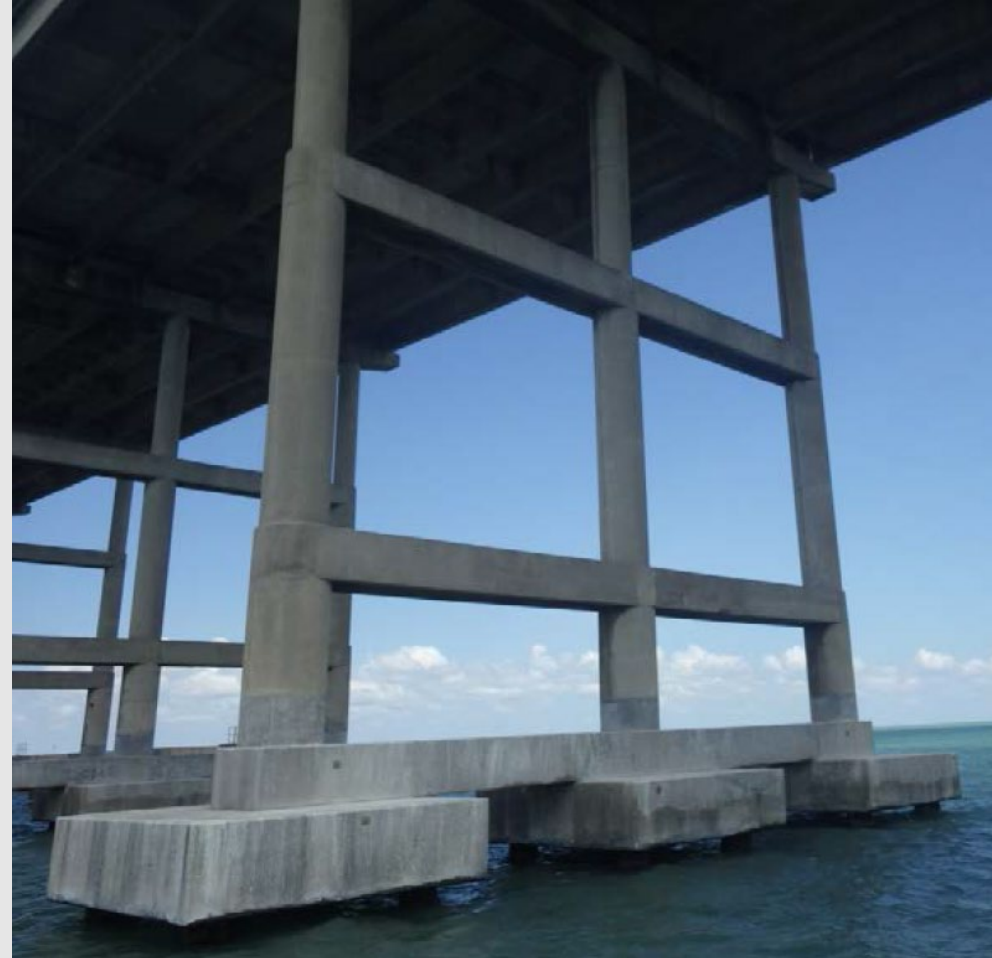
- Found Zn metalizing of 2004/2005 to be completely consumed at some locations.
- 2011 TSZ had nearly twice as much coating blistering as did the 2004/2005
- Half of the 2004/2005 bents tested showed ineffective cathodic protection based on Polarization Testing and Half-Cell potential.

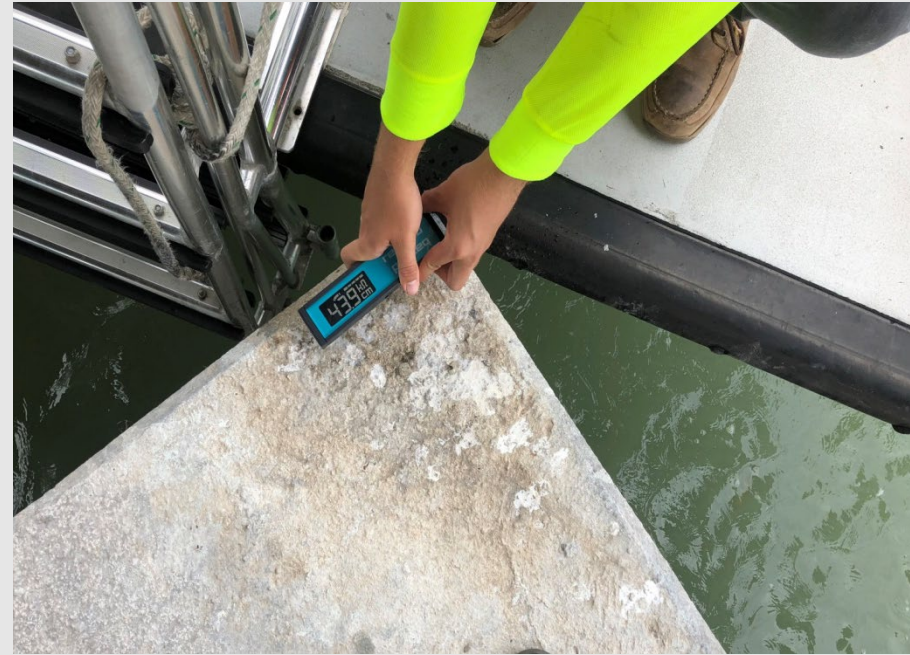
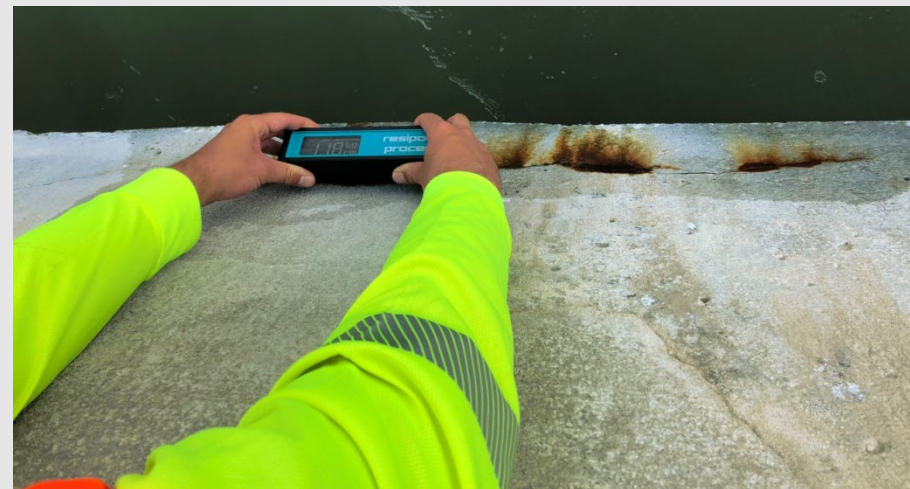
- TxDOT review
 - Extensive literature research on metalizing and corrosion evaluation and mitigation plans
 - June 20 and 21, 2018 field trip by TxDOT employees using resistivity meters and coating sampling.
 - Visual assessment confirmed areas of no remaining metalizing at various locations
 - Approaching end of useful coating life after 7 years at locations coincident with what appears to be poor construction quality (honeycombing).

- TxDOT review
 - Resistivity readings of 11-70 k Ω -CM in many footings.
 - Some top of footing readings were in the single digits.
 - Corrosion is active
 - 2011 application is also approaching the end of the useful life

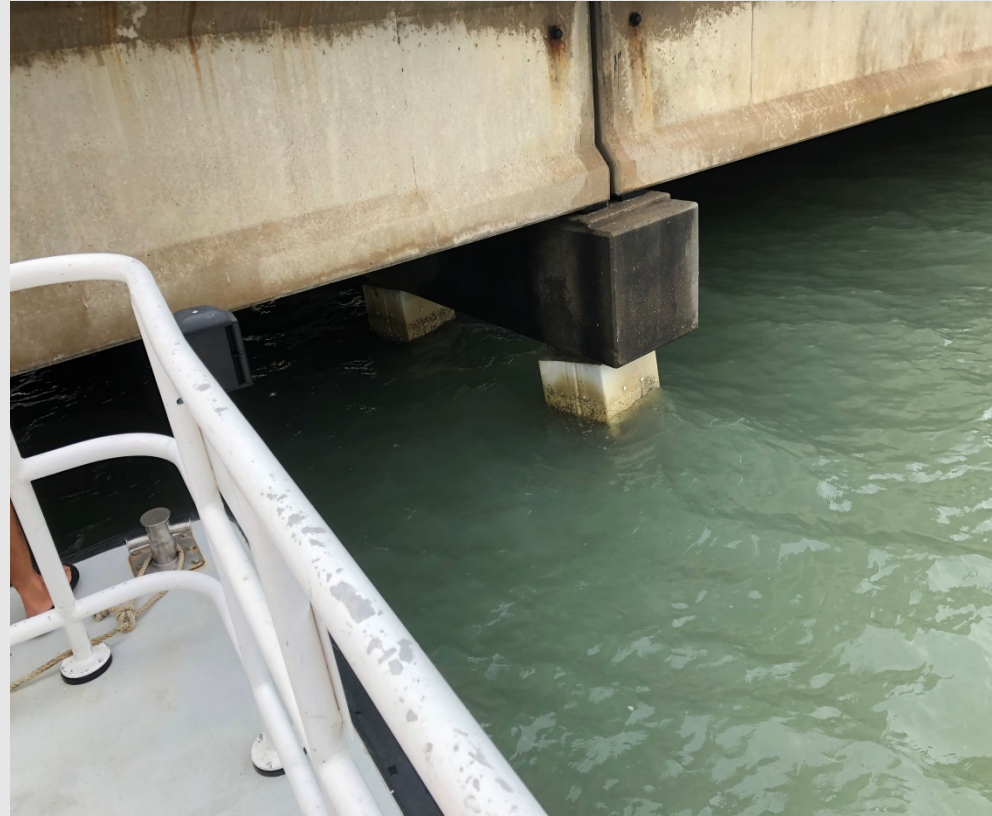
- TxDOT review
 - The use of bulk zinc anode for Bents 1 to 7 and 140 to 151 appears to be quite effective
 - The cathodic protection at these bents is still effective with protection extending into the bent caps.
