# Sunshine Bridge Emergency Repair

Southeast Bridge Preservation Partnership  
Baton Rouge, Louisiana  
4/17/2019

Zhengzheng (Jenny) Fu, P.E.  
LADOTD Bridge Design Administrator

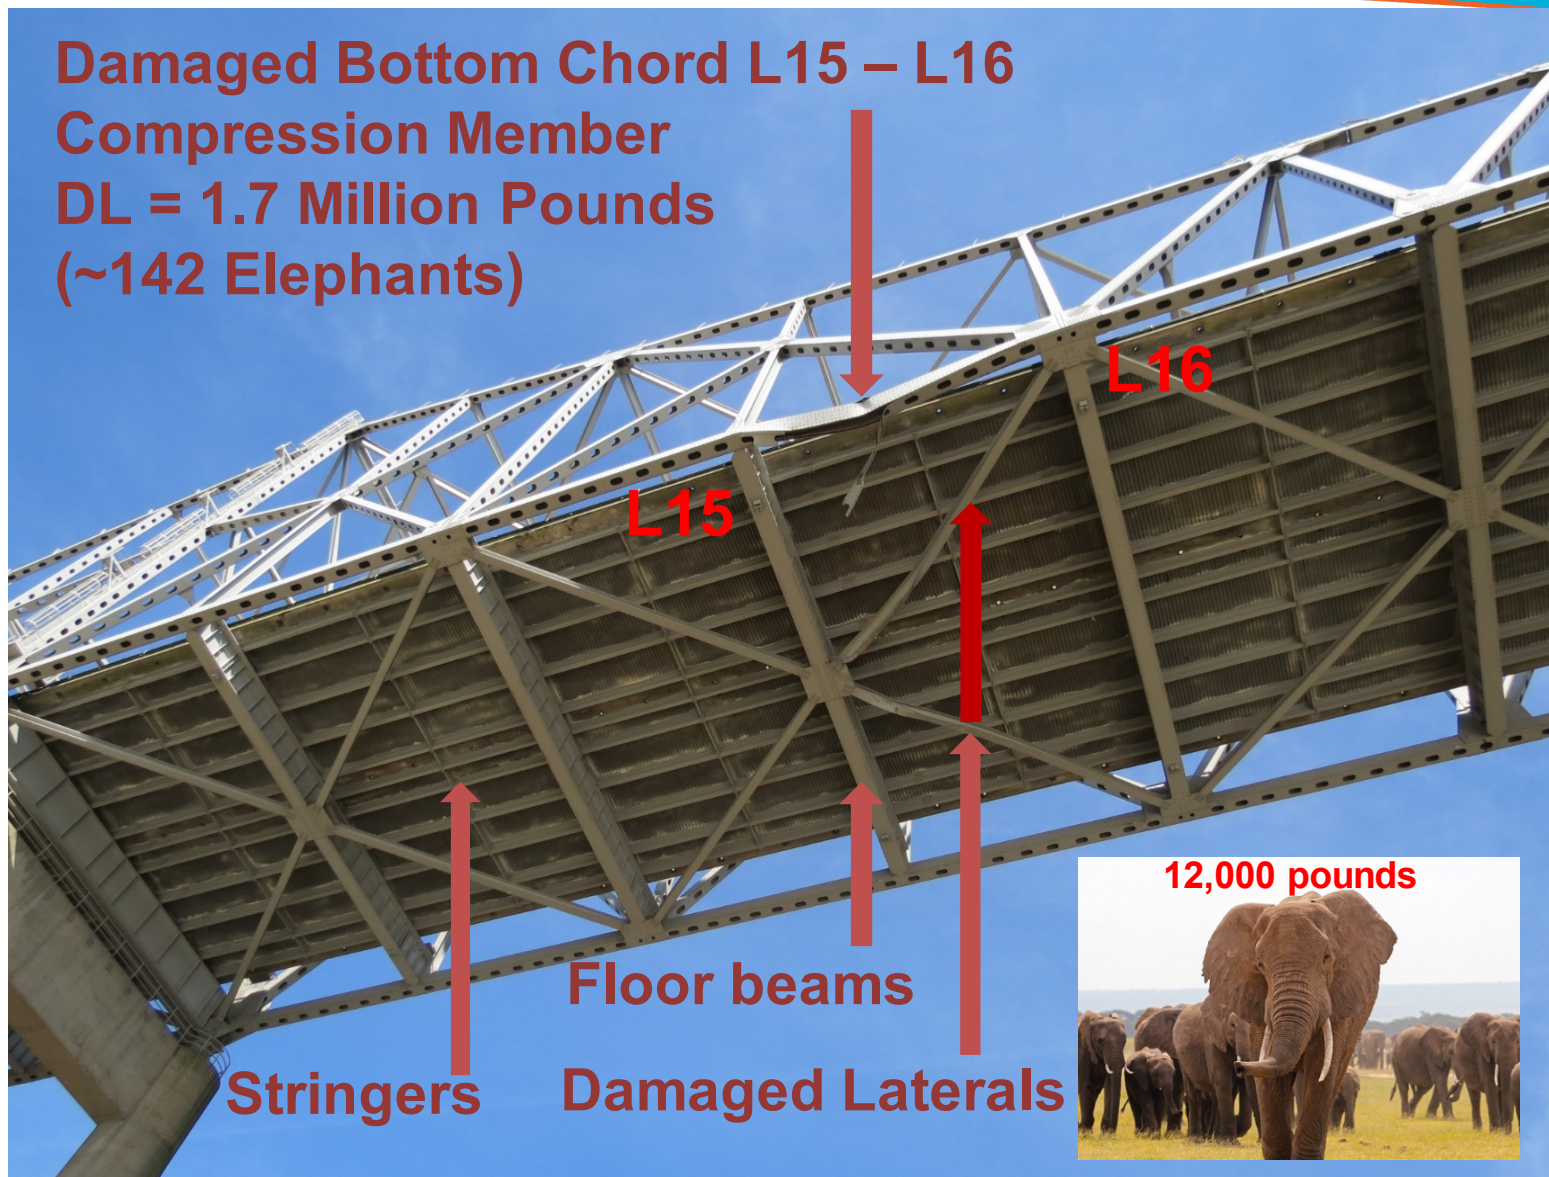
**Damaged Bottom Chord L15 – L16**  
**Compression Member**  
**DL = 1.7 Million Pounds**  
**(~142 Elephants)**

**Where did these elephants go after impact?**  
**How many trapped in the damaged chord?**

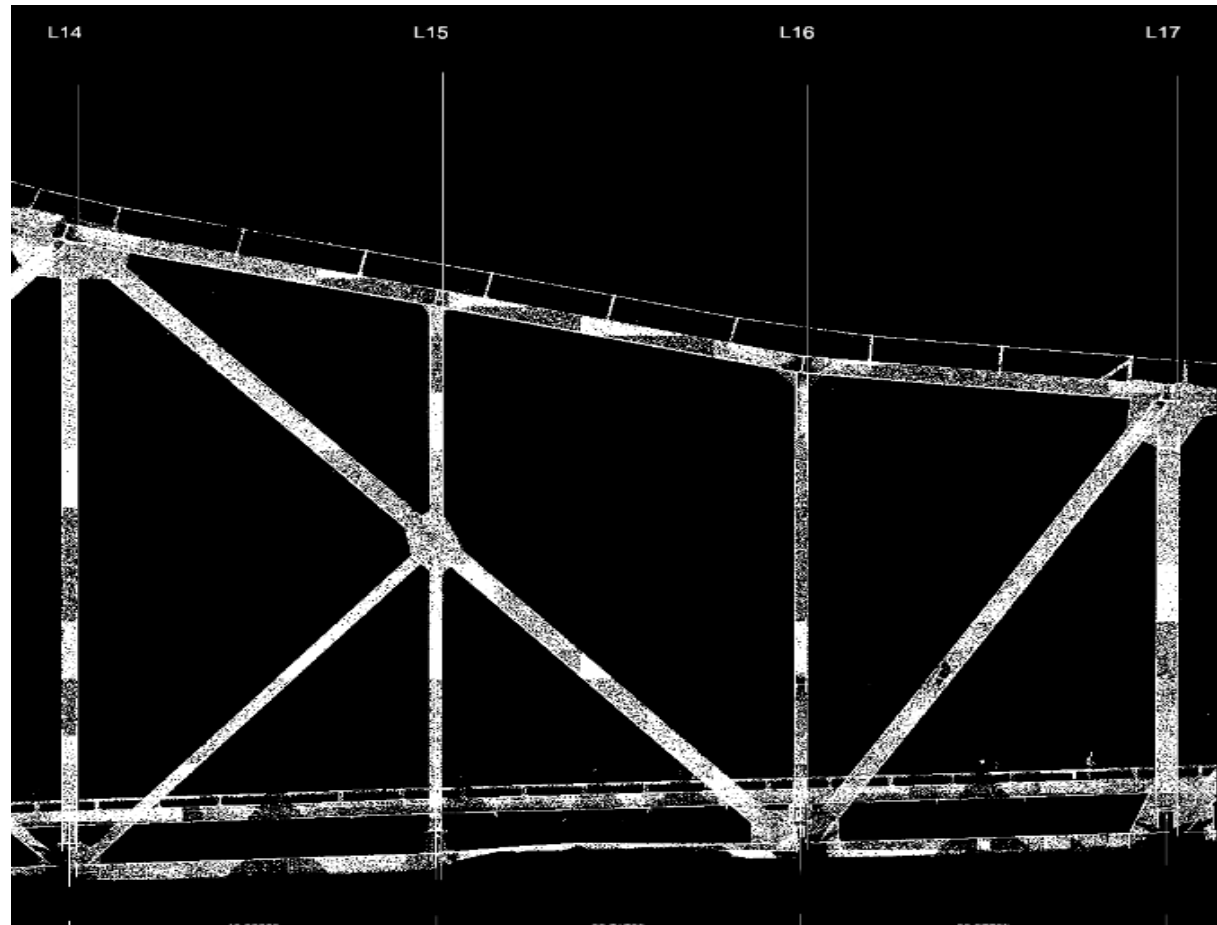
L15 (39.72') L16 (40') L17

**Panel between L15 – L16 Shorten by ~ 3 3/8'''**

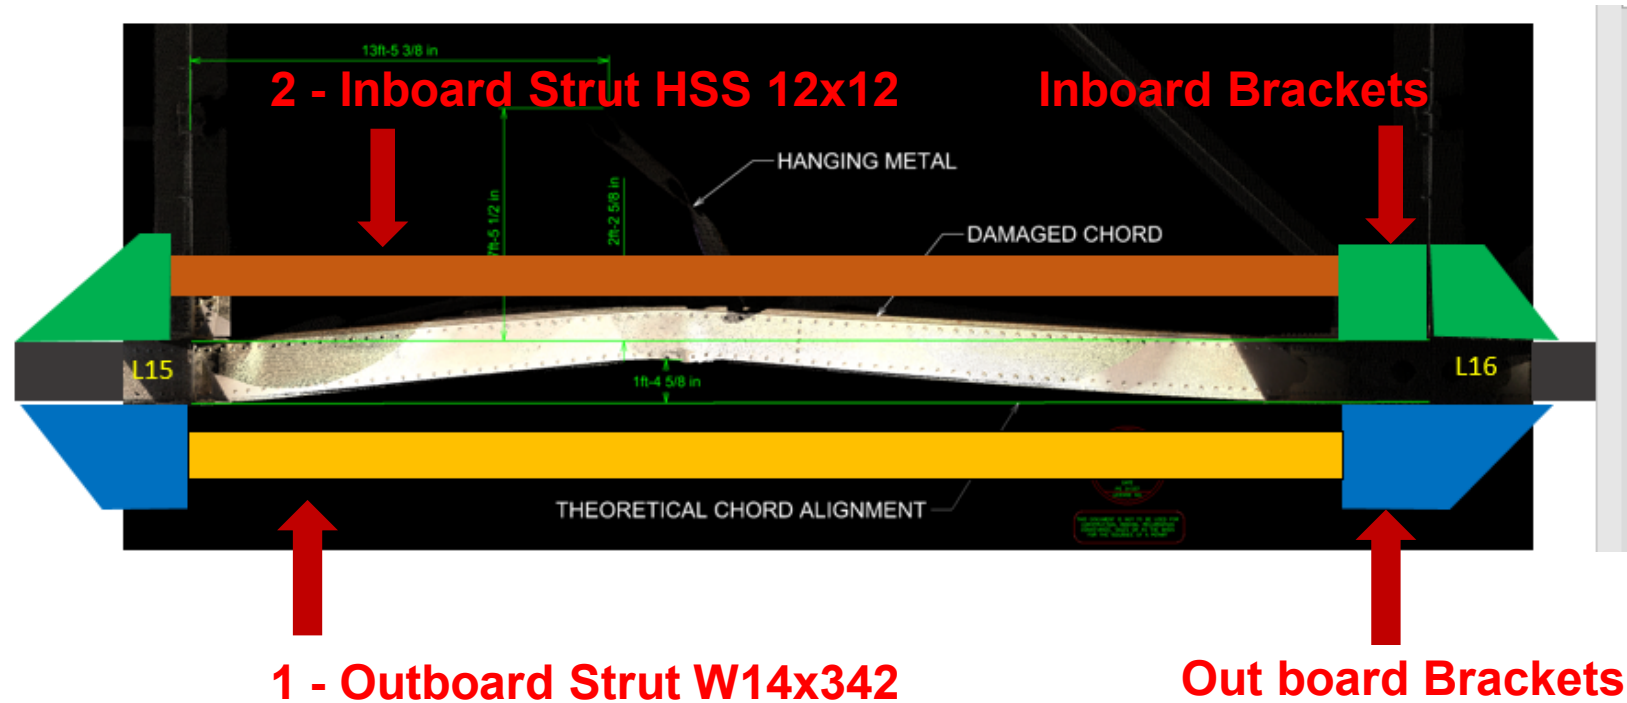
# Step 1a – Design Jacking Frame

Jacking System Capacity =  $1.5 \times 1,700,000 \text{ lbs} = 2,550,000 \text{ lbs}$

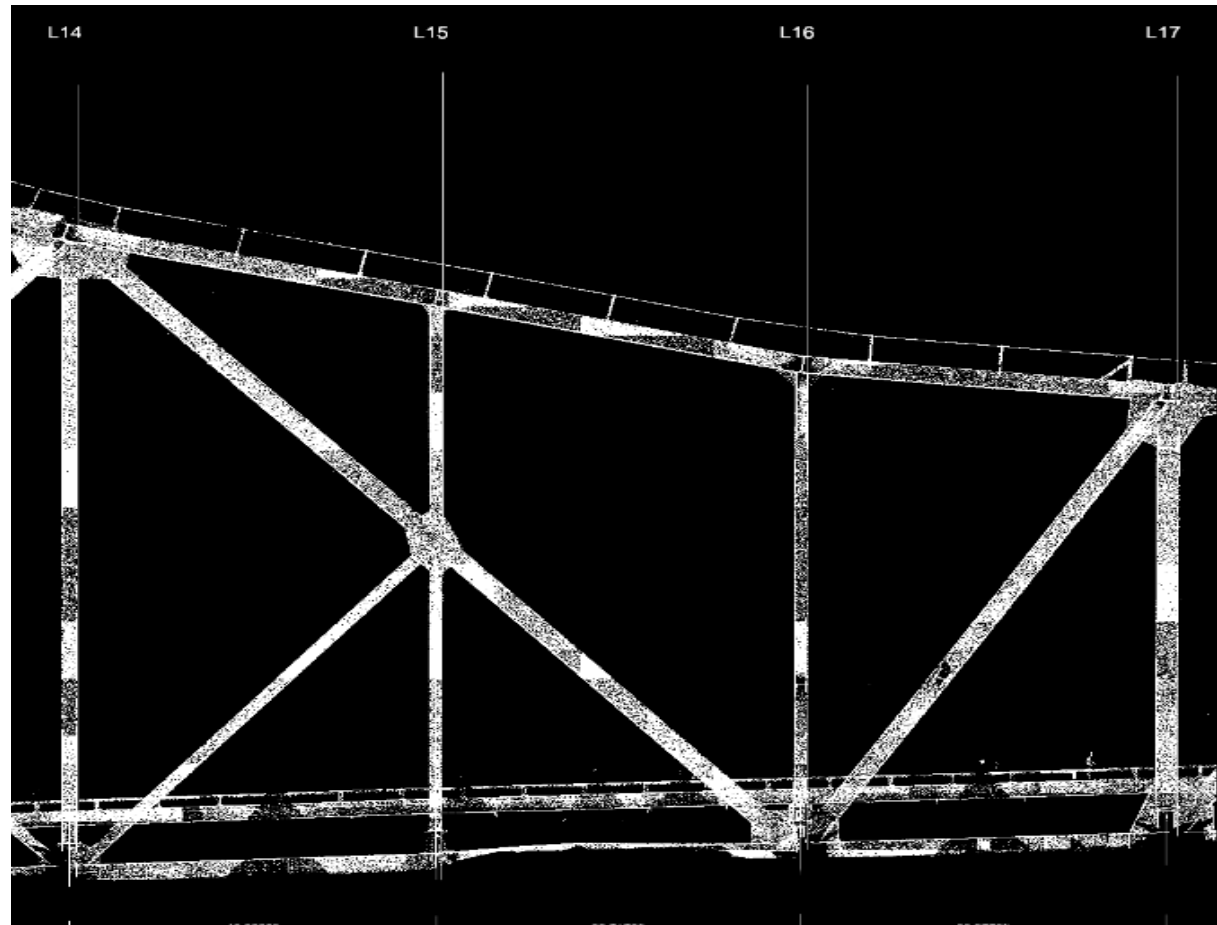
L15 (39.72') L16 (40') L17

Panel between L15 – L16 Shorten by ~ 3 3/8'''

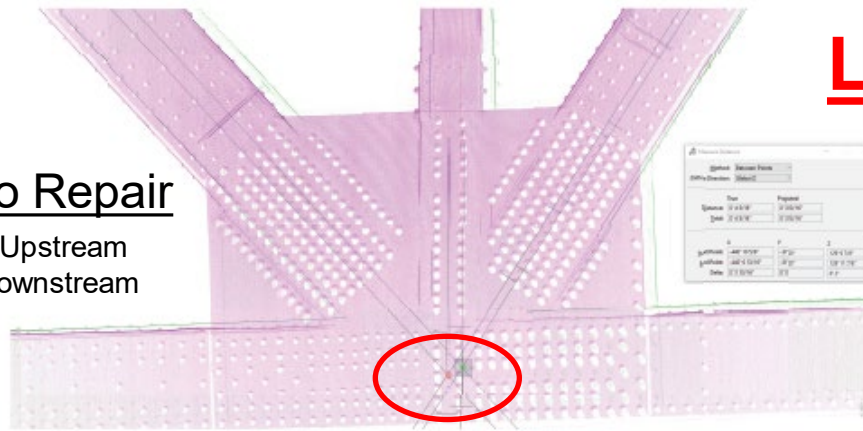
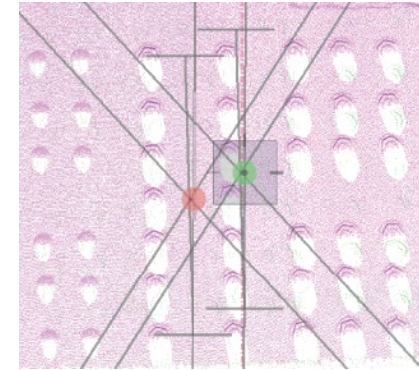
## Prior to Repair

X	Y	Z
Start Point:	-440' 10 5/8"	-31' 0"	129' 9 7/8"
End Point:	-440' 6 13/16"	-31' 0"	129' 11 7/8"
Delta:	0' 3 13/16"	0' 0"	0' 2"

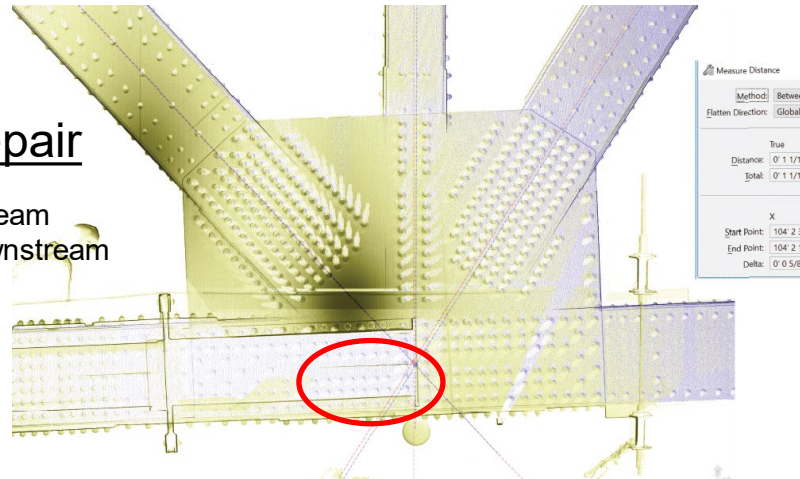
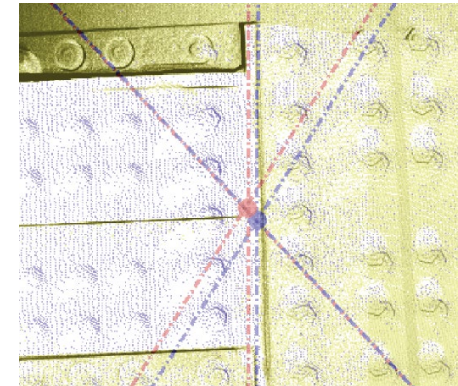
## After Repair

X	Y	Z
Start Point:	104' 2 3/4"	144' 10 7/8"	-4' 8"
End Point:	104' 2 1/16"	144' 10 7/8"	-4' 7 3/16"
Delta:	0' 0 5/8"	0' 0"	0' 0 13/16"

## Geometry Restored

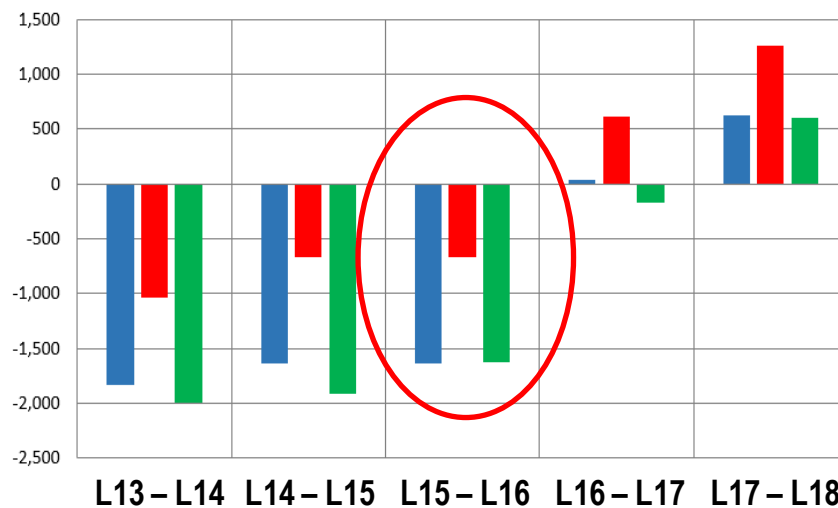
Downstream Bottom Chord Load Changes in Kips

**Load Restored**

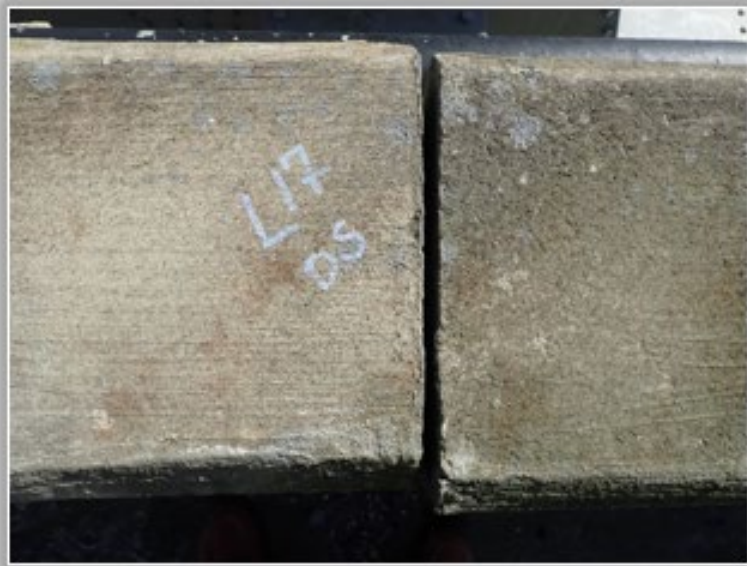
## Barrier Deck Joint at L17 Before and After Repair
