# US 190 MISSISSIPPI RIVER BRIDGE REPAIR, REHABILITATION, AND PAINTING

A COMBINED HIGHWAY/RAILROAD BRIDGE REHABILITATION

Durk Krone, P.E., TRC Engineers, Inc., Baton Rouge, LA

SESSION 3  
APRIL 17, 2019

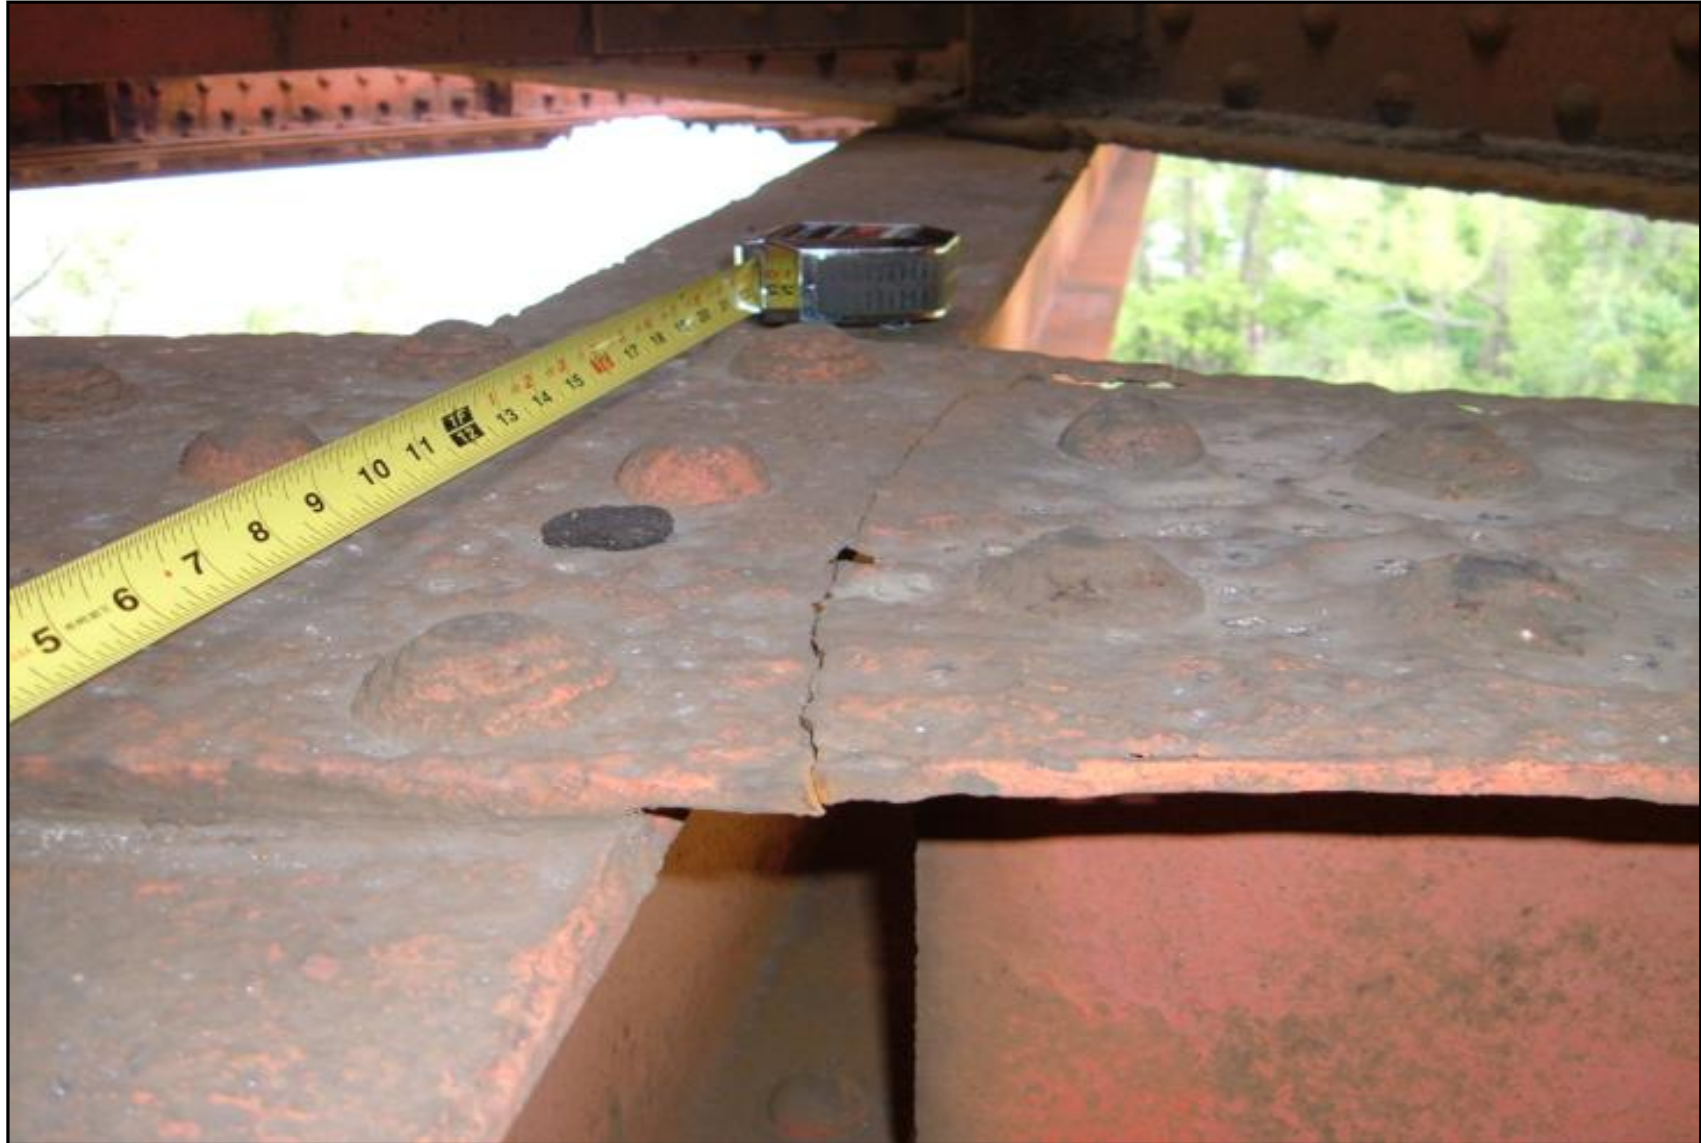
# CRACKED HORIZONTAL GUSSET PLATES

**CENTER  
HORIZONTAL  
GUSSET  
PLATES OF  
TRUSS LOWER  
LATERALS  
WERE  
TYPICALLY  
CRACKED**

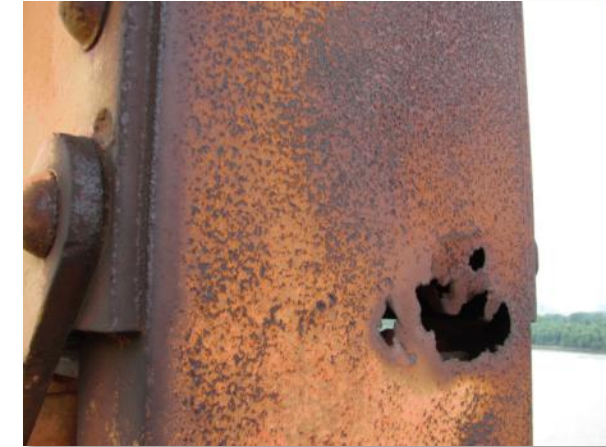
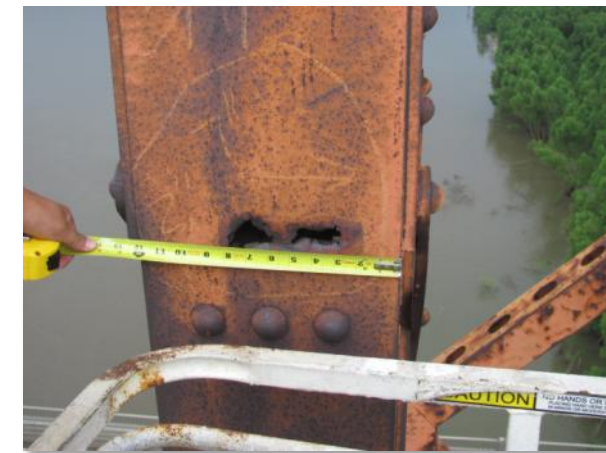
# TRUSS MEMBER DETERIORATION

**VERTICAL TRUSS MEMBERS**

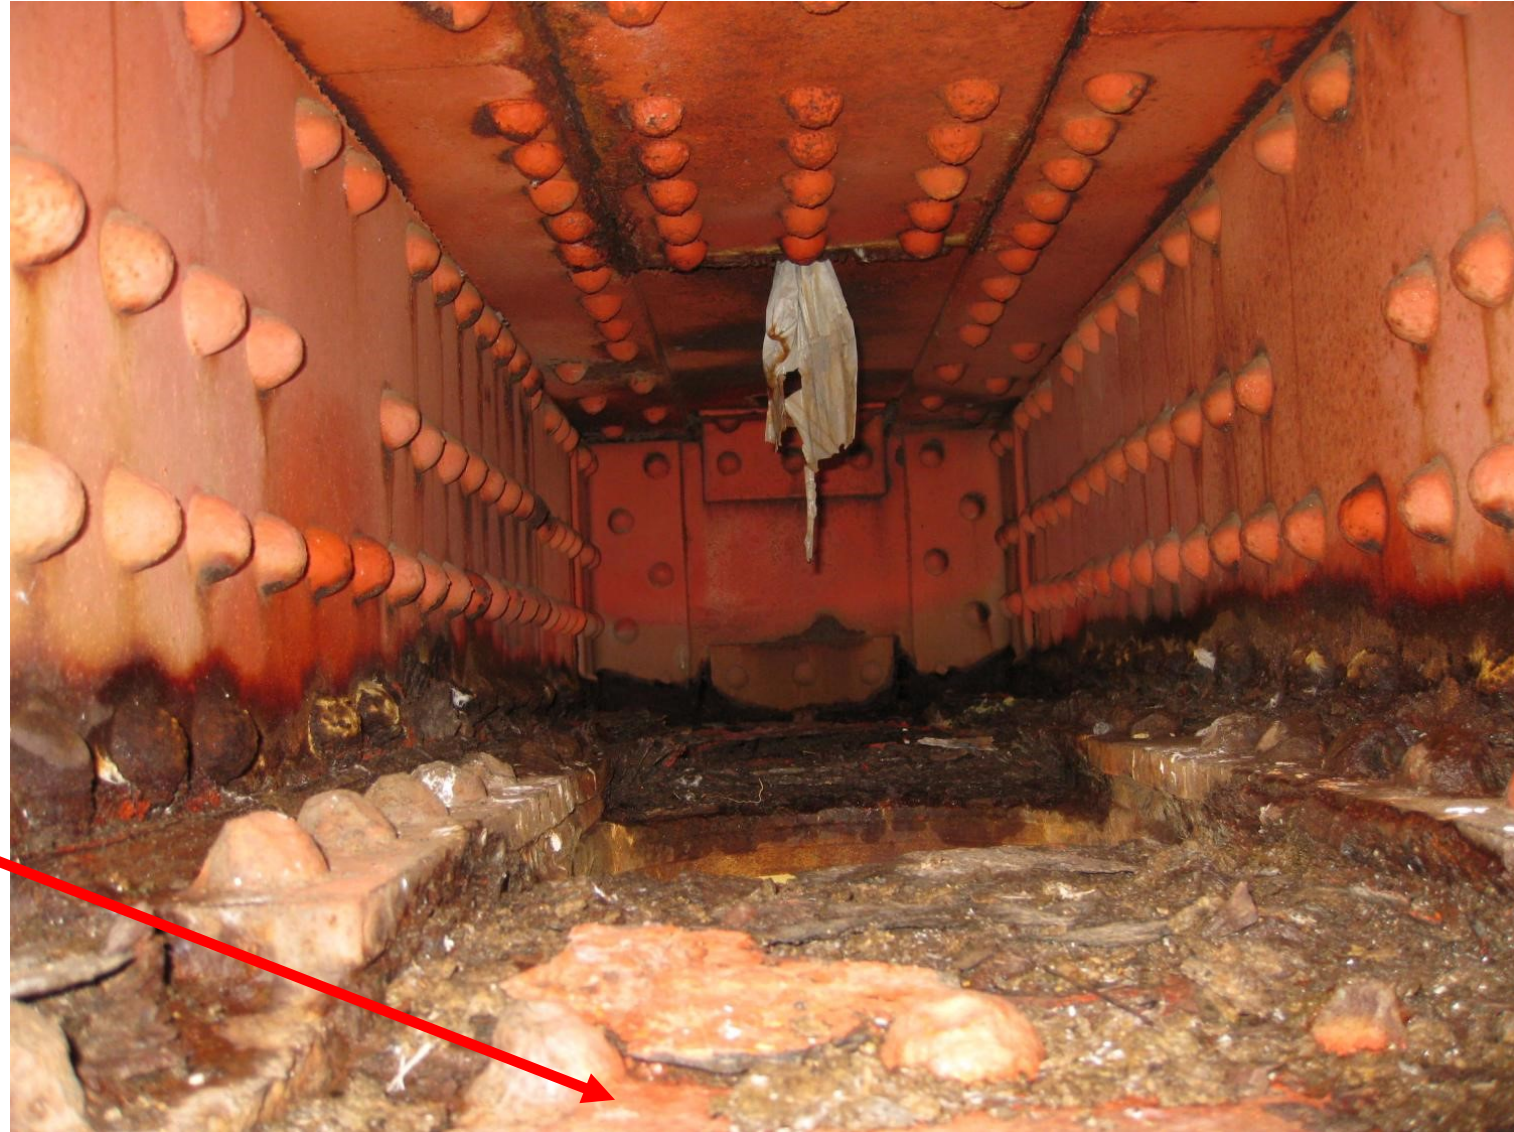
# REMOVING RIVETS IN CHORD MEMBERS

**DETERIORATION  
INSIDE LOWER  
CHORD**

**LIMITED ROOM  
FOR EQUIPMENT**

**LOWER CHORD  
INTERNAL  
MID-PLATE**

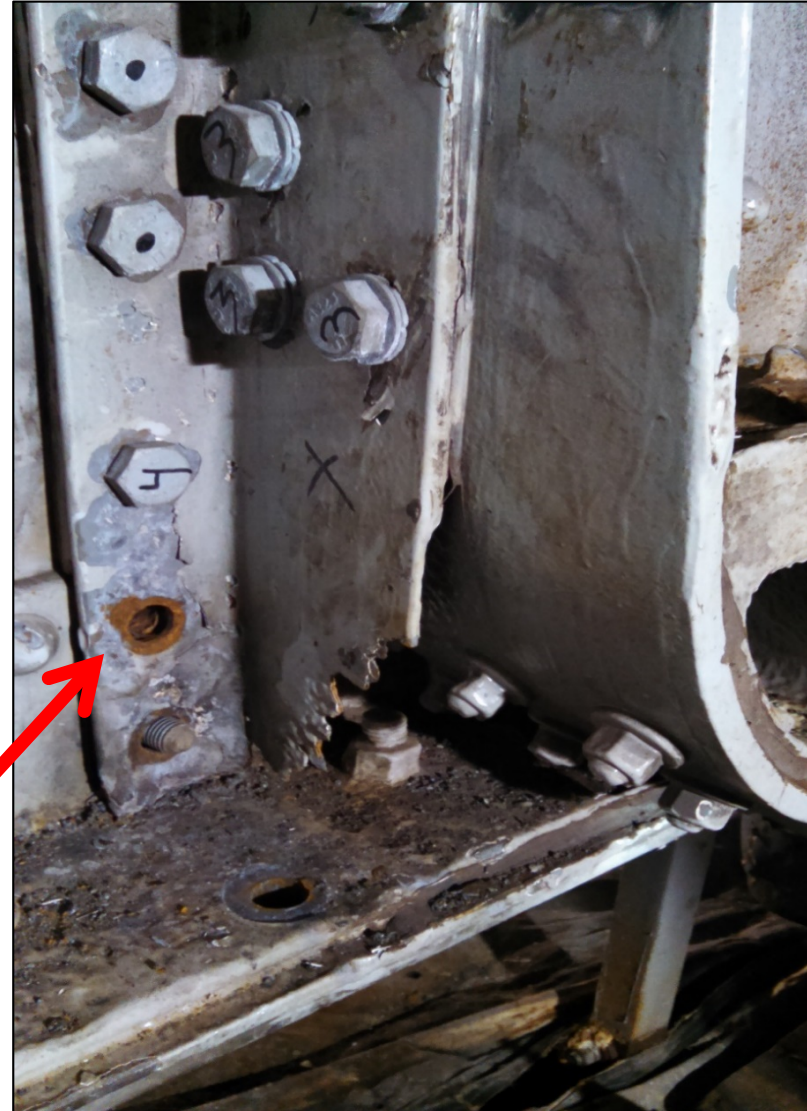
# RR STRINGER STIRRUP BEARING REPAIR

**DETERIORATED  
CONNECTION  
ANGLE**

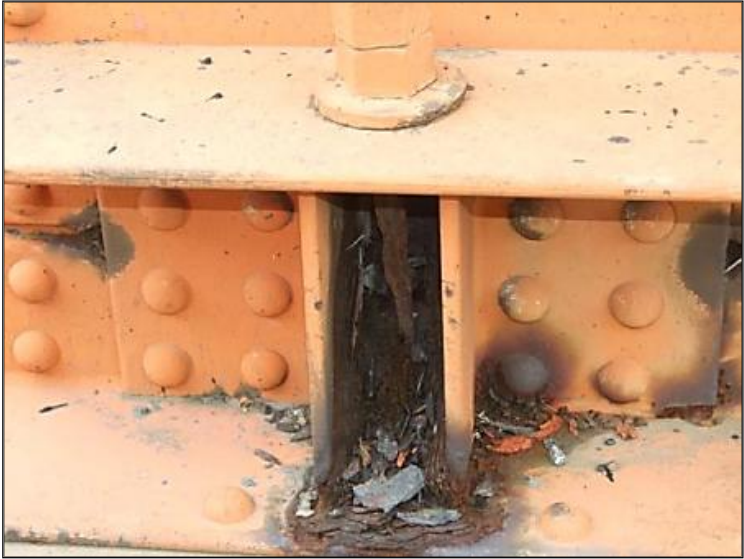
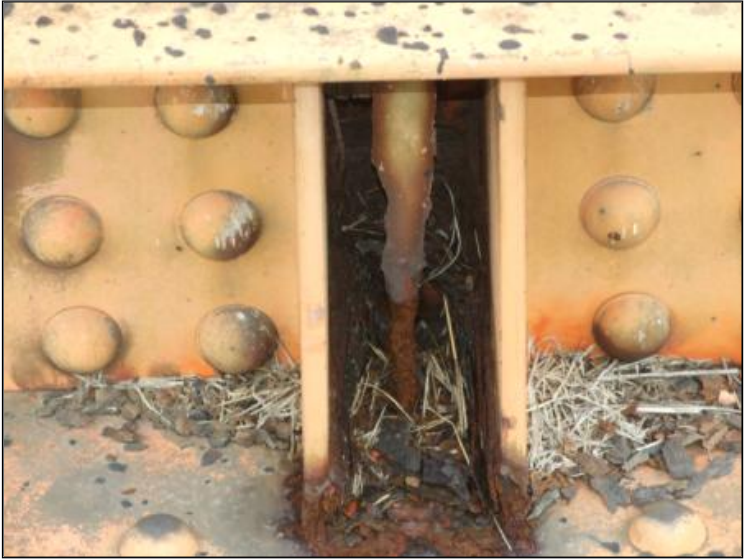
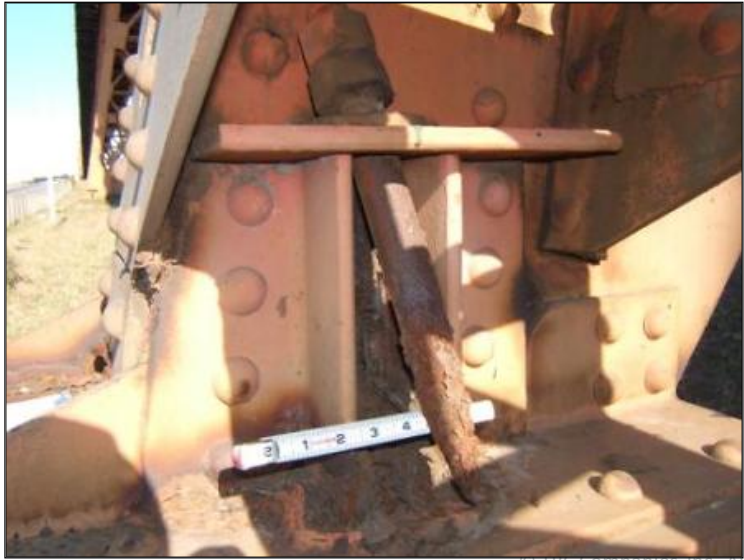
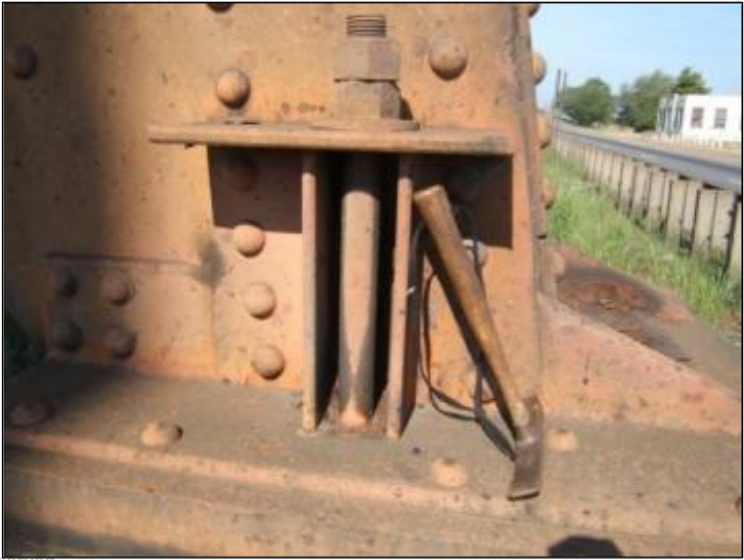
# TOWER ANCHOR BOLTS

**OR  
WERE  
COMPLETELY  
ABSENT**

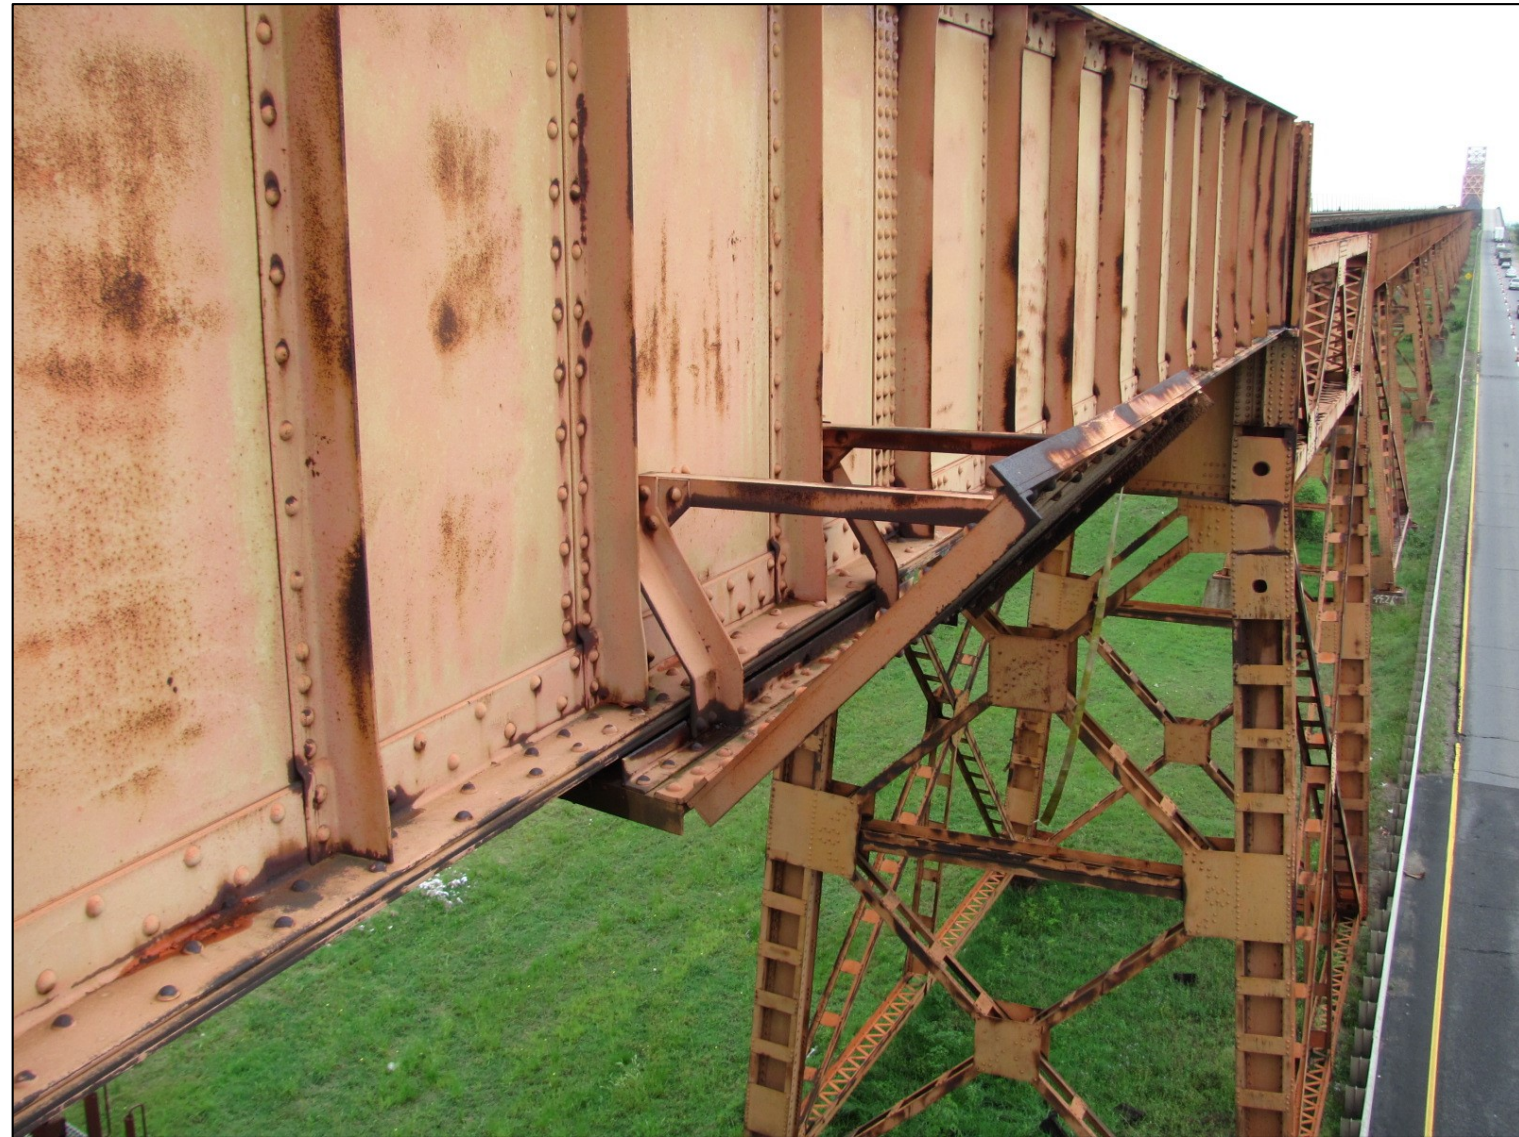
# ANCHOR BOLT REPAIR – TYPE II

**PEDESTALS  
TOO CLOSE  
TO ROAD  
FOR  
EXCAVATION**

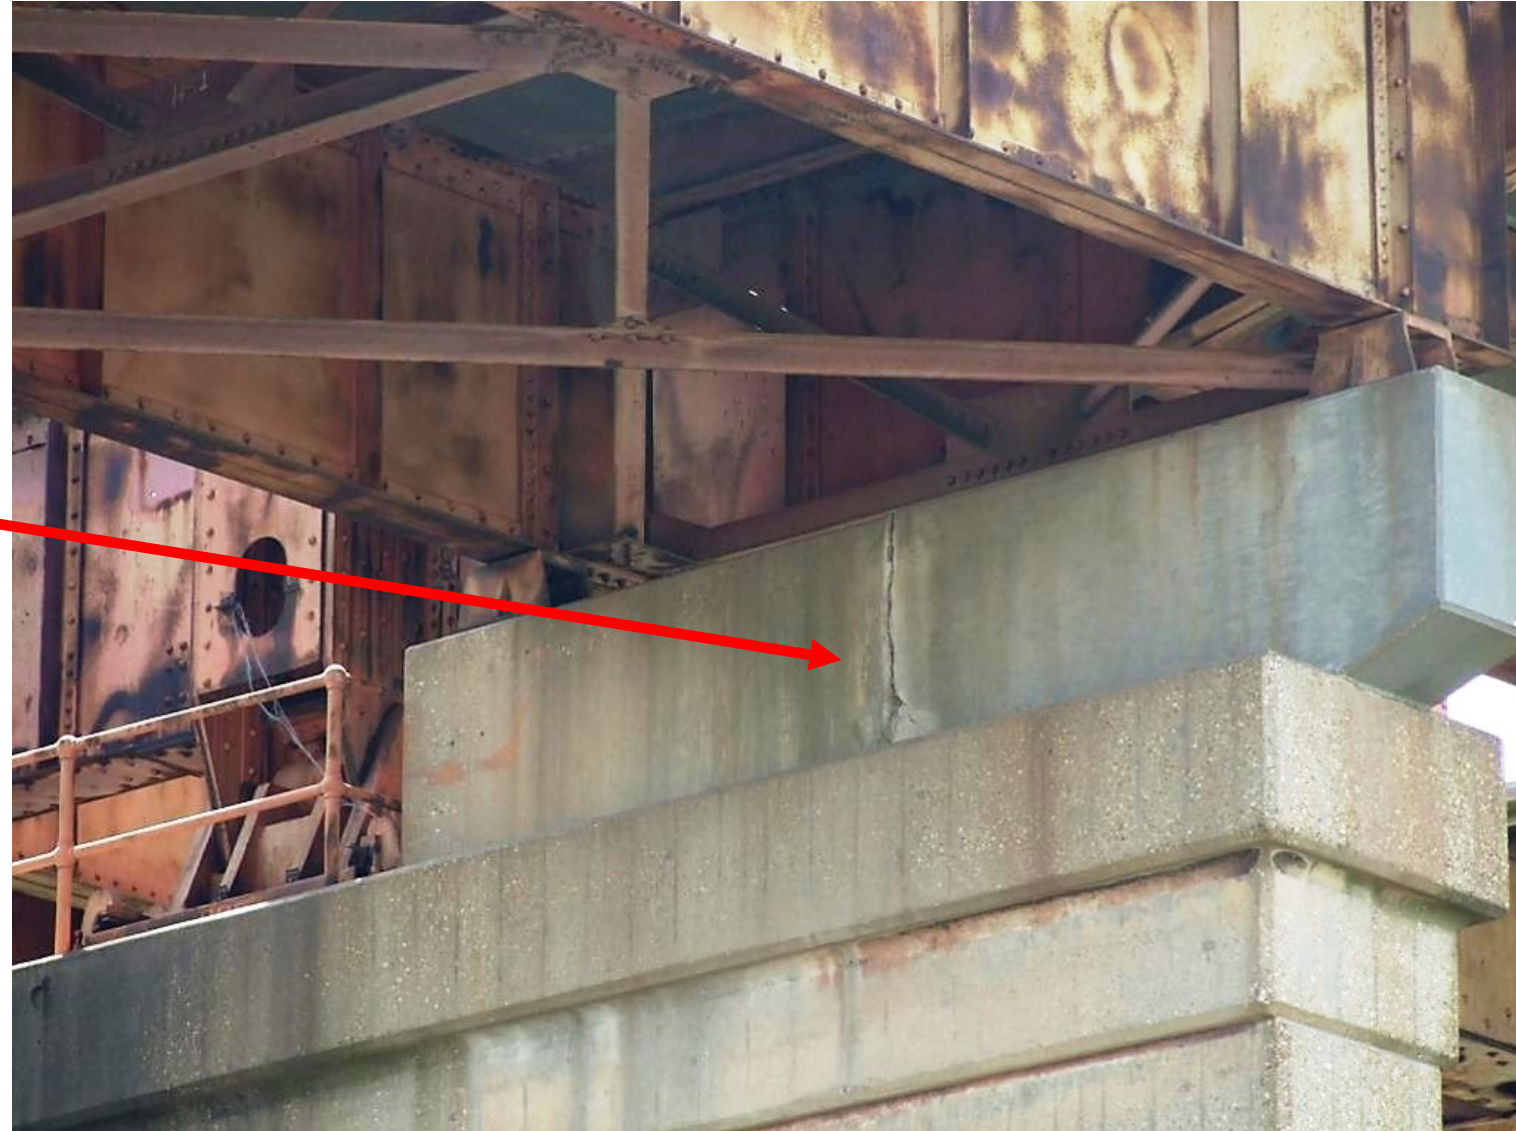
# PEDESTAL REPAIRS AT PIERS 1 & 6

**HIGHWAY GIRDER  
PEDESTALS WERE  
WIDENED IN 1988  
AND HAD  
TYPICALLY  
CRACKED AT  
INTERFACE TO  
OLD CONCRETE**

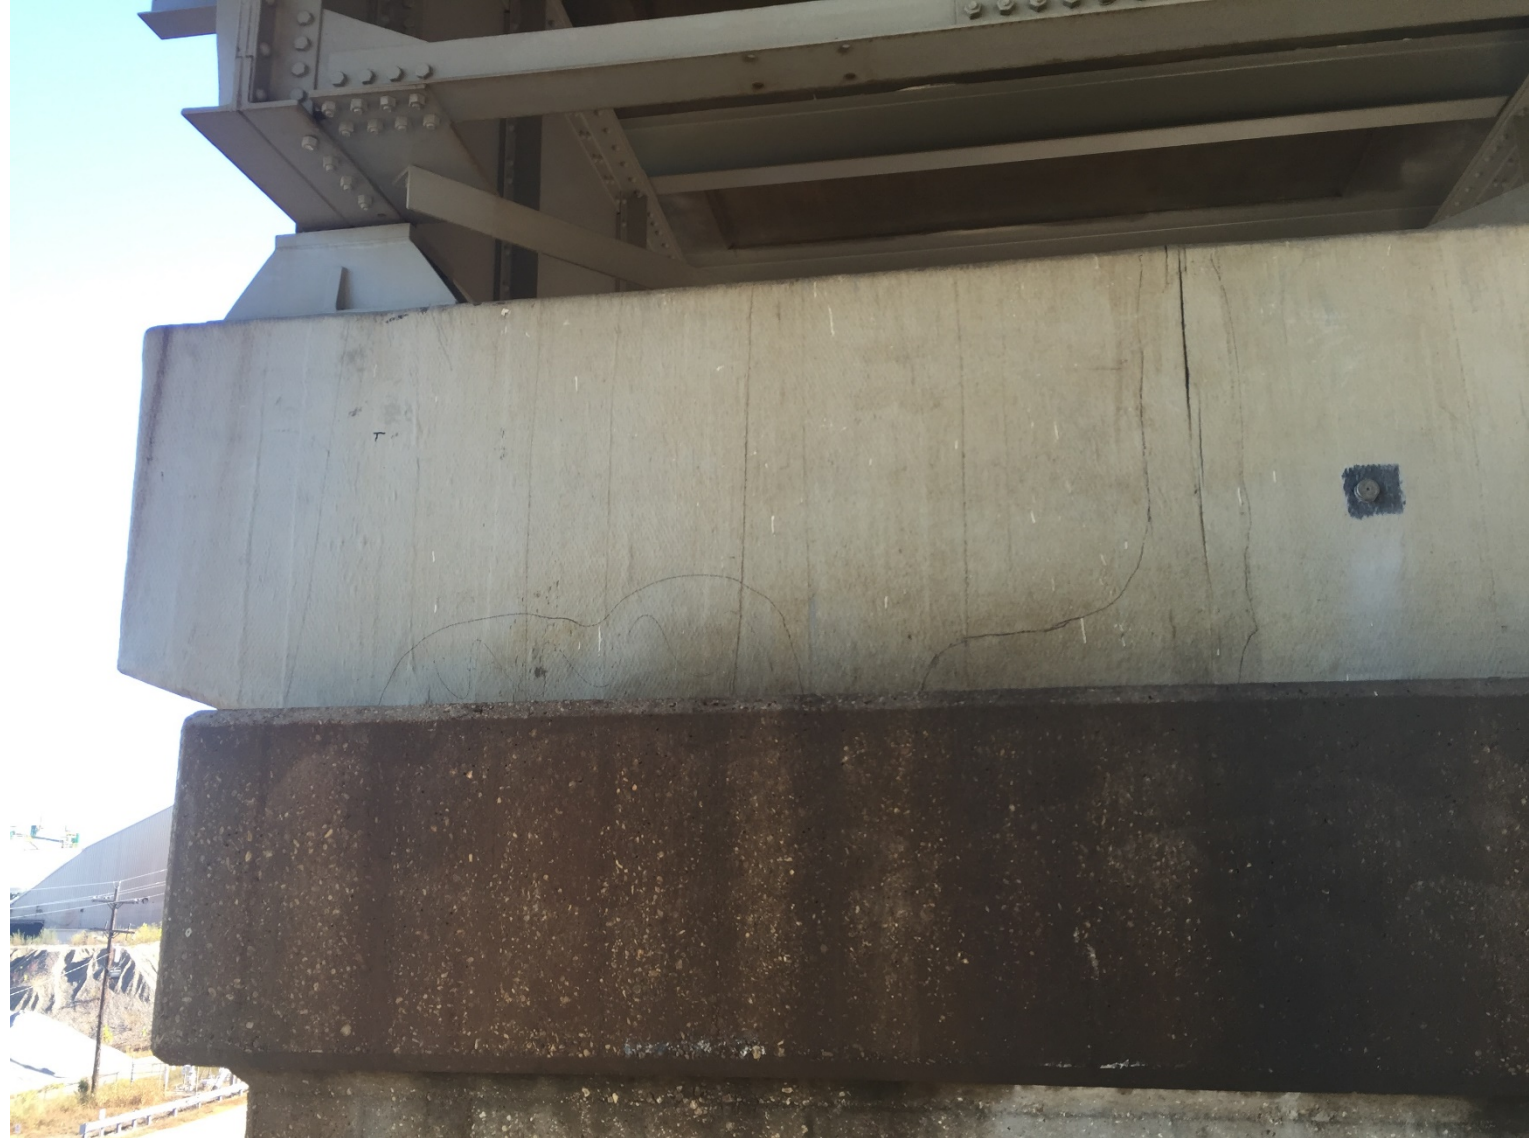
# PEDESTAL REPAIRS AT PIERS 1 & 6

**FIBERWRAP FIBER  
ORIENTATION  
WAS INCORRECTLY  
APPLIED BY  
CONTRACTOR AND  
FAILED!**
