# Eight Year Performance of a Recycled Freeway Surface in Ontario

First Western States Regional  
In-Place Recycling Conference  
June 3 – 5, 2008  
Salt Lake City, Utah

***Tom Kazmierowski, P.Eng.***  
**Materials Engineering and Research Office**  
**Ministry of Transportation Ontario**

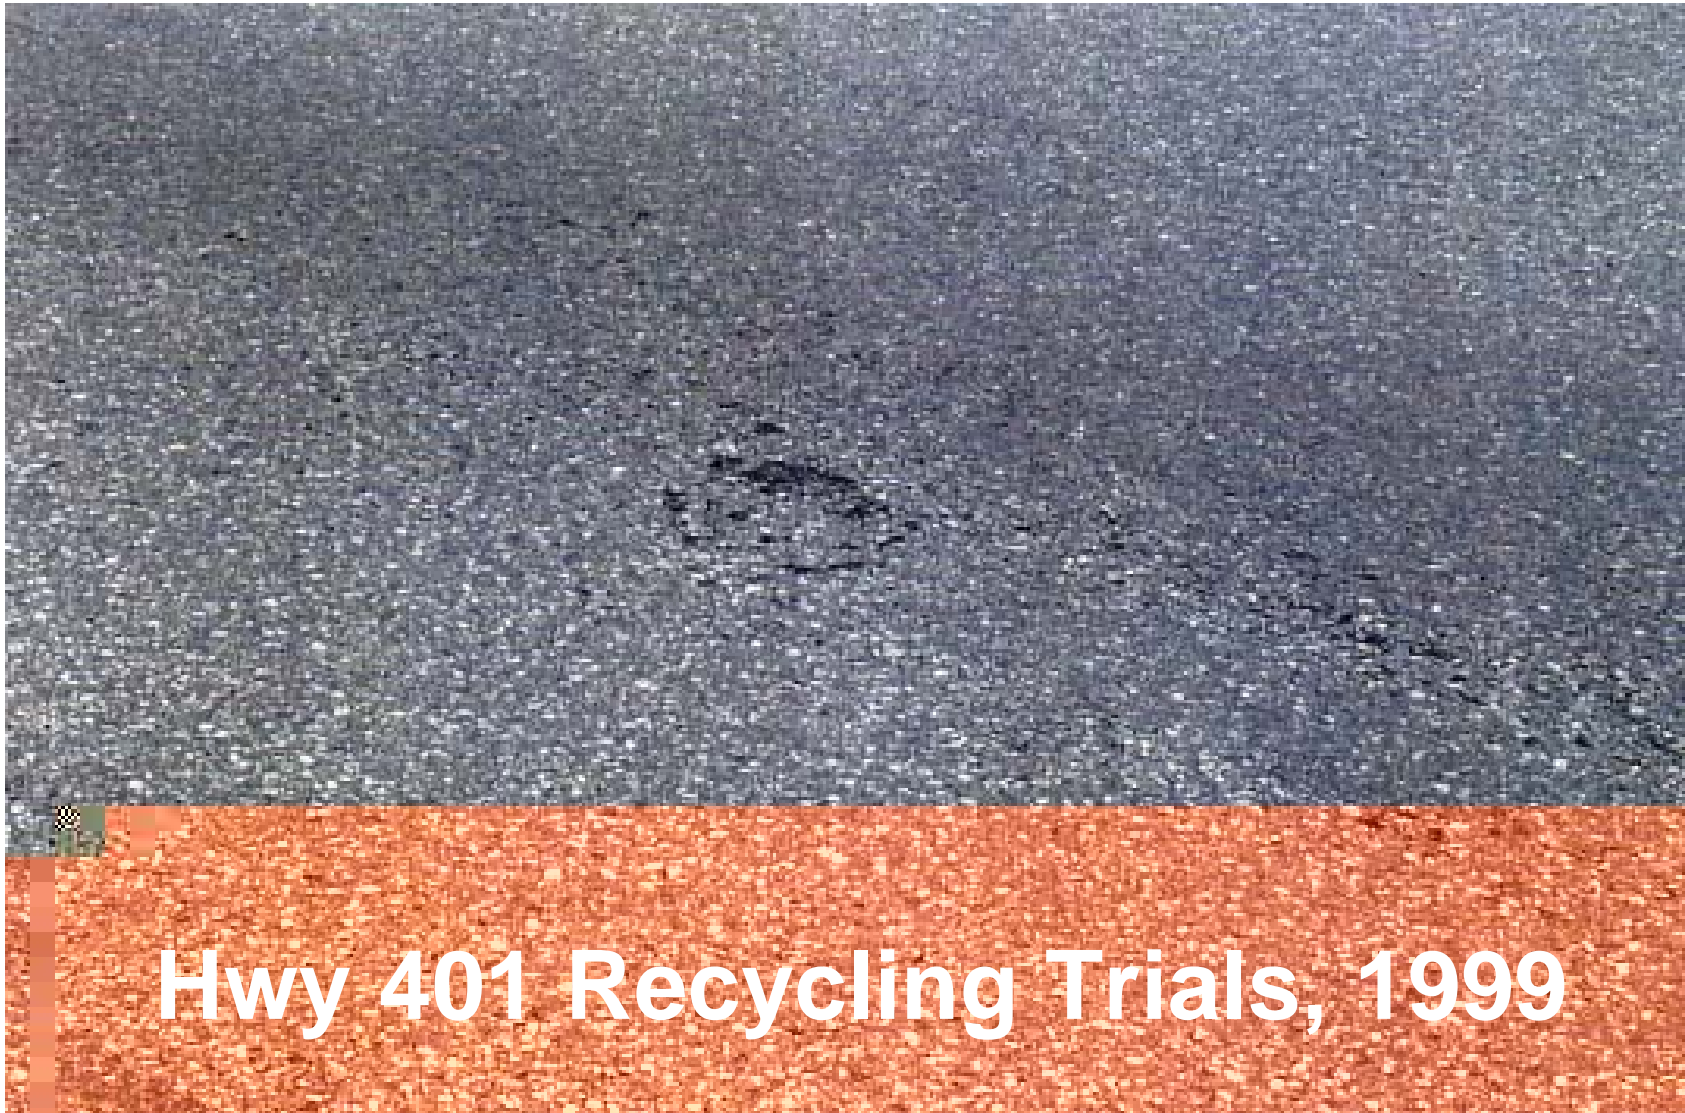
# Pre-Construction Conditions...

- Road Radar survey found 340 mm HMA over 910 mm granular material
- Material Properties better than usual

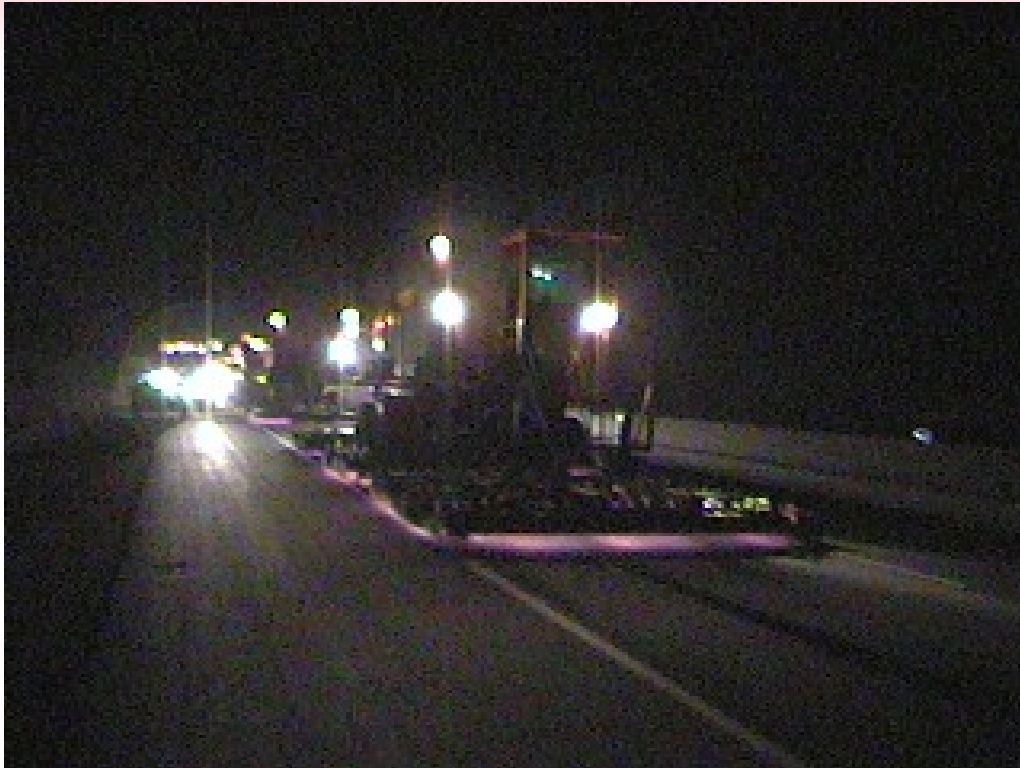
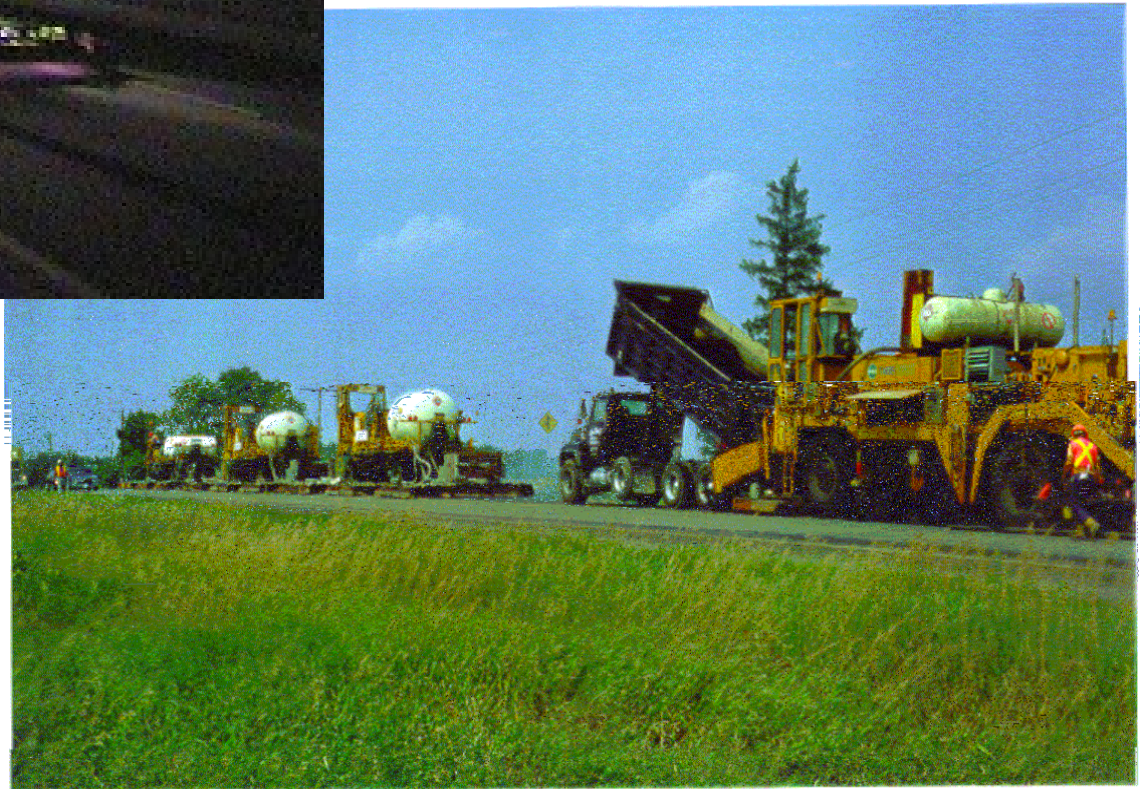
## ■ Taisei Rotec Section:

- 0.44 L/m<sup>3</sup> rejuvenating oil & 15 mm HMA (PG 58-28 & diabase agg)
- Paved at 26°C to 18°C
- Distresses included:
  - moderate midlane segregation throughout
  - Intermittent slight segregation along longitudinal joint

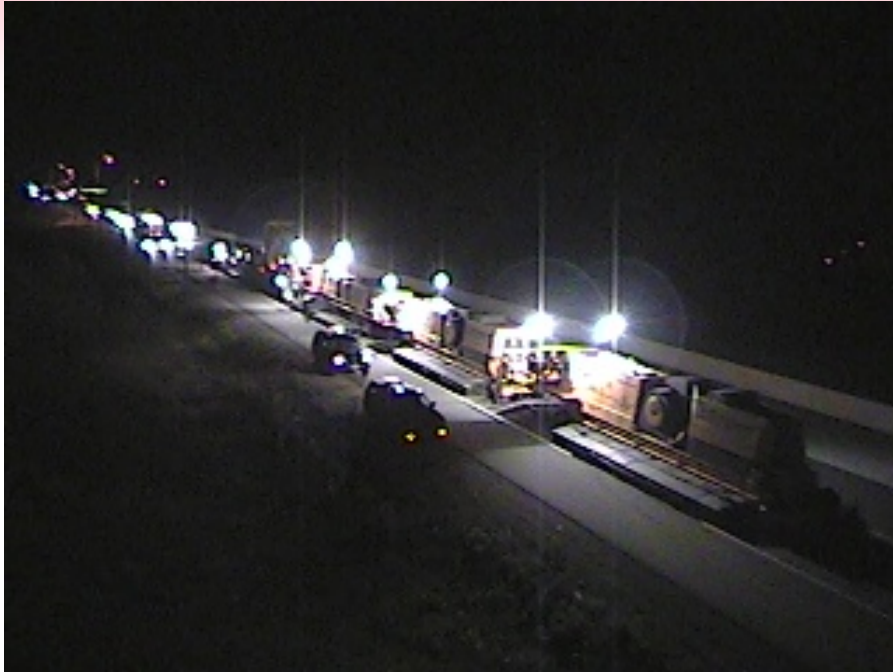
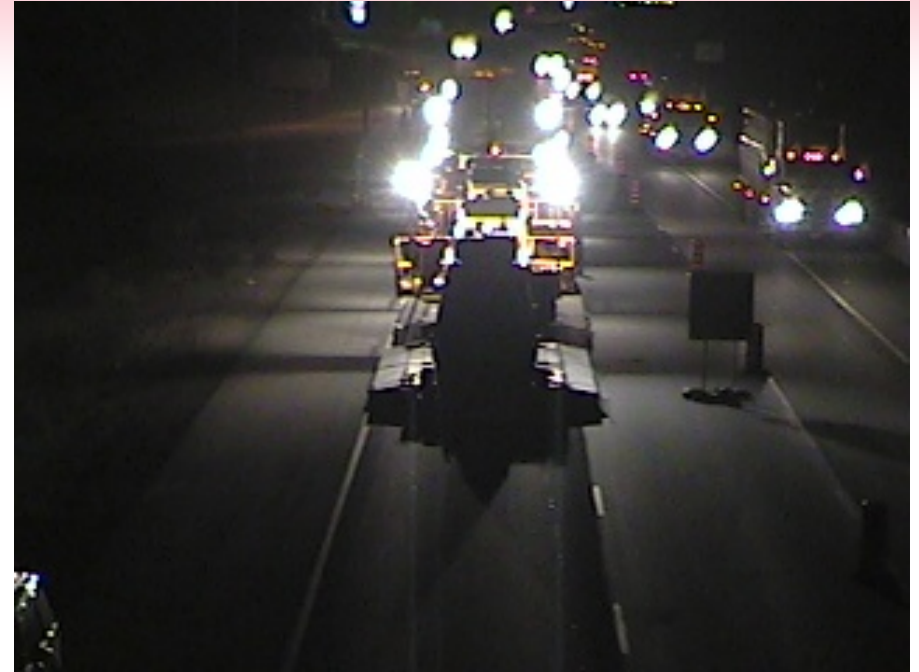
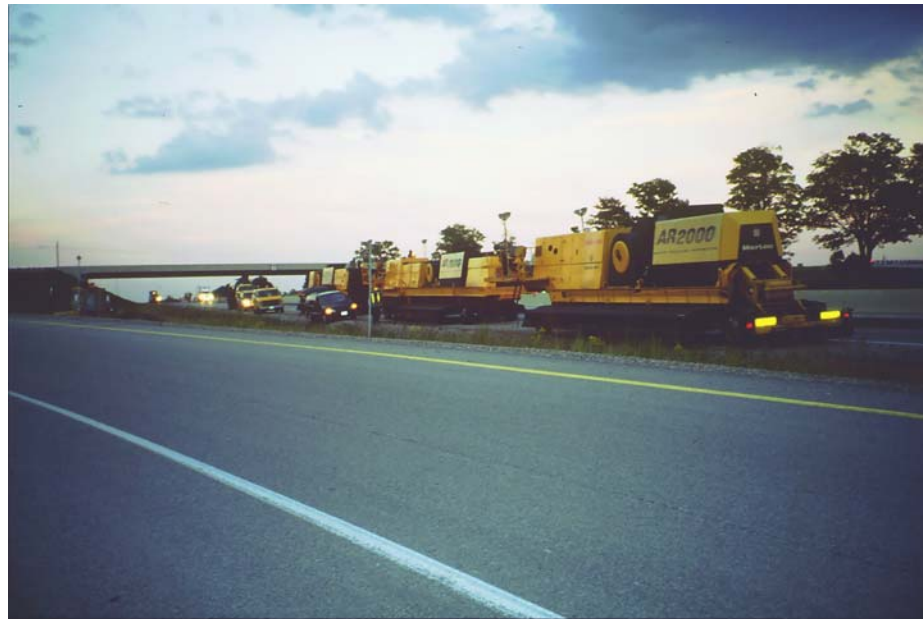
### ■ Martec HIR:

- Material removed in two stages
- 0.43 L/m<sup>3</sup> rejuvenating oil & 10 mm HMA (PG 58-28 & meta-arkose agg)
- Paved at 24°C to 13°C
- Distresses included:
  - Isolated areas of moderate segregation
  - slight segregation along longitudinal joint

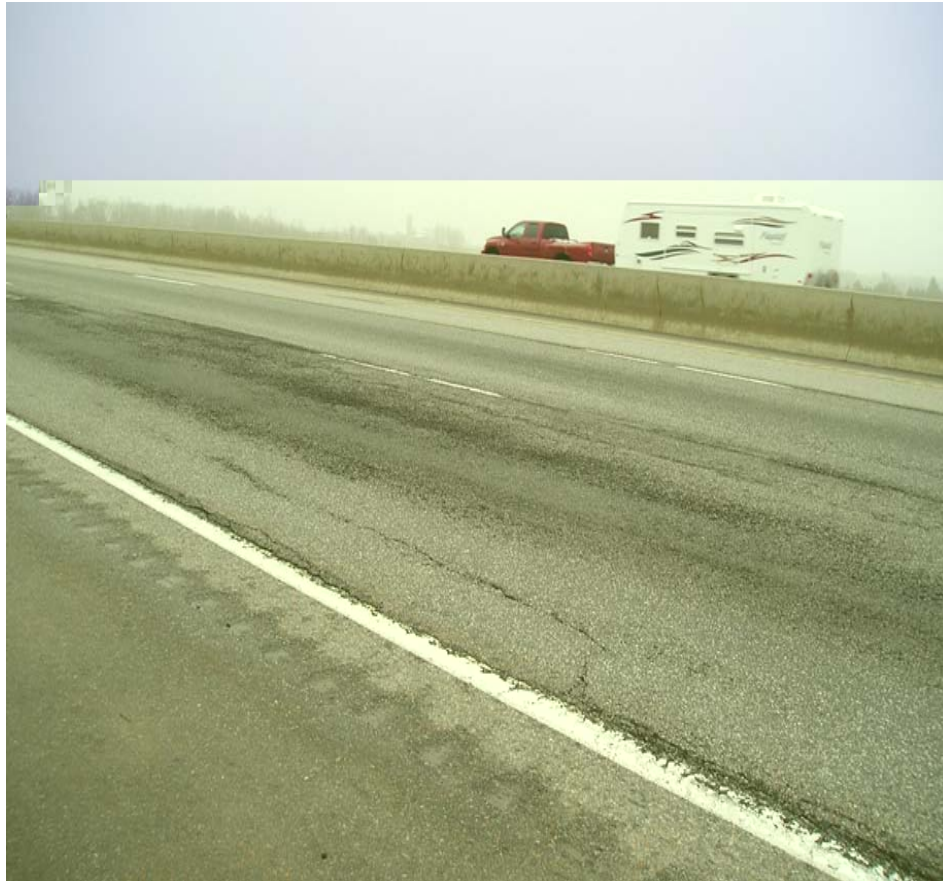
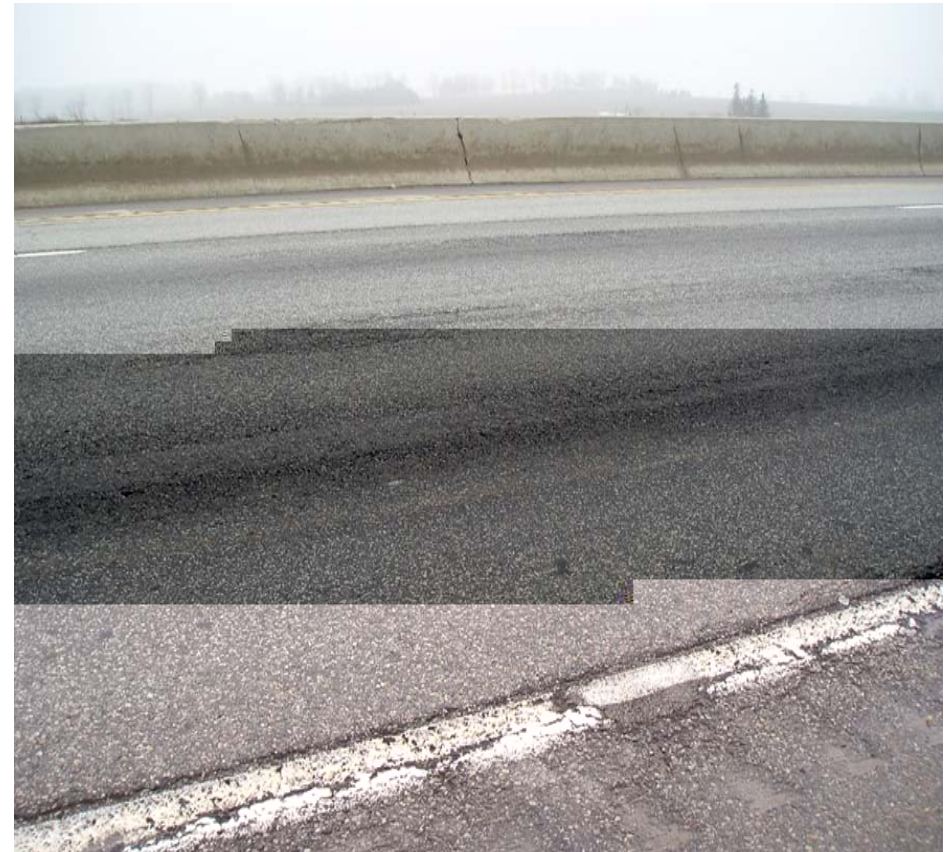
# Findings – Taisei Rotec HIR

- **Martec HIR provided best initial performance. Recently ravelling & cracking has increased. Expect 9 to 10 yr life.**
- **RHM DFC similar long term performance. Expect 9 to 10 yr life.**
- **New DFC's un-repaired end-load segregation shortened life expectancy - 7 to 8 years.**
- **Taisei Rotec HIR's material segregation defects & scallops provide an expected 7 to 8 yr life.**

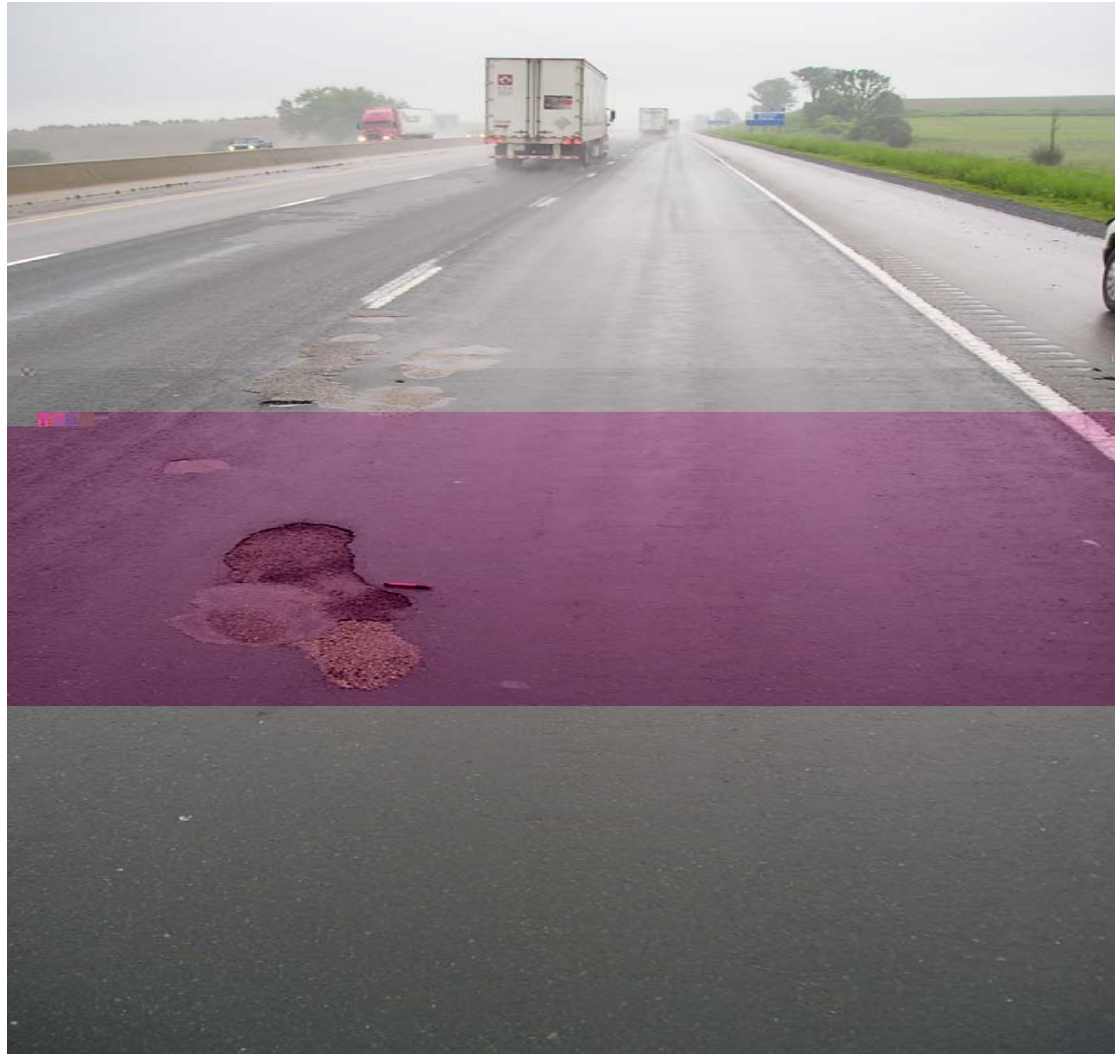
# Findings – L3 Microsurfacing

- **Did not meet their 5 to 7 year life expectancy**
- **MTO now routinely tack coats surfaces prior to microsurfacing**
- **Not expected to hold a dry and ravelling pavement for more than a few years**
