Palomino Road Repair Project Using Tire-Derived Aggregate

Palomino Road Slide Repair Project

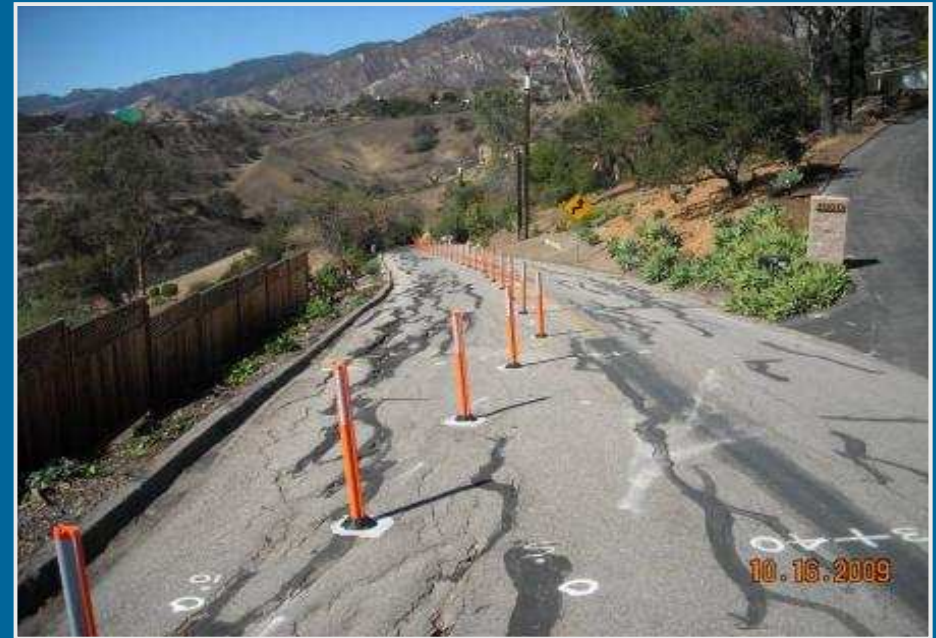
- ❖ Roadway has been diligently crack-sealed and overlaid with fresh asphalt for last 2 decades or more.
- ❖ As the down-slope portion of the roadway has settled, new asphalt and asphalt concrete dike have been added to direct water to drainage facilities.
- ❖ Increased weight on supporting soil and embankment contributed to continuing failure of lane and AC dike.

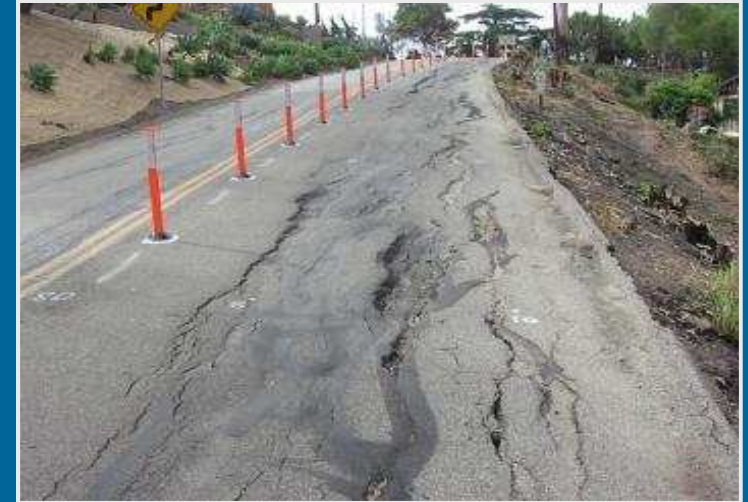
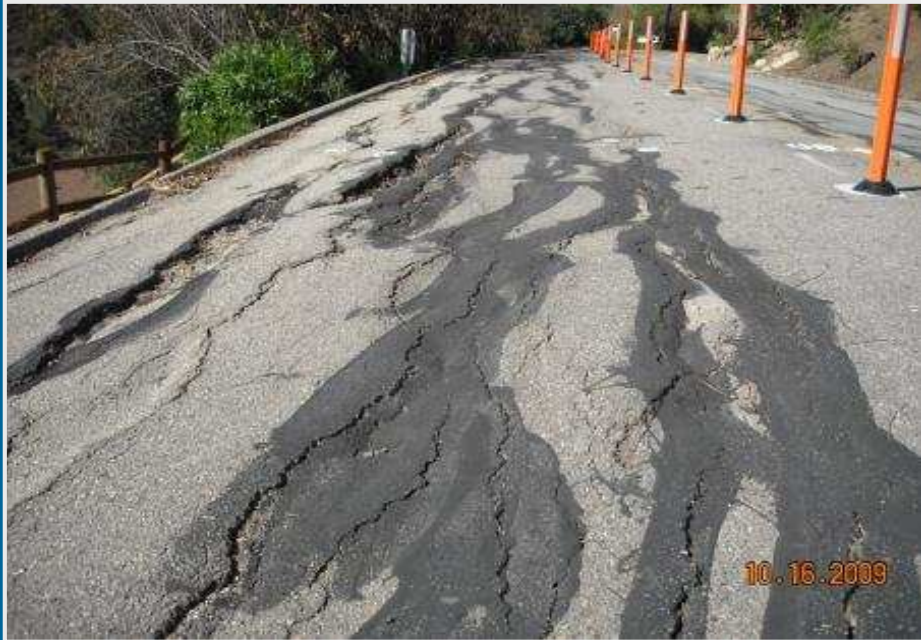
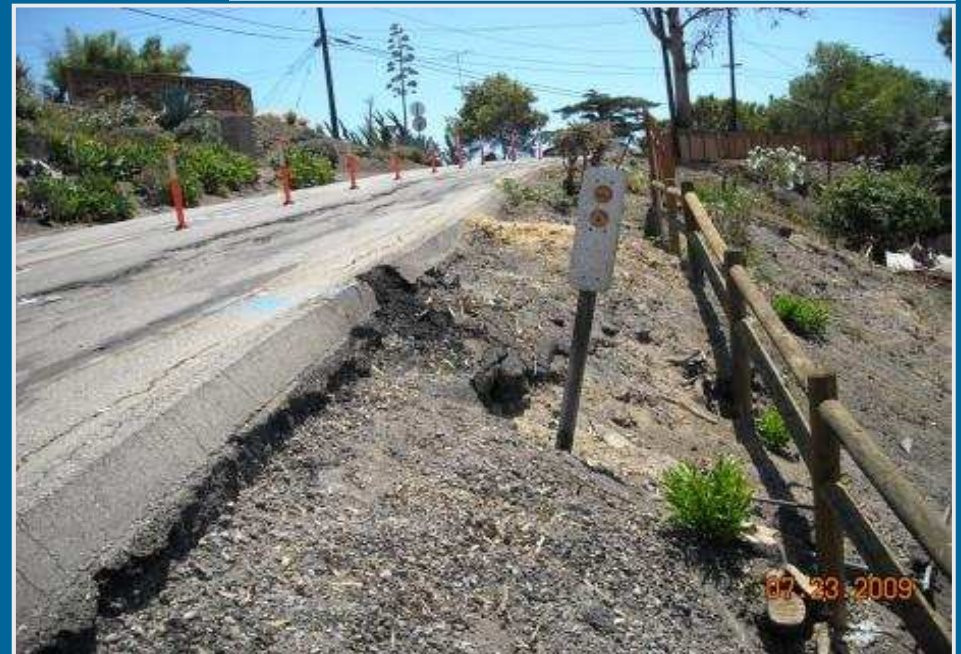
Pre-Project Conditions

- Extensively failed roadway structure section
- Previous repairs included installation of intercept drain.
- Sole access point for 50 single family residences.
- Continued failure exacerbated by heavy equipment post-Jesusita Fire (2009) caused County to close southbound lane of traffic for safety.
- Single lane stop-controlled traffic control in place for 1 year.

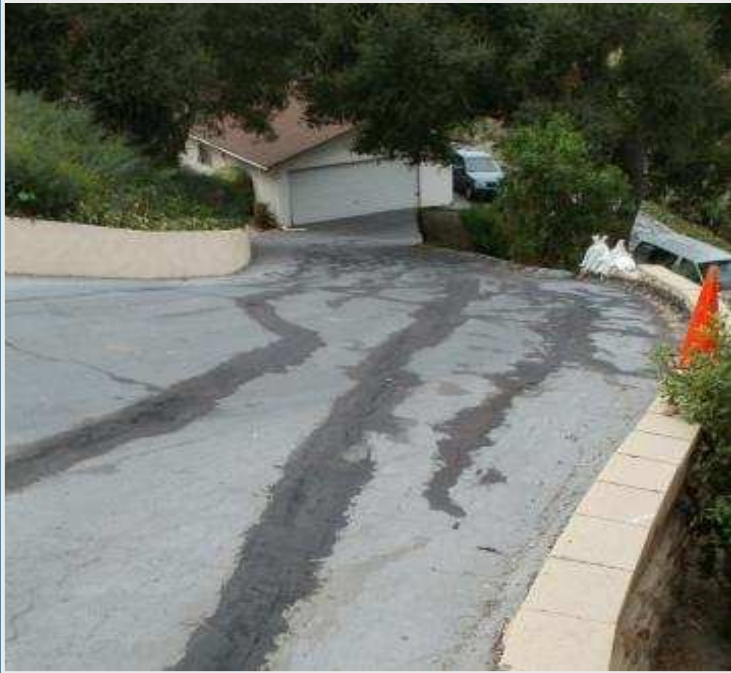
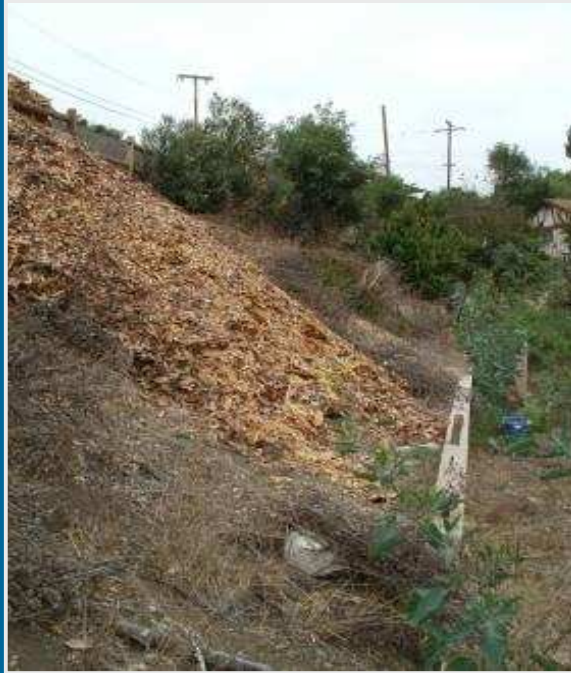
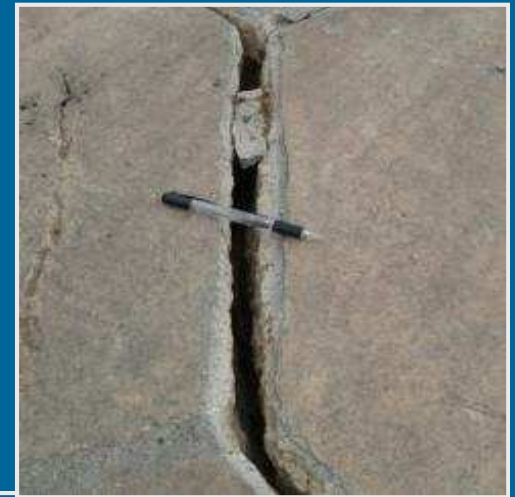
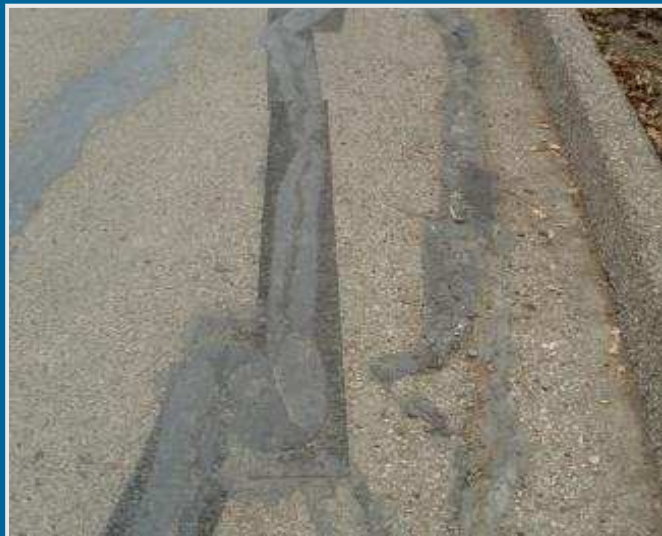
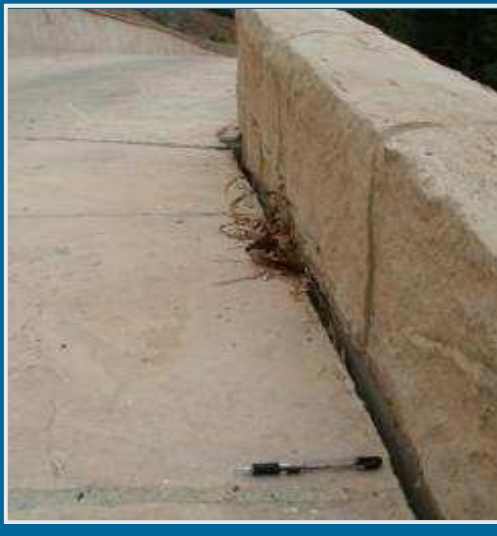
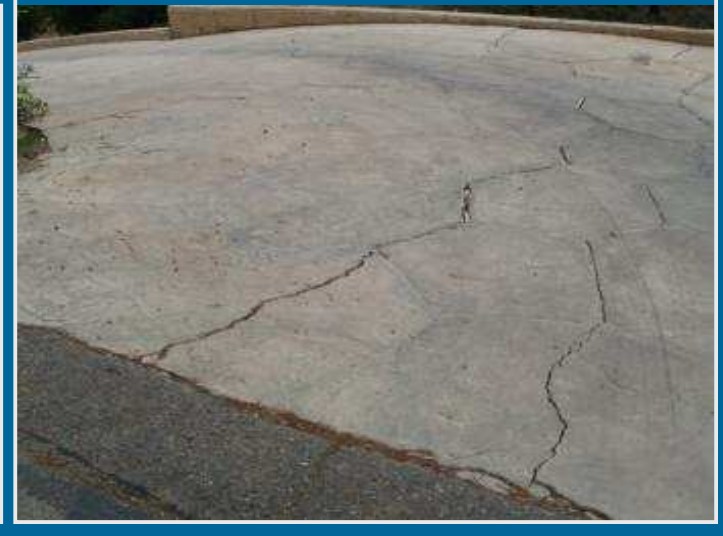
Failures Outside the Limits of Project
