Taking Opportunities as they Come

Deck Preservation Work During the
I-40 Rockslide Closure

Chris Lee, PE

NCDOT Bridge Maintenance Engineer, Division 14

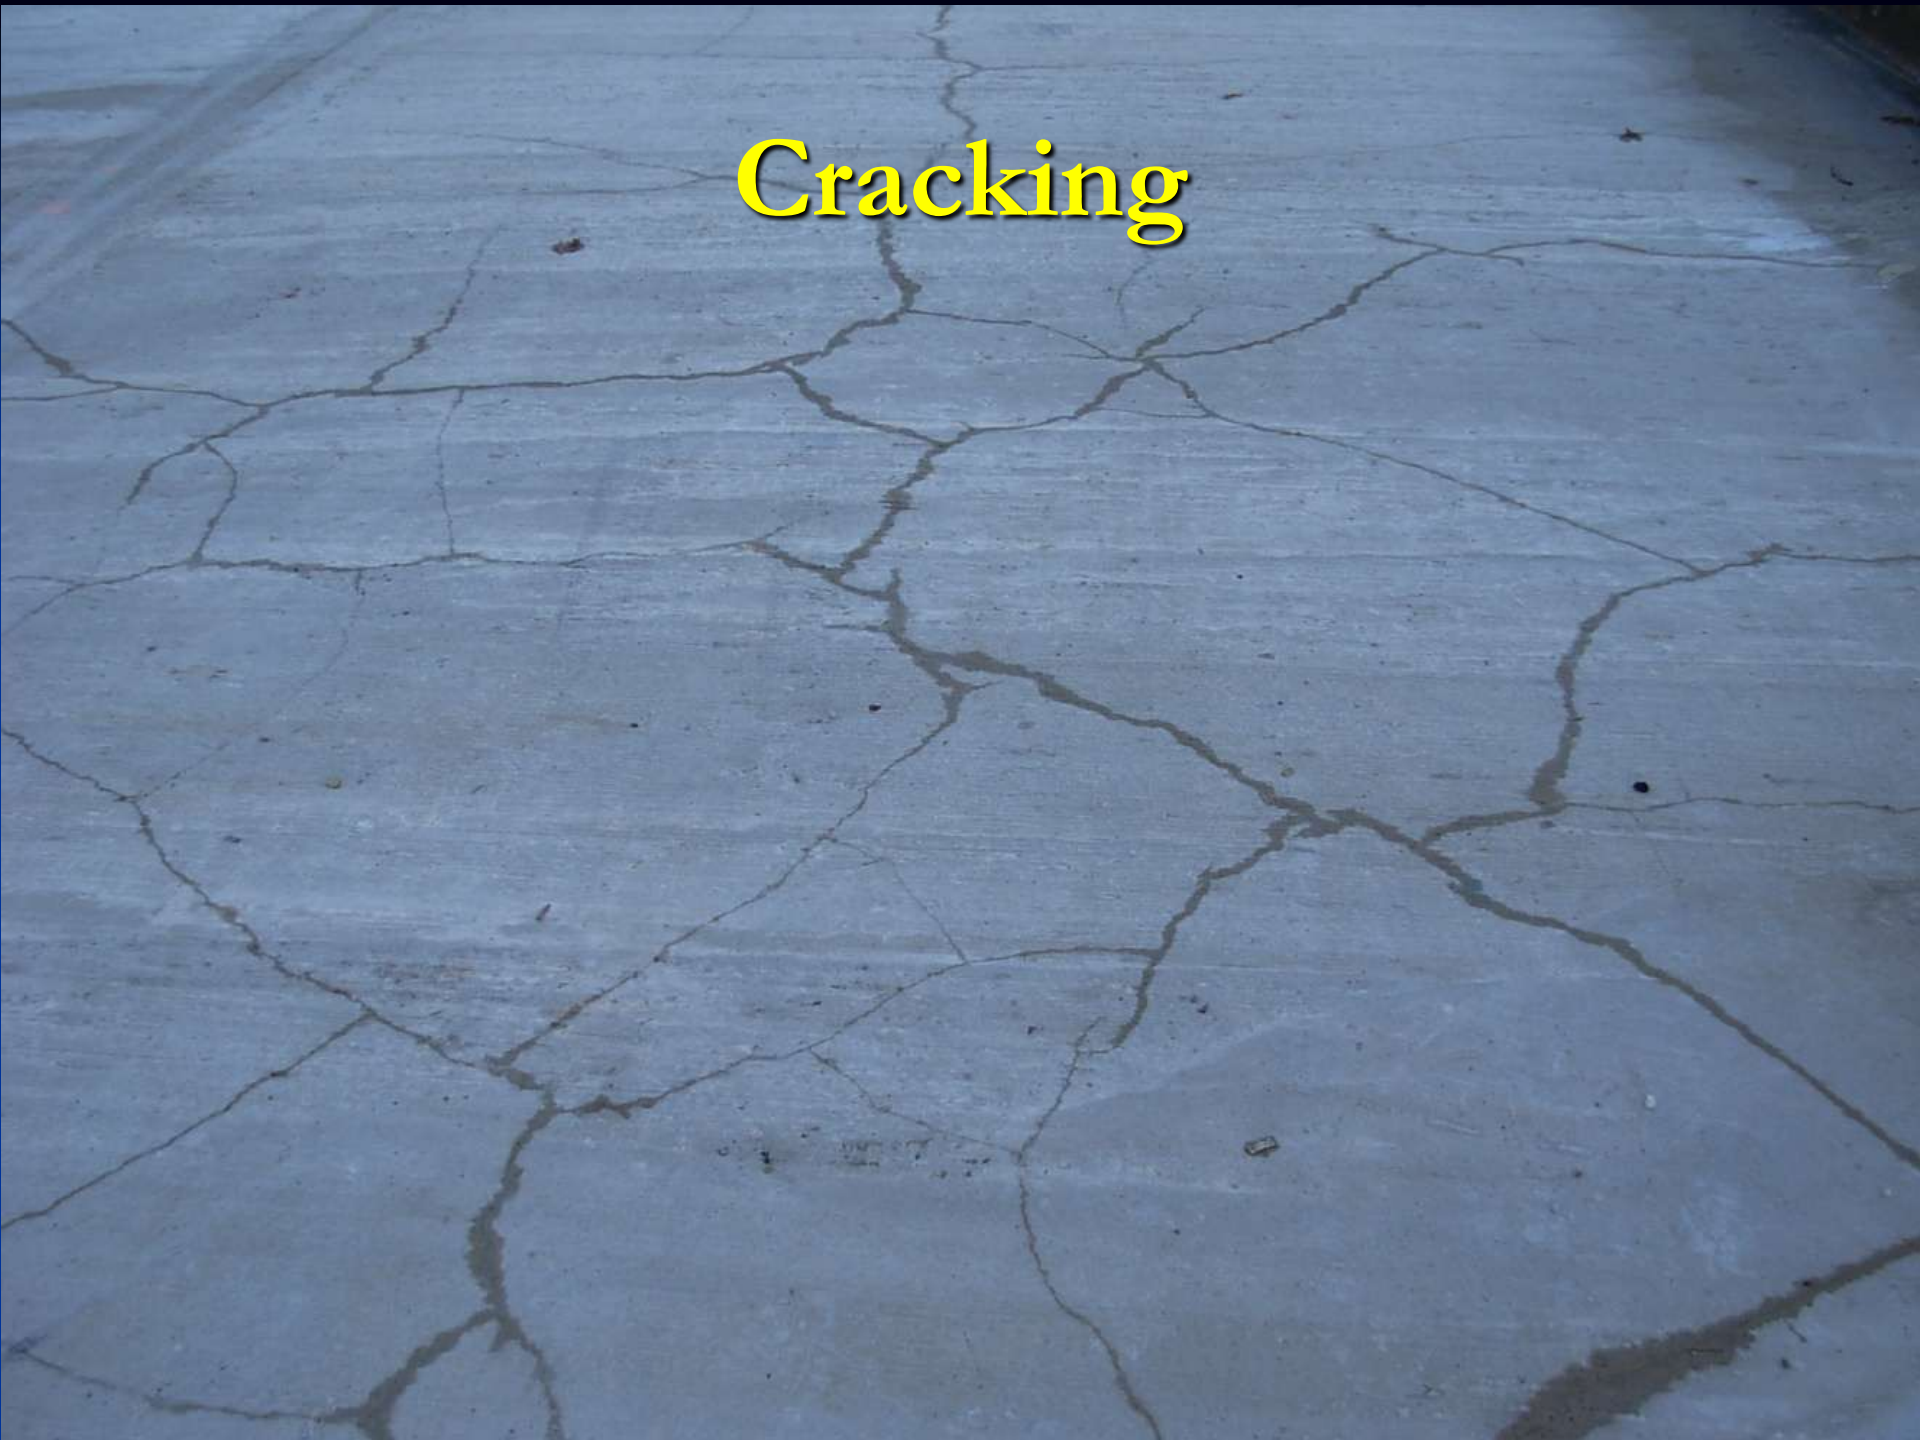
Cracking

Ambient Air Temperature – 47 F – 50 F

Humidity – avg. 18-20%

Deck Temp. – 51 F

Concrete Mix Temp. – 60 F

Wind Speed – Sustained 10 mph, gusts to 25+

Concrete Mix Air Content – Avg. 5%

3 Hr. Cylinder Break – 4200 PSI

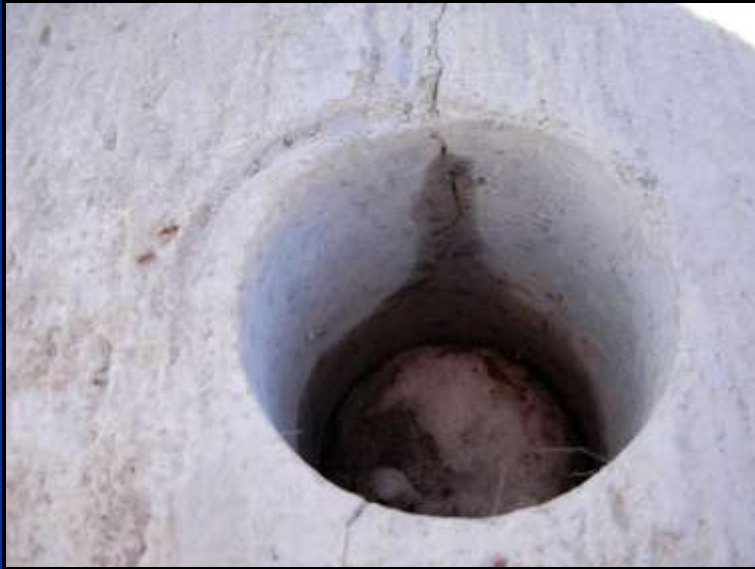
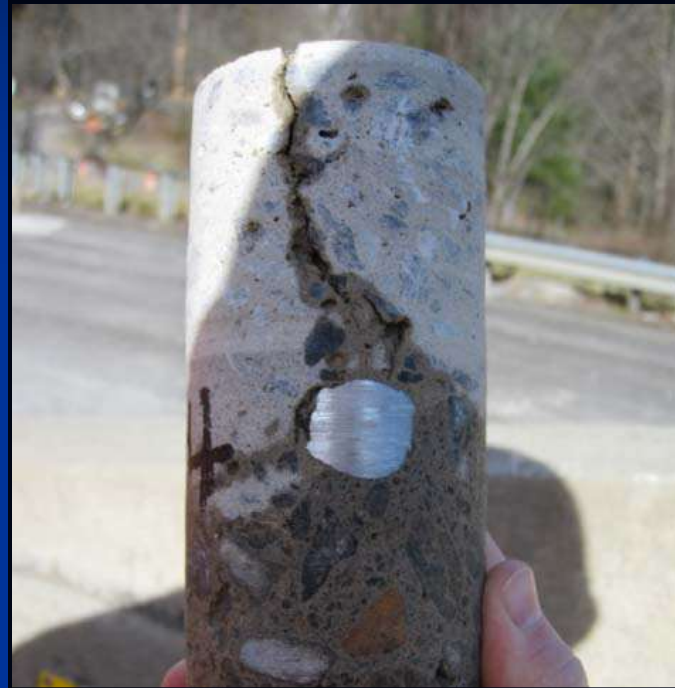
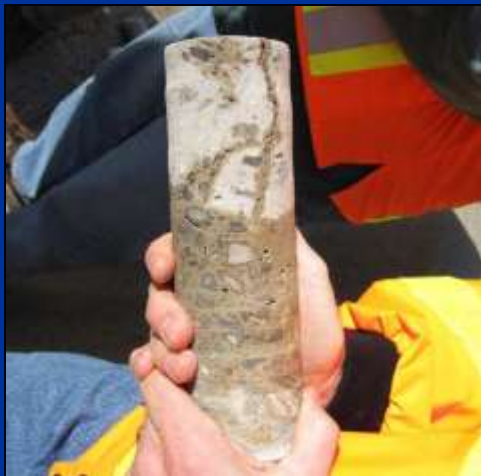
Core Samples

Full Depth Cracking is apparent

Avg. Cracking – 0.006 – 0.010 in.

Some as large as 0.014 in.

Within 2- 3 SF areas

- Consultation with FHWA, VDOT, Contractor, and NCDOT staff
- Remove and replace?
- Deck sealing

- BASF Methacrylate Sealant
- Light sand over top for skid resistance
- Sealants were placed in February 2010 (approx. 2 months after construction began)
