# Repair Procedures: Pros & Cons of Repair Alternatives

**Southeast Bridge Preservation Partnership**  
**Thursday, April 14, 2011**

***Siva Venugopalan***  
*Principal Engineer*  
*Siva Corrosion Services (SCS)*  
[Siva@SivaCorrosion.com](mailto:Siva@SivaCorrosion.com)  
[www.SivaCorrosion.com](http://www.SivaCorrosion.com)

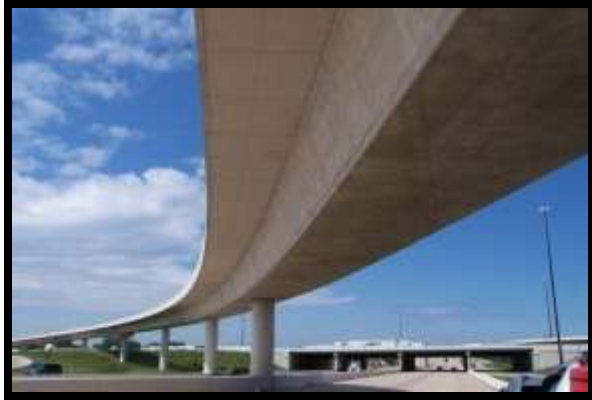
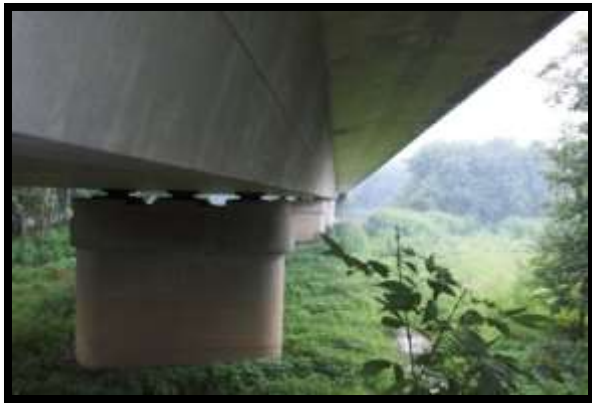
# Problems in PT

- Visual evaluation cannot quantify problems
- Low pH grout and high chloride content can increase the rate of corrosion of tendons
- Problematic voids need to be identified
- Cancerous corrosion can cause sudden failures as more wires/strands break

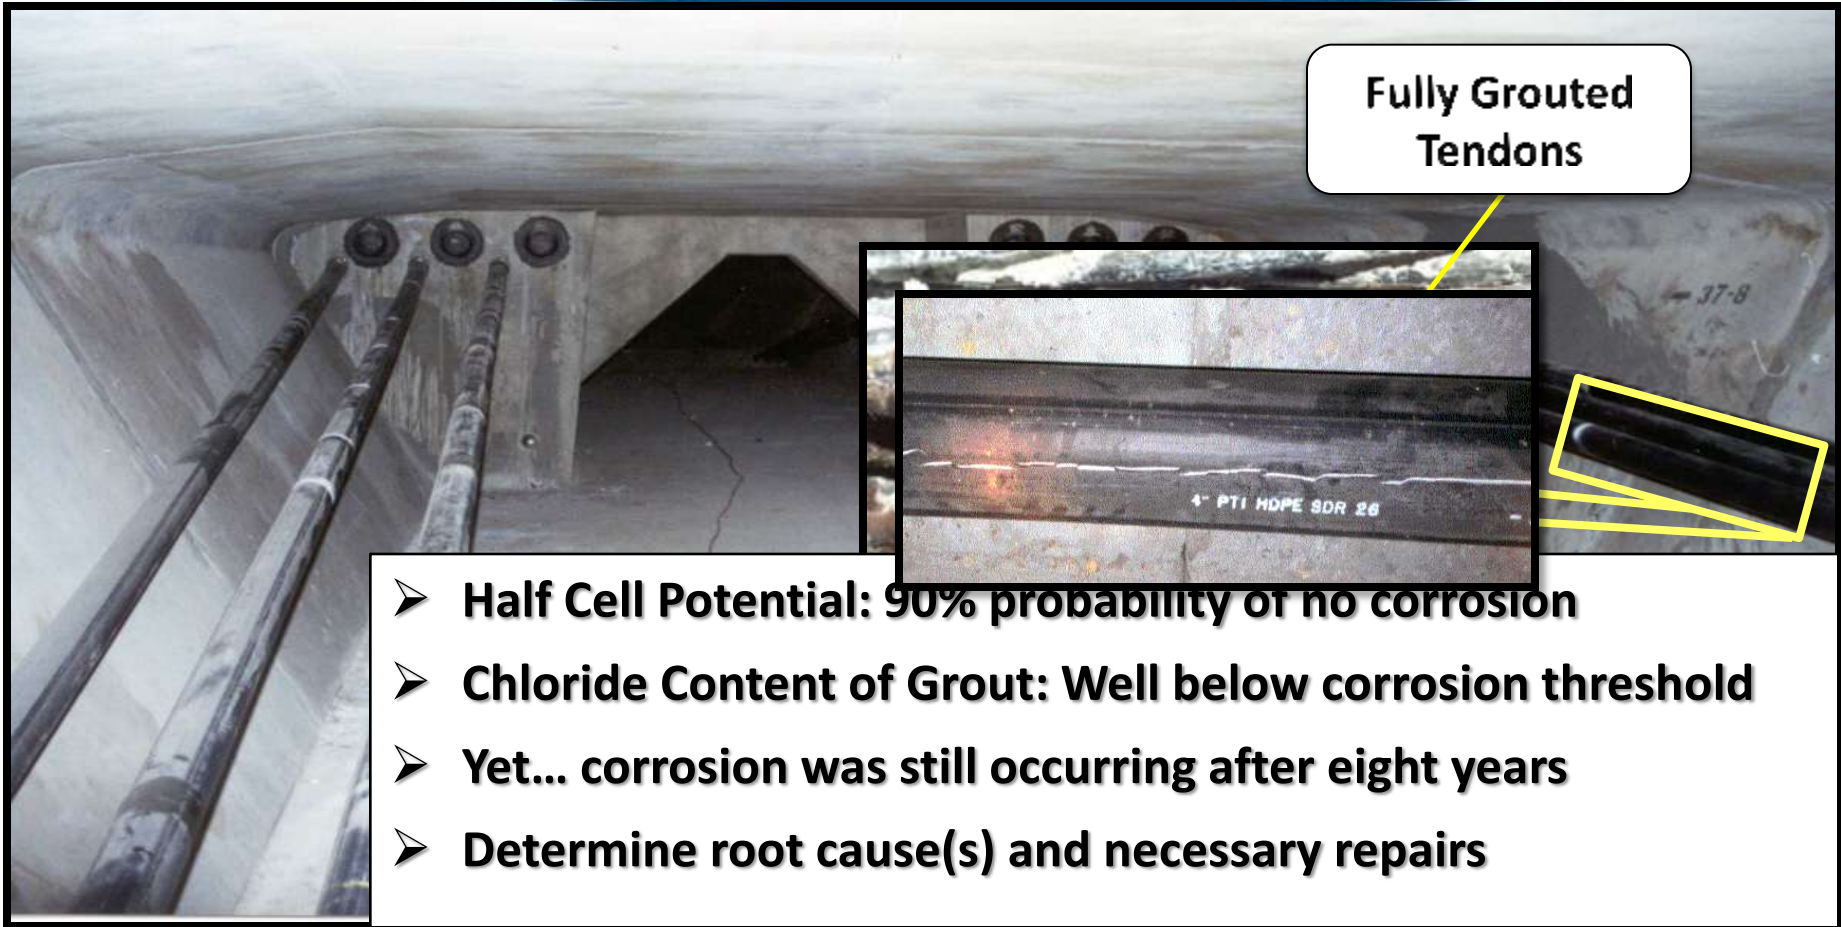
# PT Box Girder – External Tendons

- **Half Cell Potential: 90% probability of no corrosion**
- **Chloride Content of Grout: Well below corrosion threshold**
- **Yet... corrosion was still occurring after eight years**
- **Determine root cause(s) and necessary repairs**

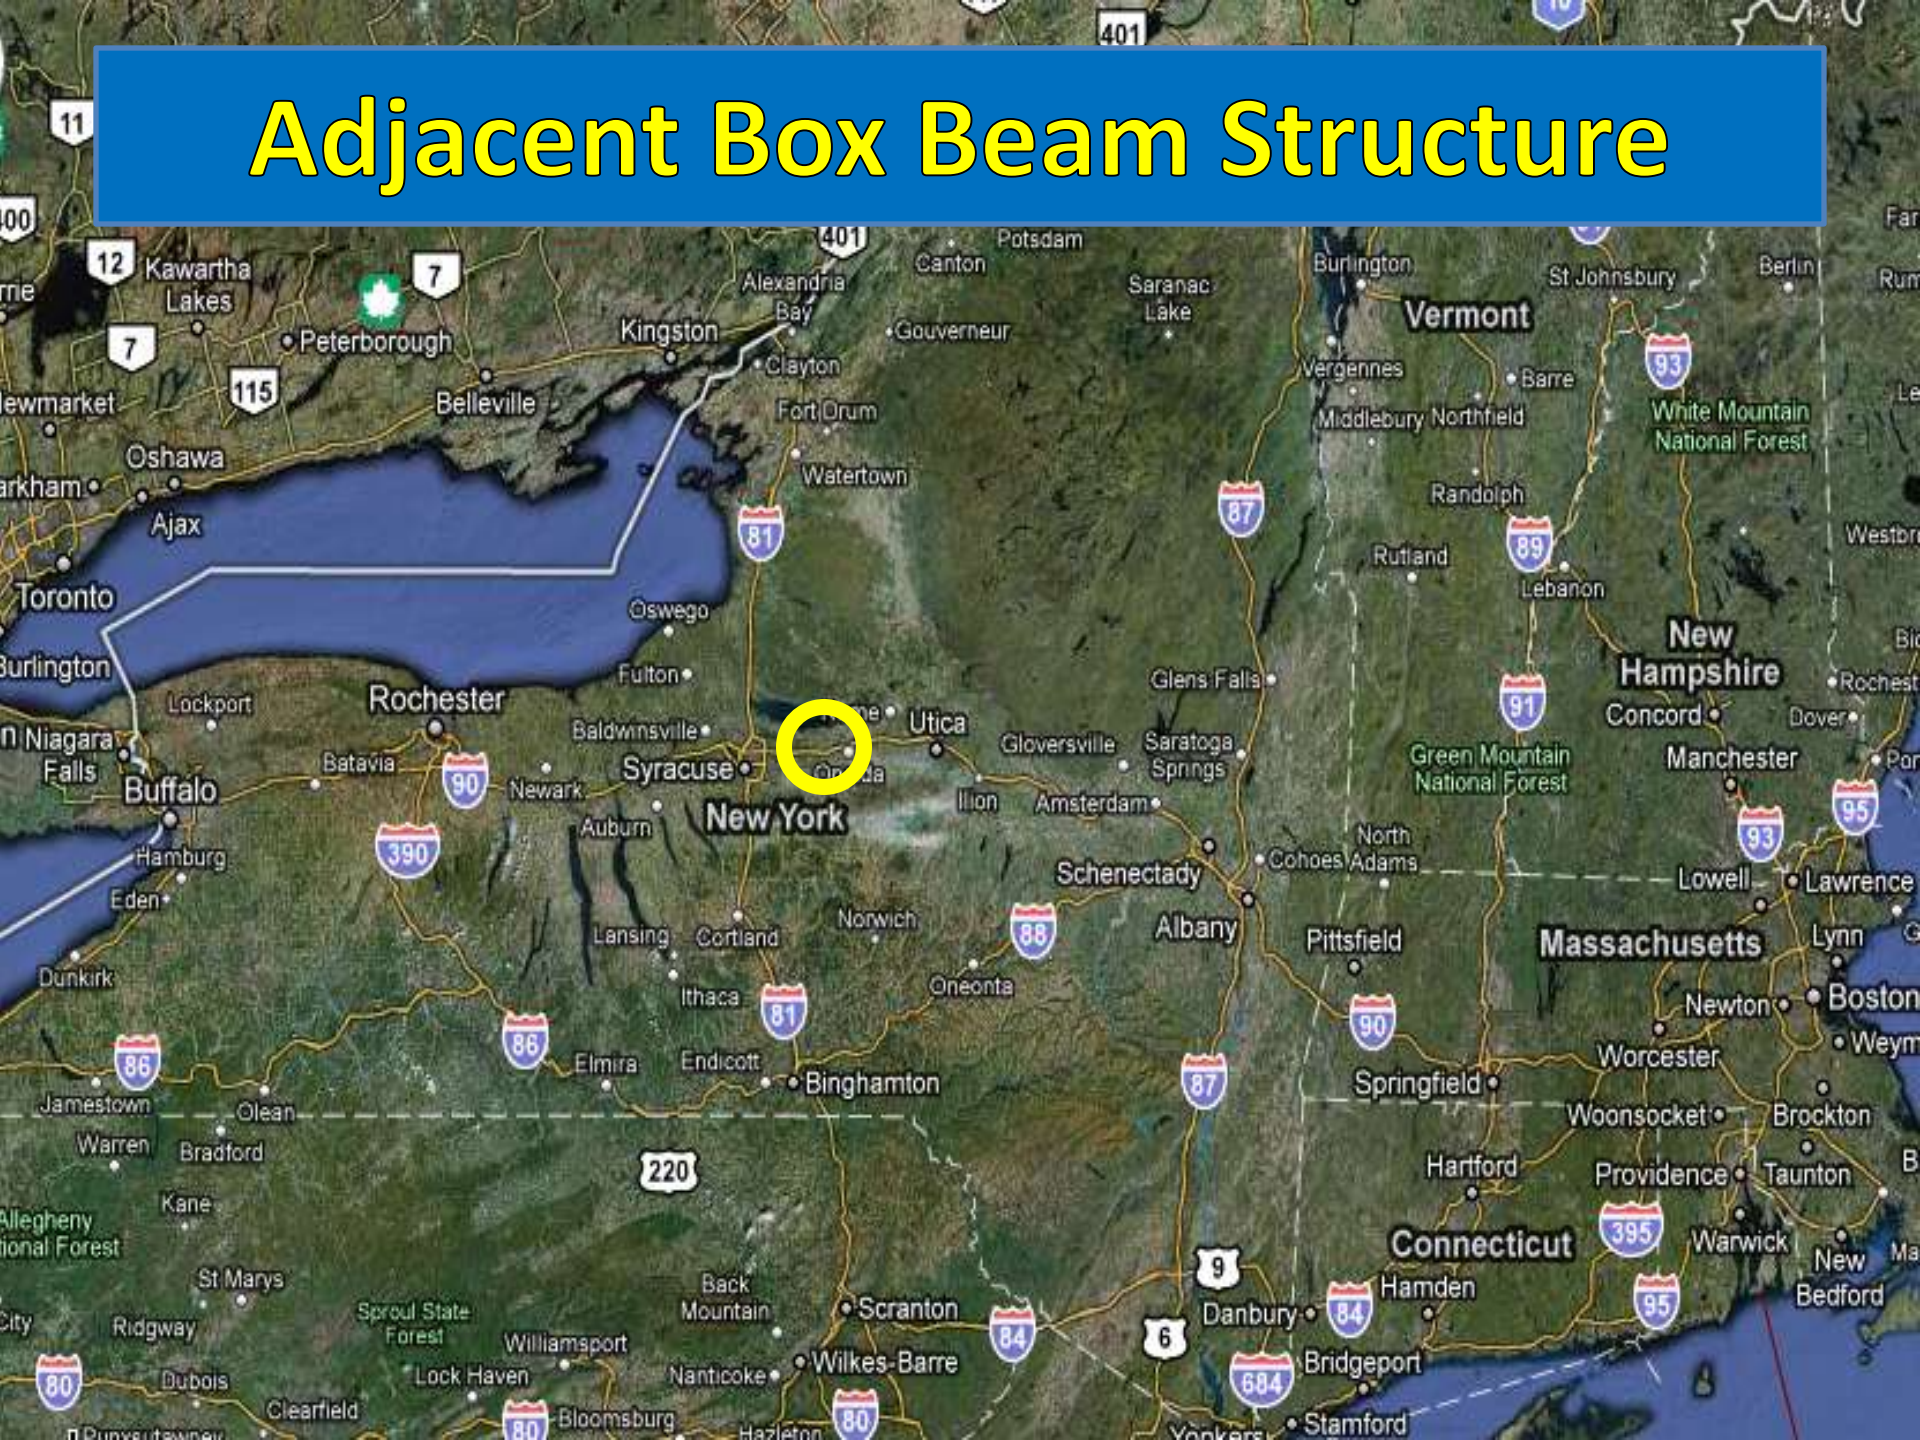
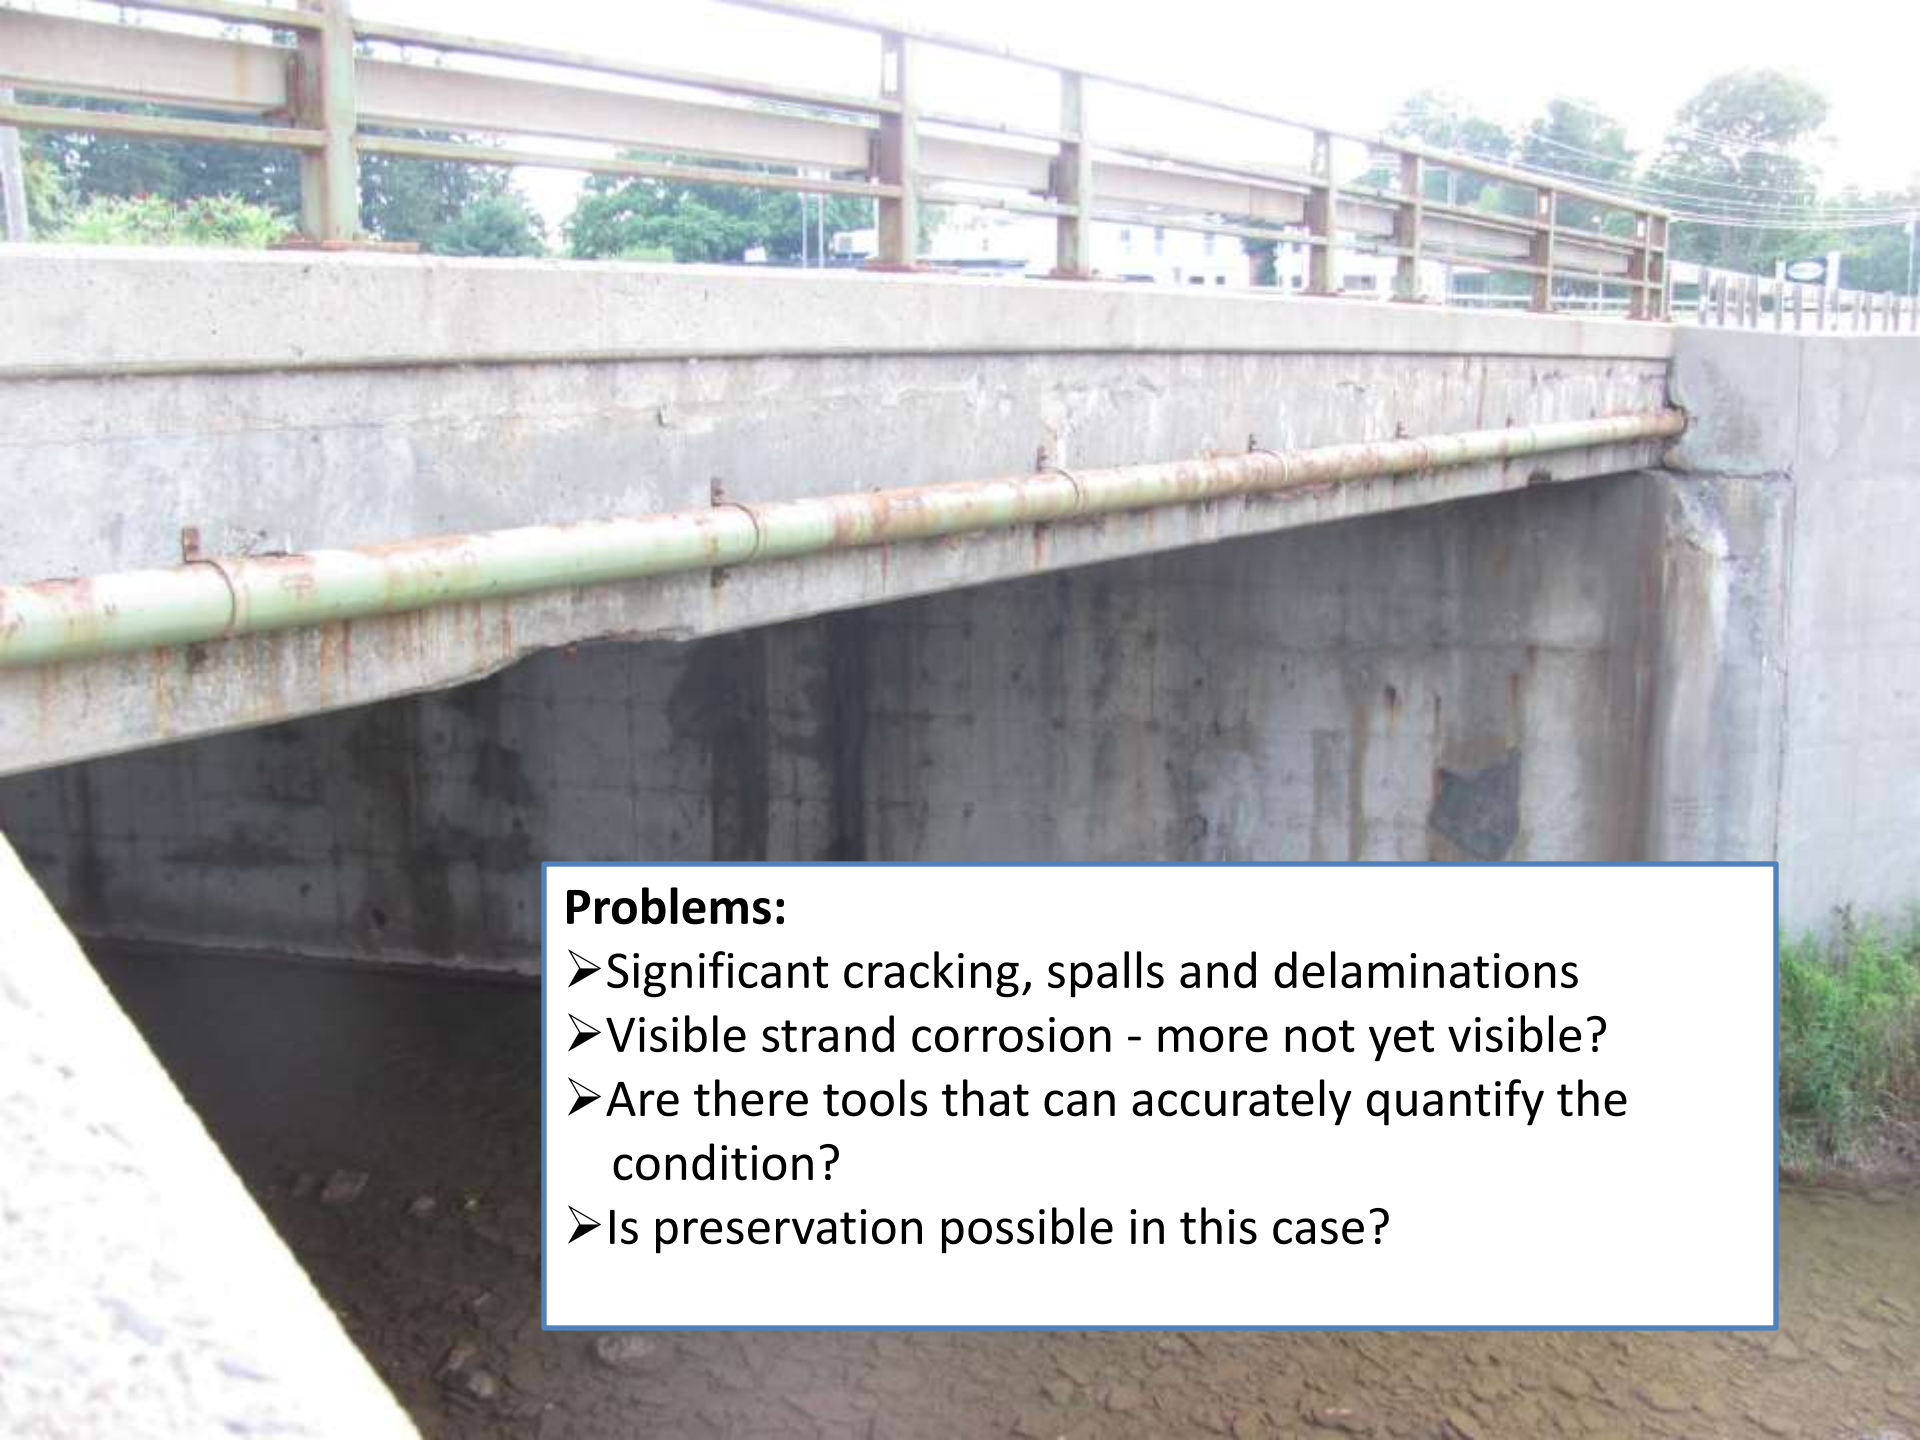
# Adjacent Box Beam Structure

- Significant cracking, spalls and delaminations
- Visible strand corrosion - more not yet visible?
- Are there tools that can accurately quantify the condition?
- Is preservation possible in this case?

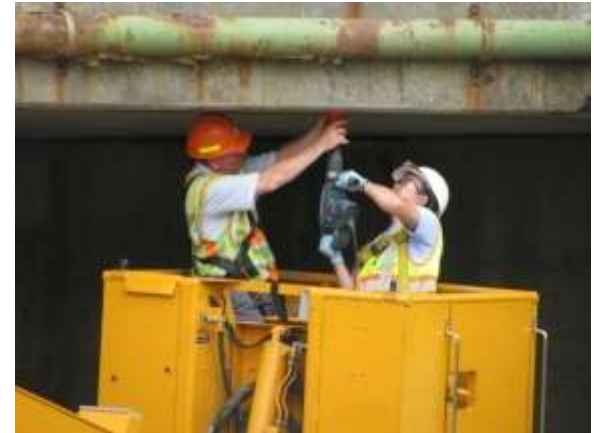
# Water in Beam

- Half-inch hole was drilled
- Water drained for a few hours
- Chloride concentration of the water was very high
- Resistivity of the water was low

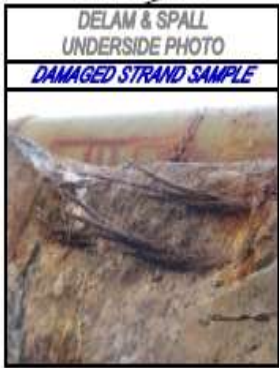
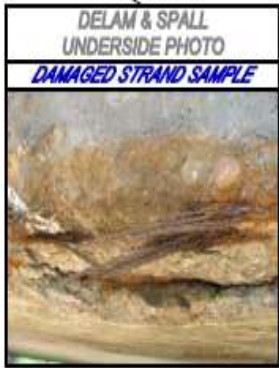
*BEAM 20 - UNDERSIDE  
BRIDGE #2 OVER SCONONDOA CREEK  
N.T.S.*

31% Concrete  
Damage

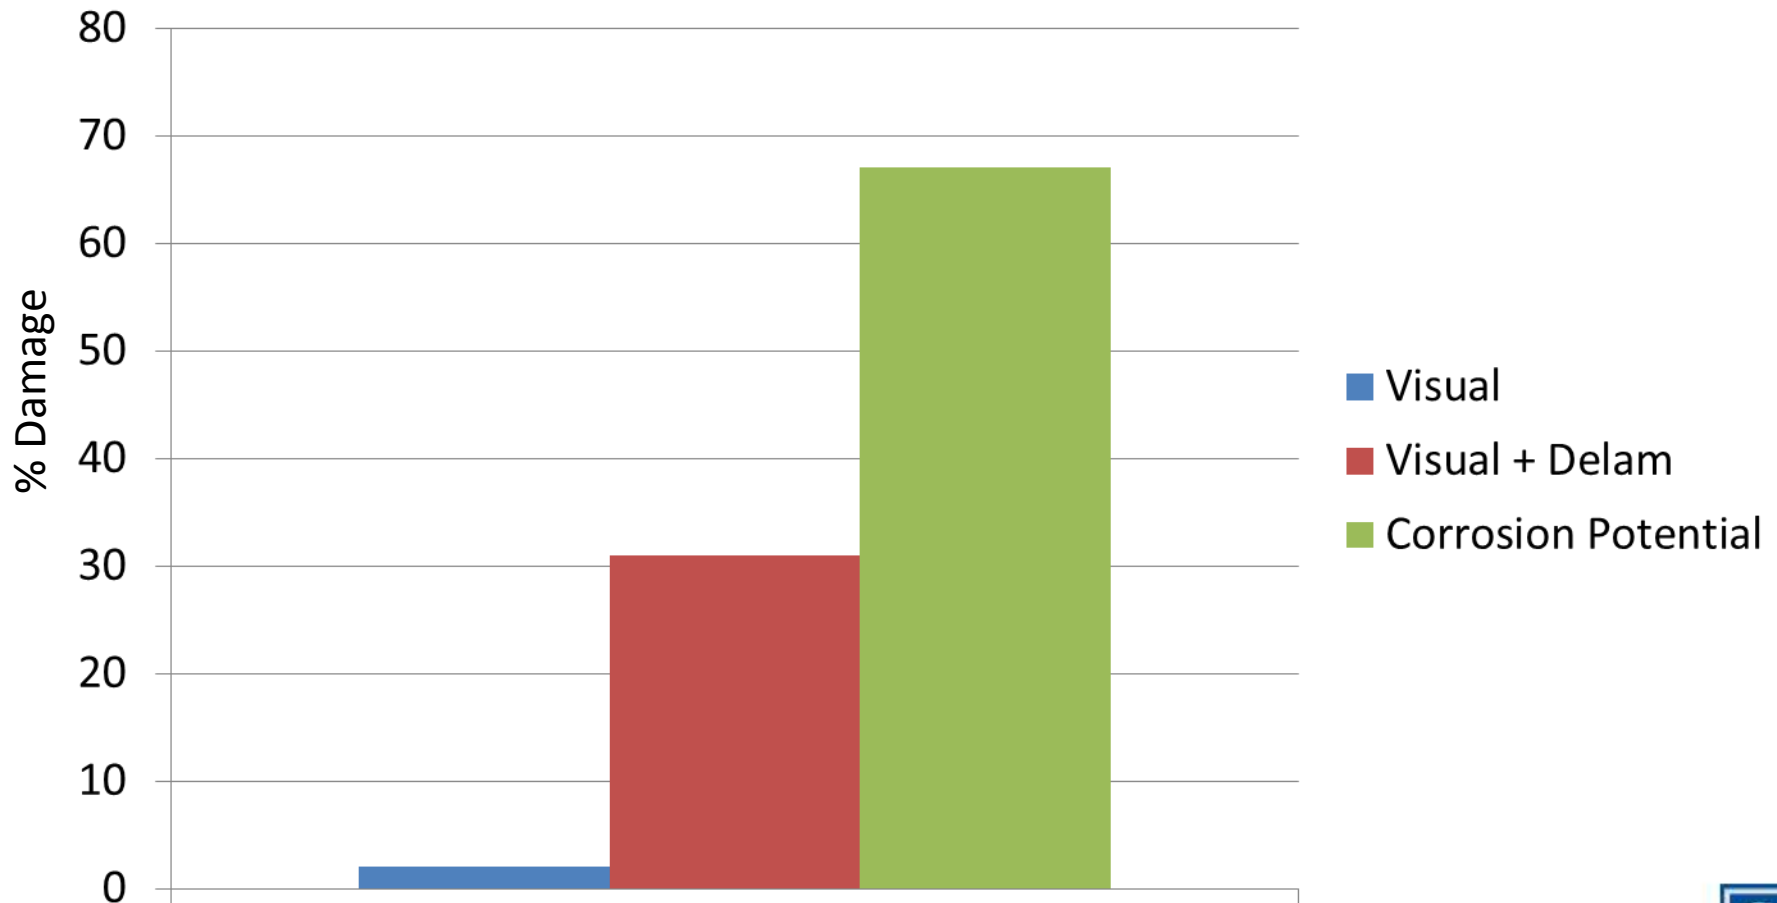
# Visual/Delam/Potential Data

- Visual data – only a small percentage of the beam corroding
- Visual & delam data – 31% of the beam corroding
- Corrosion potential data – 67% of the beam corroding
- Evaluate before visual signs of distress to achieve and exceed service life goals

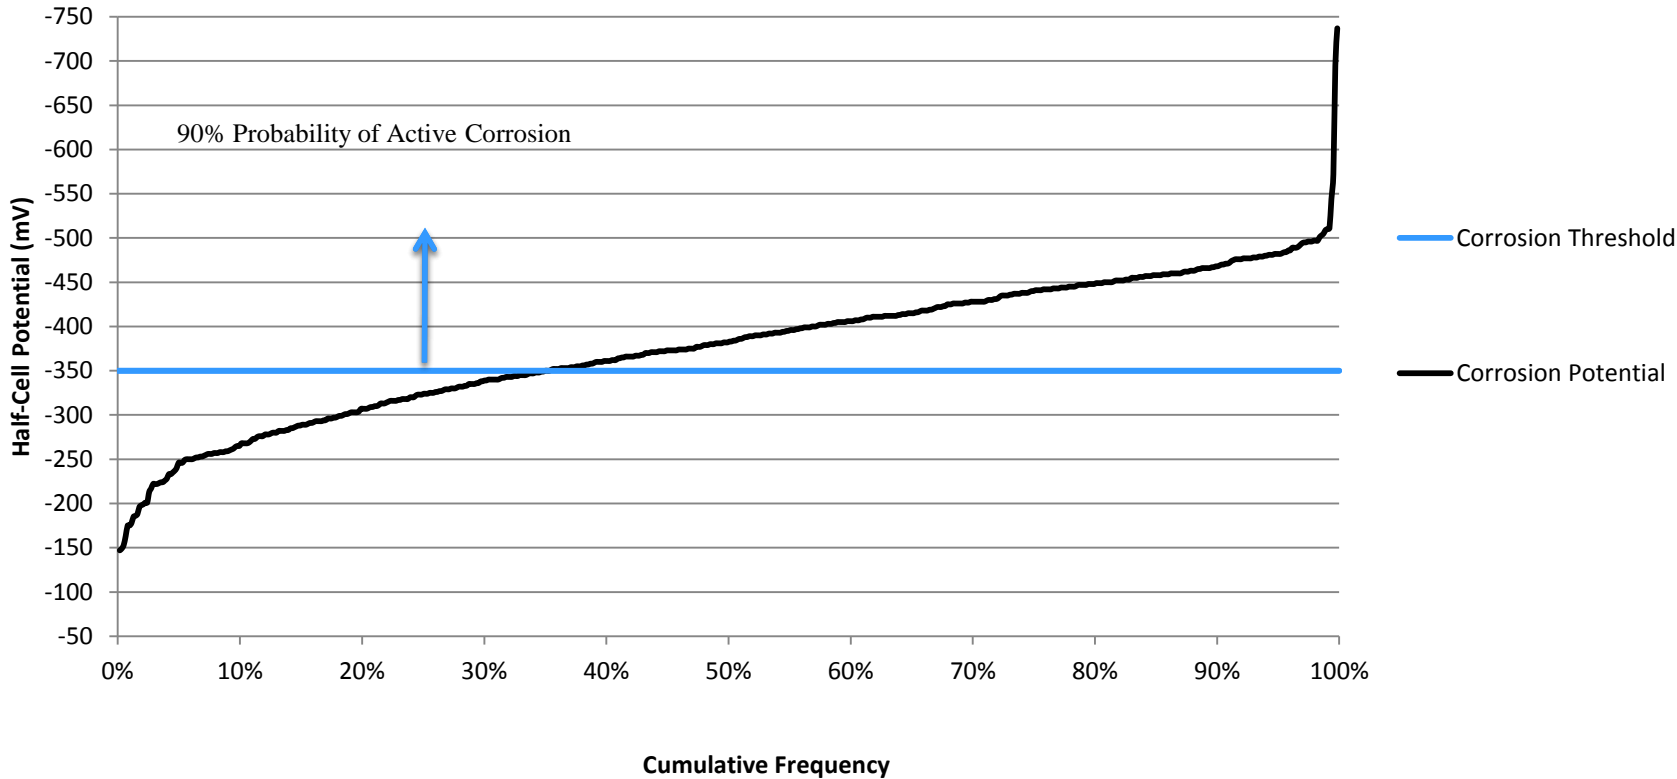
# Boulevard – Structure Total Corrosion Potential

- Visible concrete damage – significant increase
- High chloride readings behind rebars
- Near future concrete damage will result
- Significant weakening of the structure within five years if the rate of corrosion is not reduced

- Based on a unique methodology, we developed recommendations for repair / replace / life extension
- Concrete repairs on all bridges
- ECE to lower chloride level near rebars and repolarize rebars
- Sacrificial CP to maintain polarization of rebars
