Stillwater Bridge, Old Town, Maine

Beam End Treatment

Procedure for Structural Beam End Treatment – Stillwater Bridge

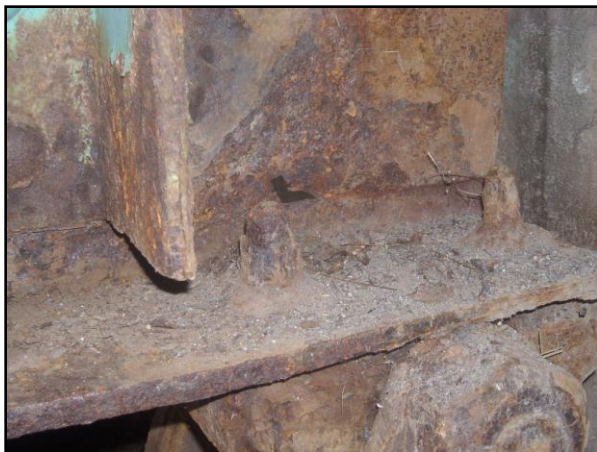
Topside the bridge appeared to have dropped $\frac{3}{4}$ ". Beam webs were deteriorated to point they were collapsing – or sliding past itself.

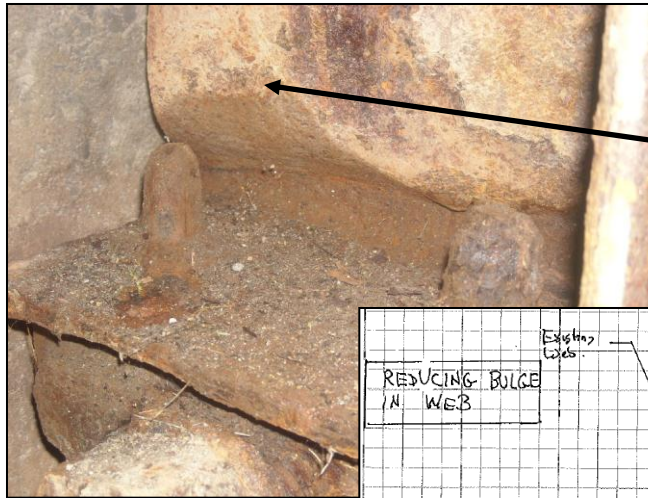
Bulge & collapse of web(s).

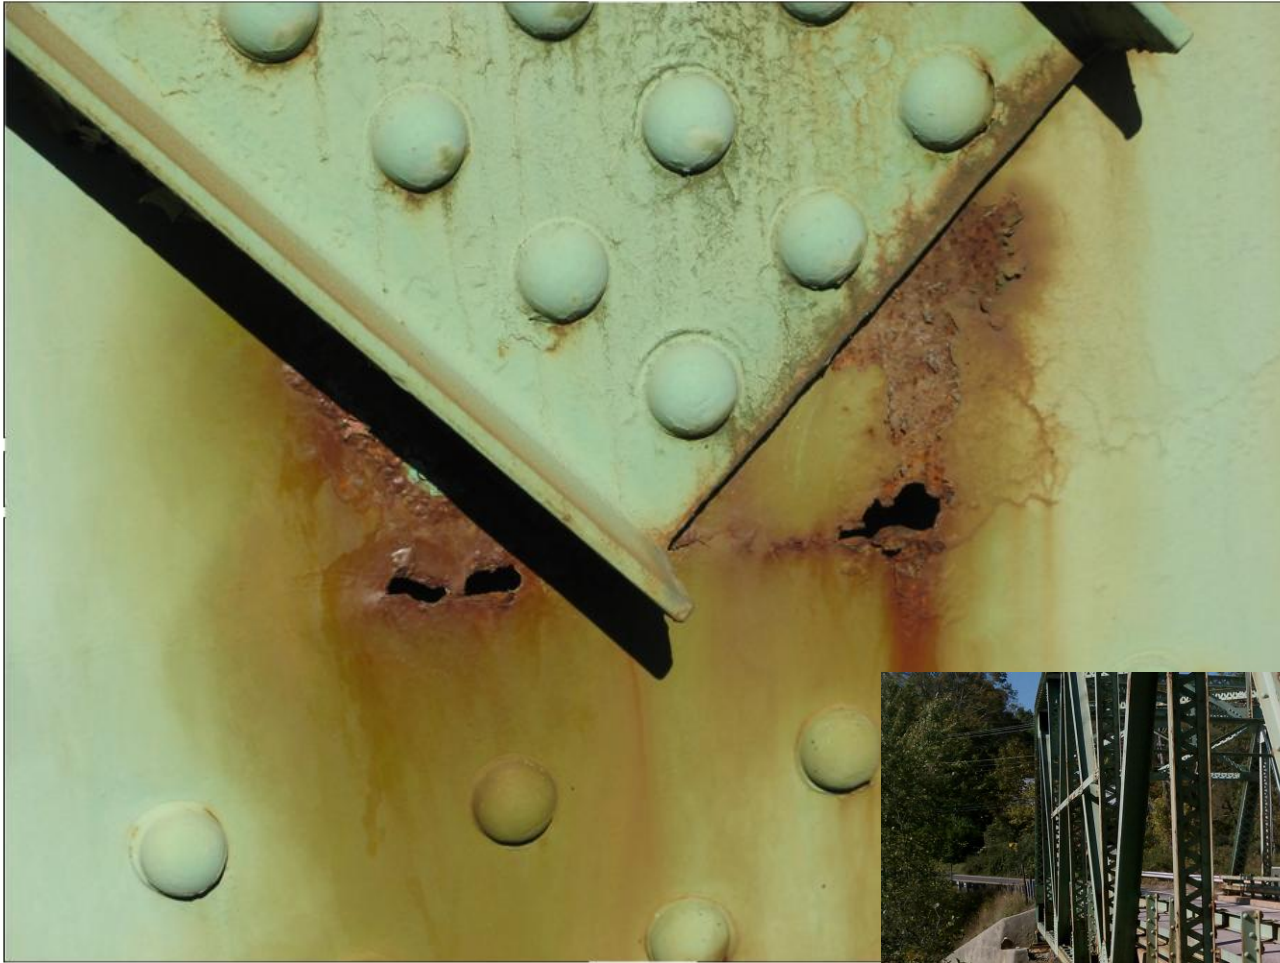
Hollis, Maine – Deteriorated Gusset Plate

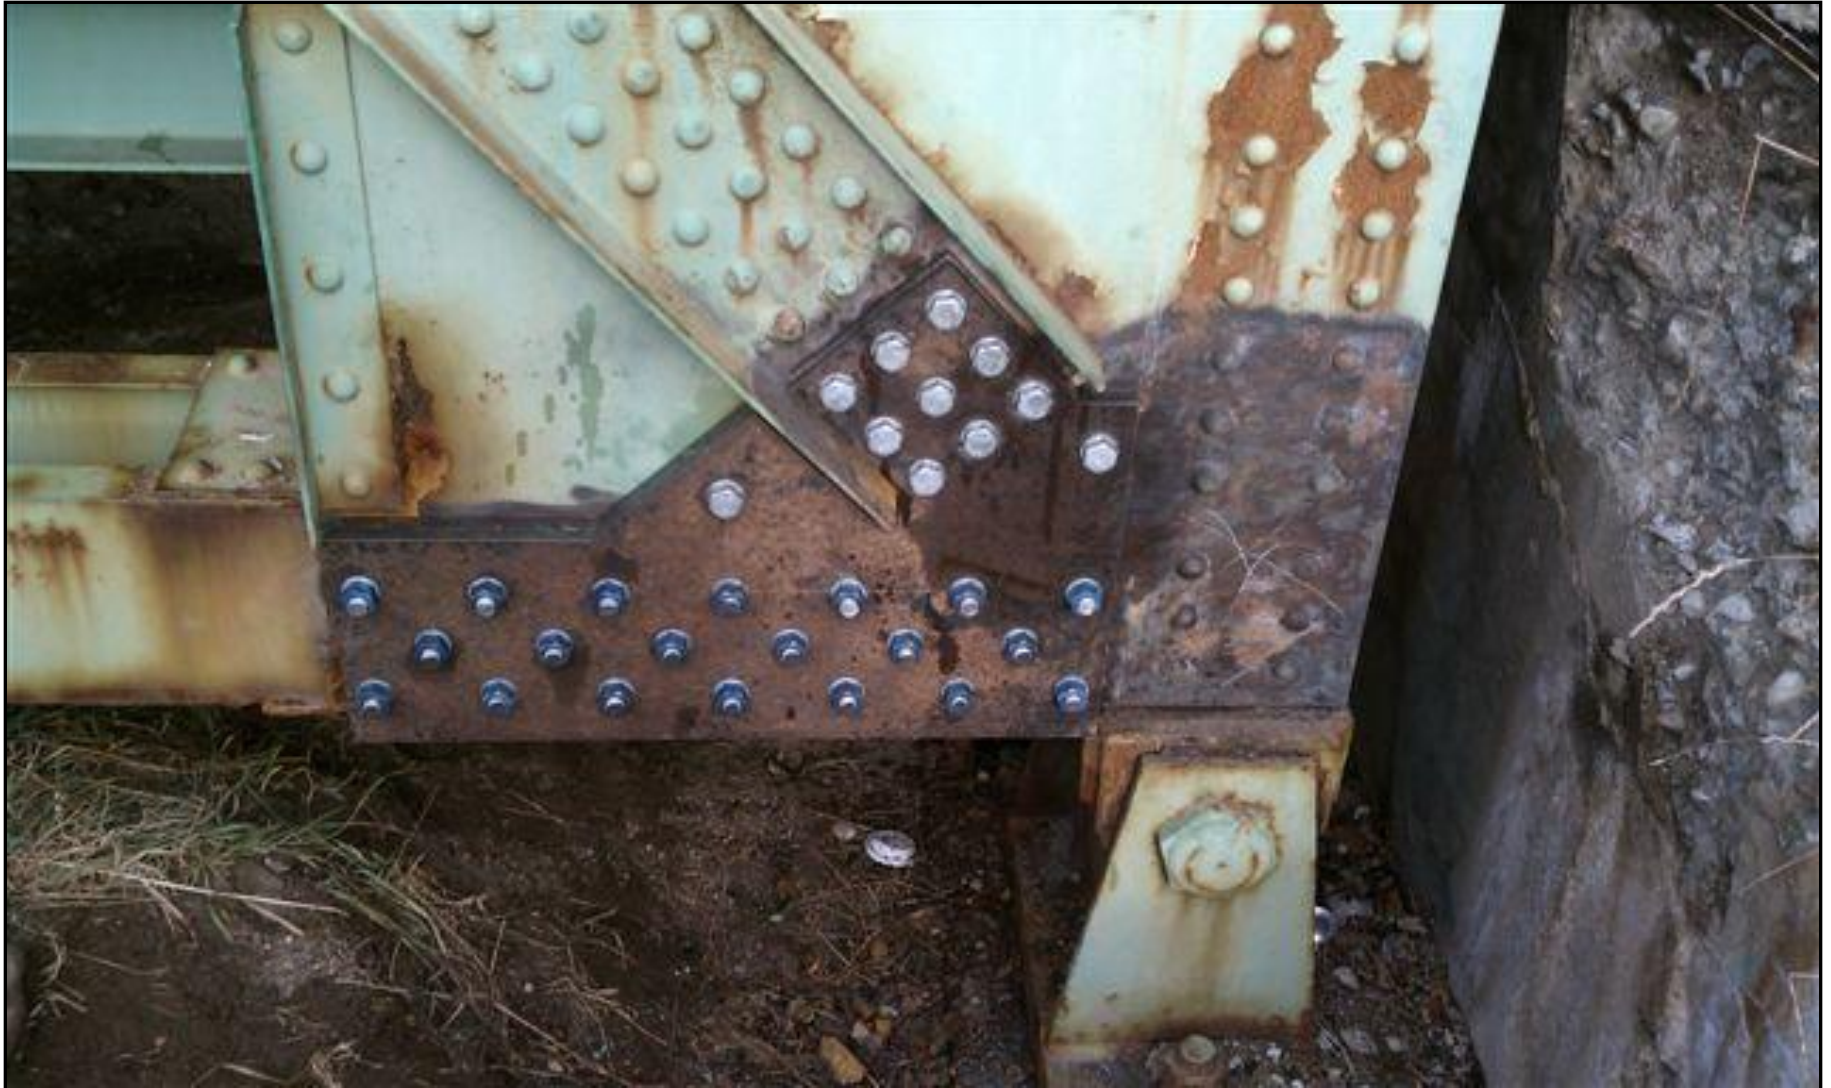
Martin's Point Falmouth Maine - Deteriorated & Collapsing Beam Webs

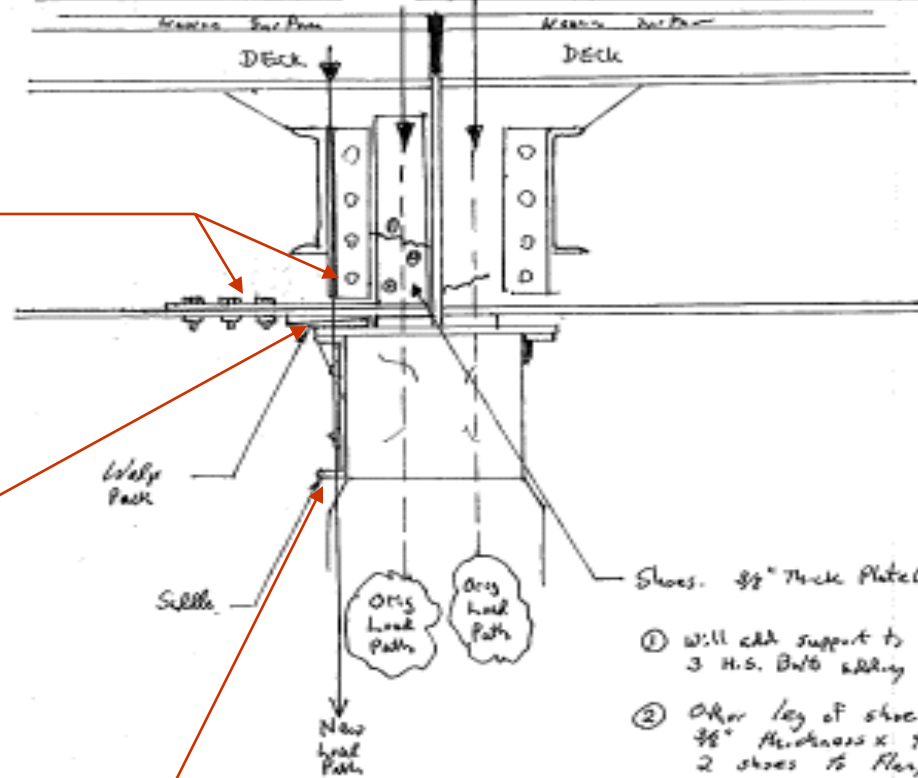
Martin's Point Repair Plan

Bottom Flanges have been reduced to $\approx \frac{3}{8}$ " in many cases.

Boomerang-shaped plates bent 90 degrees. (Shoe)

Steel Wedge Pack, changing the load path

Saddle

Shoes. $\frac{3}{8}$ " Thick Plate(s).

- Will add support to Pulley web. 3 H.S. But adding $\frac{3}{8}$ " steel.
- Other leg of shoe will add $\frac{3}{8}$ " thickness x 4" width x 2 shoes to Flange area.

Total Added area = $\frac{3}{8} \times 4 \times 2 = 3 \text{ in}^2$

Adding to Shoe increases the Flange to 6 in².

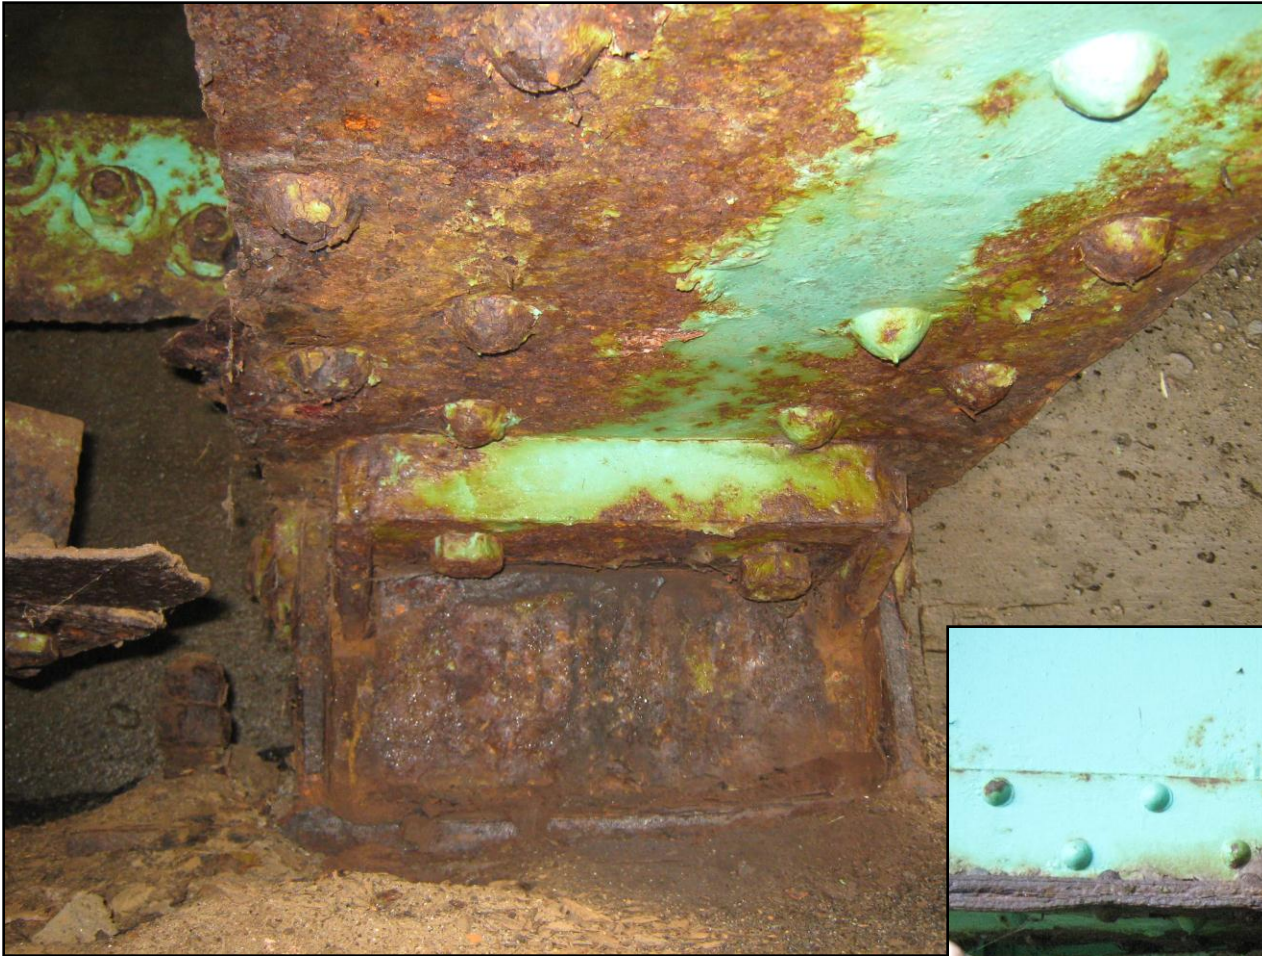
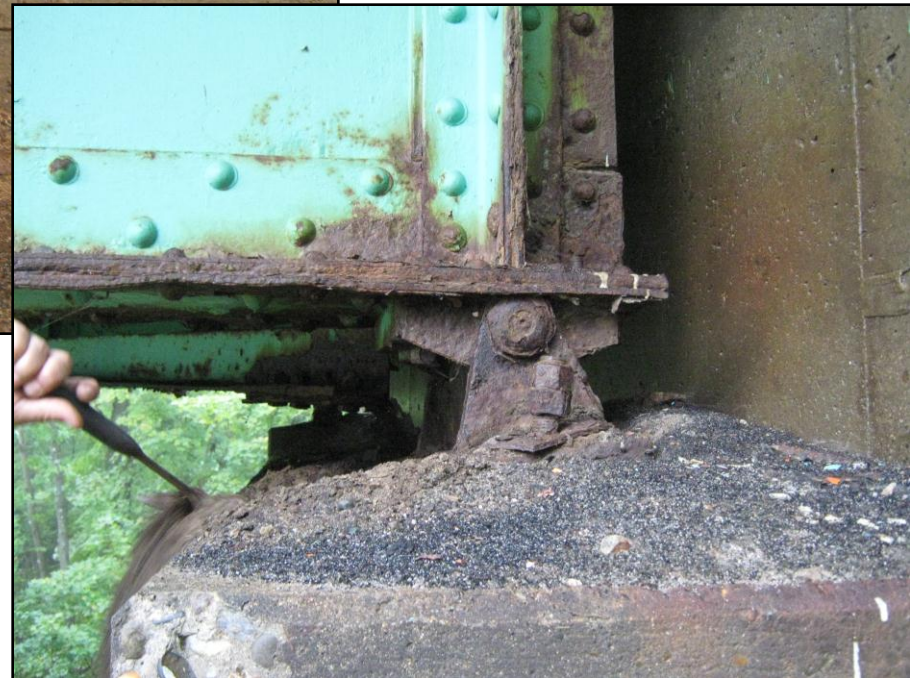
**Deteriorated Brgs &
Bottom Flanges.**
