COMPARISON OF BRIDGE DECK DETERIORATION FOUND BY NDT METHODS AND HYDRODEMOLITION

Brandon Goodwin

Civil Engineering Master's Student

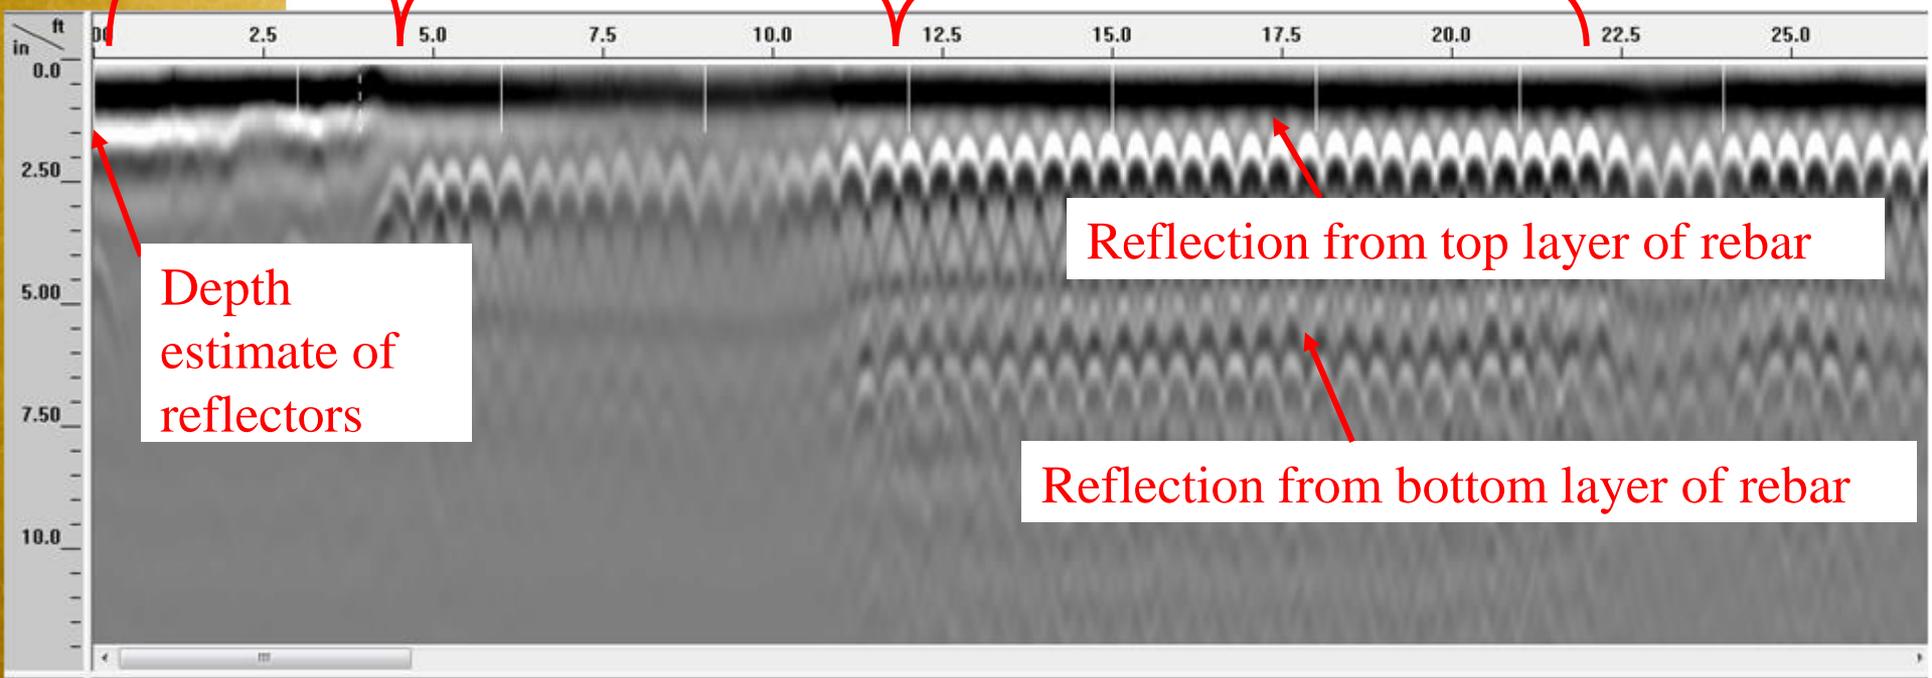
Sample GPR Results

Area without rebar

Area with evidence of deterioration of concrete

Area with no evidence of deterioration of concrete

Depth estimate of reflectors

Reflection from top layer of rebar

Reflection from bottom layer of rebar

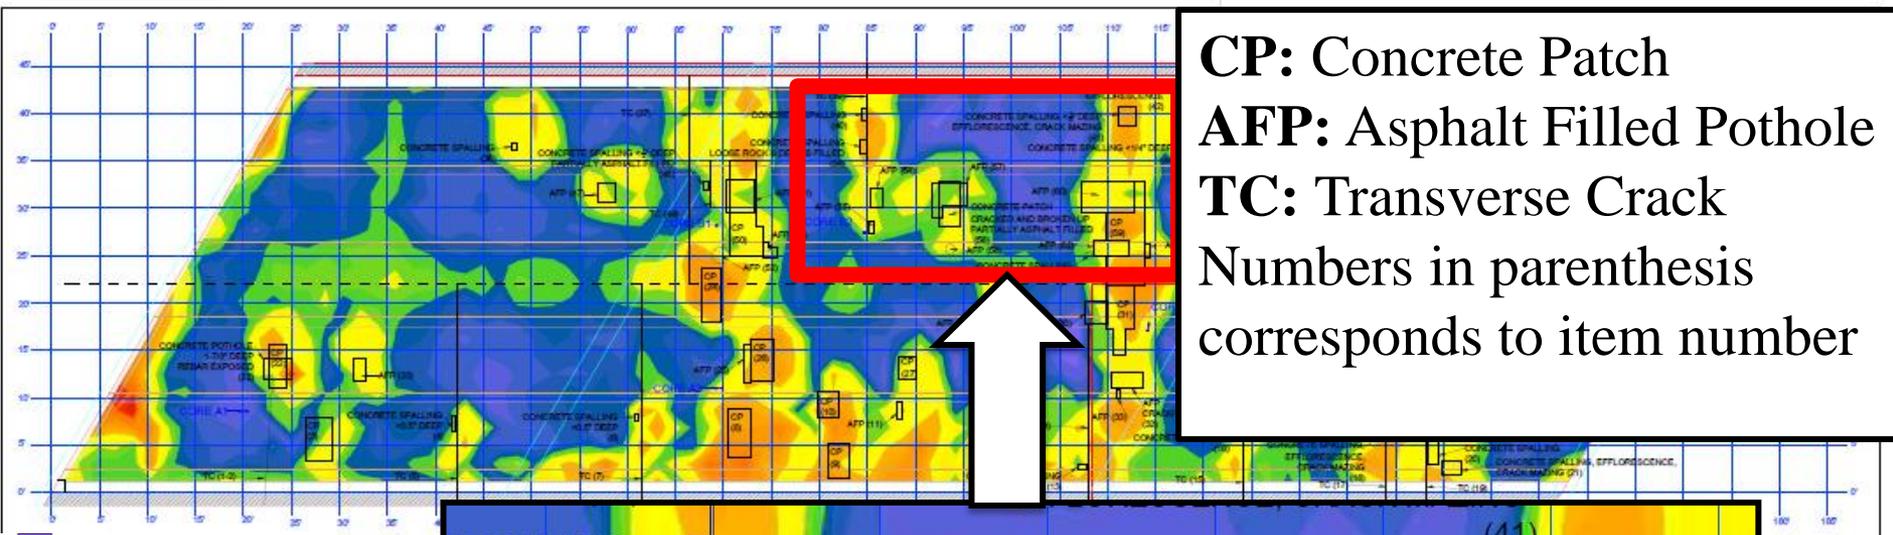
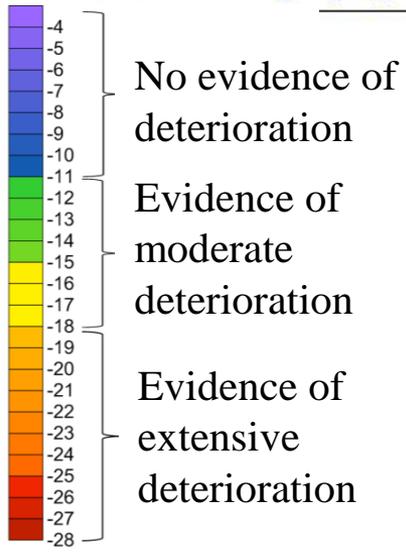
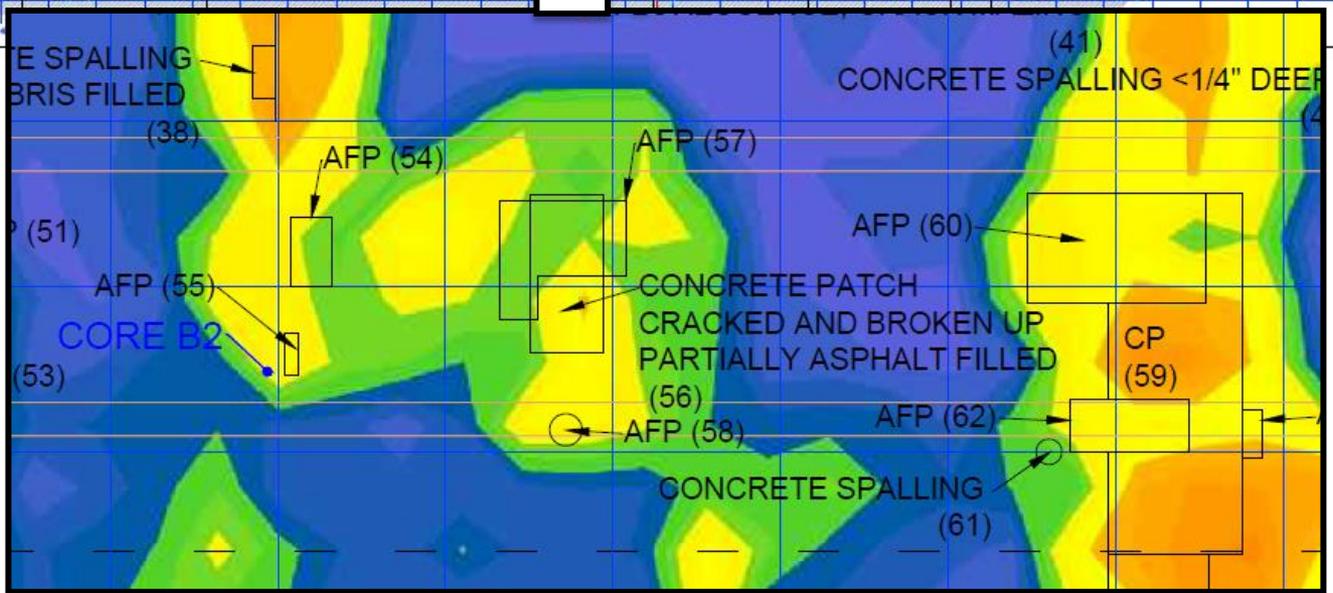
GPR and Visible Deterioration Mapping

CP: Concrete Patch
AFP: Asphalt Filled Pothole
TC: Transverse Crack
 Numbers in parenthesis corresponds to item number

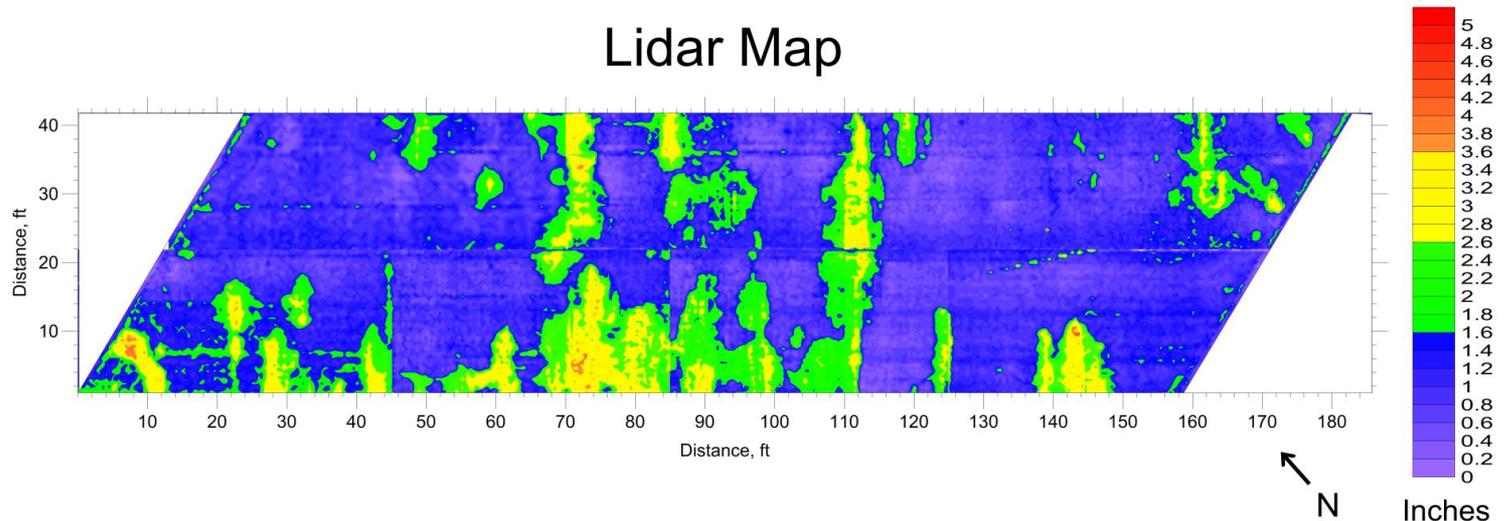
Lidar Map

- Top 0.75 in. of deck surface removed by milling
- Hydro demolition then removed remaining loose and deteriorated concrete
- Performed on all 3 of the bridges that were investigated using GPR
- Volume and locations of concrete removal was determined using LiDAR (Light Detection and Ranging)

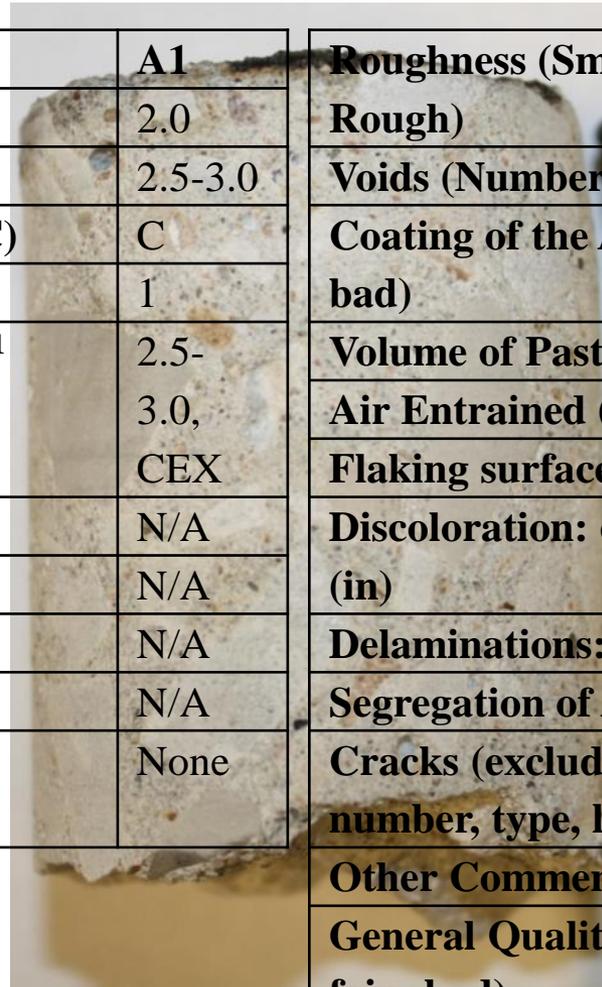
Visual Core Inspection – Core A1

Core	A1
Diameter (in)	2.0
Length (in)	2.5-3.0
Surface (Asphalt: A, Concrete: C)	C
Number of Pieces	1
#1 Length (in) and failure mode ¹	2.5-3.0, CEX
#2 Length (in) and failure mode	N/A
#3 Length (in) and failure mode	N/A
#4 Length (in) and failure mode	N/A
#5 Length (in) and failure mode	N/A
Rebar: diameter (in), length (in), orientation ², corrosion ²	None

Roughness (Smooth, Average, Very Rough)	Smooth
Voids (Number >0.25 in. diameter)	1
Coating of the Aggregate (good or bad)	Good
Volume of Paste (good or bad)	Good
Air Entrained (yes or no)	Yes
Flaking surface: thickness (in)	None
Discoloration: color, maximum length (in)	None
Delaminations: depths (in)	None
Segregation of Aggregate: depths (in)	None
Cracks (excluding fracture planes): number, type, length (in)	None
Other Comments	
General Quality of Concrete³ (good, fair, bad)	Good

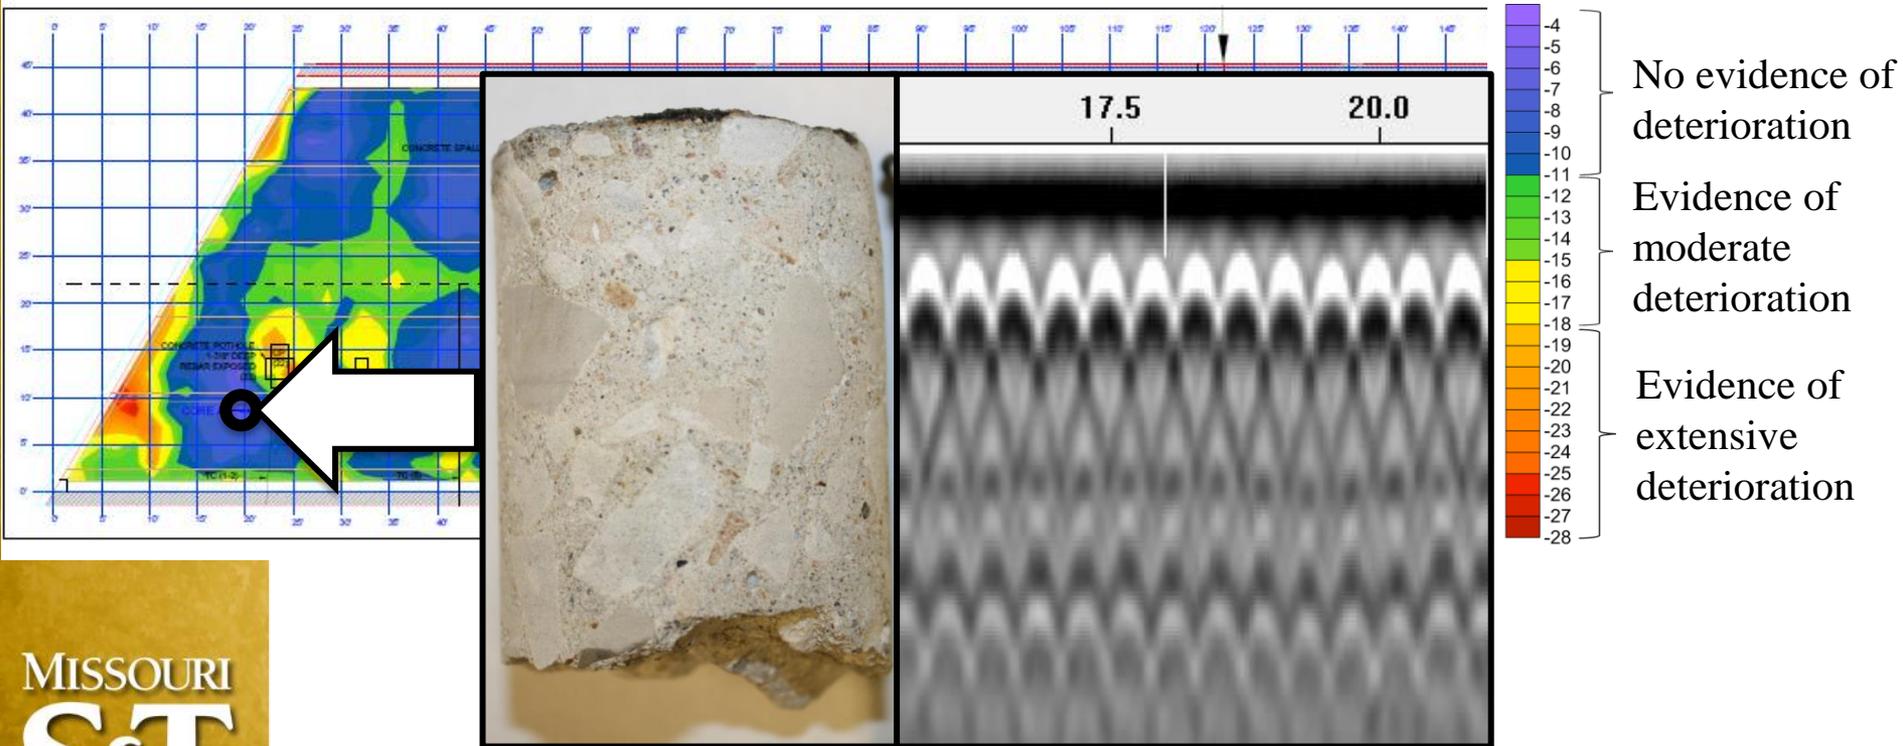
Core A1

Visual Core Rating: Good

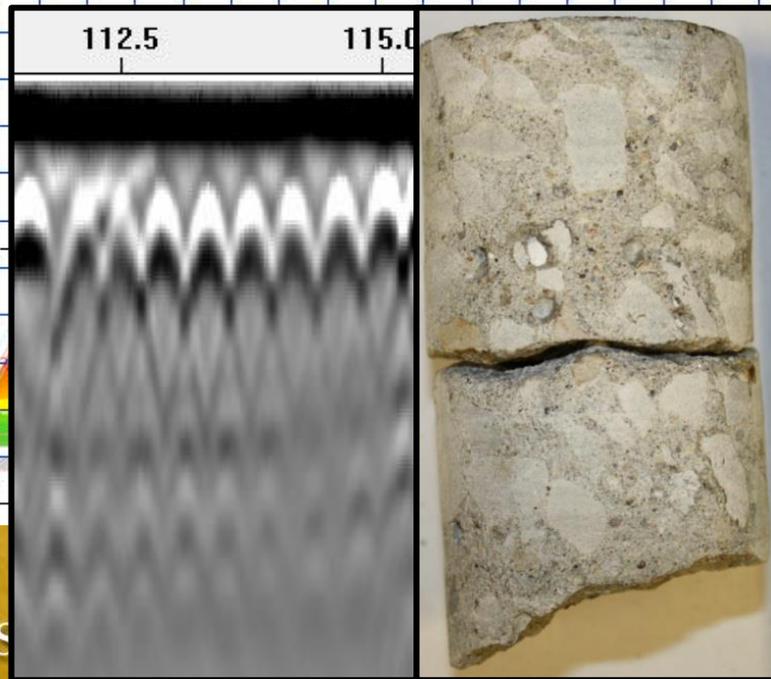
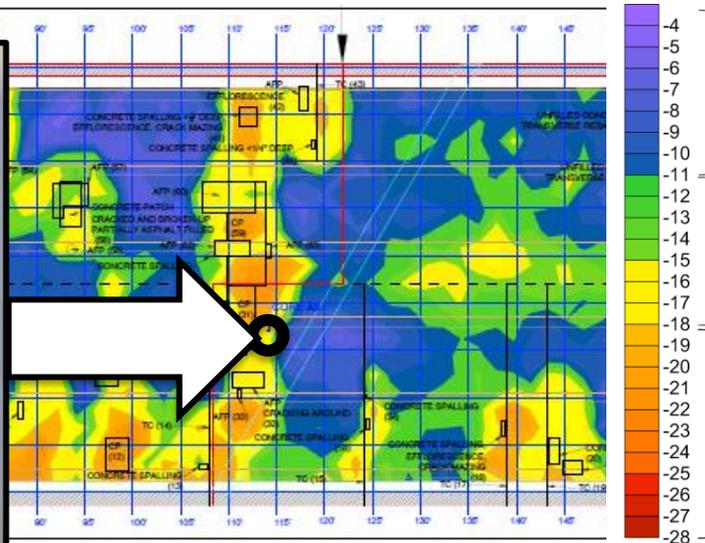
Core A3

Visual Core Rating: Fair

No evidence of deterioration

Evidence of moderate deterioration

Evidence of extensive deterioration

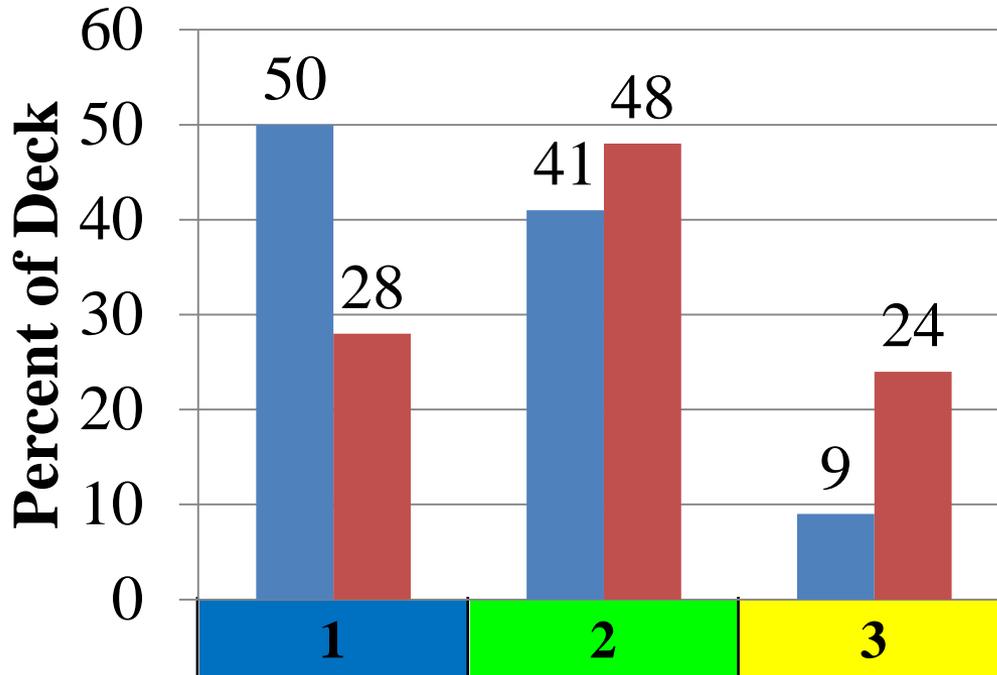
Bridge 3 Deck Condition Comparison

■ GPR
Deterioration Estimate

■ Hydro Demolition Material Removal

1	2	3
GPR	No evidence of deterioration	Evidence of moderate deterioration	Evidence of extensive deterioration
Hydro Demolition	Depth < 0.75 in.	0.75 in. < Depth < Top of Rebar	Depth > Top of Rebar

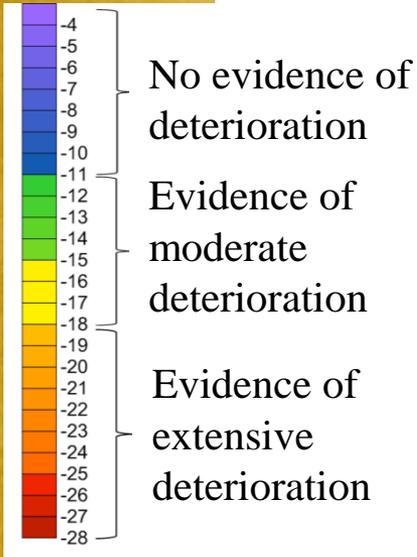
GPR and Core Correlation

VISUAL CORE RATING		
		Good	Fair	Bad
GPR MAP CLASSIFICATION	No Evidence of Deterioration	A1		
	Moderately Deteriorated	A2, B3 (Border Line No Deterioration)	A3, B2	B1
	Extensively Deteriorated			
	% Ideal Match	% Ideal Match with Border Line Correct		
	50%	67%

Note: GPR responds to saline moisture in concrete, and the moisture content does not necessarily coincide with visible core rating.

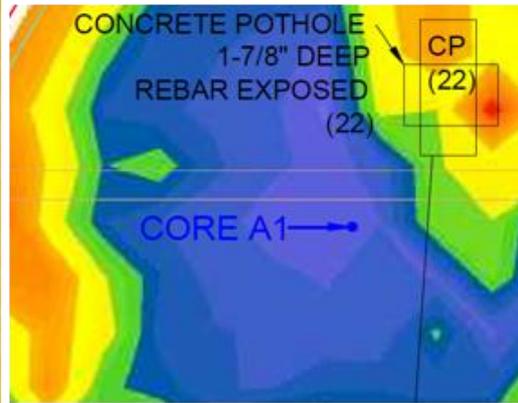
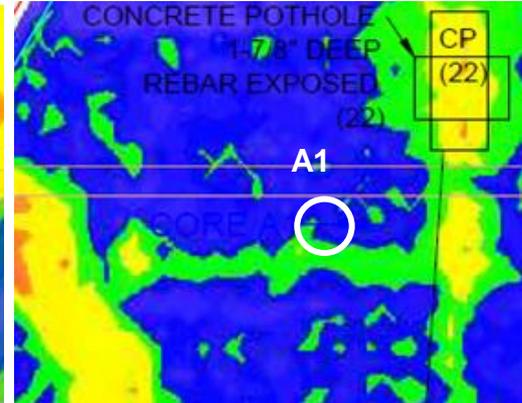
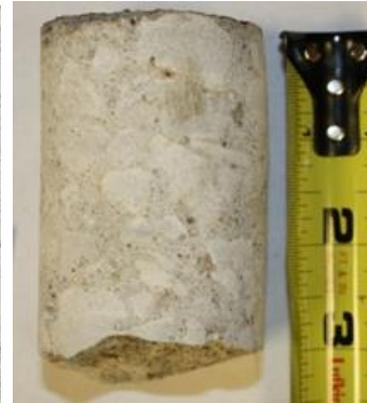
A1

Post Hydro-demolition surface
