SCENIC BRIDGE PRESERVATION

BIG SUR HWY 1 BRIDGES
2013

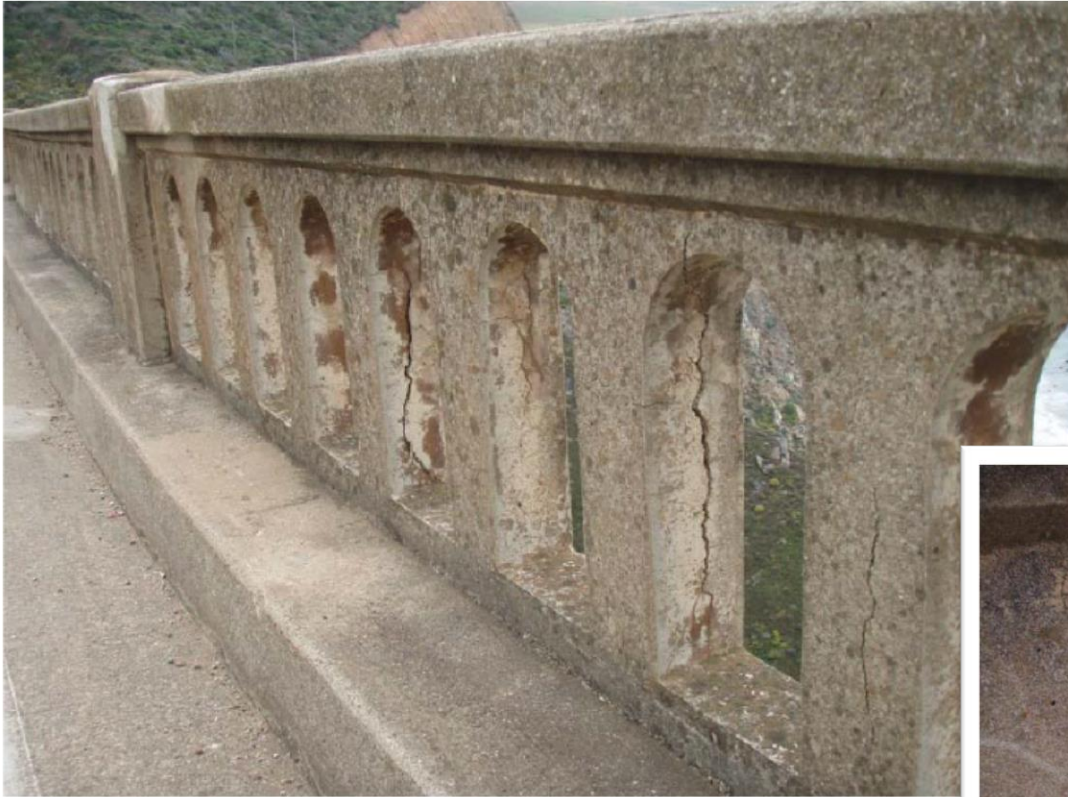
Bixby Creek Rail

- Severe cracking with unsound concrete and spalls with exposed rusted rebar.

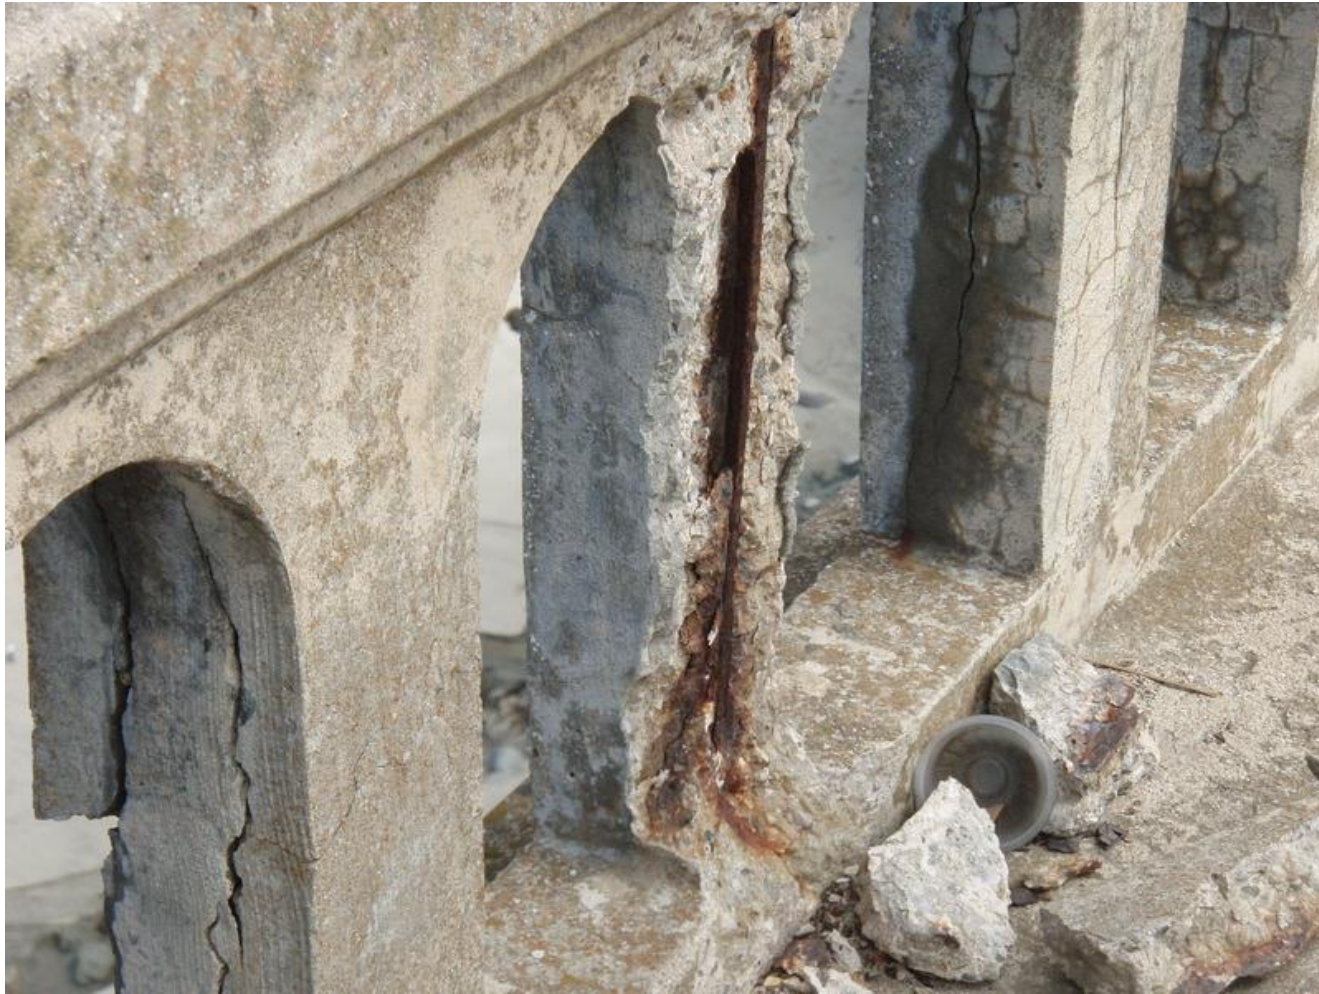
Rocky Creek Rail

- The concrete barrier rail posts are deteriorated along left and right barrier rail length. The deterioration includes large cracks, unsound concrete and spalls with exposed reinforcement.

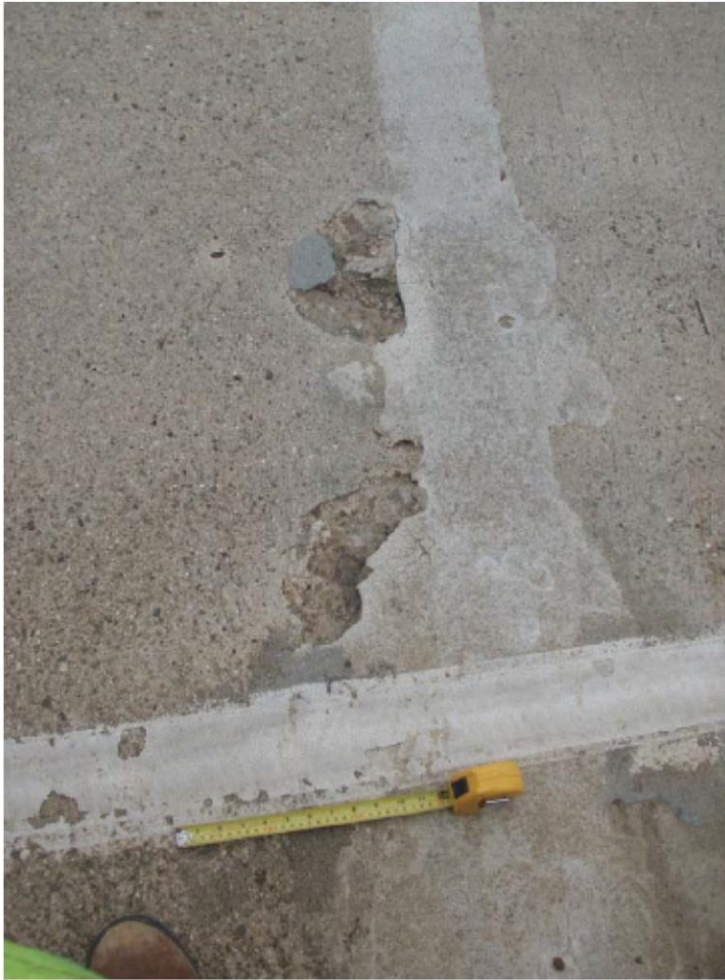
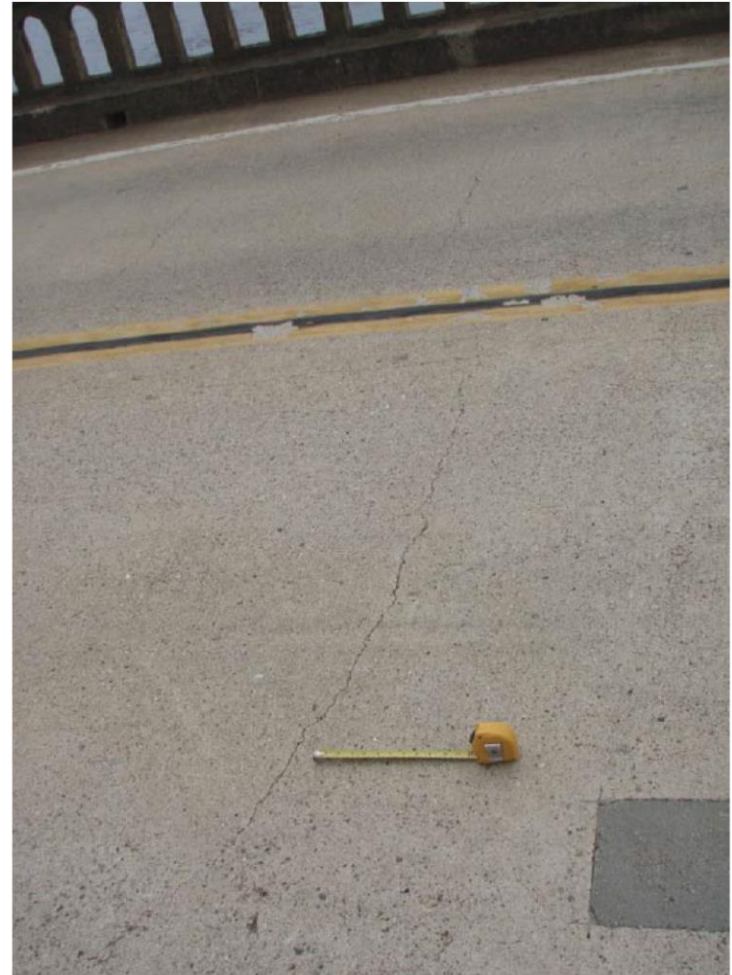
Bixby Creek Deck

- Pattern cracks spaced less than 1' apart throughout.
- 1% of the deck area is spalled or unsound.
- Chloride concentration up to 5.5 LB/CY in 0 – 1" depth; up to 2.43 LB/CY in 1" – 2" depth.

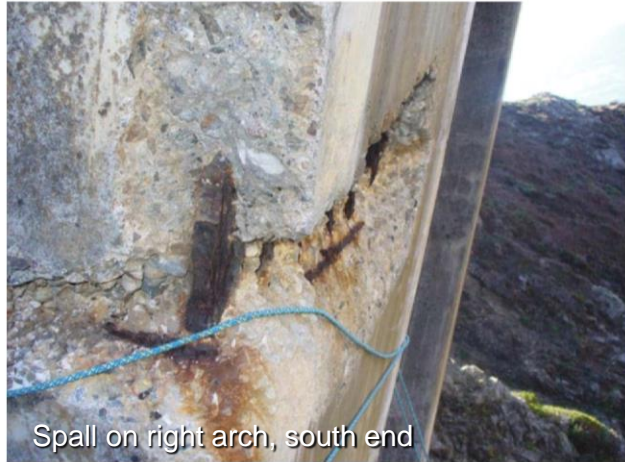
Bixby Creek Arch Ribs

- Chloride concentration in the arch ribs:

❖ 0 – 1" depth	: 1.95 LB/CY to 3.77 LB/CY
❖ 1" – 2" depth	: 0.23 LB/CY to 5.2 LB/CY
❖ 2" – 3" depth	: 2.02 LB/CY to 3.59 LB/CY
❖ (Concrete cover is approximately 3")

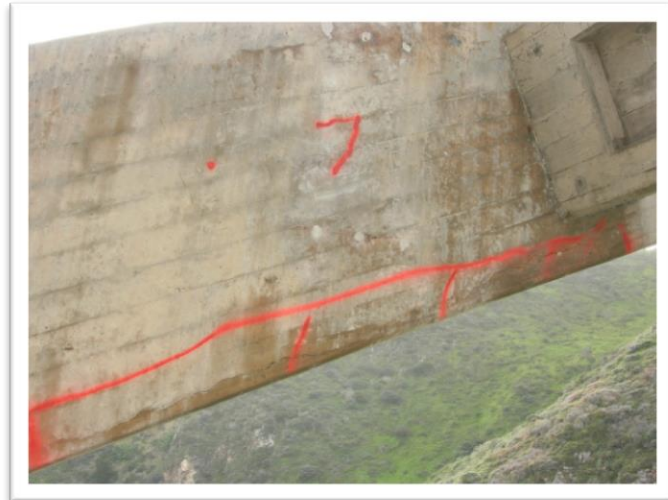
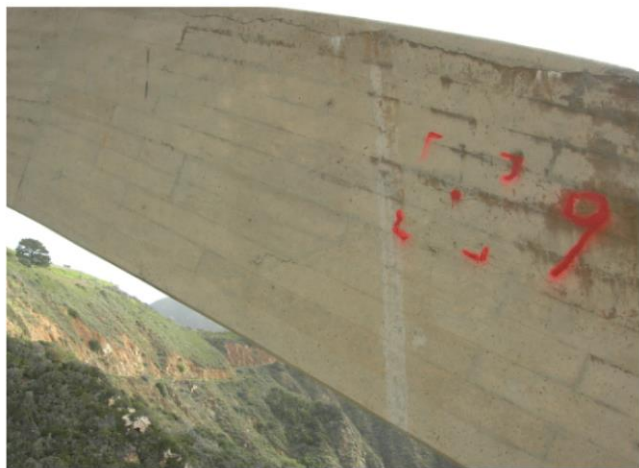
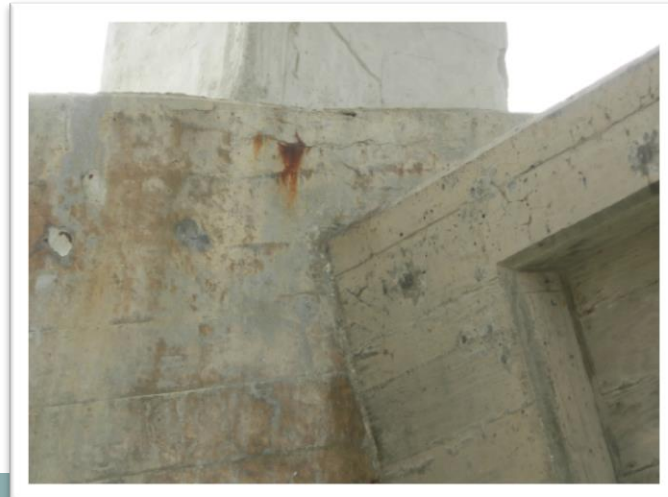
Spall on right arch, south end

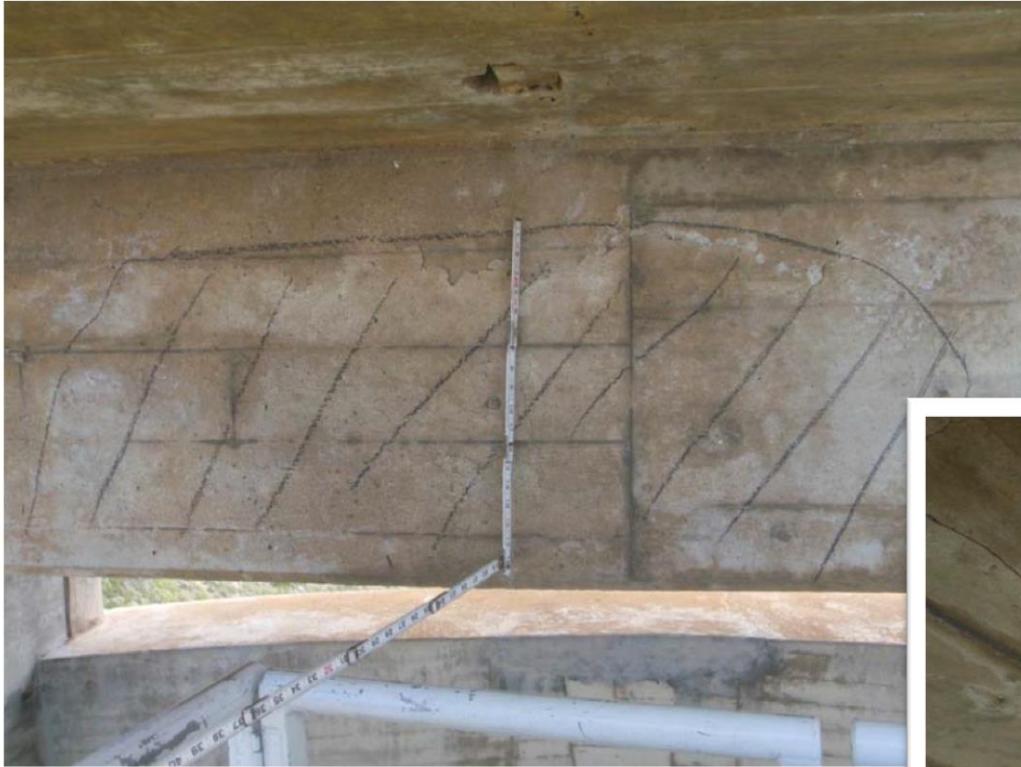
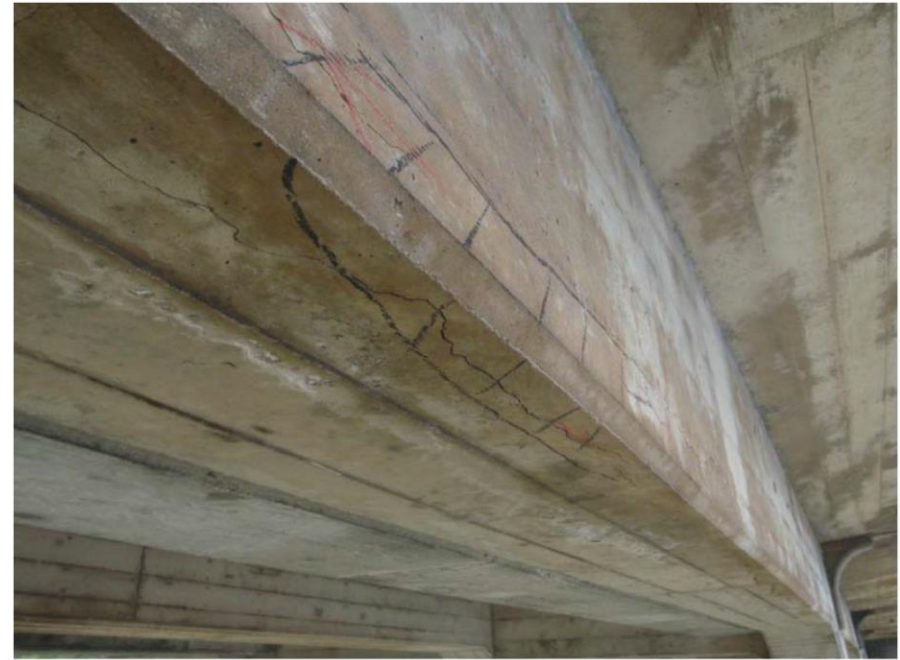
Bixby Creek Girders

- Numerous spalls and areas of unsound concrete due to rebar corrosion scattered throughout superstructure and substructure elements.

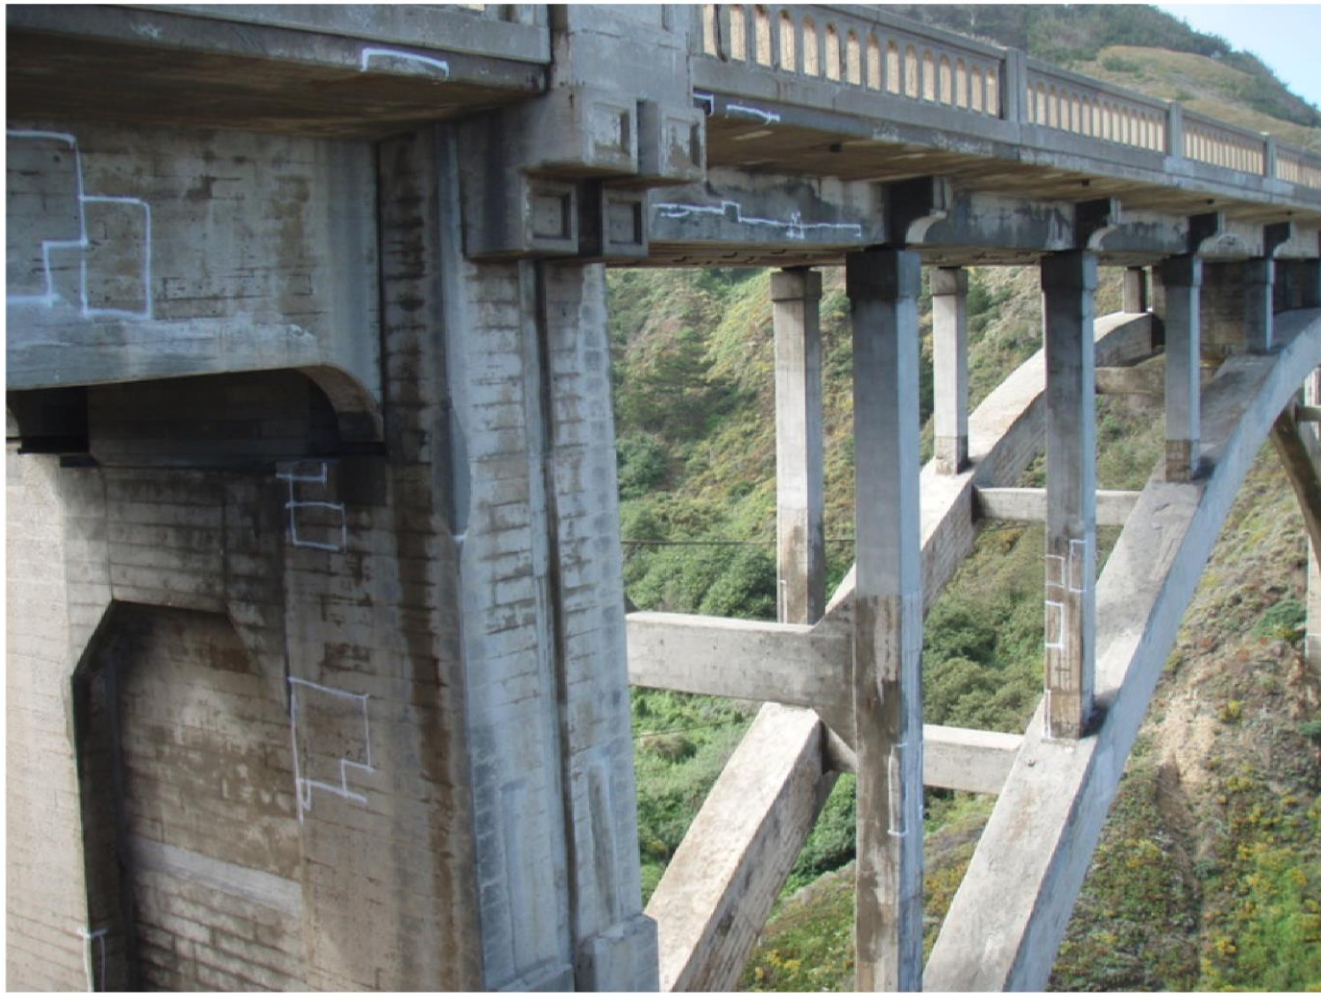
Rocky Creek Arch

- There are numerous spalls and areas of unsound concrete scattered throughout the superstructure and substructure elements.
- Chloride concentration in the arch ribs:
 - ❖ 0 – 1" depth : 5.62 LB/CY
 - ❖ 1" – 2" depth : 6.82 LB/CY
 - ❖ 2" – 3" depth : 8.74 LB/CY
 - ❖ (Concrete cover is approximately 2.5")
 - ❖ 6,200 psi concrete strength

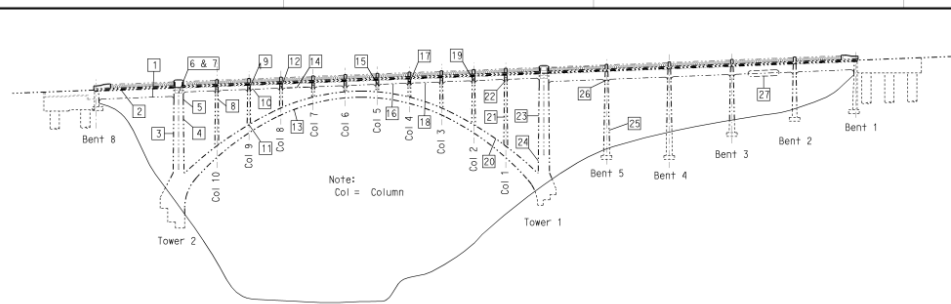
ROCKY CREEK - LEFT SIDE ELEVATION SPALL MAP
NO SCALE

ROCKY CREEK SPALL REPAIR TABLE (LEFT SIDE OF BRIDGE)					
LOCATION	DESCRIPTION	APPROXIMATE LENGTH (feet)	APPROXIMATE WIDTH (feet)	APPROXIMATE DEPTH (inches)	APPROXIMATE VOLUME (cubic feet)
1	Bottom of girder	4.0	3.00	1.0	1.00
2	Decorative haunch	2.0	3.00	2.0	1.00
3	Tower 2, left leg, backside face closest to abutment	2.0	2.00	2.0	0.67
4	Tower 2, inside corner	6.0	2.00	2.0	2.00
5	Tower 2, left leg, front face	3.0	1.50	2.0	0.75
6	Tower 2, left deck overhang	1.5	1.50	2.0	0.38
7	Tower 2, deck overhang	0.8	7.50	2.0	0.94
8	Column 10, outside face (ocean side)	1.0	1.00	1.0	0.08
9	Left exterior girder, inner face	6.0	0.33	3.0	0.50
10	Near Column 9, underside of girder	4.0	1.00	2.0	0.67
11	Column 9, backside, corner	6.0	0.33	4.0	0.66
12	Column 8, top, (prior repair)	4.0	1.00	2.0	0.67
13	Arch haunch	1.0	0.50	6.0	0.25
14	Mid-span, left exterior girder corner	10.0	2.00	0.3	0.42
15	Mid-span, left exterior girder, top of haunch, corner	2.0	0.17	2.0	0.06

16	Between Columns 4 & 5, corner	5.0	0.50	2.0	0.42
17	Between Columns 3 & 4, left exterior girder, corner	2.0	2.00	3.0	1.00
18	Between Columns 3 & 4, left exterior girder, corner	3.0	1.00	2.0	0.50
19	Adjacent to Columns 2, bottom of exterior girder, bottom face	2.0	2.00	2.0	0.67
20	Between Columns 1 & 2, adjacent to Column 1, top of arch rib	2.0	2.00	2.0	0.67
21	Column 1, link beam haunch, bottom face	3.0	1.00	2.0	0.50
22	Column 1, left exterior girder, bottom face	2.0	2.00	2.0	0.67
23	Tower 1, 40' above the top of the arch, creek side face	3.0	1.00	1.0	0.25
24	Tower 1, inside face (3 at this location)	8.0	1.00	2.0	1.33
25	Bent 5, top of link beam corner	1.0	0.50	6.0	0.25
26	Bent 5, top of column girder intersection, corner (3 at this location)	4.0	0.33	4.0	0.44
27	Span 2, left exterior girder corner (3 at this location)	22.0	1.00	6.0	11.00

See "CONCRETE SPALL REPAIR DETAIL" on MISCELLANEOUS DETAILS sheet for spall repair details.

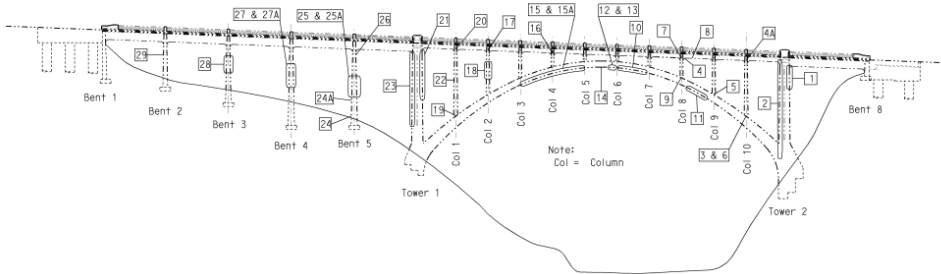
ROCKY CREEK - RIGHT SIDE ELEVATION SPALL MAP
NO SCALE

ROCKY CREEK SPALL REPAIR TABLE (RIGHT SIDE OF BRIDGE)					
LOCATION	DESCRIPTION	APPROXIMATE LENGTH (feet)	APPROXIMATE WIDTH (feet)	APPROXIMATE DEPTH (inches)	APPROXIMATE VOLUME (cubic feet)
1	Tower 2, top of tower down, interior corner	15.0	0.25	3.0	0.9
2	Tower 2, top of tower down, creek side, interior corner	100.0	0.25	3.0	6.3
3	Column 10, near top of arch corner	4.0	0.33	4.0	0.4
4	Column 8, underside of girder face	4.0	0.33	4.0	0.4
4A	Column 10, underside of girder face	4.0	0.33	3.0	0.3
5	Column 9, corner	10.0	0.25	3.0	0.6
6	Column 10, corner	25.0	0.33	4.0	2.8
7	Column 6, underside of girder face	2.0	2.00	3.0	1.0
8	Between Columns 8 & 9, girder corner	3.0	0.25	3.0	0.2
9	Column 8, near top of arch rib, corner	2.0	0.25	3.0	0.1
10	Between Columns 6 & 7, underside of arch rib face	5.0	5.00	3.0	6.3
11	Between Columns 8 & 9, underside of arch rib face	3.0	5.00	3.0	6.3
12	Between Columns 5 & 6, near Column 6, underside of arch rib face	2.0	2.00	3.0	1.0

13	Column 6, underside of arch rib face	3.0	3.00	3.0	2.3
14	Between Columns 5 & 6, underside of arch rib corner	10.0	0.50	3.0	1.3
15	Column 5, underside of arch rib face	10.0	3.00	3.0	7.5
15A	Column 3 to Column 5, entire underside of arch rib face	45.0	3.00	3.0	33.8
16	Column 4, top of column, on both sides of girder [2' x 2' x 2'-sides]	4.0	2.00	2.0	1.3
17	Column 2, top of column, on both sides of girder [2' x 2' x 2'-sides]	4.0	2.00	2.0	1.3
18	Column 2, creek side corner	15.0	1.00	3.0	3.8
19	Column 1, top of arch corner	2.0	0.25	3.0	0.1
20	Column 1, top of column, on both sides of girder [2' x 2' x 2'-sides]	4.0	2.00	2.0	1.3
21	Tower 1 corner, (cumulative visual estimate)	10.0	0.33	4.0	1.1
22	Column 1, mountain side below link beam, corner	3.0	1.00	3.0	0.8
23	Tower 1, mountain side corner	40.0	0.50	6.0	10.0
24	Bent 5, lower link beam corner (creek side = 3', mountain side = 2')	5.0	0.50	3.0	0.6
24A	Bent 5, 10' above link beam corner	1.5	0.50	3.0	0.2

25	Bent 5, at upper link beam corner	3.0	1.00	3.0	0.8
25A	Bent 5, upper link beam haunch, corner	2.0	1.0	3.0	0.5
26	Bent 5, link beam haunch corner	5.0	0.5	3.0	0.6
27	Bent 4, mountain side of link beam corner	5.0	1.0	3.0	1.3
27A	Bent 4, mountain side of link beam corner	2.0	1.0	3.0	0.5
28	Bent 3, at link beam corner	3.0	0.5	6.0	0.8
29	Bent 2, at link beam, 10' from ground, corner	10.0	1.0	3.0	2.5

NOTES: (APPLY TO THIS SHEET ONLY)
 See "CONCRETE SPALL REPAIR DETAIL" on MISCELLANEOUS DETAILS sheet for spall repair details.

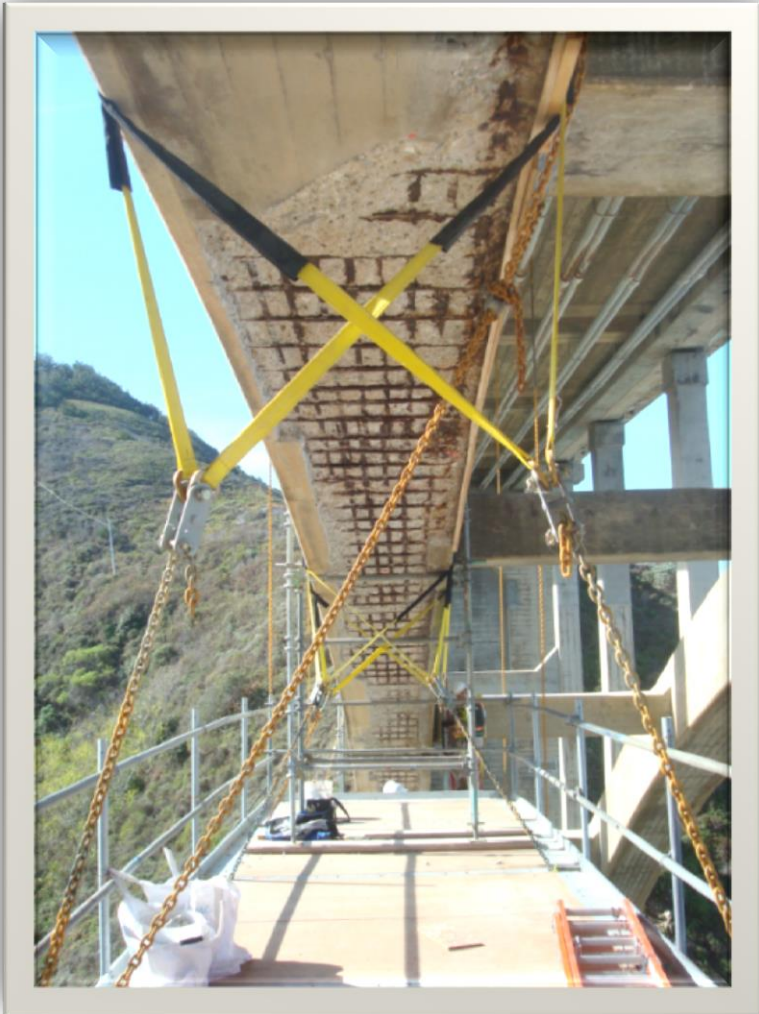
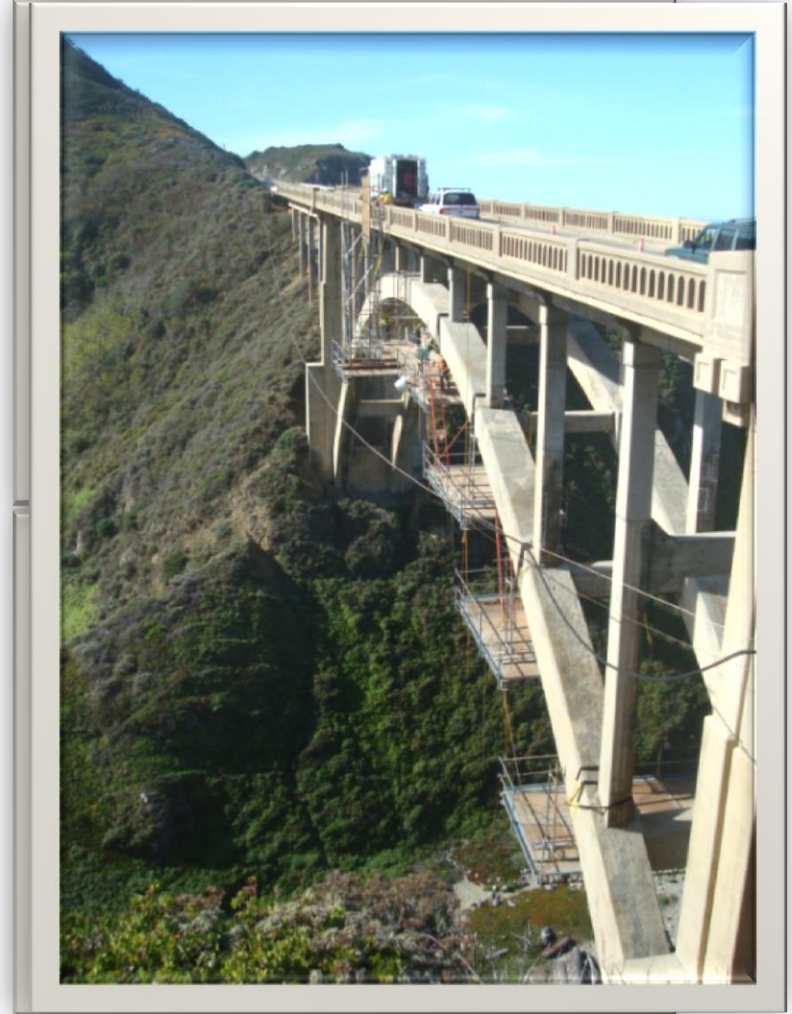
Rocky Creek Bridge

- Unsound concrete removed was twice the original assessment.
- Sounding did not locate all the unsound areas.
- Have flexible funding to allow for changes in scope of work.
- There is a prevailing need to apply corrosion mitigation measures to all Big Sur spandrel arch bridges.
