Route 89, Mansfield CT, Rubberized Chip Seal

I-91, New Haven/North Haven CT, Polypatch and Ultra-Thin Bonded HMA

Route 169 Canterbury/Brooklyn, SAMI topped with an Ultra-Thin Bonded HMA Overlay

Route 63 Cornwall/Cannan CT, Microsurfacing

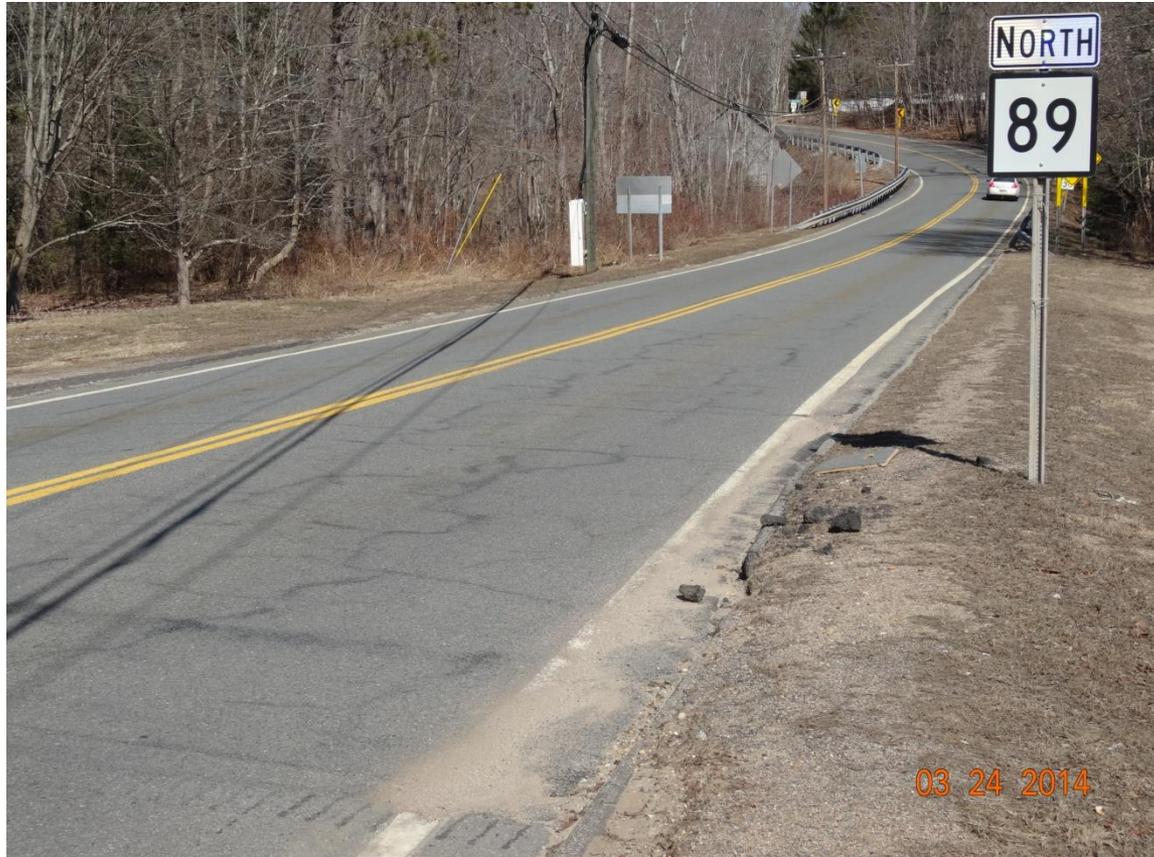
Placed in 2011, Rural Major Collector, ADT 4400

Treatment: Crack seal followed by rubberized chip seal (10% rubber)

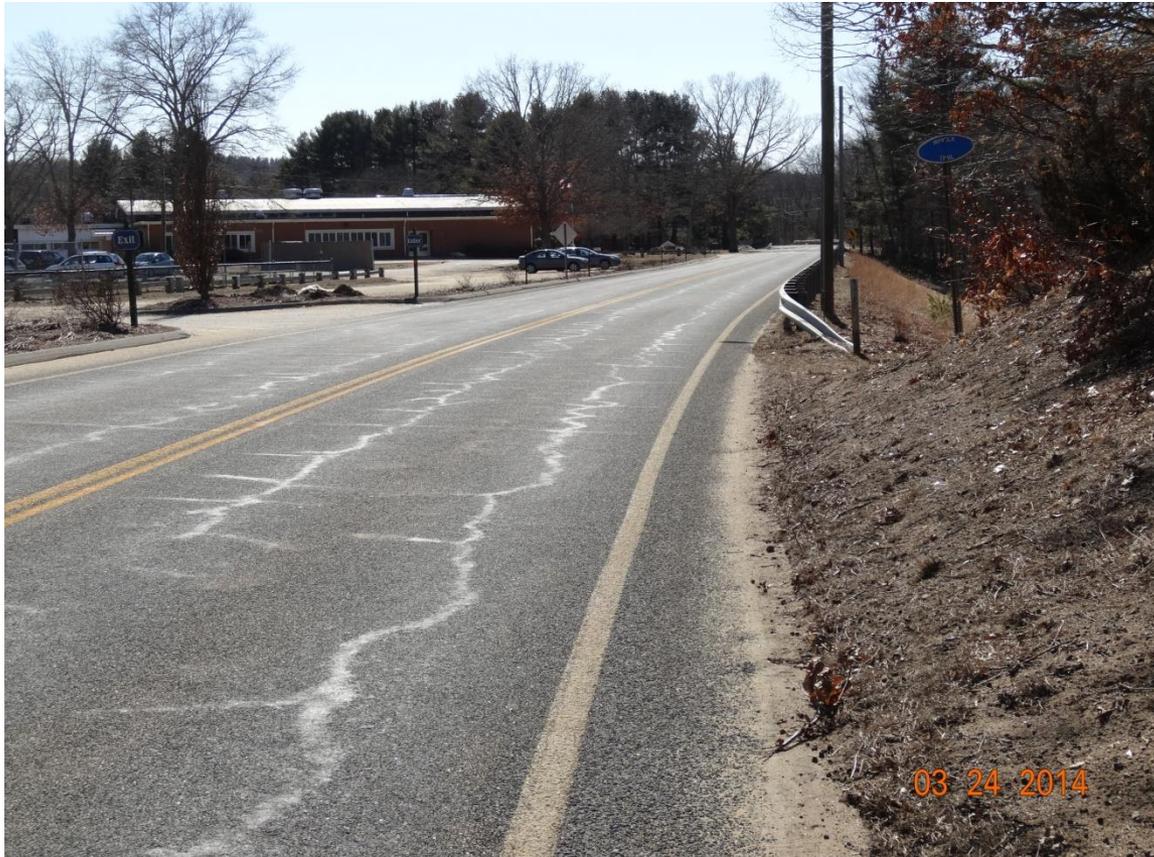
Route 89, Mansfield CT, Rubberized Chip Seal

Good photo of sealed cracks reflecting through the chip seal. This is what you want – all the pavement over the cracks saturated with rubber binder.

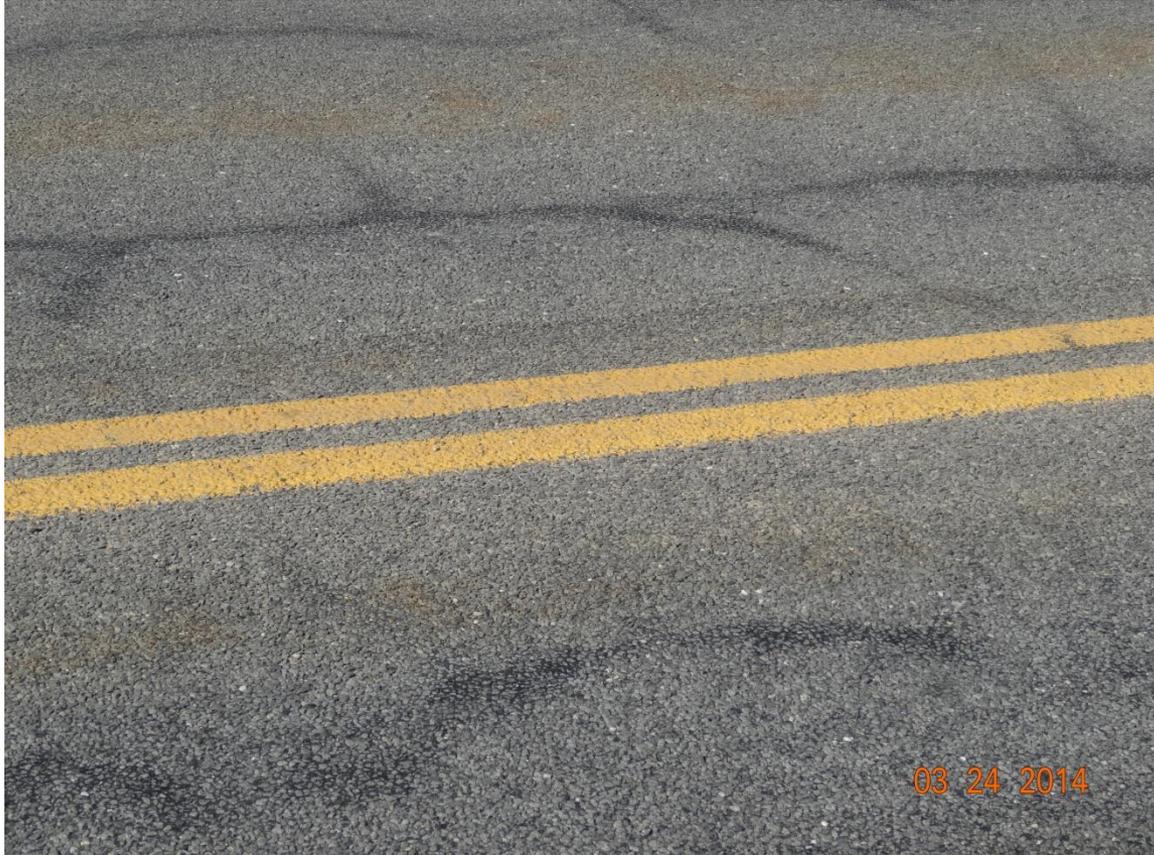
Route 89, Mansfield CT, Rubberized Chip Seal

The result – Not one crack reflecting through.

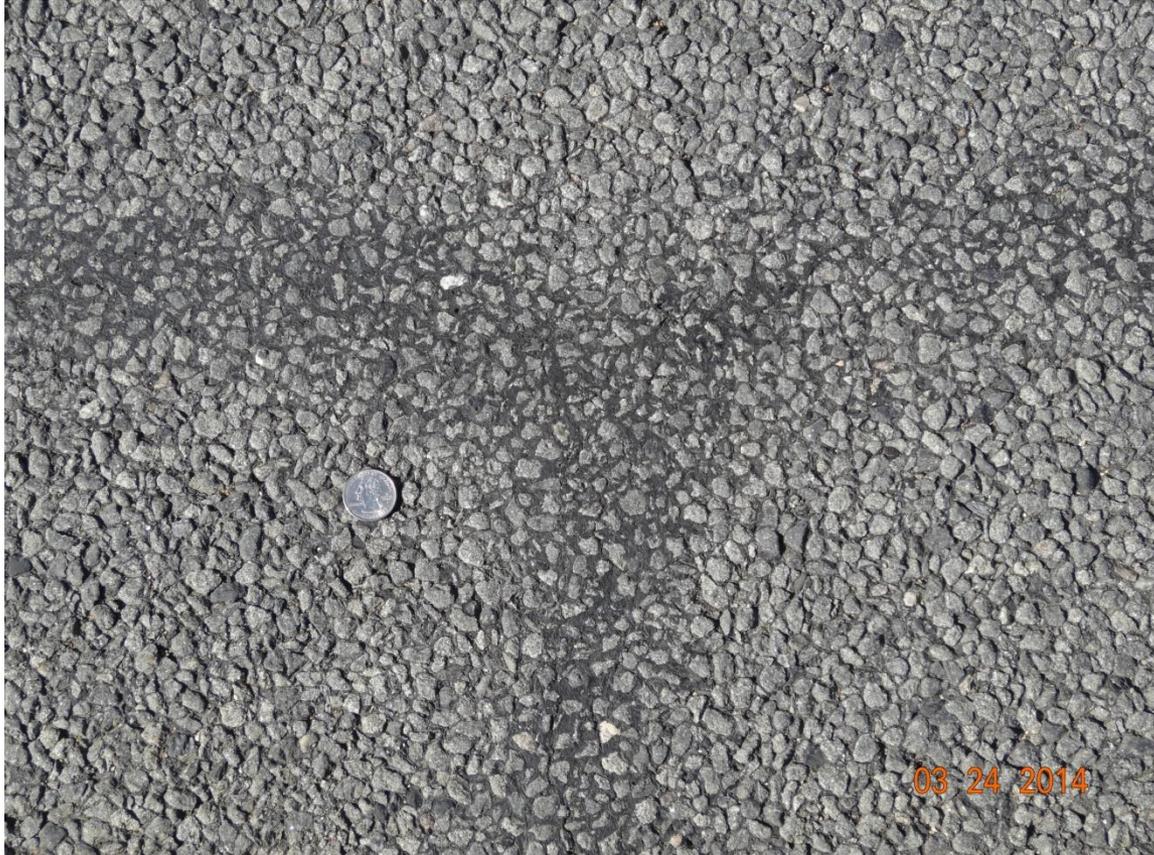
Route 89, Mansfield CT, Rubberized Chip Seal

Close up showing the extra rubberized binder content over the cracks. Notice the excellent texture and chip retention of the surrounding chip seal surface. This is exactly what you want to see with a successful rubberized chip seal.

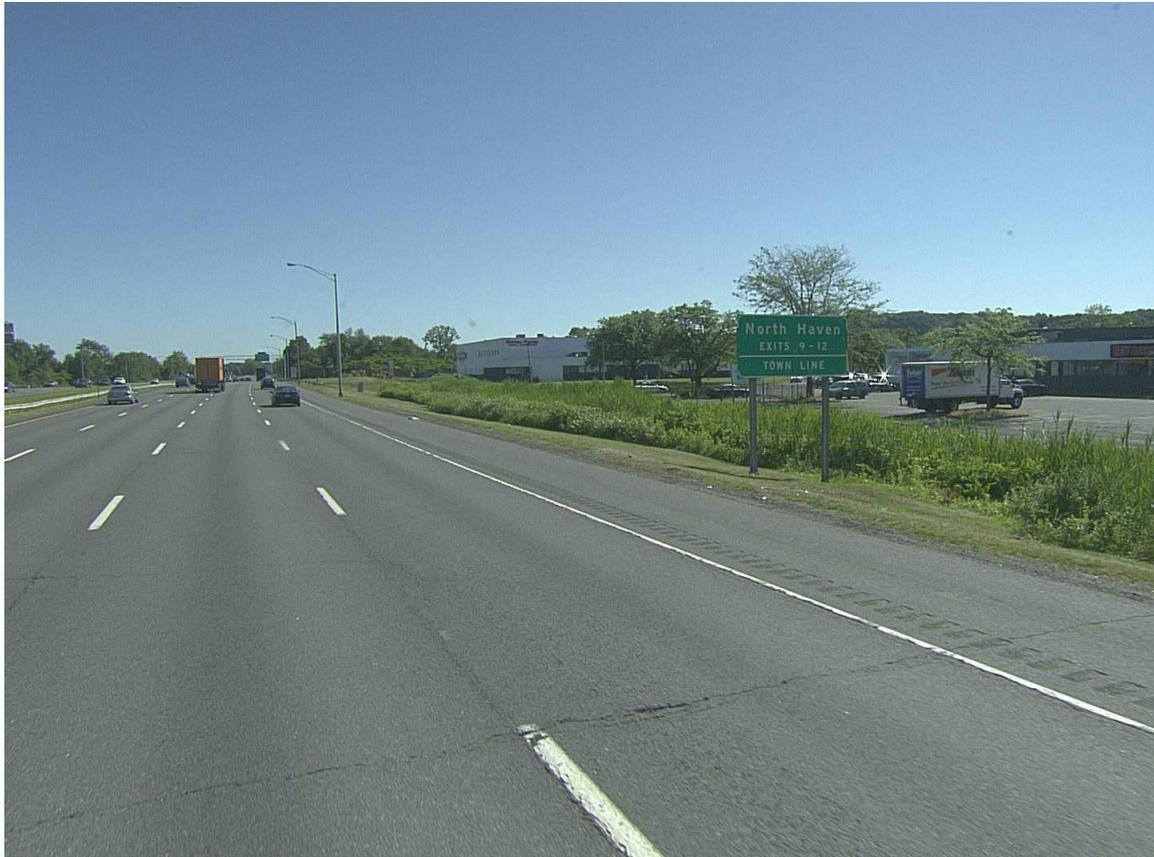
I-91 New Haven/North Haven CT, Interstate ADT- 132,000 VPD. Low severity transverse cracks were sealed with rubberized crack seal and medium to high severity cracks were patched with "PolyPatch." The patches typically were 1 inch deep by 10-12 inch wide. The roadway was then overlaid with a 5/8 inch thick Ultra-Thin Bonded HMA wearing surface.

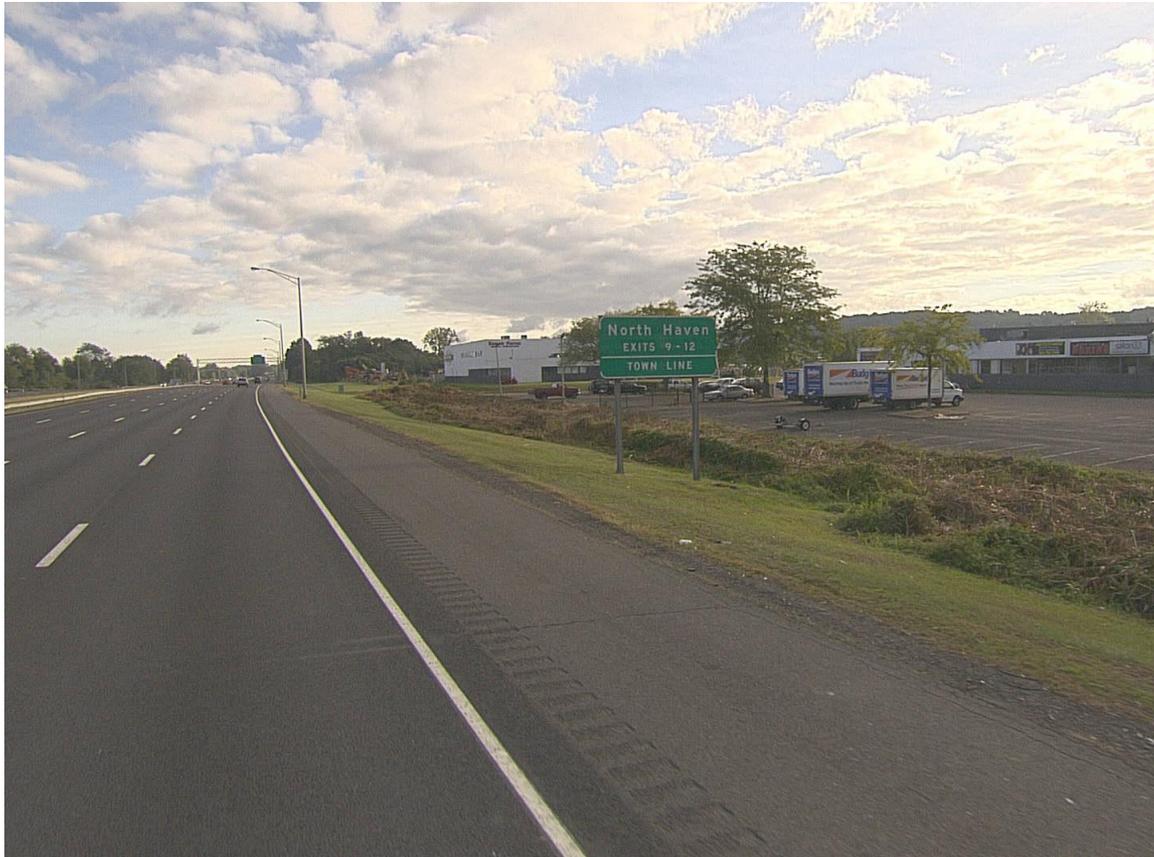
I-91, New Haven/North Haven CT, Polypatch and Ultra-Thin Bonded HMA

Here's a photo of the same location one year later. Notice the fat spot where the PolyPatch was placed.

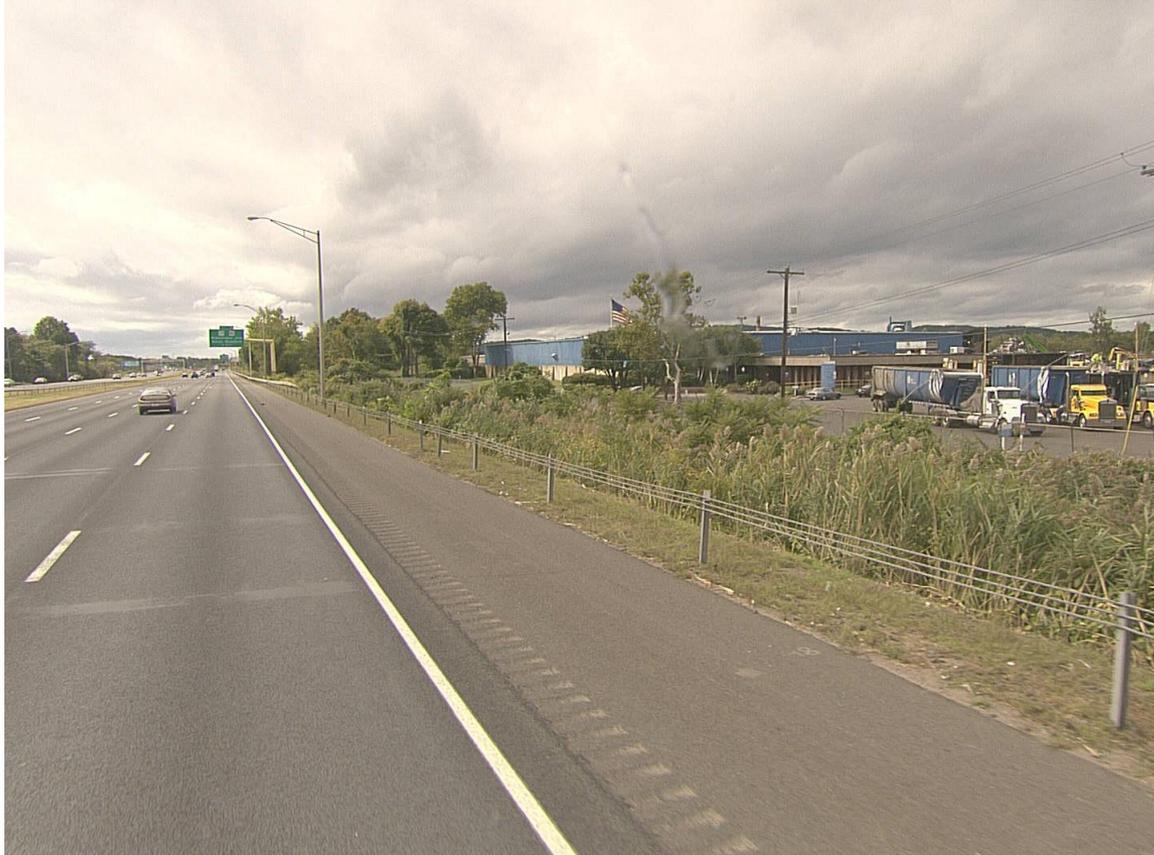
I-91, New Haven/North Haven CT, Polypatch and Ultra-Thin Bonded HMA

Typical photo (after 2 years), showing Polypatch under the Ultra-Thin Bonded HMA overlay.

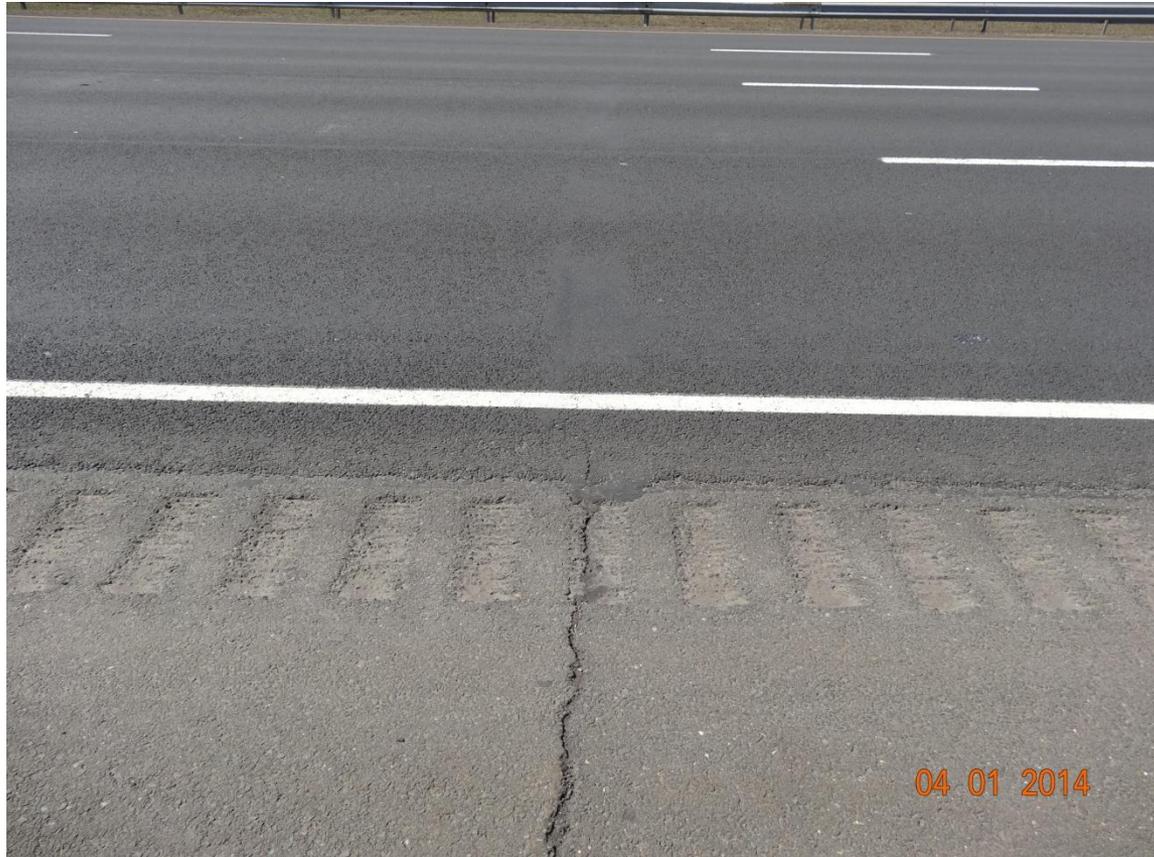
I-91, New Haven/North Haven CT, Polypatch and Ultra-Thin Bonded HMA

Typical PolyPatch treatment under the Ultra-Thin Bonded HMA overlay after two years.

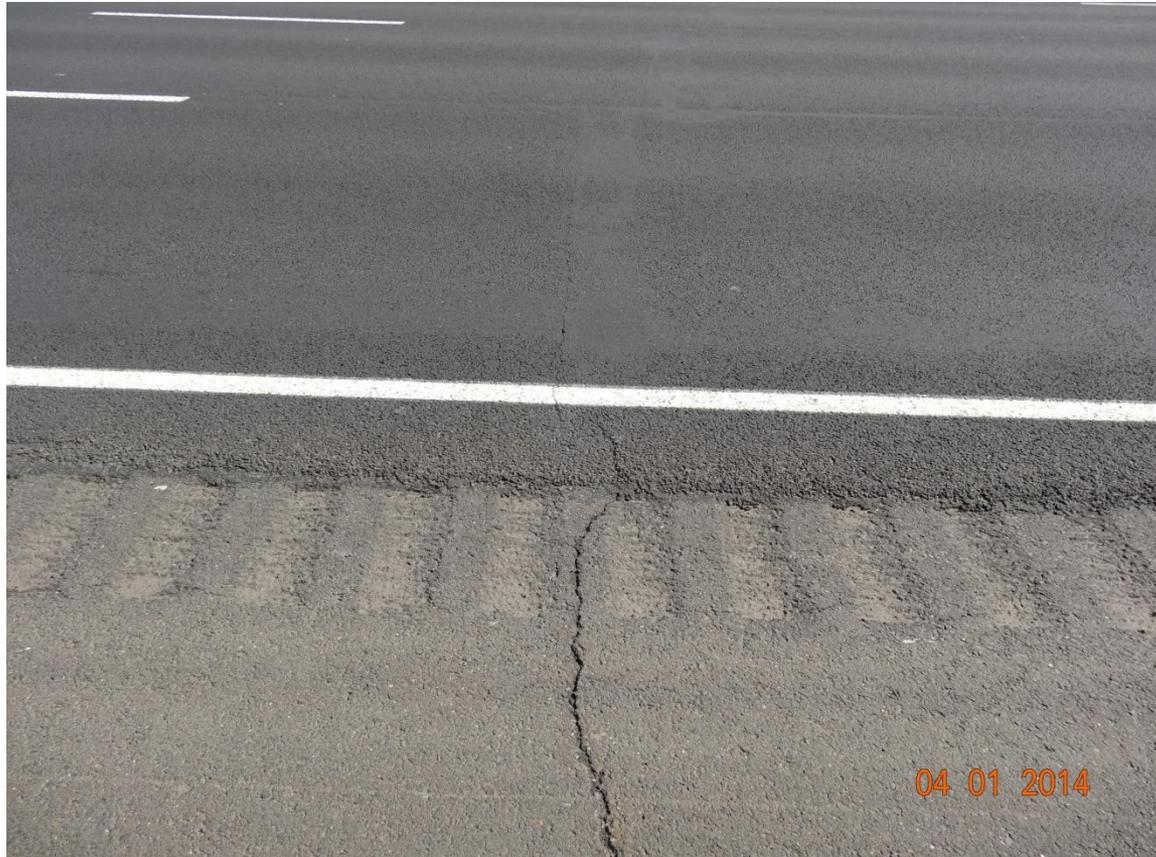
I-91, New Haven/North Haven CT, Polypatch and Ultra-Thin Bonded HMA

Some patches showing tight reflective cracking along the outside edges of the underlying PolyPatch.

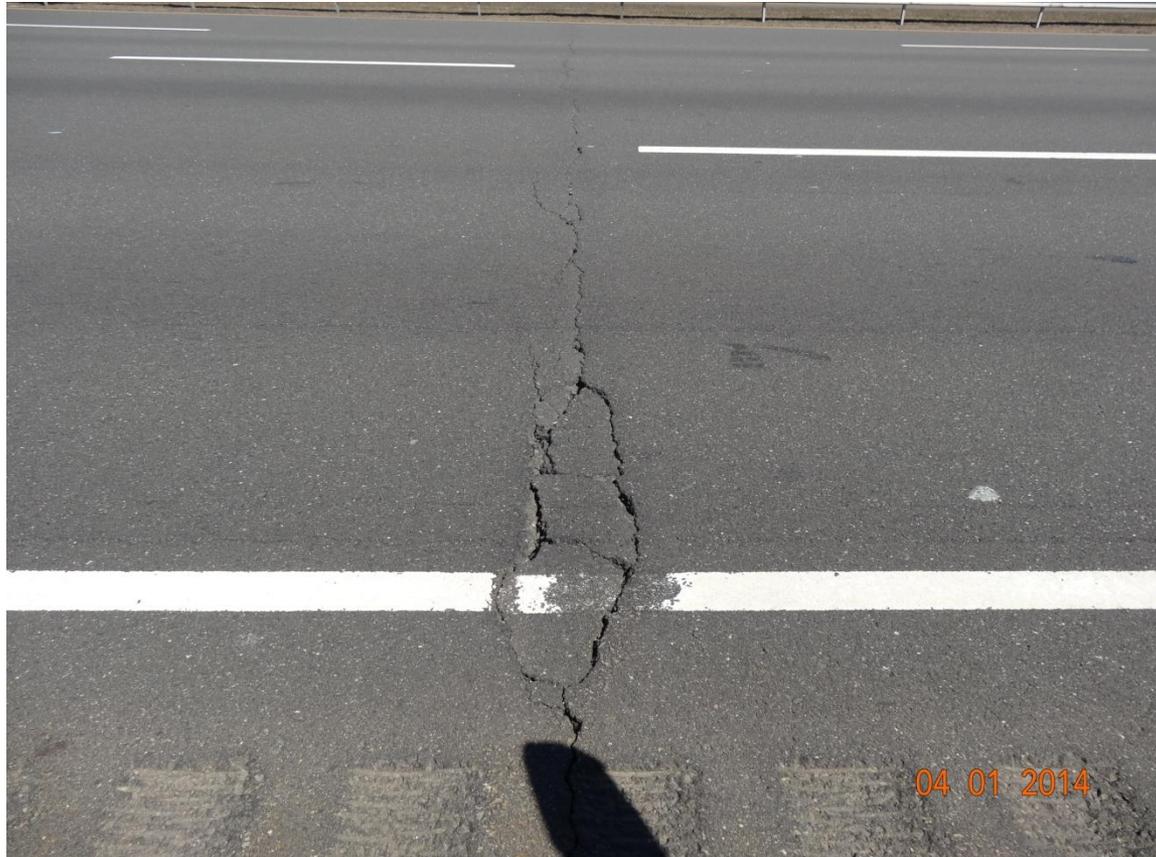
I-91, New Haven/North Haven CT, Polypatch and Ultra-Thin Bonded HMA

Control Section - Milled and paved the same year with two (2) inches of Superpave HMA 0.5 inch.

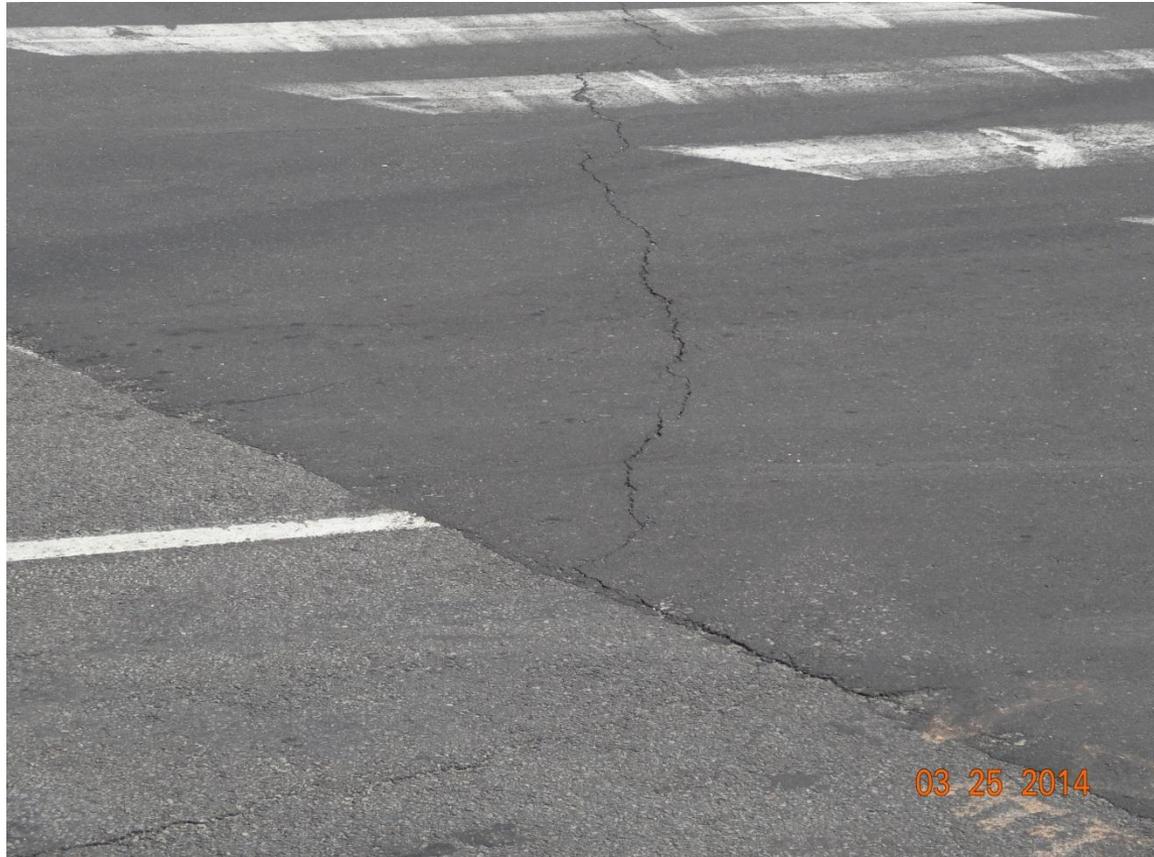
Route 169 Canterbury/Brooklyn, SAMI topped with an Ultra-Thin Bonded HMA Overlay

Sami and Ultra-Thin placed in 2011 adjacent to 2 inch mill and overlay done in 2012. Cracks take longer to come through and with much less severity compared to conventional mill and overlay with dense graded hot mix asphalt.

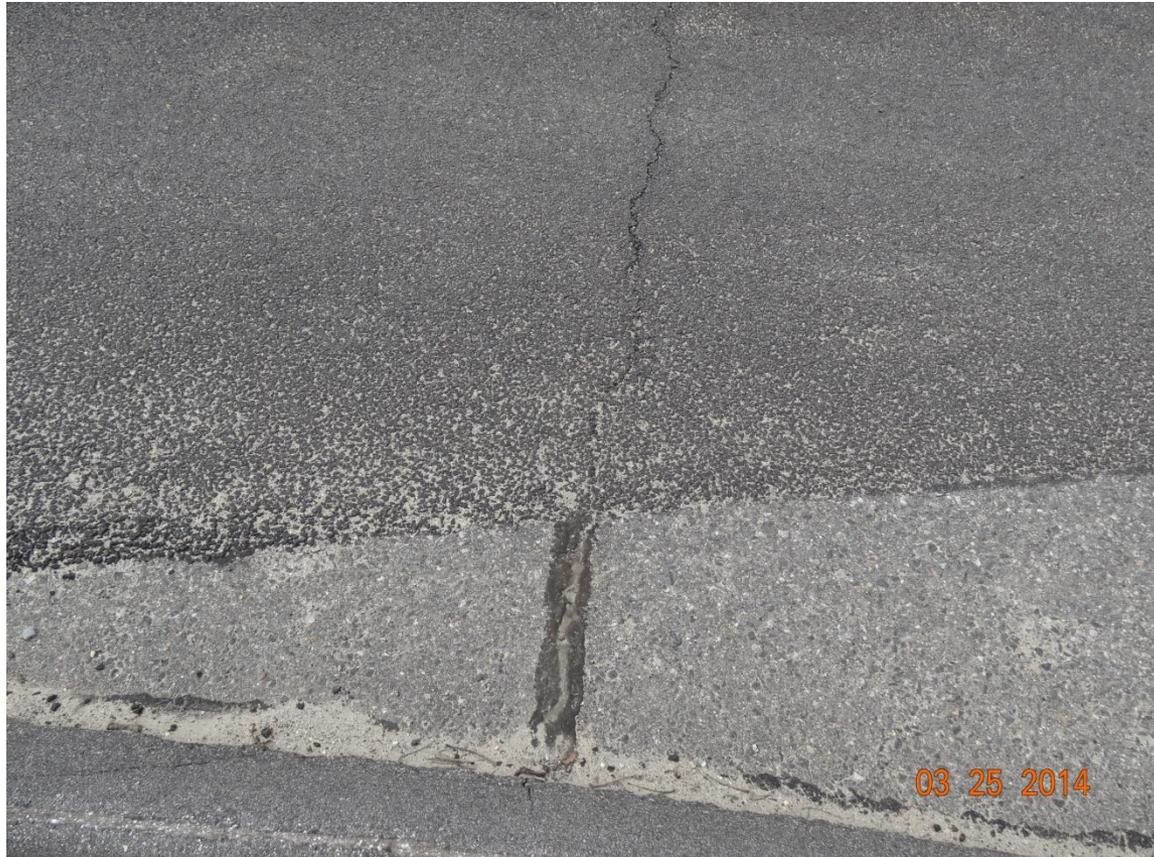
Route 169 Canterbury/Brooklyn, SAMI topped with an Ultra-Thin Bonded HMA Overlay

Crack reflection after 2 years. The more aggressive working cracks will reflect through the Ultra-Thin Bonded HMA overlay.

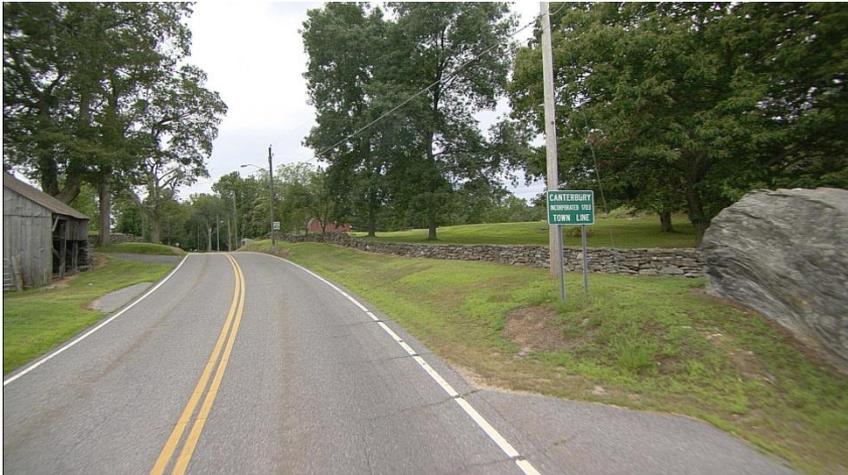
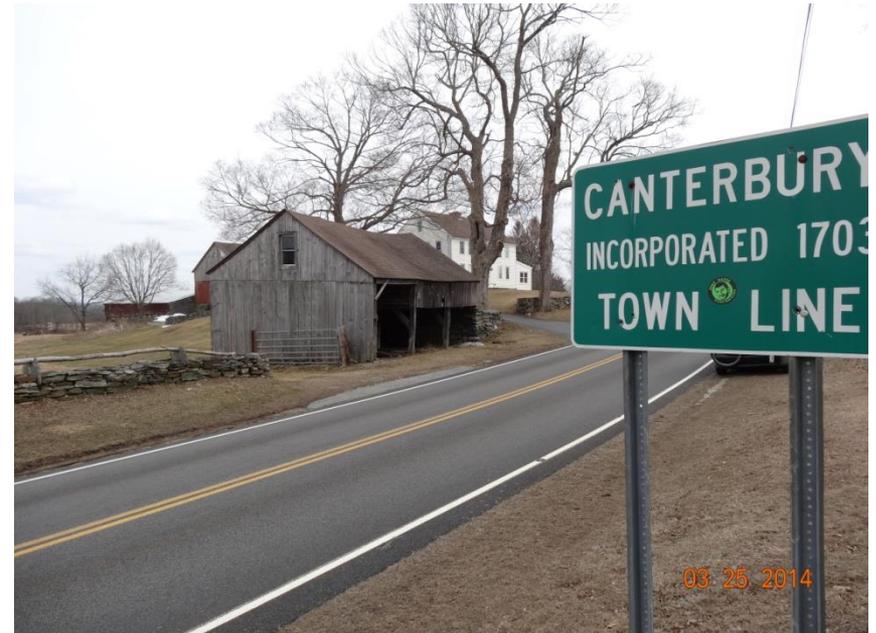
Route 169 Canterbury/Brooklyn, SAMI topped with an Ultra-Thin Bonded HMA Overlay

This road had a significant amount of environmental cracking.

Many of the lesser working cracks haven't reflected through yet.

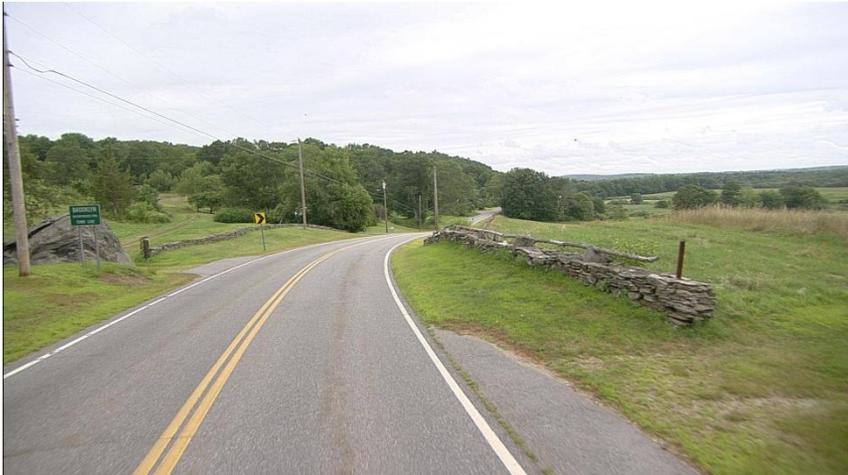
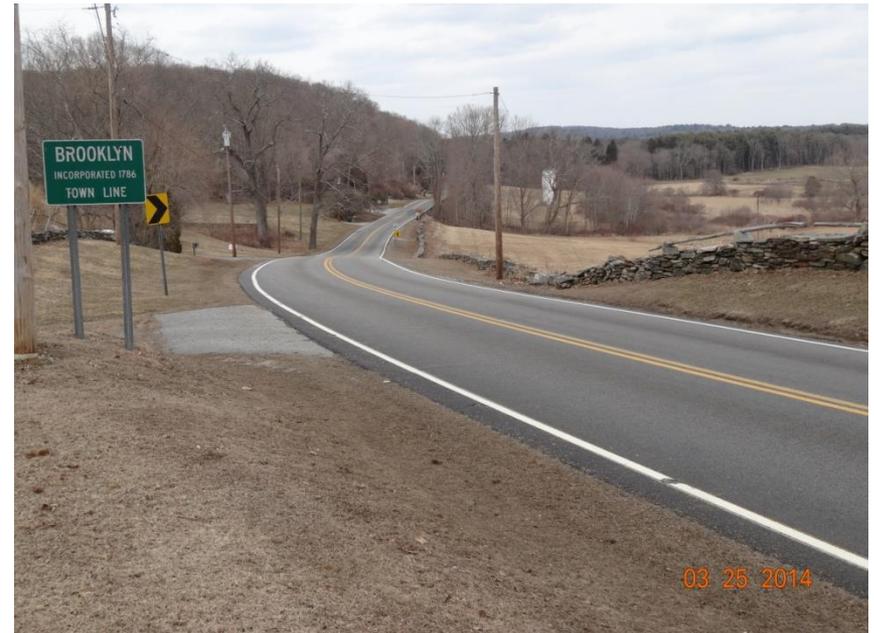
Route 169 Canterbury/Brooklyn, SAMI topped with an Ultra-Thin Bonded HMA Overlay

Same section as previous slide looking in the opposite direction. A lot of thermal cracking...

Notice the large number of cracks that haven't reflected through yet.

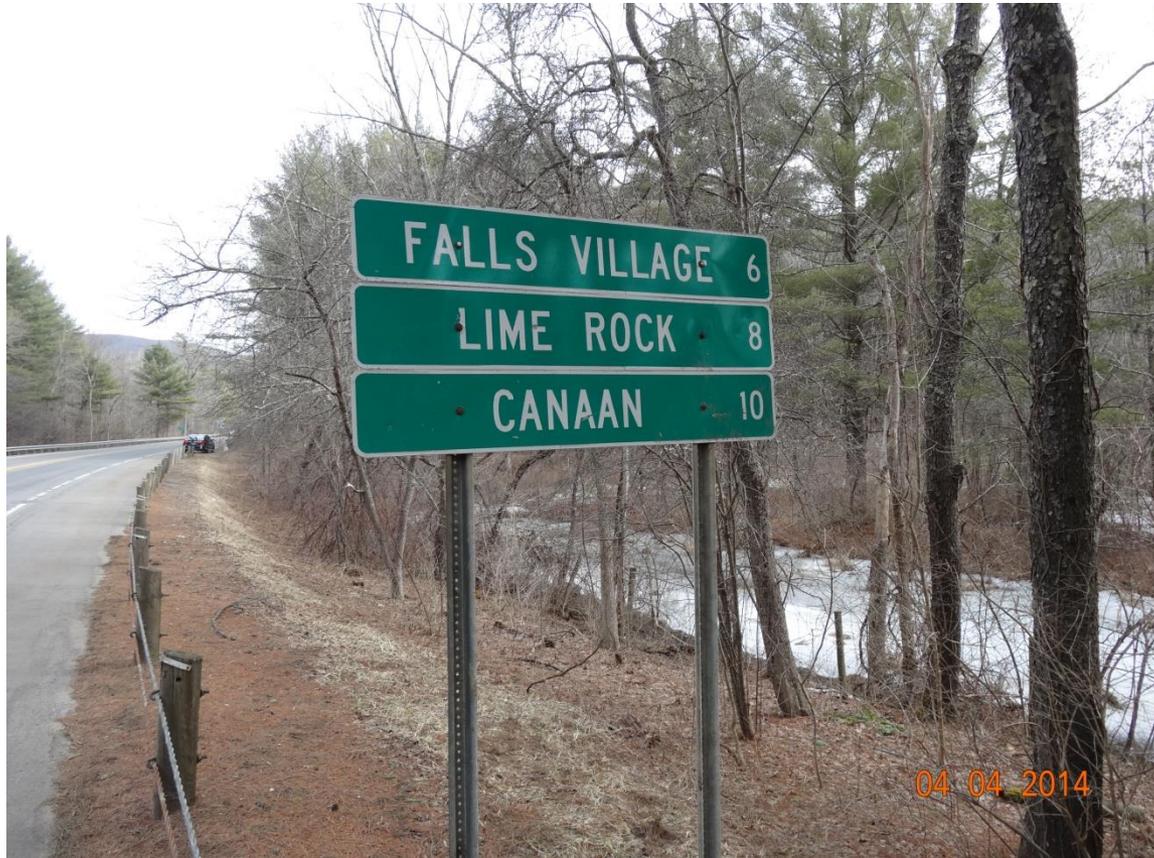
Route 63, Rural Major Collector, 2600 ADT, Microsurfaced in 2011. It was surface patched, crack sealed, and tack coated. It then received a leveling scratch coat followed by a final surface application.

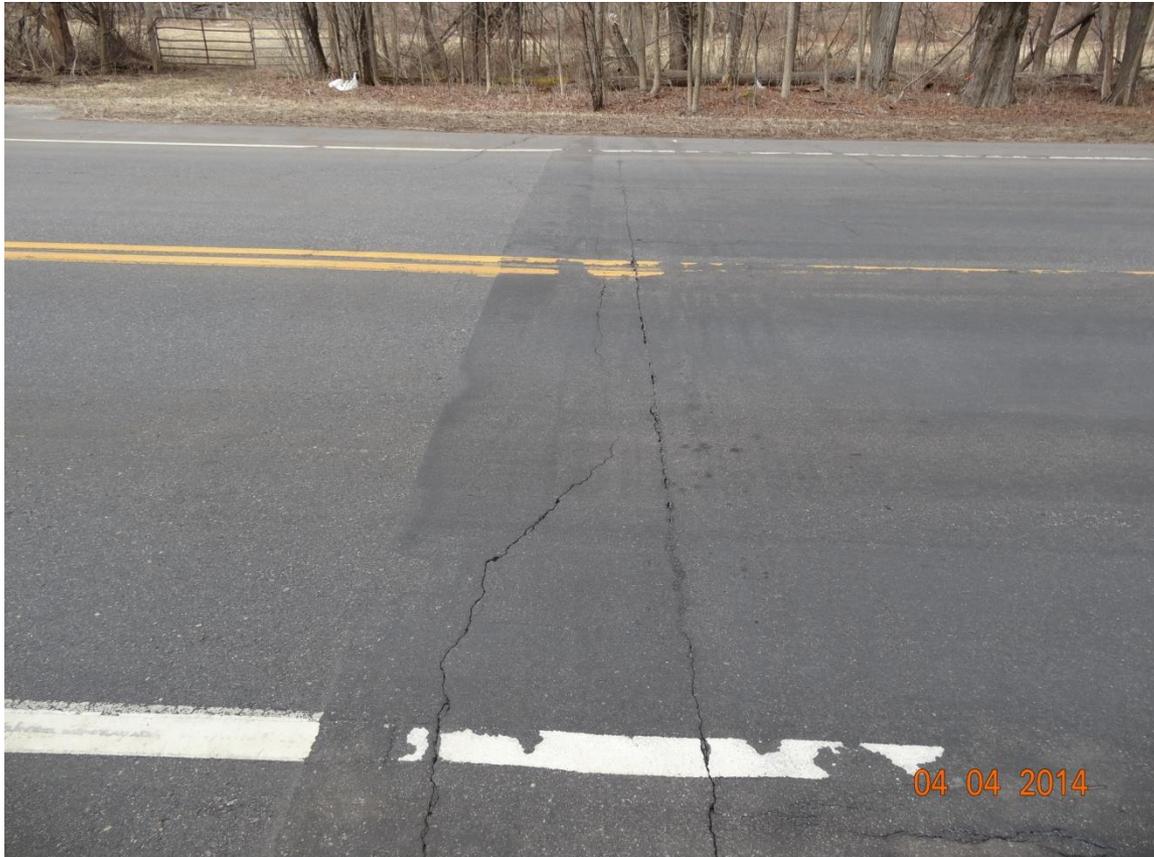
Route 63 Cornwall/Cannan CT, Microsurfacing

Nearly all cracks come through, but usually significantly smaller than the underlying cracks.

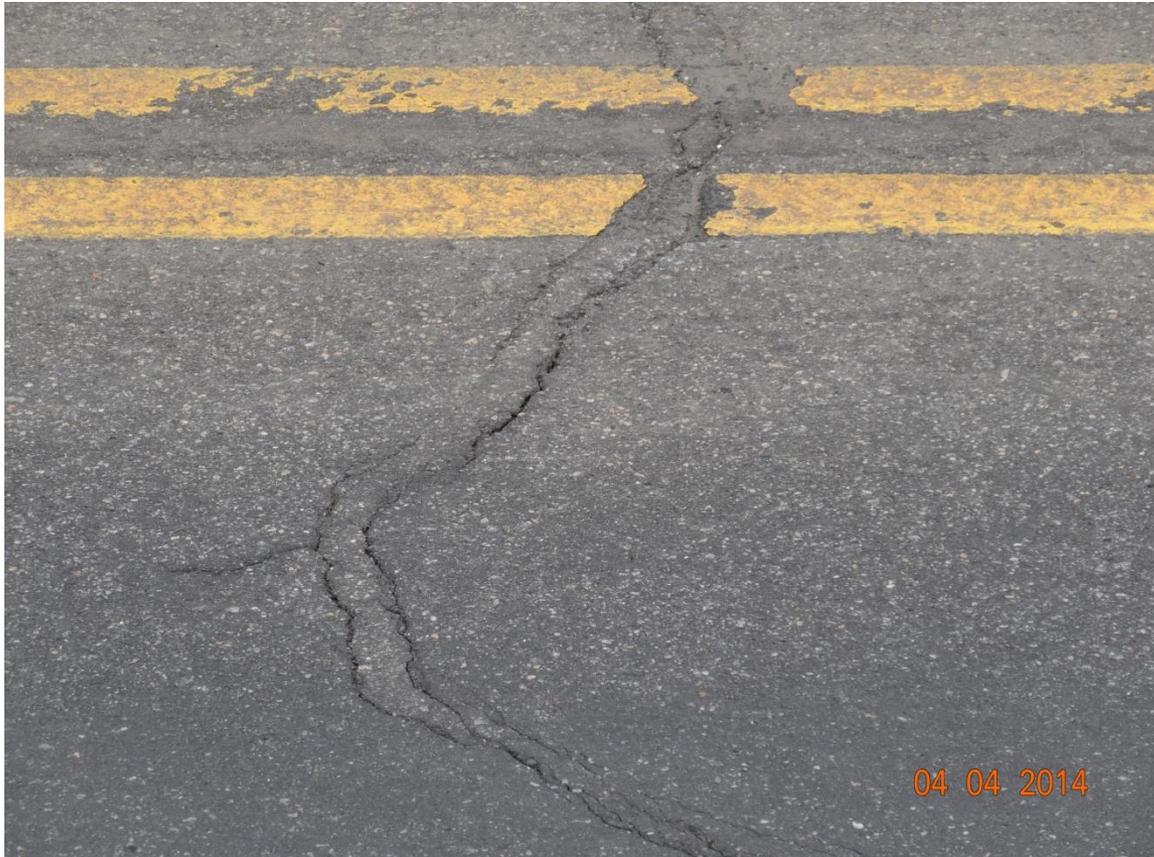
Route 63 Cornwall/Cannan CT, Microsurfacing

Even high severity cracks don't come through in their full width due to the aid of crack seal and the ability of the microsurfacing slurry to fill cracks and irregularities and bond well to the existing road surface.

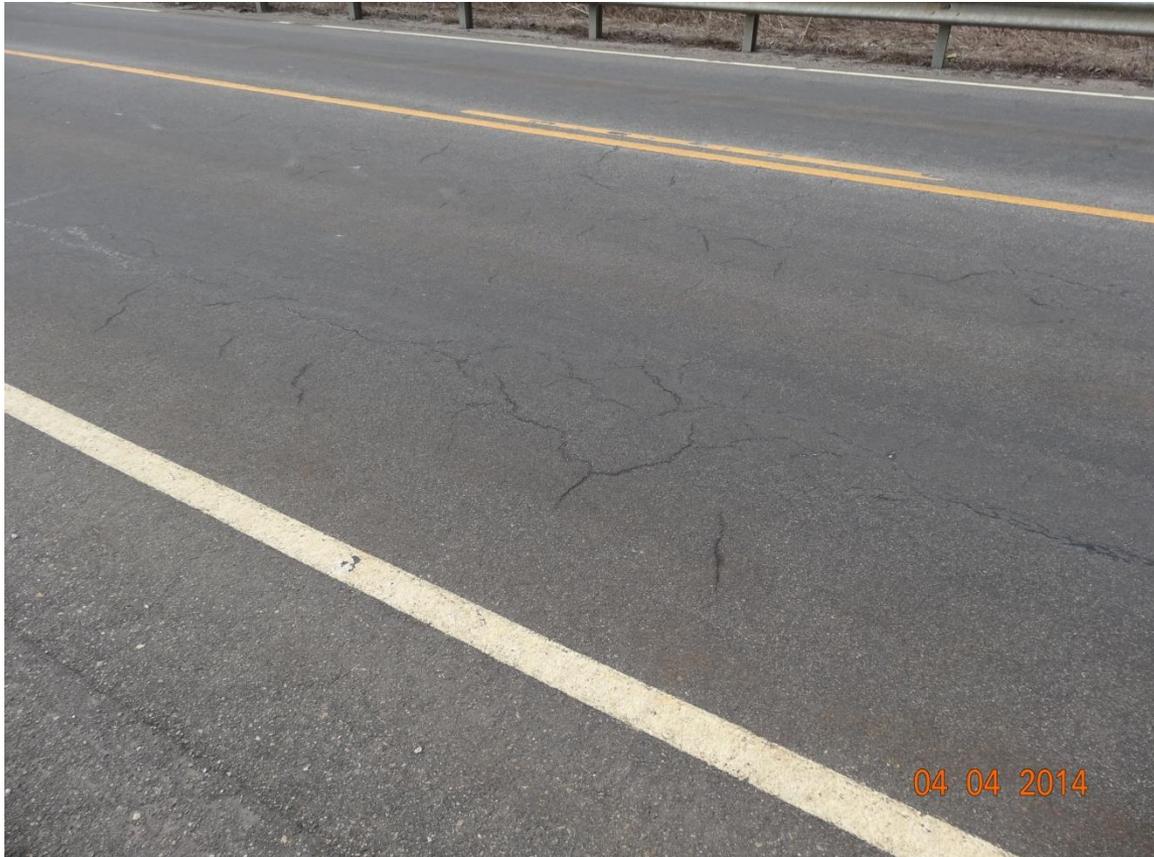
Route 63 Cornwall/Cannan CT, Microsurfacing

Most all the cracks will come through but typically much tighter and with good integrity – meaning they are bonded well to the pavement underneath and are resilient to spalling and delamination

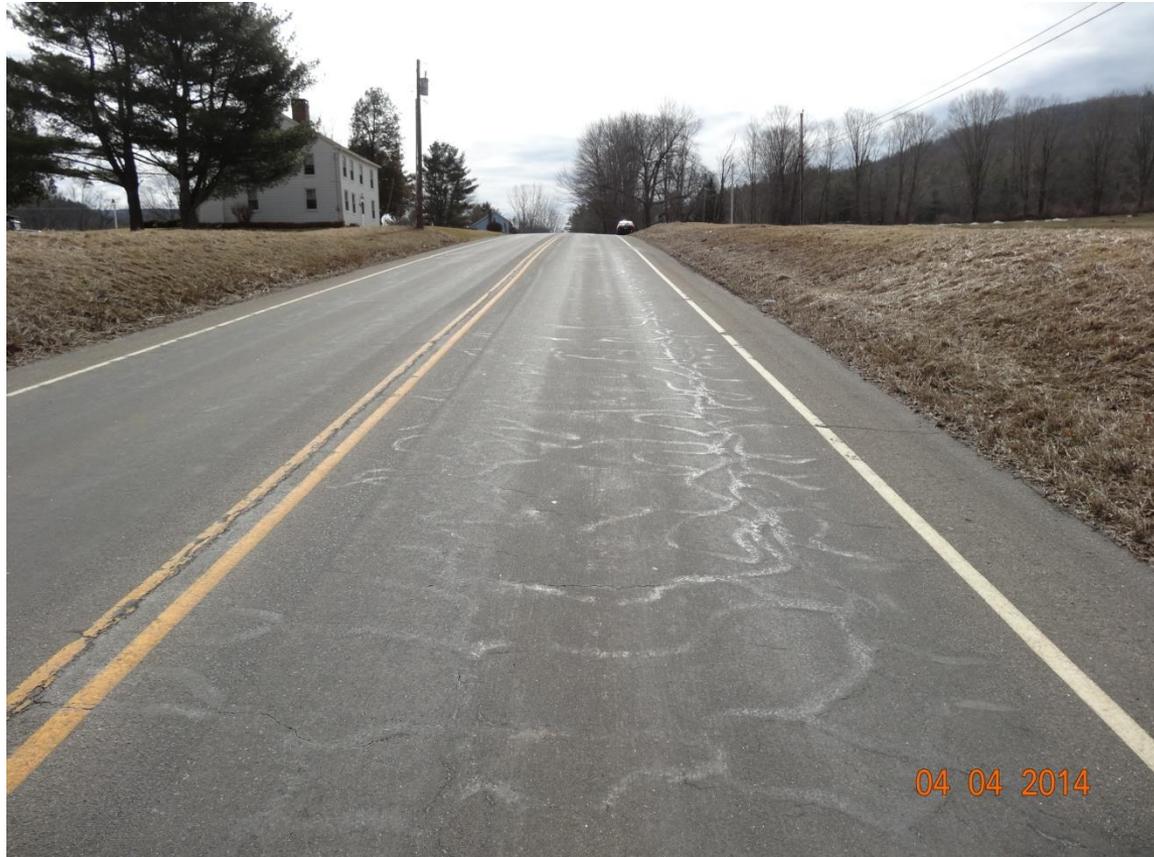
Route 63 Cornwall/Cannan CT, Microsurfacing

Just the right light angle and the underlying crack seal is apparent. Most of these cracks have reflected through but are so tight and full of crack seal that the surface is holding up very well and the cracks are showing no spalling or delamination.

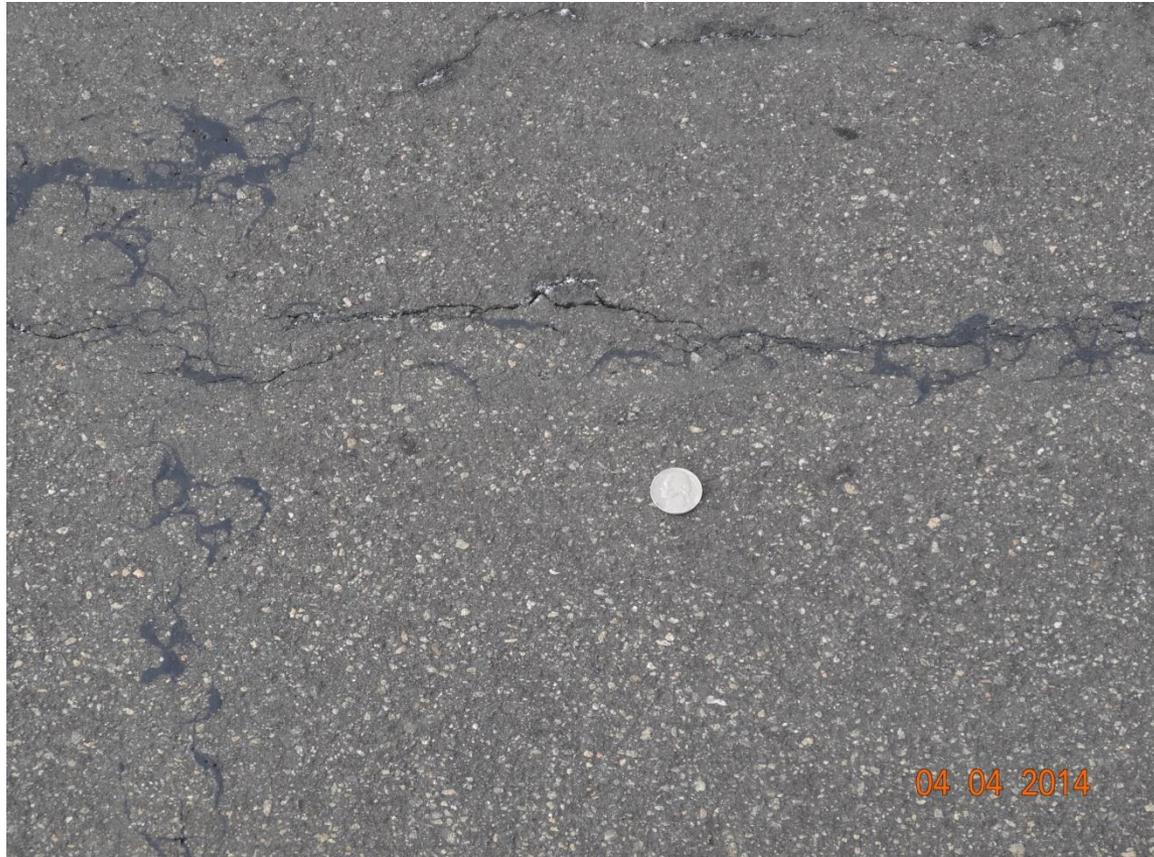
Route 63 Cornwall/Cannan CT, Microsurfacing

Close up of reflective cracking from previous slide. Notice fat spots of asphalt that have migrated up into the crack – likely during the hottest summer days..

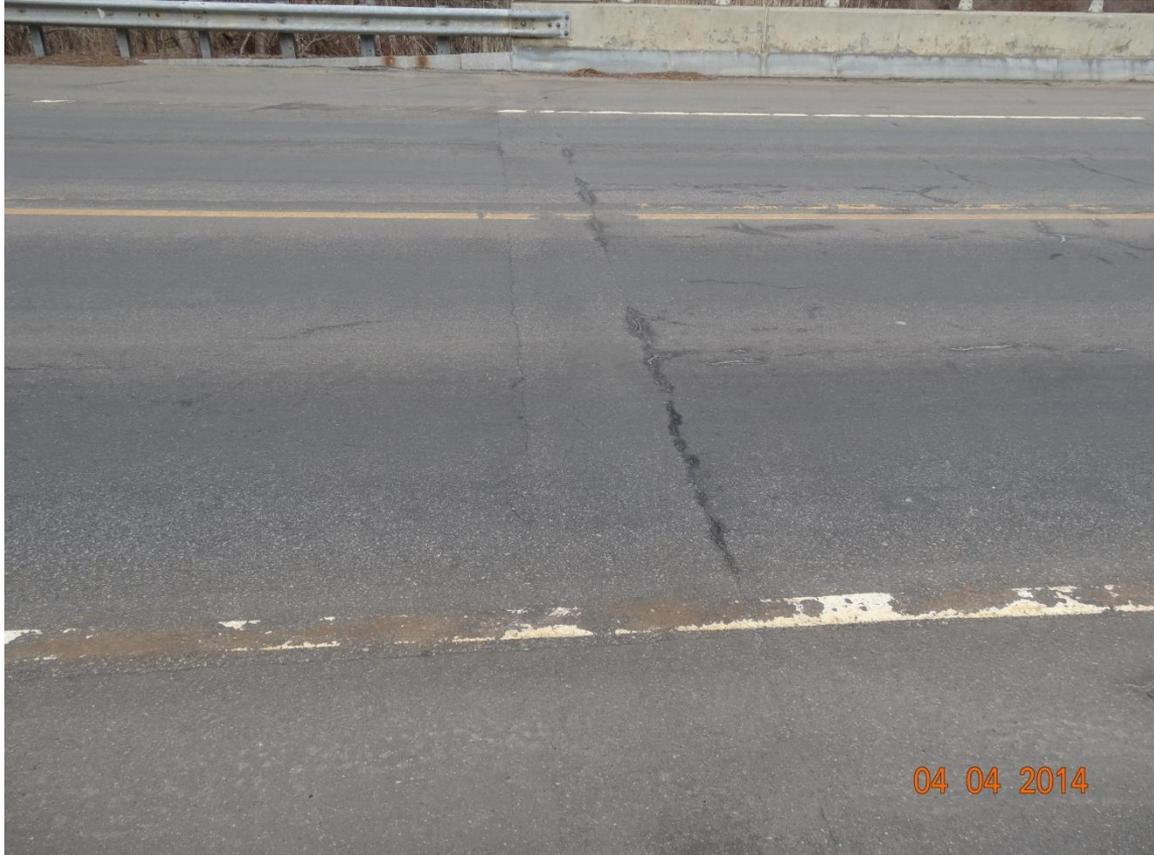
Route 63 Cornwall/Cannan CT, Microsurfacing

We took the opportunity to see if microsurfacing would stick well to existing asphaltic plug joints. This project had several small bridges (30-50 feet), all with asphaltic plug joints. The microsurfacing adhered and performed well when placed over existing asphaltic plug joints in that were in fair to good condition.
