# **Extending the Life and Performance of OGFC in North Carolina**

**SEPPP Annual Meeting**

**May 29, 2014**

Cecil Jones, PE

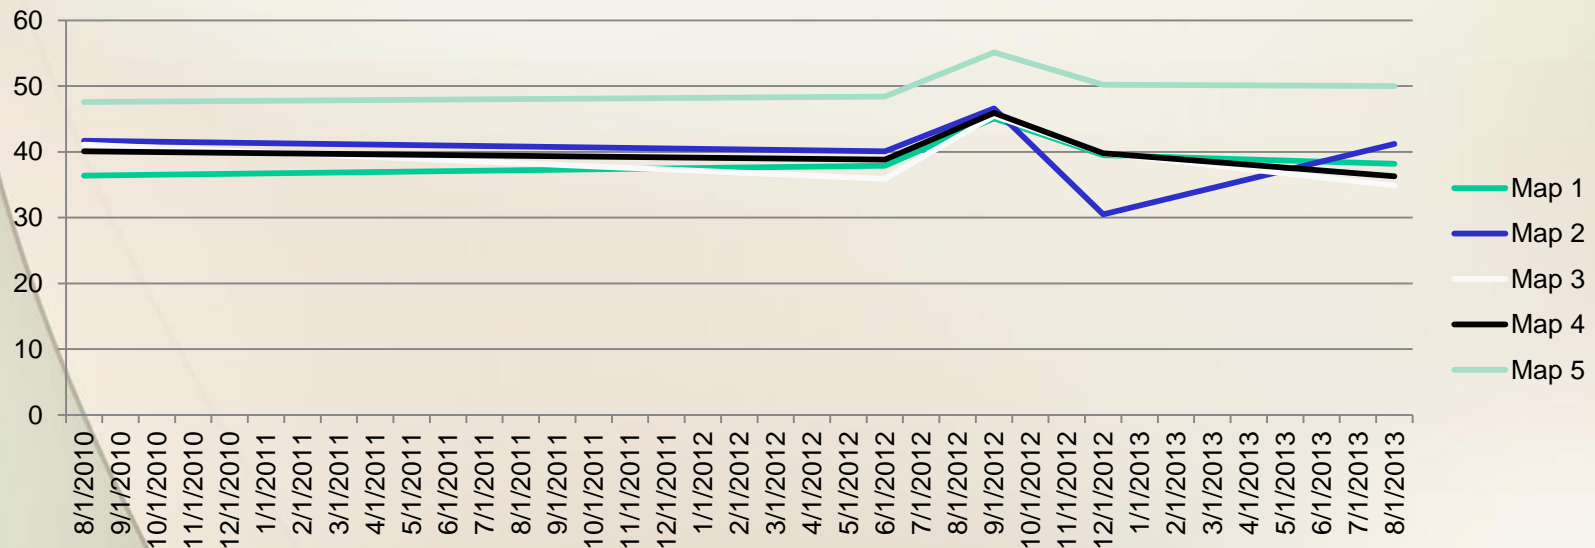
# Skid Results

8/12/10	6/21/12	9/11/12	12/10/12	8/20/13
Map 1	35.4	37.9	45.1	39.5	38.2
Map 2	41.7	40.1	46.6	39.5	41.2
Map 3	41.1	35.9	45.5	39.8	34.9
Map 4	40.1	38.8	45.9	39.8	36.3
Map 5	47.6	48.4	55.1	50.2	50.0
