# In Service Replacement of Box Girder Bottom Slab

WSDOT Bridge No. 5/537S - Span 11

Craig R. Boone, P.E., S.E.

2015 Western Bridge Preservation Partnership Meeting  
Portland, Oregon  
May 18-20, 2015

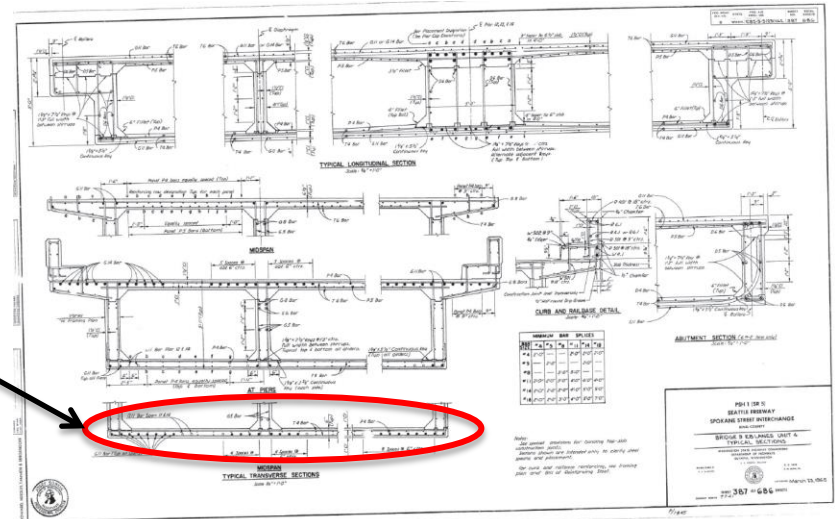
Positive reinforcement to be removed and replaced ((8) #11 bars at each web)

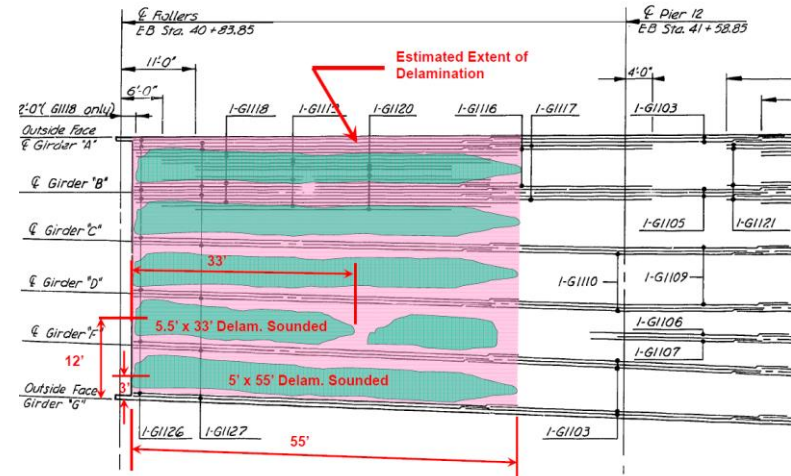
- Sounding of the soffit with a rock hammer found that approximately 70% of the Span 11 bottom surface was delaminated

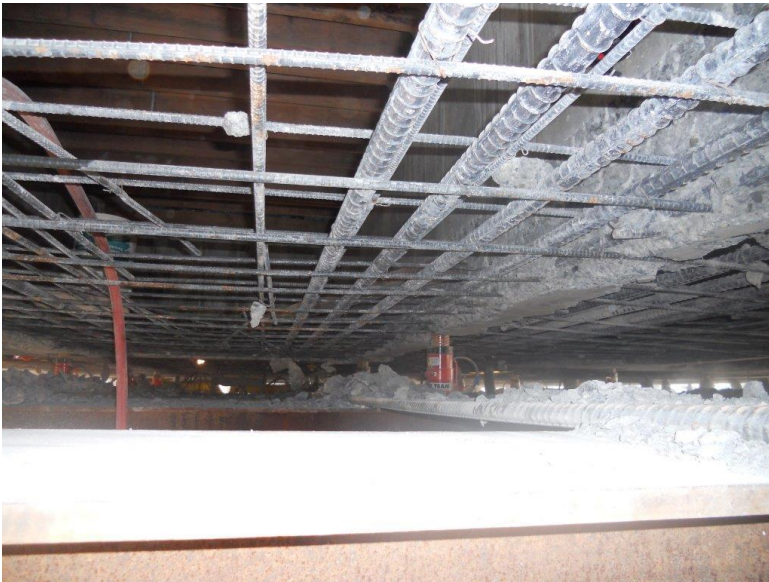
Original reinforcing steel exposed.

- Contractor chose to remove all concrete with small pneumatic tools

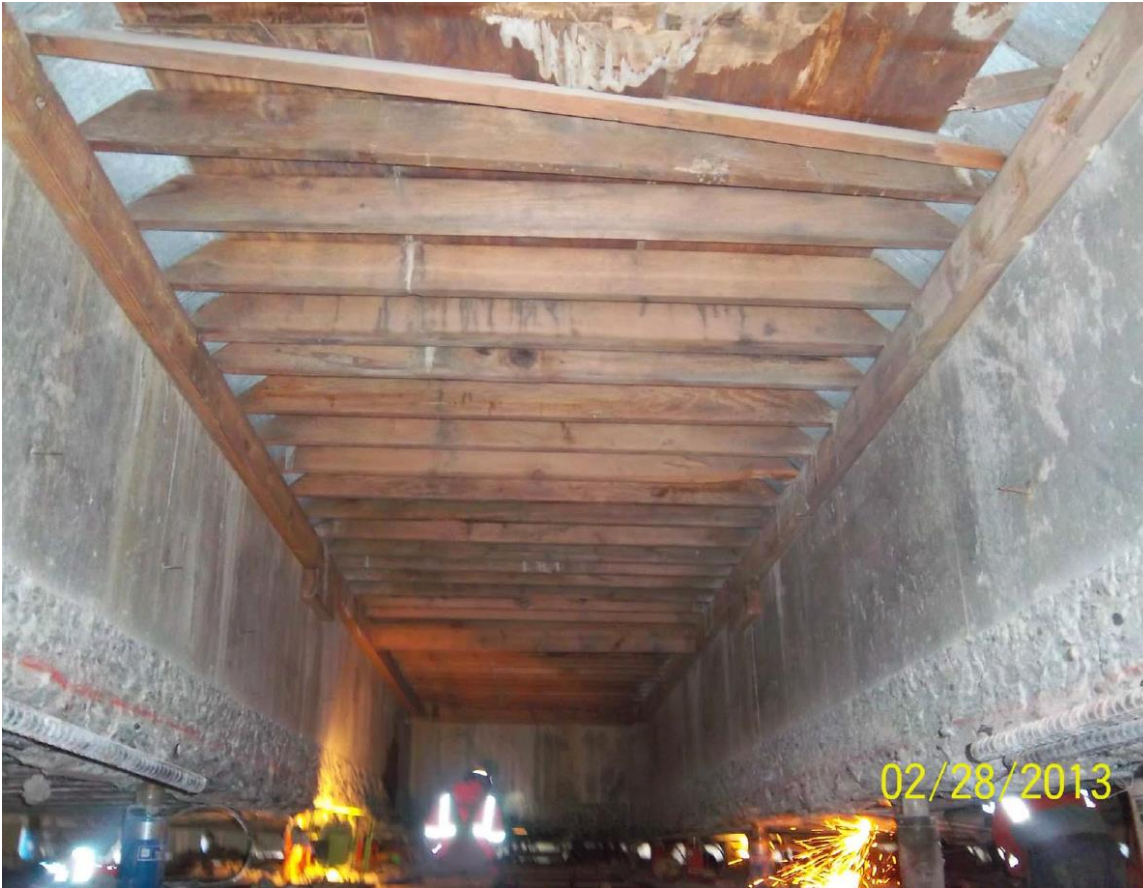
Existing top slab  
formwork was  
removed

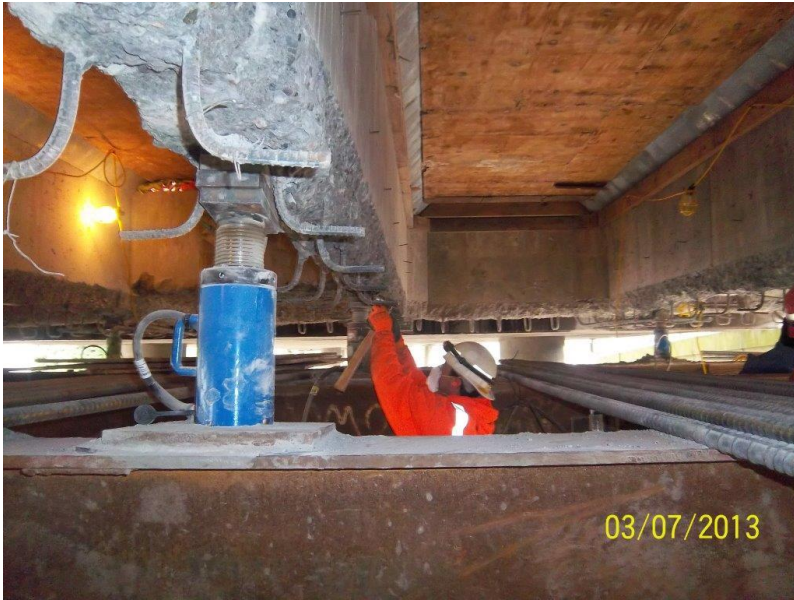
Bottom slab and reinforcing steel completely removed

Placing new reinforcing steel
