BRIDGE JOINT PERFORMANCE IN CALIFORNIA

TONY BRAKE, M.S, P.E.
Tony_Brake@dot.ca.gov
Senior Bridge Engineer
CA State Dept. of Trans.

MAY 2016
Salt Lake City, UT

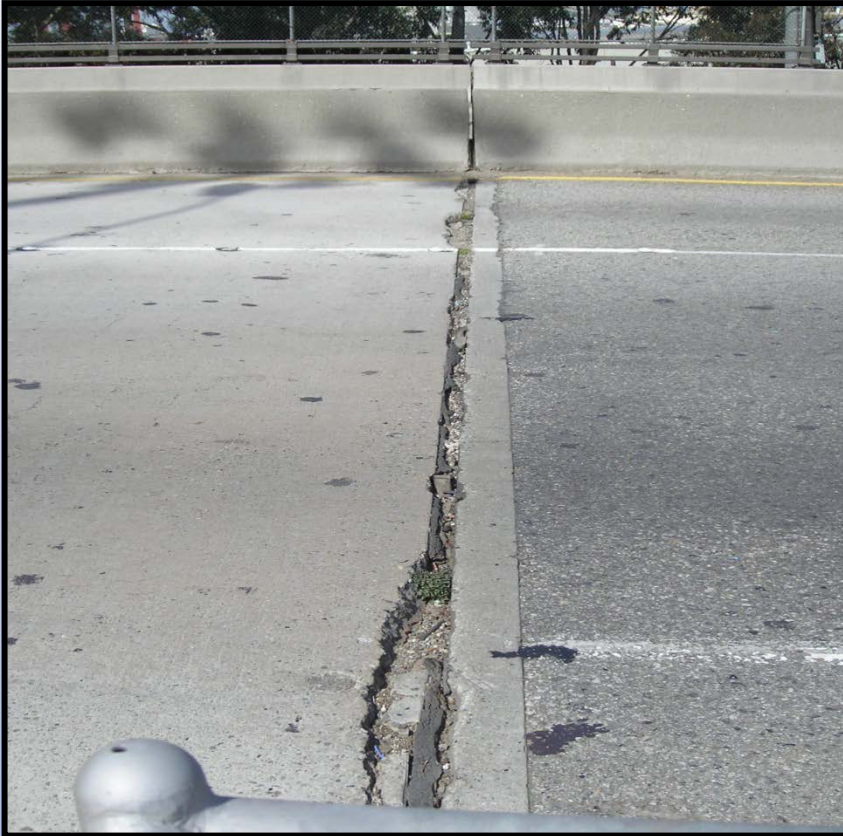
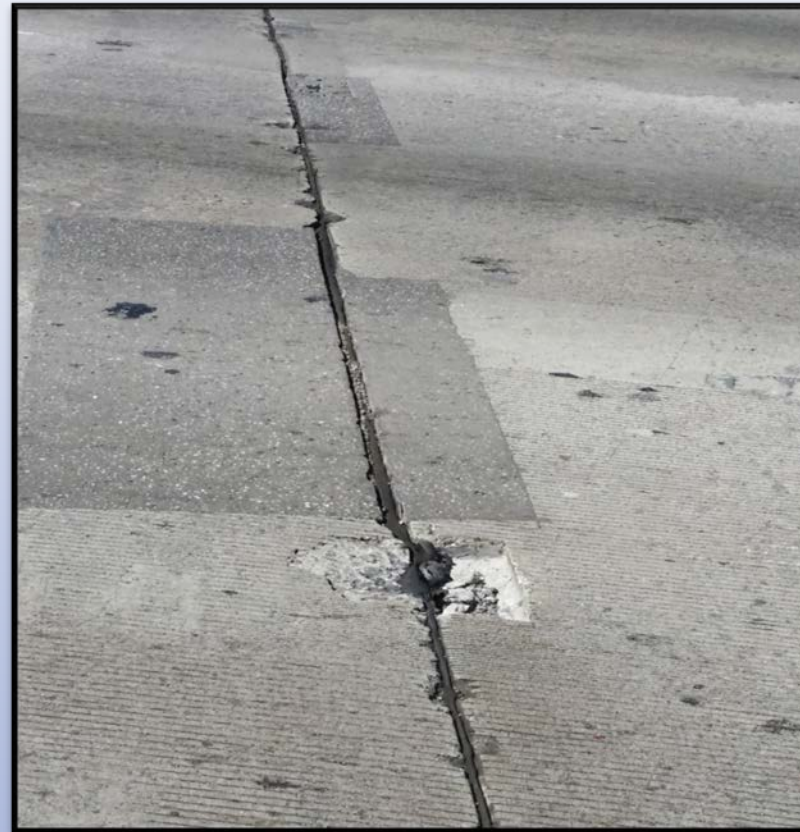
TYPE A & AL EXPANSION JOINT SEALS, Maintenance

Spall repairs: sometimes the repair has failed after in-place for a few months. This is common for Type A, Type B, and Bonded Joint Seals.

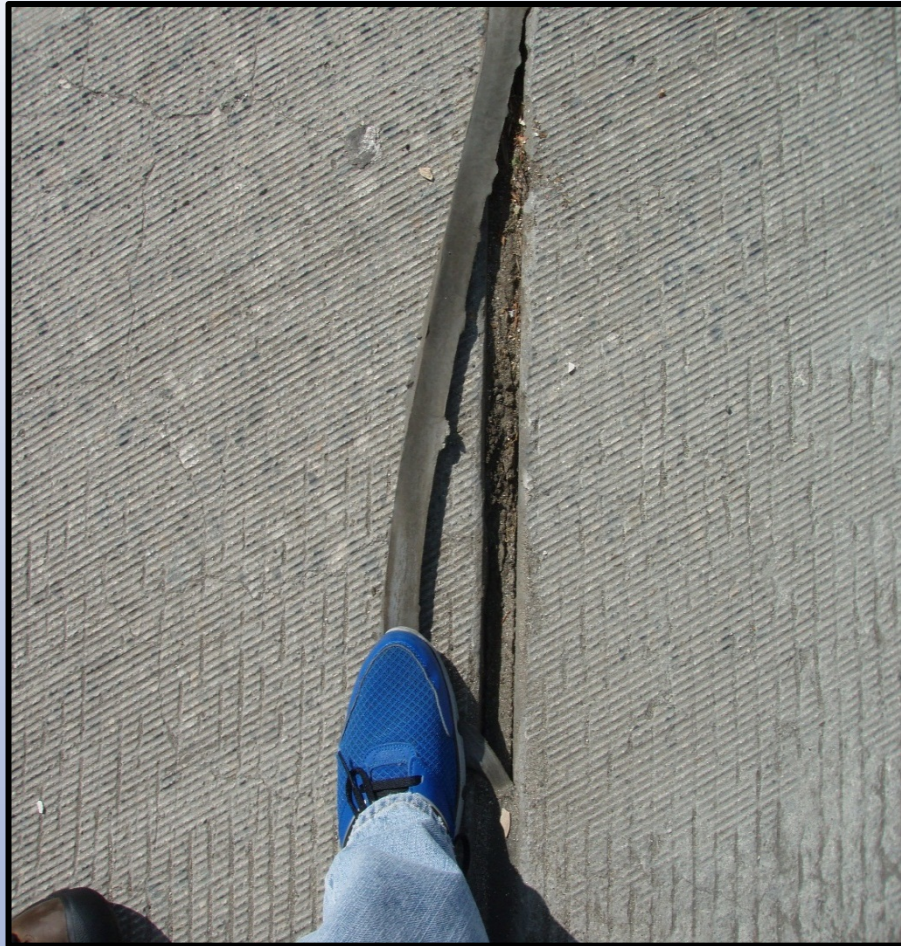
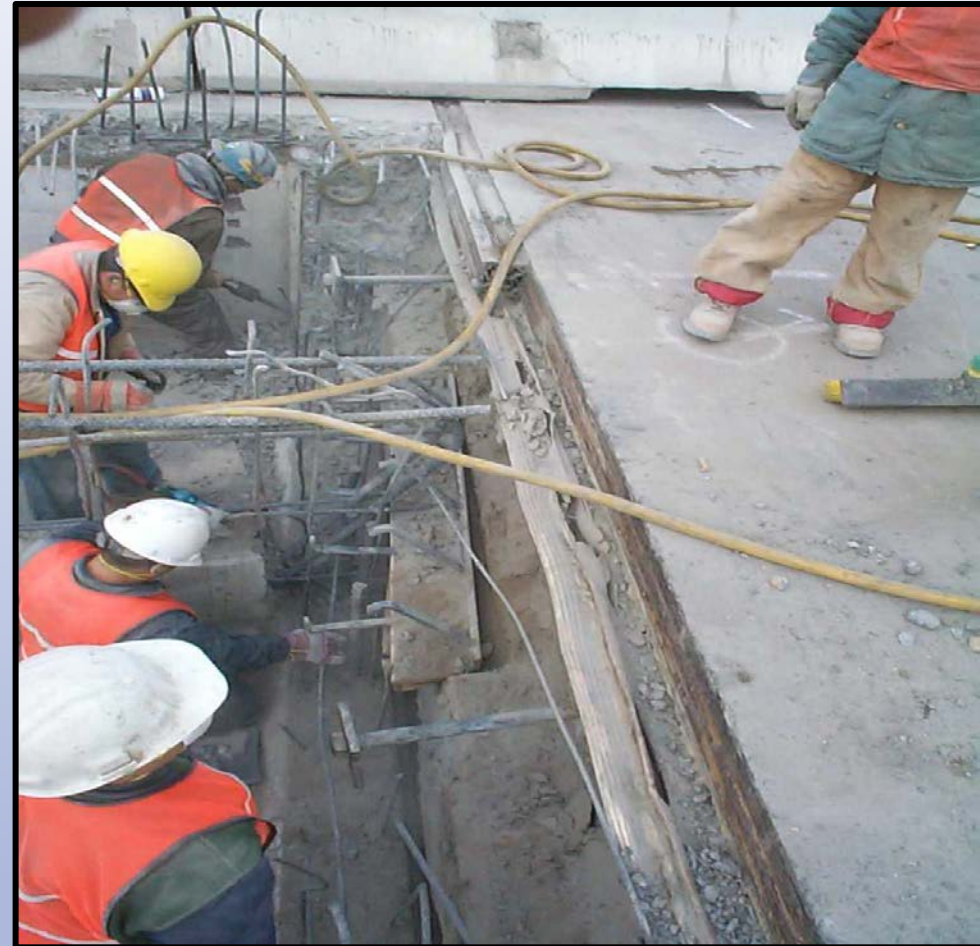
TYPE A & AL EXPANSION JOINT SEALS, Maintenance

New joint only 1 year old, failure due to lack of adhesion. Hinge reconstruction.

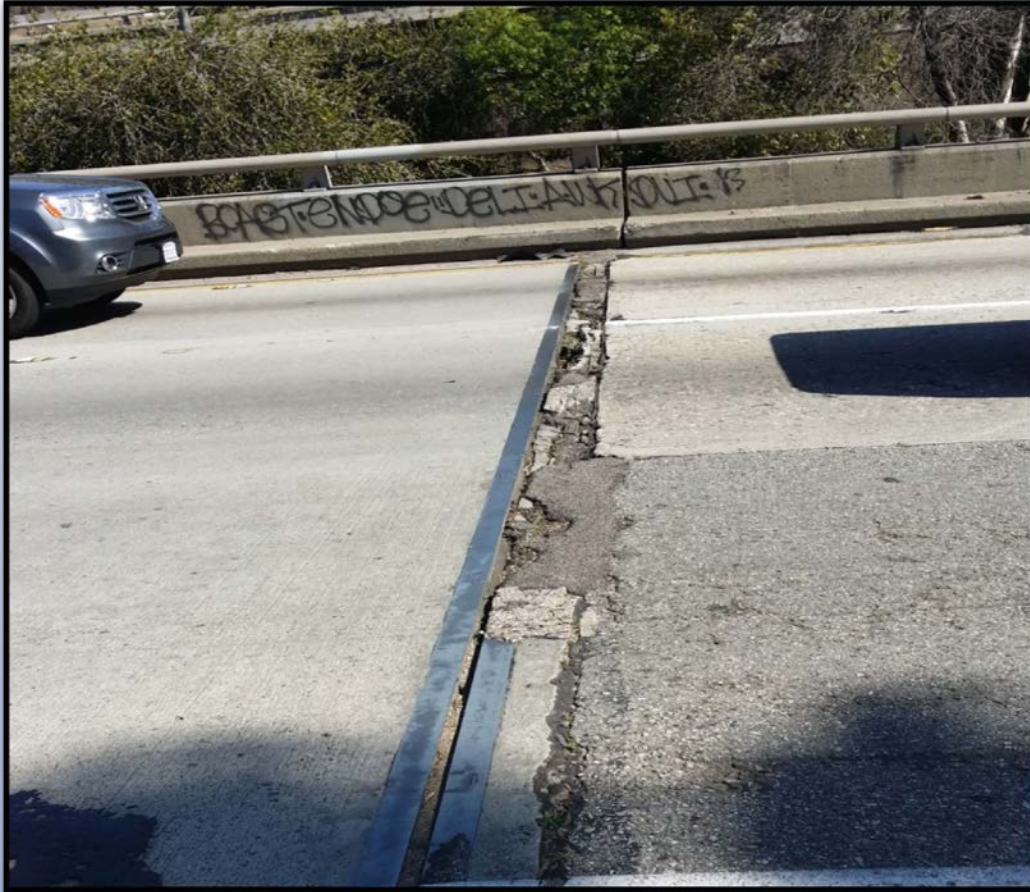
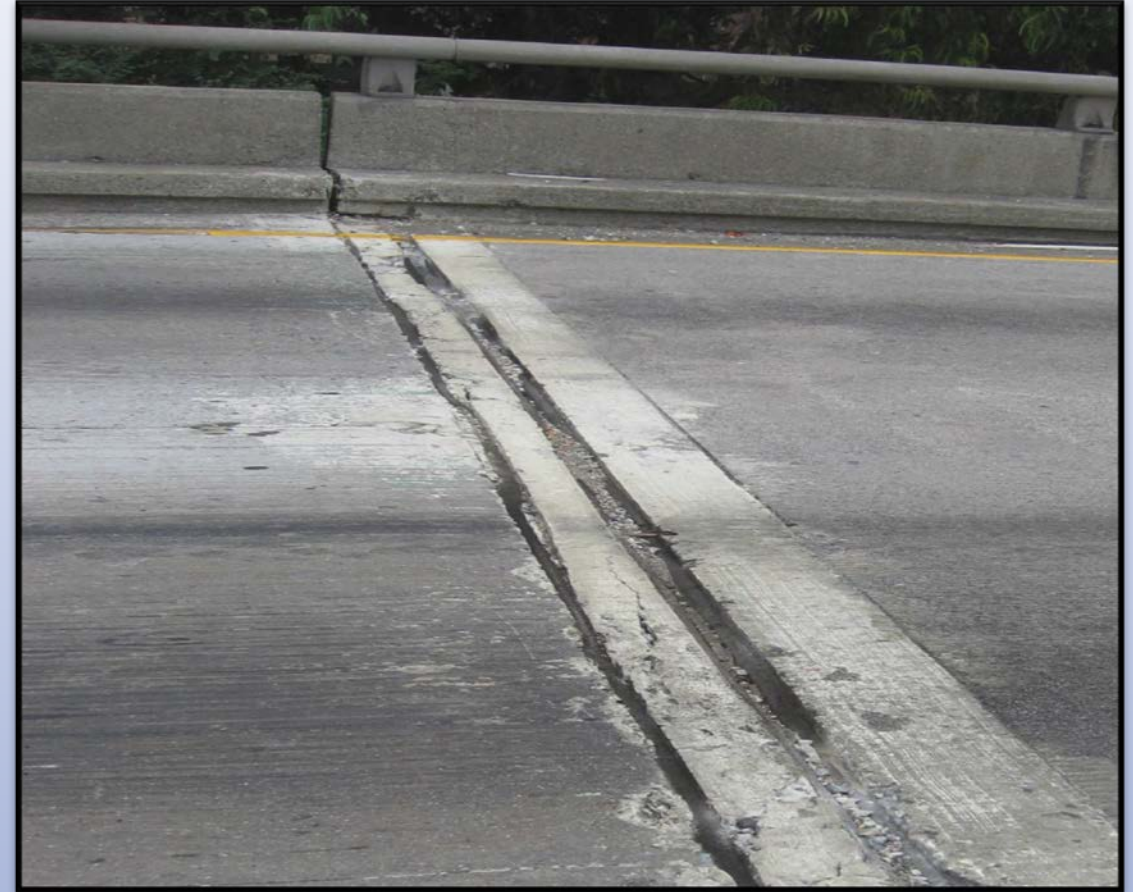
TYPE B EXPANSION JOINT SEAL, Maintenance

Backwall failure for seat abutments. Sometimes the new concrete fails after only a few months. Notice the armored angle failure due to breakage of anchors.

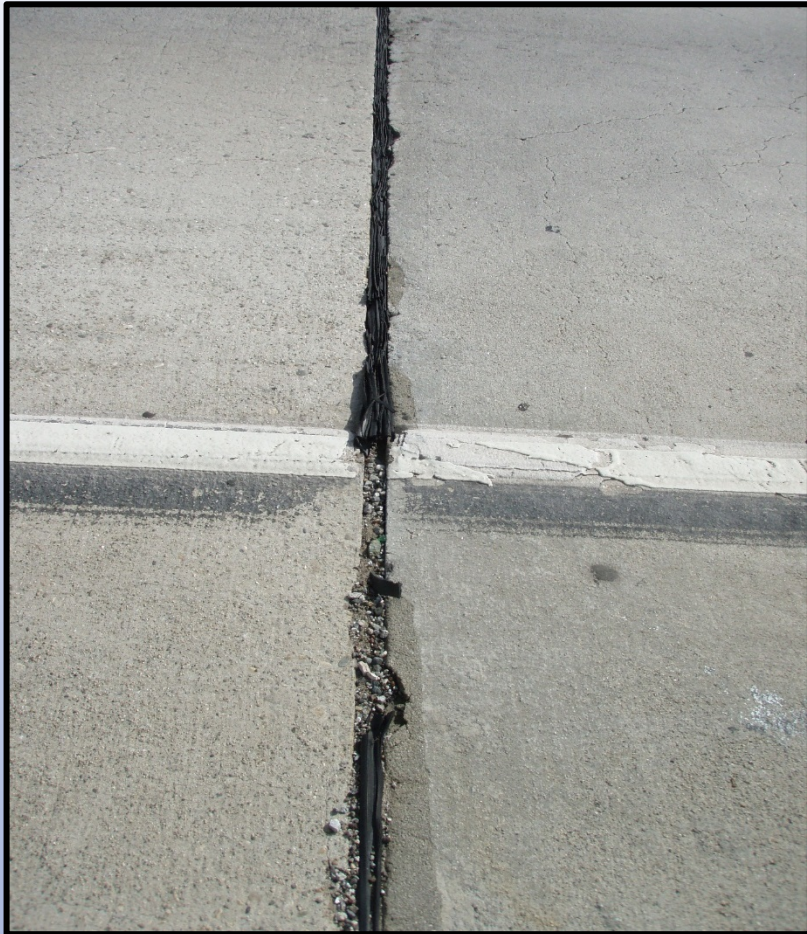
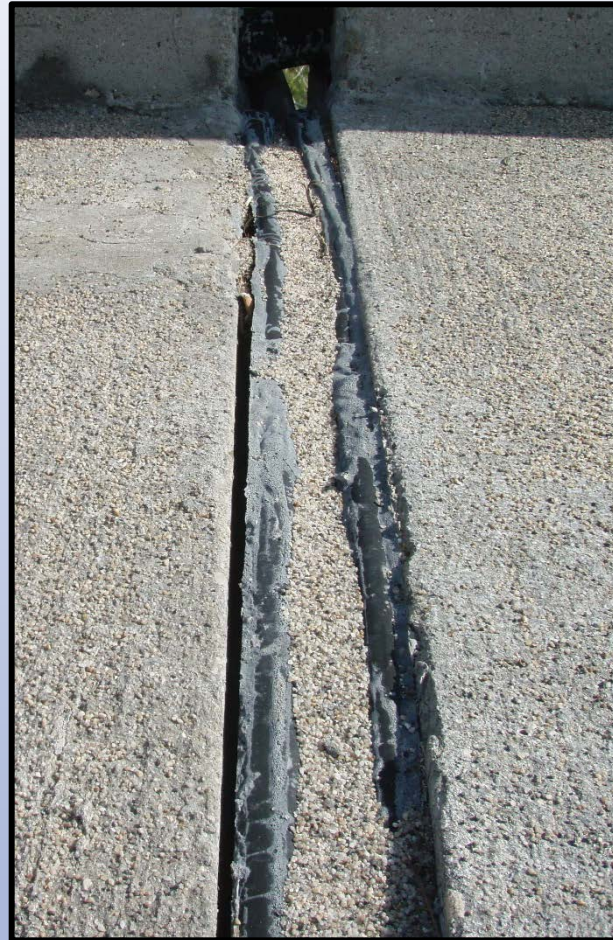
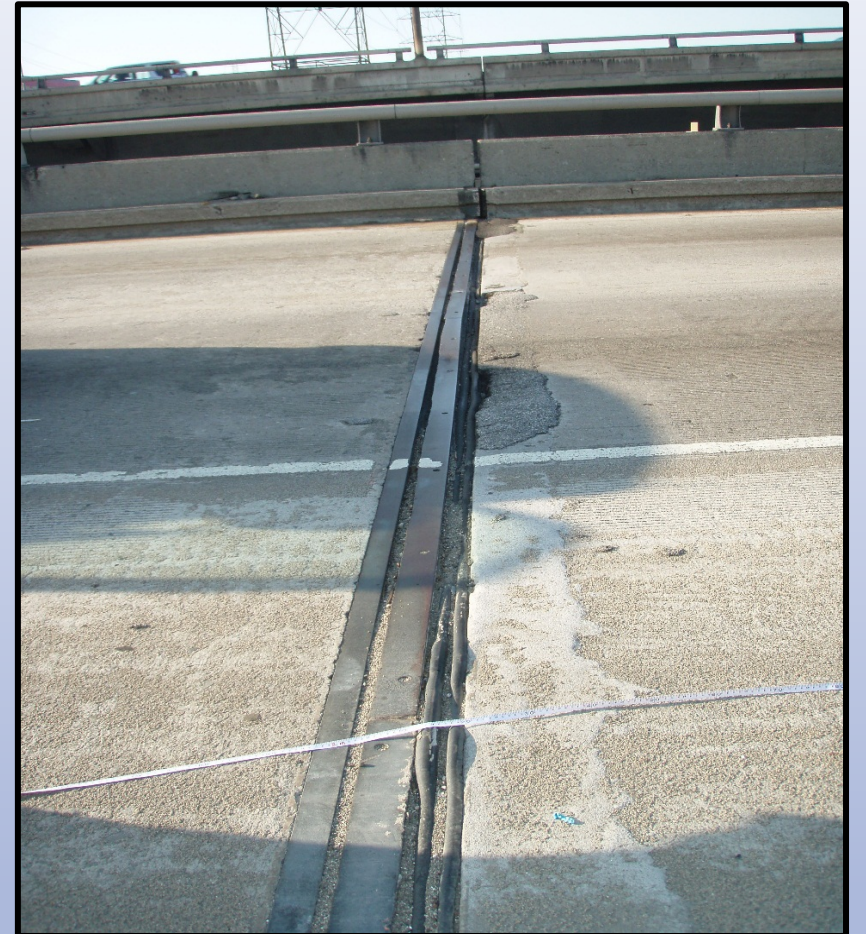
TYPE B EXPANSION JOINT SEAL, Maintenance

Age, crushing, bulging. Sometimes the joint gap is too large for the seal. Joint palls.

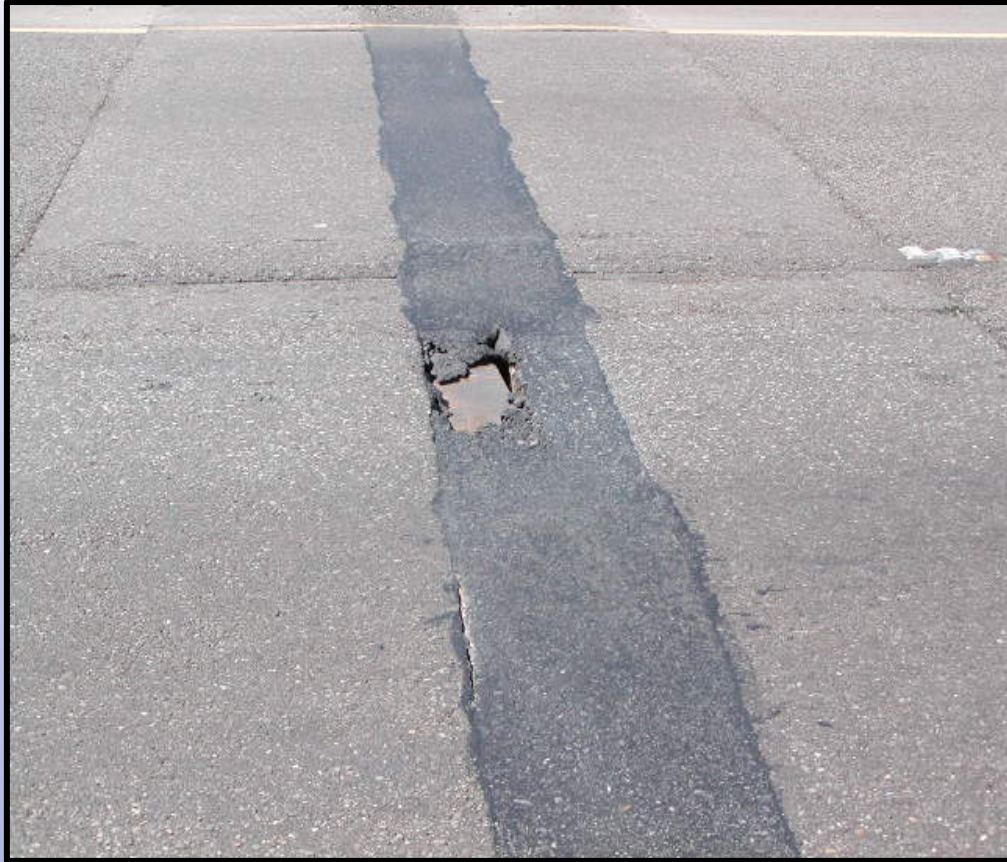
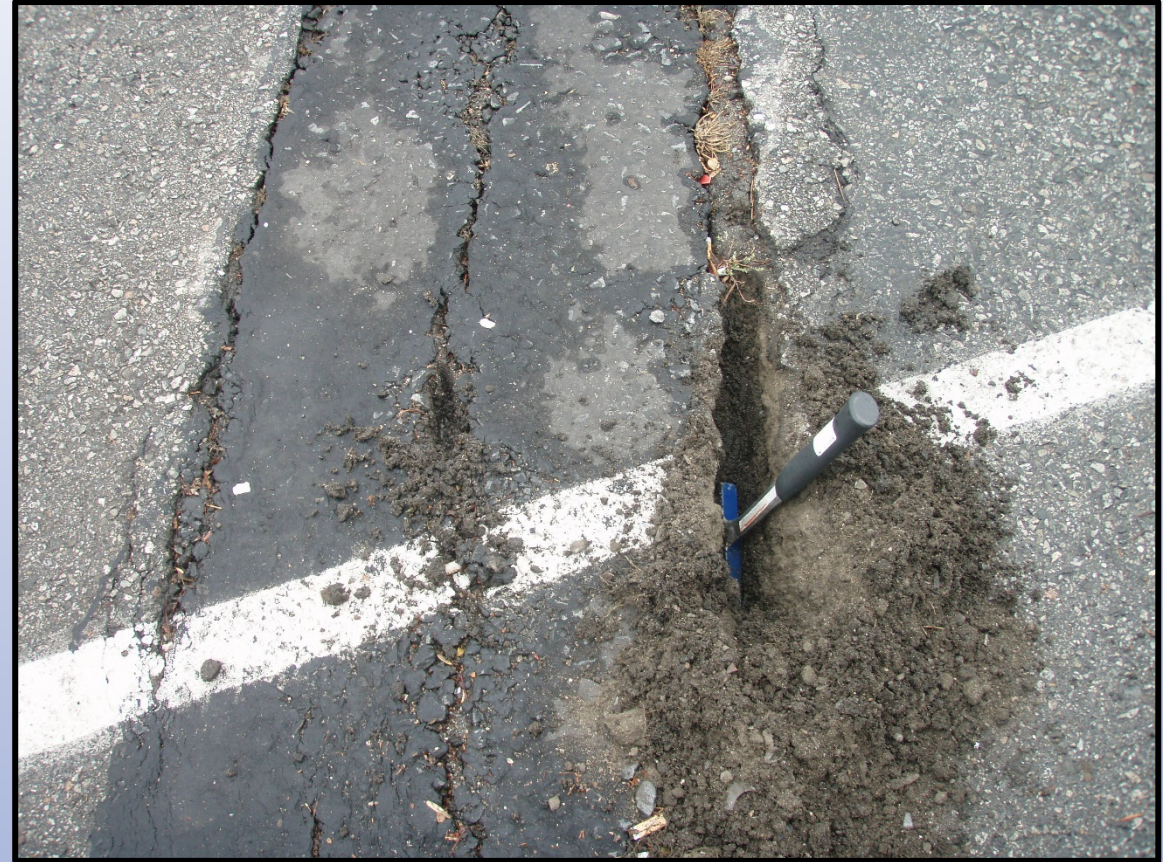
ASPHALTIC PLUG EXPANSION JOINT SEAL, Maintenance

Deterioration of elastic expansion material. Transverse failure at AC interface.

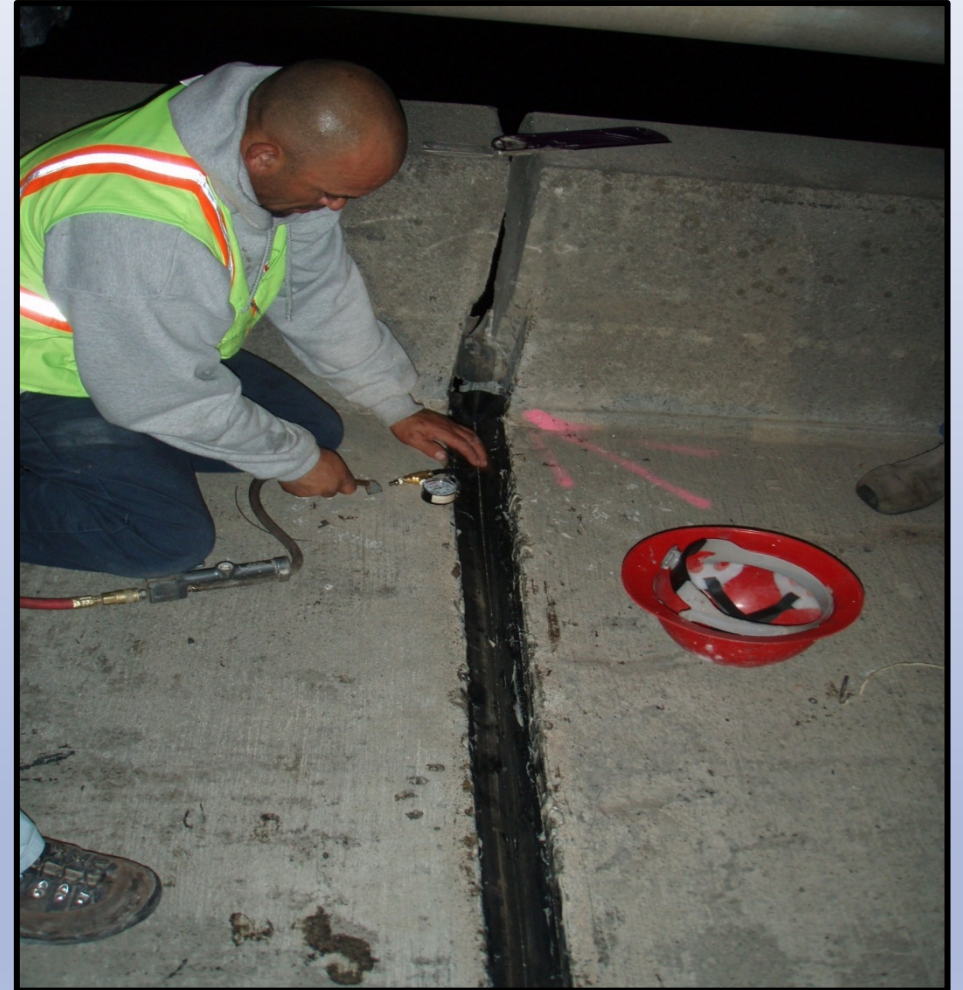
BONDED EXPANSION JOINT SEAL, Maintenance

- First use in Southern CA was 2006.
- For joints with skews ≥ 20 degrees.
- Adhesive bonded to the sides of the joint opening.
- Have identified 1 joint with a partial length that did not receive proper amount of adhesive bond thus resulting in a joint that was not fully sealed.

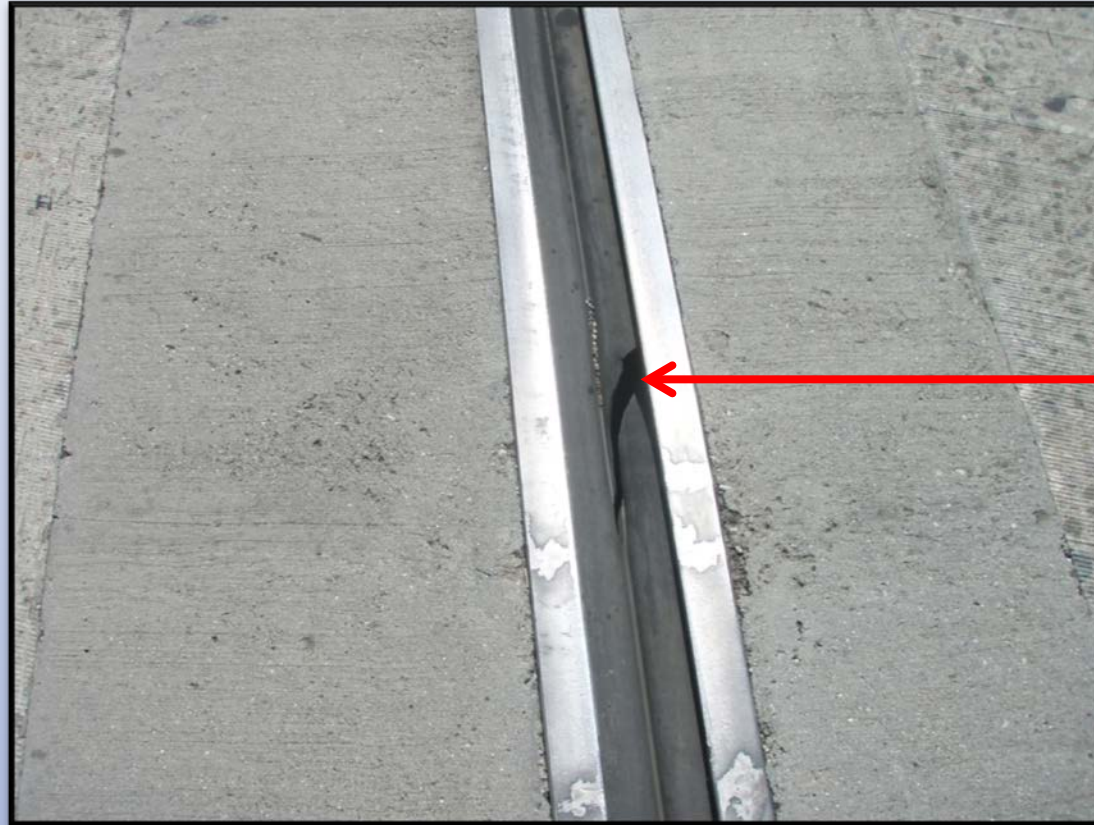
TEAR IN GLAND

Torn neoprene gland. Also applies for the Modular Joint Seal Assembly.
Neoprene glands are proprietary to the manufacturer of the joint.

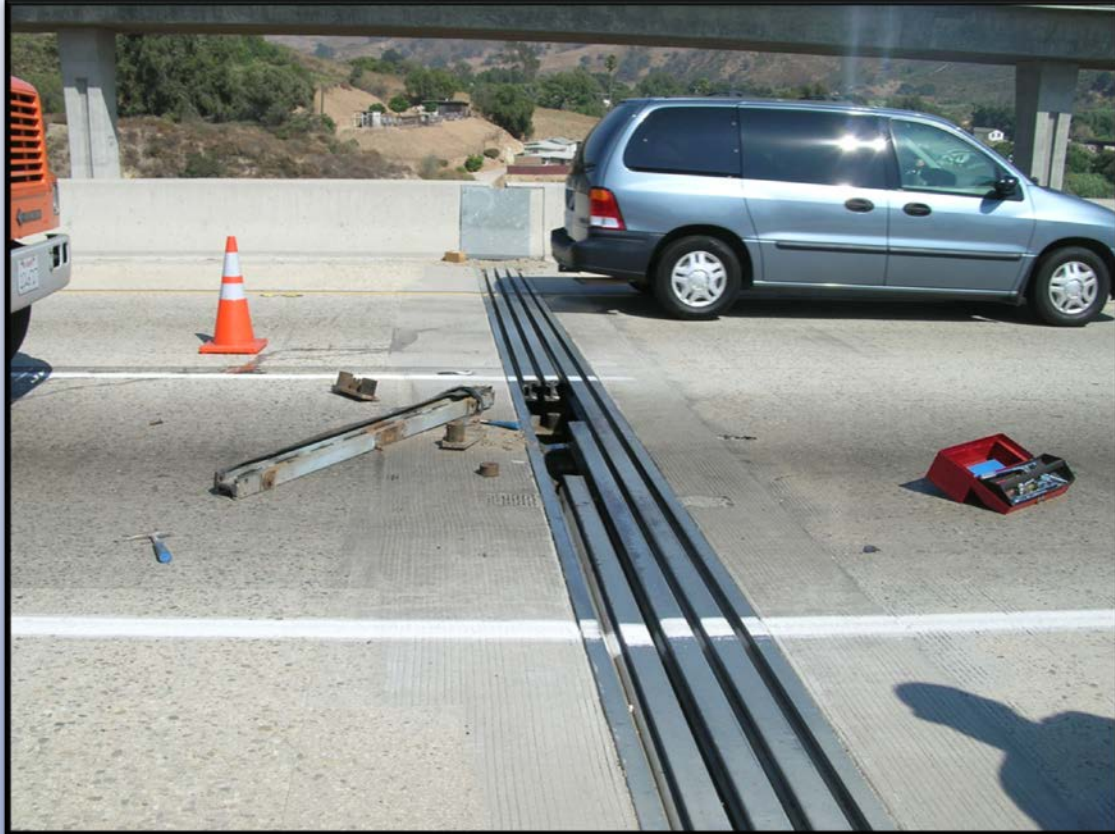
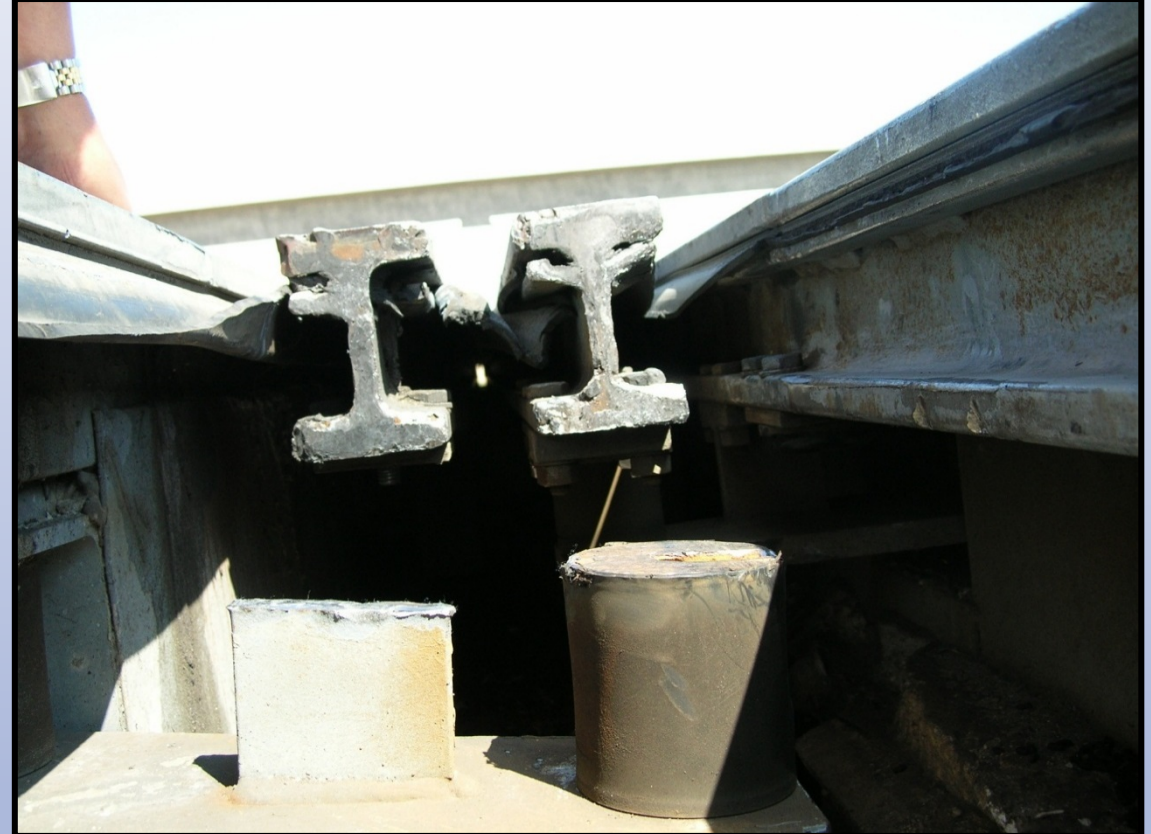
MODULAR EXPANSION JOINT SEAL, Maintenance

Broken center transverse beams.

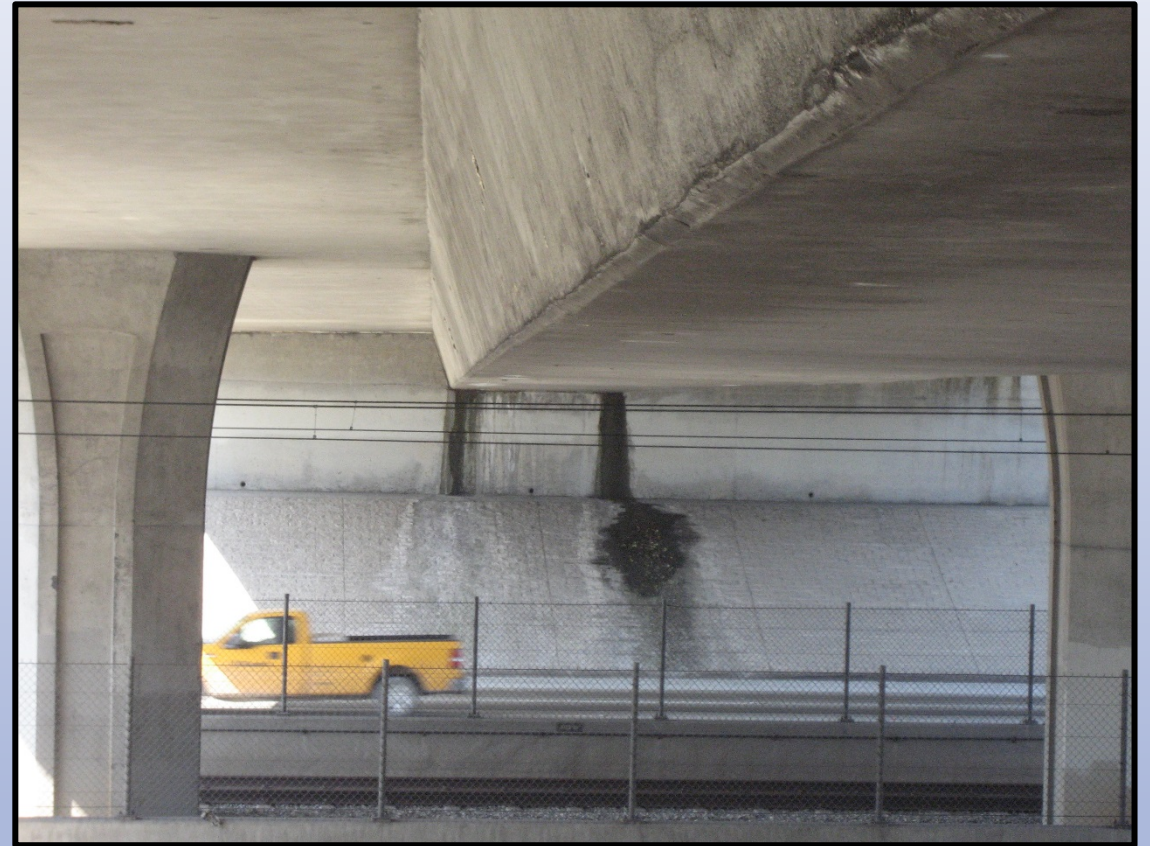
Failed and Leaking Joint Seal

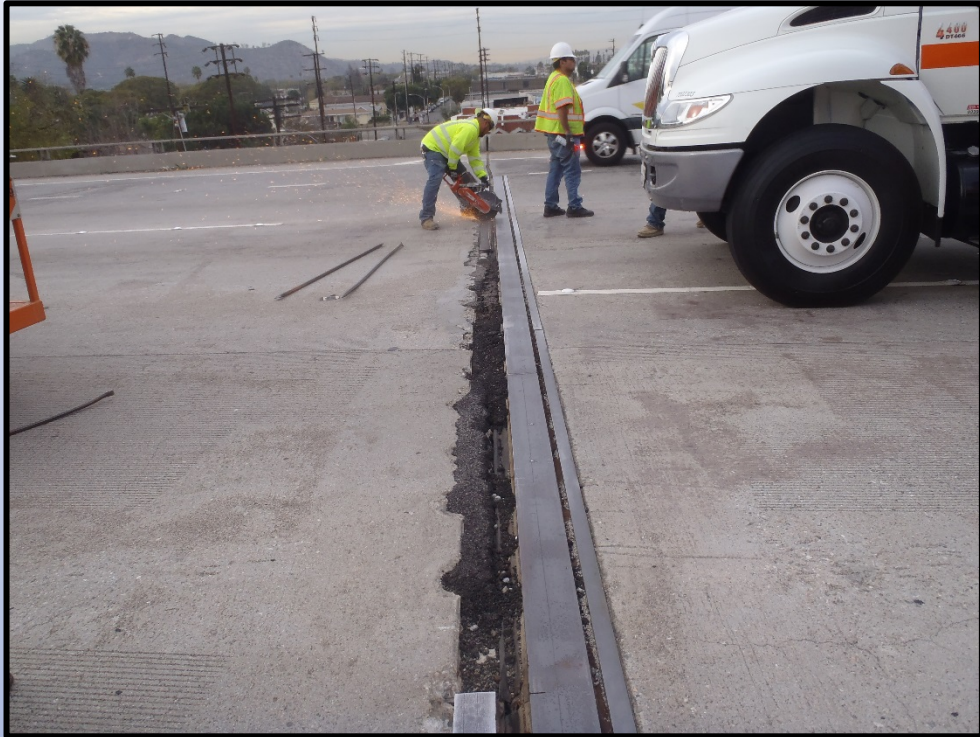
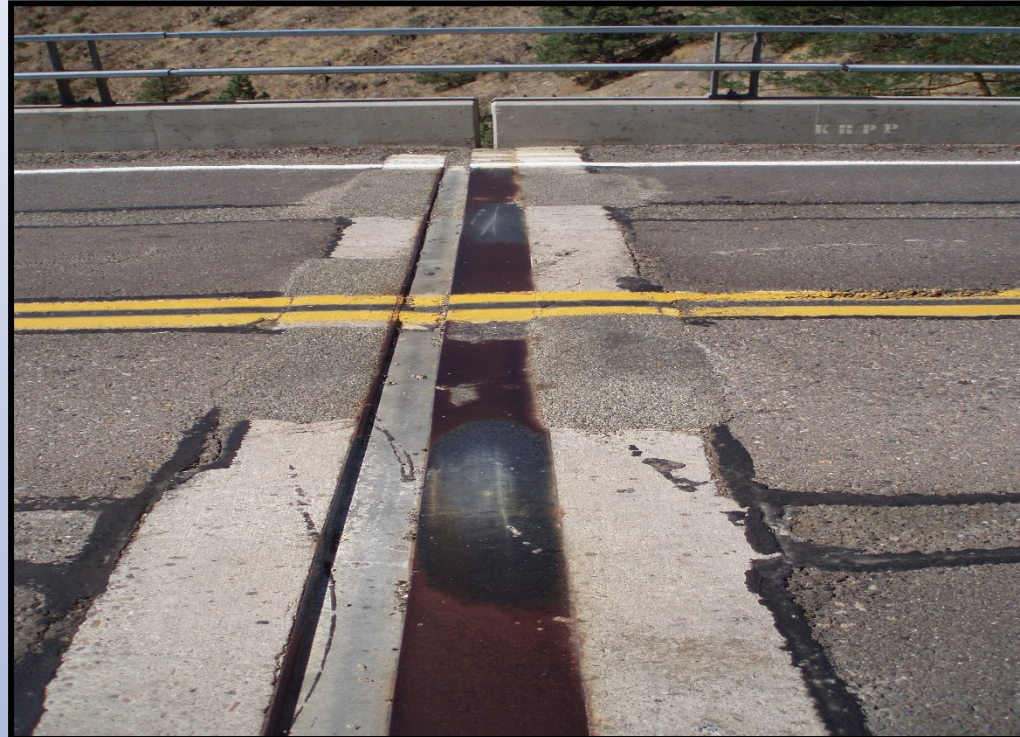
STEEL SLIDING PLATE, Maintenance

Anchorage Breakage on the Steel Elements. Joint Closes Permanently or gets Paved Over

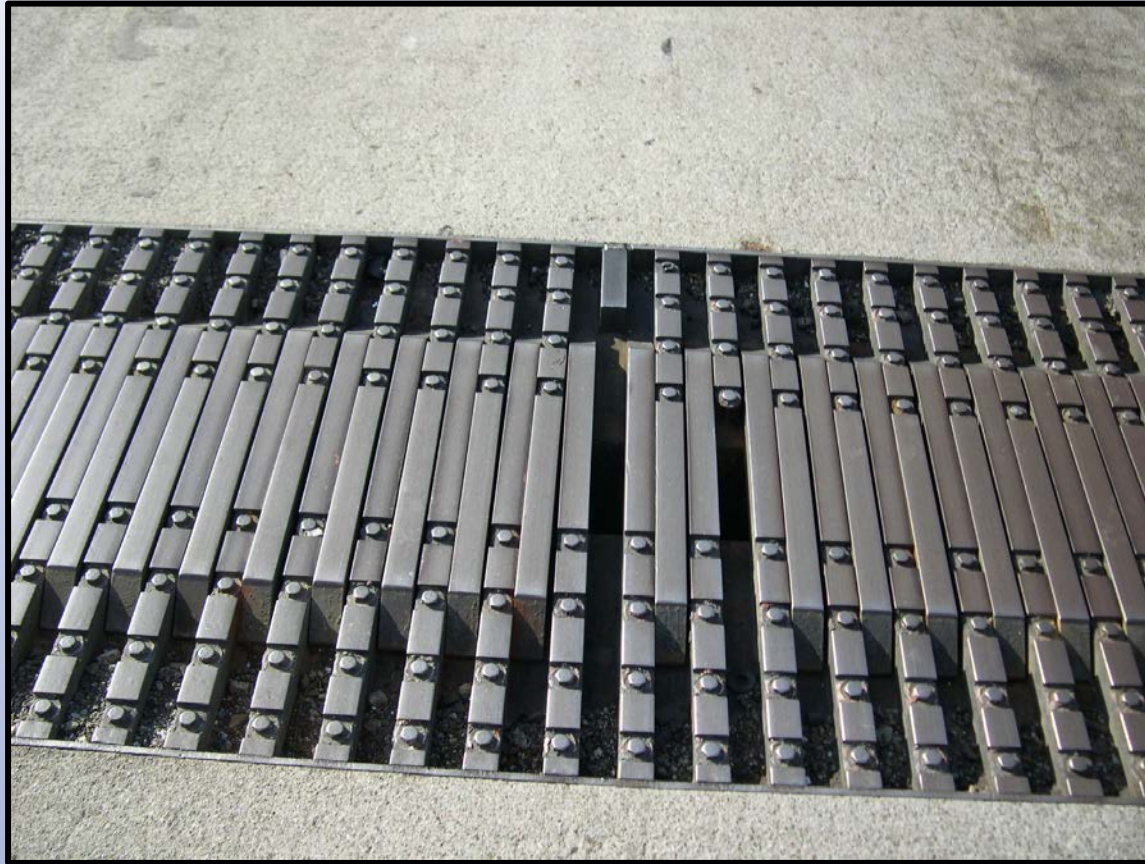
Breakage of the Steel Finger Elements.

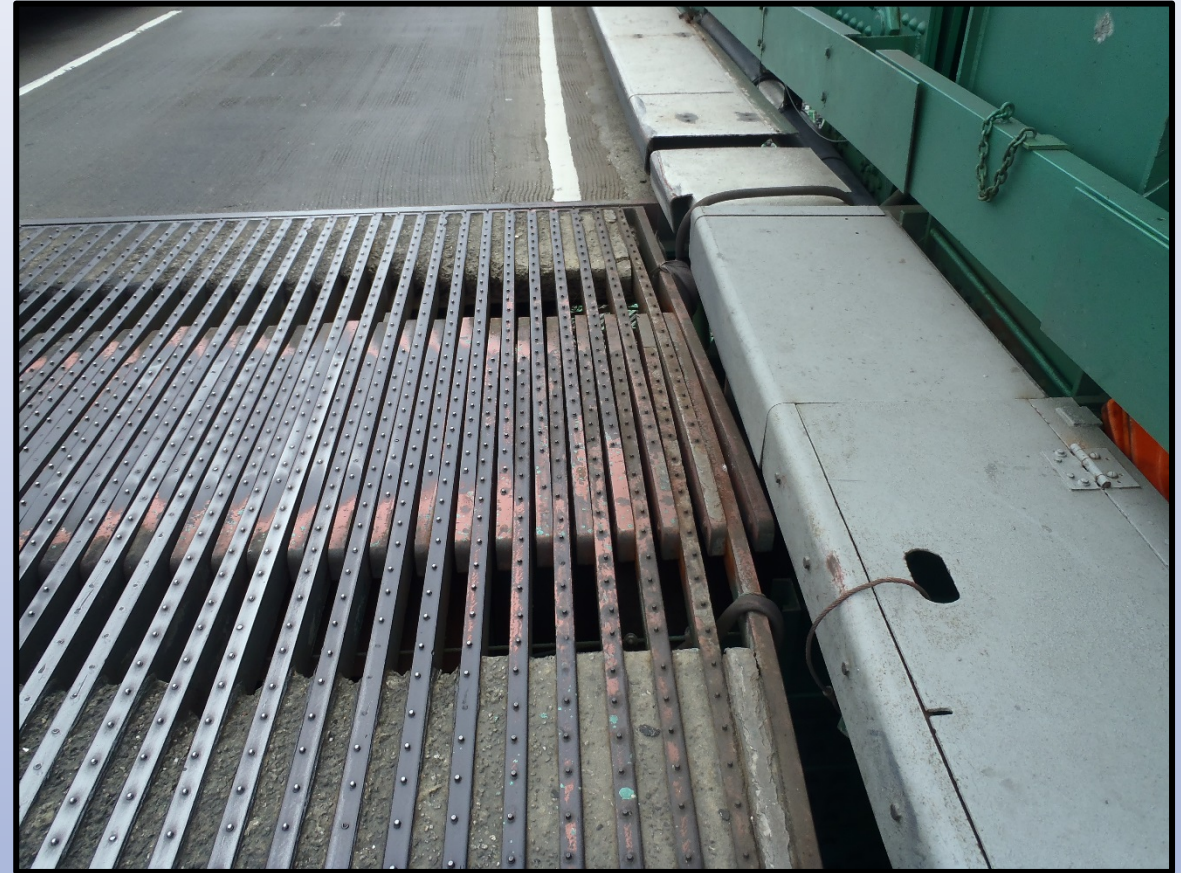
Large gap widths between the steel fingers.

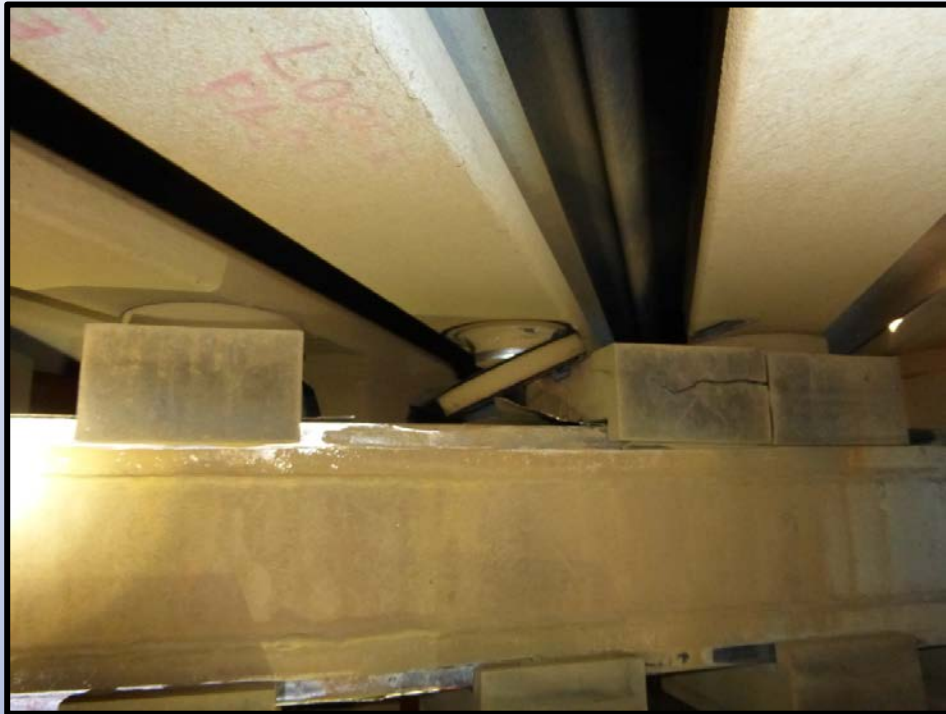
2003 New Carquinez Suspension Bridge. Pier 1 & Abutment 4. Problems found 2012.
