Oregon's Approach to Timber Pile Repair

2016 WBPP Annual Conference

By: Travis Kinney, P.E.

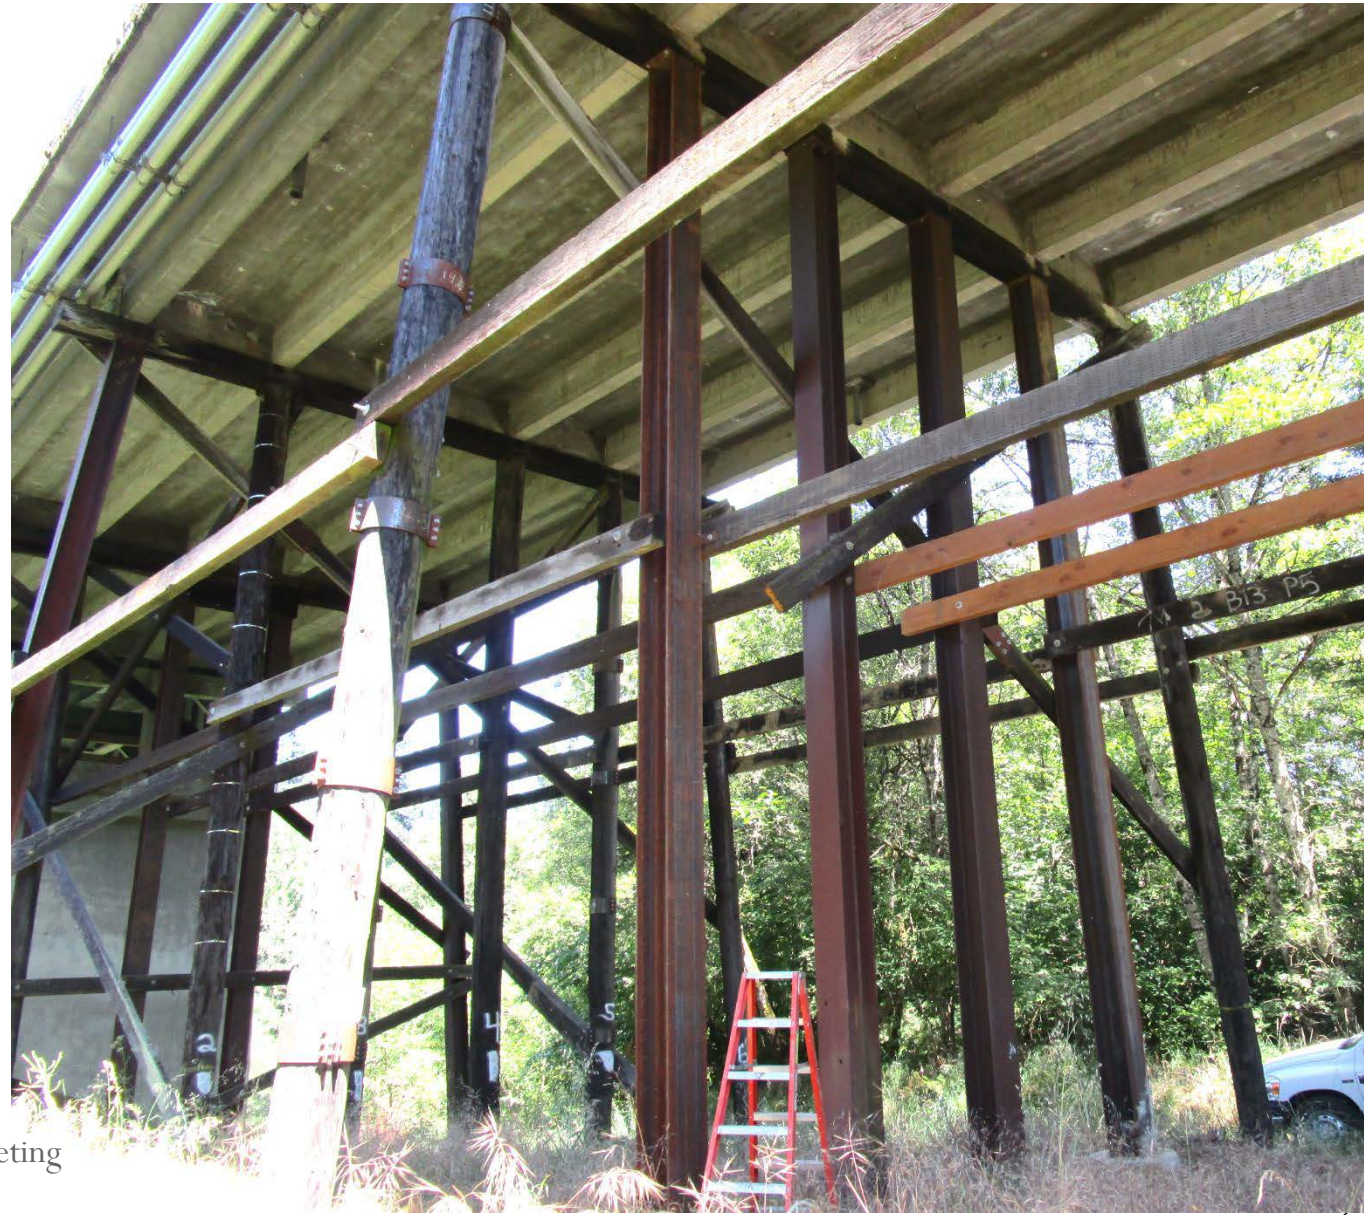
Replacing bridges 1-piece at a time

- 85 of the original 204 timber piles have been repaired.
- The remaining 119 are just waiting their turn.

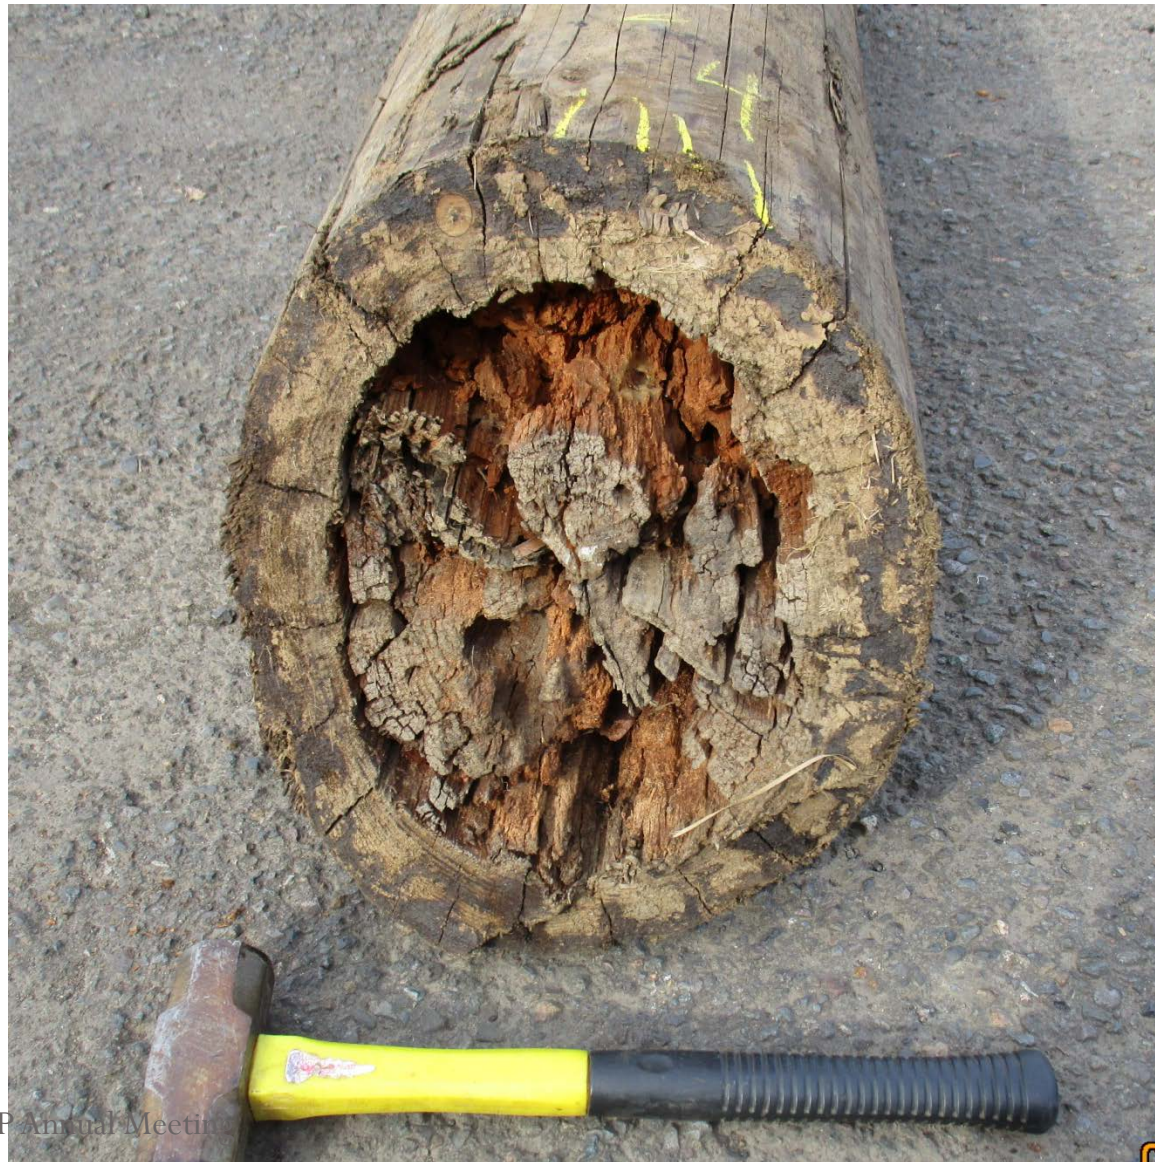
How much rot is too much to repair?

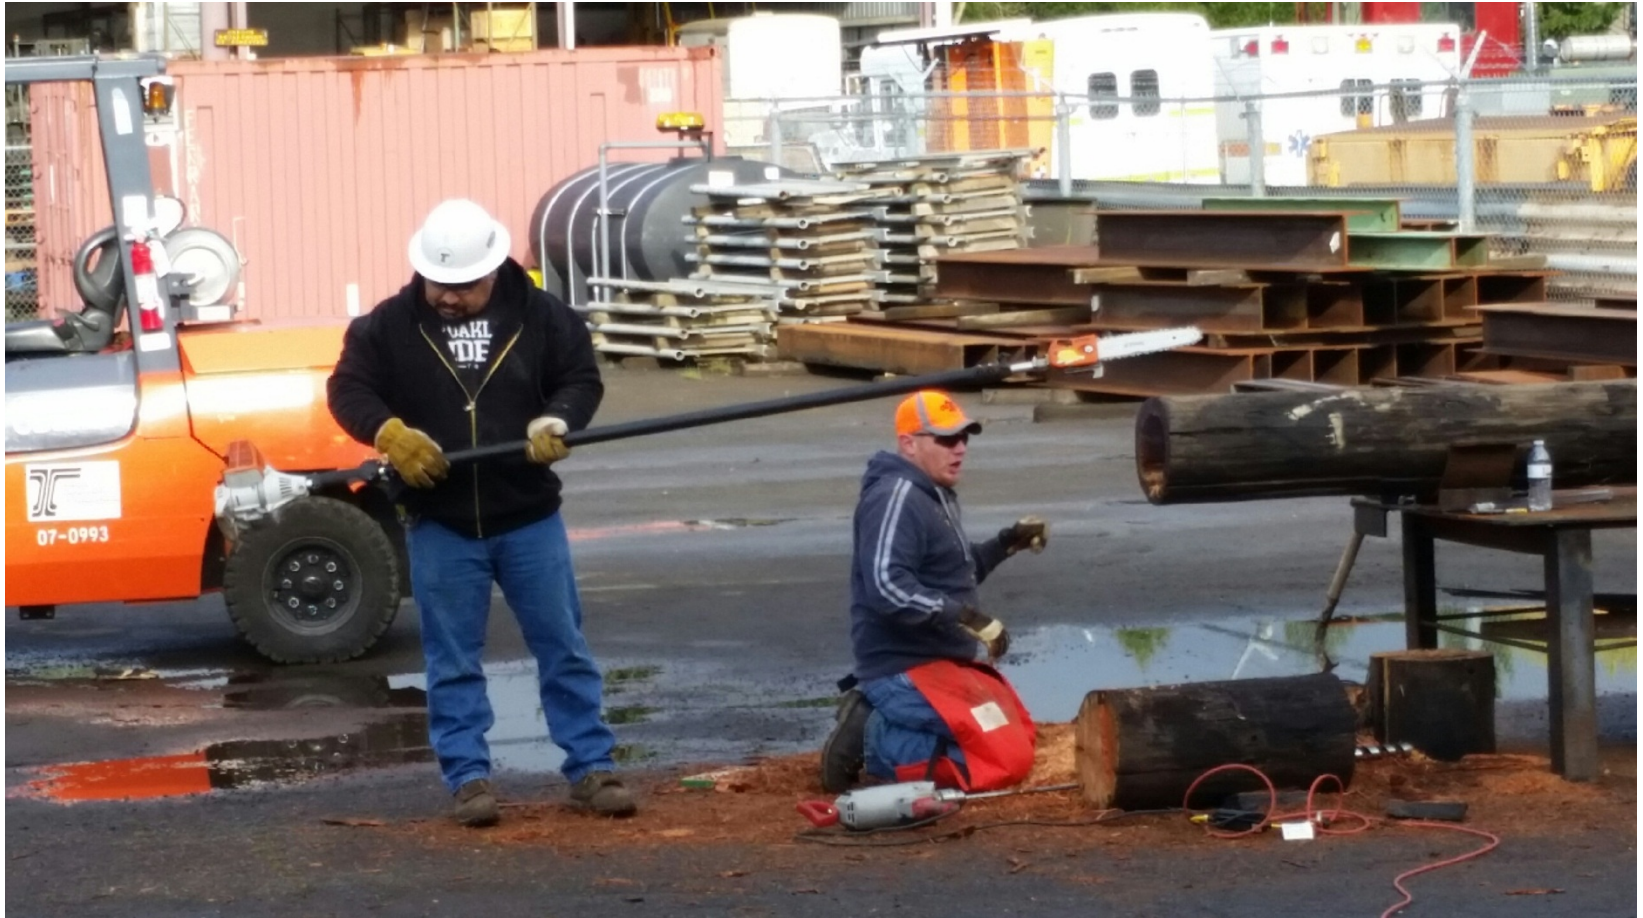
When auger isn't deep enough...
