When Preservation Fails: A Story of Alsea Bay

Western Bridge Preservation Partnership

Rebecca Burrow, P.E.

ODOT Bridge Preservation

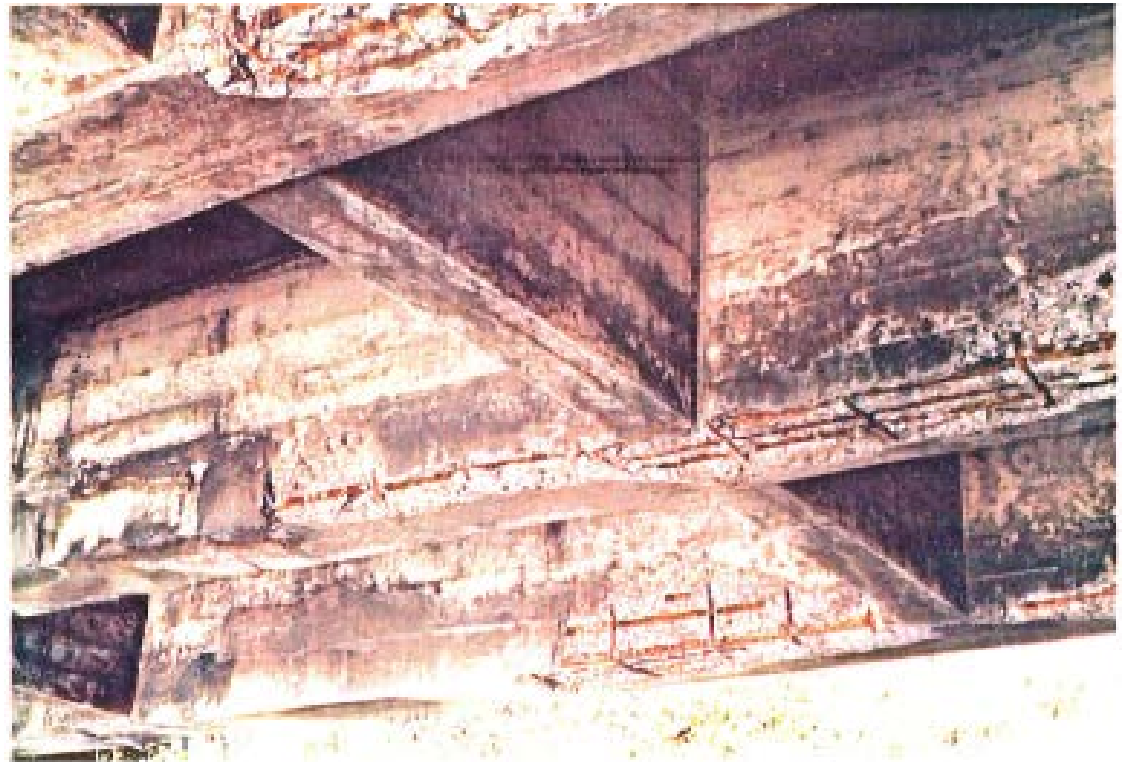
Scaling, 1984

LOOSE CONCRETE ON ALSEA BRIDGE
TO BE REMOVED BY HIGHWAY DIV

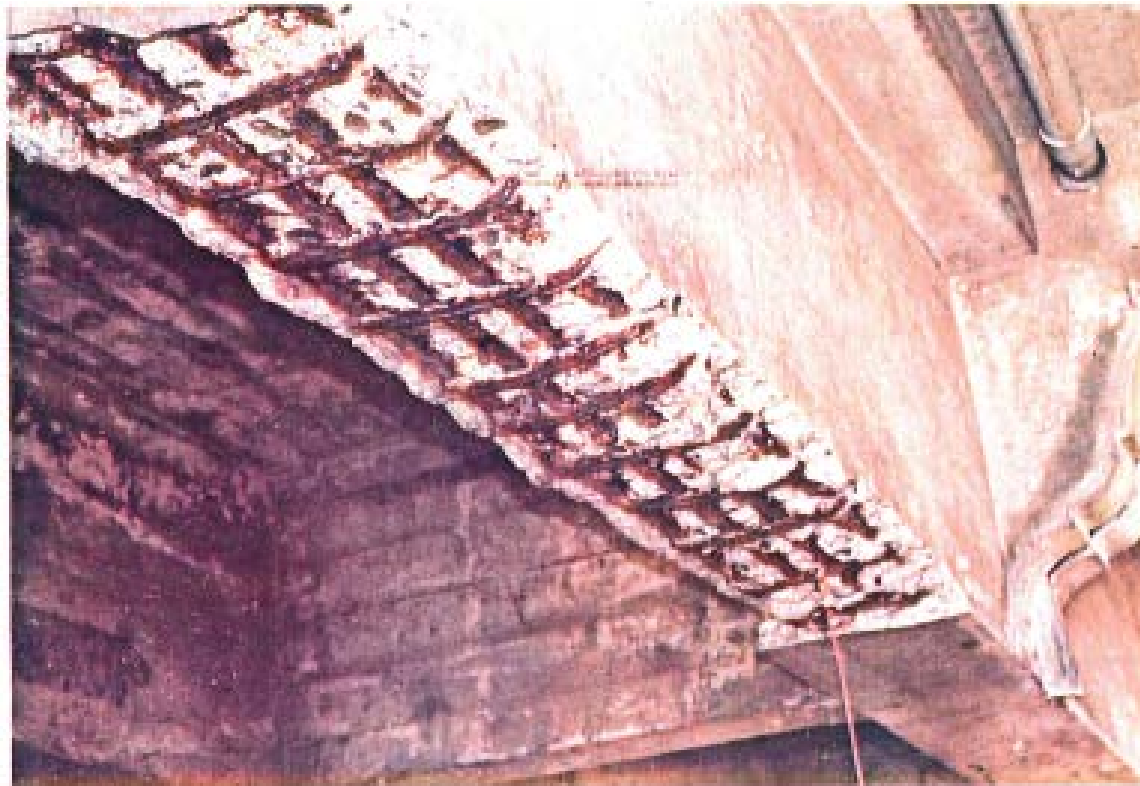
Scaling, 1984

LOOSE CONCRETE ON ALSEA BRIDGE
TO BE REMOVED BY HIGHWAY DIV
