Hawthorne Viaduct Beam Repair Carl Morgan and Mike Faulkner

Multnomah County

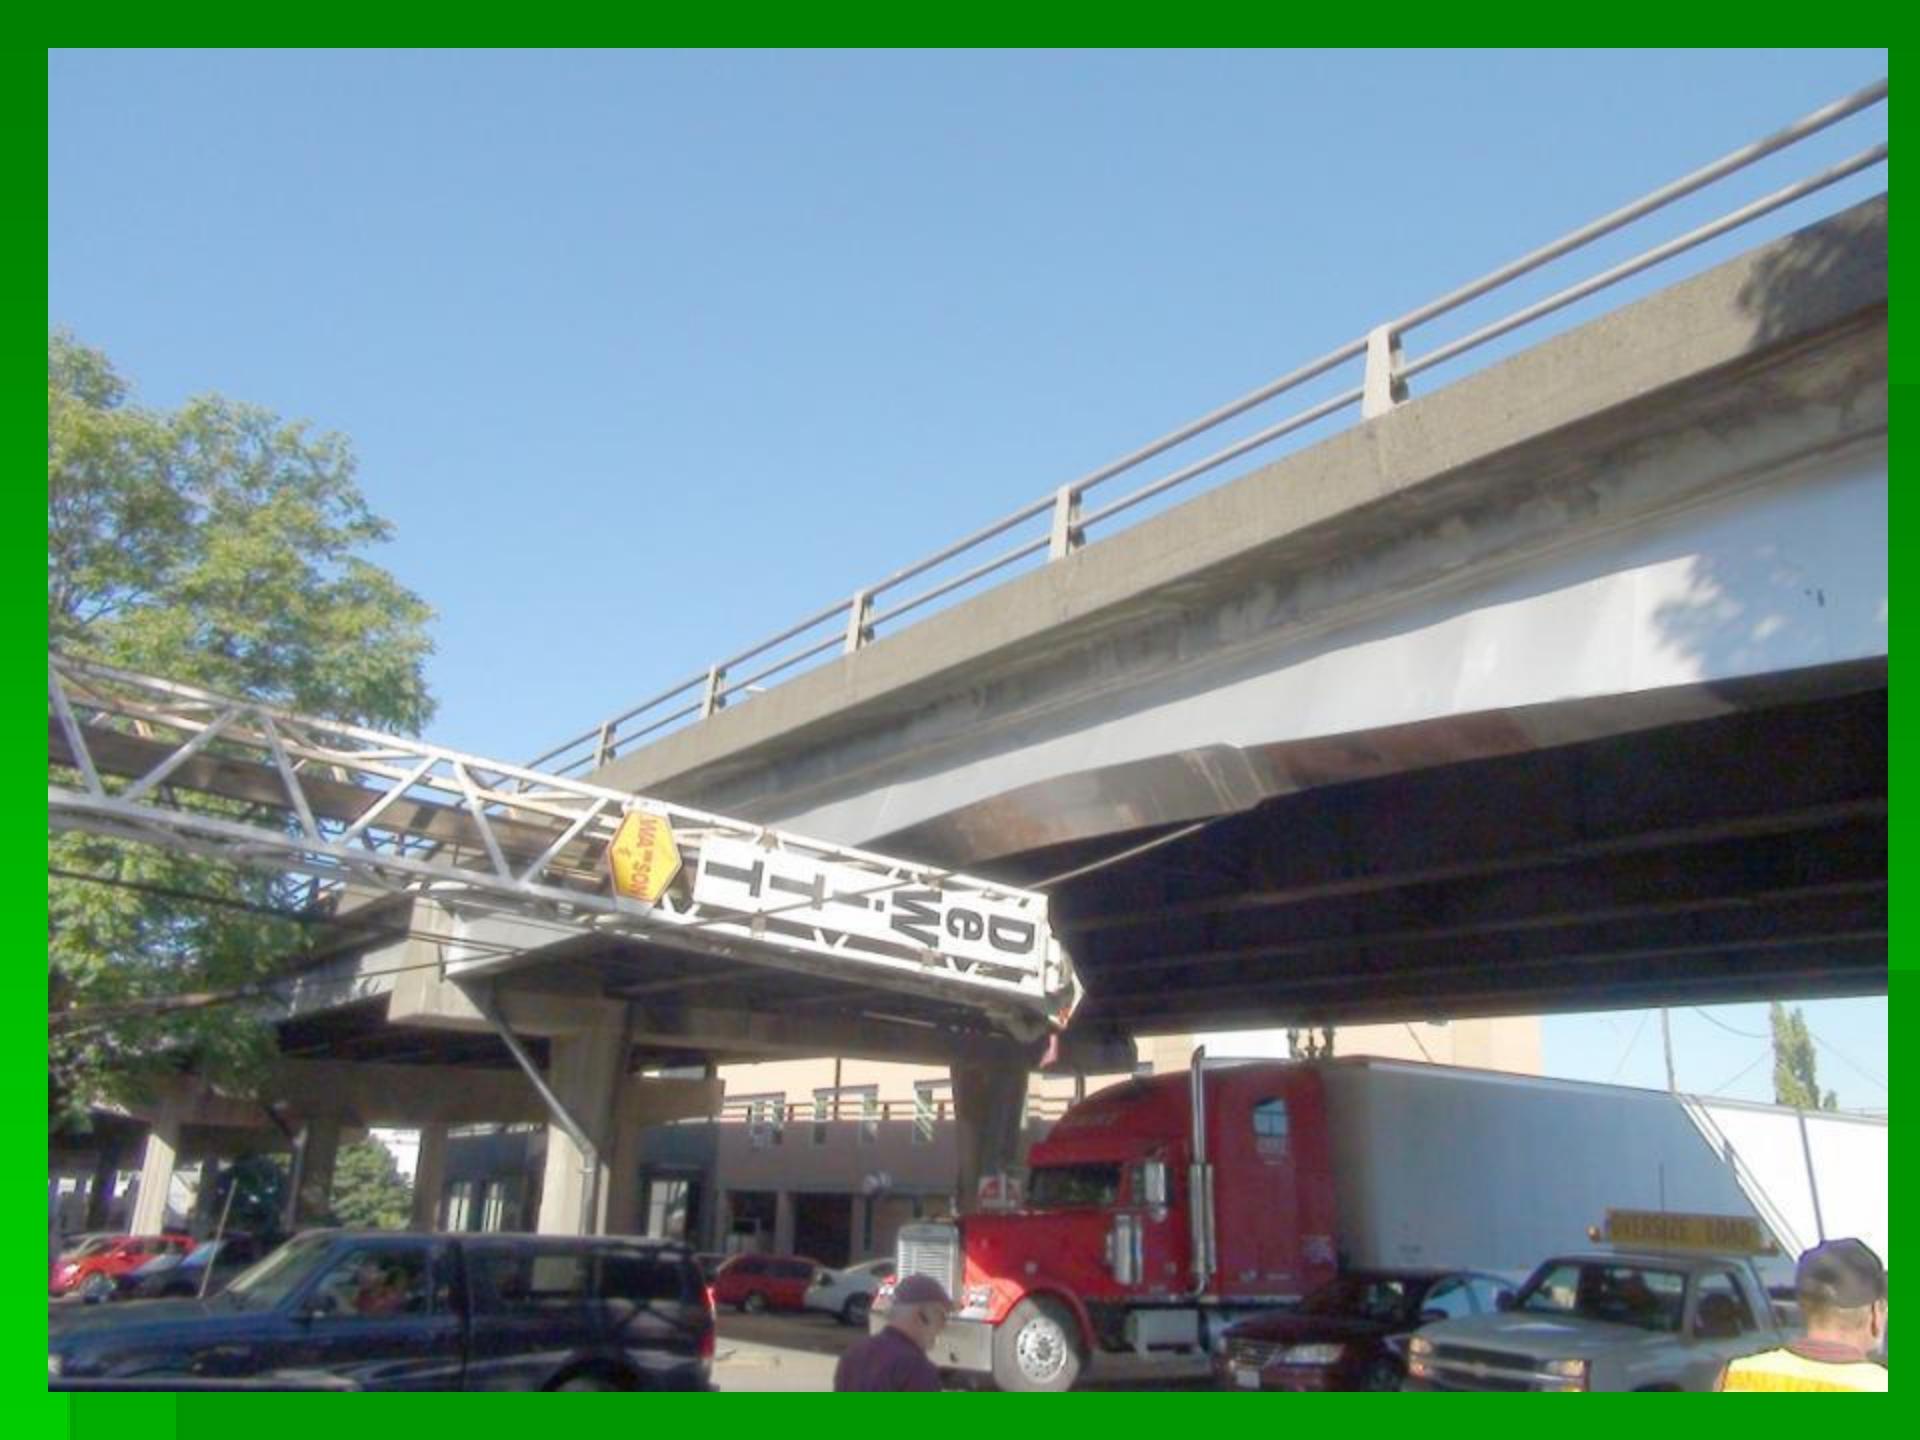
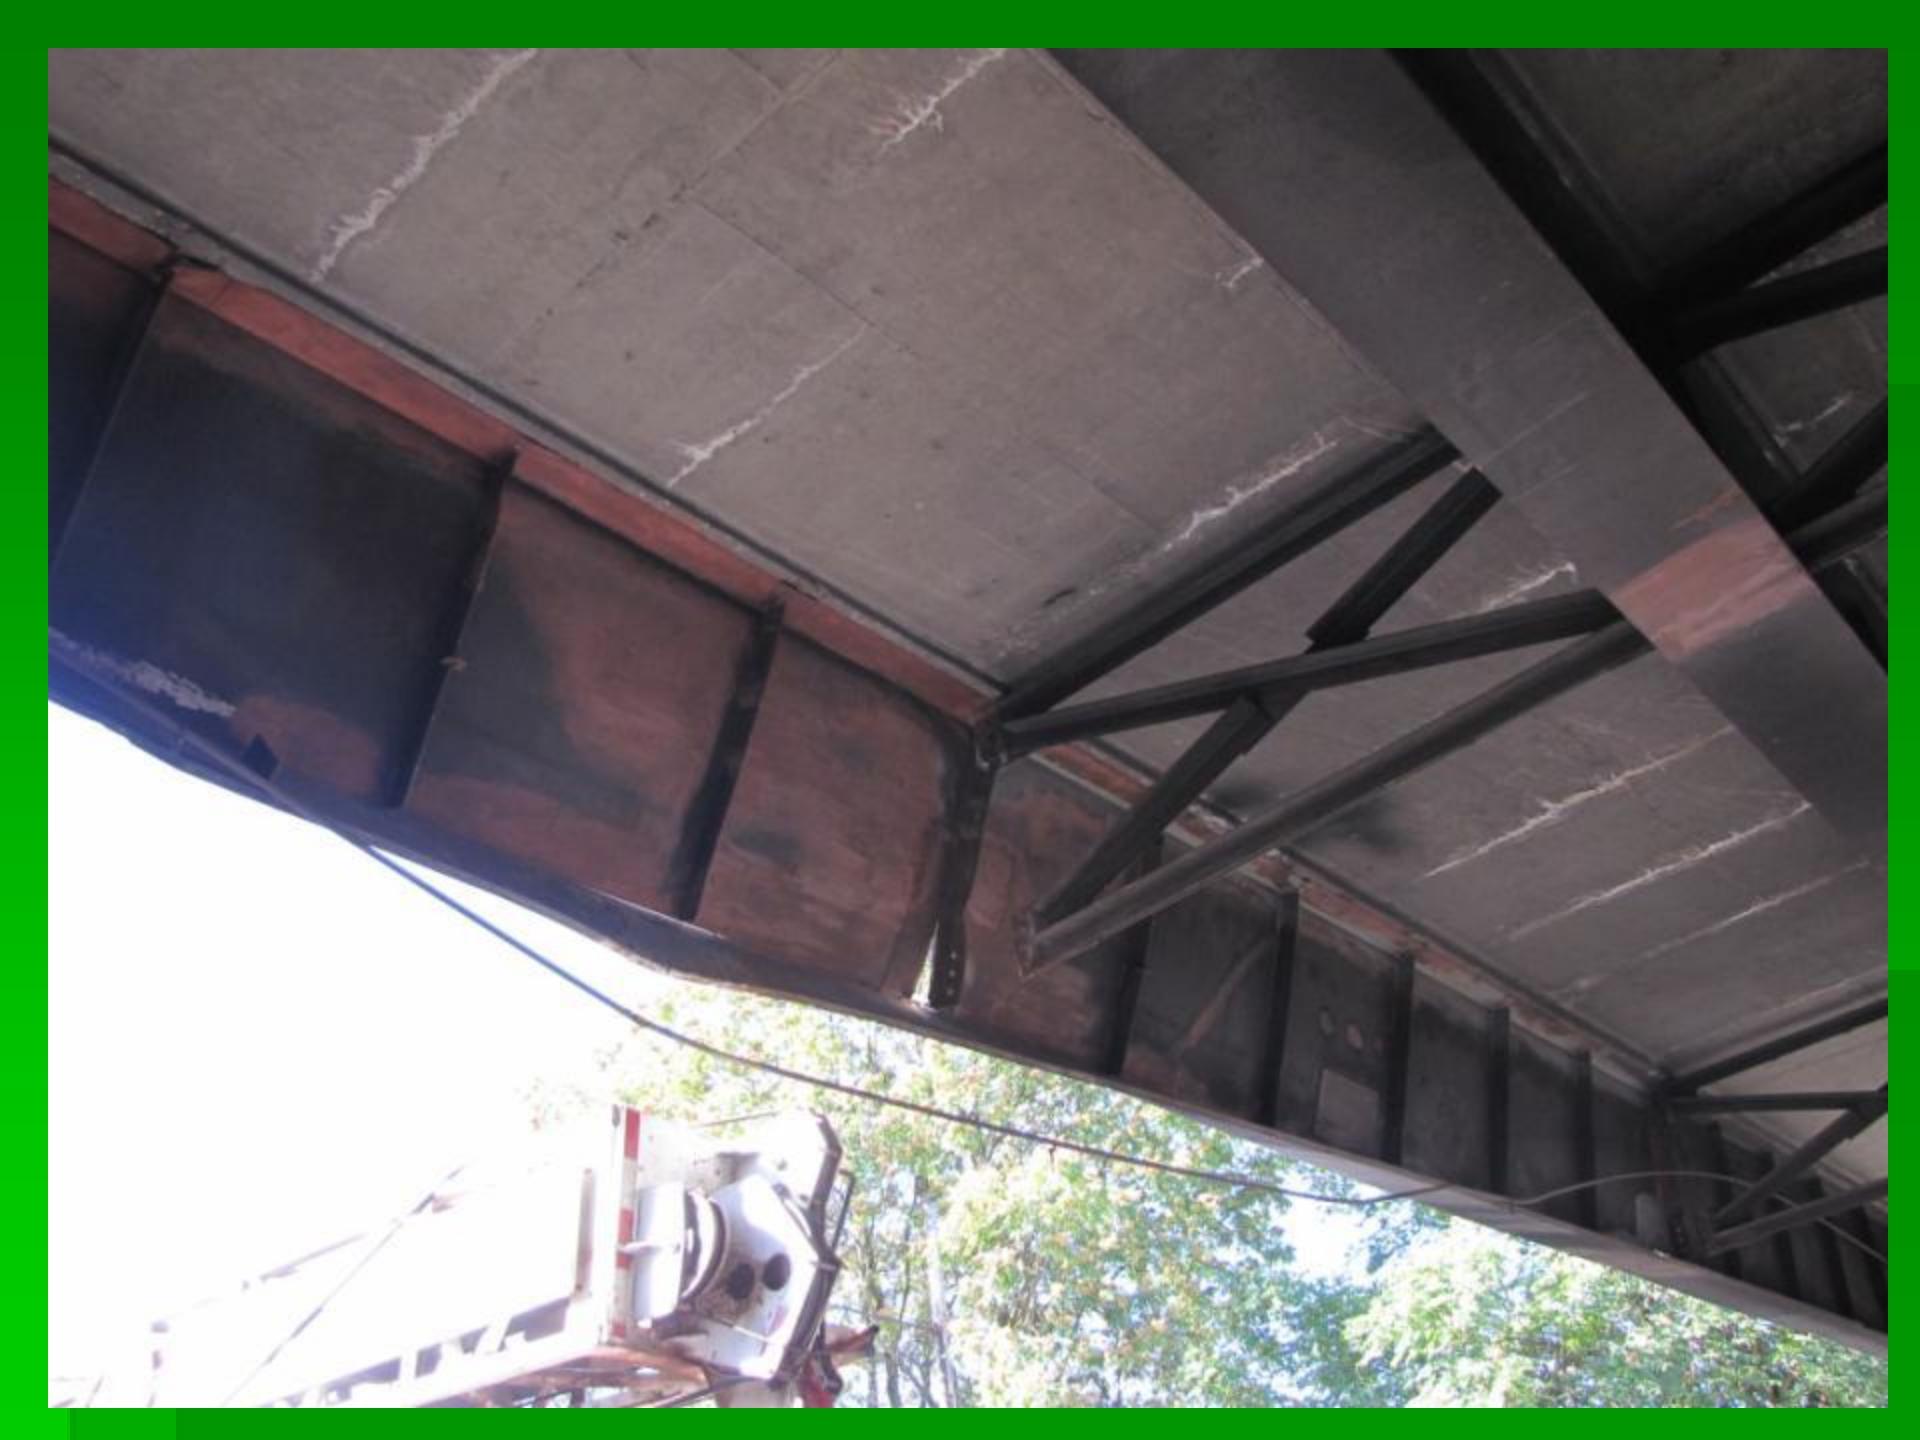
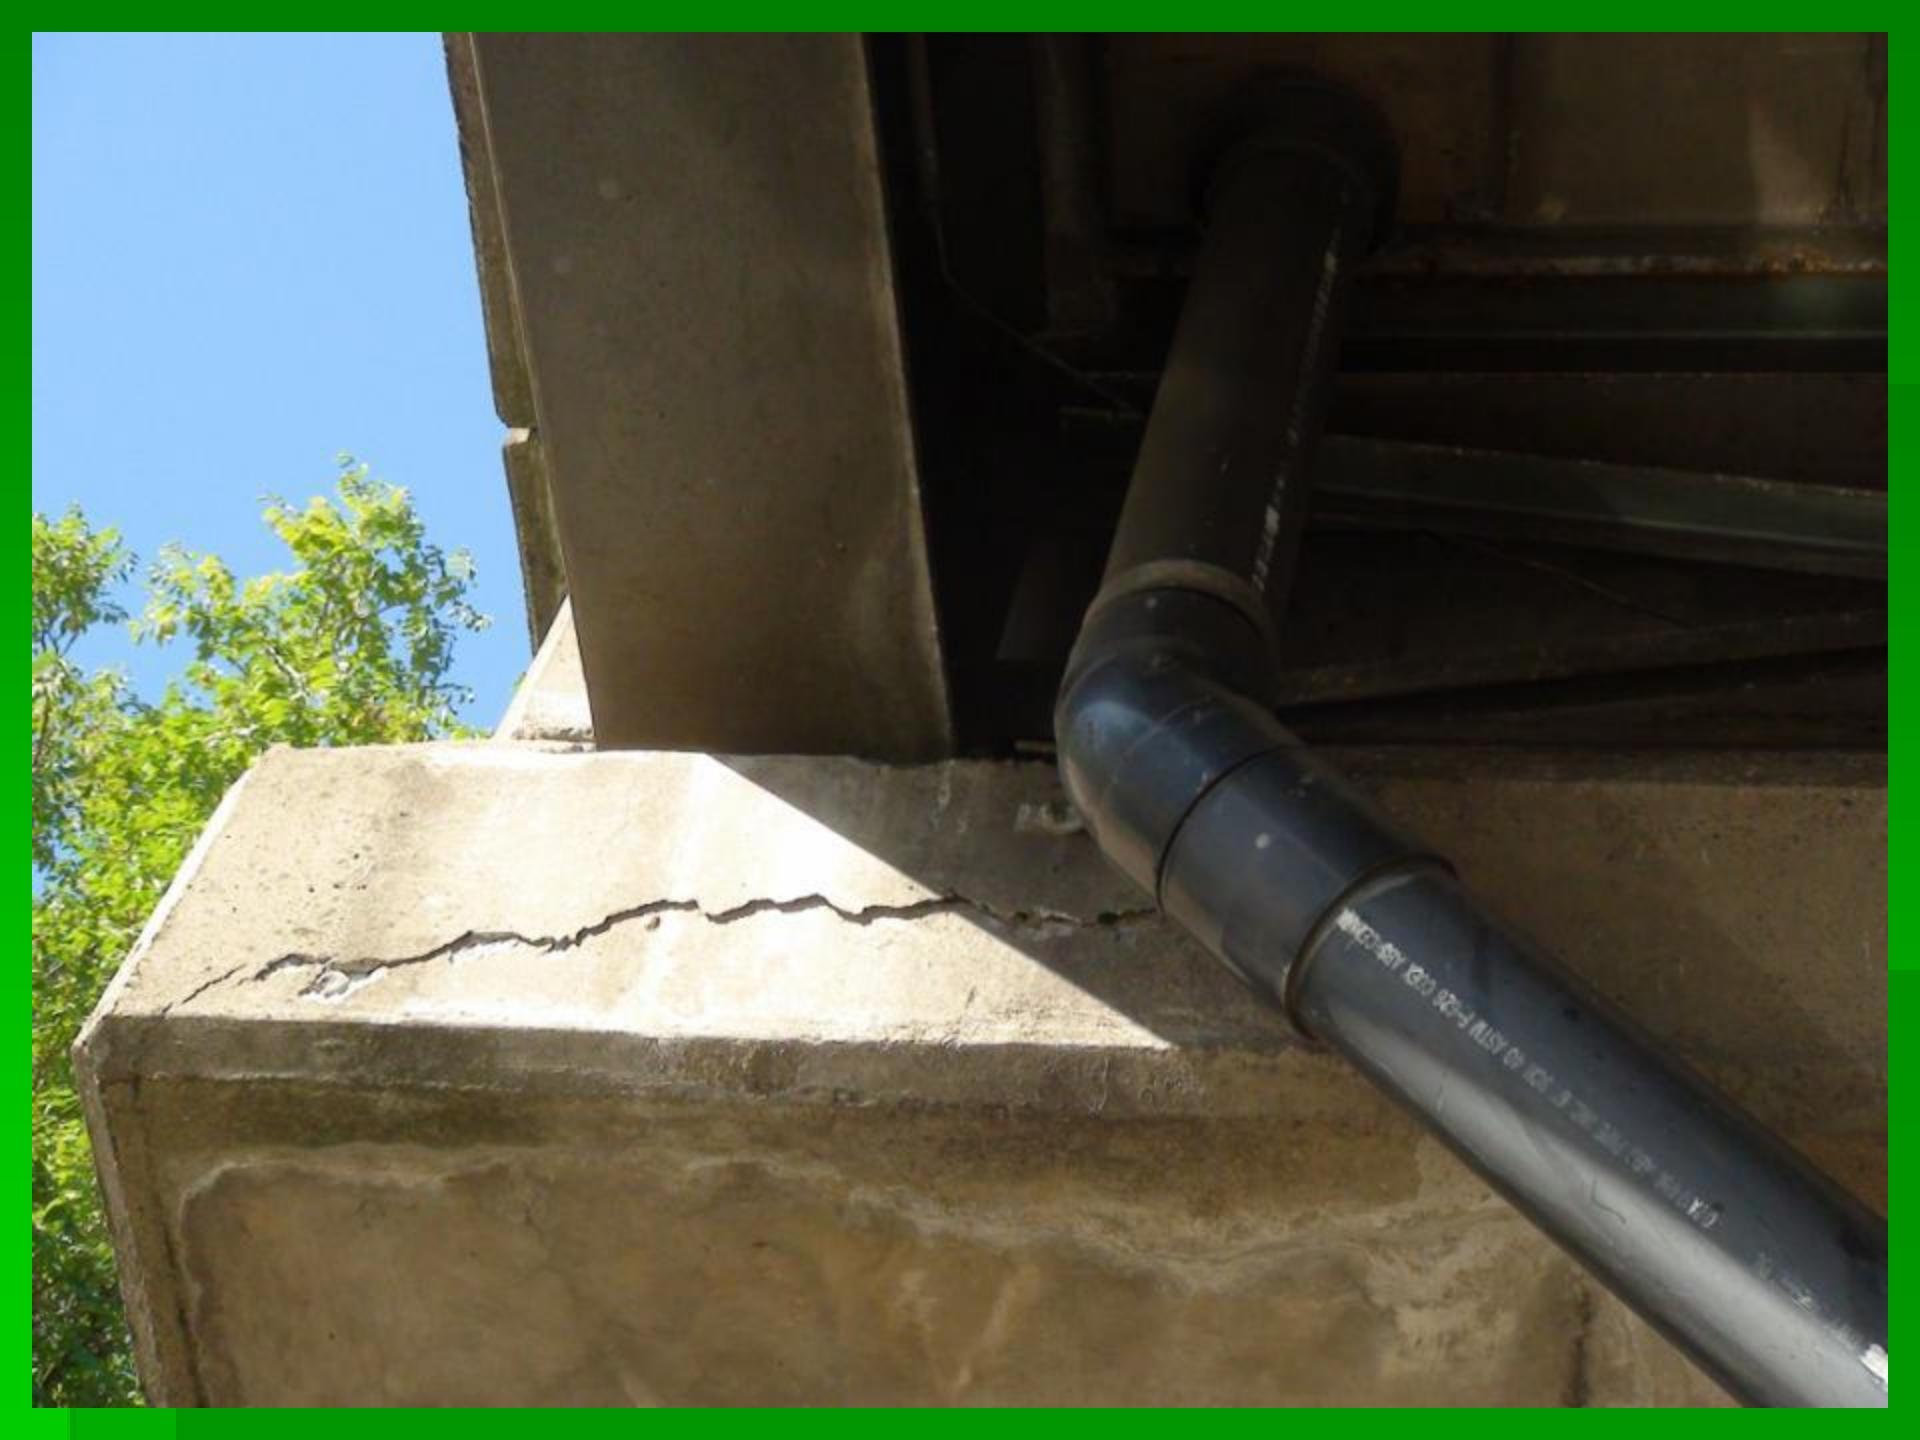
The day of the hit

- Beam hit October 2010
- The team inspected the damage
- Extensive beam and cap damage
