# Full Depth Reclamation

## Additive Selection Guidelines

David Schinckel

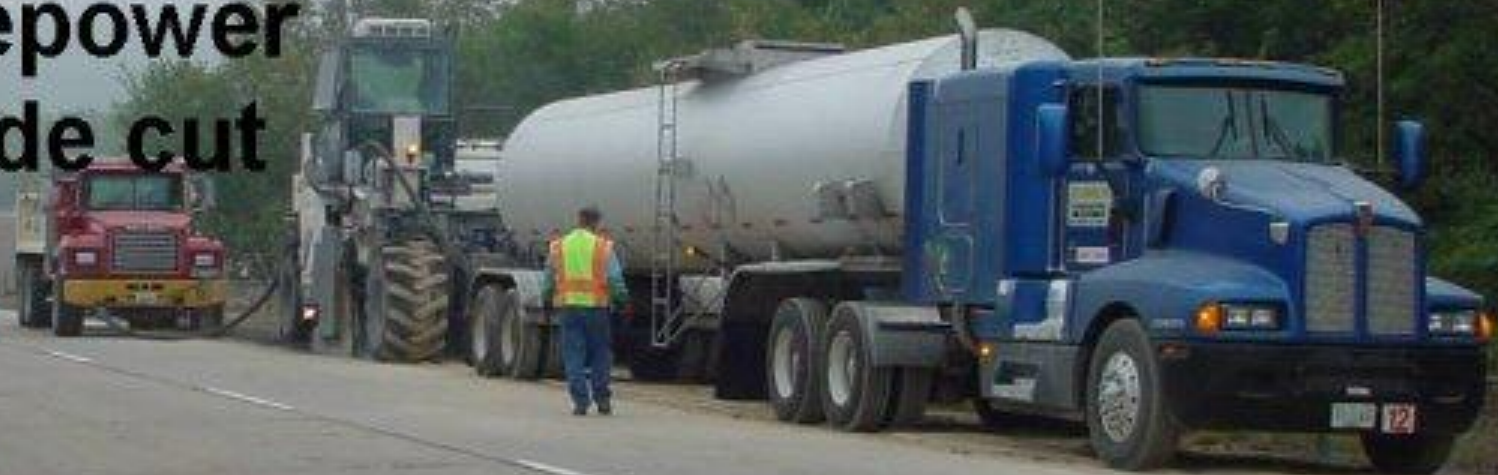
- Wirtgen
- WR2500
- 610
- Horsepower
- 8' wide cut

- Can cut to a depth of 20"
- Operating weight = 70,000
- Foamed Asphalt System

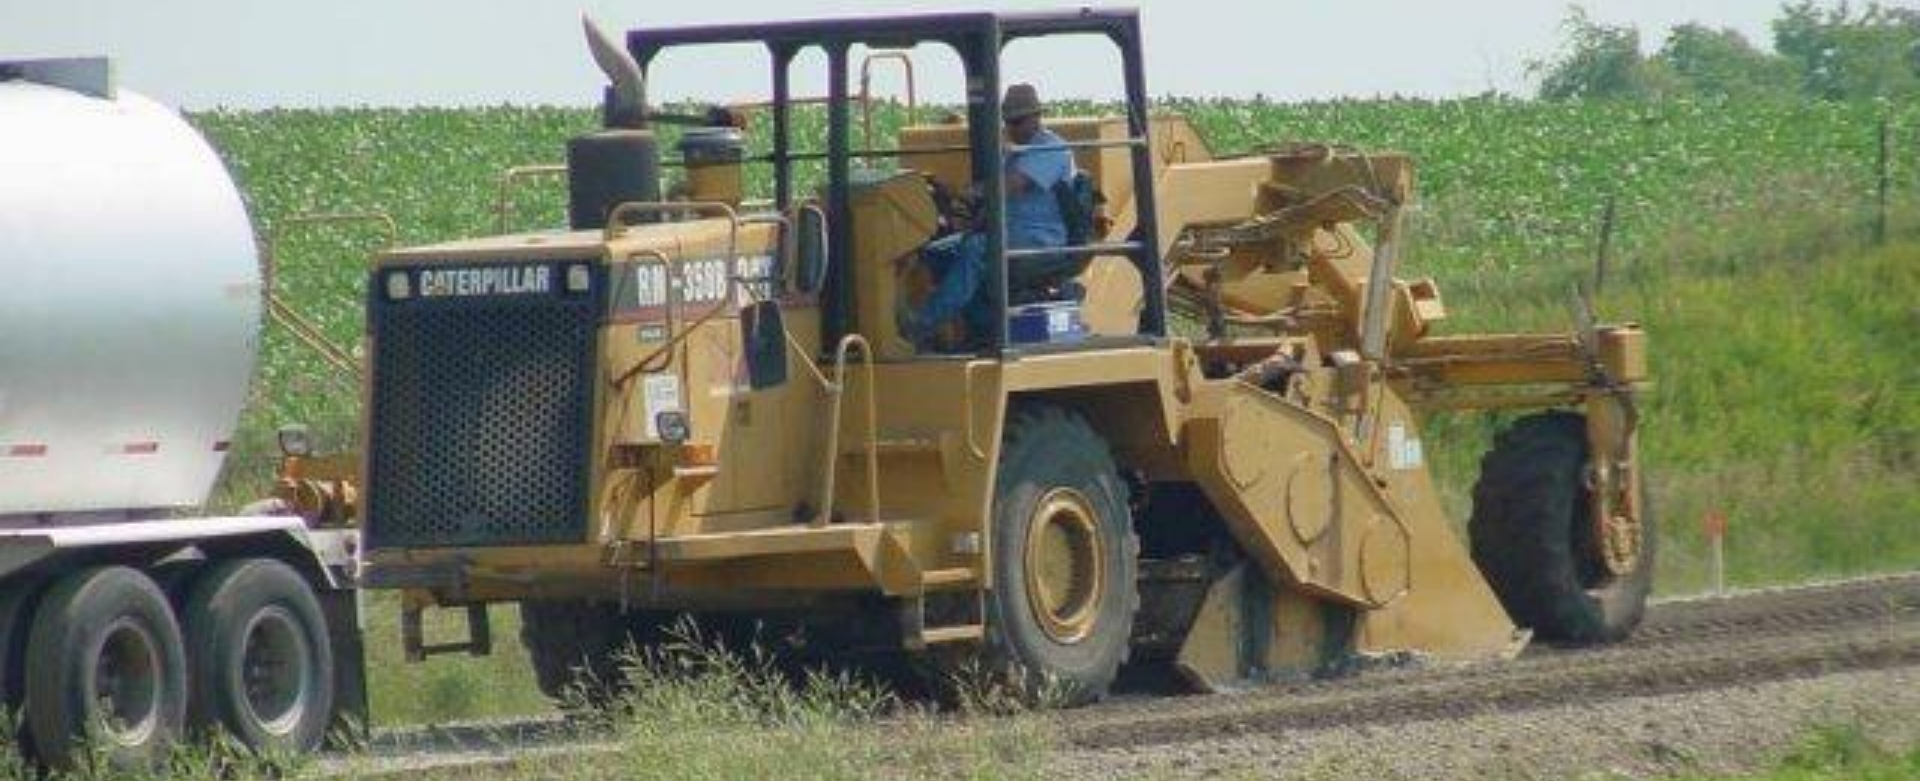
- Cat RM-350 B
- 470 horsepower

- 8' wide cut
- Can cut to a depth of 18"
- Operating Weight = 50,000 #

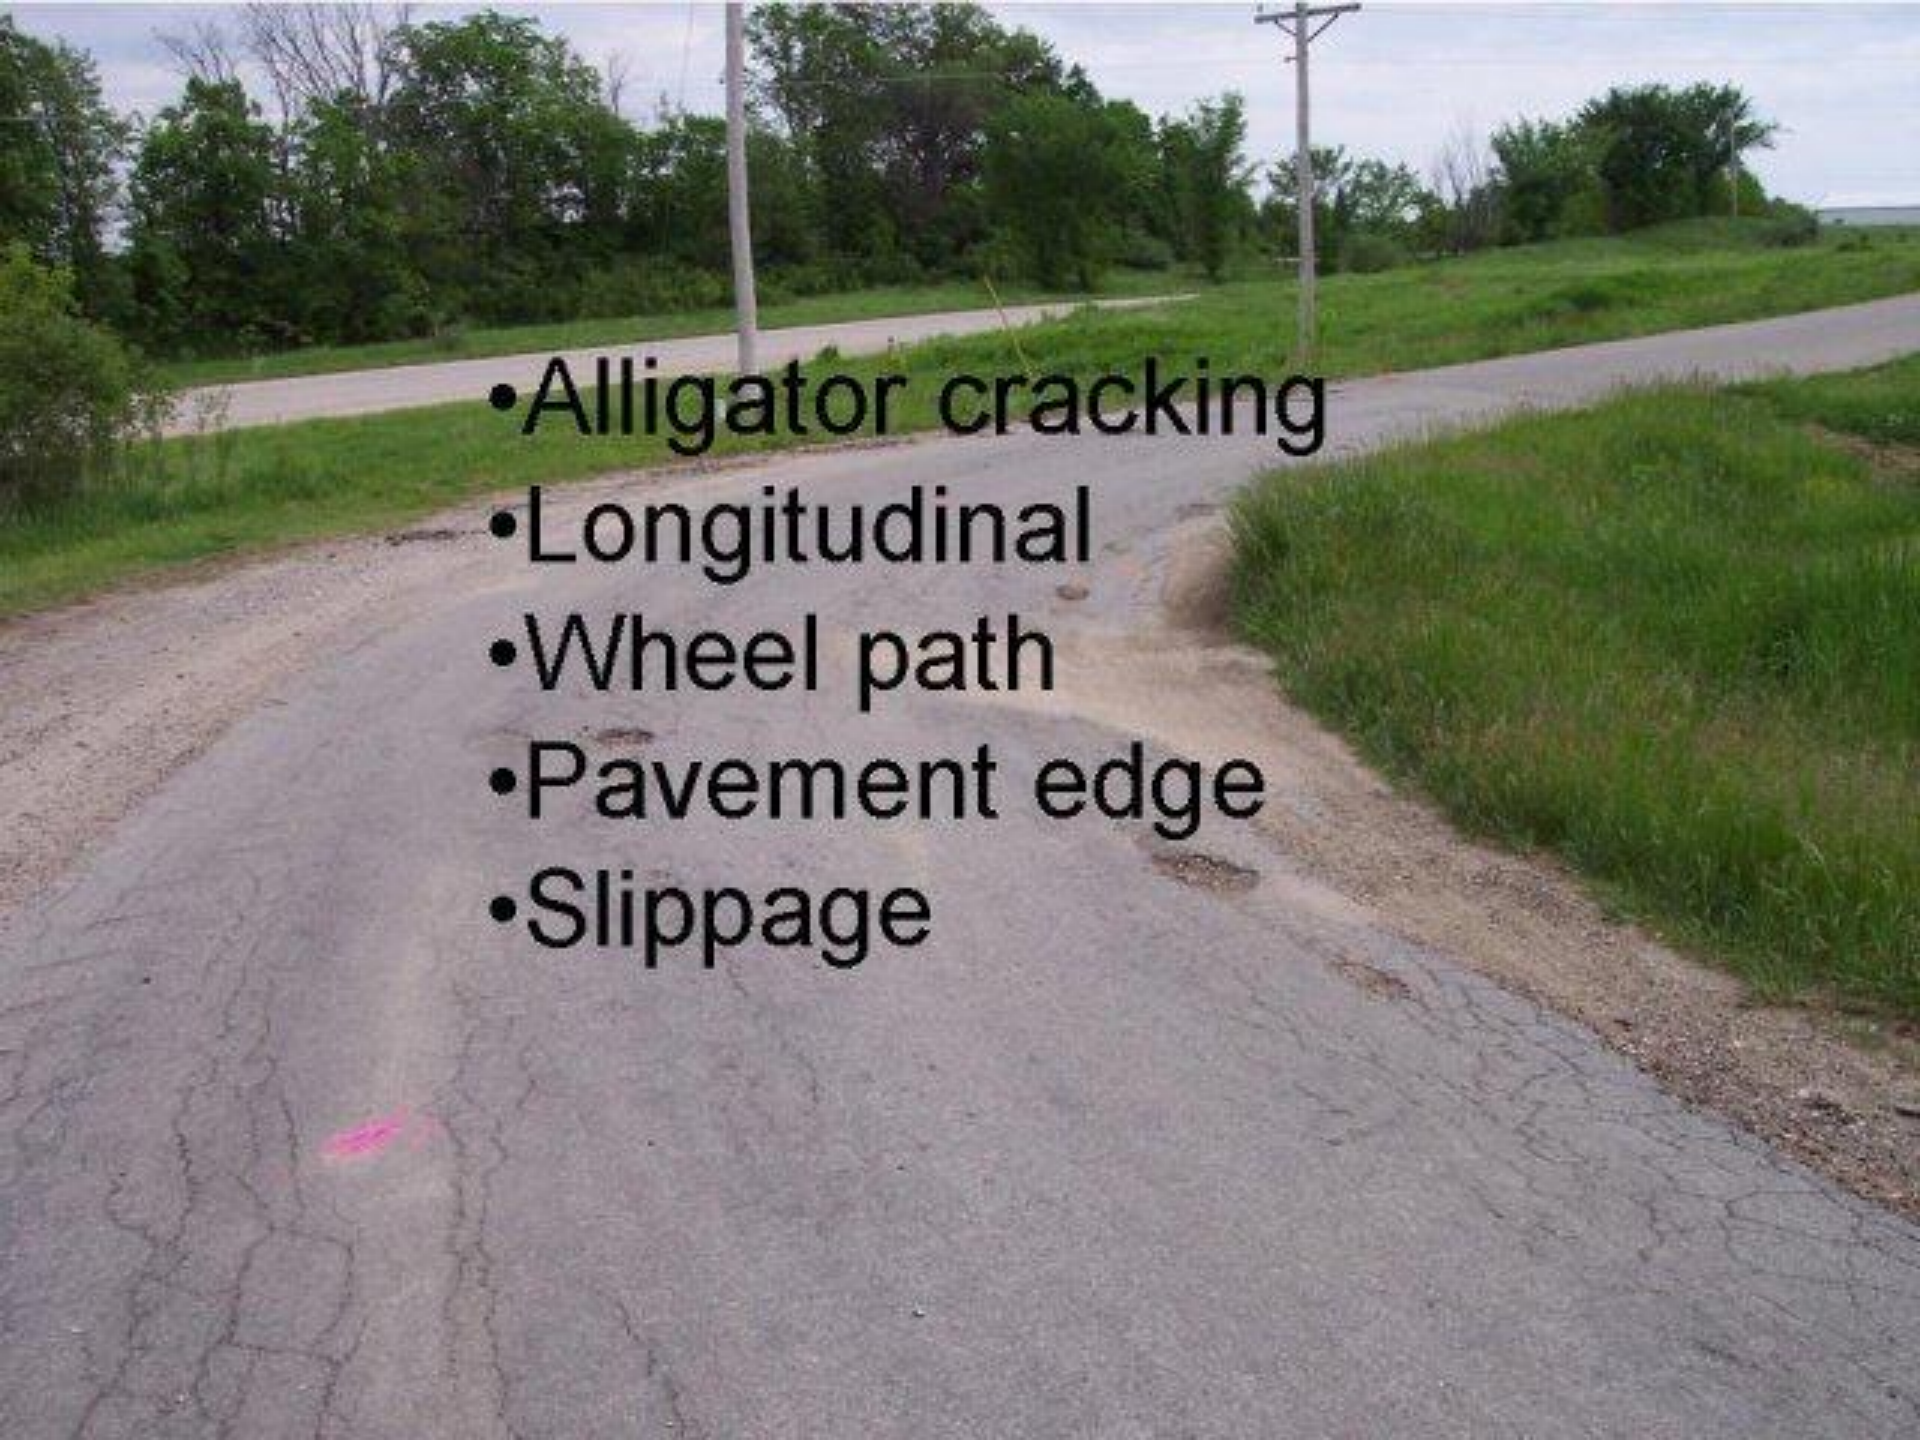
- The image shows a close-up view of a paved road surface. The asphalt is heavily deteriorated, showing a pattern of interconnected, irregular cracks that resemble the scales of an alligator. This is a classic sign of alligator cracking, which is caused by structural failure of the pavement layers. The road is surrounded by green grass and trees in the background. A utility pole is visible on the right side of the road.
- Alligator cracking
  - Longitudinal
  - Wheel path
  - Pavement edge
  - Slippage

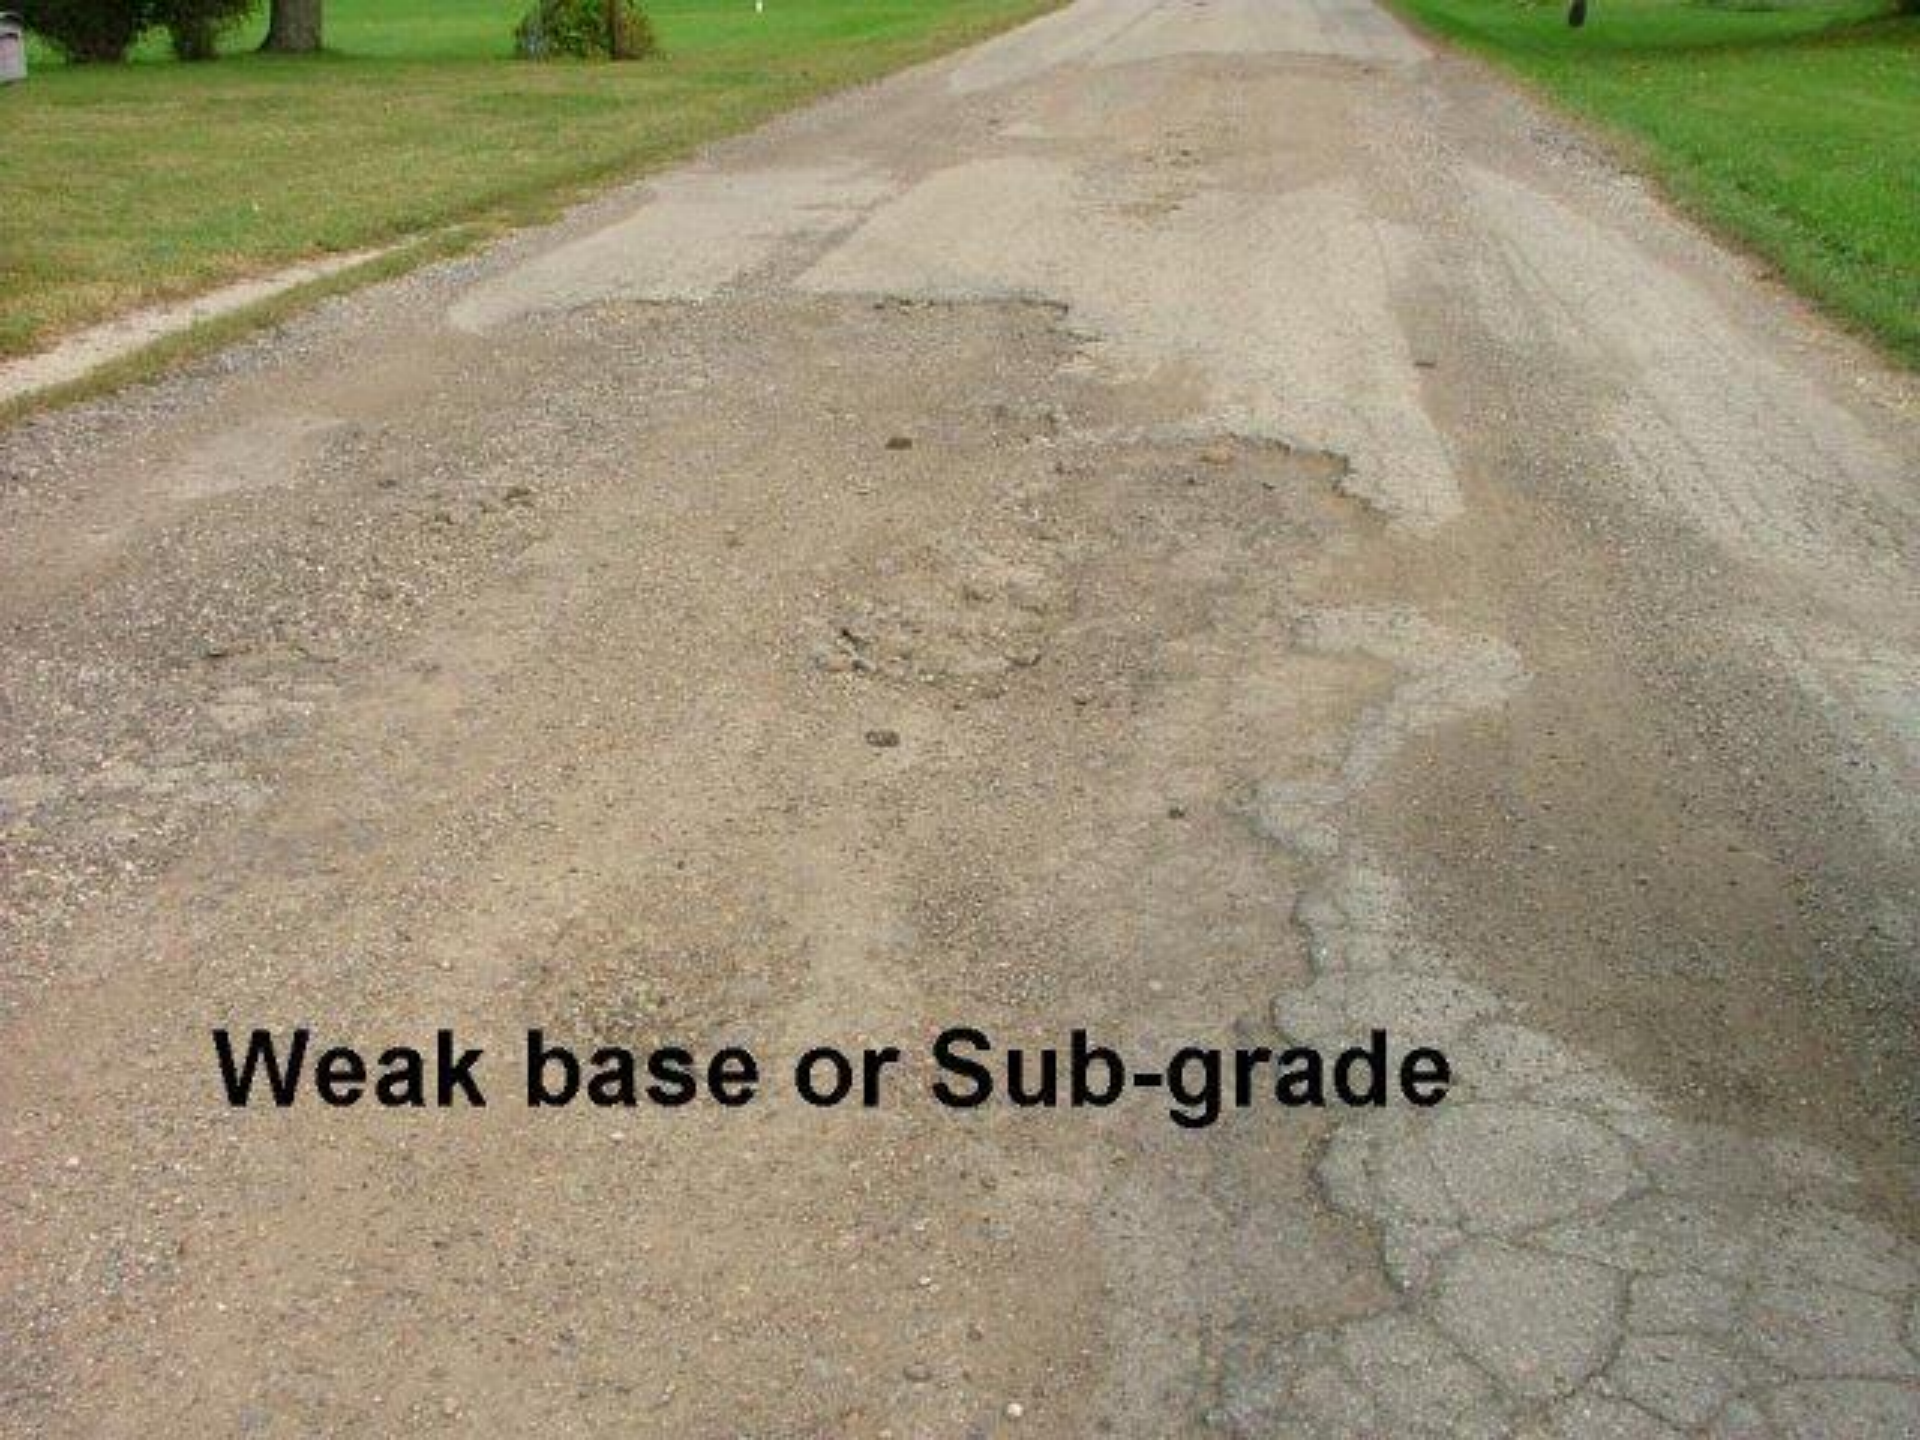
A photograph of a road with significant potholes and uneven pavement, indicating a weak base or sub-grade. The road surface is light-colored and shows extensive cracking and crumbling. The surrounding area is green grass.

**Weak base or Sub-grade**
