**Case Study**  
**1994 CIR Project**  
**Newport, Delaware**

# Topics to be Covered

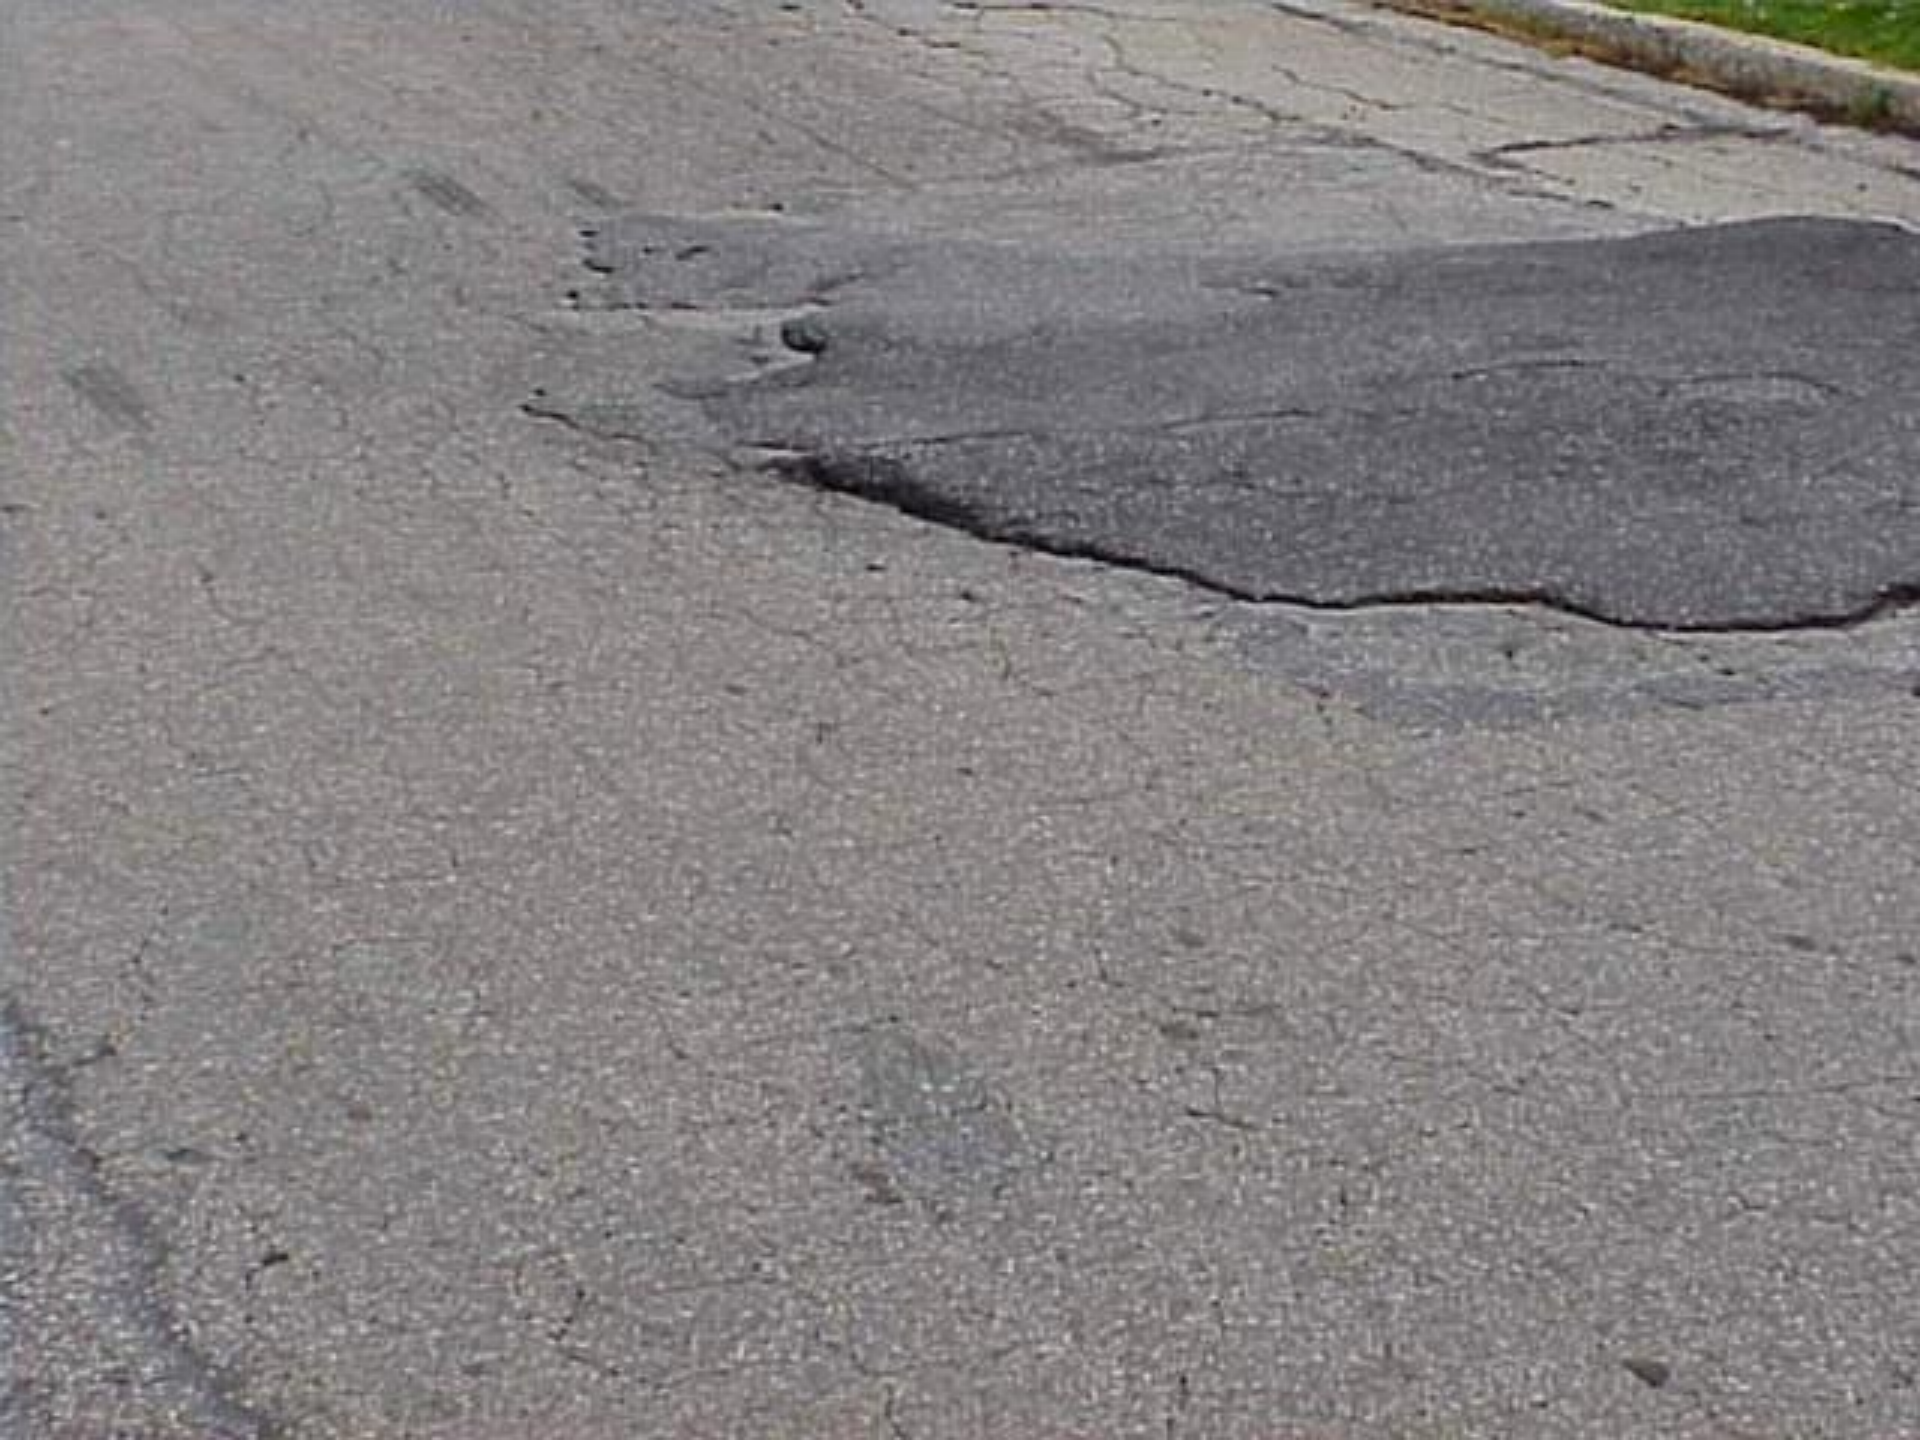
- Pavement Distresses
  - Extensive Fatigue Cracking (HS - HE)
  - Significant Transverse Cracking (HS – ME)
  - Significant Raveling (MS/HS)
- Poor Cross-Slope
- Poor Drainage
- Curb repairs

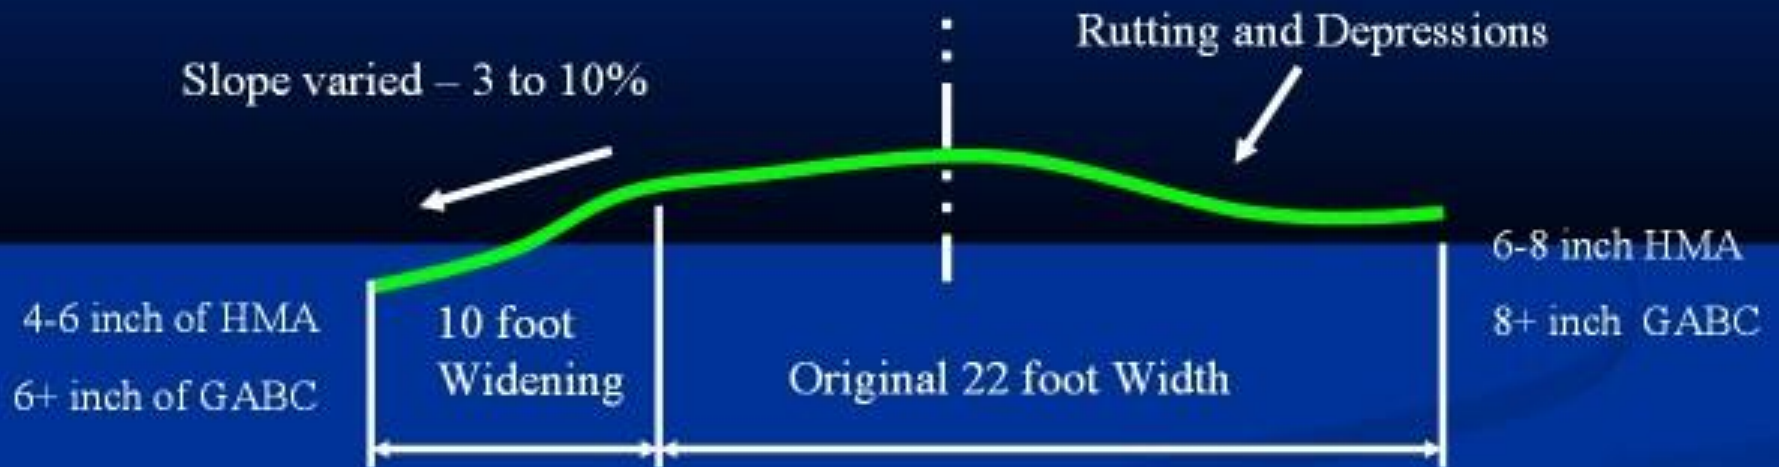
# Existing X-Section

## Original Cross-Section

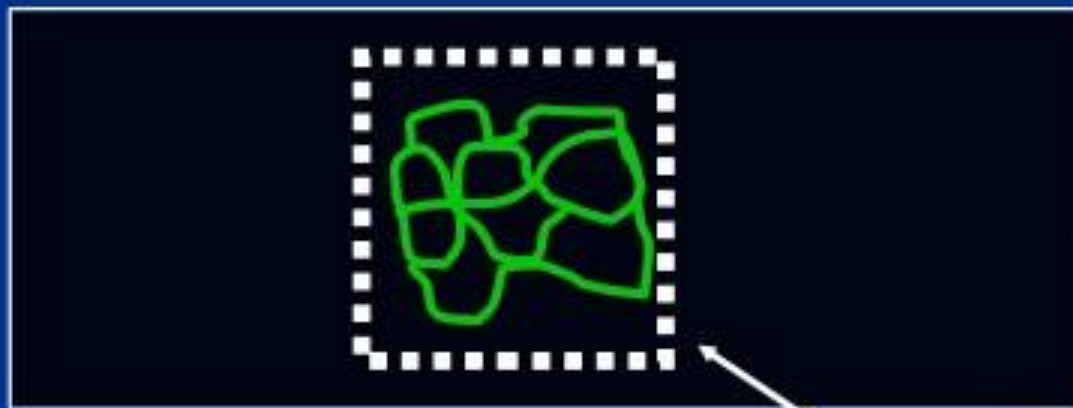
Section View

Plan View

Area to be  
Patched

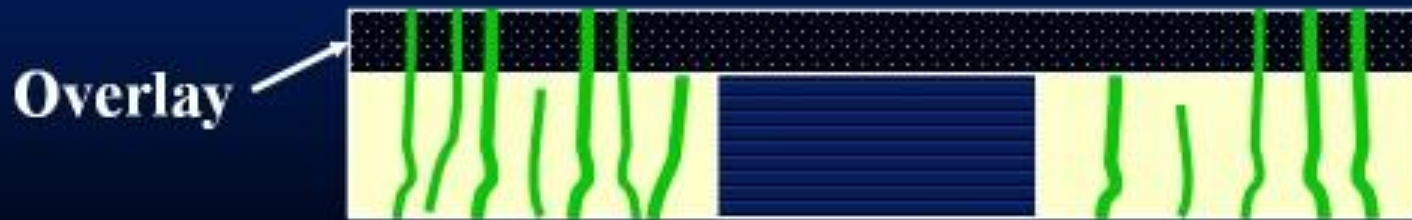
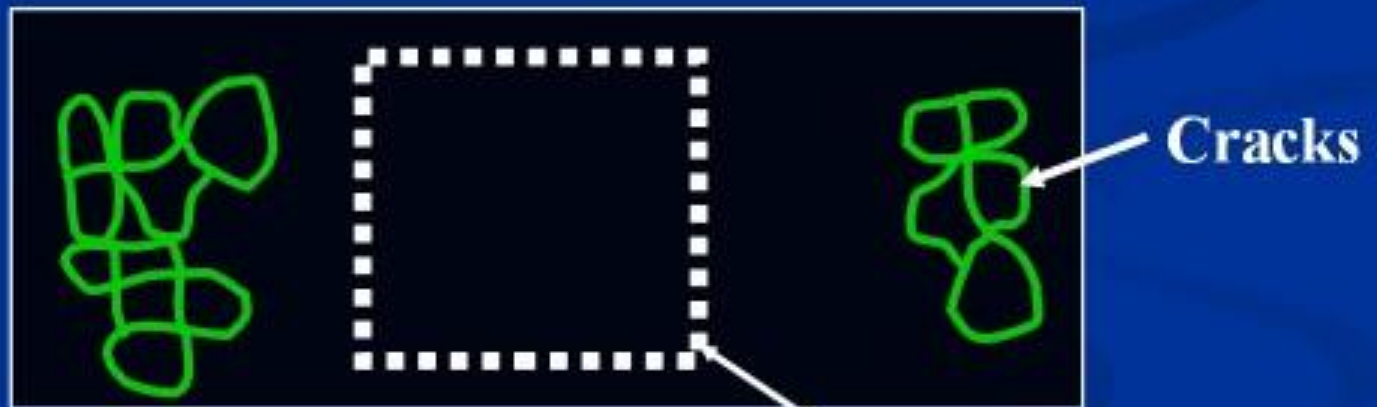
# After Overlay

Section View

Plan View

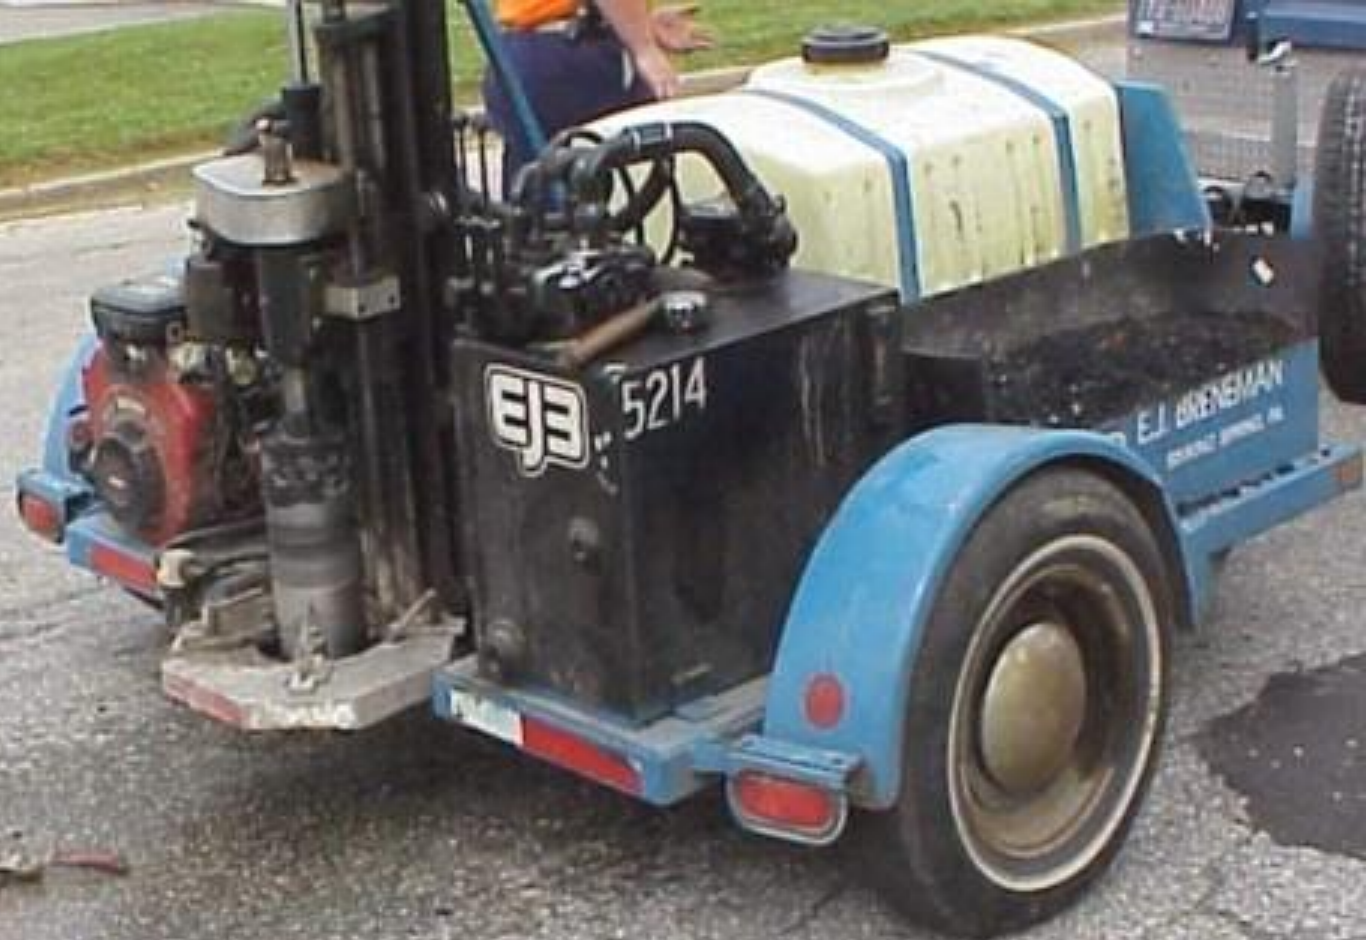
## Pavement Coring

- Test Pits
  - Confirmed that adequate material existed for CIR
- Other Identified Benefits
  - Reshape the roadway easily with the CIR process
    - Time/Cost savings
  - Greatly reduce the amount of patching
  - Quick in-out – minimal disruption to businesses
  - Utilize existing in-place materials

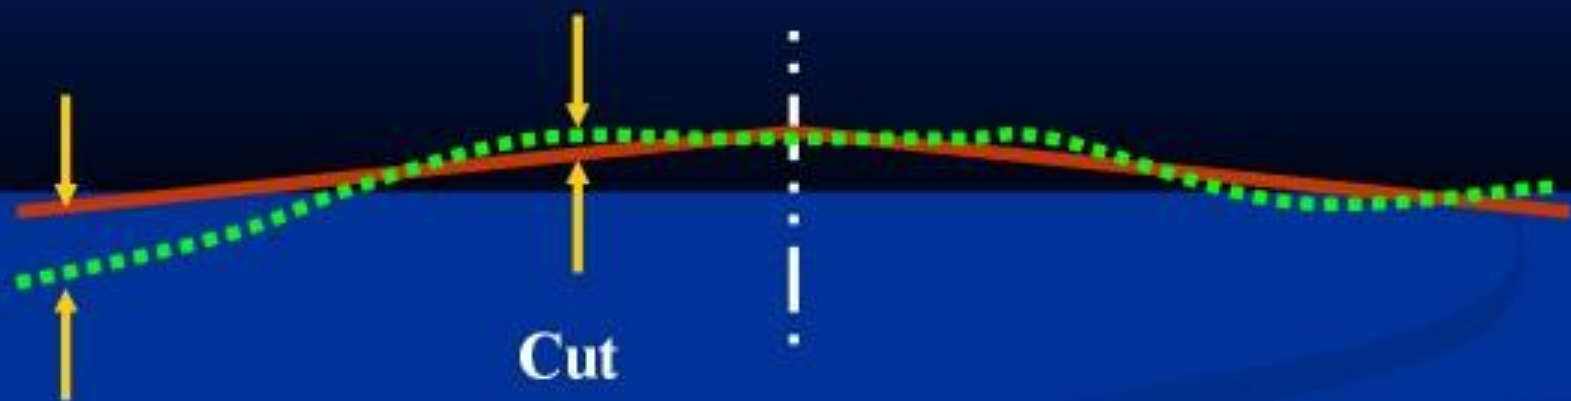
# Existing and Proposed X-Section

**Fill**

**Cut**

..... Existing Cross-Section

———— Proposed Cross-Section

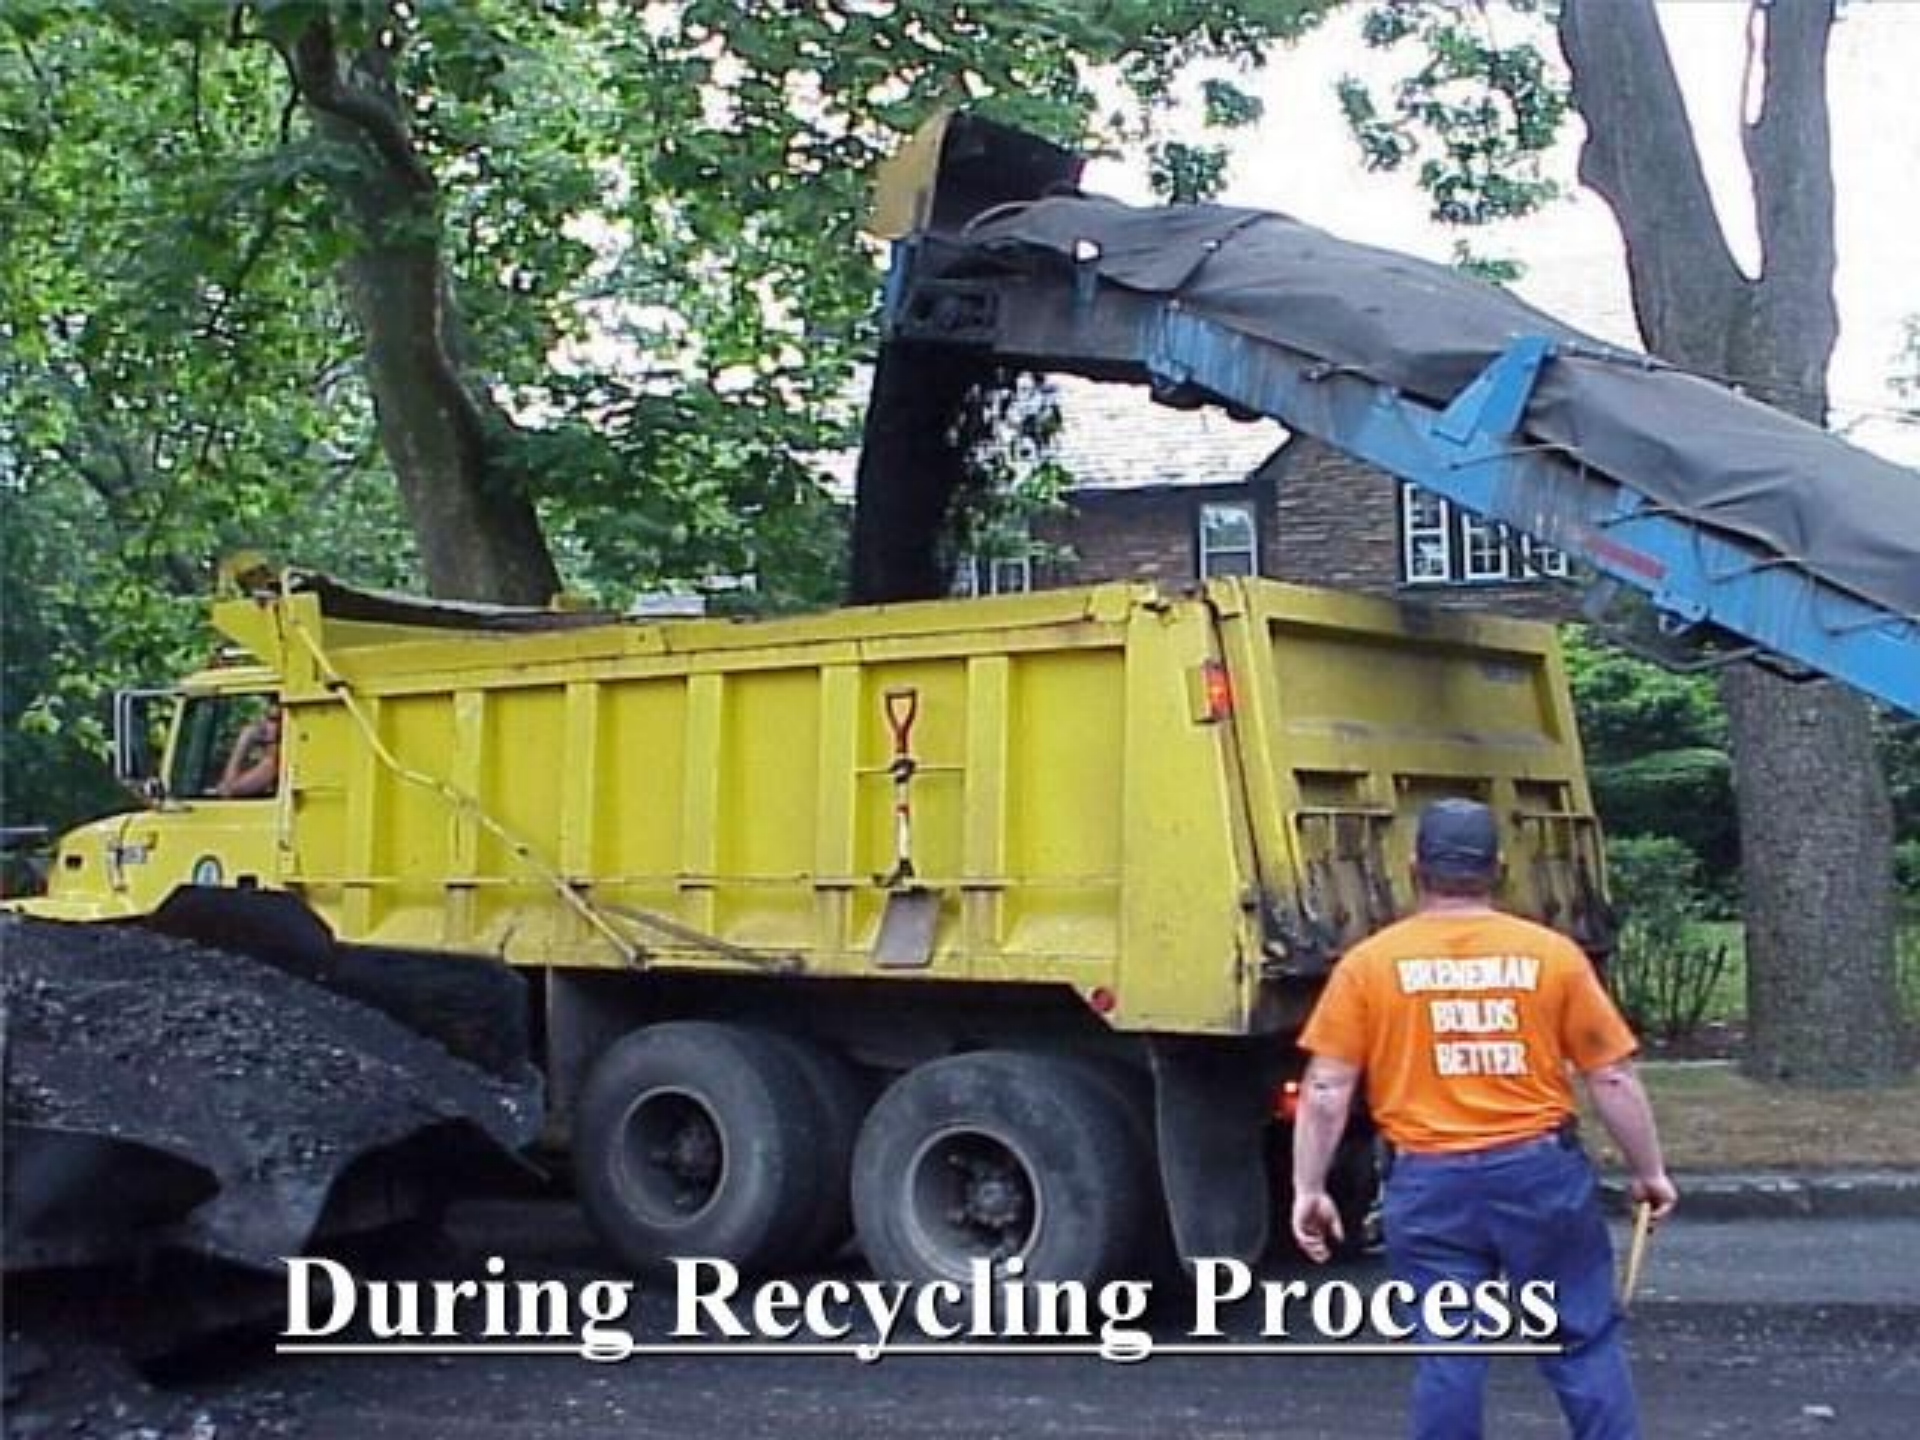
During Recycling Process

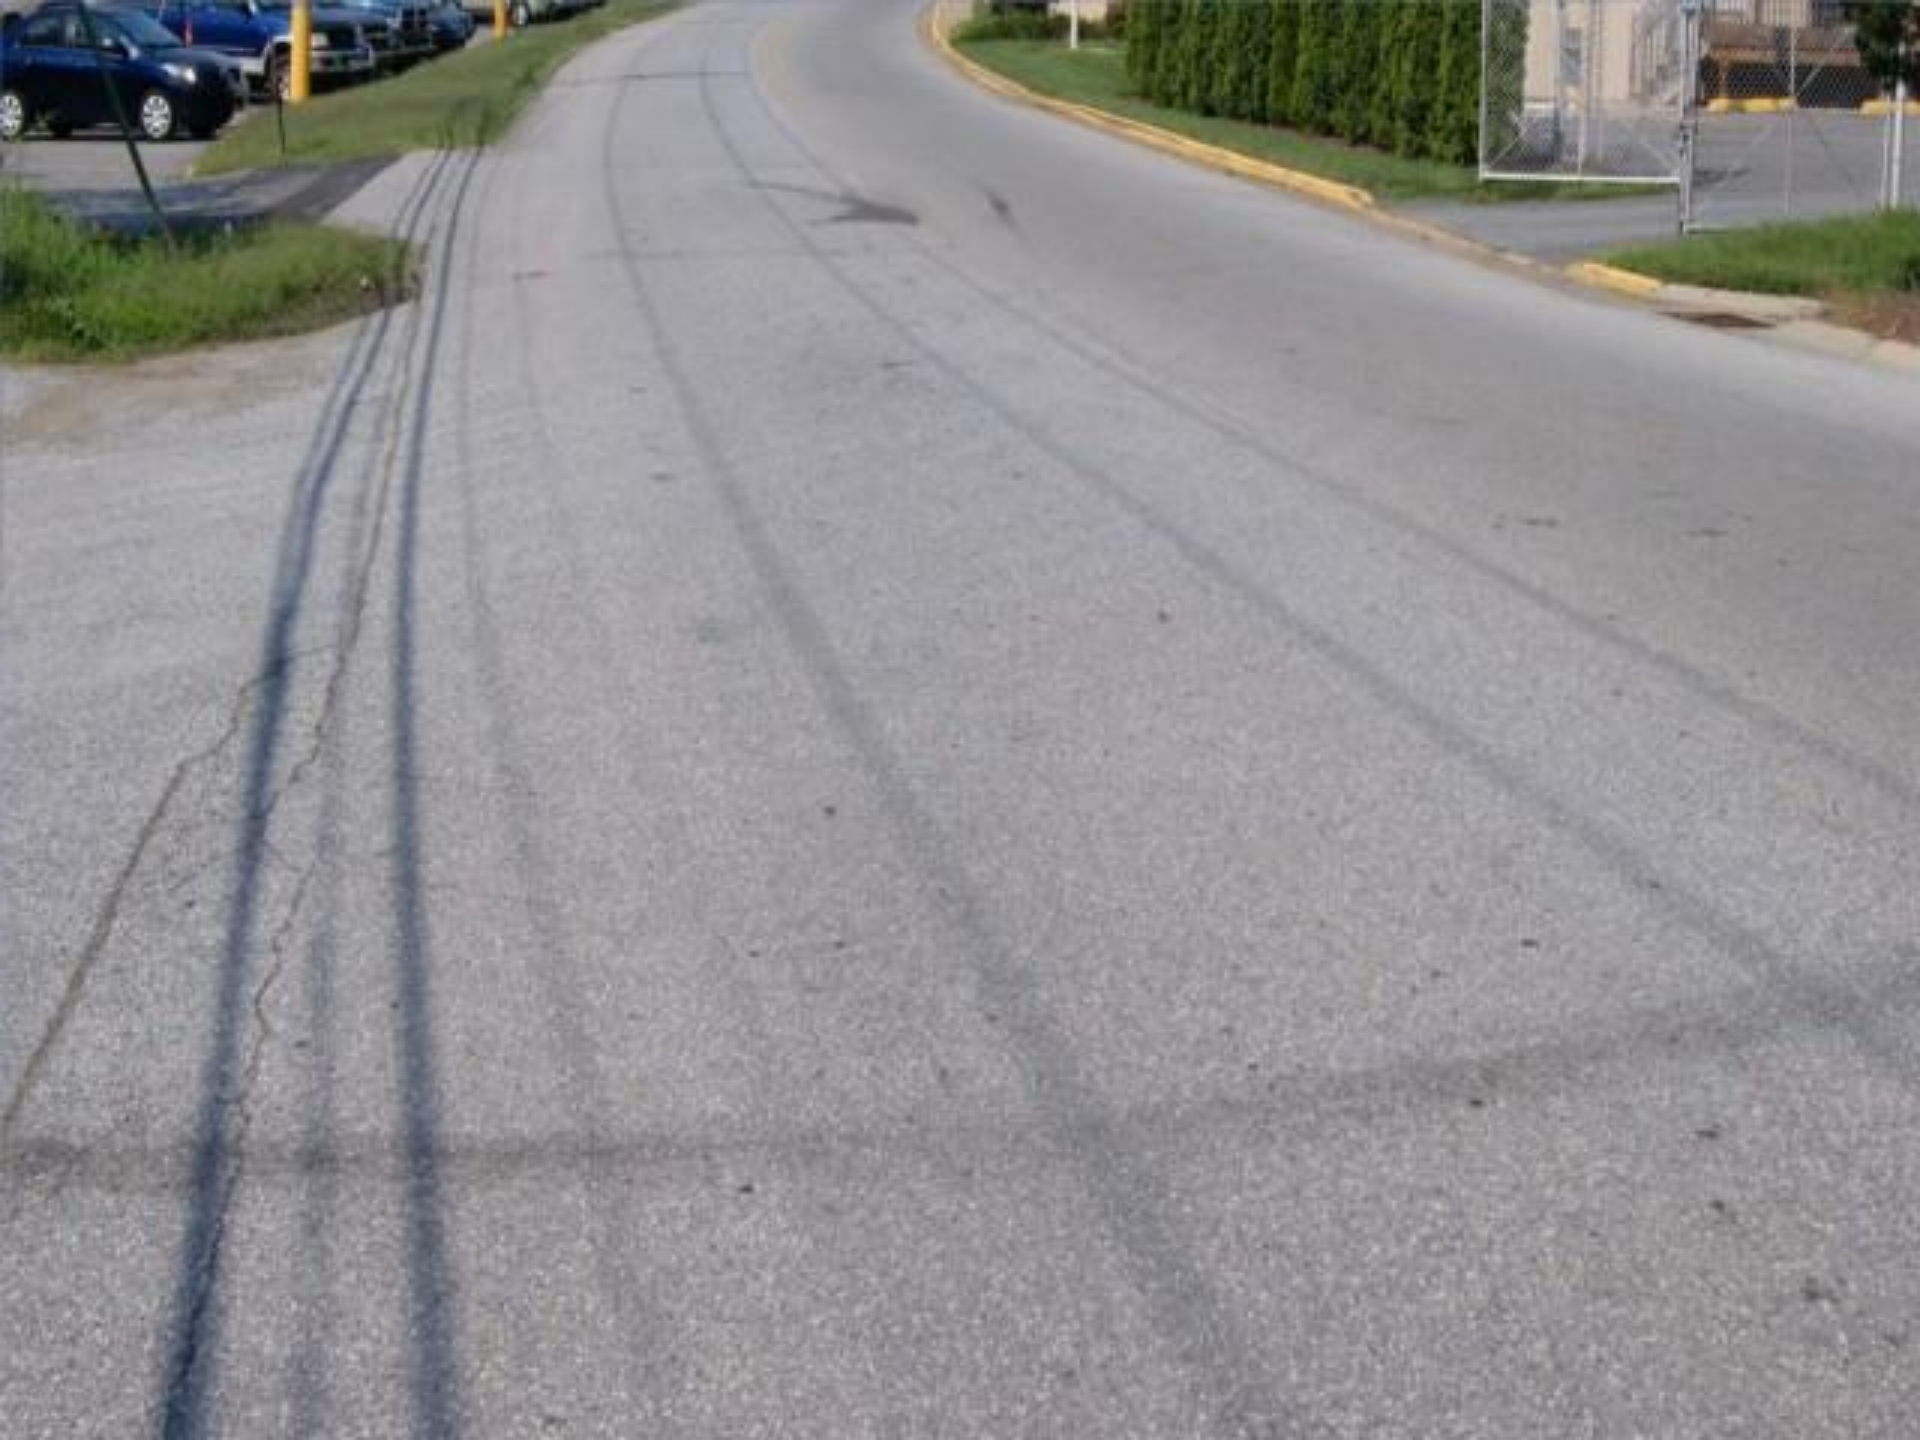
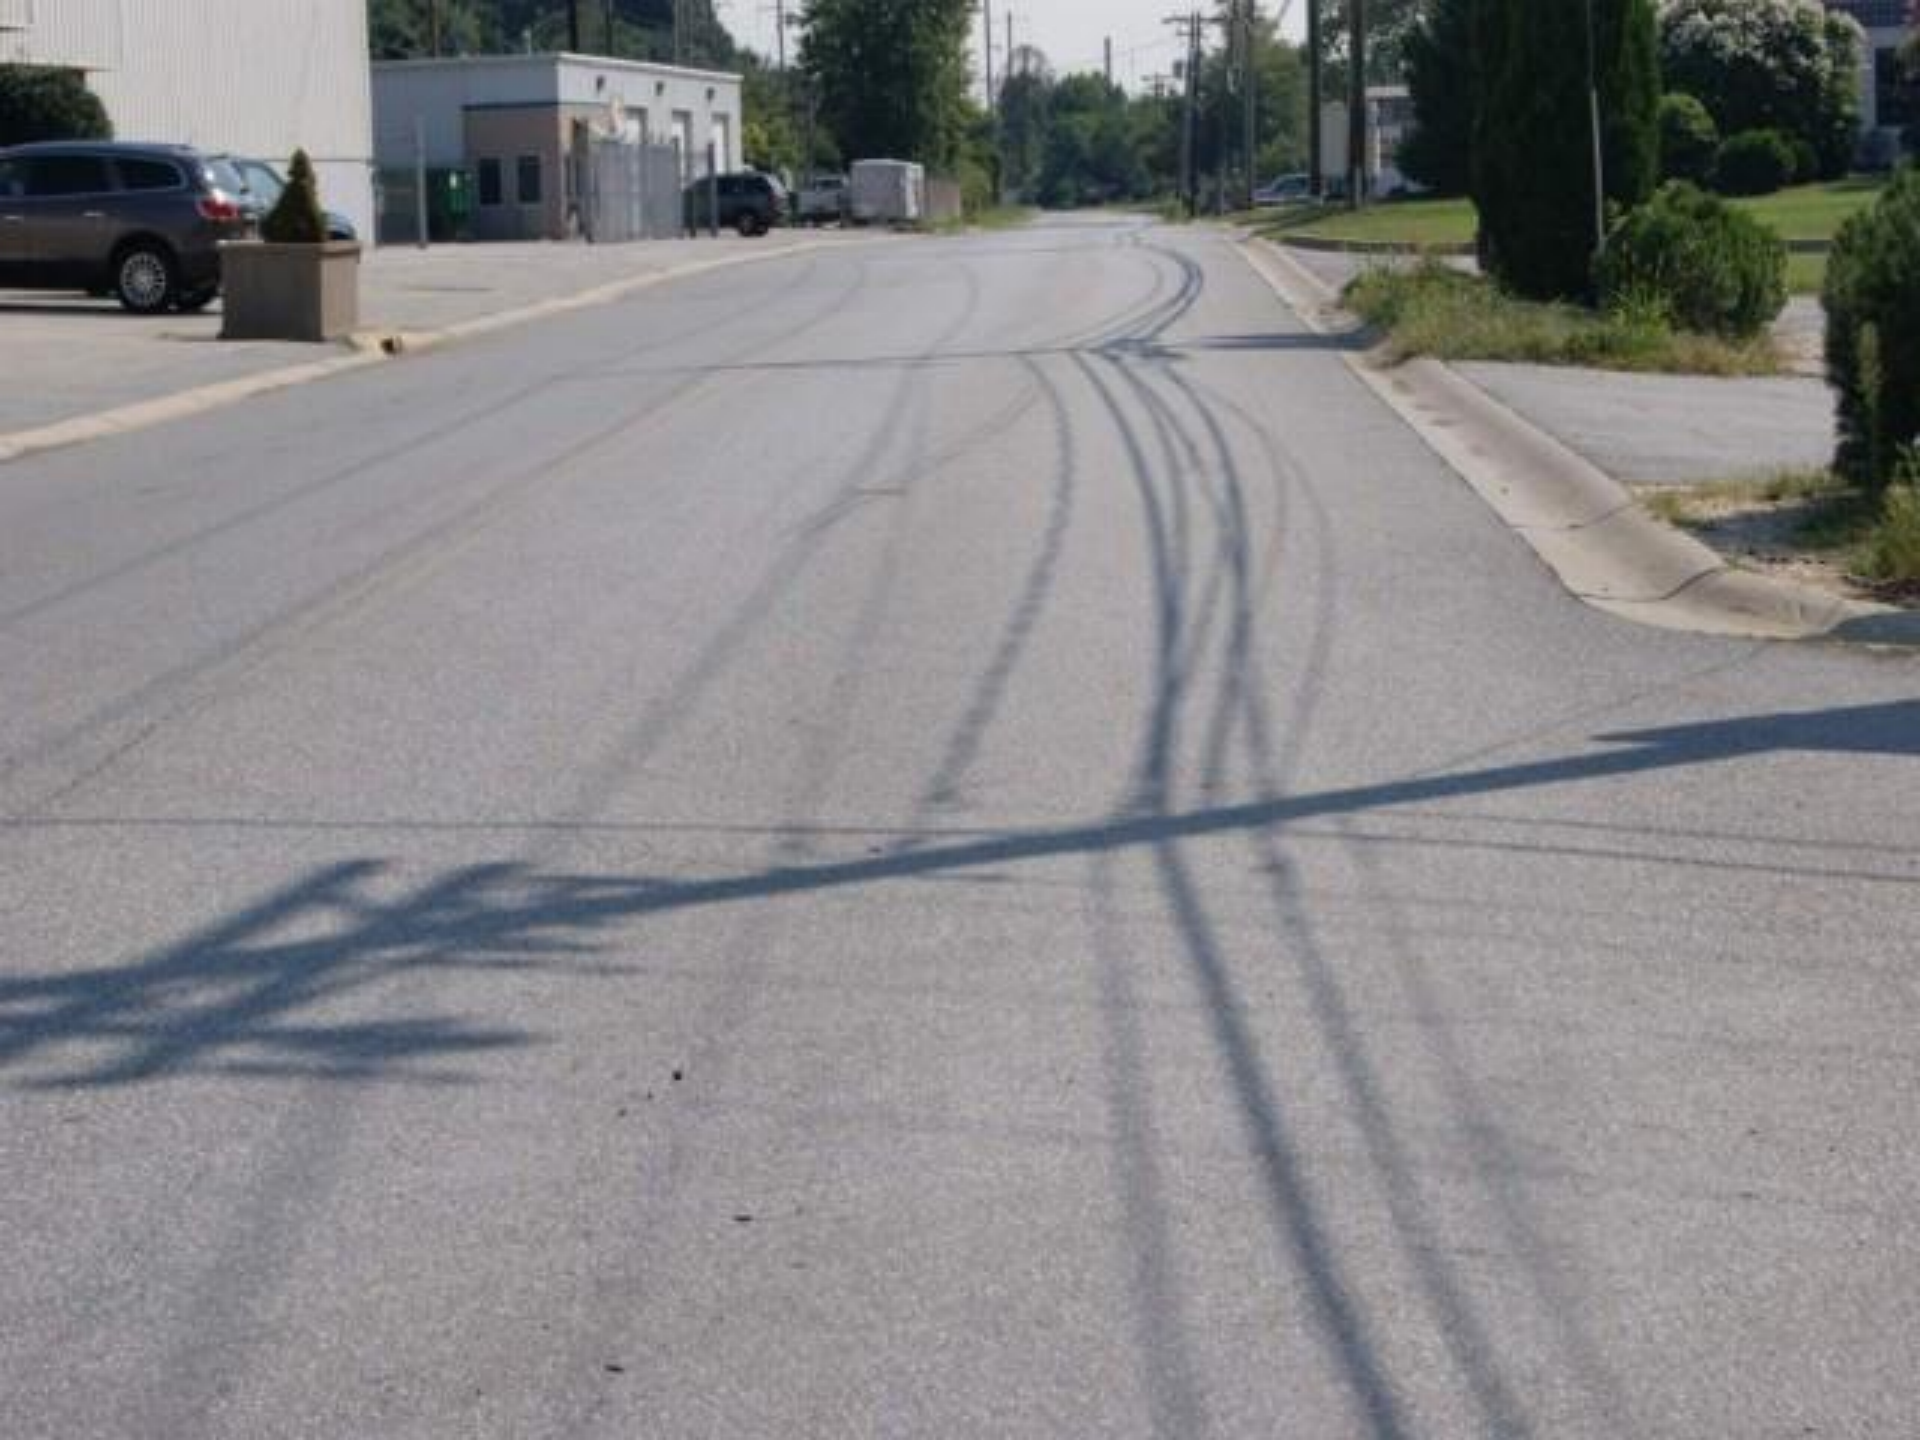
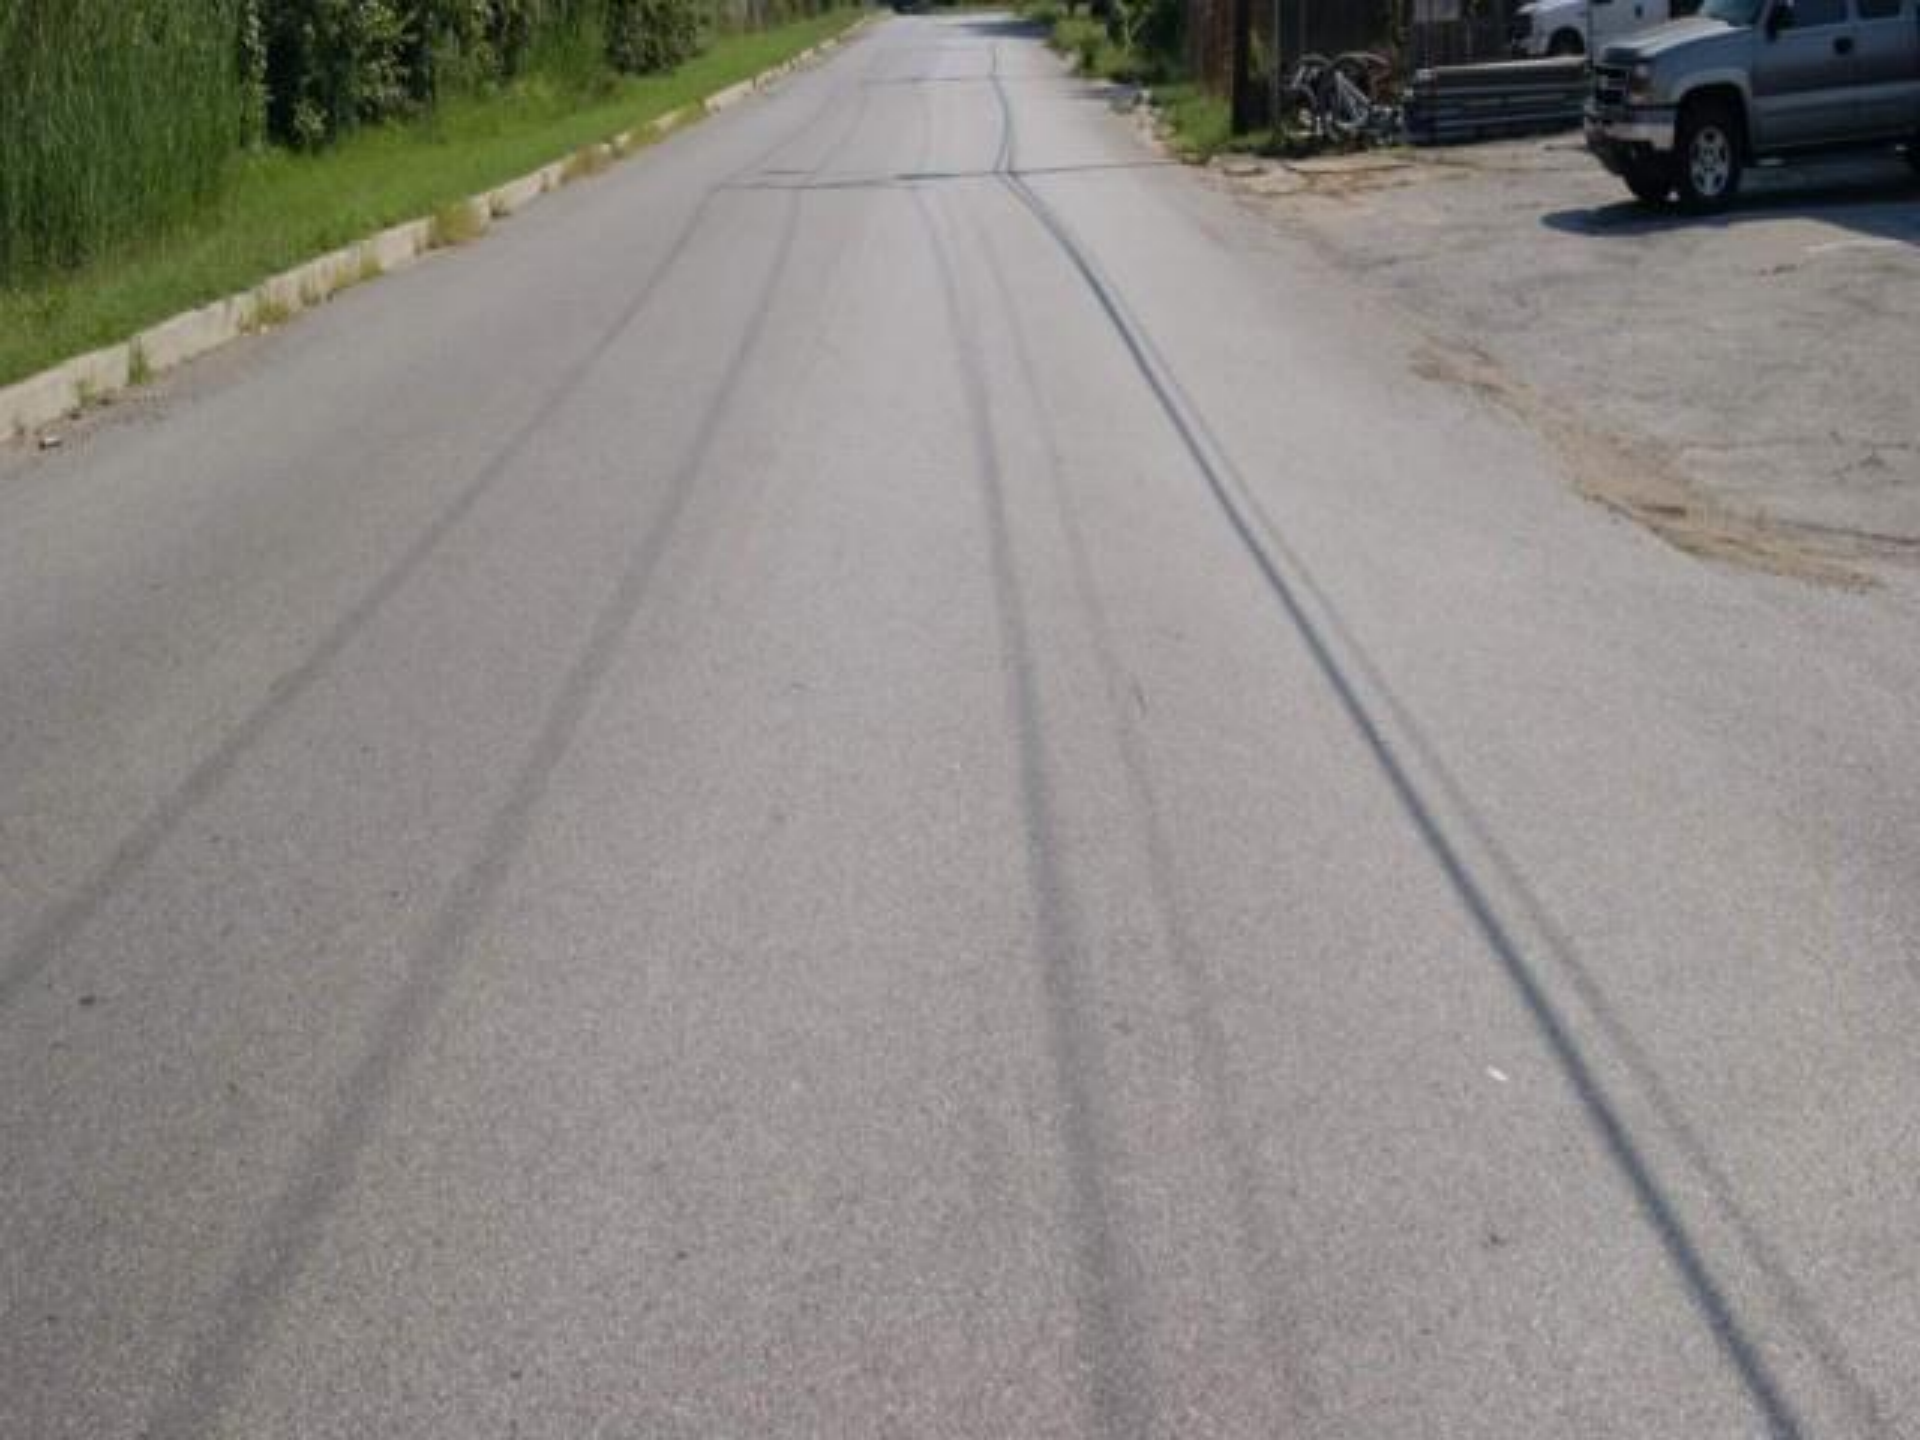
# The Good!!!

*For a 16-year old Road – Pretty darn Good*
