**Case Study**  
**1994 CIR Project**  
**Newport, Delaware**

# Topics to be Covered

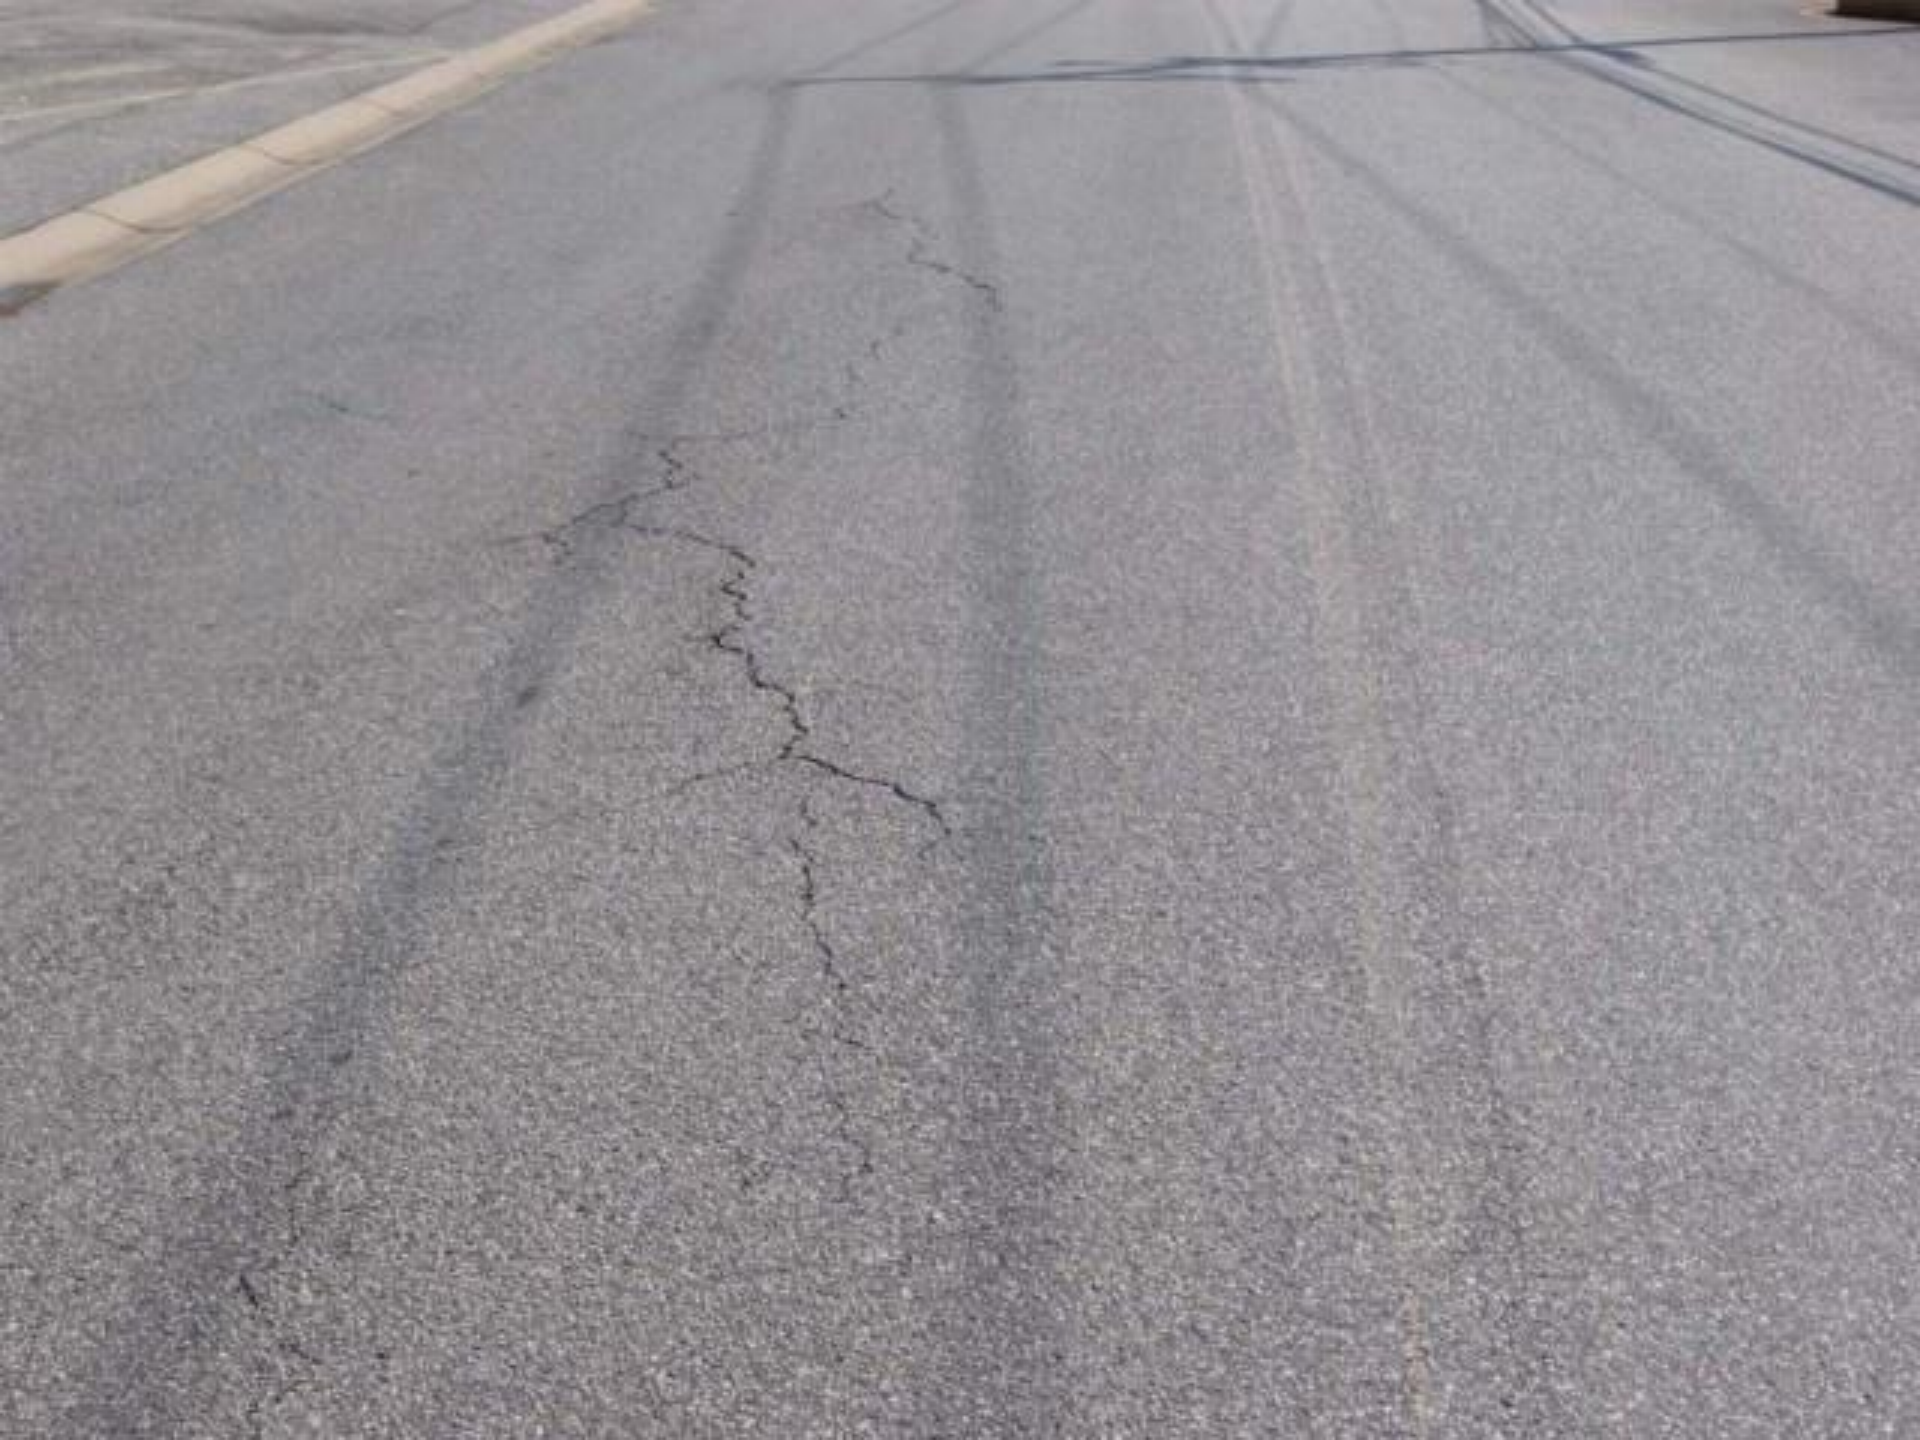
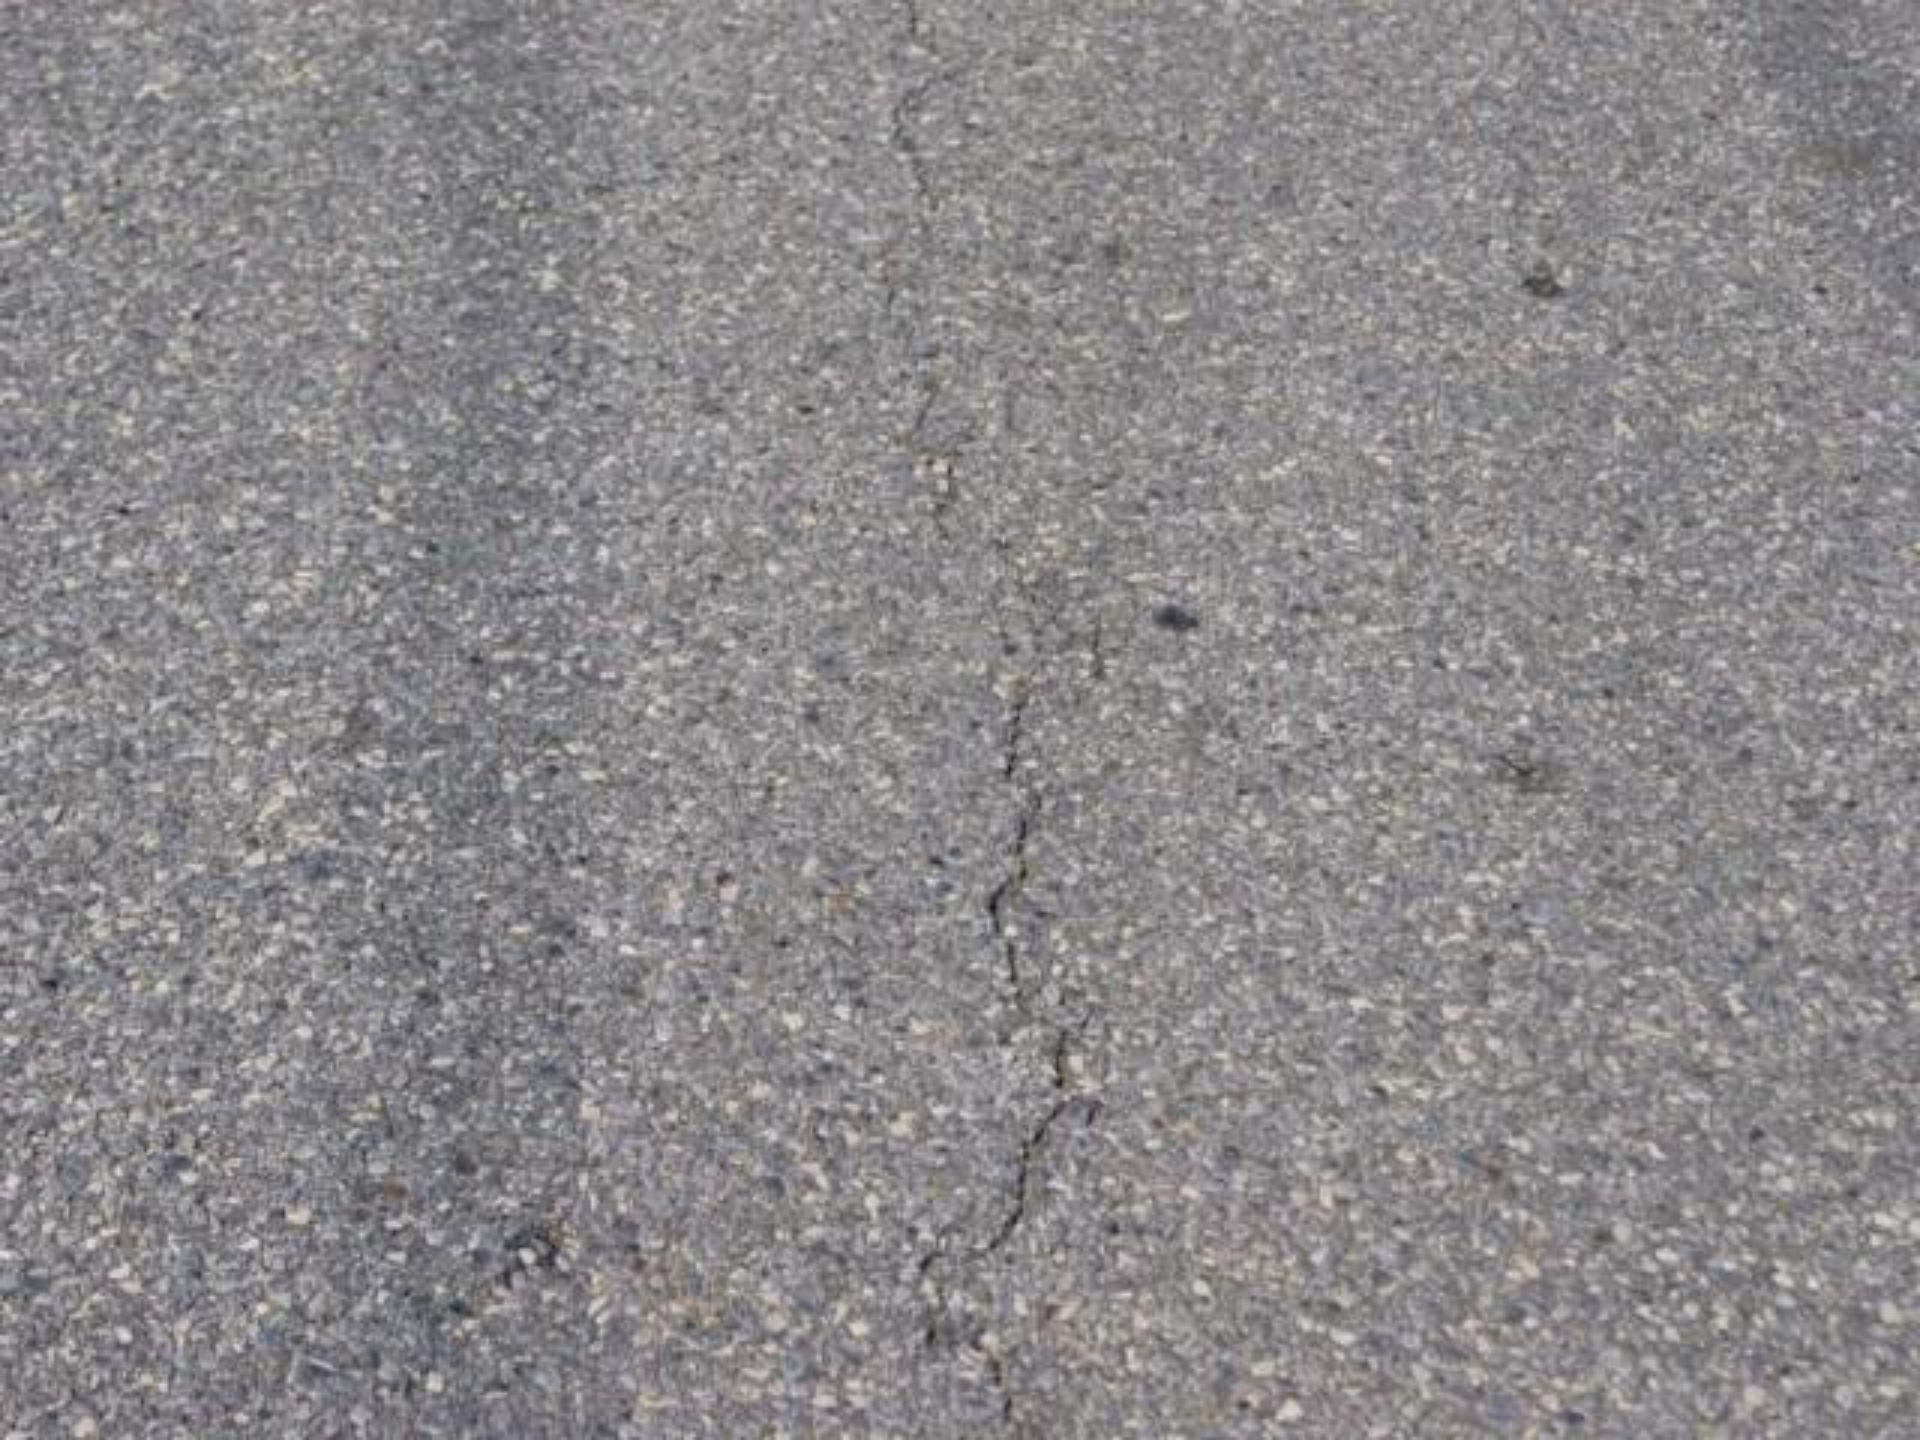
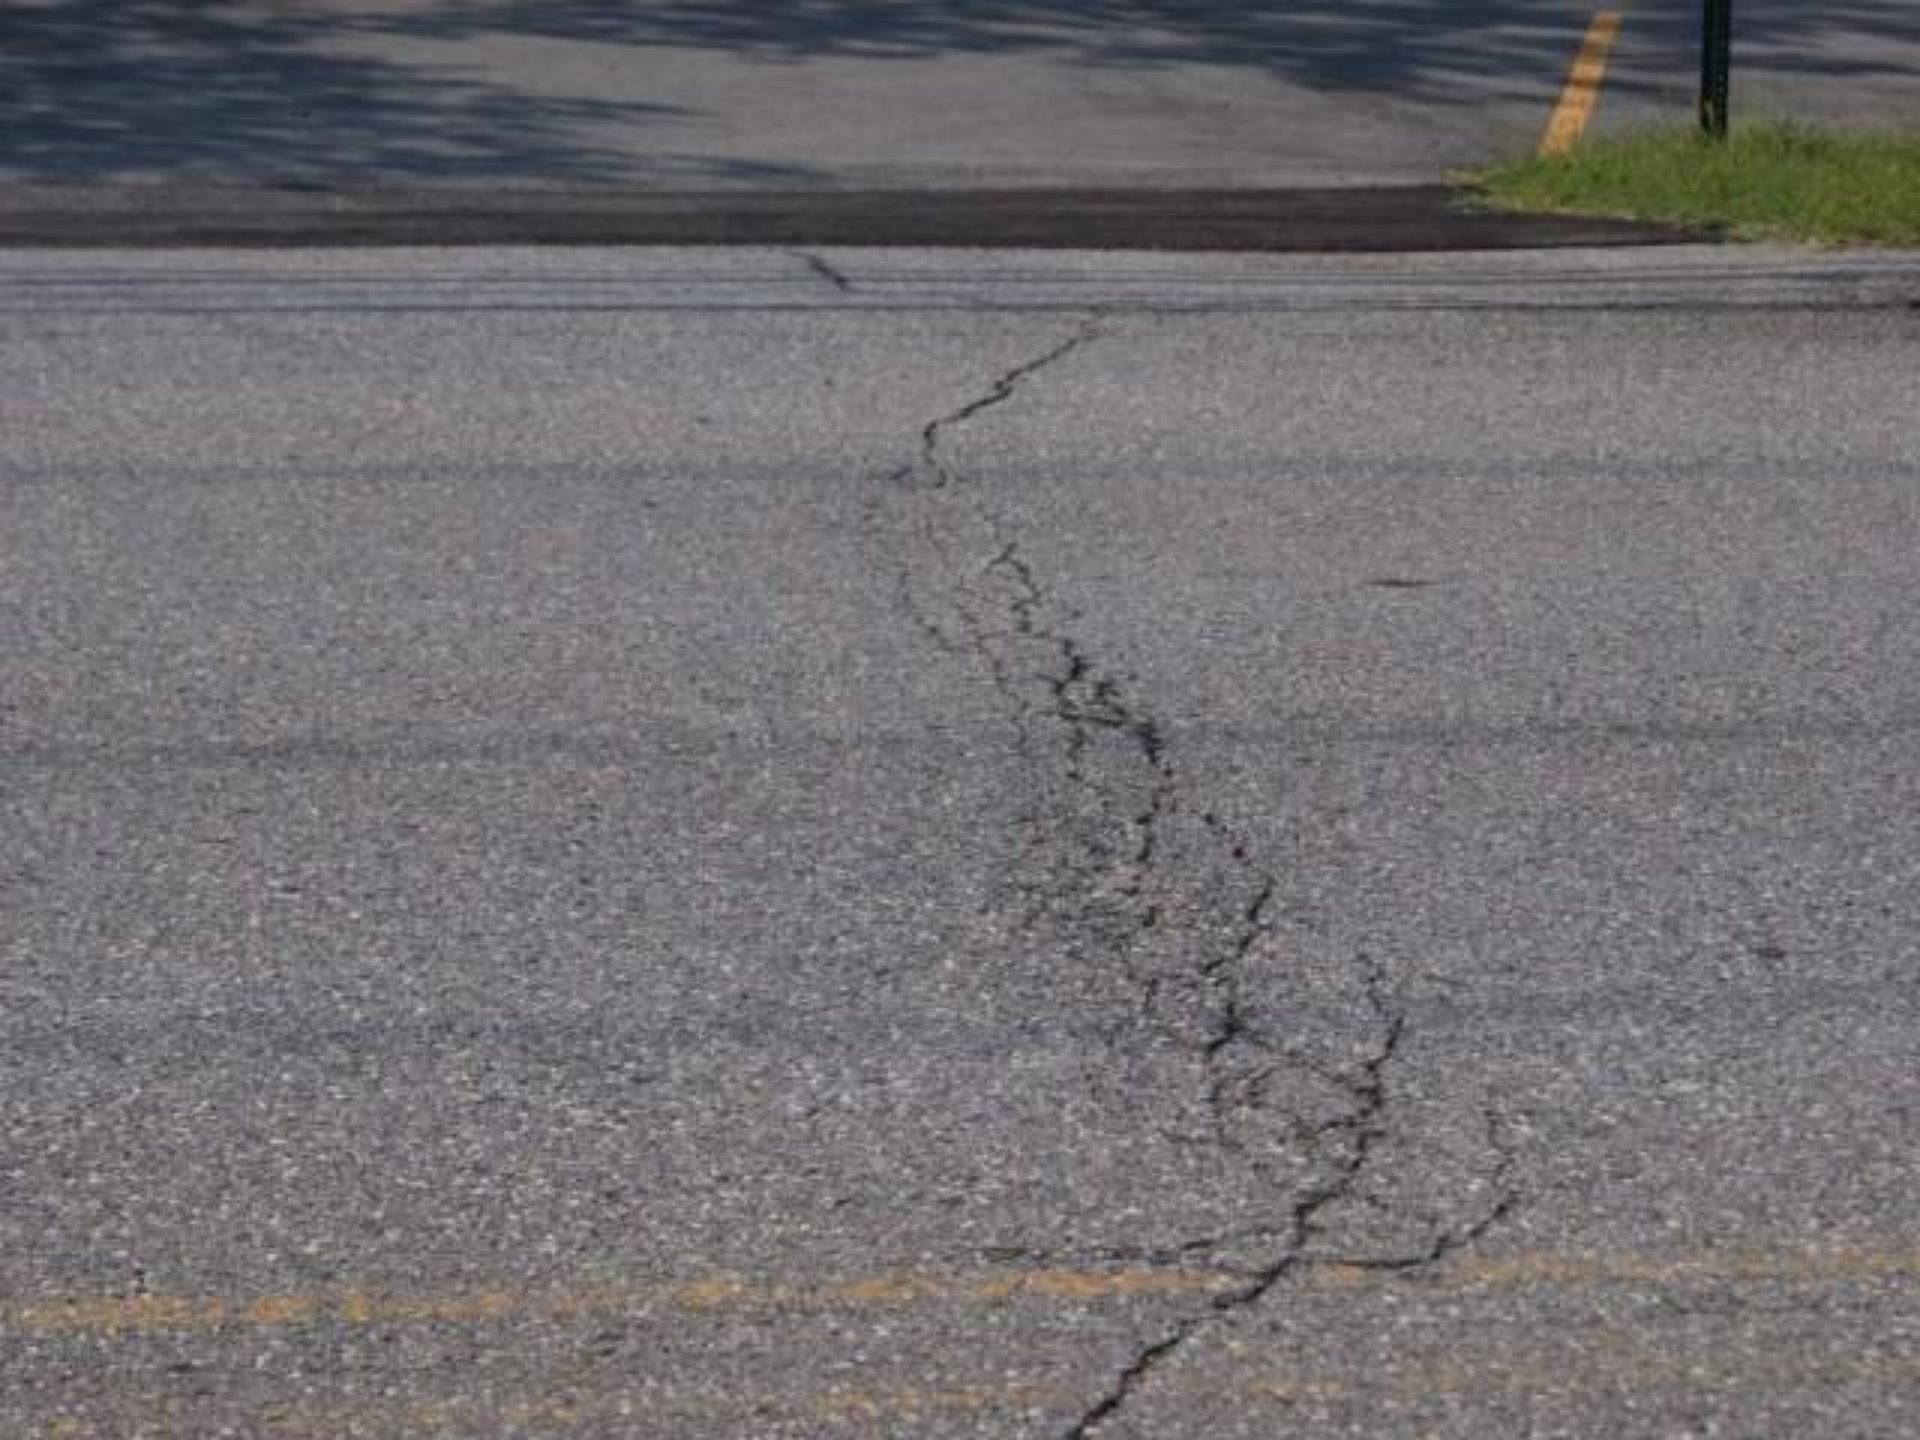
# It's Not all Perfect

*A Few Spots with Distress*

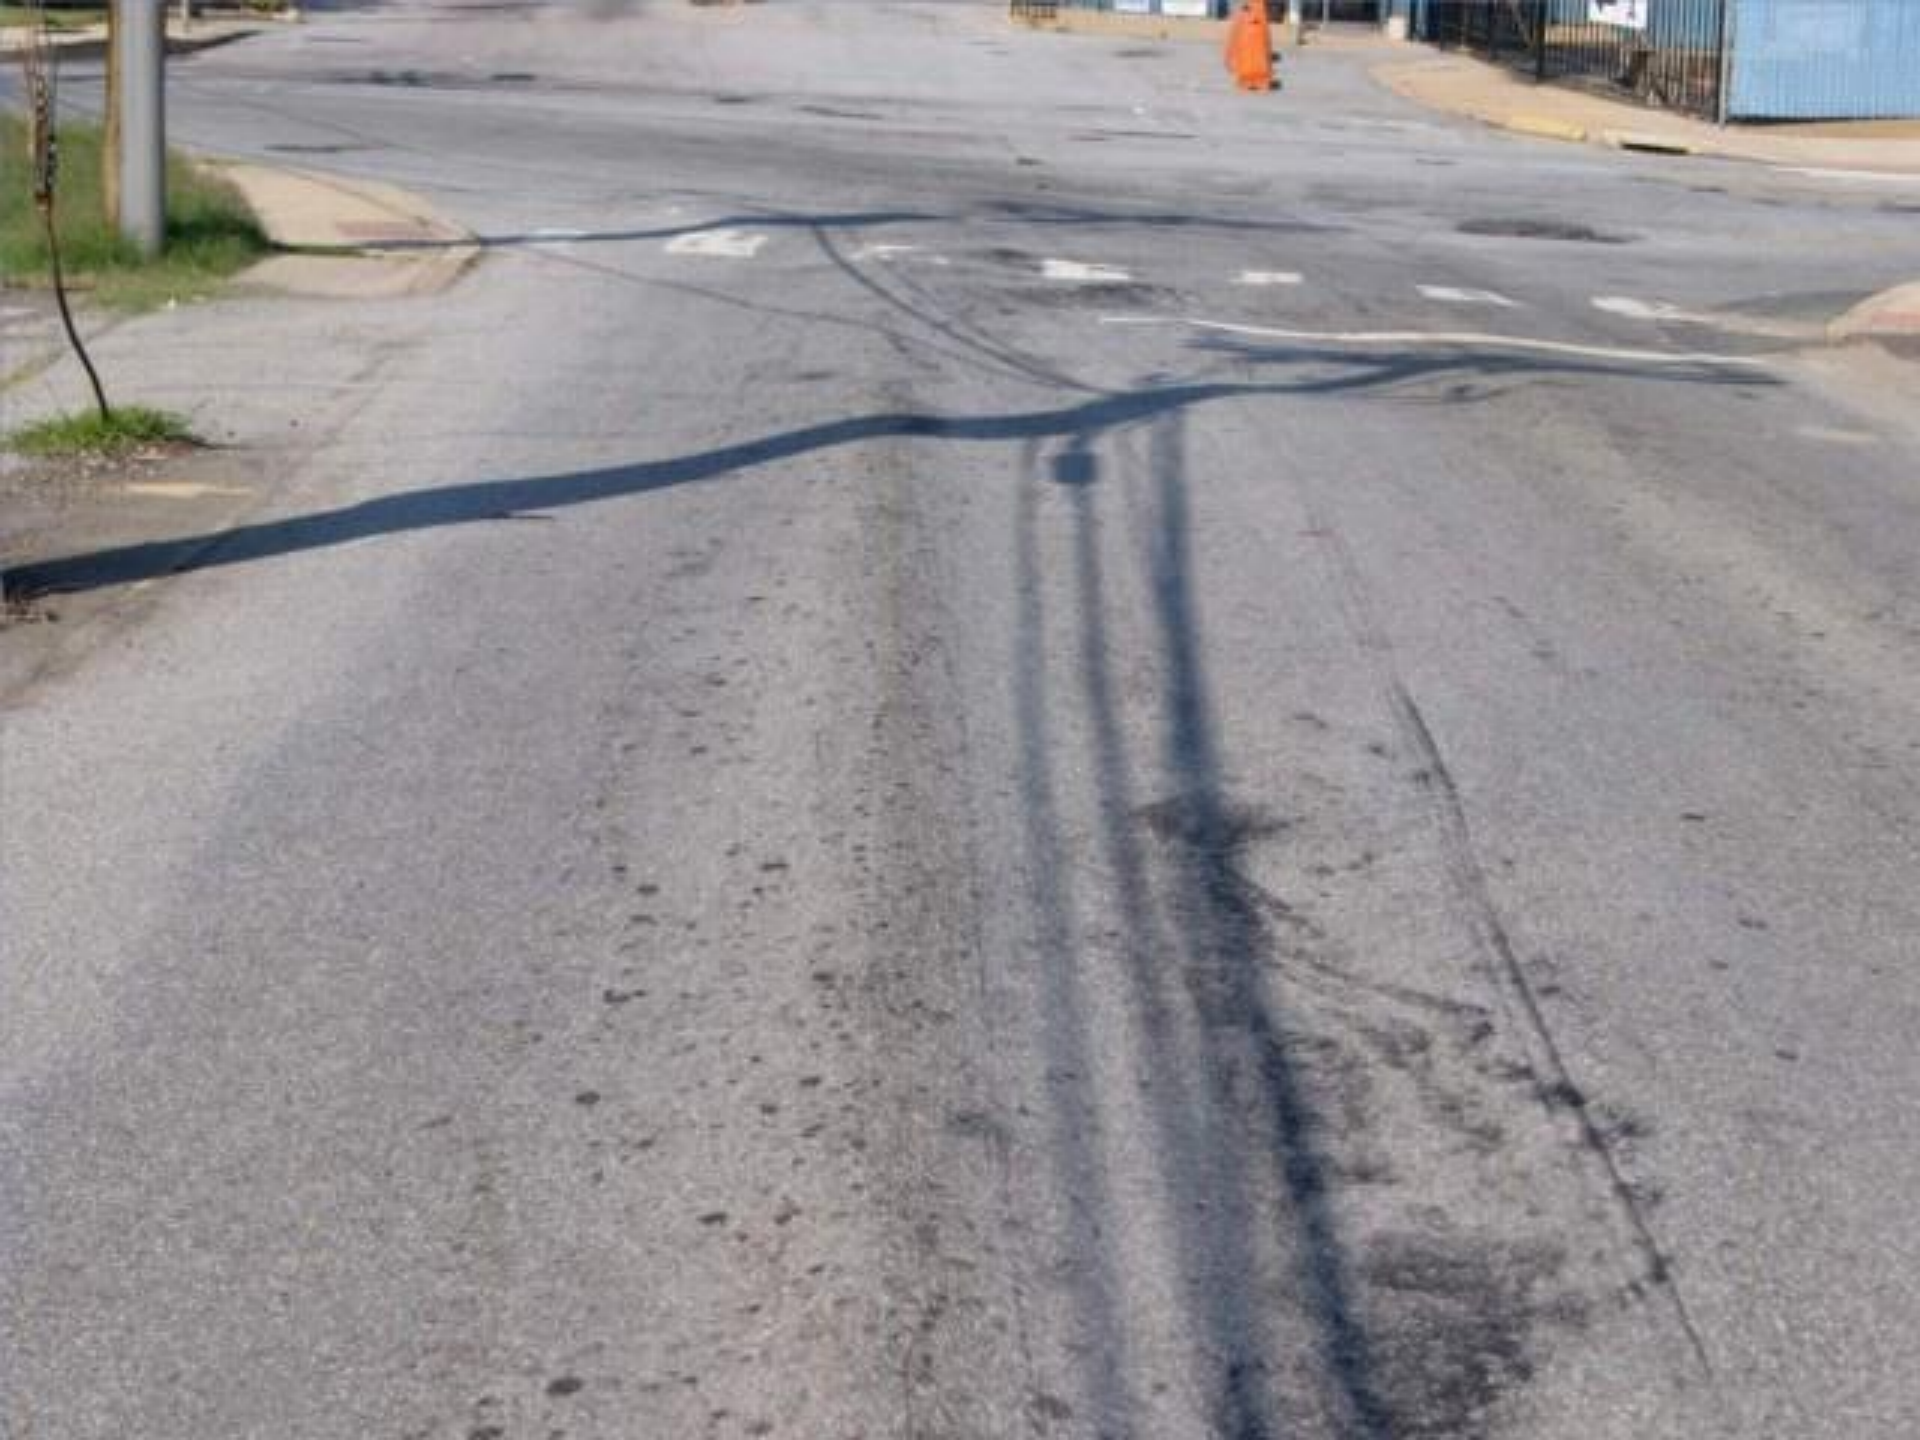
# One Significant Issue

Serious Rutting Occurred Early On in Two Locations

A Subgrade Moisture Problem

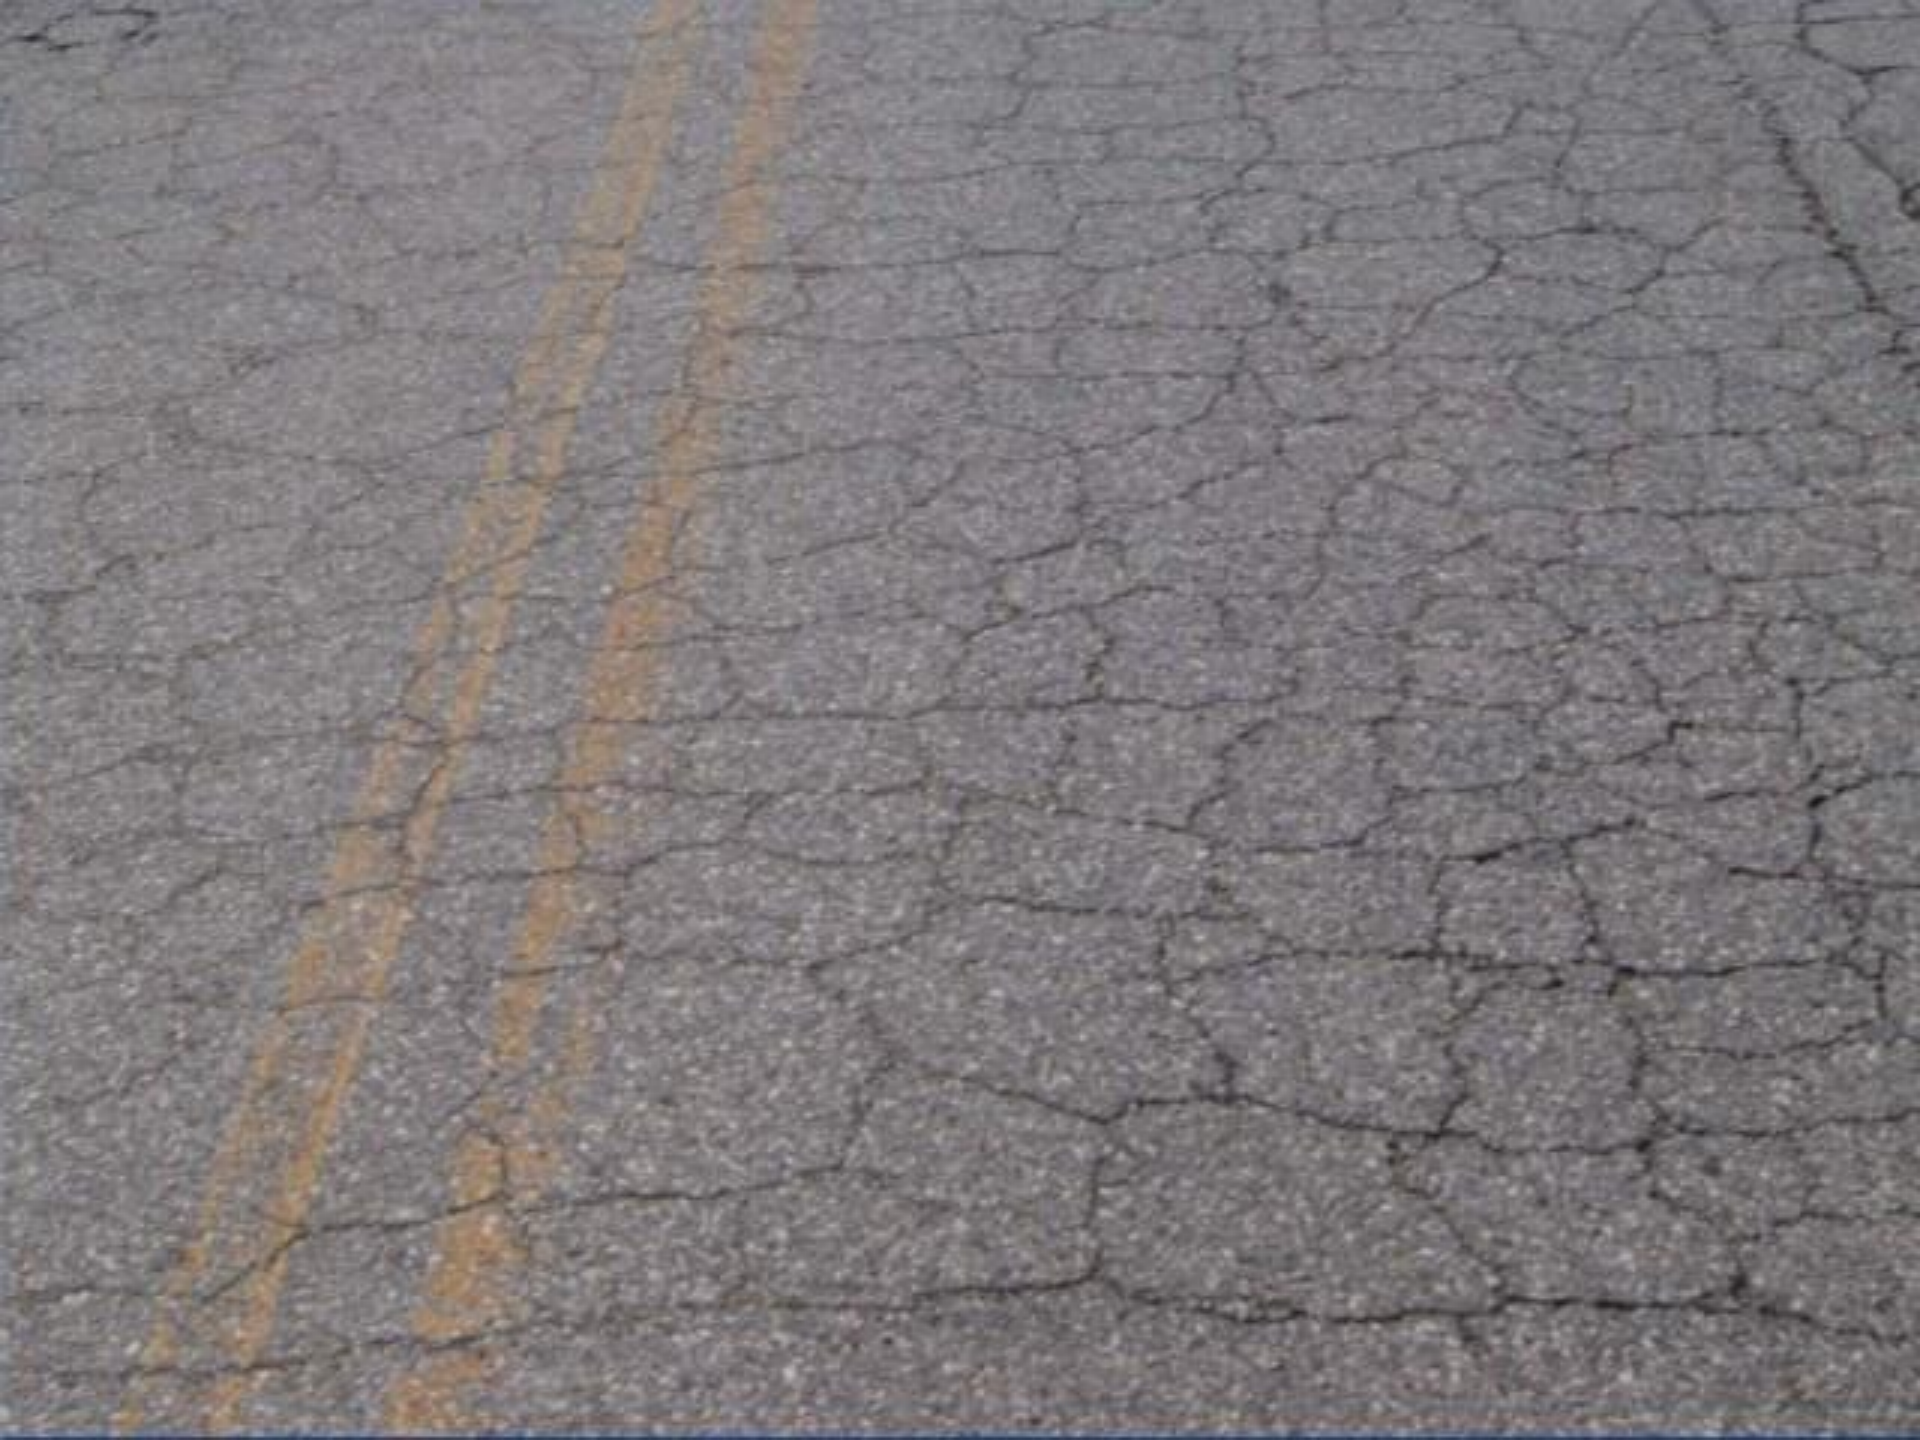
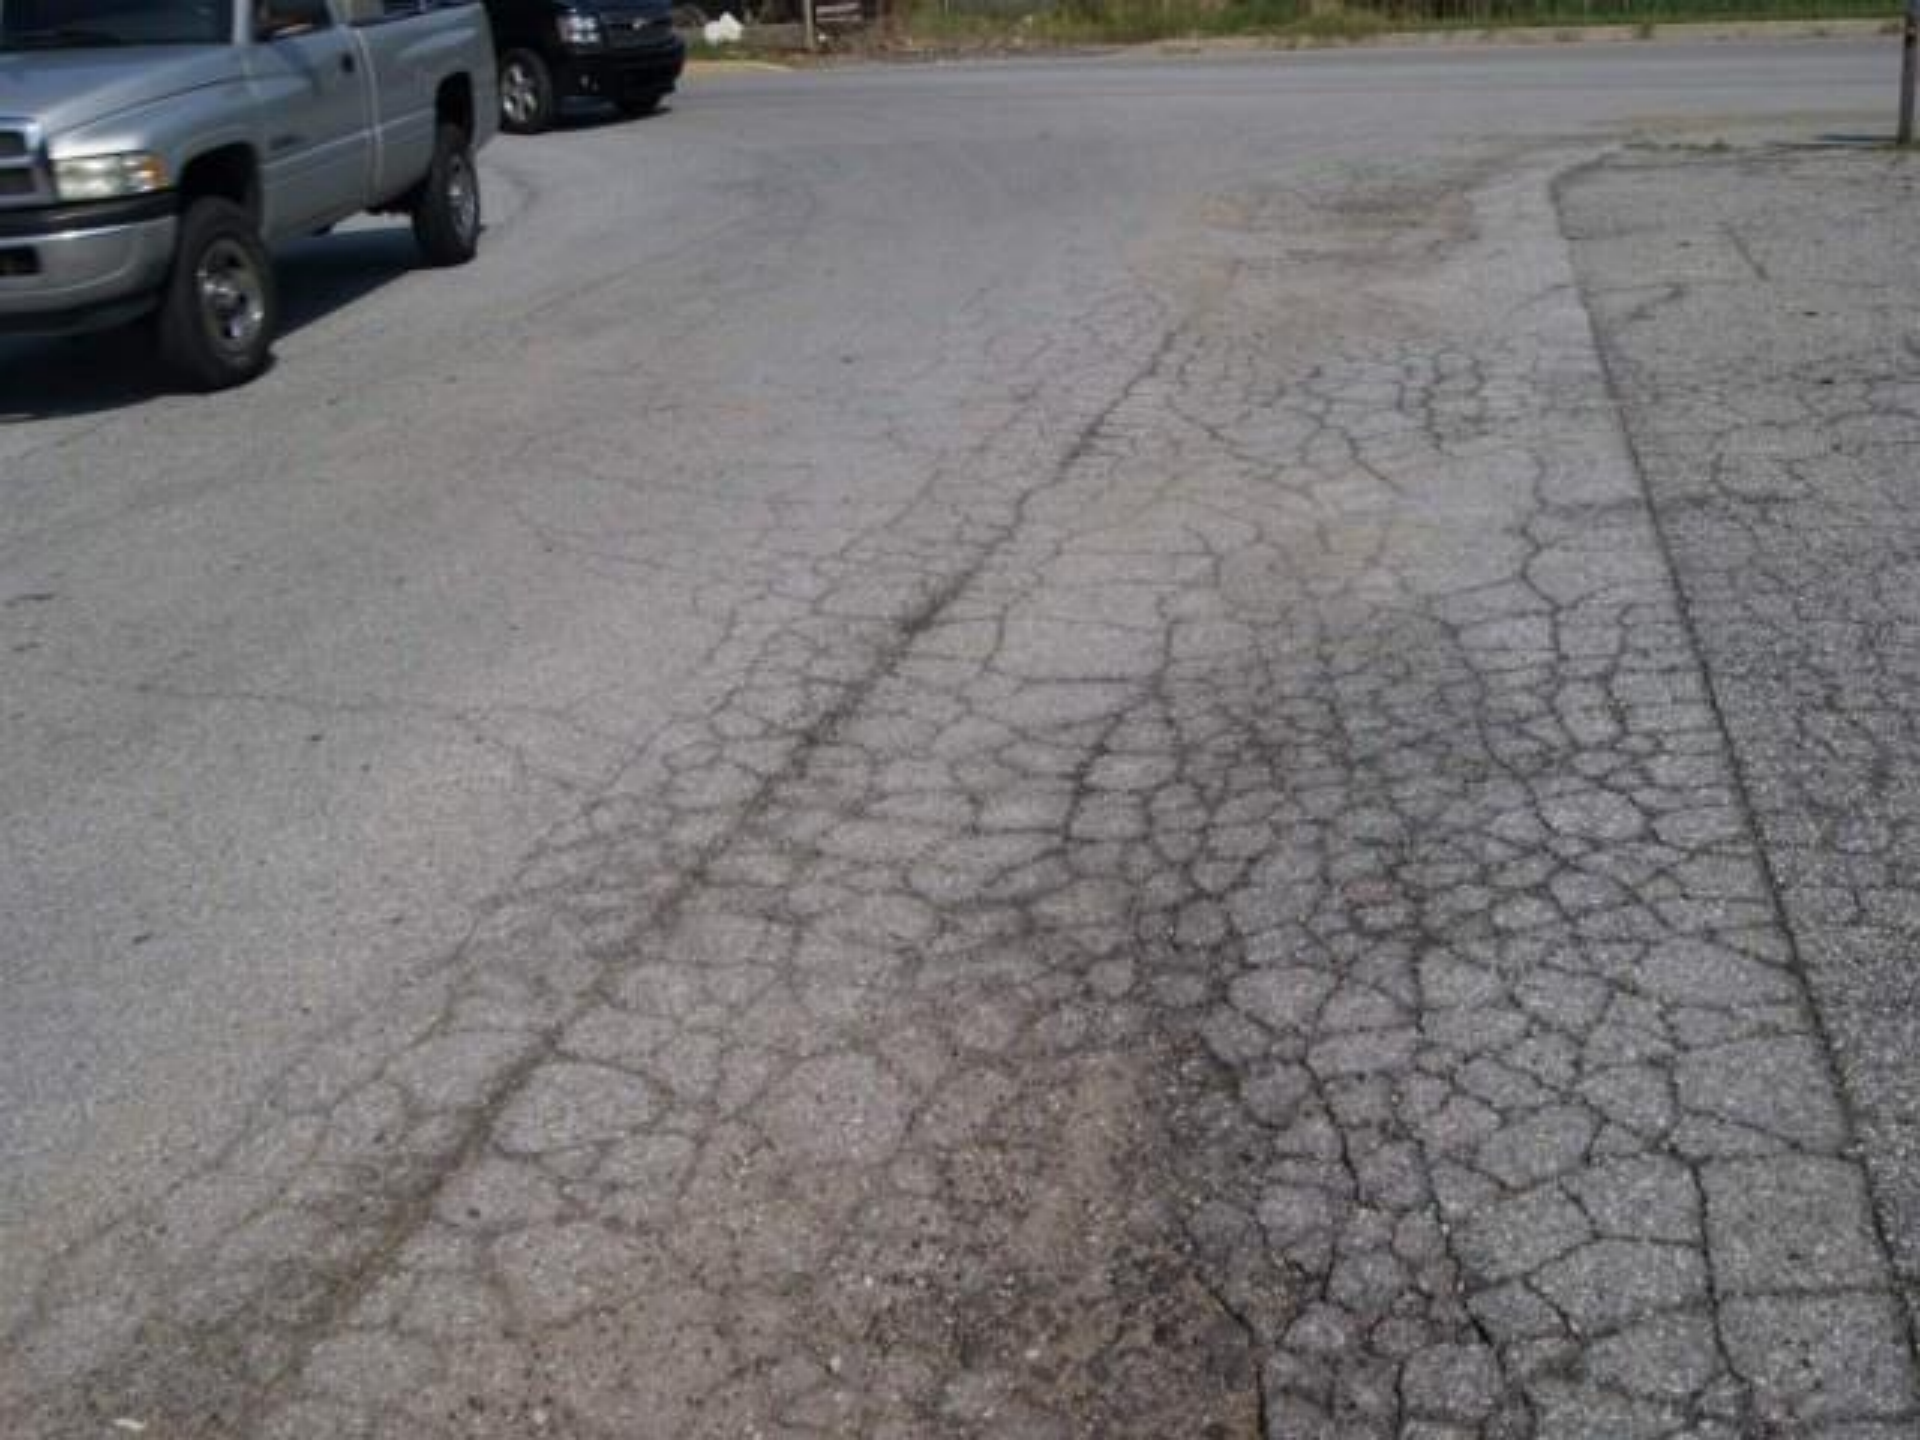
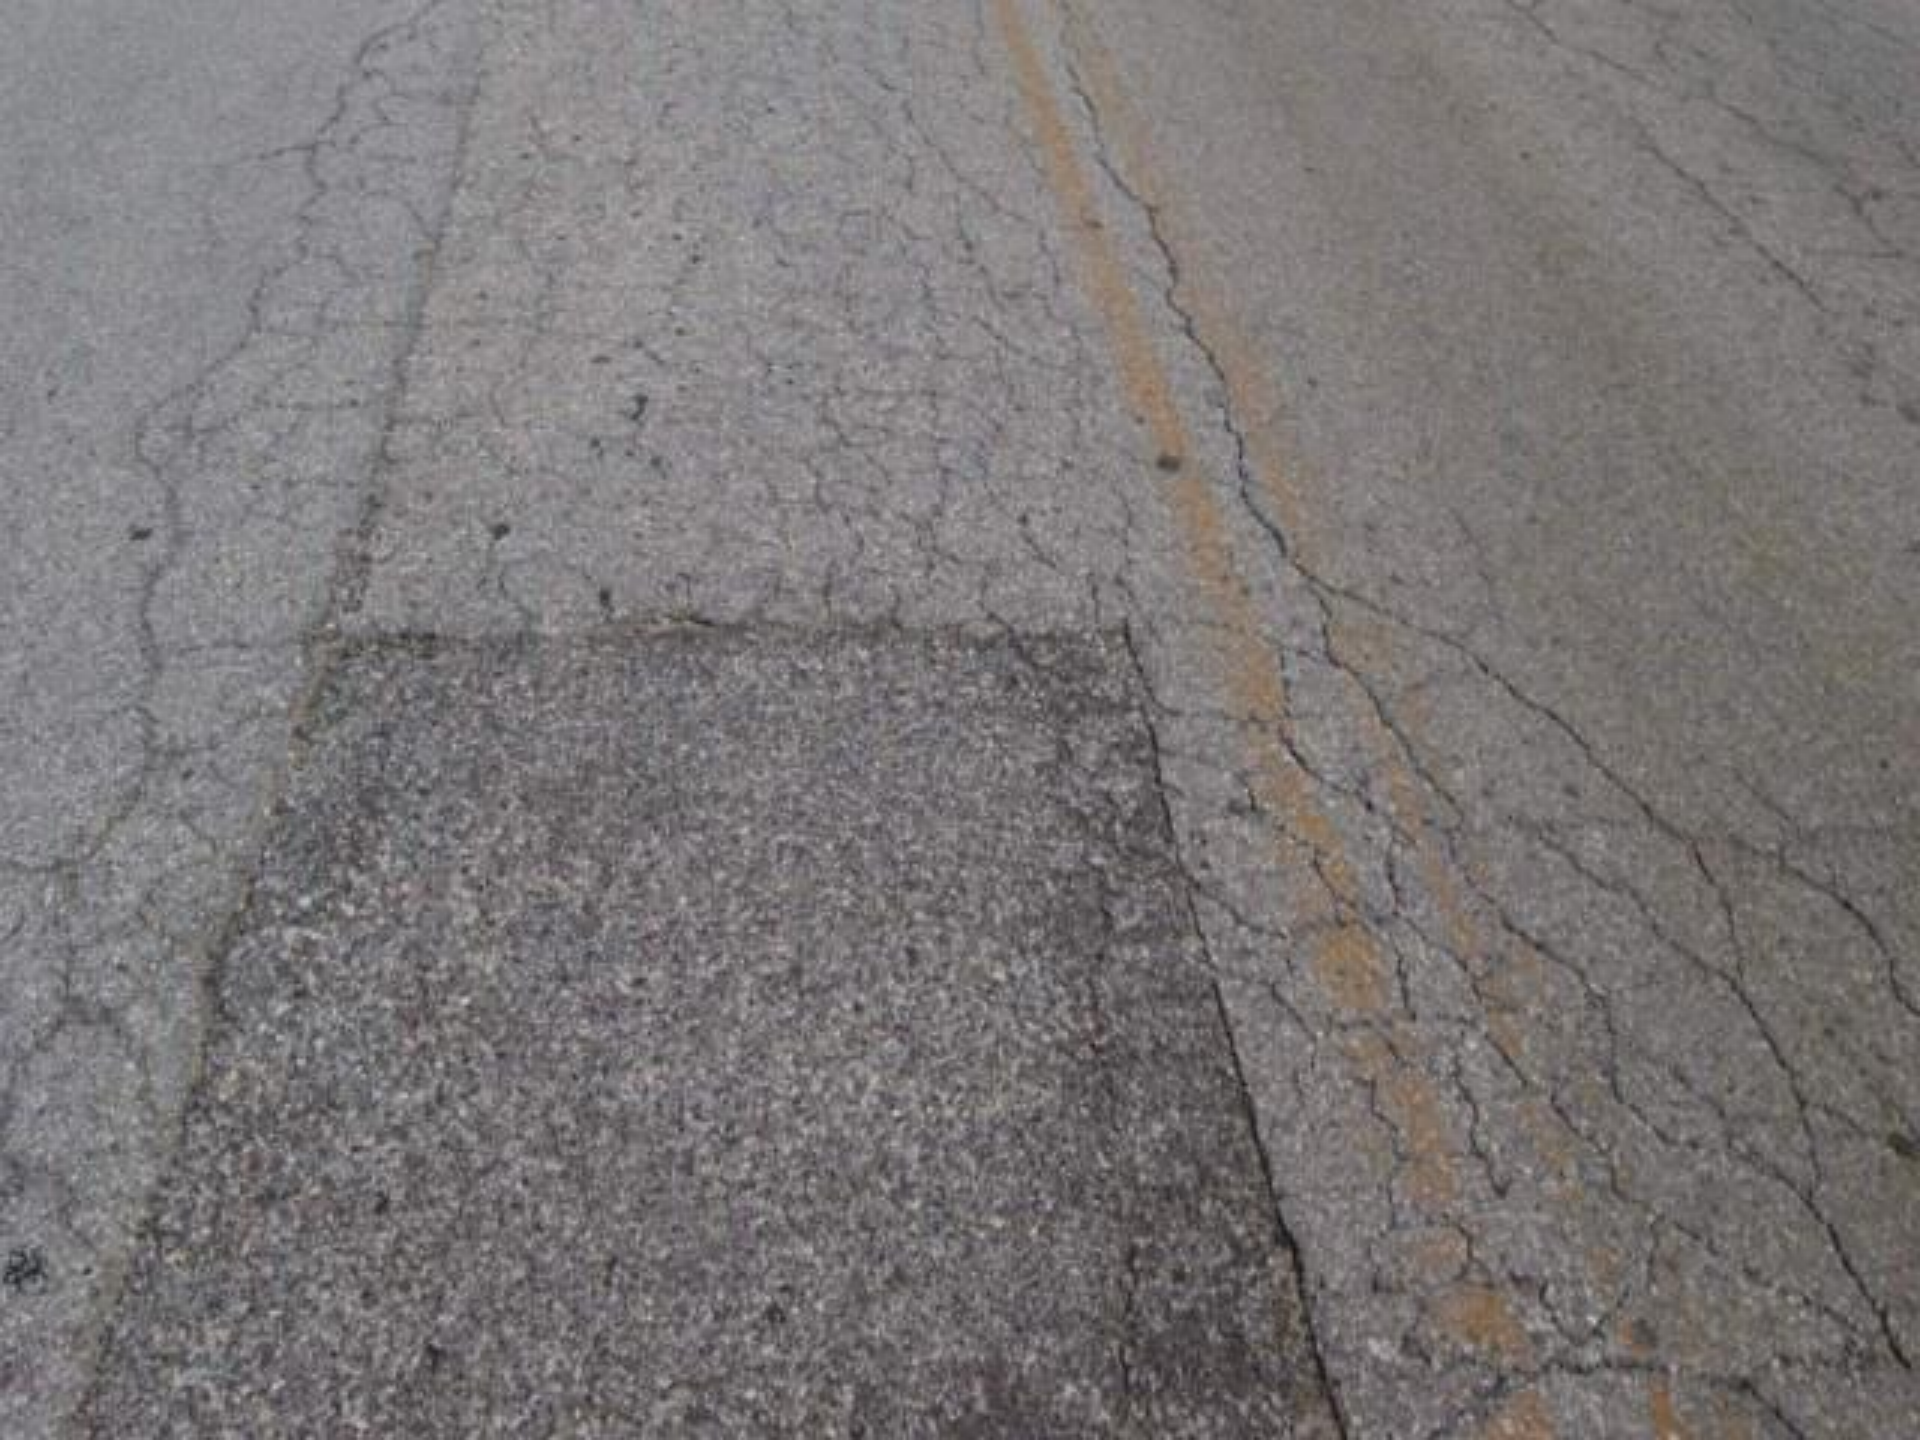
# Patch and Overlay Street

- Side Road in the Industrial Park
- Receives approximately  $\frac{1}{3}$  the traffic loading as the Main Road
- Pavement Structure
  - Slightly less asphalt
  - Similar aggregate base
  - Similar subgrade

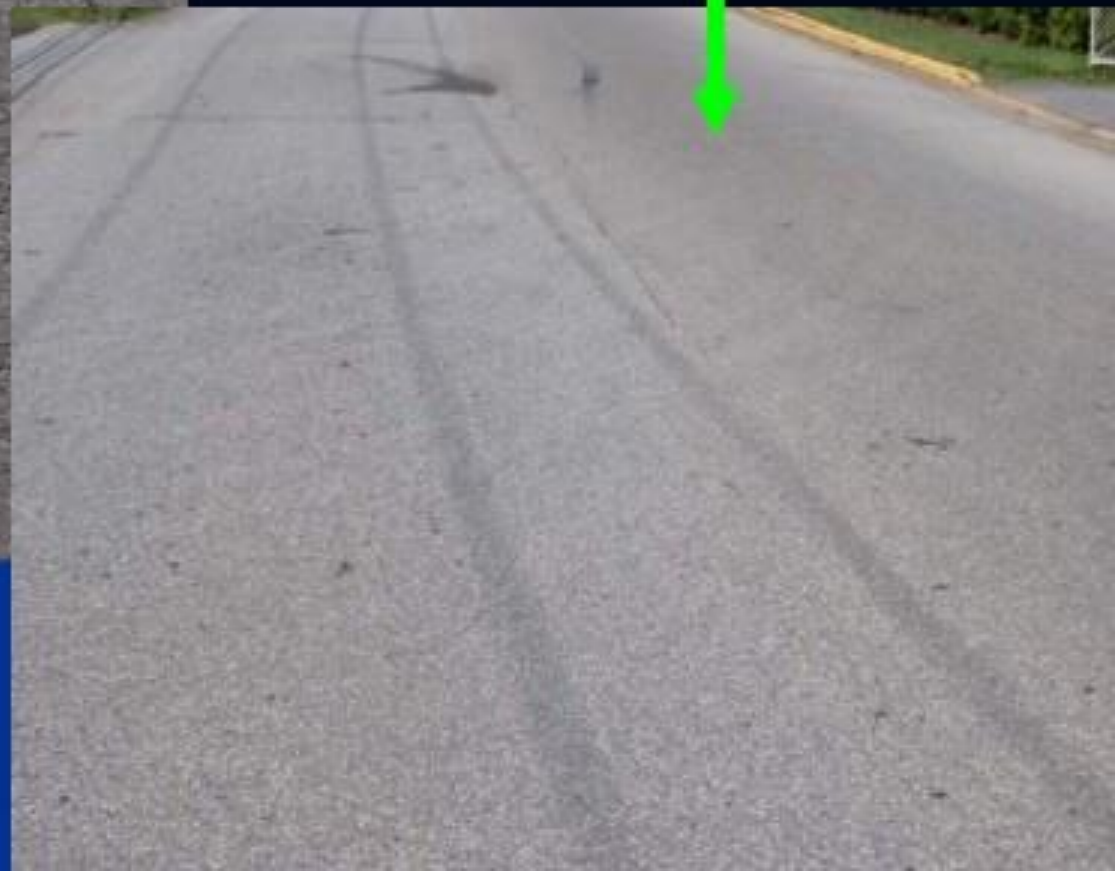
1994 Cold In-place Recycling

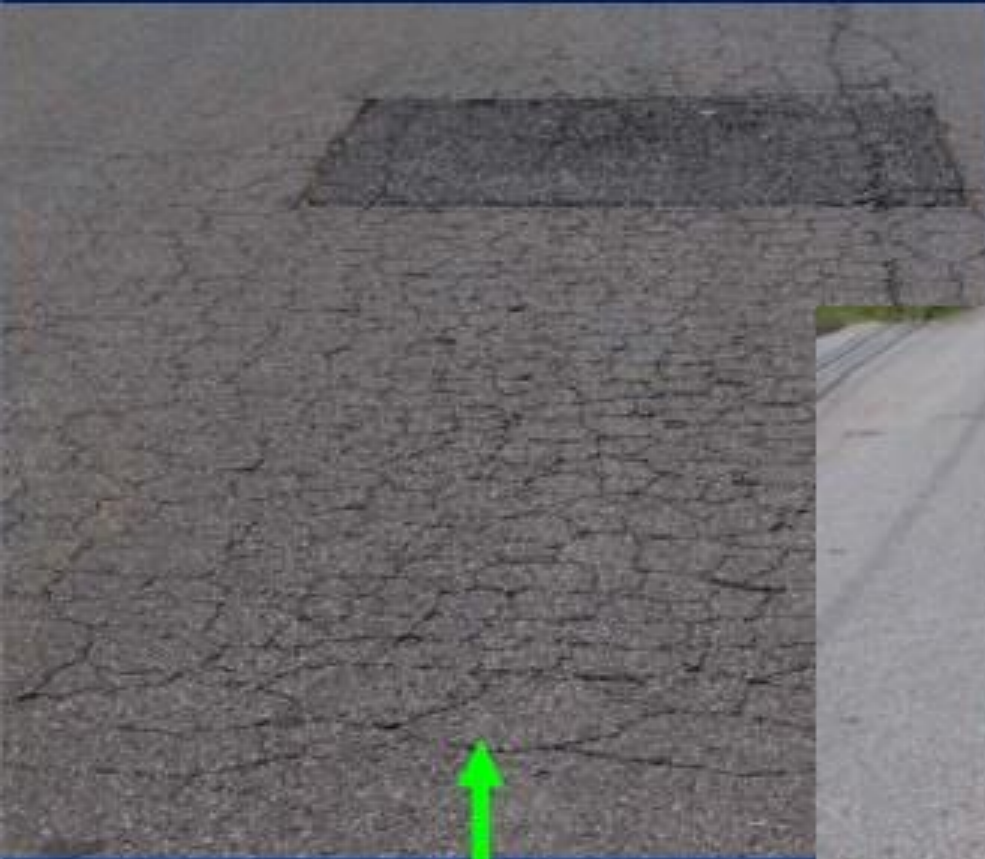
1994 Patch, Mill & Fill
