**Case Study**  
**1994 CIR Project**  
**Newport, Delaware**

# Topics to be Covered

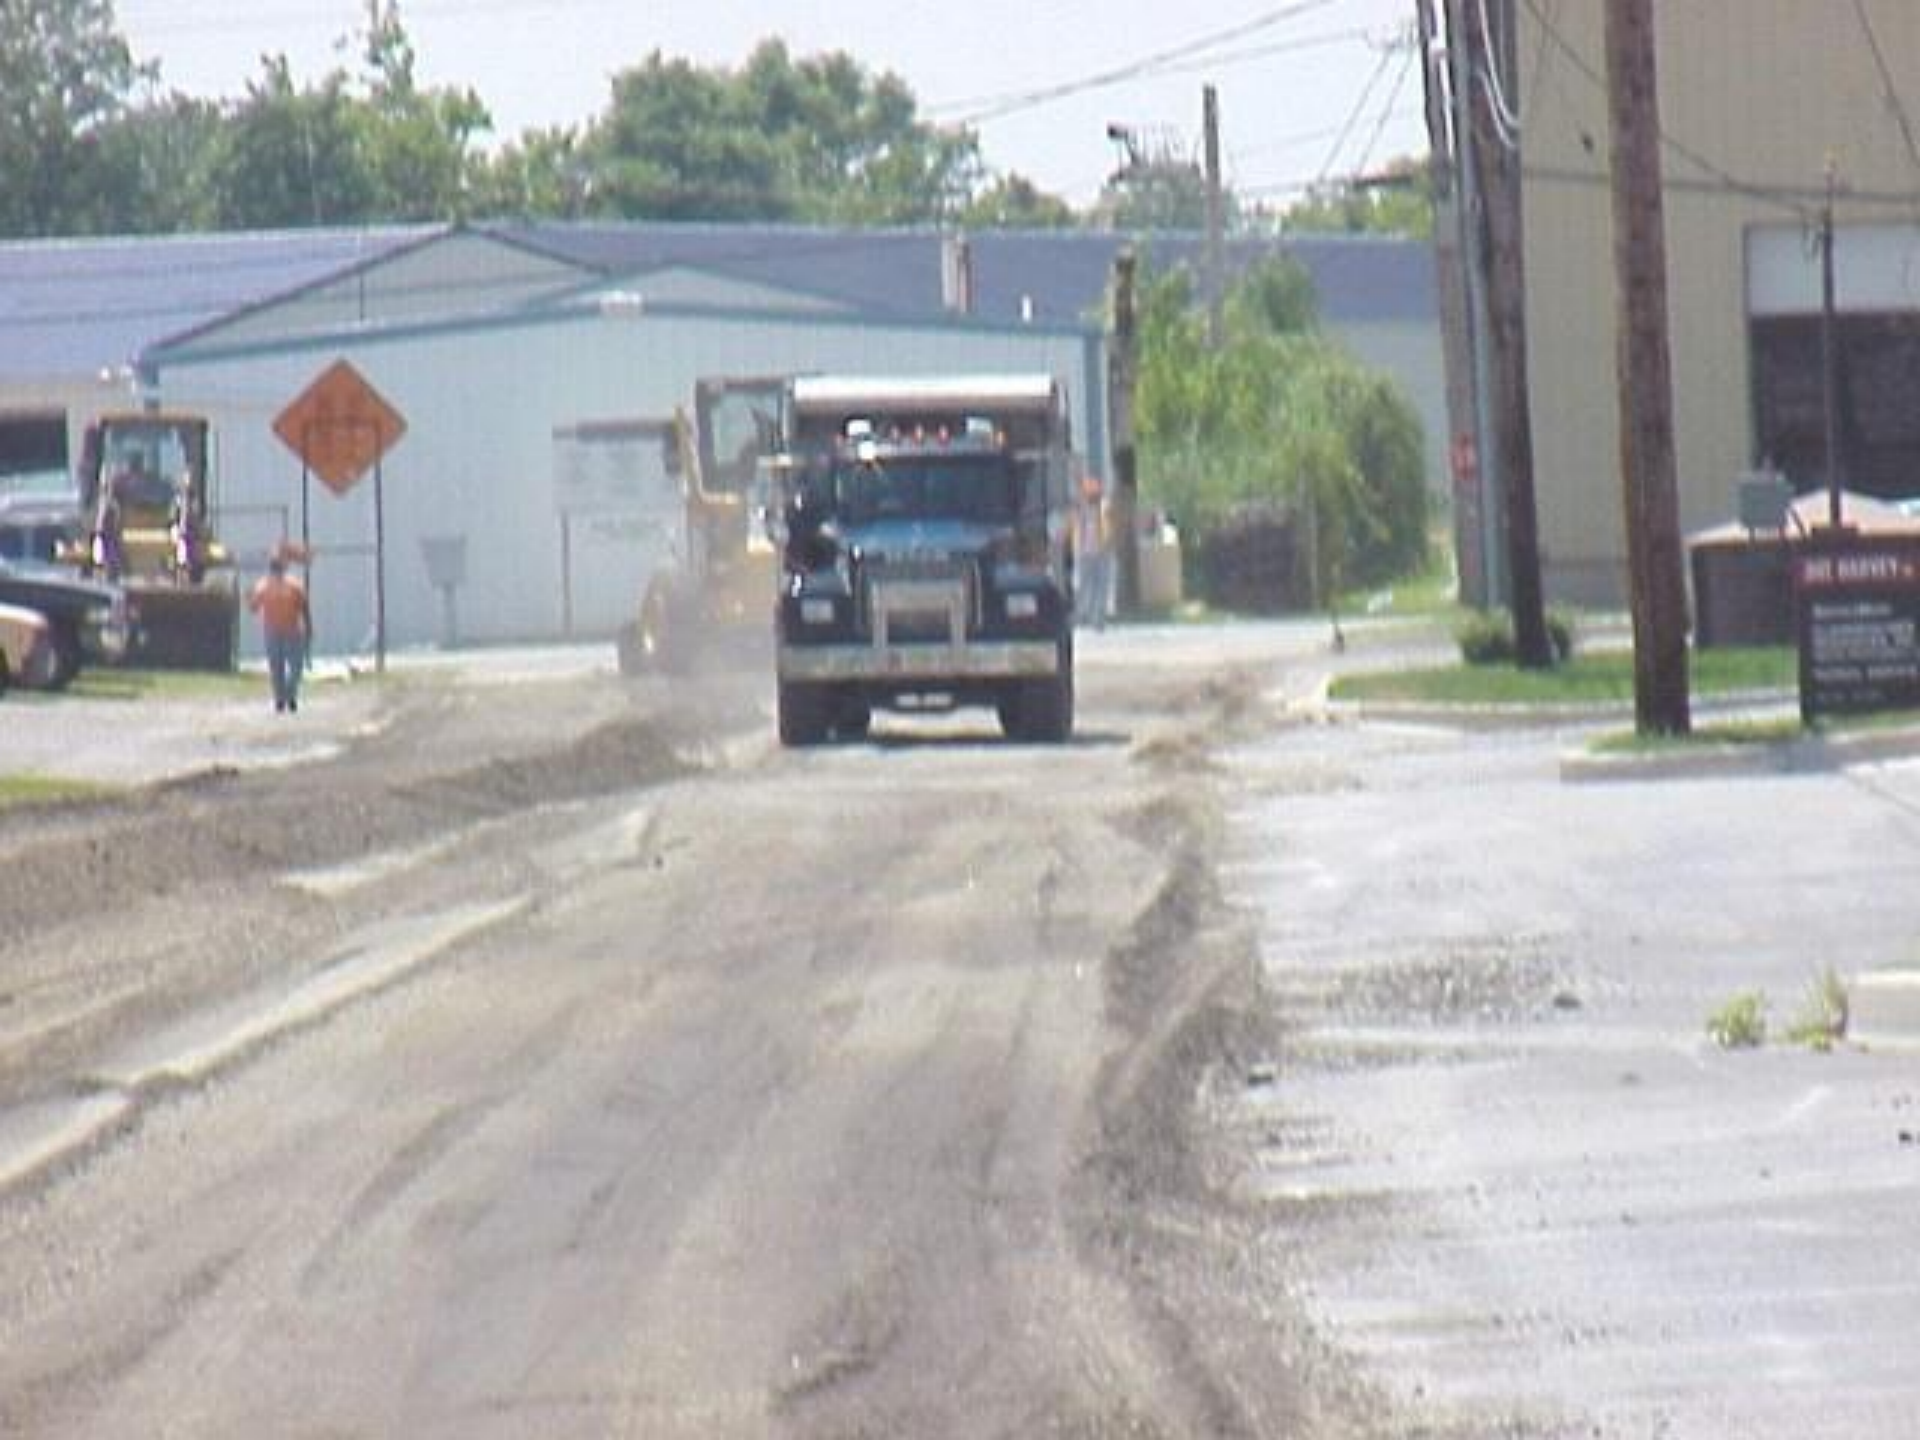
- The remaining streets did not have adequate HMA thickness for CIR
- Significant Aggregate Base
  - Granular material with minimal fines
  - Asphalt Emulsion Binder
- Rehabilitated in 2001 using FDR
