An Introduction to **STADIUM**®

Service Life Prediction Software for Optimal Management of Concrete Infrastructure

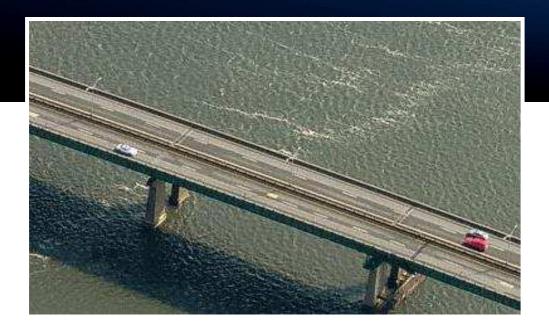
Parkway Bridges - NJTA

Southbound Structure:

- Year of construction: 1956
- Precast and cast-in-place concrete elements

Northbound Structure :

- Year of construction: 1973
- All elements under investigation were precast

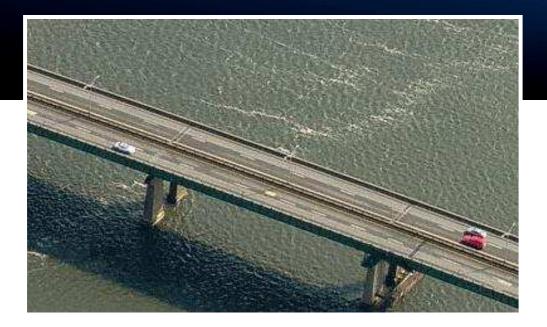
Coring Program

Total number of cores: 56

31 cores from the northbound structure:

- 15 in the box beams
- 16 in the prestressed piles

25 cores from the southbound structure:

- 12 in the I-beams
- 13 in the pile caps

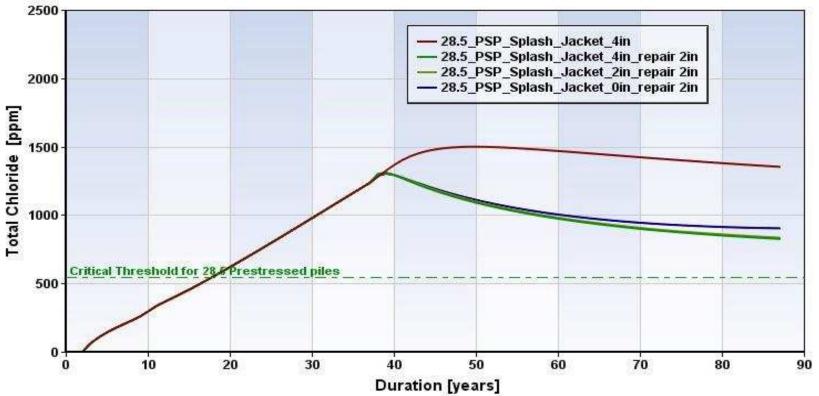
Pre-stressed Piles (Jackets)

Content vs. Time at 3.5 [in]
