# Corrosion Mitigation Systems for Concrete Structures

Vector Corrosion Technologies

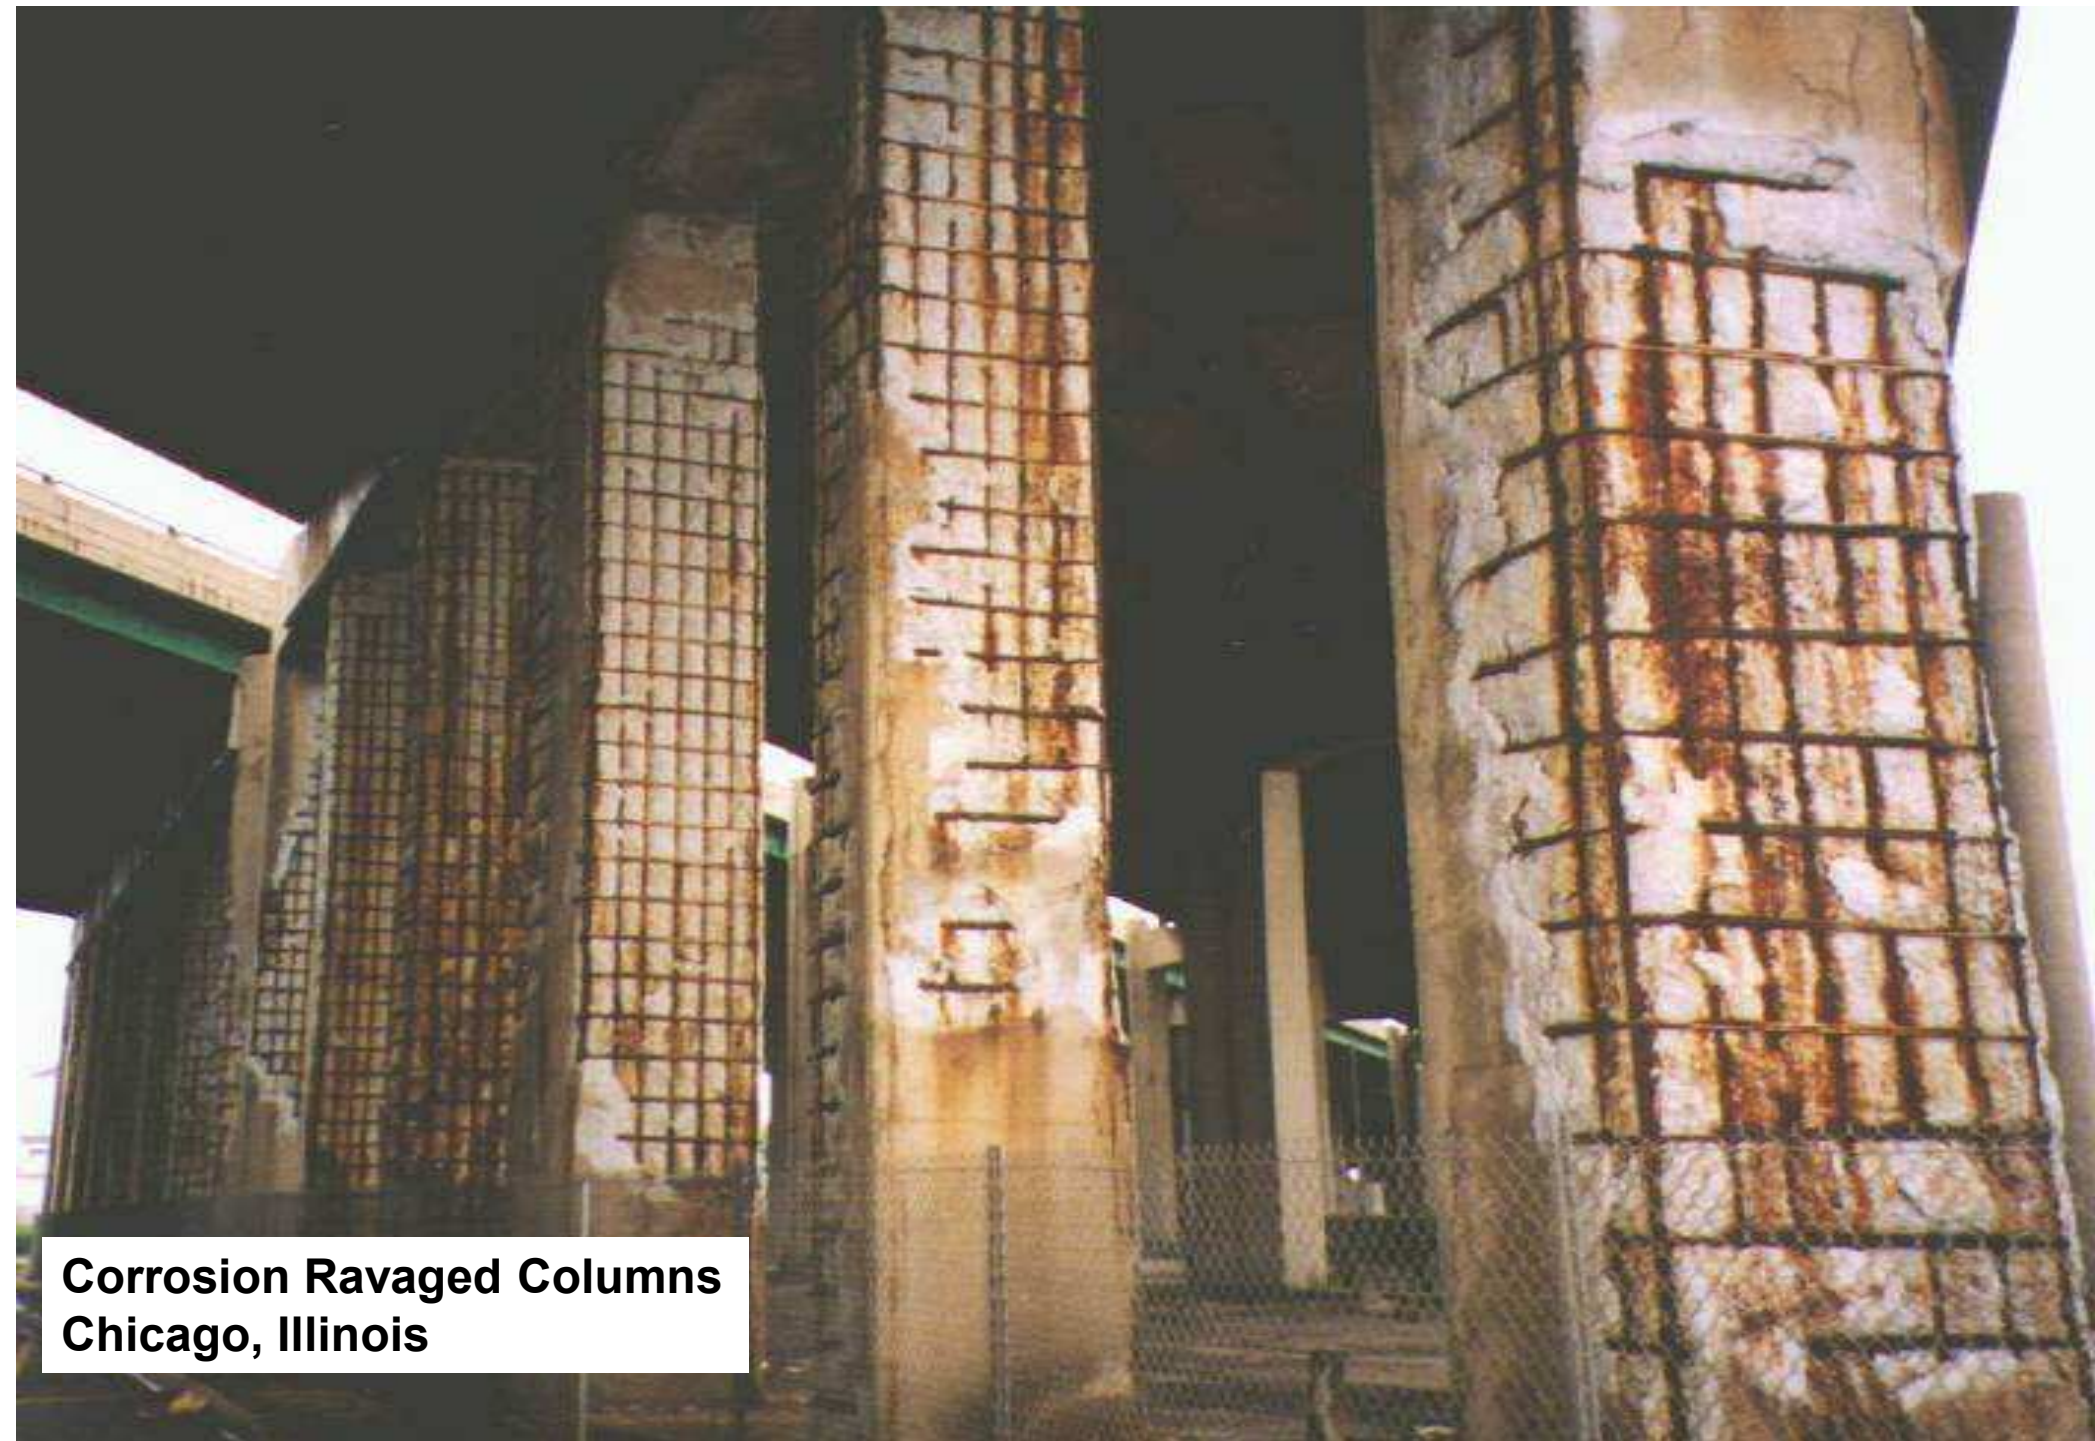
**Corrosion Ravaged Columns  
Chicago, Illinois**

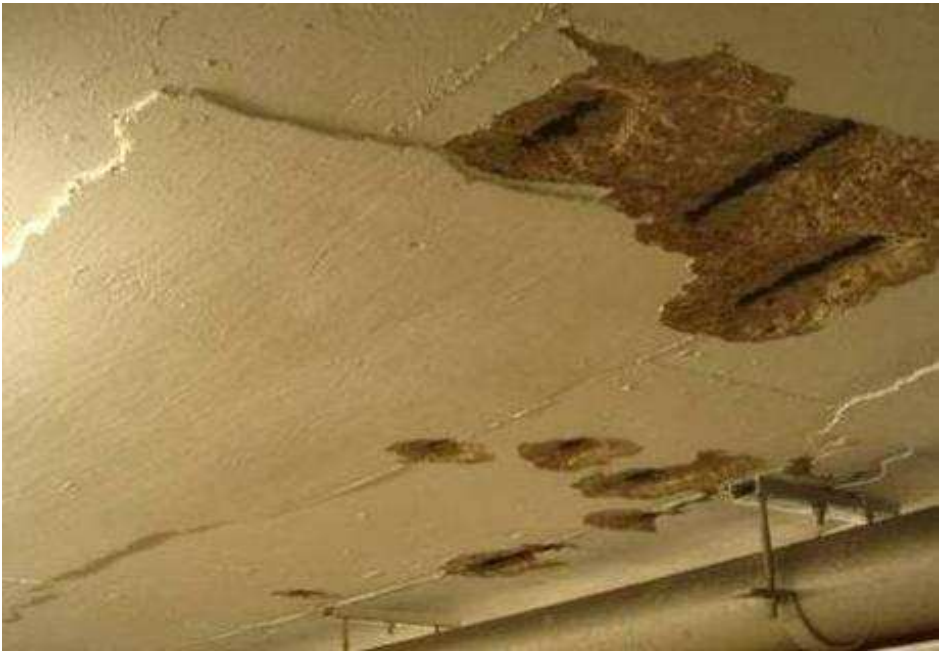
**Underside of Parking Deck**

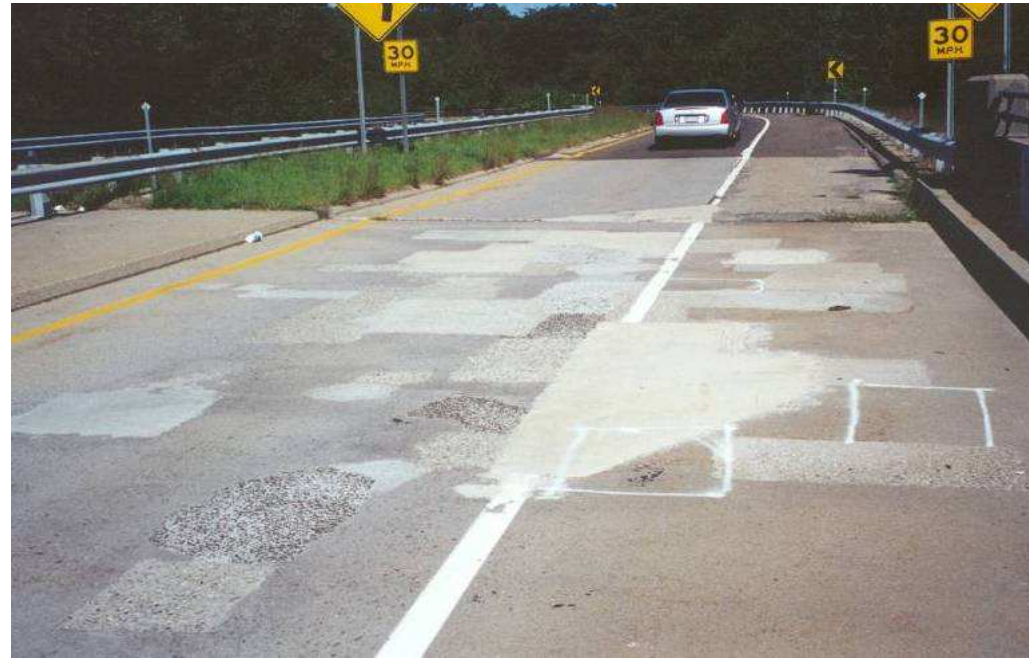
**Bridge Deck**

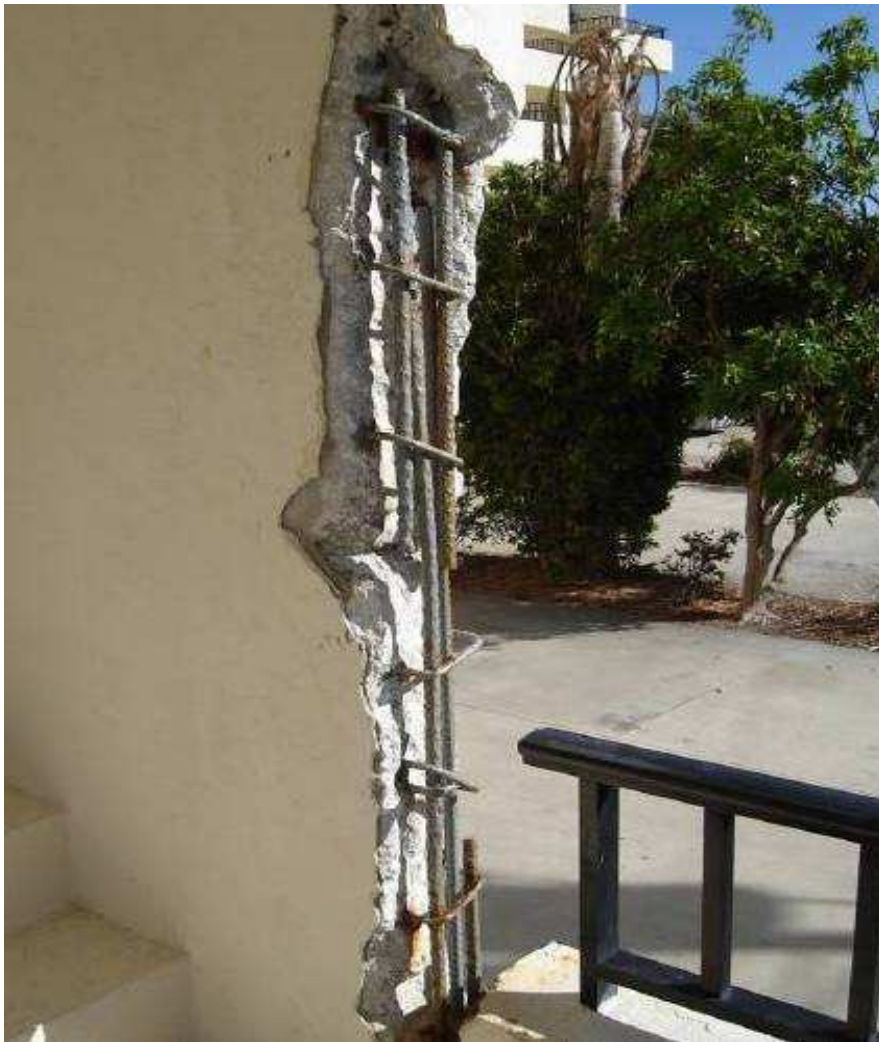
# Visual Inspection

- Identify areas of visual damage
  - Rust stains on surface
  - Cracks
  - Spalls
  - Exposed steel
- Note exposure conditions and other observations

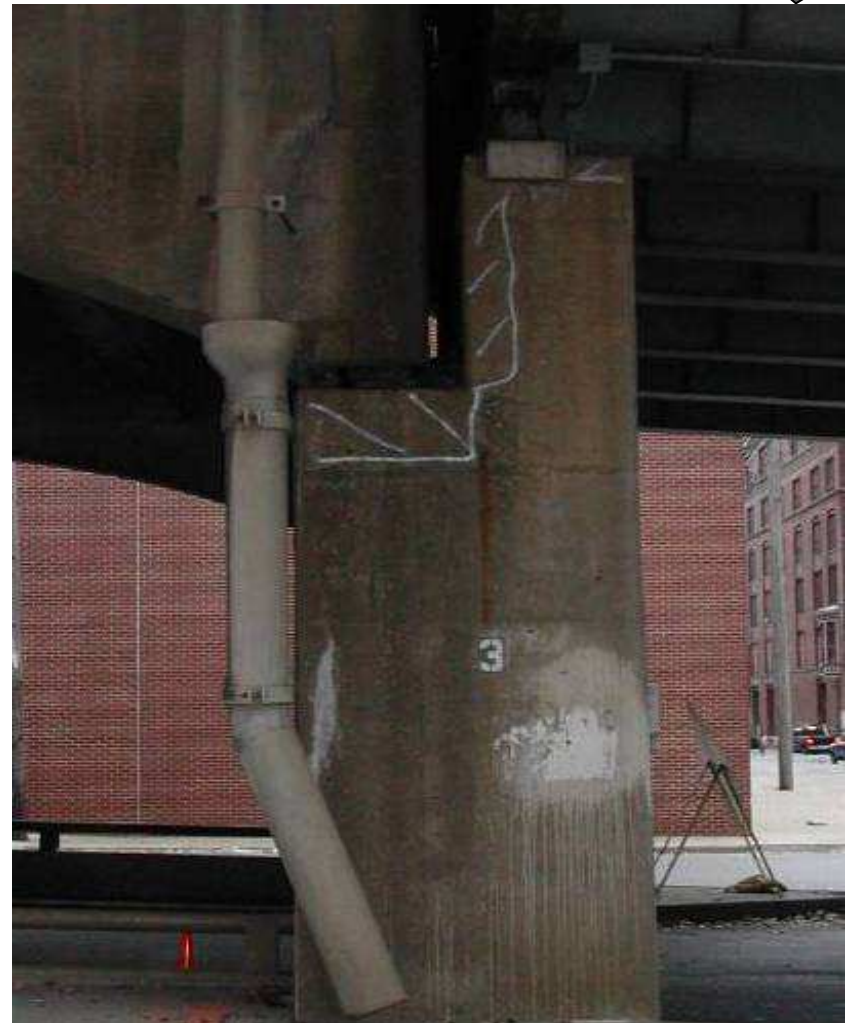
# Delamination Survey

- Performed as per ASTM D4580
- Locate areas where concrete has lost bond with rebar and delaminated concrete which has not yet spalled
- Also known as “Sounding”
  - Hammer test
  - Chain drag

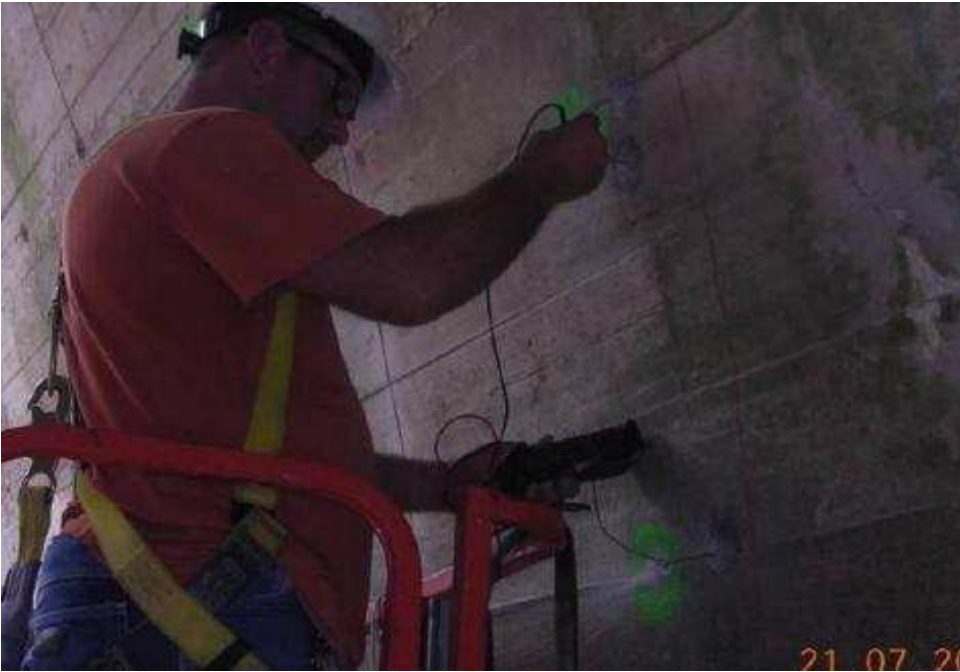
# Rebar Continuity

- Verify electrical continuity of the steel
  - Discontinuous steel may pose problems for cathodic protection
- Typical Criteria
  - Less than 1 mV or
  - Less than 1 ohm resistance

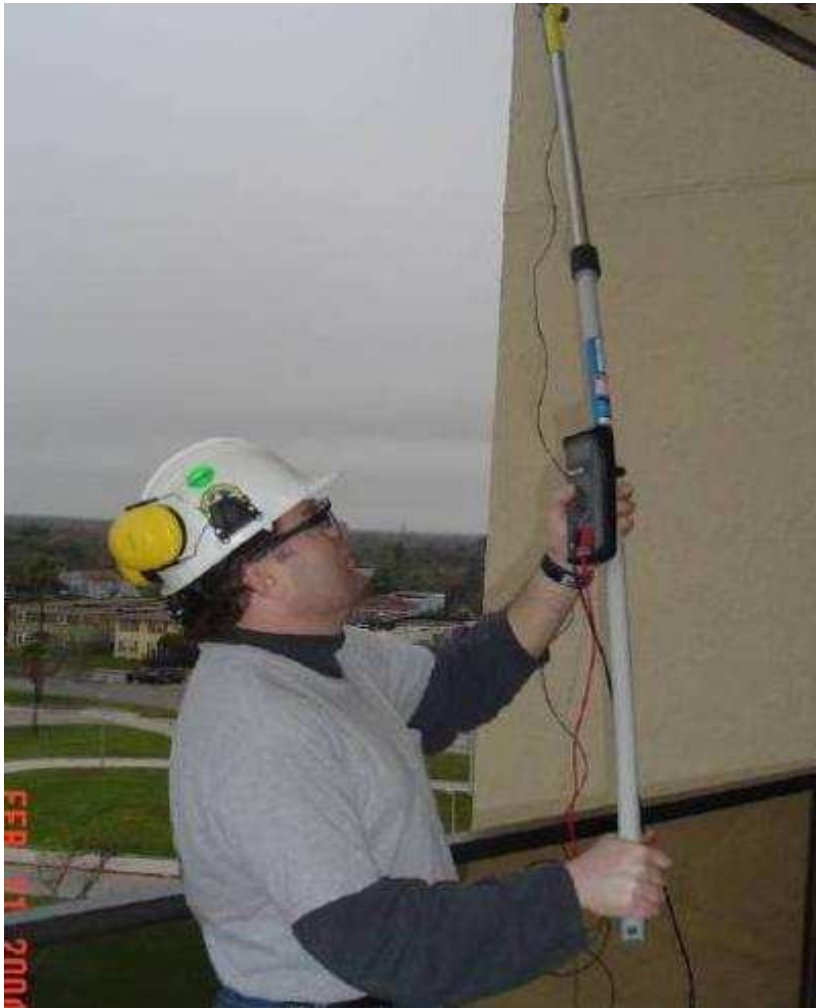
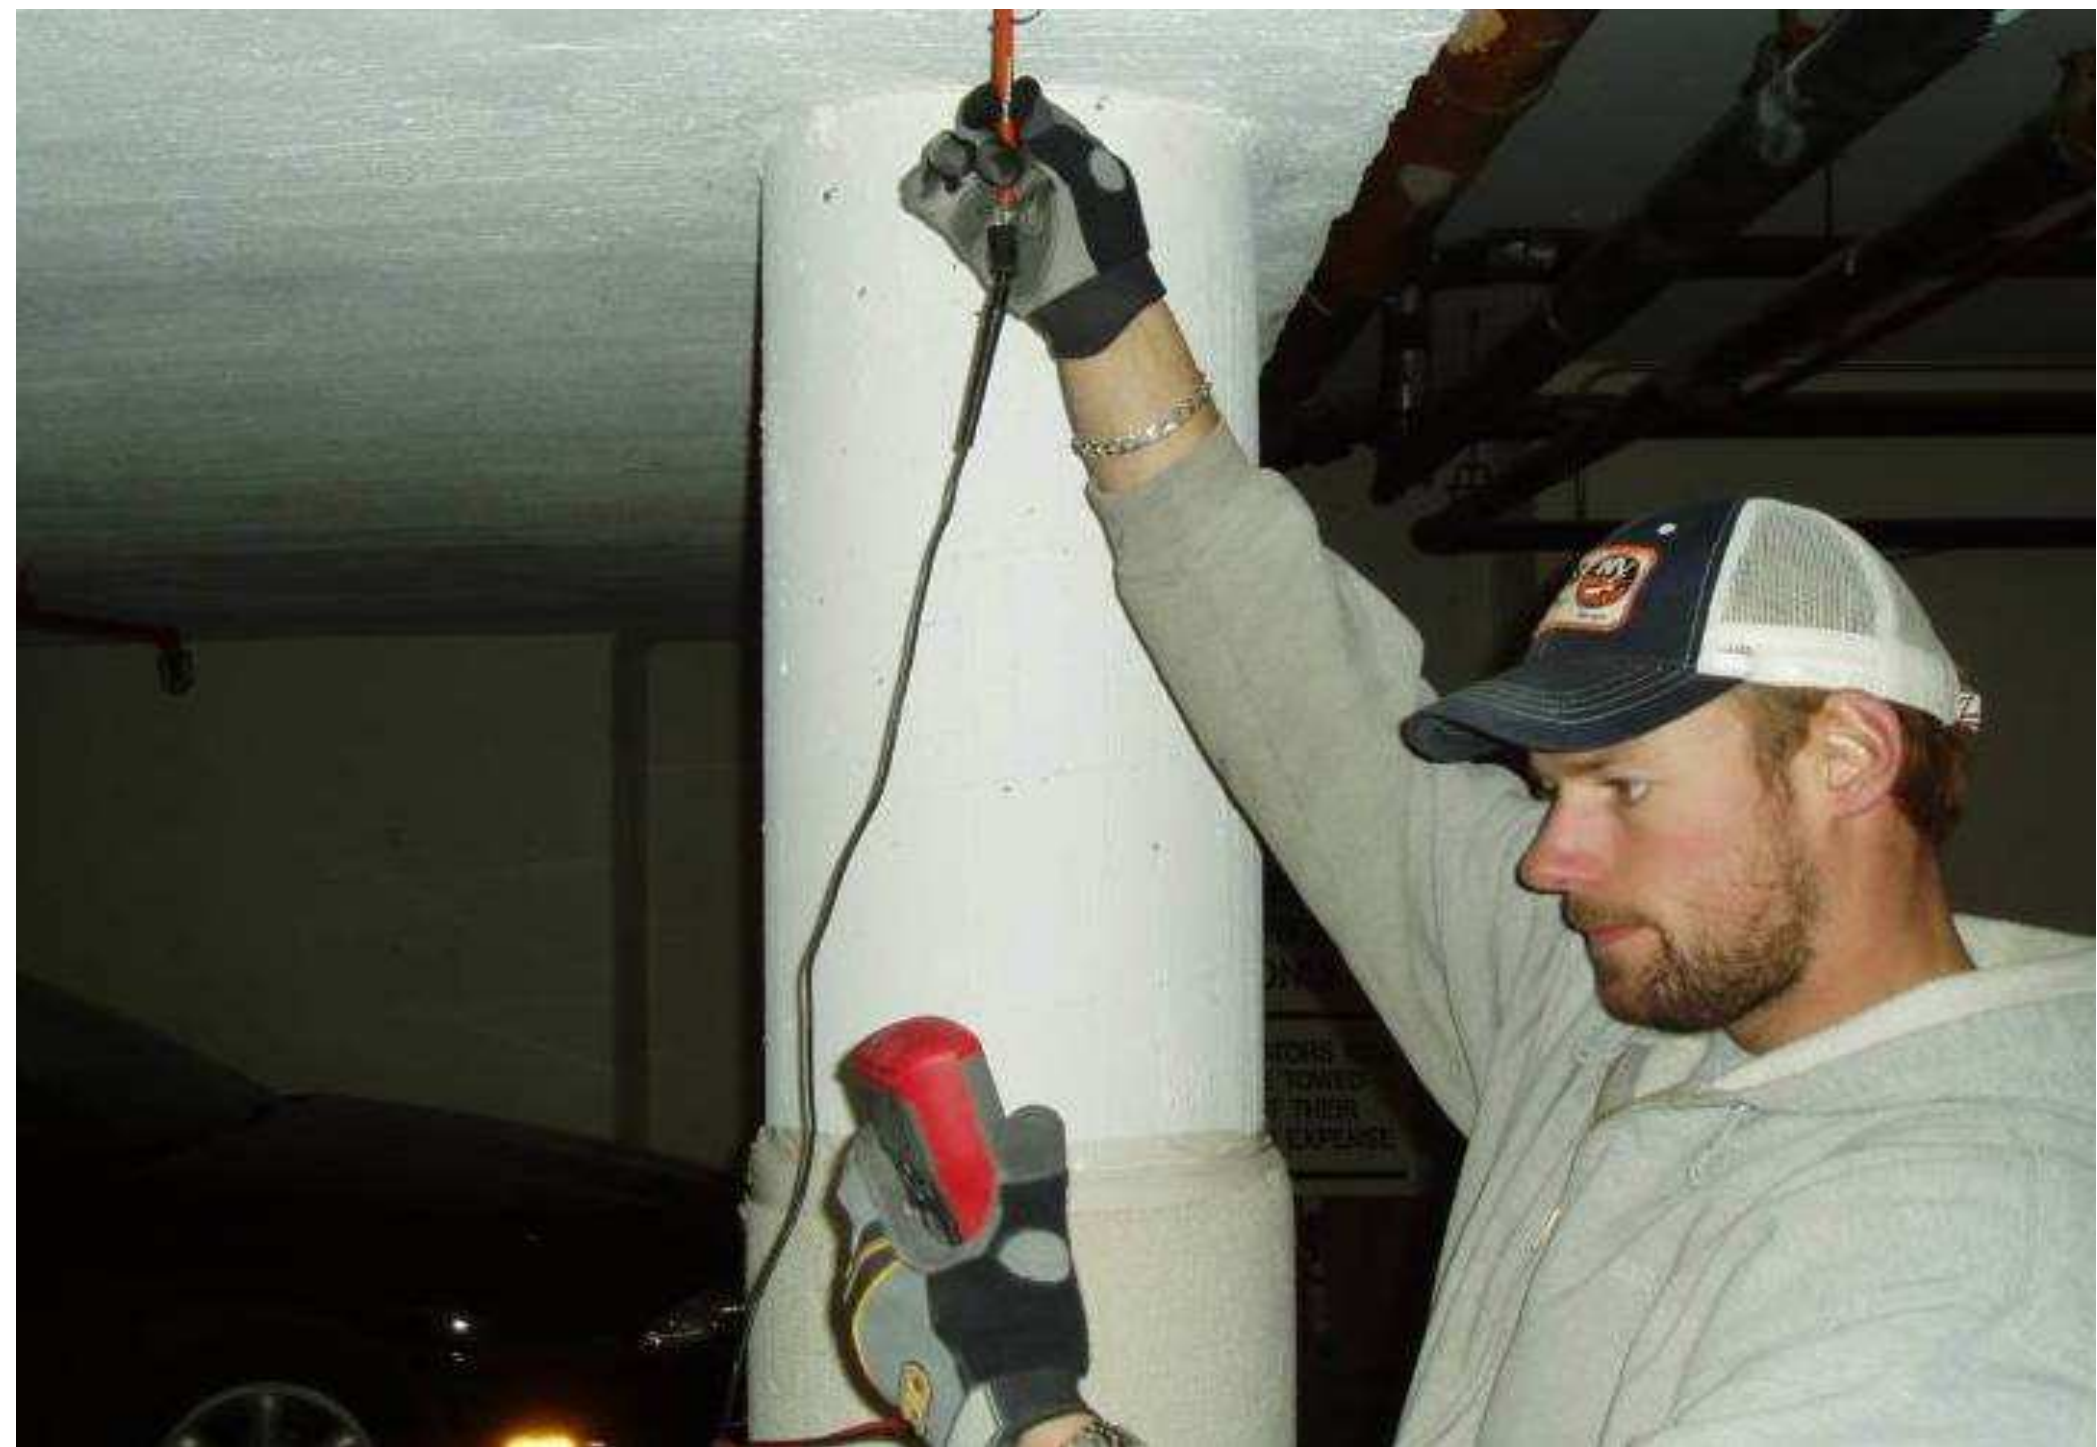
# Corrosion Potential

- To determine the probability of corrosion by measuring the potential (voltage) of the reinforcing steel
- Uses a reference electrode:
  - copper-copper sulfate
  - silver-silver chloride
- Performed as per ASTM C876-91

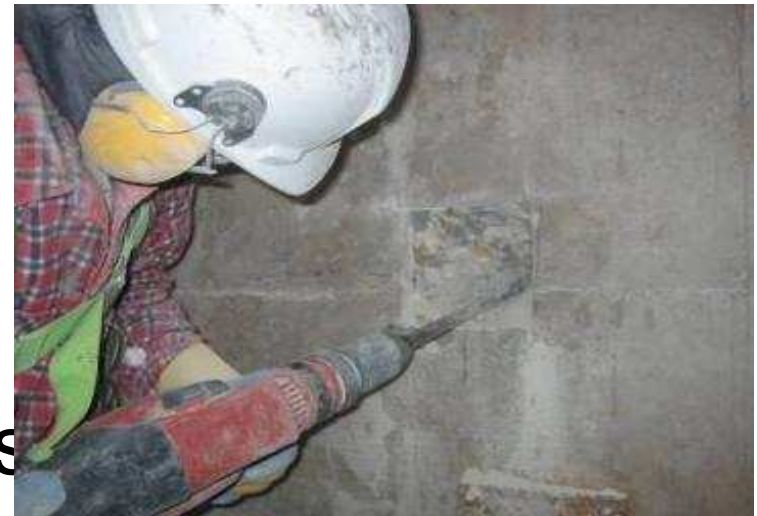
# ICRI No. 310.1R–2008 Guideline for Surface Preparation for Repair of Concrete Deterioration Resulting from Reinforcing Steel Corrosion

- Remove concrete from full circumference of all reinforcing steel.
- Remove corrosion by-products from steel
- Expand area of patch outside area of active corrosion (clean steel).

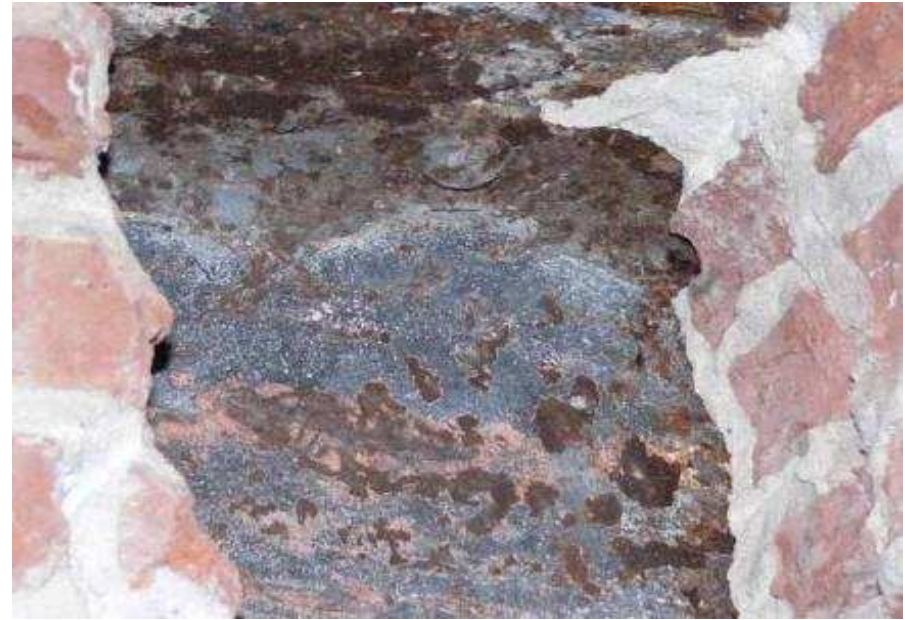
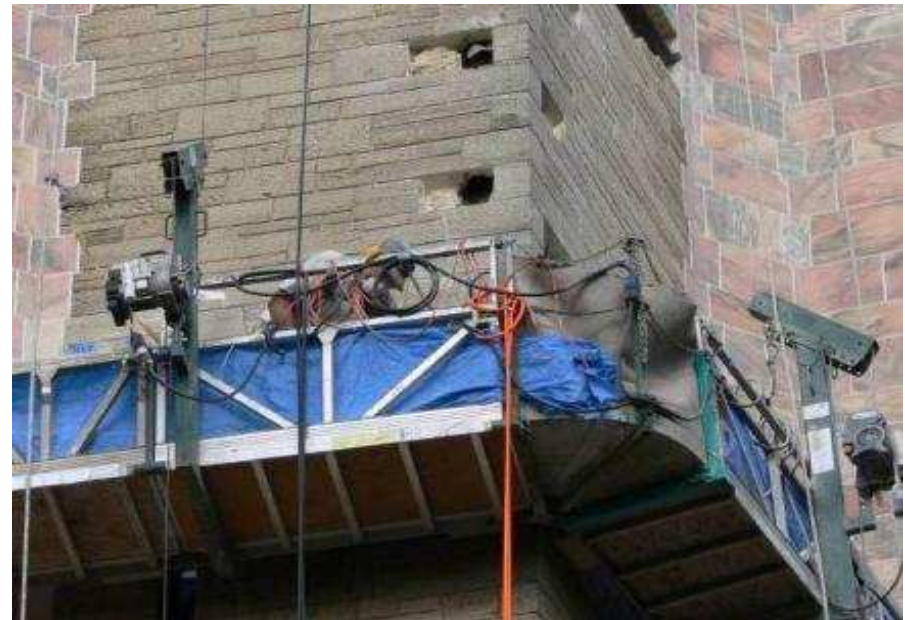
# Bok Tower

- Moisture intrusion caused corrosion of steel beams
- Corrosion damage of exterior stone
- ICCP with discrete anodes installed to protect steel frame

- Discrete anodes placed in ½ in. diameter holes
- 32 in. spacing above and below beams
- Installed from the interior through brick masonry

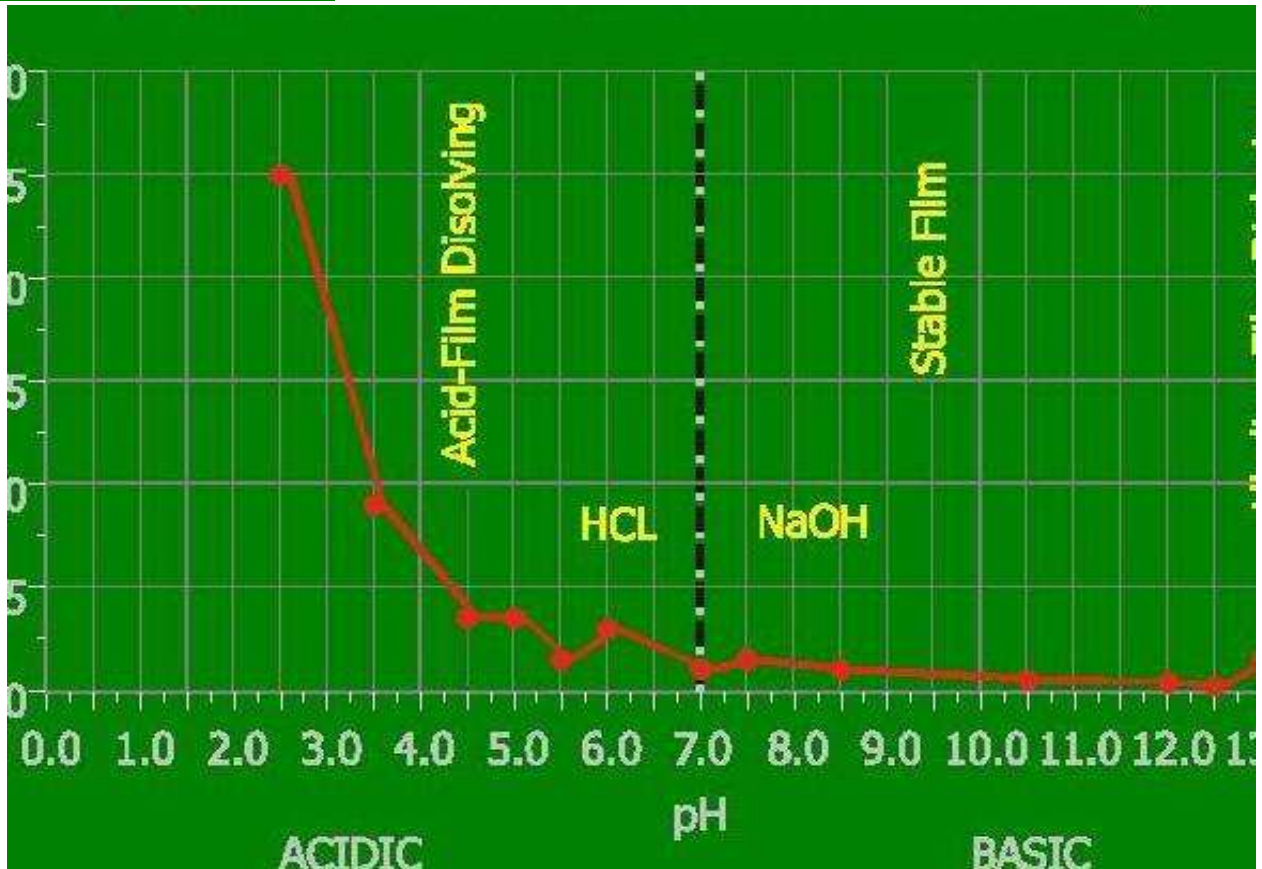
# Activation Technology

- High pH is corrosive to zinc but not to steel
- Allows zinc anodes to provide protection to reinforced concrete over time

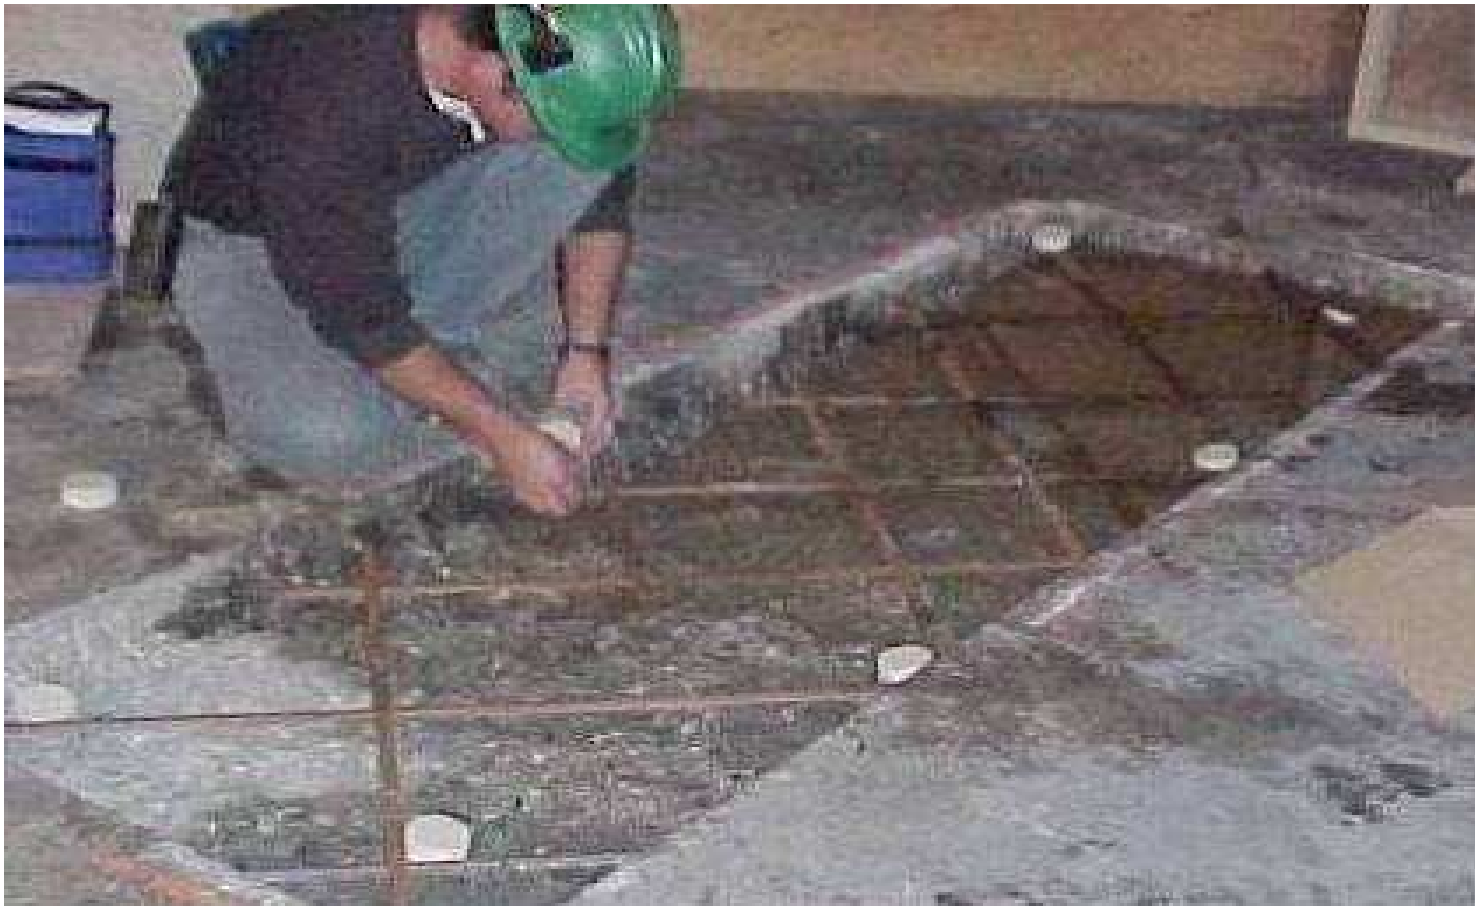
# Discrete Galvanic Anodes

**Installing anodes around the perimeter of the repair.**

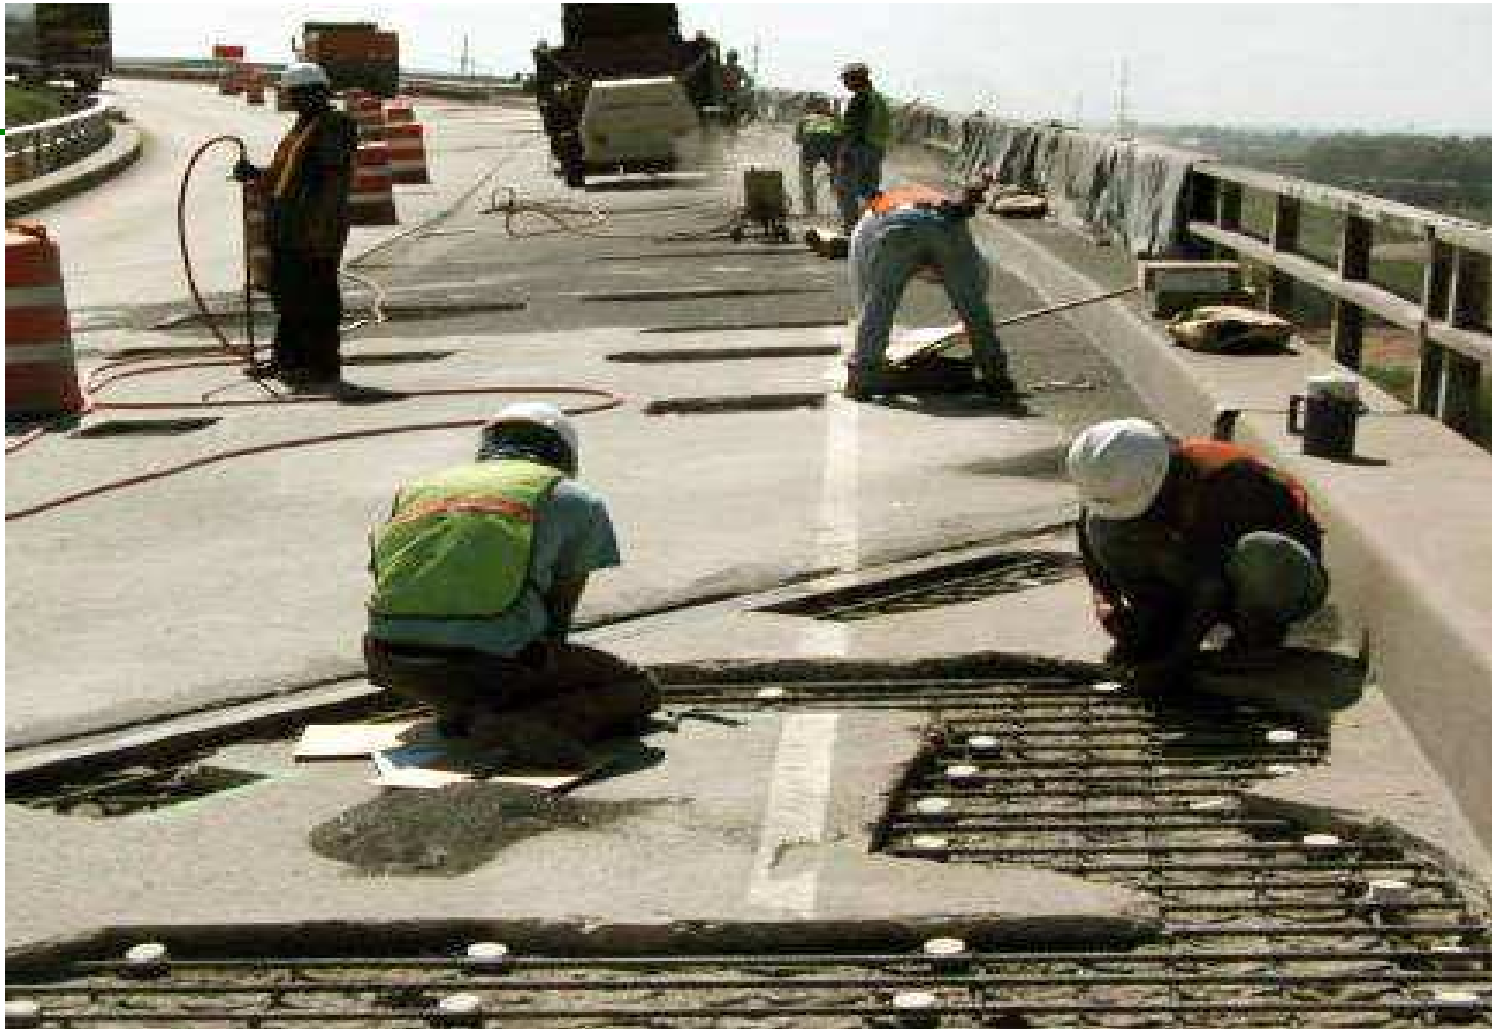
**Bridge Deck - Chip and Patch Repairs.  
Colorado DOT – Greeley, CO**

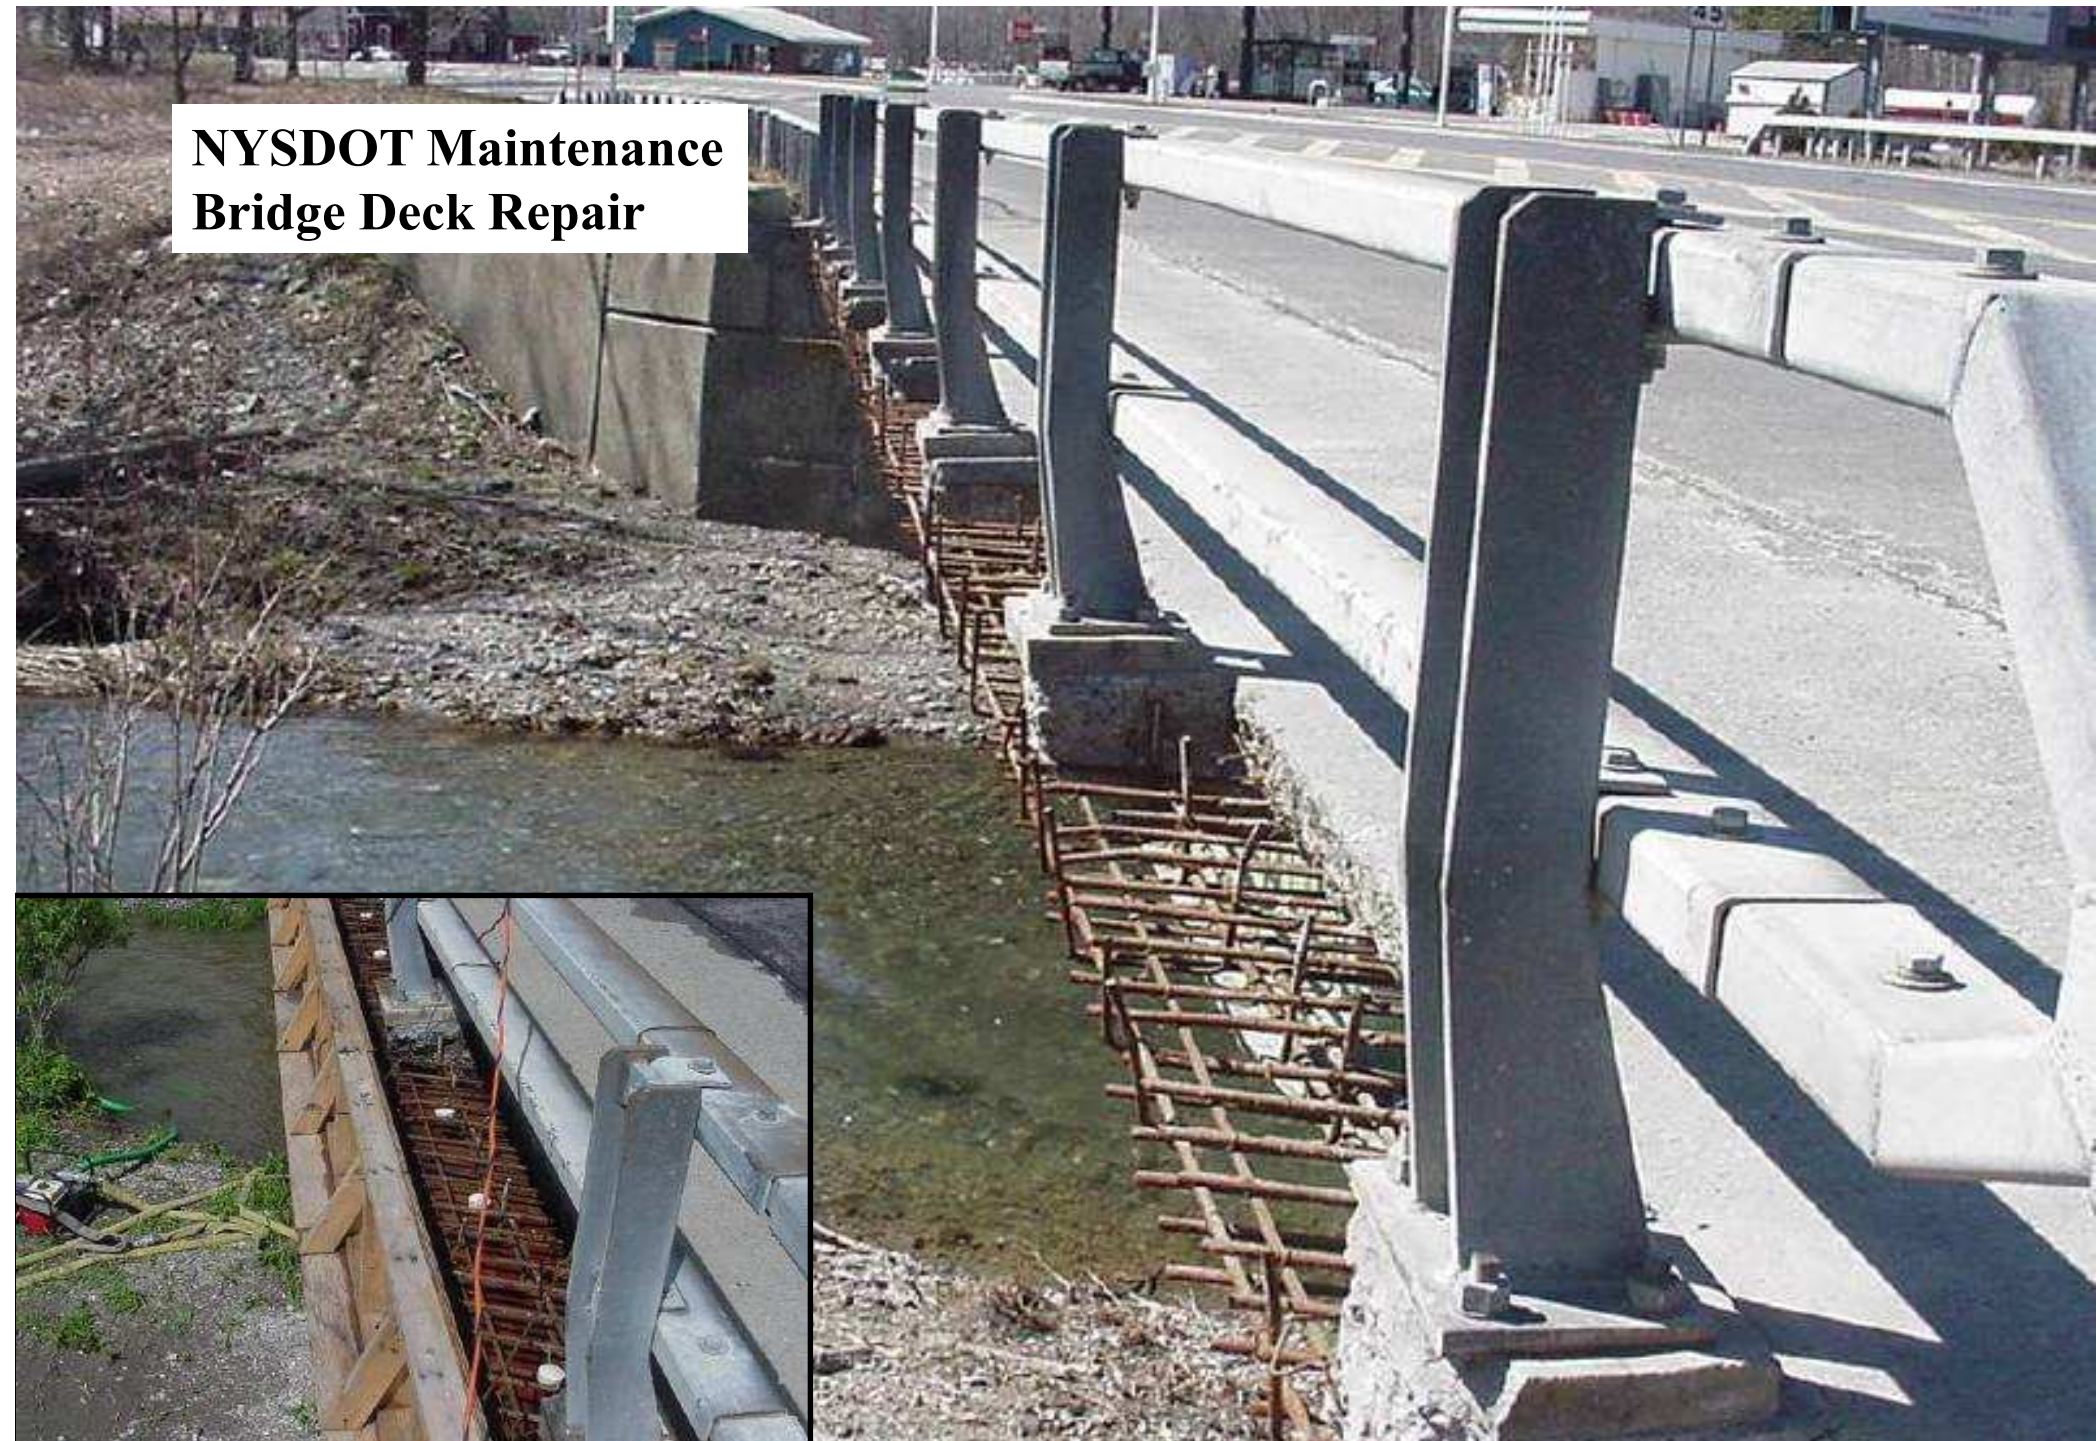
**Patch Repair  
Arch Bridge**

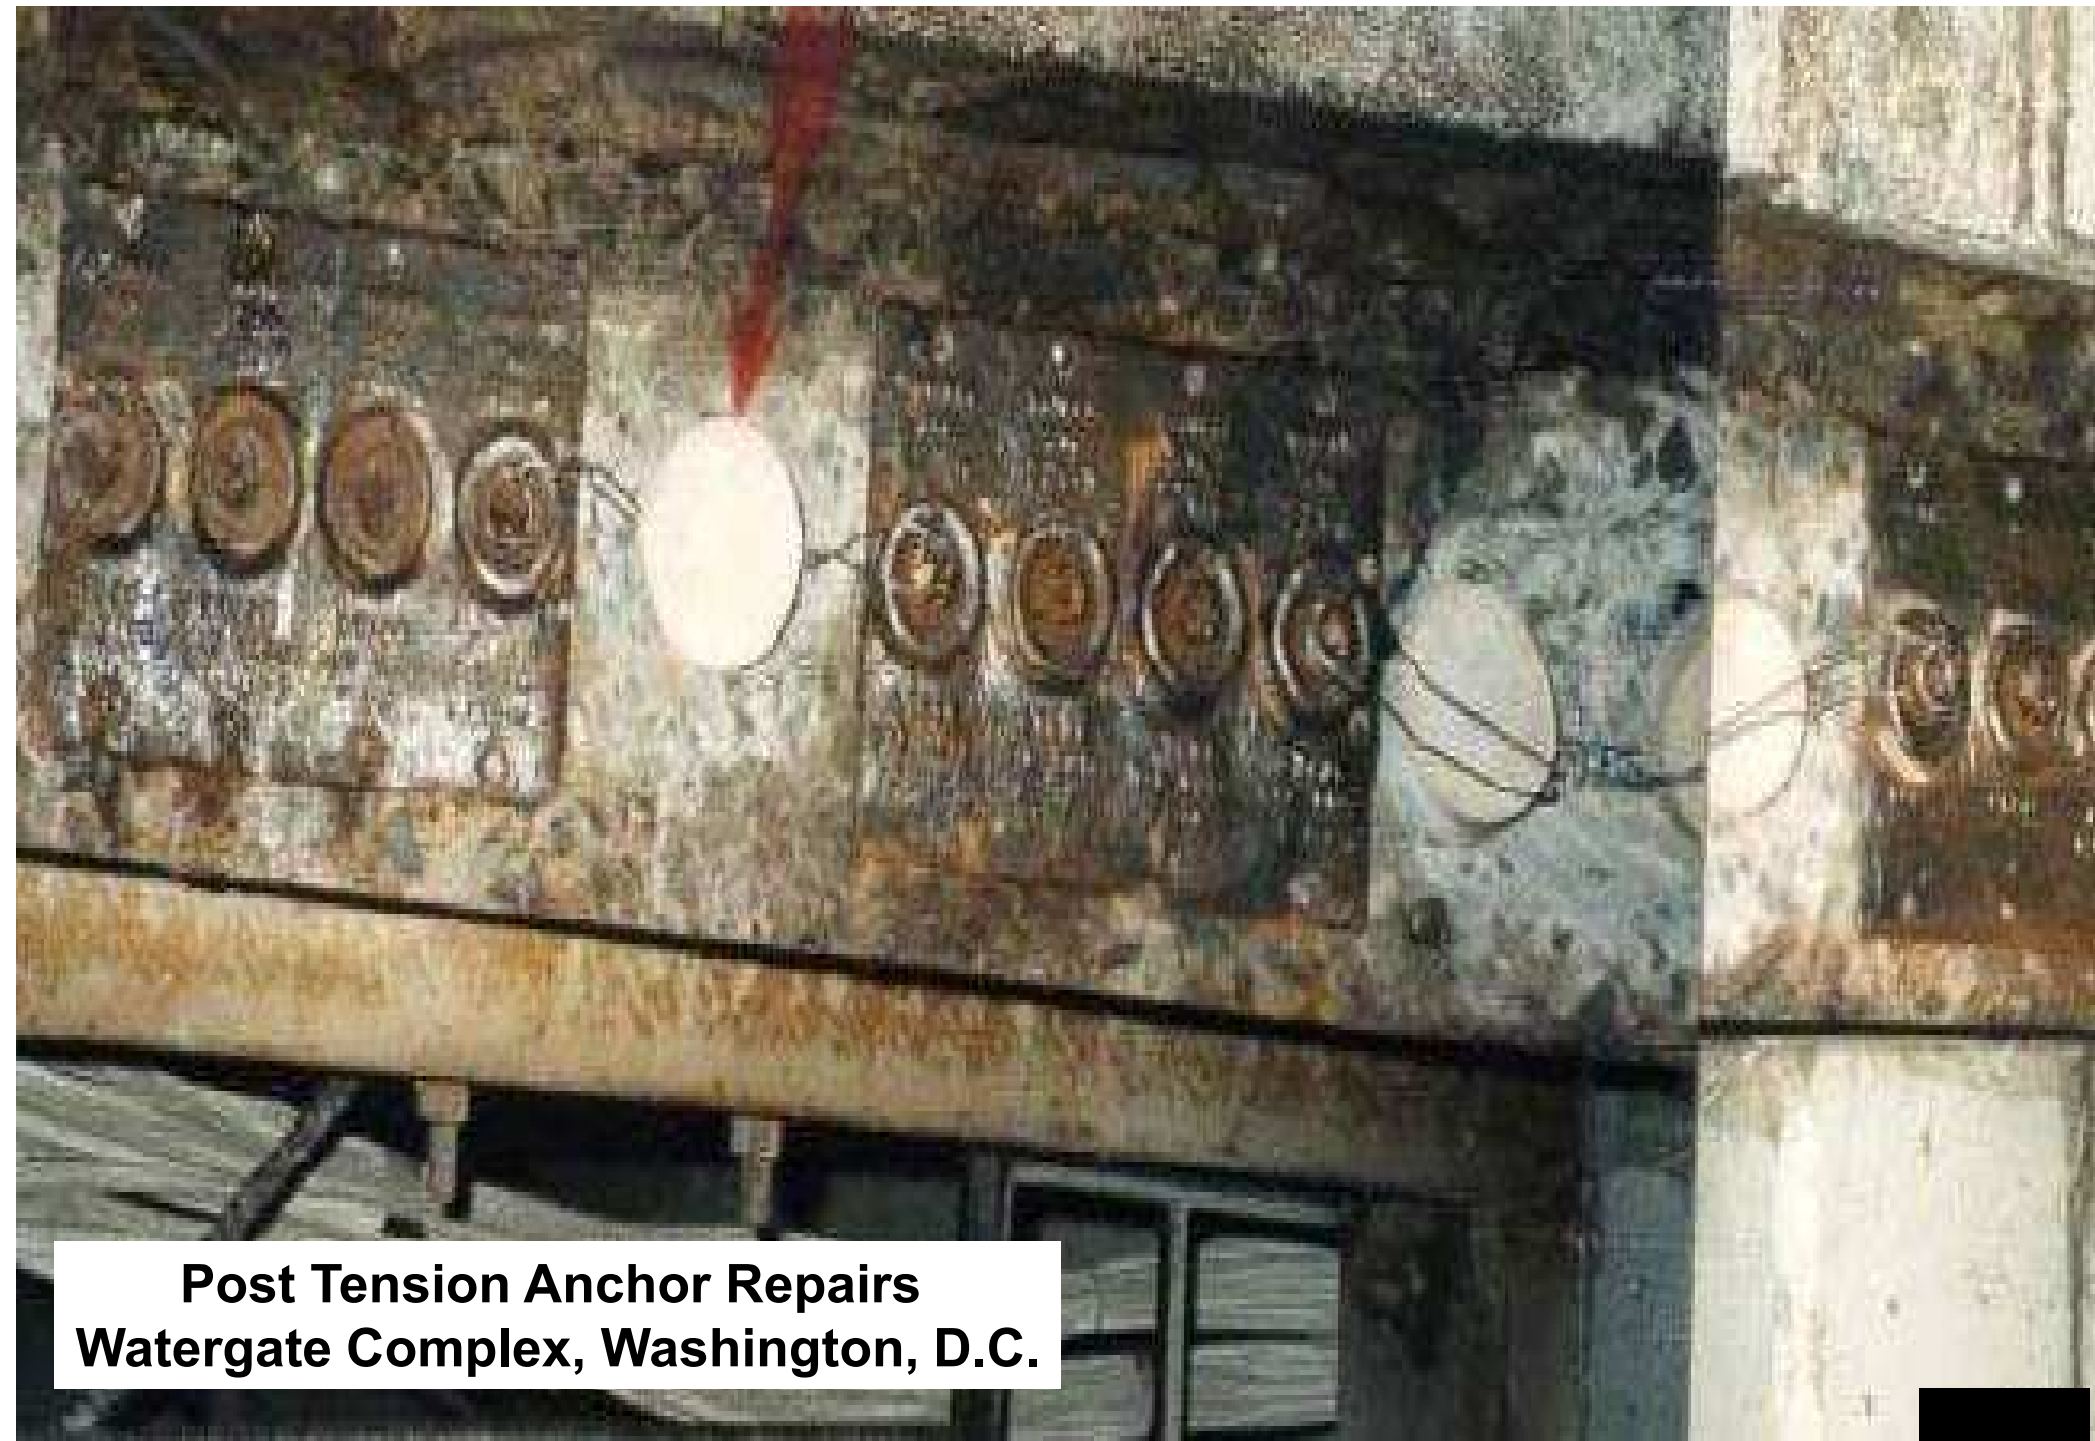
**Post Tension Anchor Repairs  
Watergate Complex, Washington, D.C.**

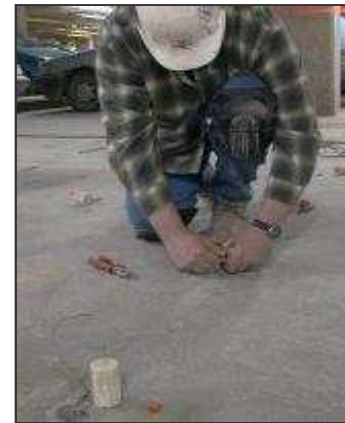
# Point Anodes for Sound Concrete

- Embedded anode for corrosion control
- Installed into drilled holes
- Protect sound but contaminated areas
- Corrosion “hot spots”
