# Corrosion Mitigation Systems for Concrete Structures

Vector Corrosion Technologies

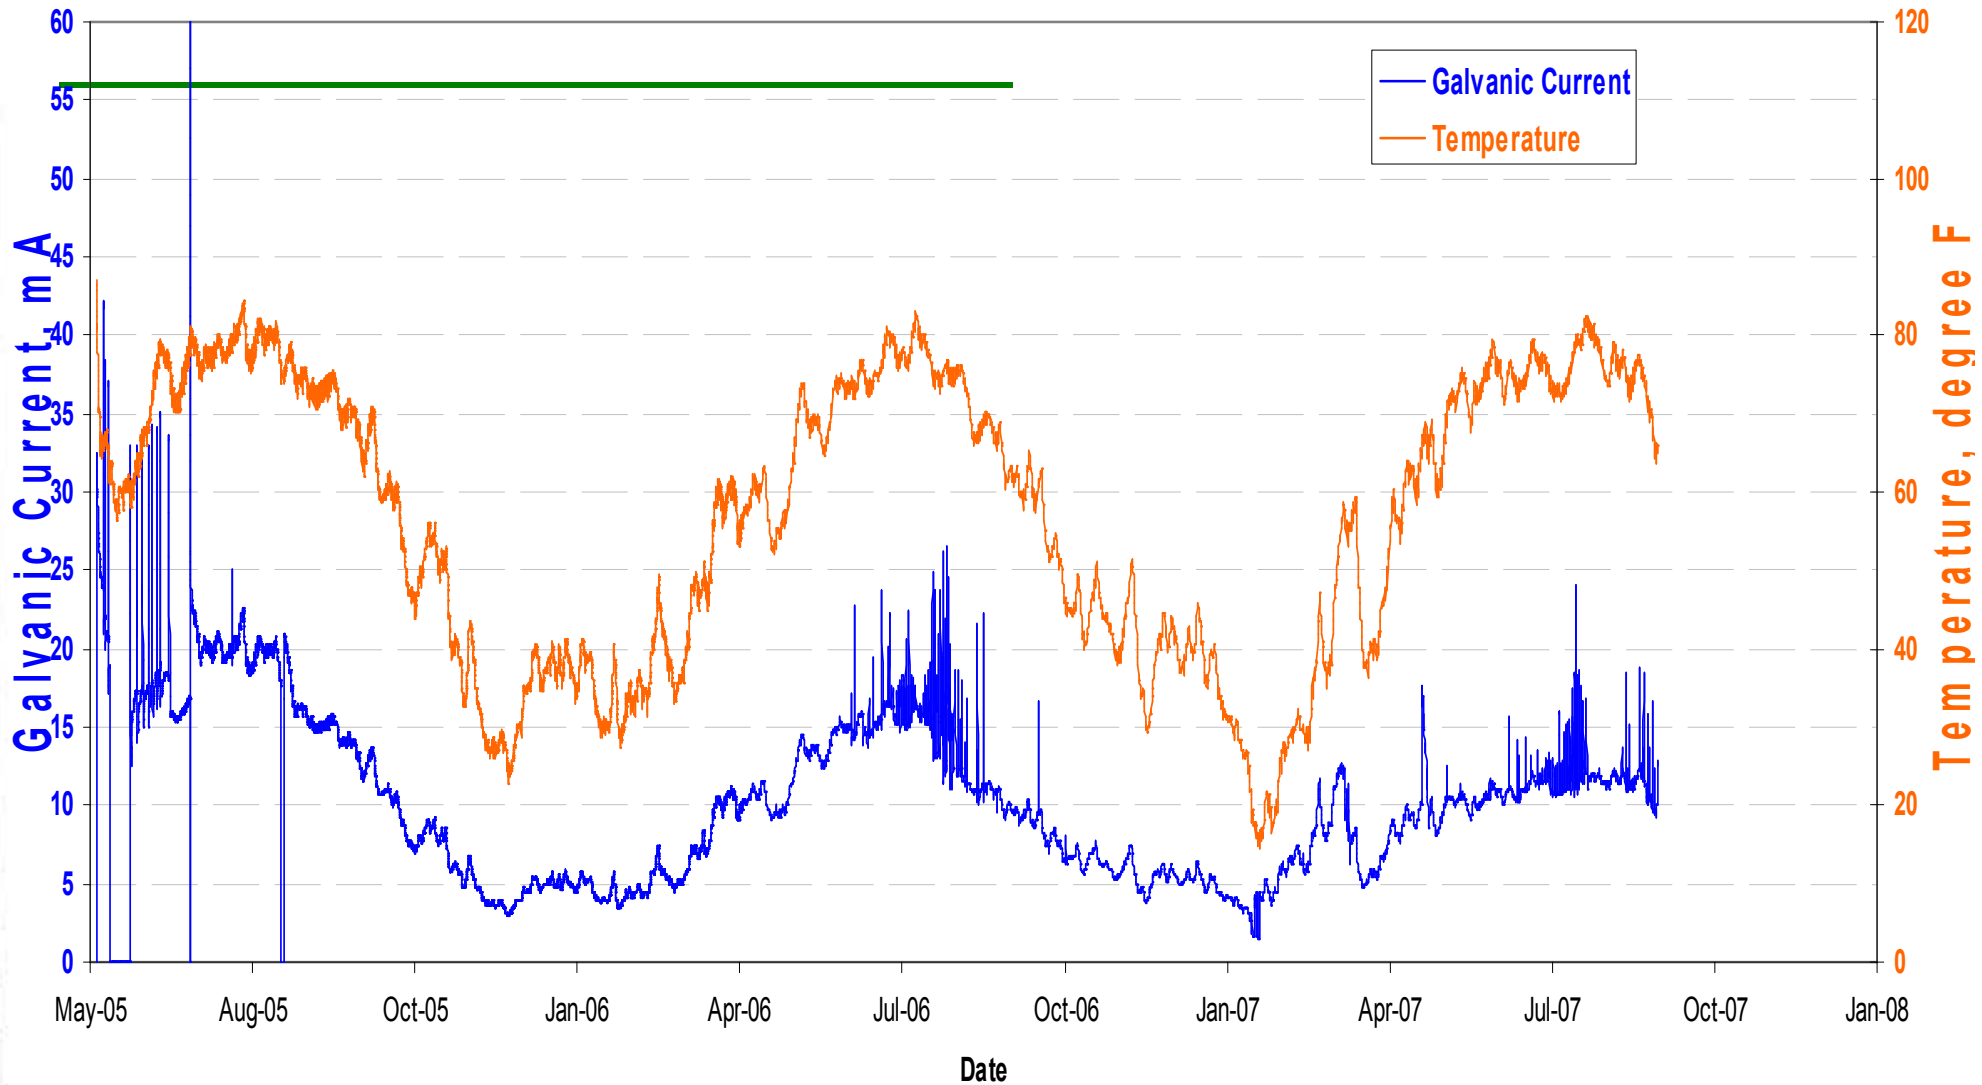
# Kirkwood Road – Protective Current

<b>Date</b>	<b>Temp</b>	<b>mA/m<sup>2</sup></b>	<b>Polarization</b>	<b>Instant Off</b>
<b>5/6/05</b>		<b>37.7</b>		<b>654*</b>
<b>7/20/05</b>		<b>13.9</b>	<b>346</b>	<b>1000</b>
<b>8/16/05</b>	<b>87</b>	<b>12.9</b>	<b>333</b>	<b>987</b>
<b>10/26/05</b>	<b>54</b>	<b>5.4</b>	<b>394</b>	<b>1048</b>
<b>12/7/05</b>	<b>51</b>	<b>3.2</b>	<b>339</b>	<b>993</b>
<b>5/1/06</b>	<b>57</b>	<b>7.5</b>	<b>335</b>	<b>989</b>
<b>12/20/06</b>	<b>40</b>	<b>4.3</b>	<b>500</b>	<b>1154</b>
<b>5/30/07</b>	<b>79</b>	<b>7.5</b>	<b>446</b>	<b>1100</b>
<b>9/20/07</b>	<b>75</b>	<b>9.7</b>	<b>484</b>	<b>1138</b>

Protection Criteria: Polarization > 100 mV or Inst. Off > 850 mV

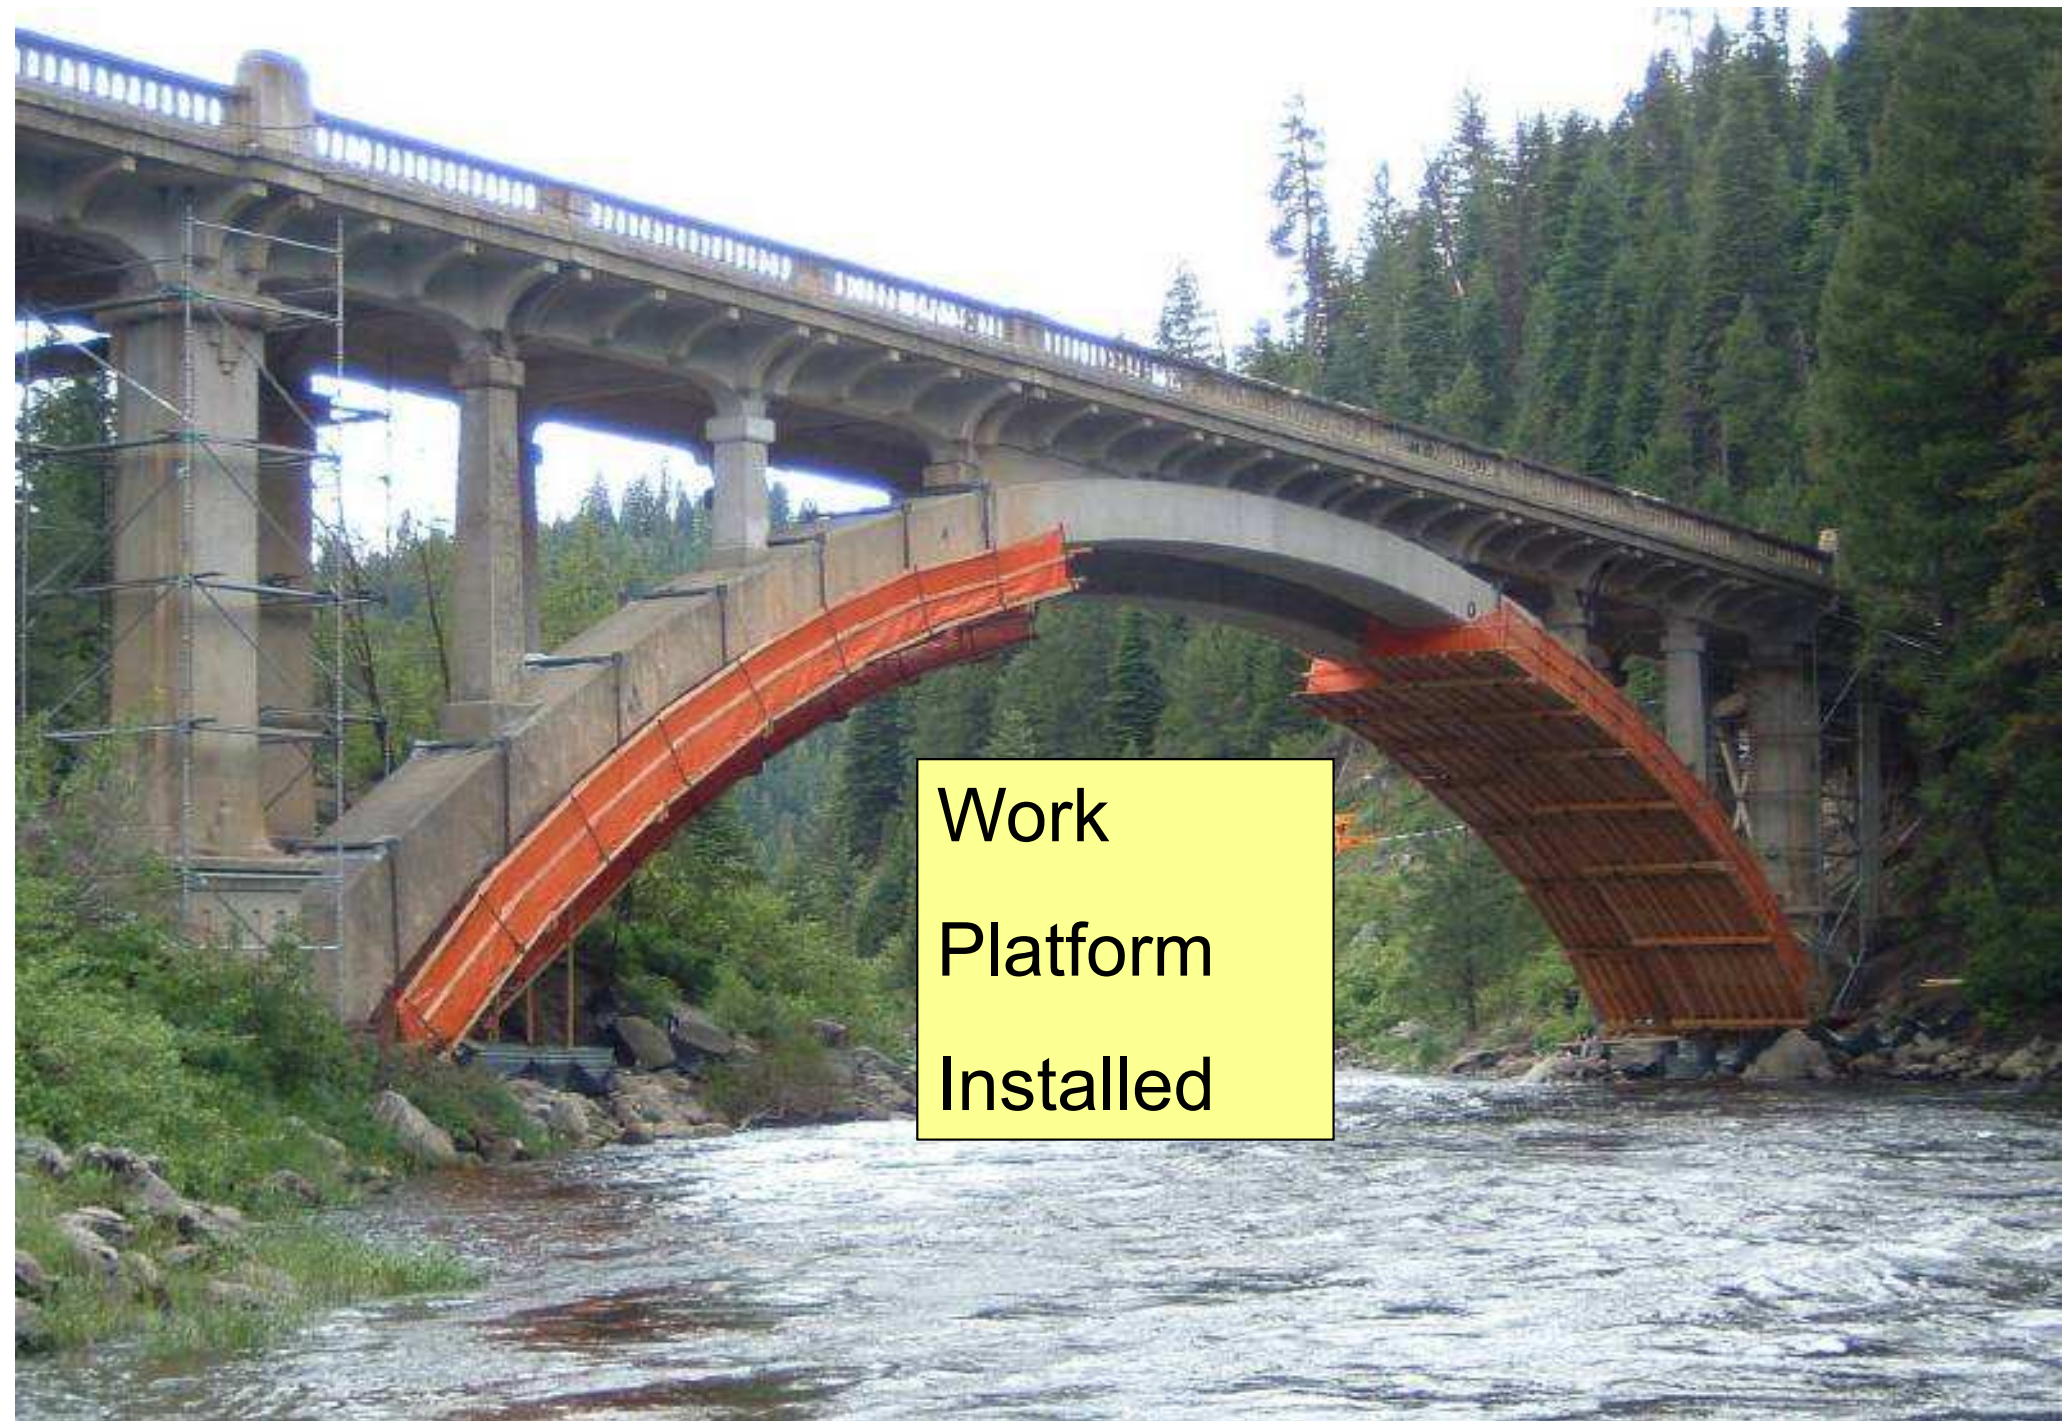
Work  
Platform  
Installed

- Began July 20, 2006
- Completed September 14, 2006
- Treated Approximately 8,000 sf
- Temporary process, so no system left in place
- Addressed the source of the problem by reducing chlorides & increasing pH around rebar
- Minimal Aesthetic Impact
- Allowed structure to be rehabilitated rather than replaced.
- Also placed discrete XP+ anodes in patches
