Impact of Thin Overlay on Top-Down Crack Resistance of Aged Pavement

Nelson Gibson, Jack Youtcheff
FHWA Office of Infrastructure R&D

Kevin McGhee
Virginia Department of Transportation

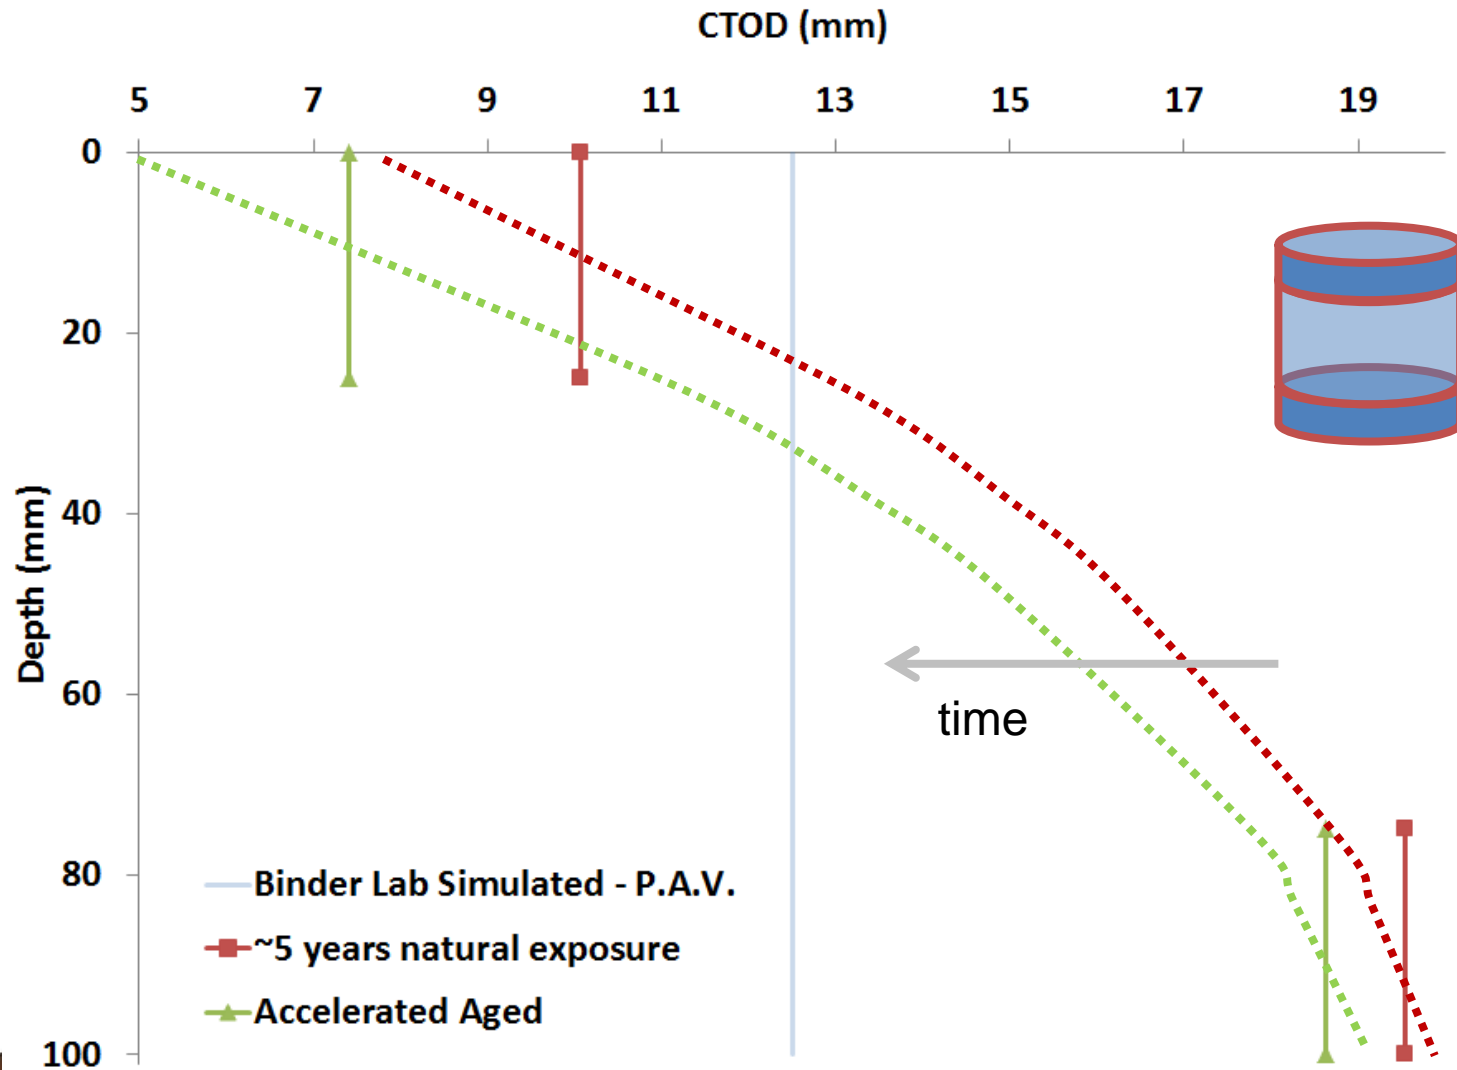
• Embrittlement of In-Situ Asphalt Binder

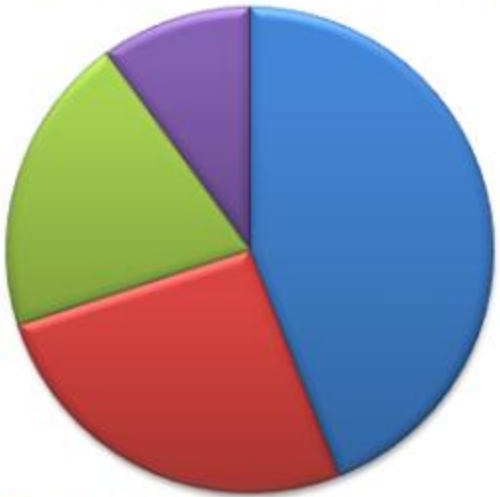
4.75mm HMA Contents

- 44% Fine Agg. Screenings (#10)
- 26% Sand (Manufactured)
- 20% RAP (Fine)
- 10% Sand (Natural)

- ✓ Virgin Asphalt Binder PG 76-22
- ✓ Extracted Binder PG 82-22

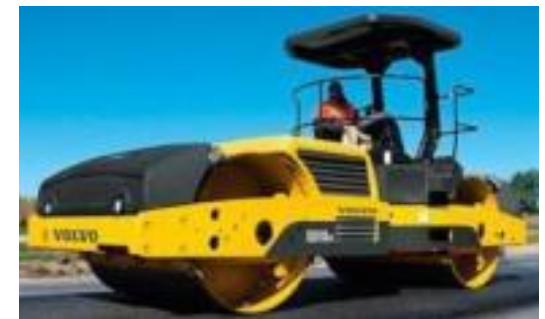
- Rolling and Achieving Density
 - Initial rolling was 2 vibratory and 1 static
 - 15,000 lb roller (DD 70-HF) as breakdown
 - 8,000 lb (DD 34-HF) as finish
 - 13% air voids rather than 10% air void target
 - VaDOT & contractor identified 27,000 lb roller is ideal

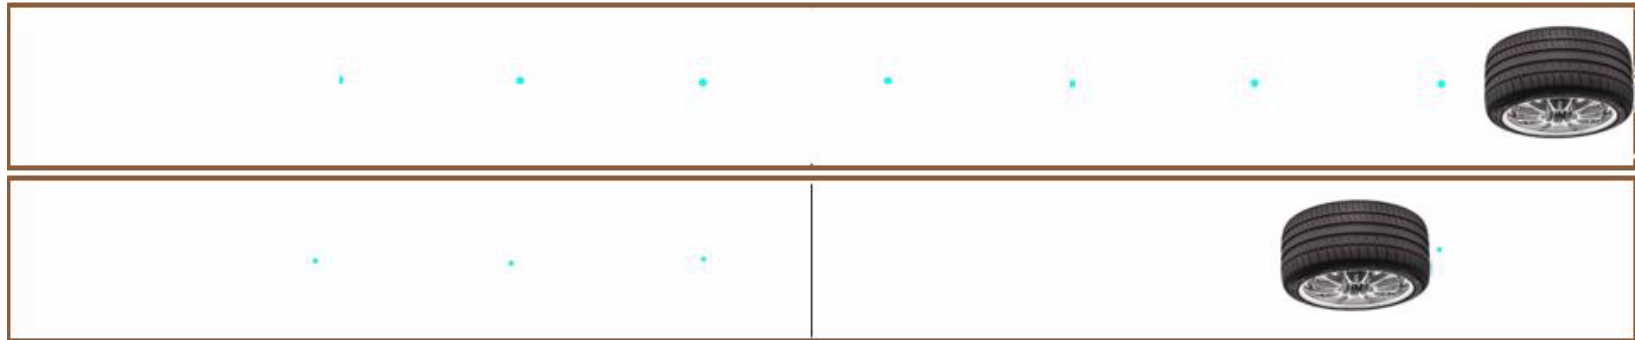
Development of Fatigue Cracks under APT Loading

The development of fatigue cracks within loaded wheel paths are illustrated

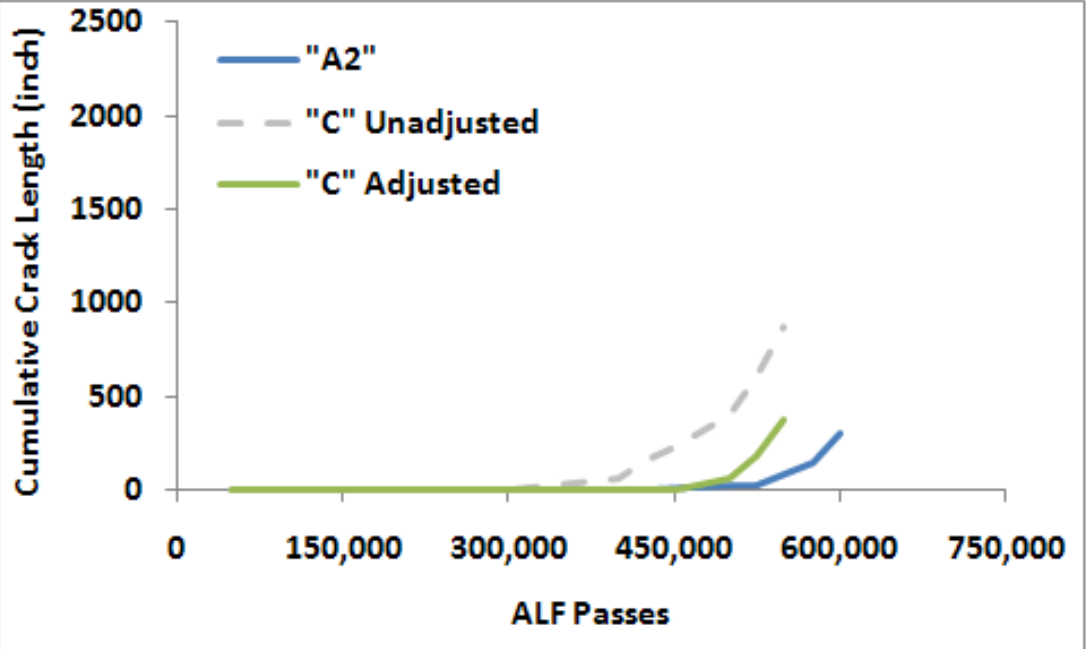
Lane 8 Control 70-22

A1:B = Effect of Aging on
Conventional HMA
(no preservation treatment)

A2:C = Effect of
"New" unaged
4.75mm on Aged
Pavement

- Thin overlay allows 8-year-old-PLUS structure to perform like a 3-year-old structure
 - 425,000 - 500,000 passes to first crack
- While without milling-and-overlay the structure performed significantly less
 - 50,000 passes to first crack
- When the overlay was aged, the overlay provides little benefit

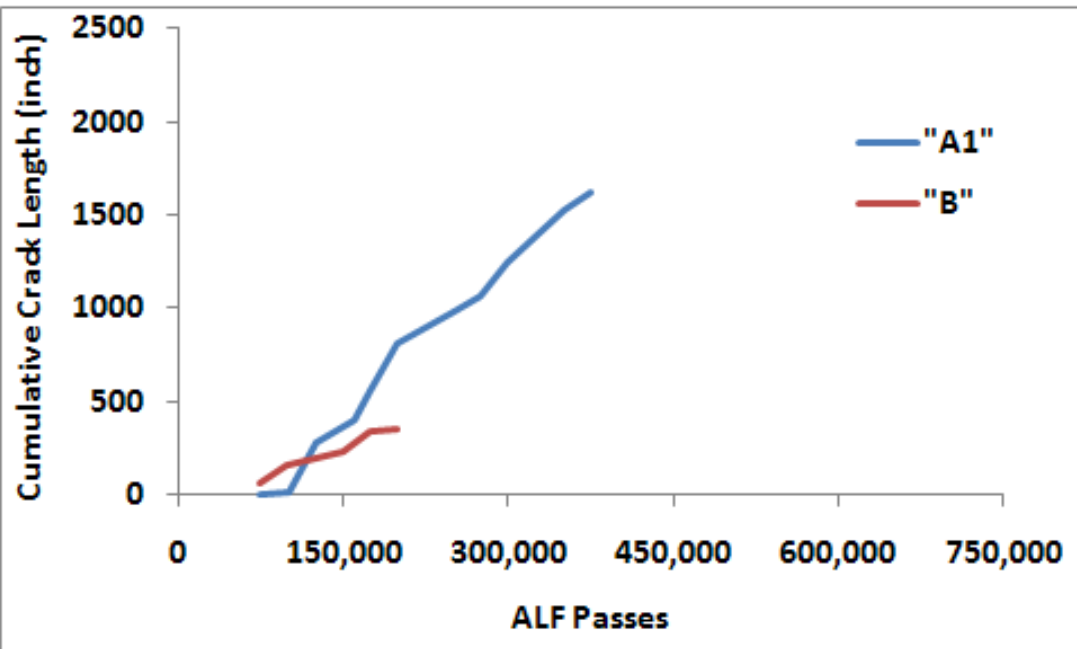
Lane 10

A1:B = Effect of Aging on
Conventional HMA
(no preservation treatment)

A2:C = Effect of
"Old" Aged 4.75mm
on Aged Pavement

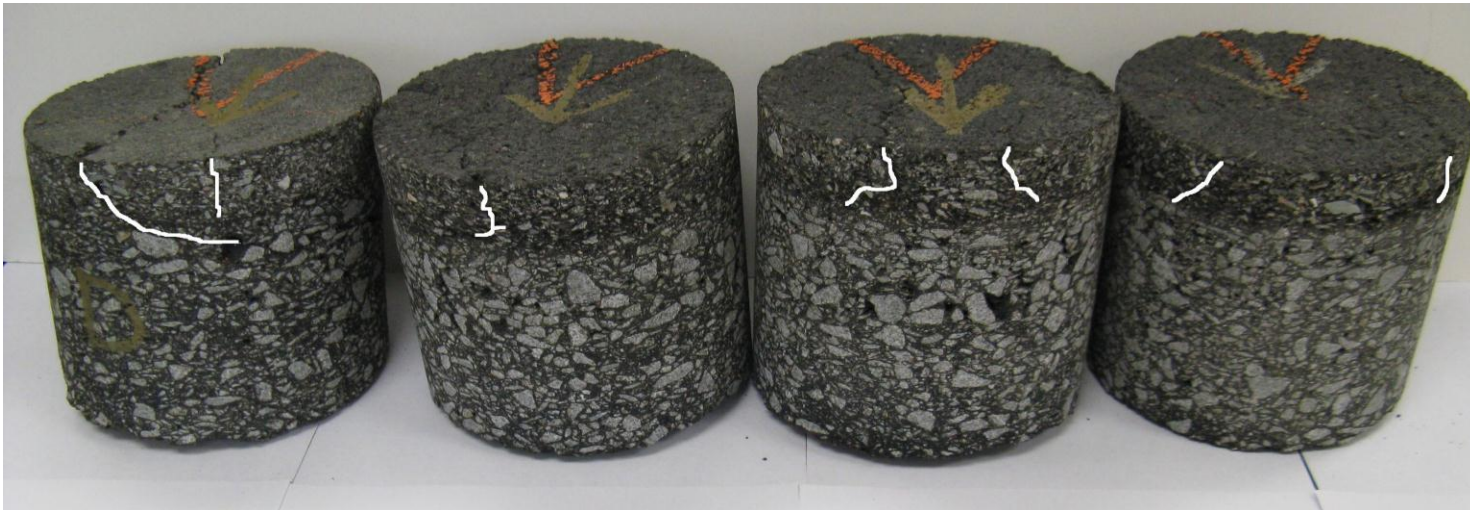
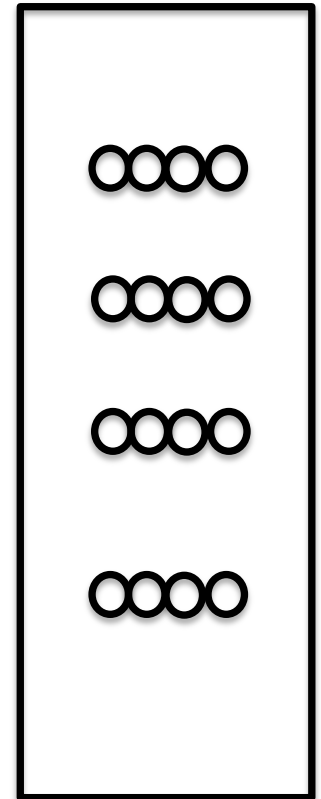
Vertical Crack Profiles

- Cores taken across the width of the wheel path

- Superpave 4.75mm NMAS mixture designed with 20% RAP content and WMA production
- Large rollers recommended to achieve density even though fine mix and higher binder content
- Aged pavements developed top-down cracking rather than bottom-up

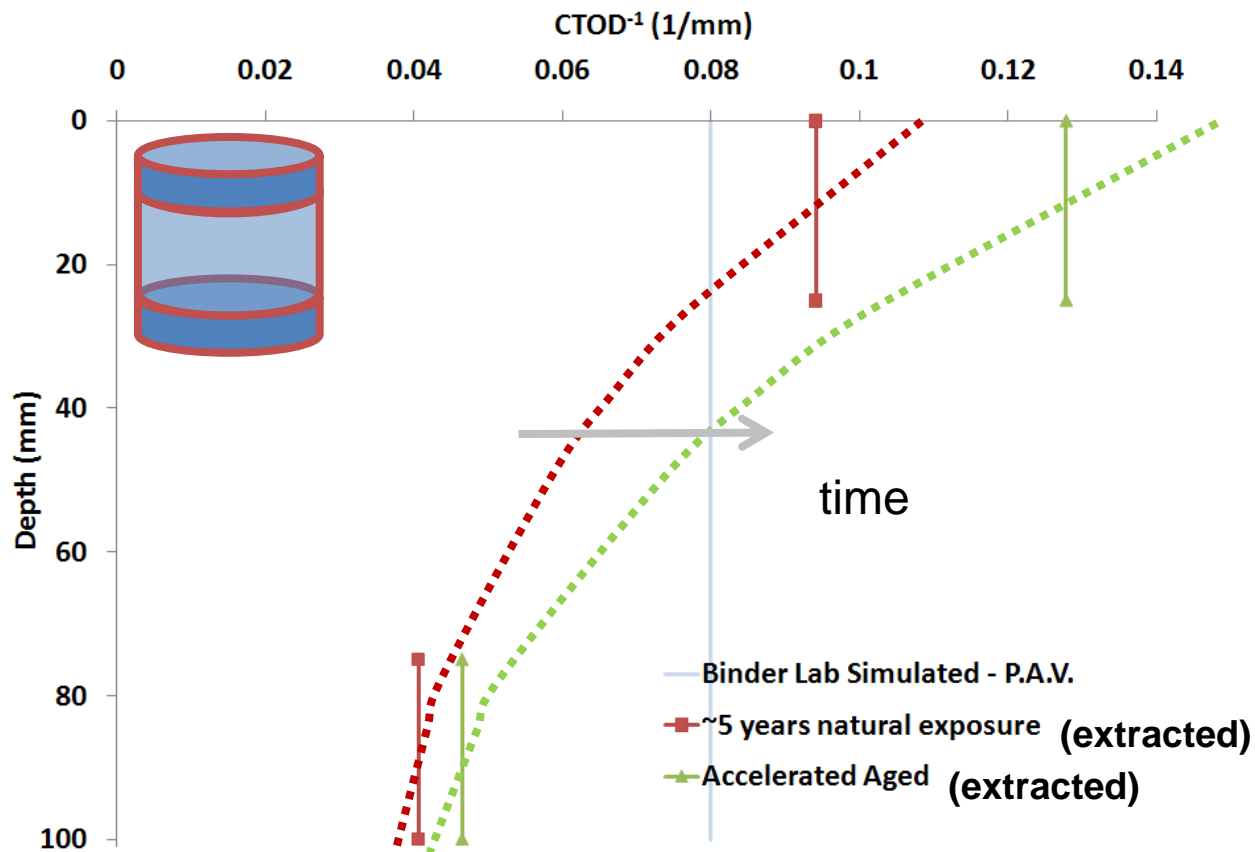
- Embrittlement of In-Situ Asphalt Binder
