Joint Distress in Portland Cement Concrete Pavements

Presenter: Larry Sutter
Michigan Technological University
Michigan Tech Transportation Institute

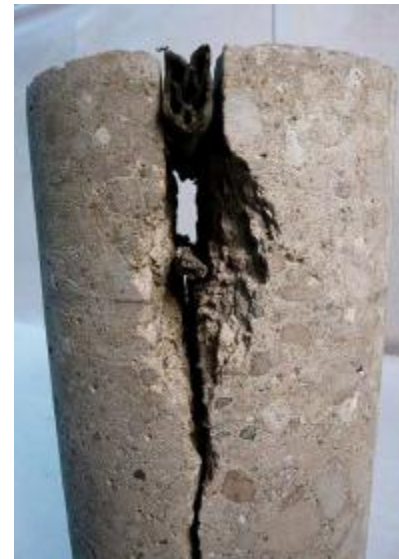
- Sites in WI, MI, IA, & MN
 - Analysis still on-going
- Different manifestations
 - Related to type/permeability of base, sealant, & materials
- Top Down vs. Bottom Up vs. Inside Out...
- Commonalities
 - Entrapped water

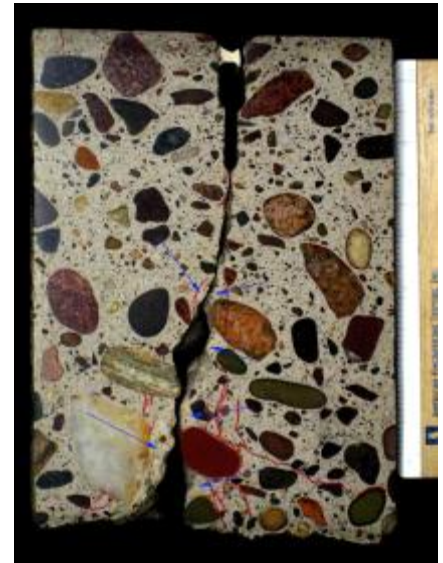
- A Tale of Two Cores
 - Same slab – same joint
- Top Down vs. Bottom Up

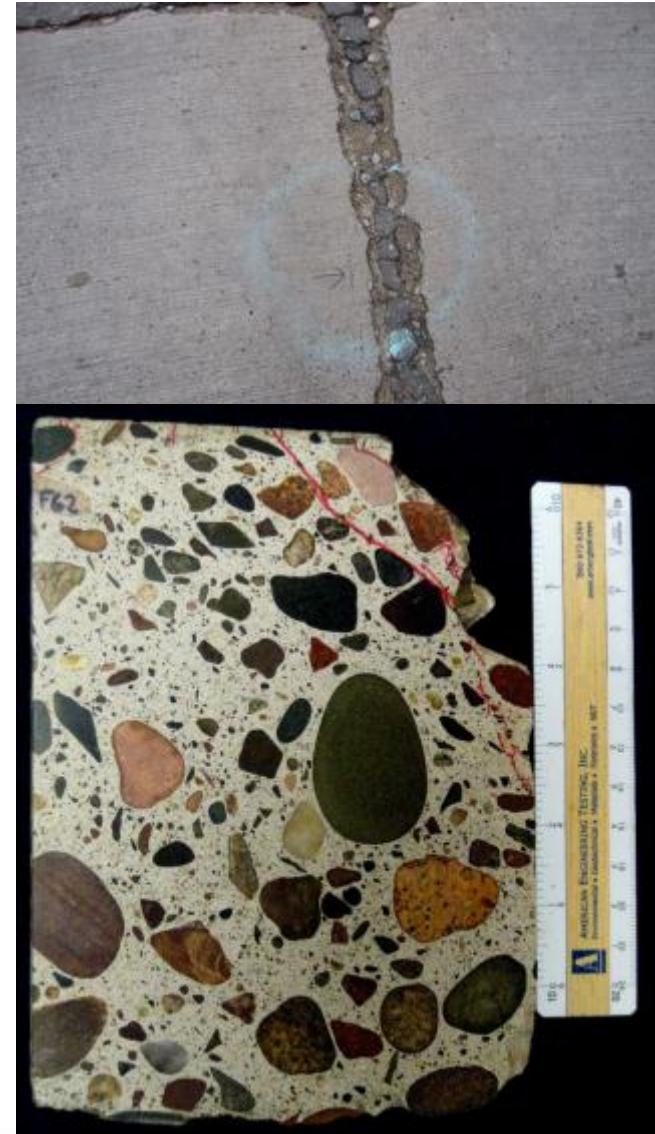
- A Tale of Two Cores
 - Same slab – same joint
- Cracking parallel to the joint observed on the surface
 - Common observation
- Cracking sub-surface appears to be parallel to the deterioration front
 - F-T damage
- Results in the V-shaped top down damage

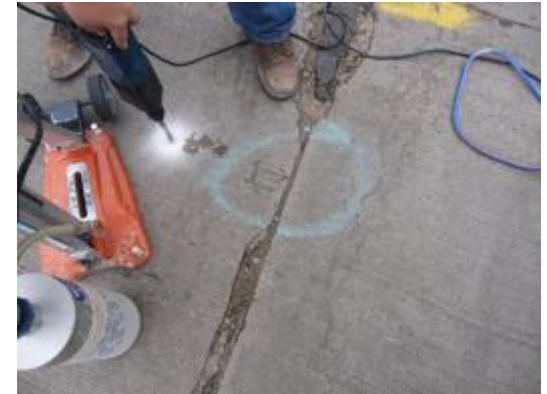
- A Tale of Two Cores
 - Same slab – same joint
- Area with less distress
- Cracking emanating from the bottom up
- Core hole drained significantly slower than all other core holes on the slab
- Water trapped at the bottom but F-T?

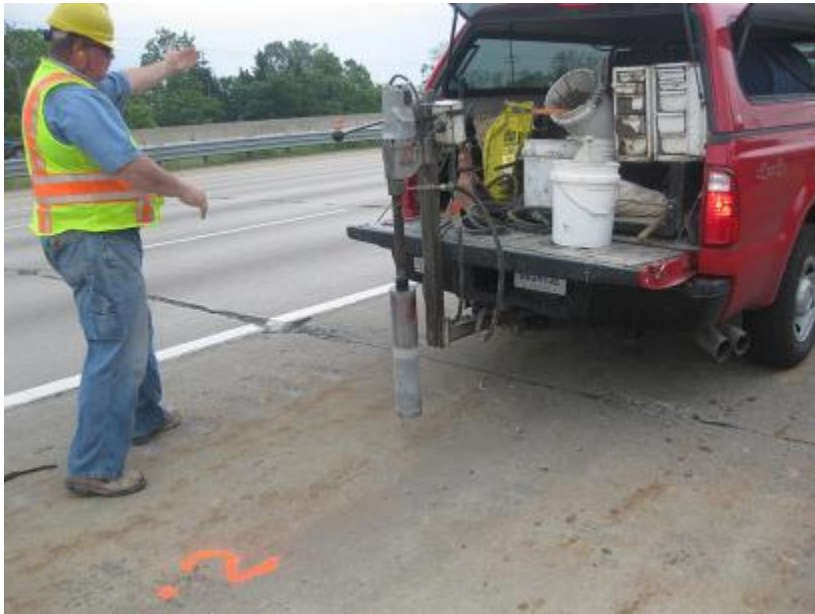
- Site 2 - showing deterioration at joint
- Site 4 - not exhibiting deterioration at joint

- Site 2
 - Poor air-void system
 - Alkali-silica reaction with fine aggregate particles and related cracks extending into hardened paste, but only within the top inch
 - Low paste density, high chloride ingress
- Site 4
 - Adequate air-void system
 - Alkali-silica reaction with fine aggregate particles, but without cracks extending into hardened paste
 - Higher paste density, lower chloride ingress

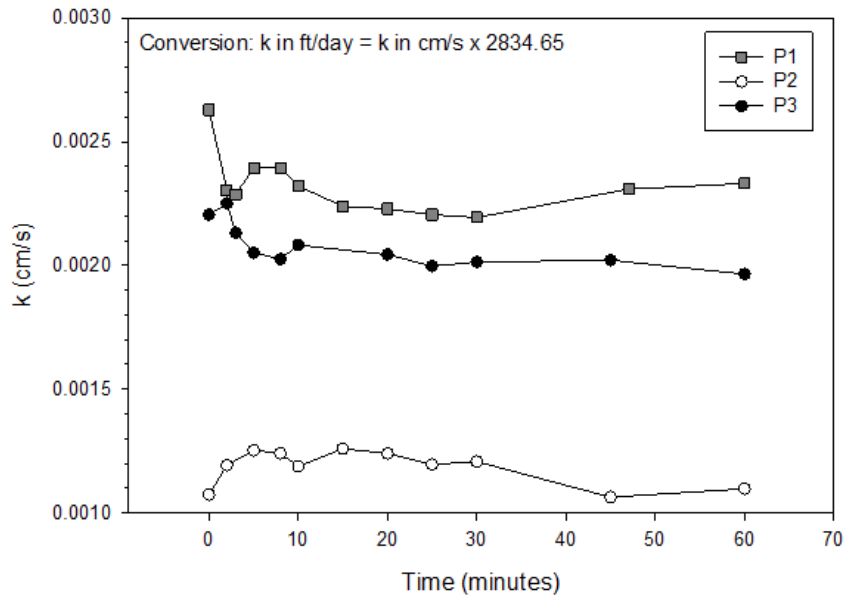
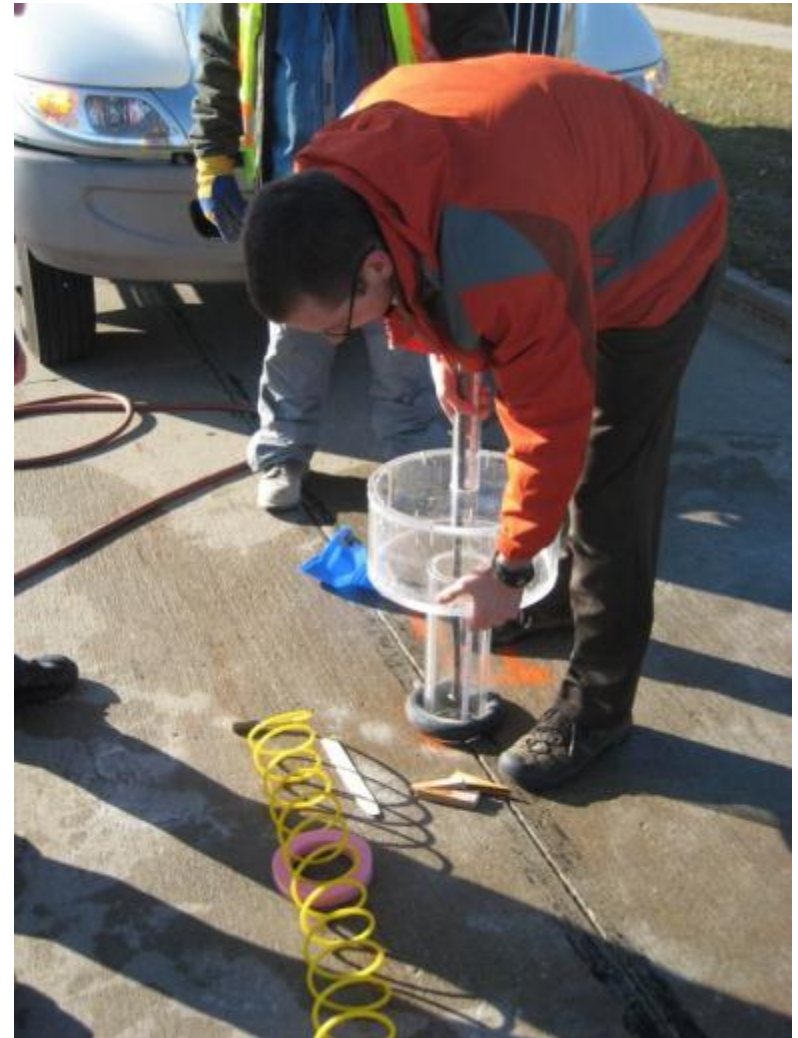
- Other Observations
 - Base layer drainage

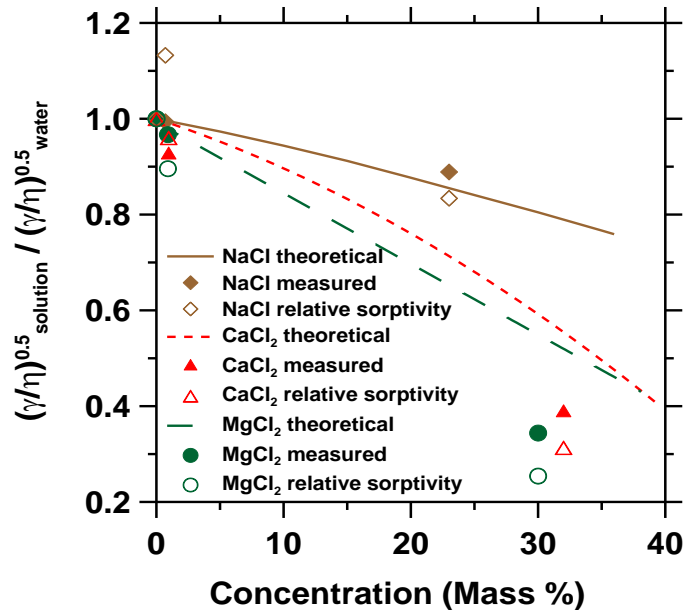
Salt Water Solutions are not the Same as Water

- Slower abs. with salt solns.
- Different phase diagram
- Different equilibrium RH

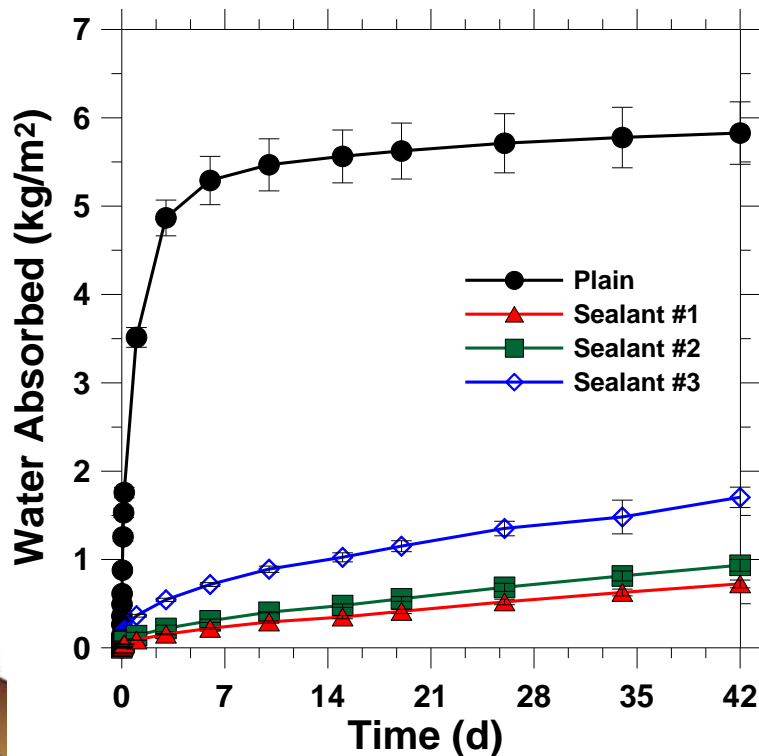
Can We Use Concrete Sealers/Pore Blockers to Reduce Saturation

- Sealers can keep out water
- FT behavior differs – new test in development
