Dowel-Bar Retrofit Using Polyester Polymer Concrete

Shakir Shatnawi, Ph.D., P.E.

**President, SHATEC ENGINEERING
CONSULTANTS, LLC**

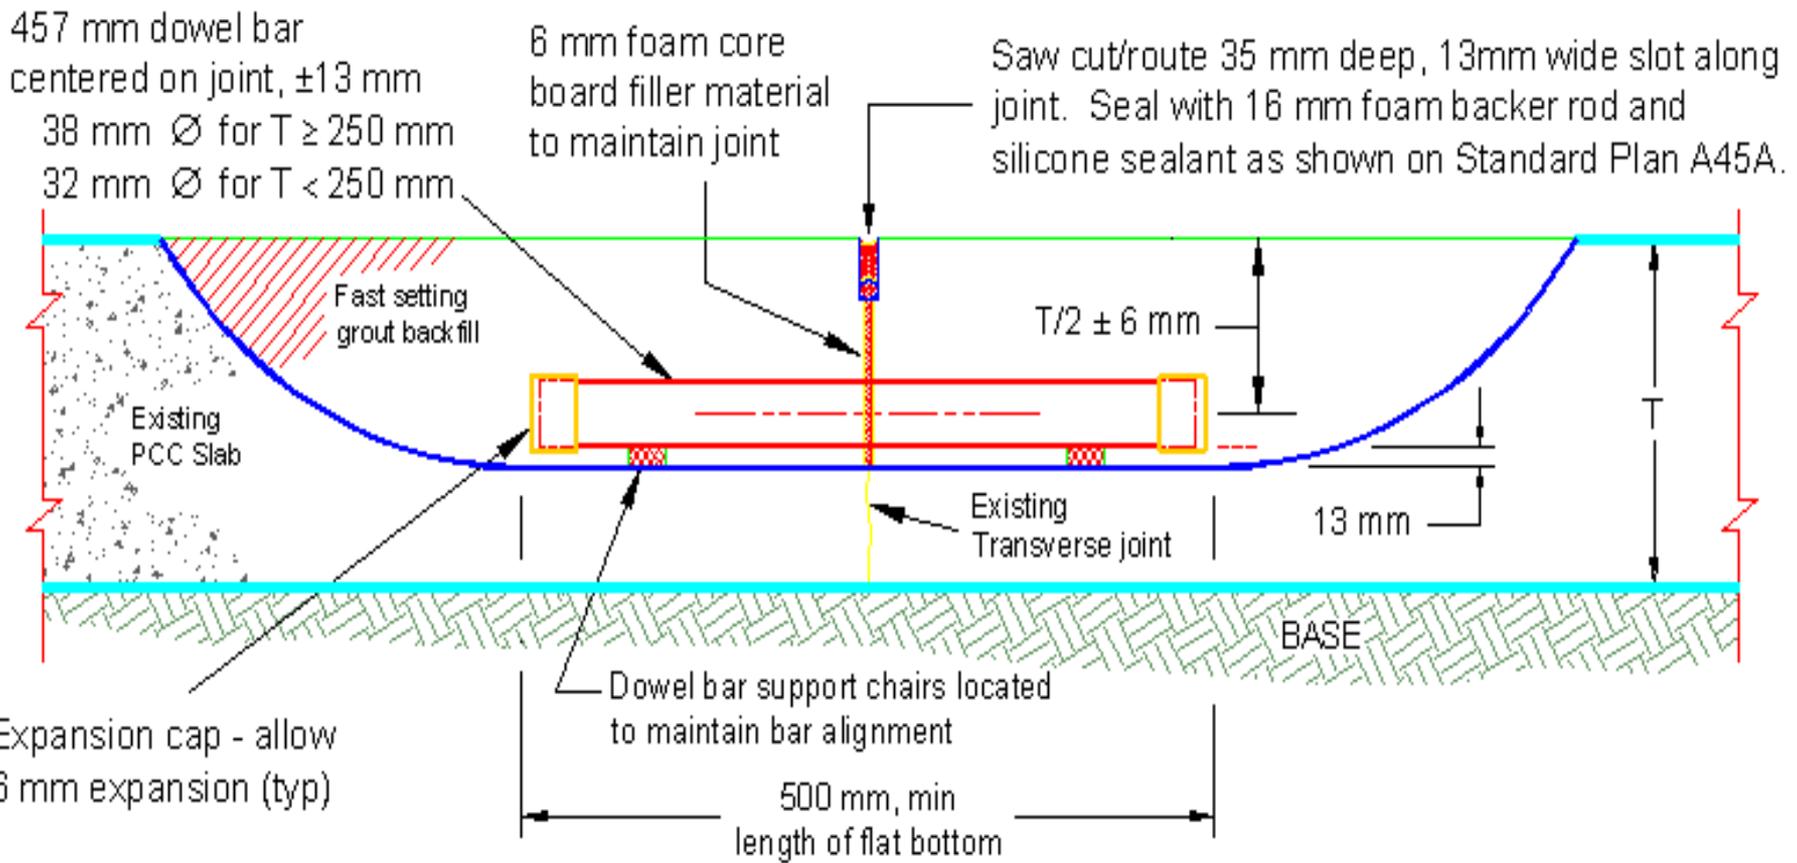
-DBR Assembly Schematic View

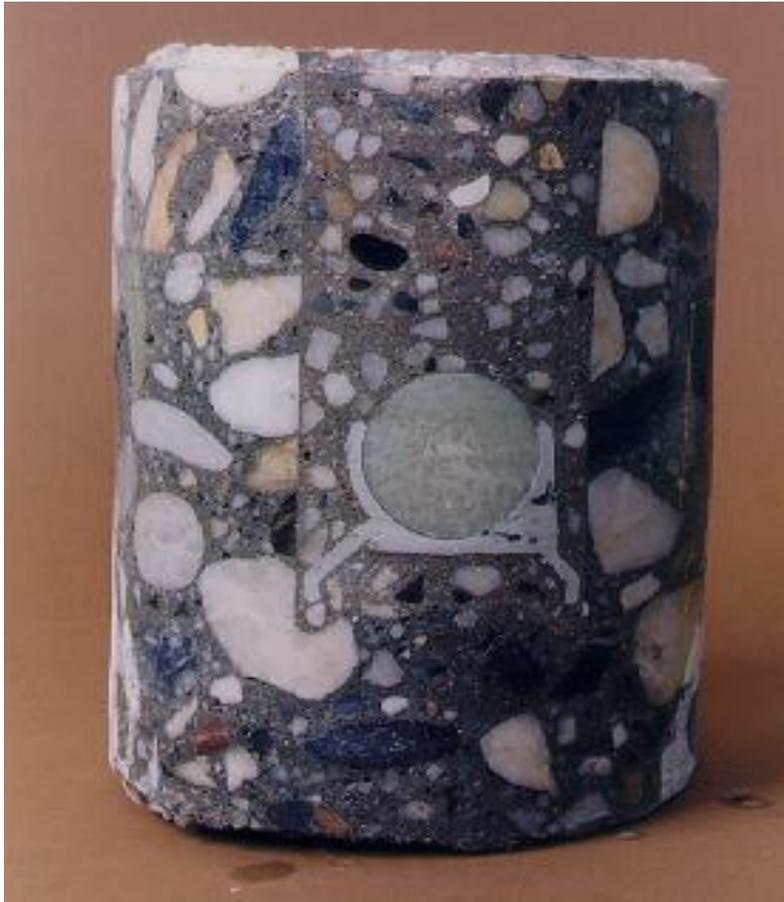
Core showing grout and dowel

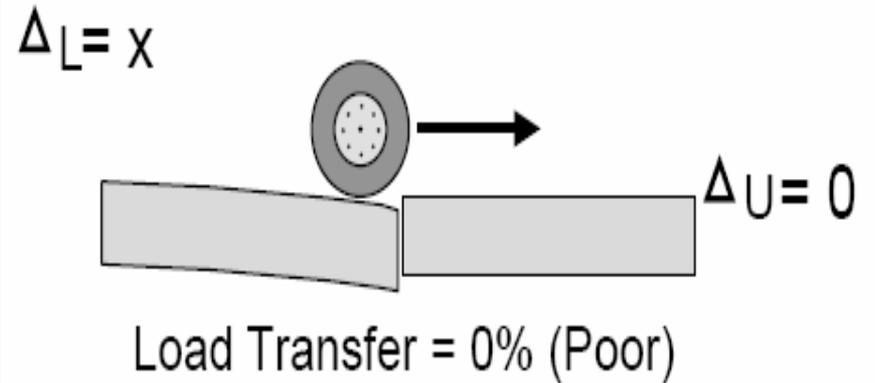
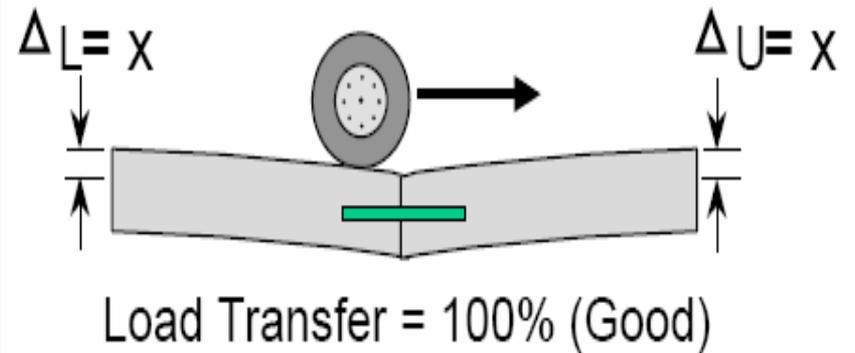
Improving load transfer

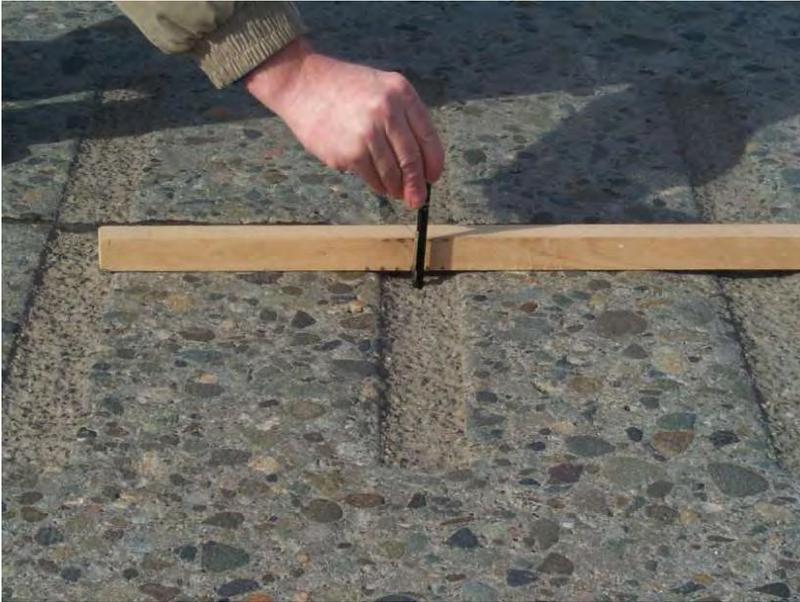
Studded Tire Wear

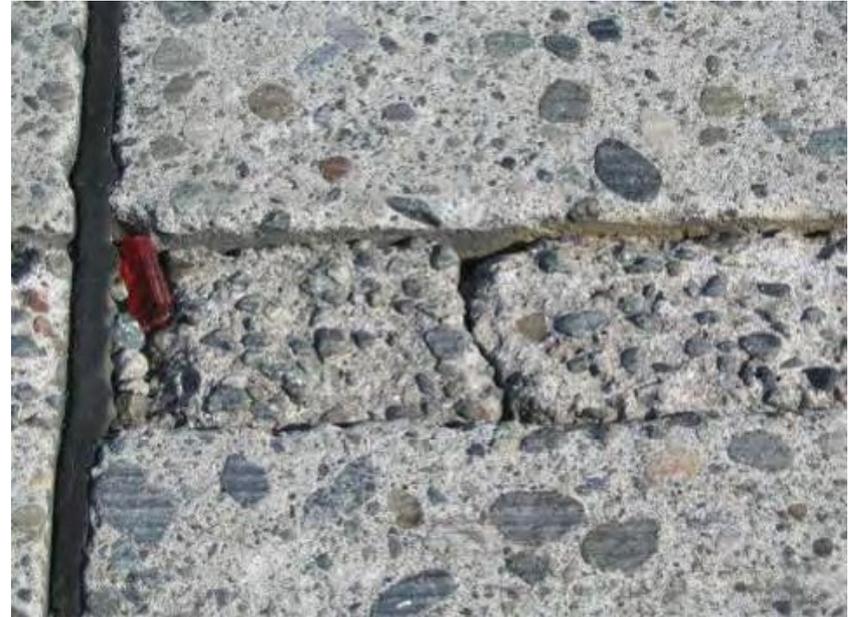
Backfill Cracking

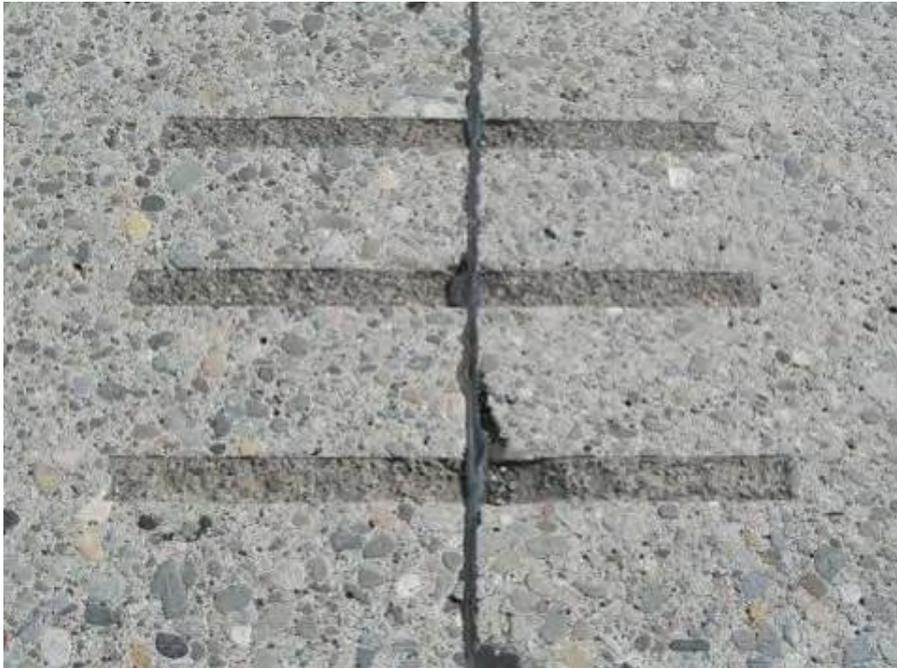
Backfill Spalling

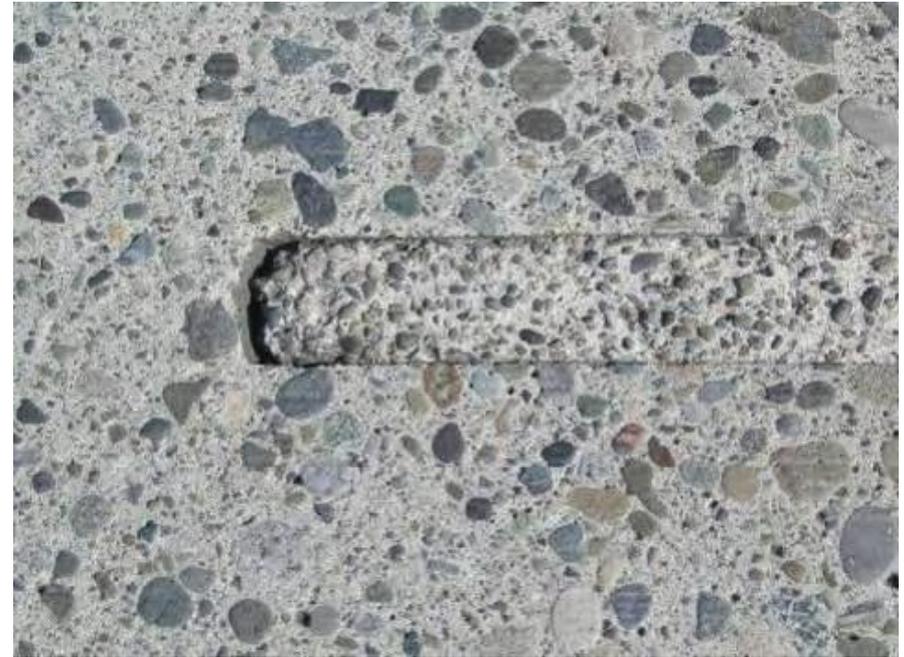
Backfill Debonding

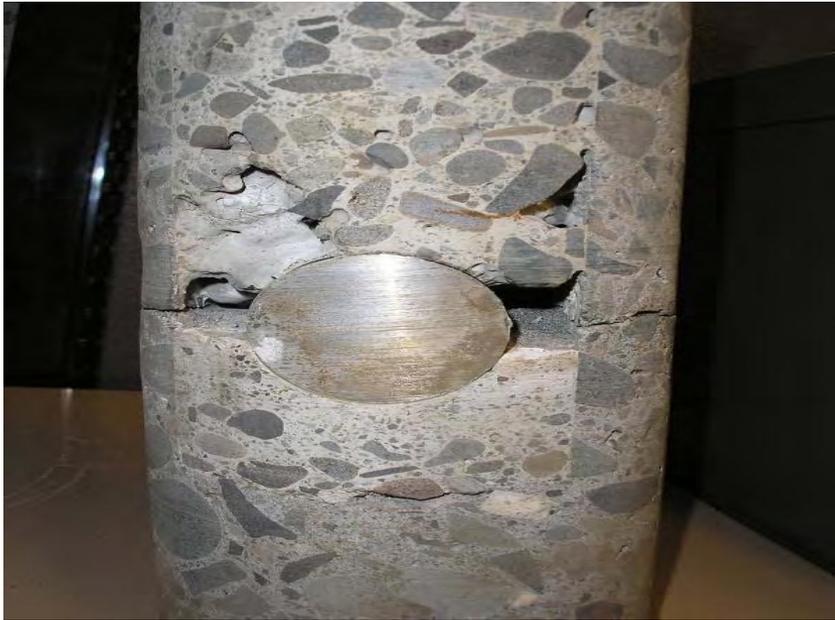
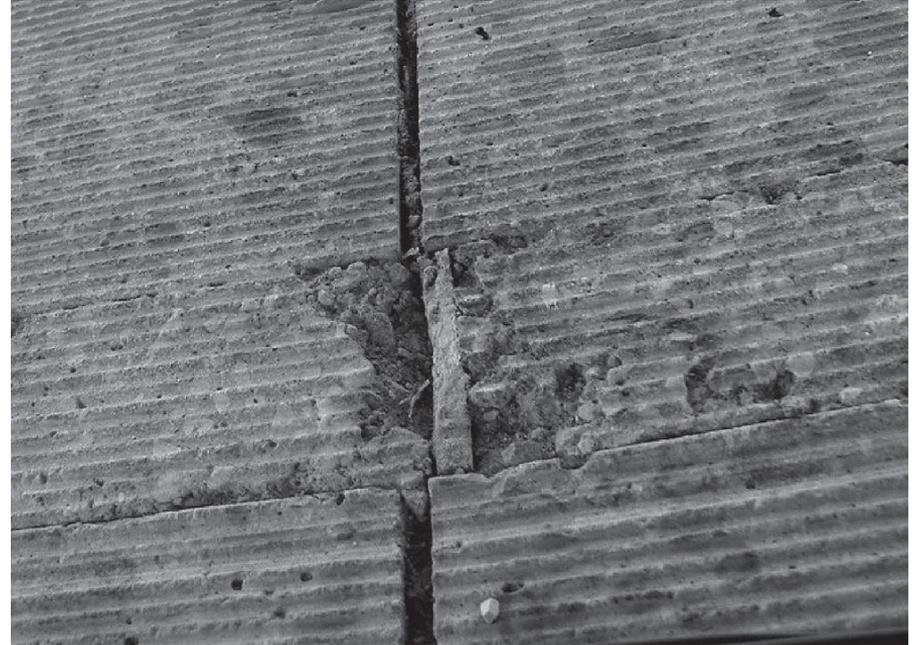
Poor Consolidation Foam Board Misalignment

- Poor consolidation is the most common problem. Under-vibration results in honeycombing.
 - No requirement for proper consolidation. Difficulty of backfill to flow below the dowel.
 - Excessive vibration-misalignment and non-uniform strength.
- Inadequate Adhesion to existing pavement.

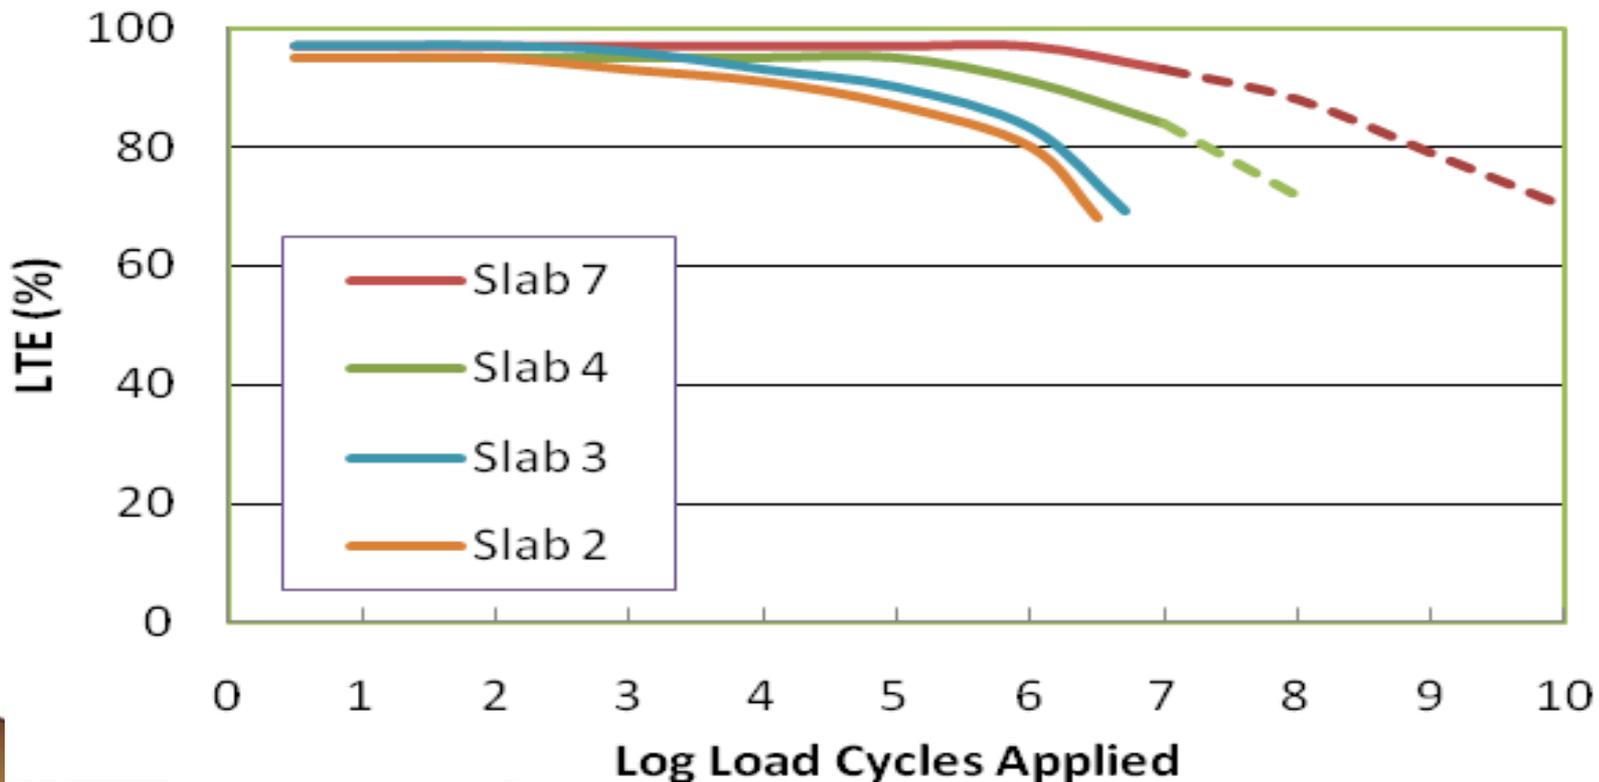
MN Minne-ALF Experiment (2001)
9000 Single Load Cycles

Slabs 2&3: 4000 PSI C. Strength
Slabs 4&7: 5000 PSI C. Strength
Slab 4 is poorly Consolidated

LTE = 70% - Slab 7 - $N_f = 100,000,000,000$ Cycles

Slabs 2&3 - $N_f = 10,000,000$ Cycles (<1000 times)

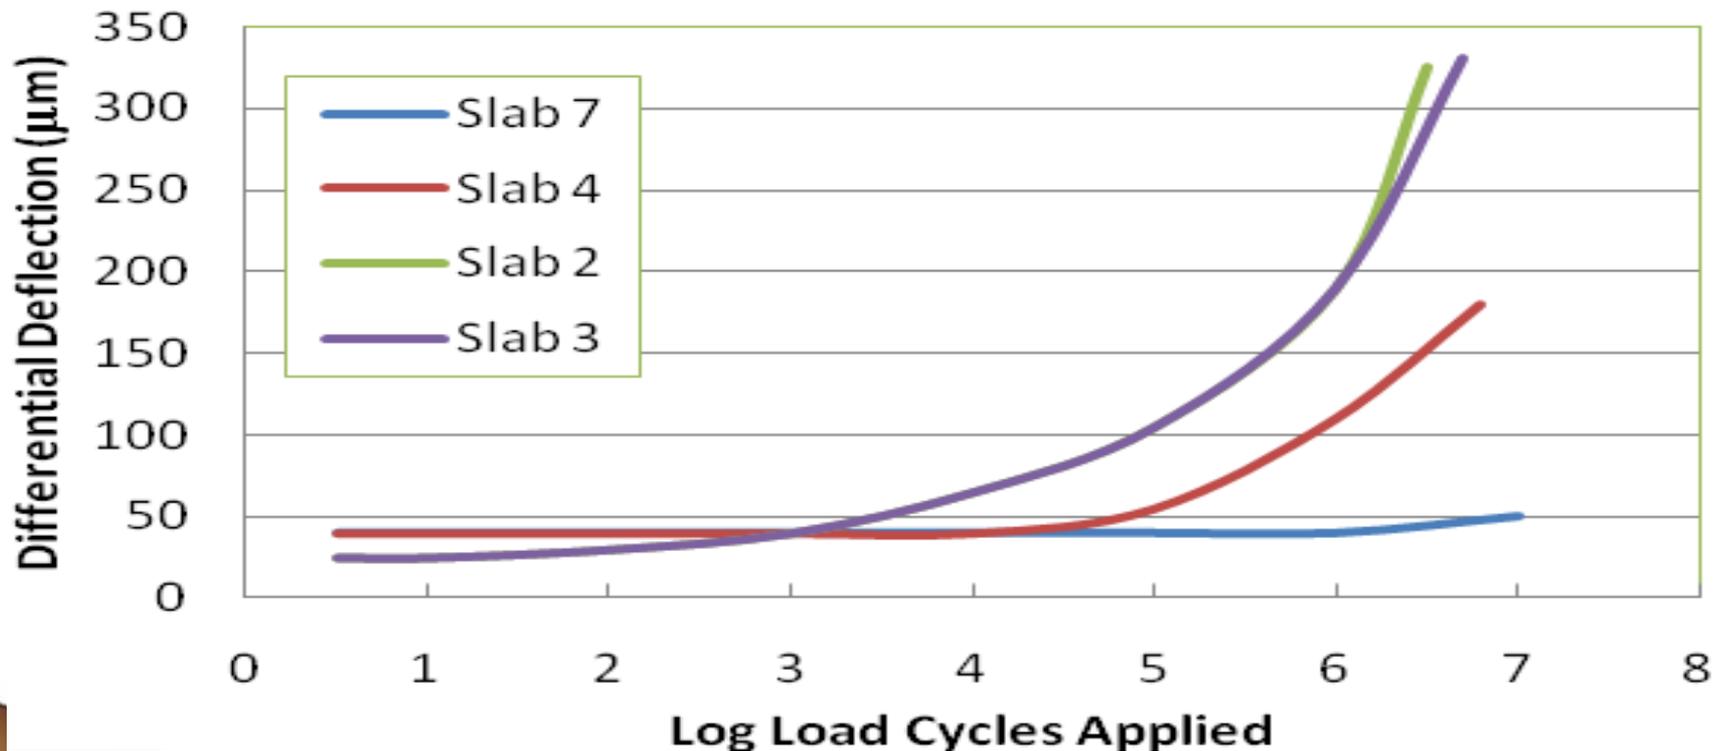
Minne-ALF Experiment-Embacher et al. (2001)

9000 Single Load Cycles

Slabs 2&3: 4000 PSI C. Strength

Slabs 4&7:5000 PSI C. Strength

Slab 4 is poorly Consolidated

Slab 7 DD=53 micro-m

Slabs 2&3 DD=325 and 331 Micro-m

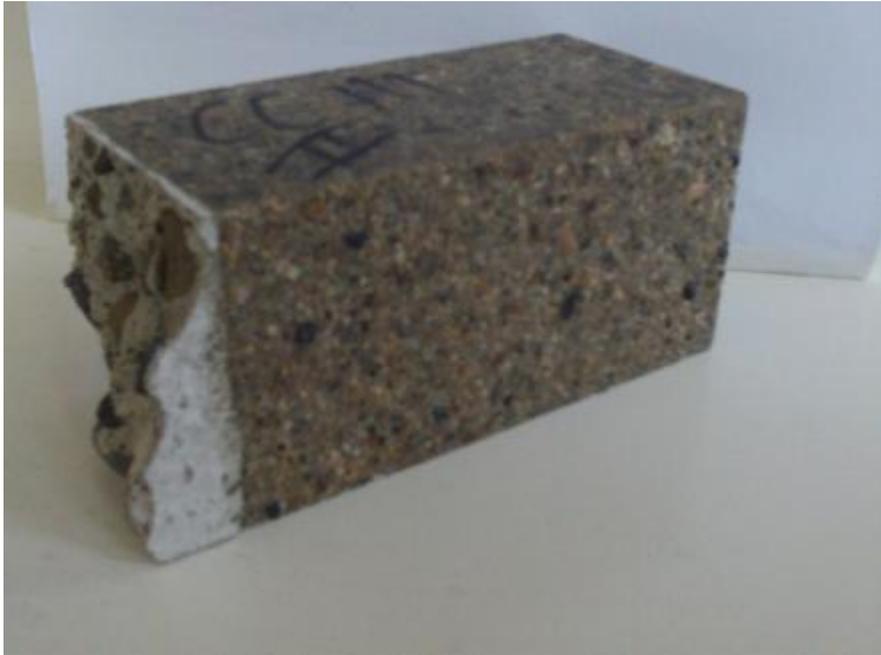
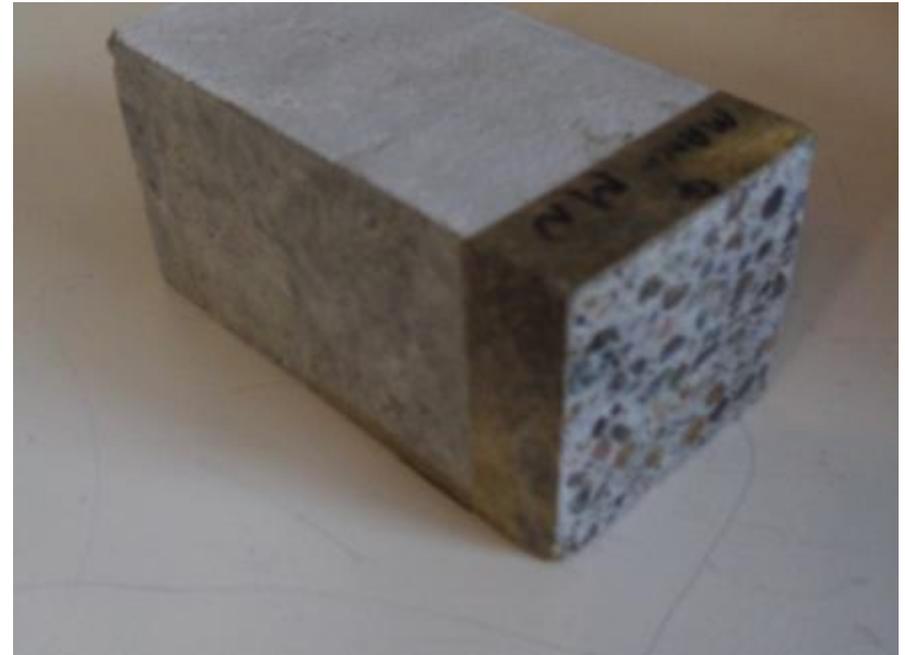
-Bond Strength CT-551

- PPC: 1200-1800 psi
- Min 500 PSI (SSD)

- PCC: 400-500 psi
- Min 300 psi (SSD) & 400 PSI (Dry)

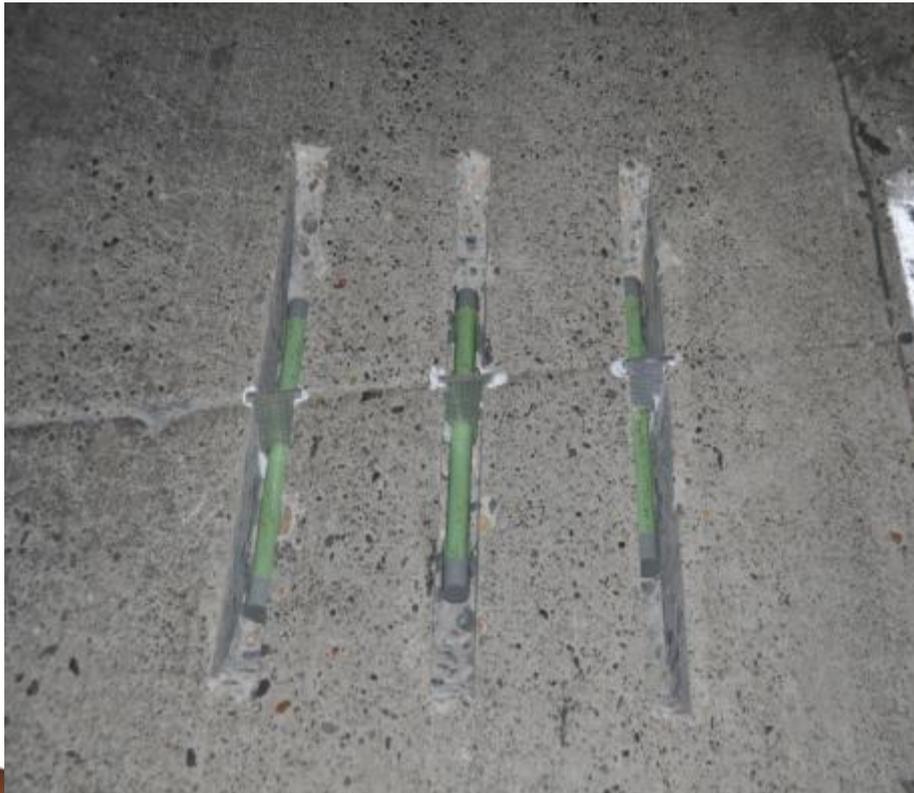
- 8 inch thick PCC
- 2004 ADT: 149,000-184,000
- 2030 ADT: Forecasted at 246,000-299,000.
- Polyester Polymer Grout (Kwik Bond) in 2010
- 61,200 dowels
- Diamond Grinding

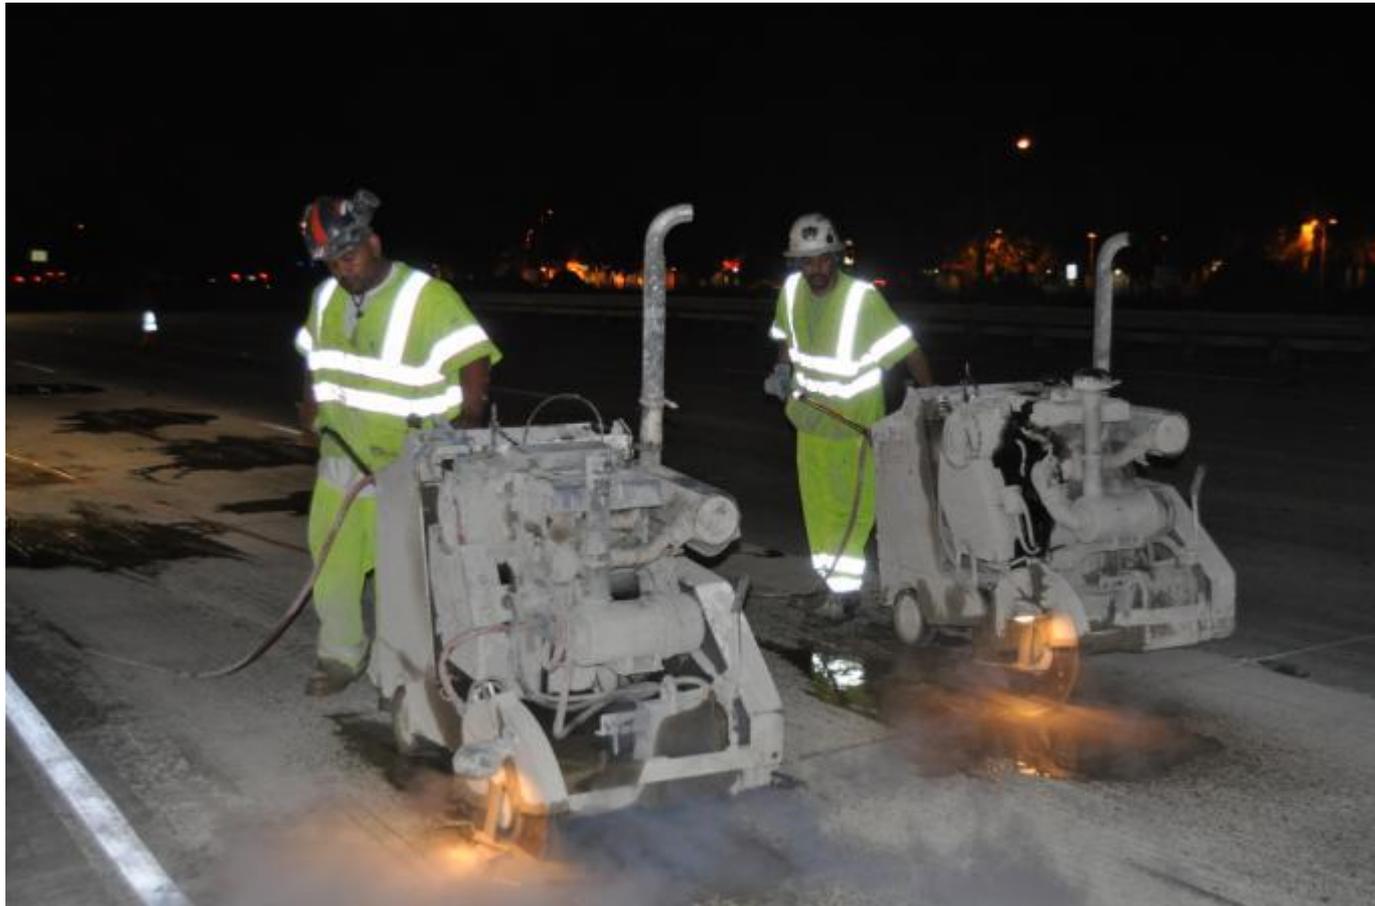
Cutting the Slots

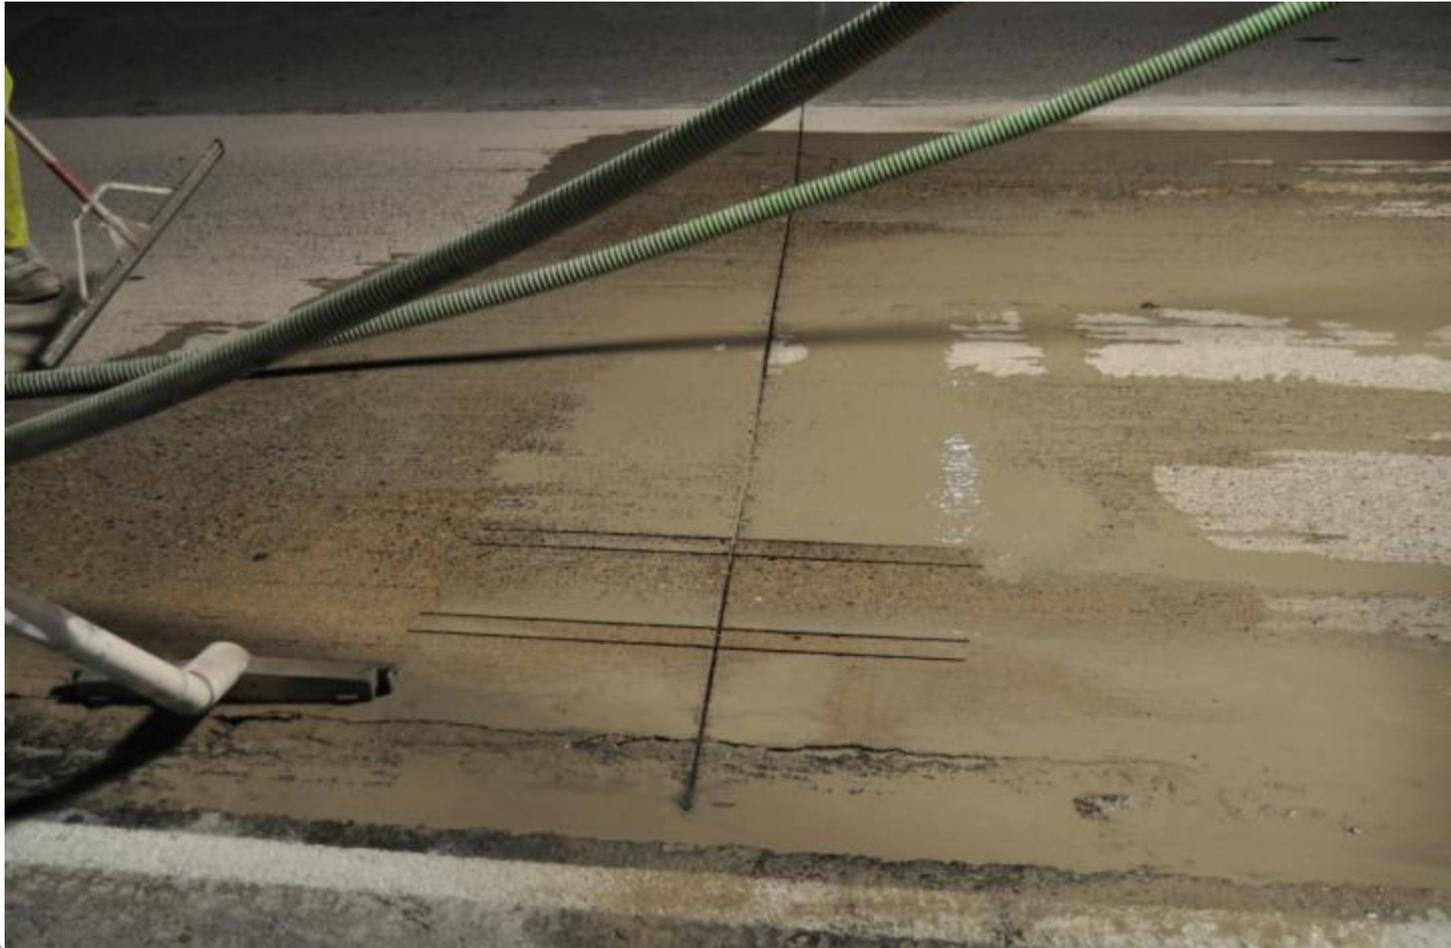
Cutting the Slots

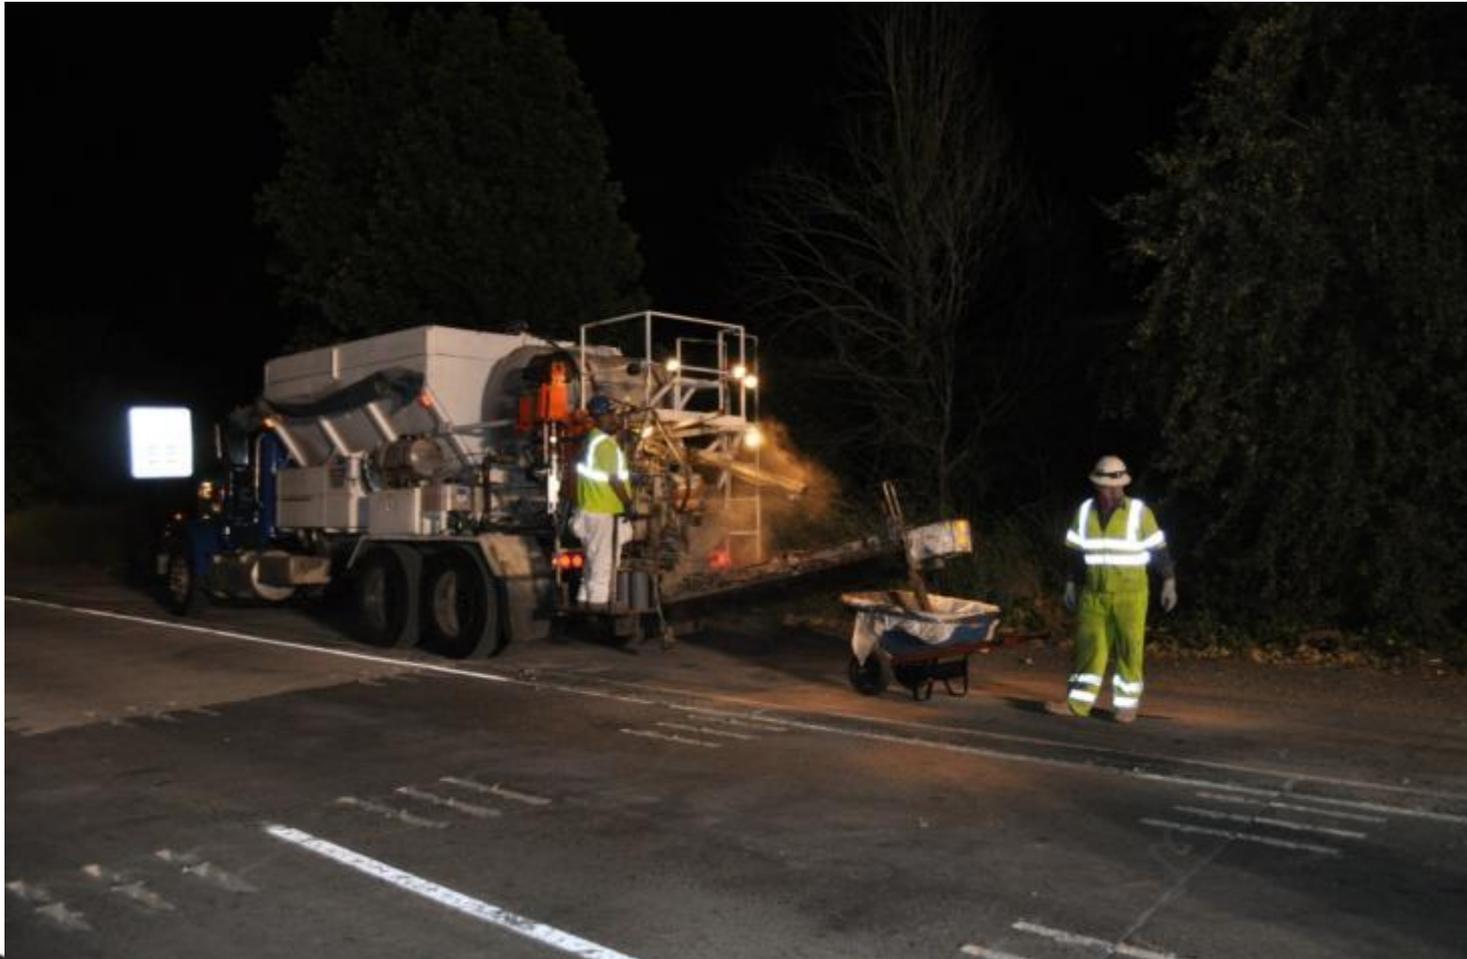
Ready to Pour PPC Grout

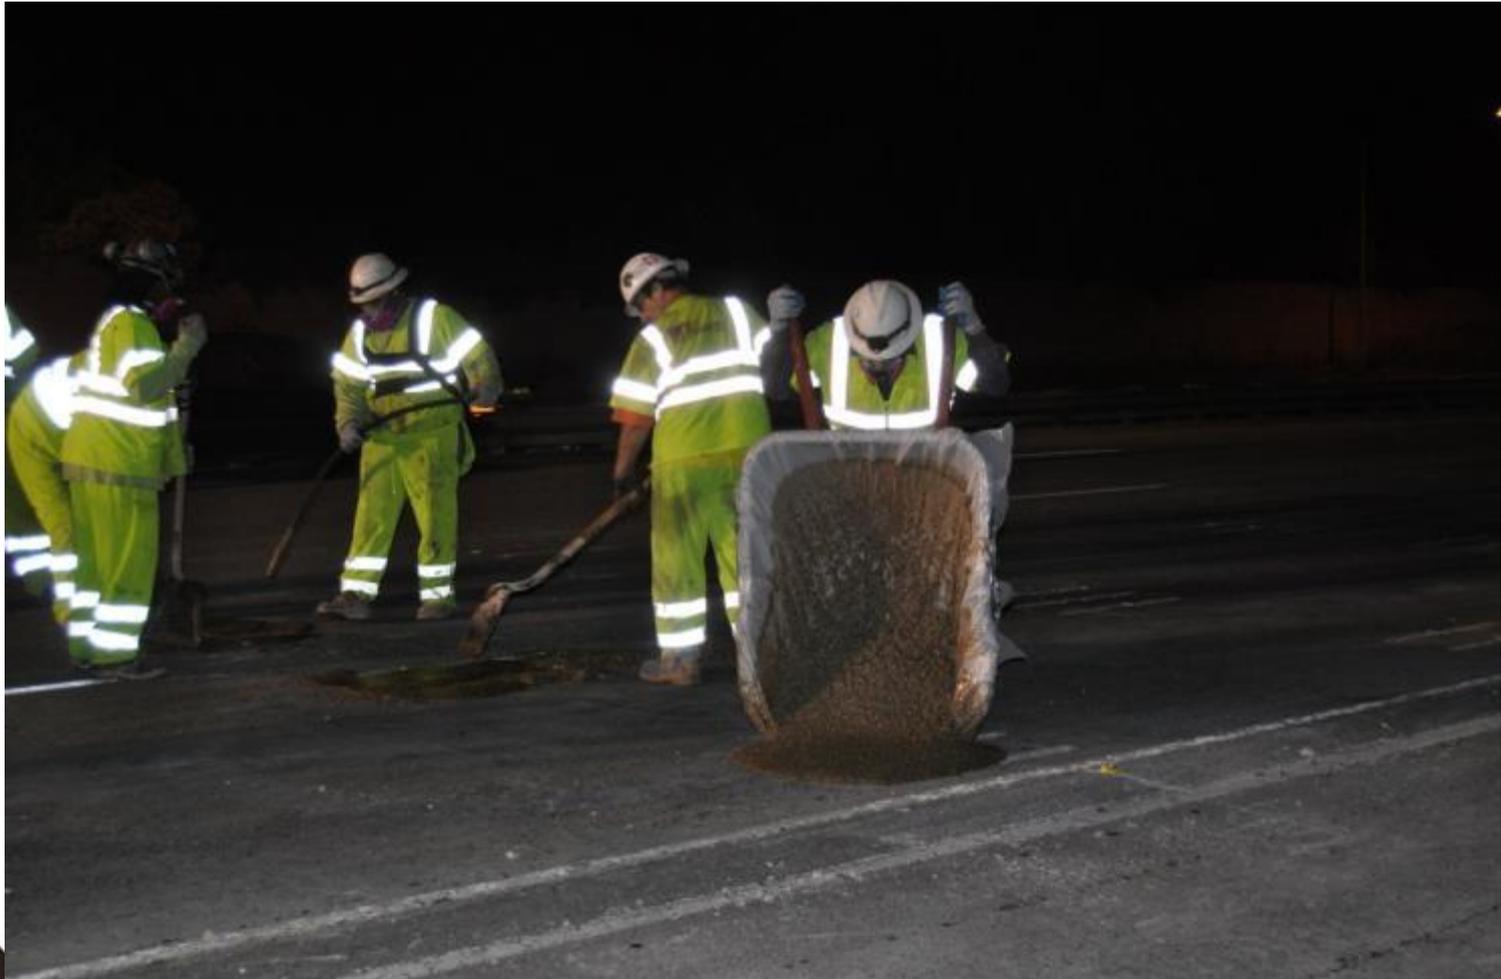
Low Viscosity PPC Grout

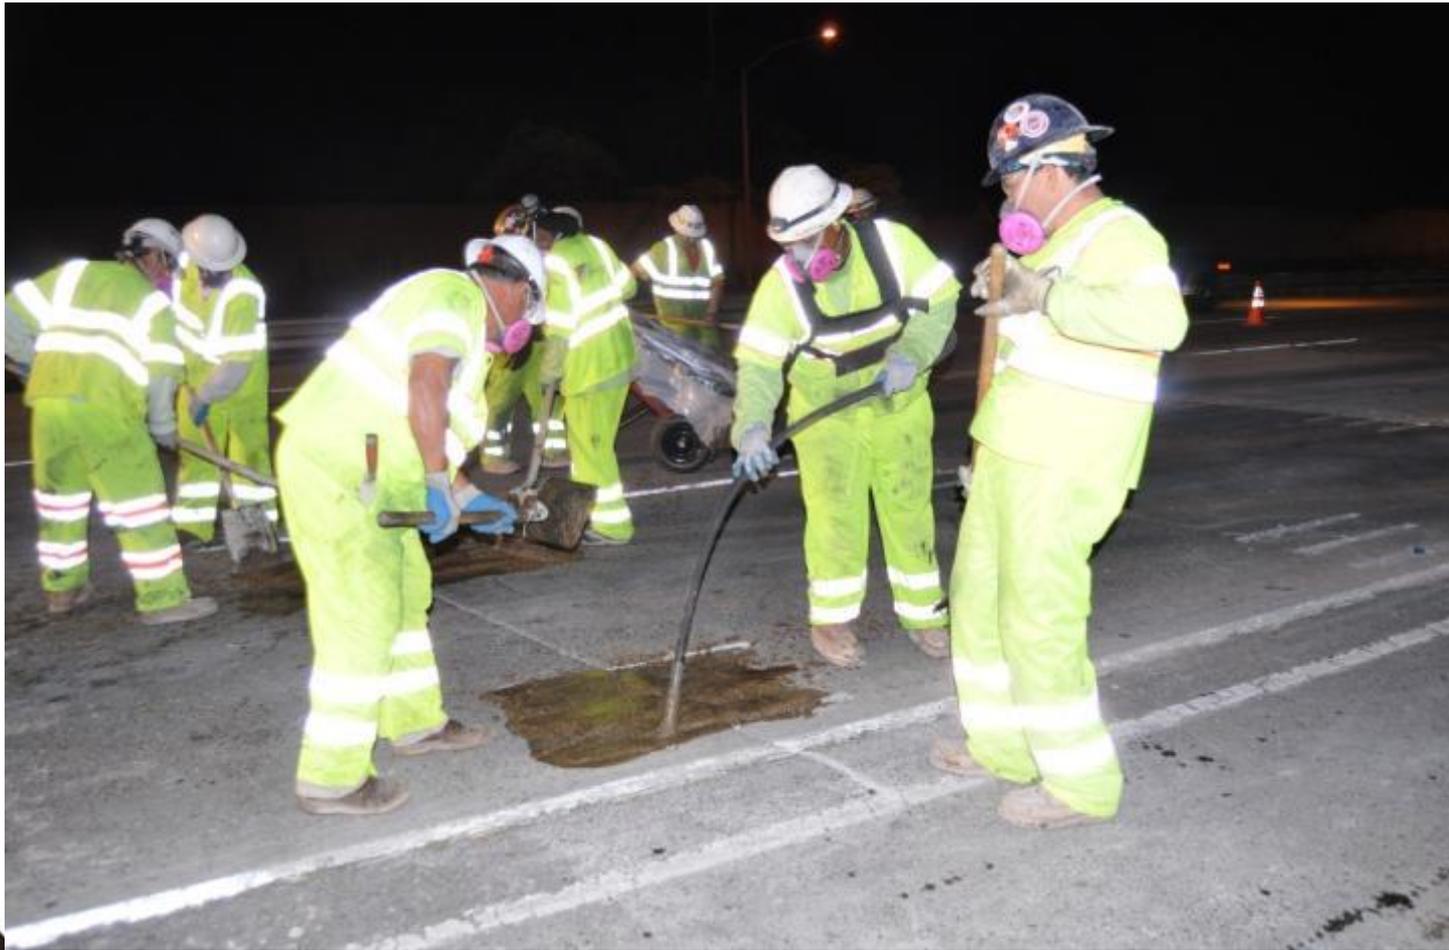
Minimum Vibration

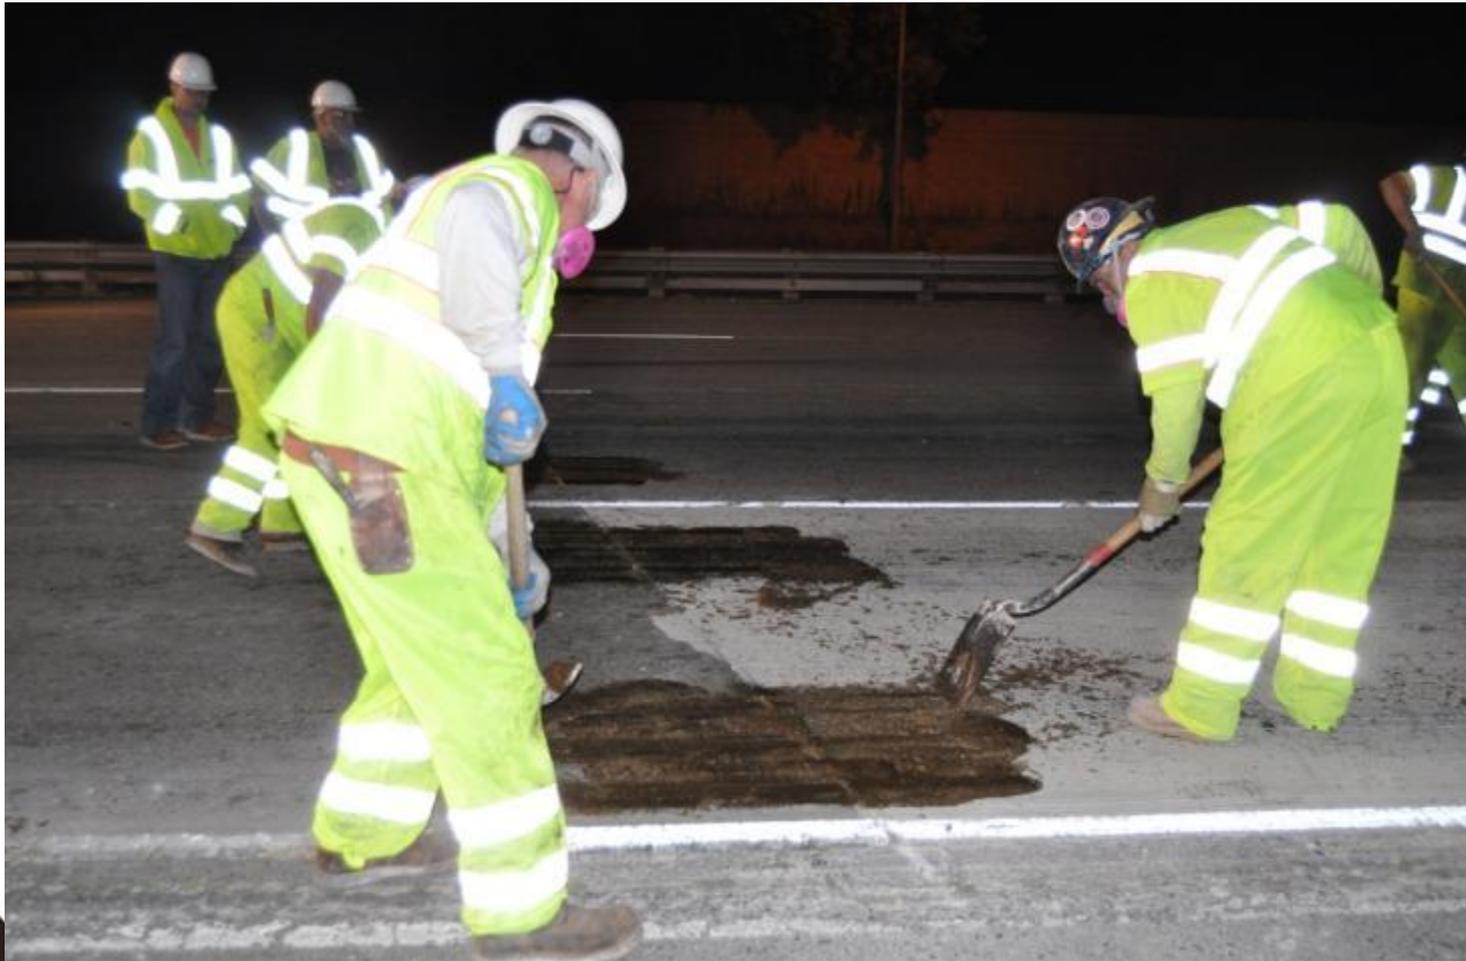
Making Sure Slots are Filled Completely

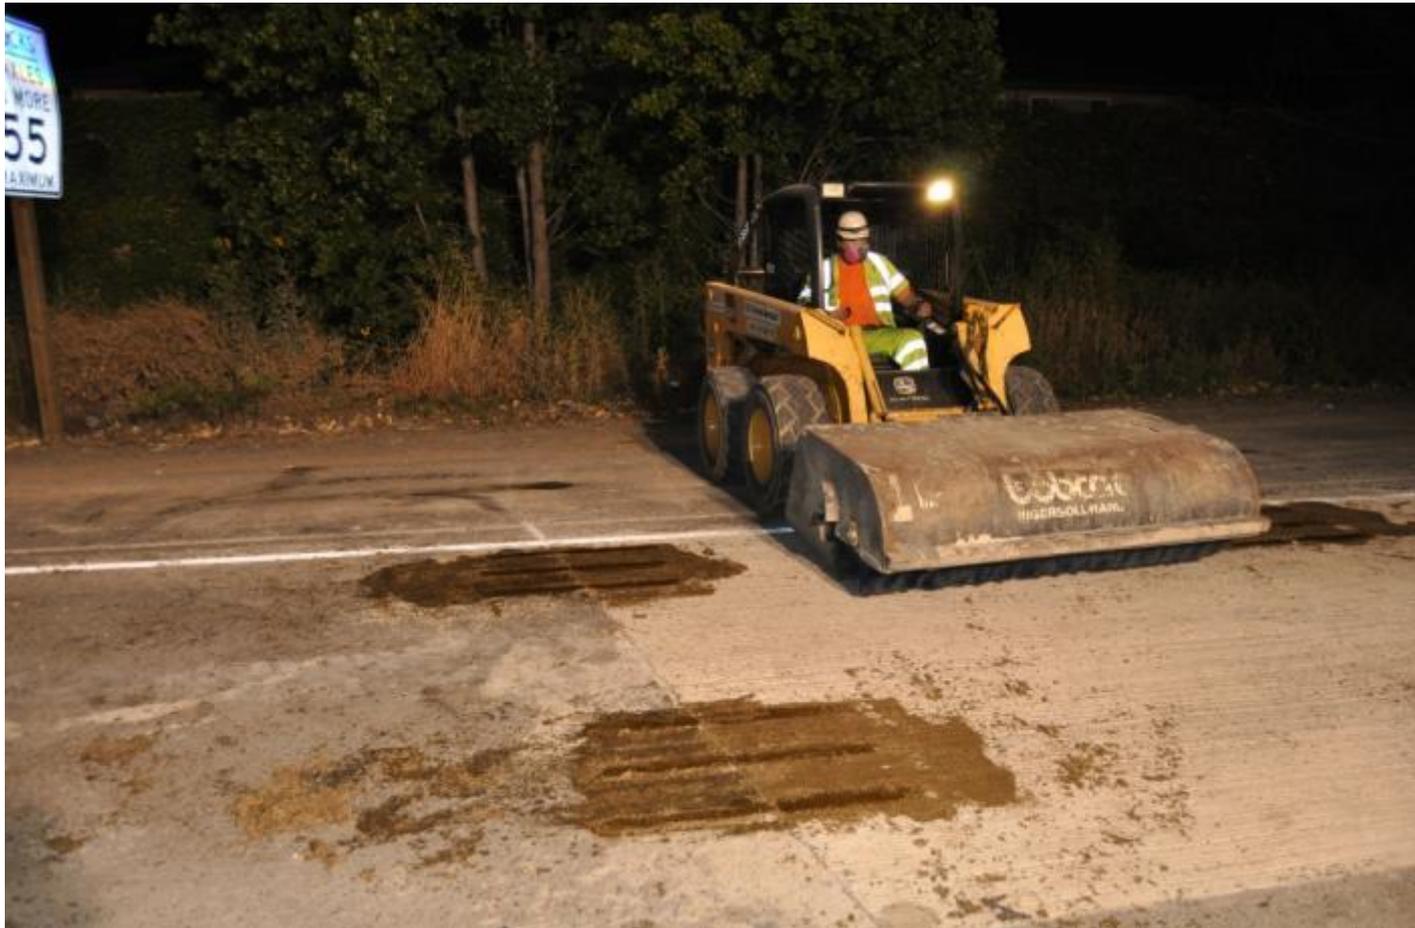
Completed DBR Installation

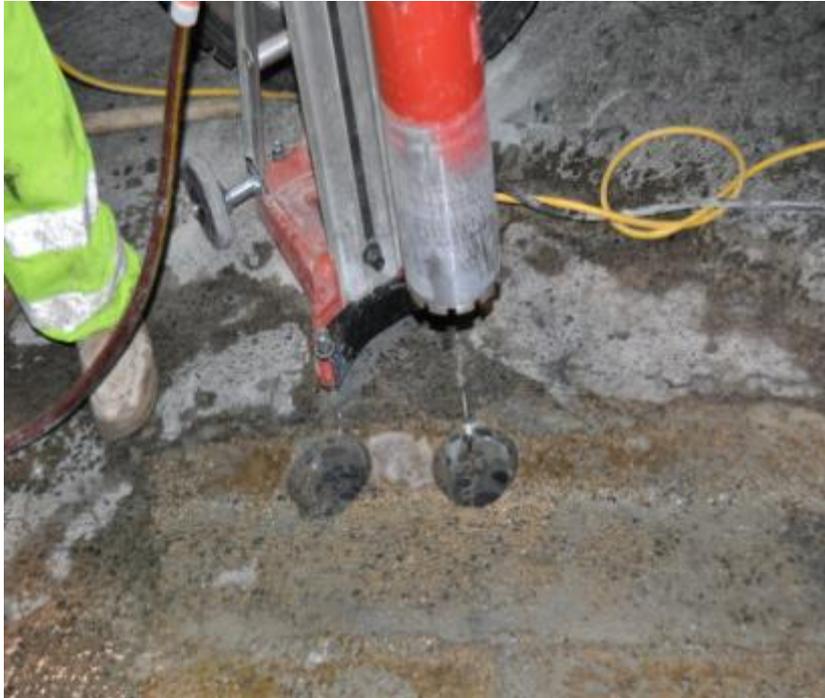
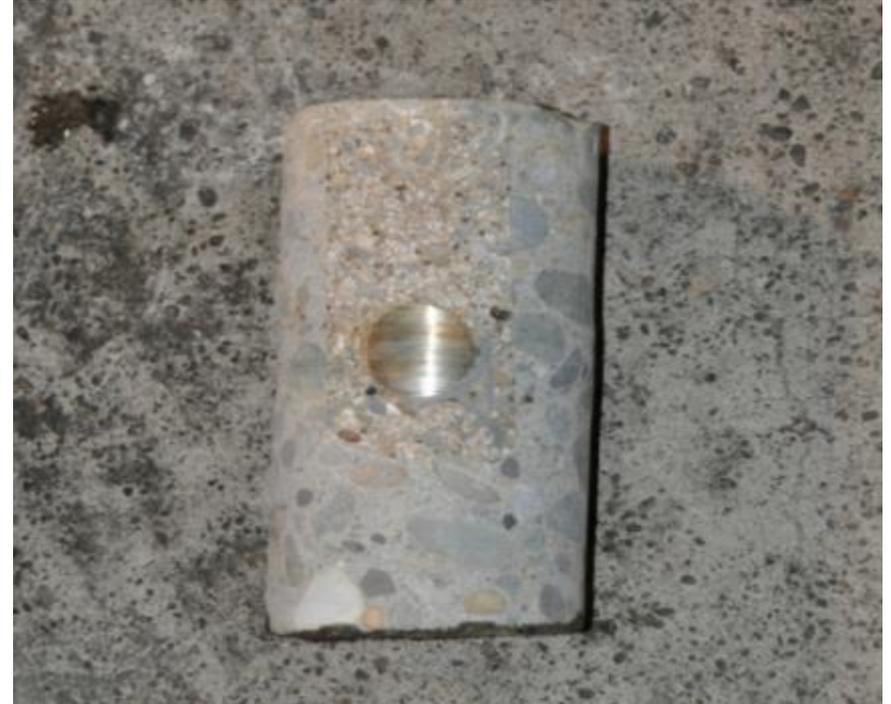
Extracted Core

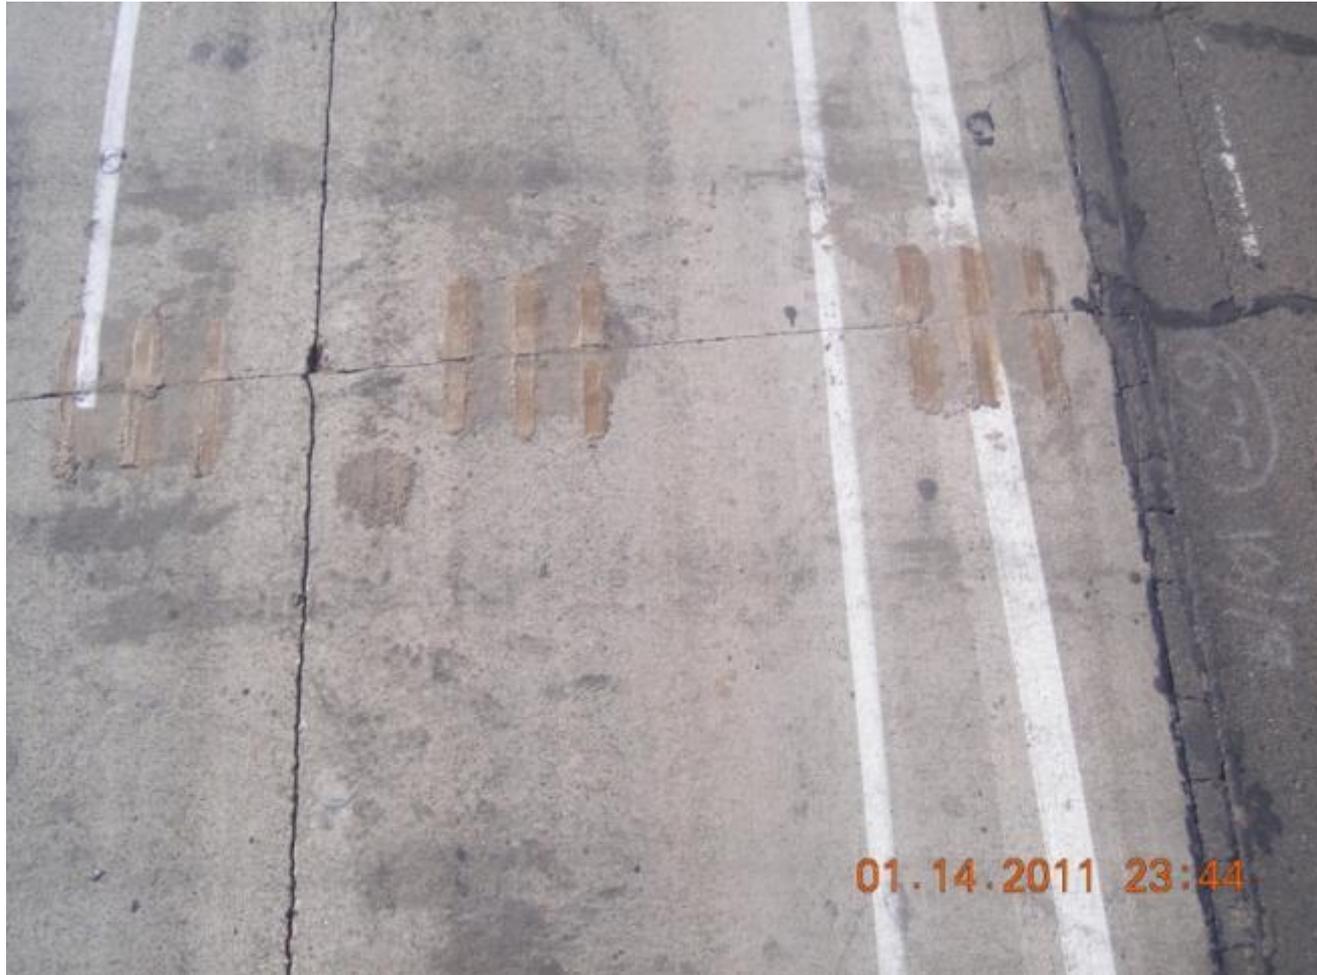
Before Grinding
