Dowel-Bar Retrofit Using Polyester Polymer Concrete

Shakir Shatnawi, Ph.D., P.E.

**President, SHATEC ENGINEERING
CONSULTANTS, LLC**

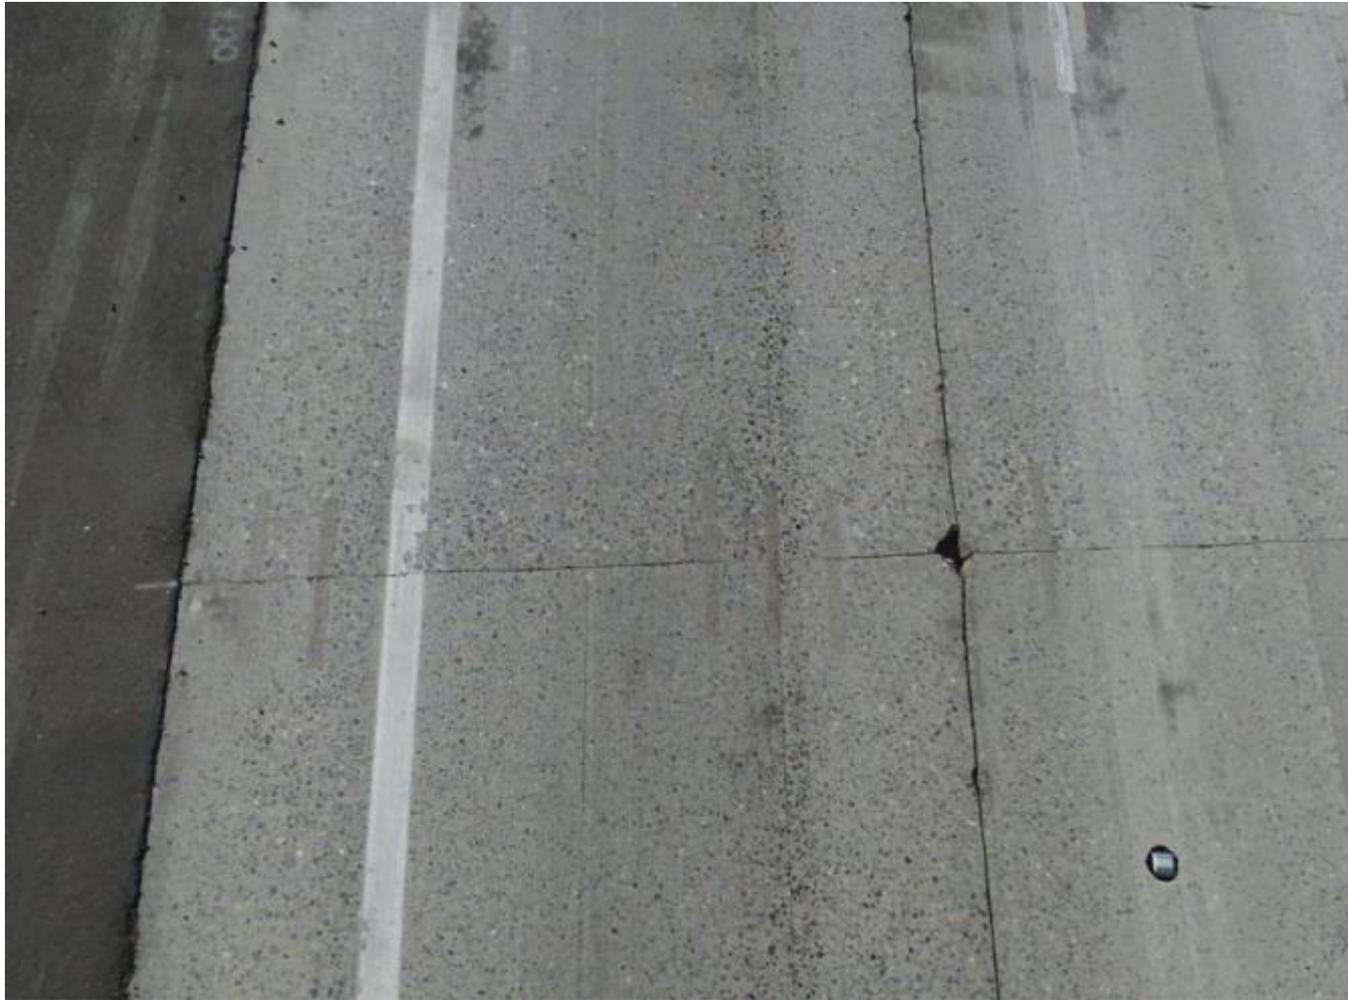
After Grinding
