Cable Dehumidification Systems for Suspension Bridges

Daniel Faust, P.E. AECOM, Inc.

TSP2 Western Bridge Preservation Partnership Meeting

May 8-10, 2013

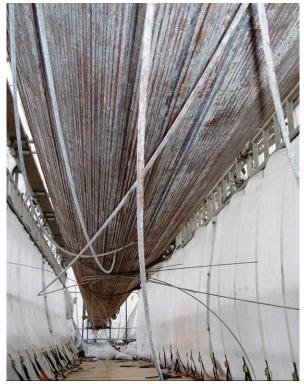
Broken wires

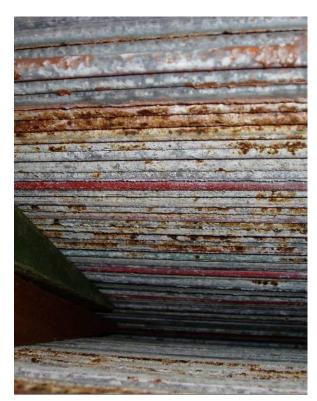
Internal corrosion

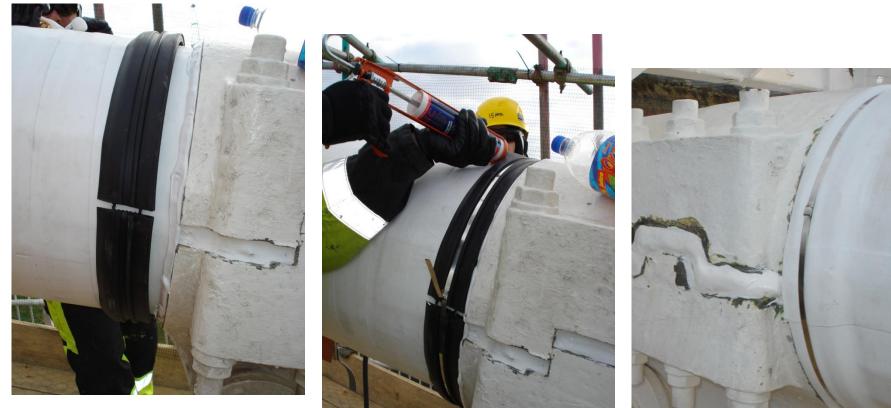
Making the cables airtight – cable band sealing

Wrap & seal

Install wedge & seal

Finish

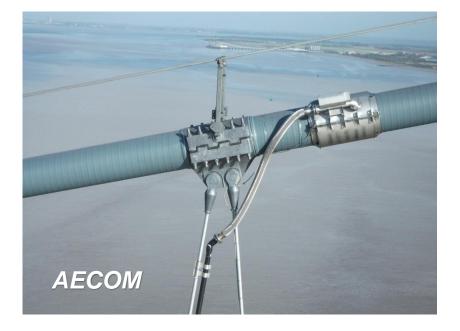
Injection sleeve

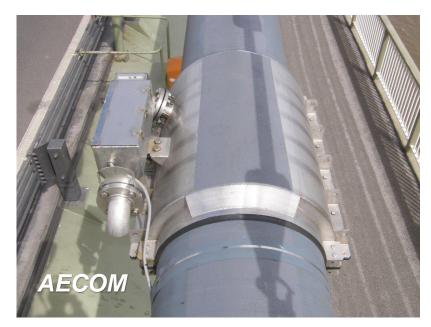
Exhaust sleeve

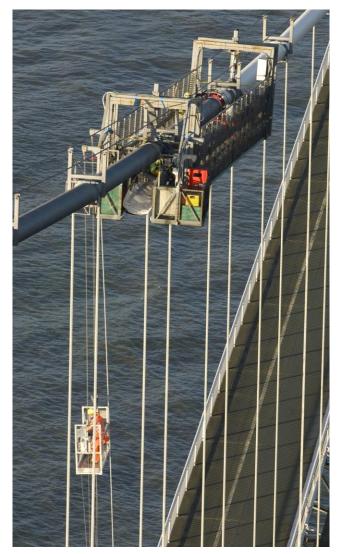
Worker/Material Hoist

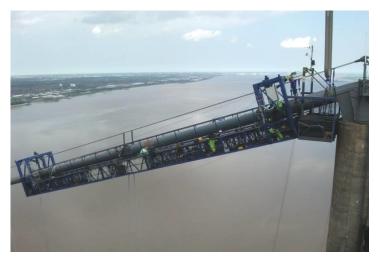
Gantry at tower top

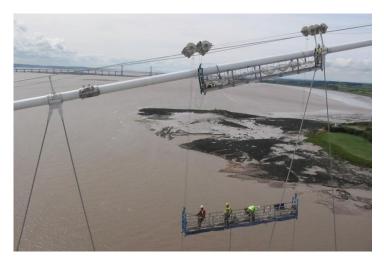
Severn Gantry

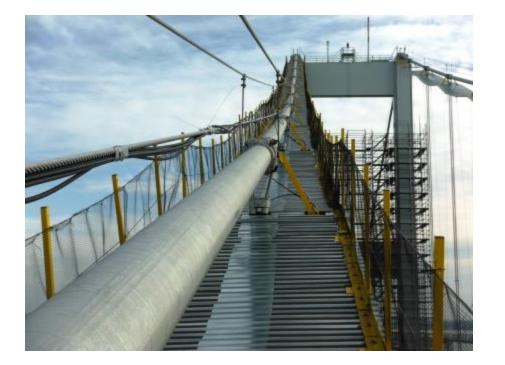
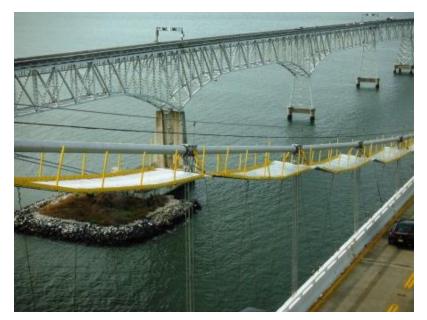
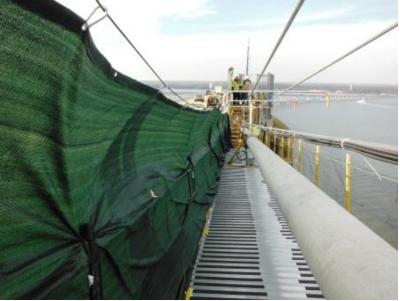
Main Cable Access - Catwalks

Full length catwalks installed to allow access by multiple trades at different times to different parts of the cables

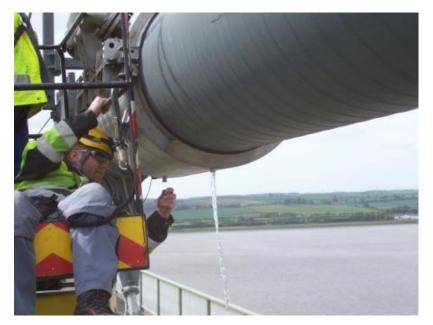
Draining water from mid span exhaust sleeve during initial drying

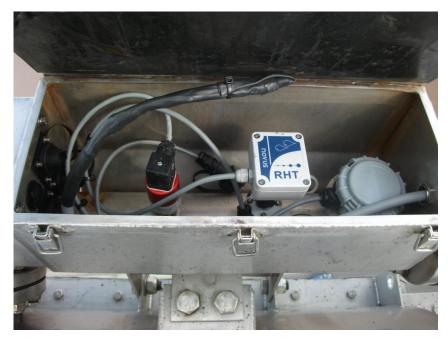
Opening sensor boxes facilitate inspection or replacement

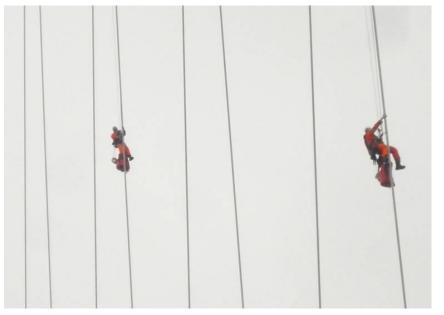
Installation of signal cables down suspenders
