Polymer Modified Joint (PMJ) Performance in Ohio

Mike Brokaw, P.E., Bridge Operations Engineer
MWBPP 2016 Annual Meeting, Milwaukee, WI

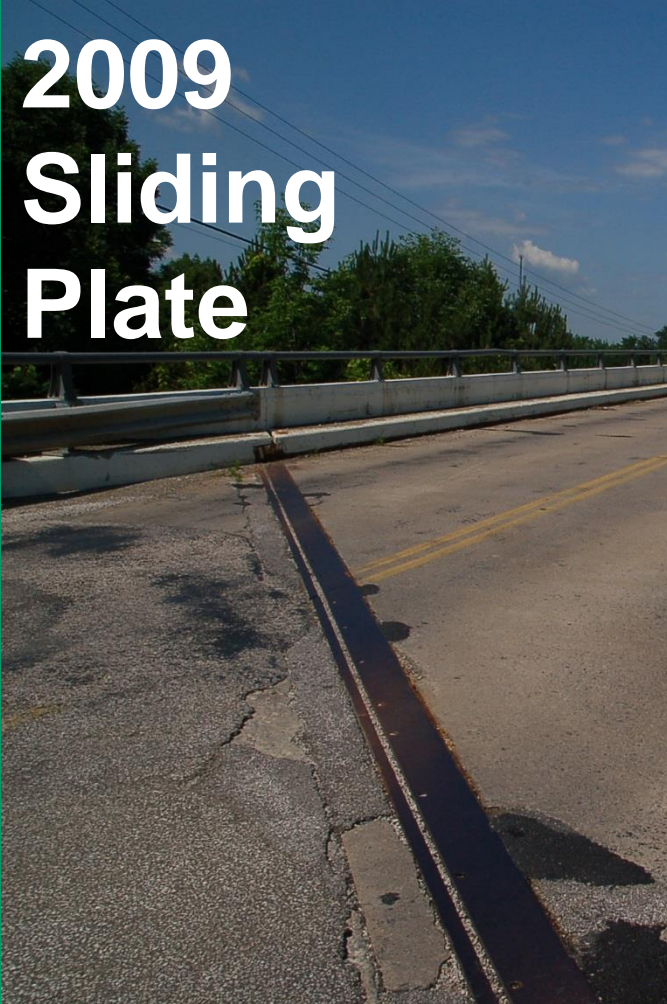
2009
Sliding
Plate

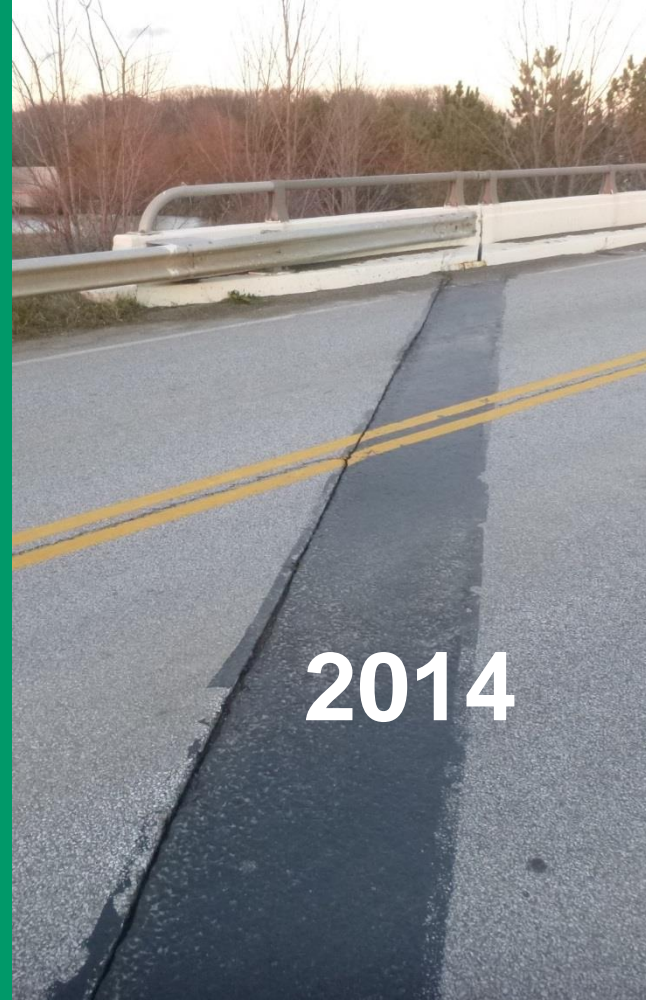
2014

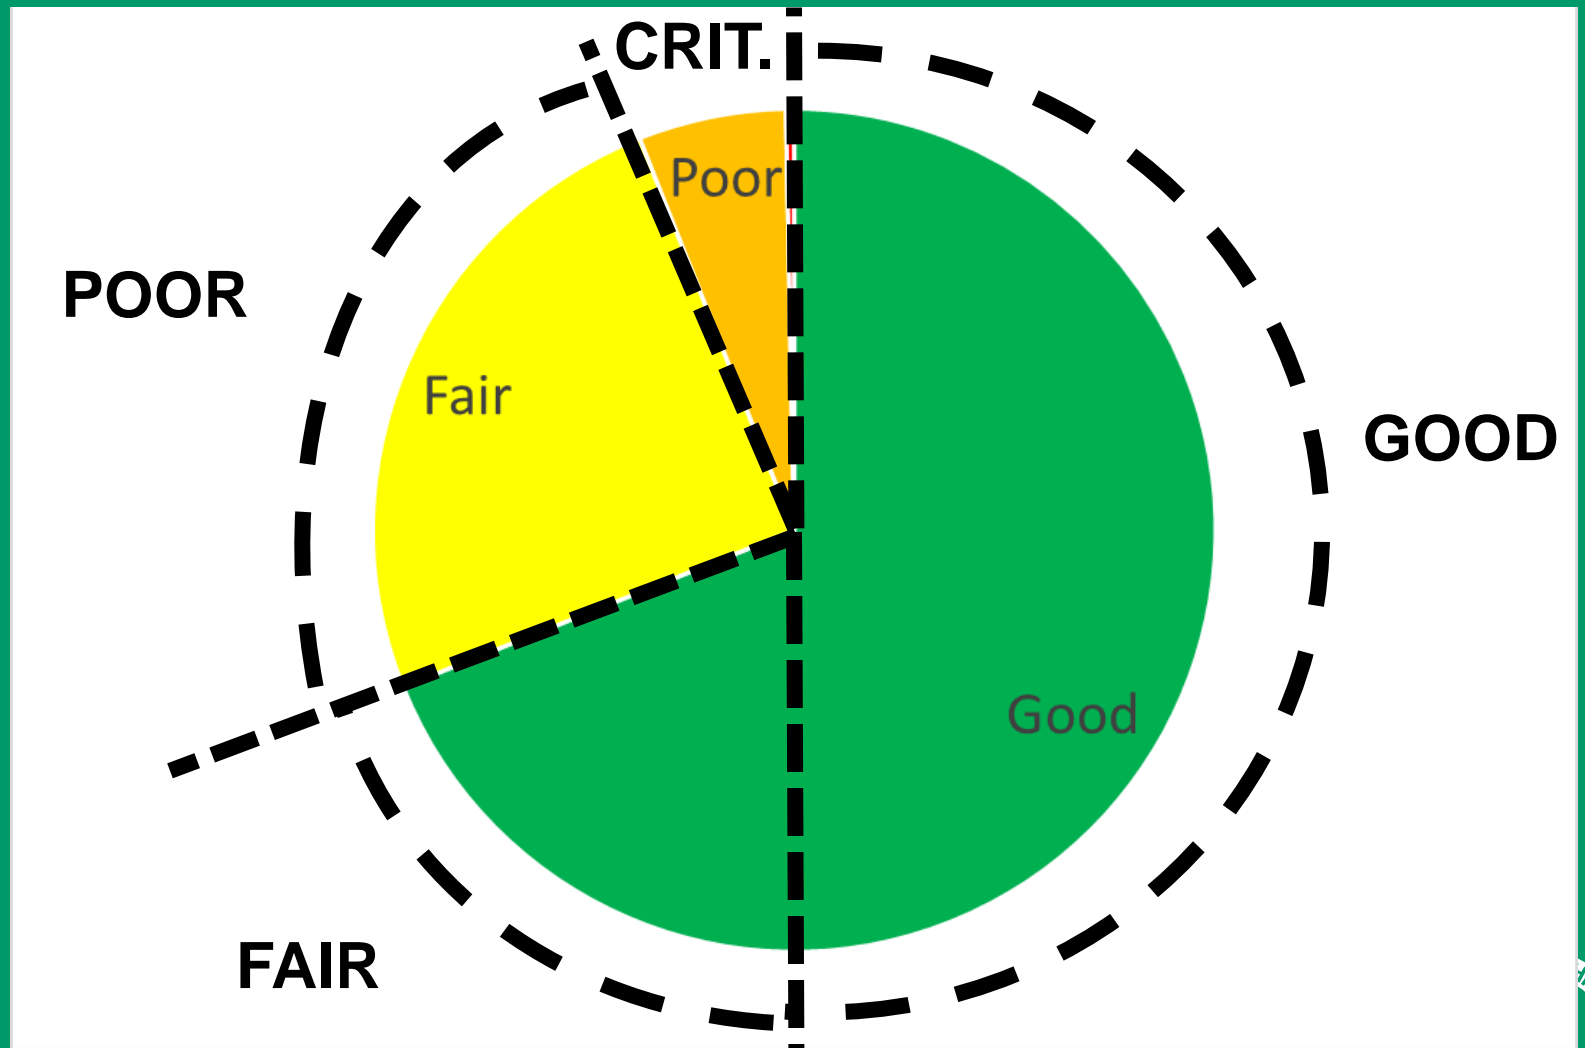
Current vs. Predicted Conditions

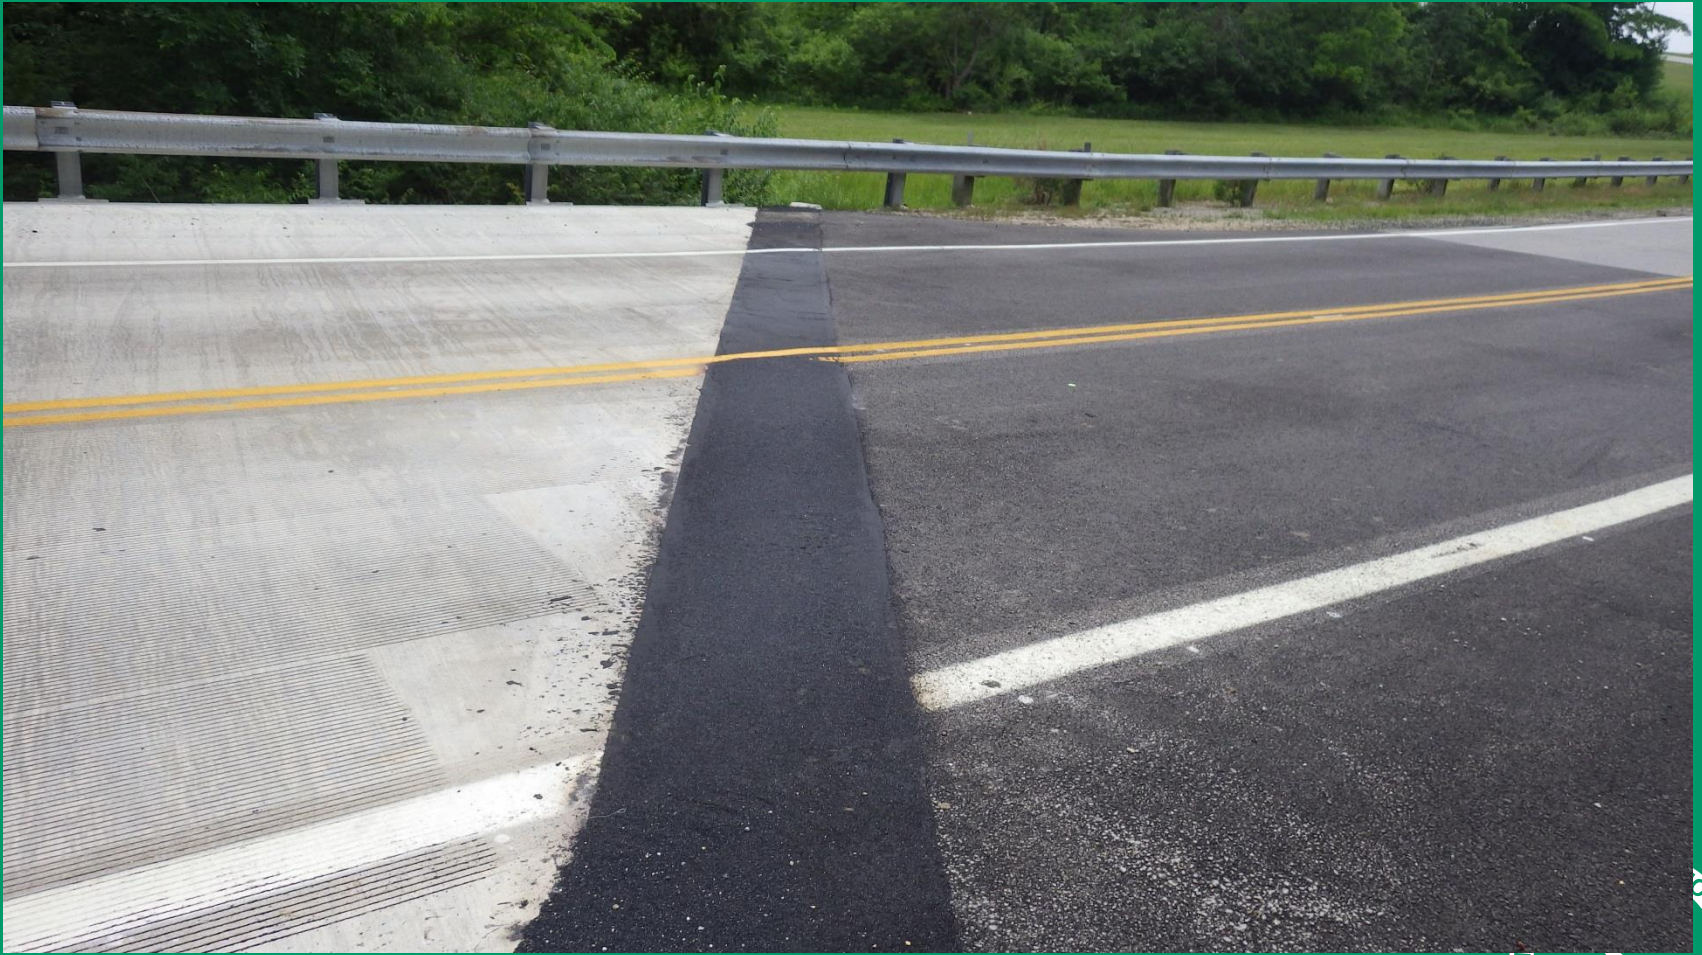
Good to Good

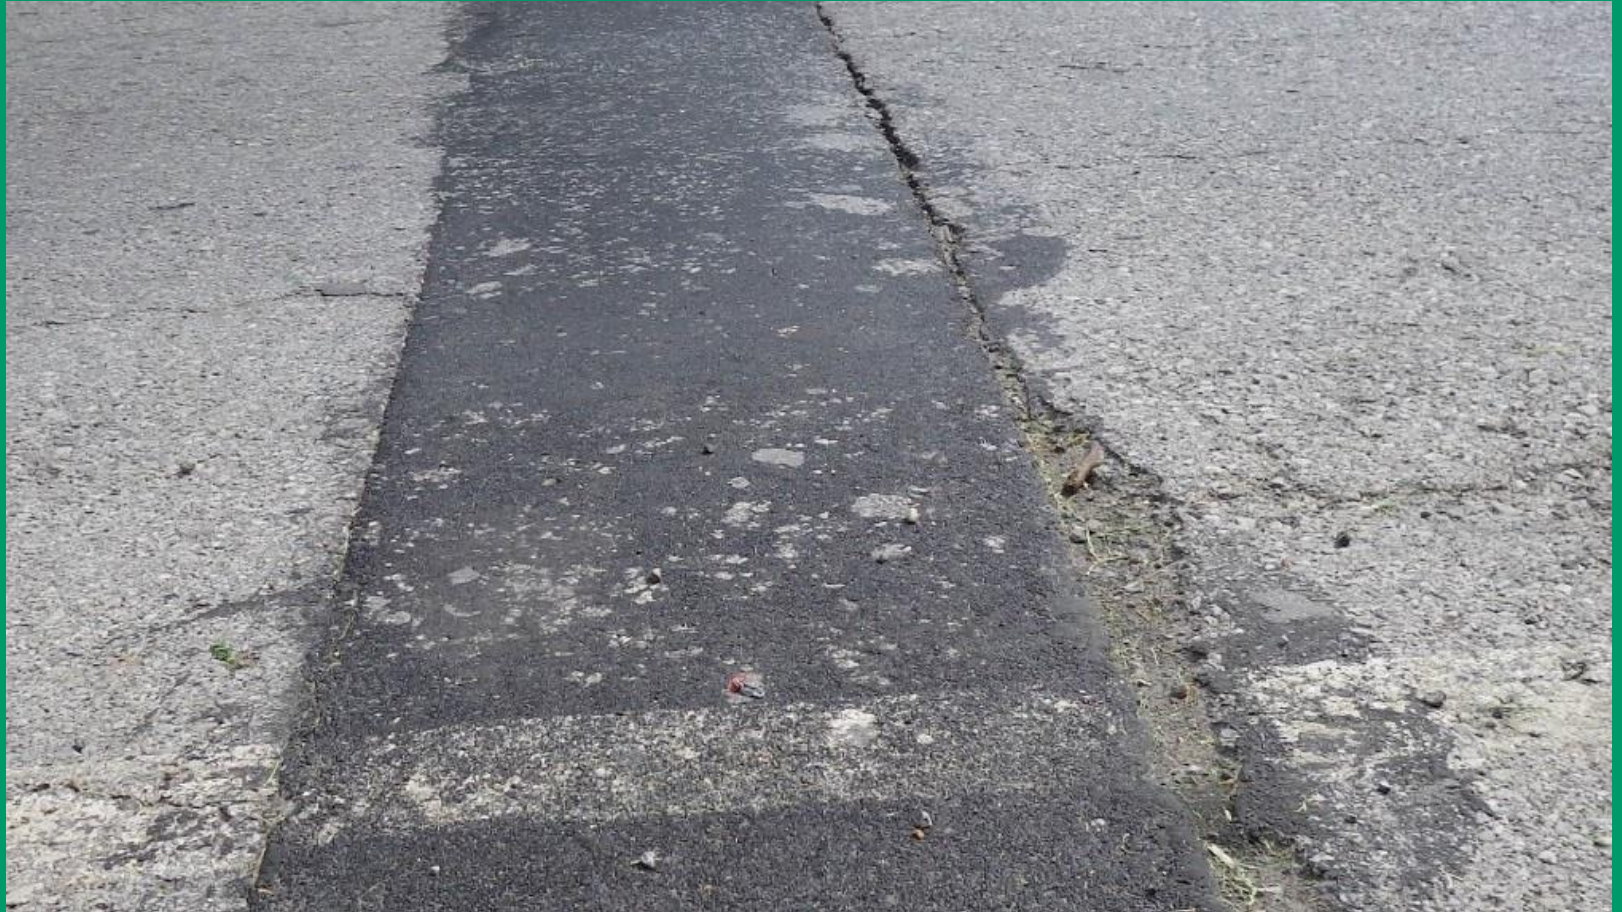
Fair to Poor

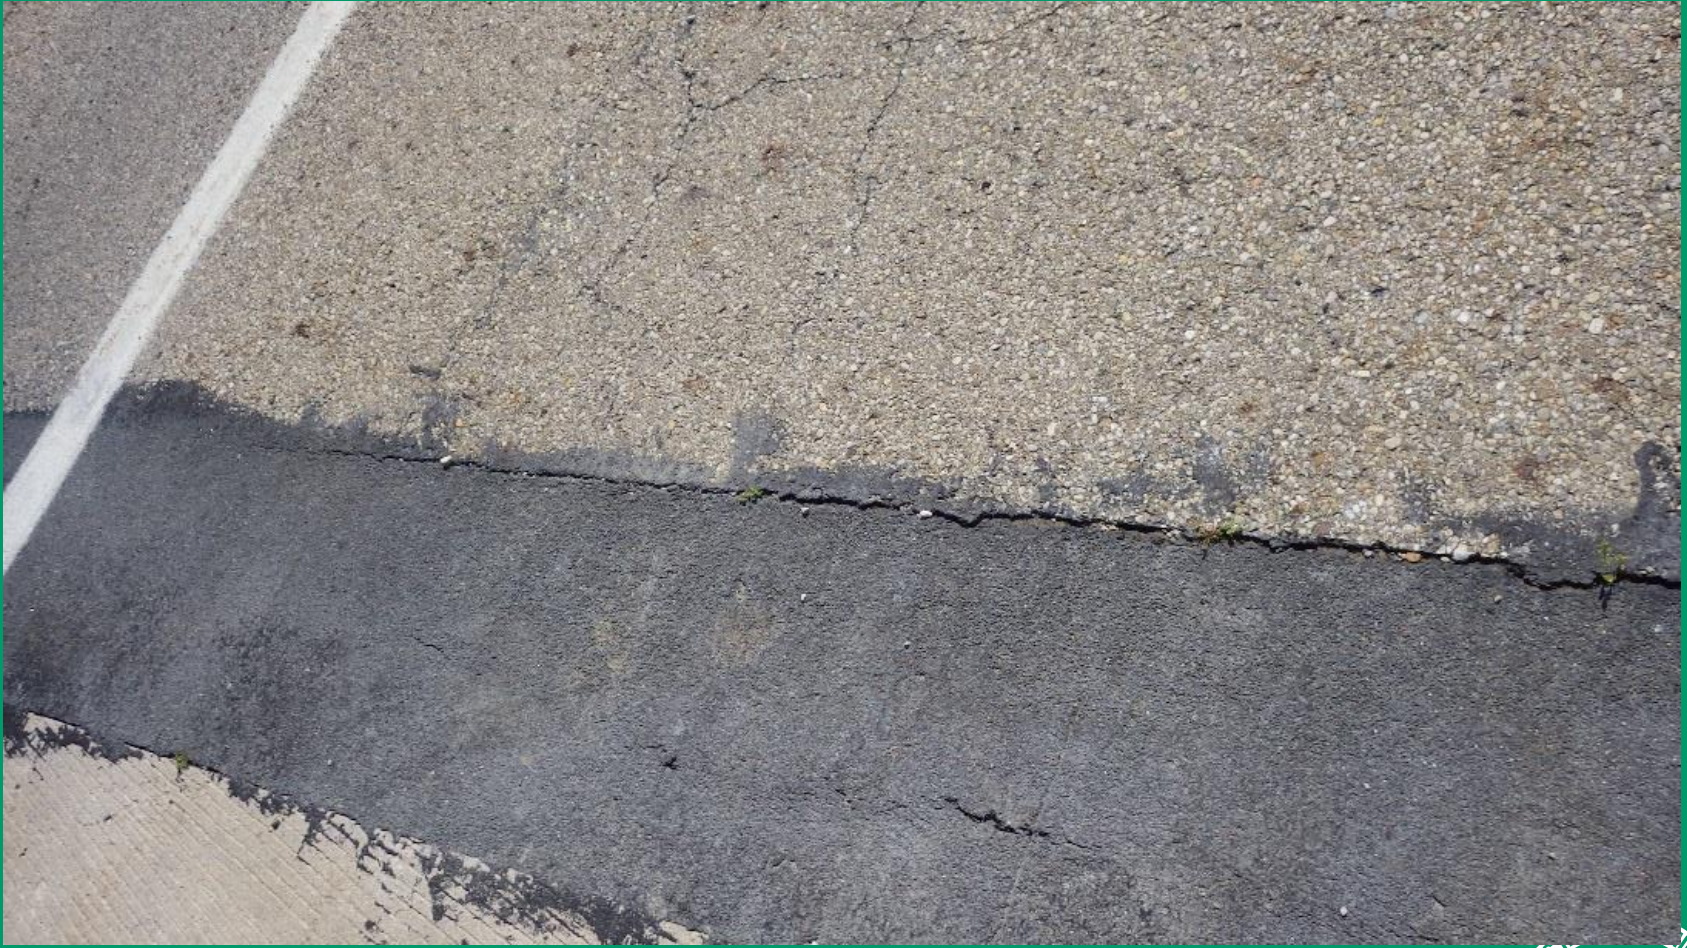
Fair to Poor

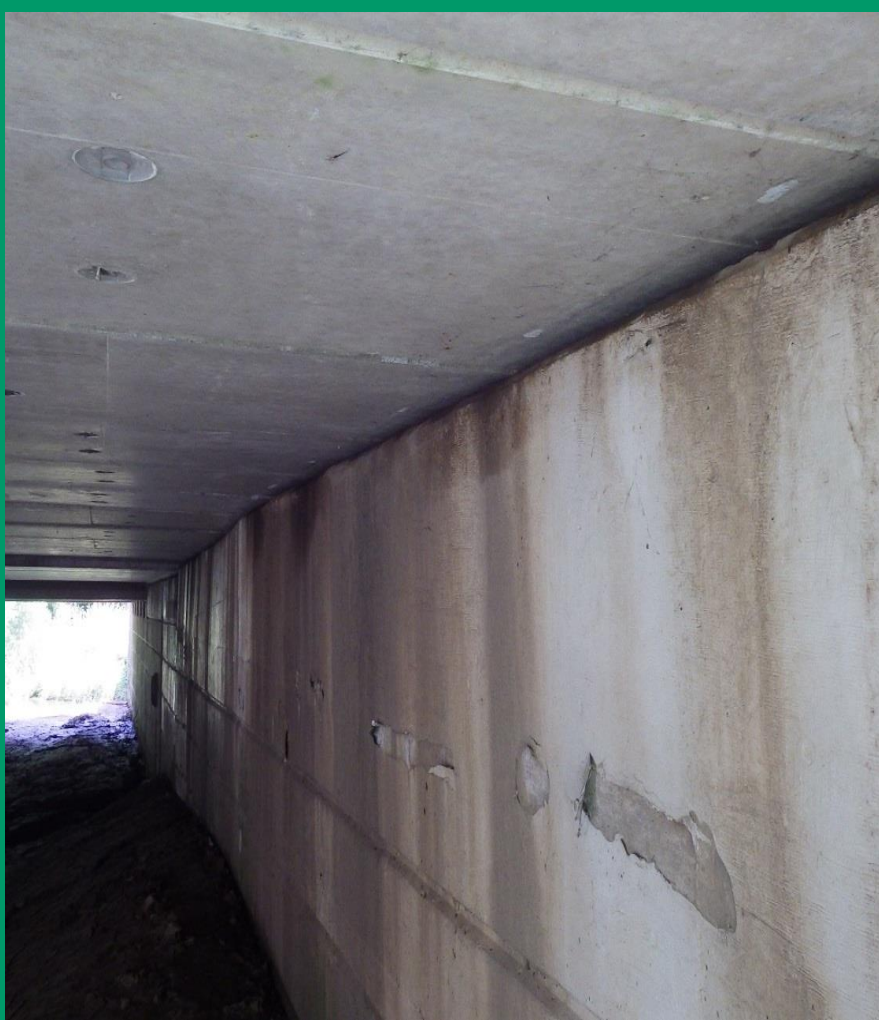
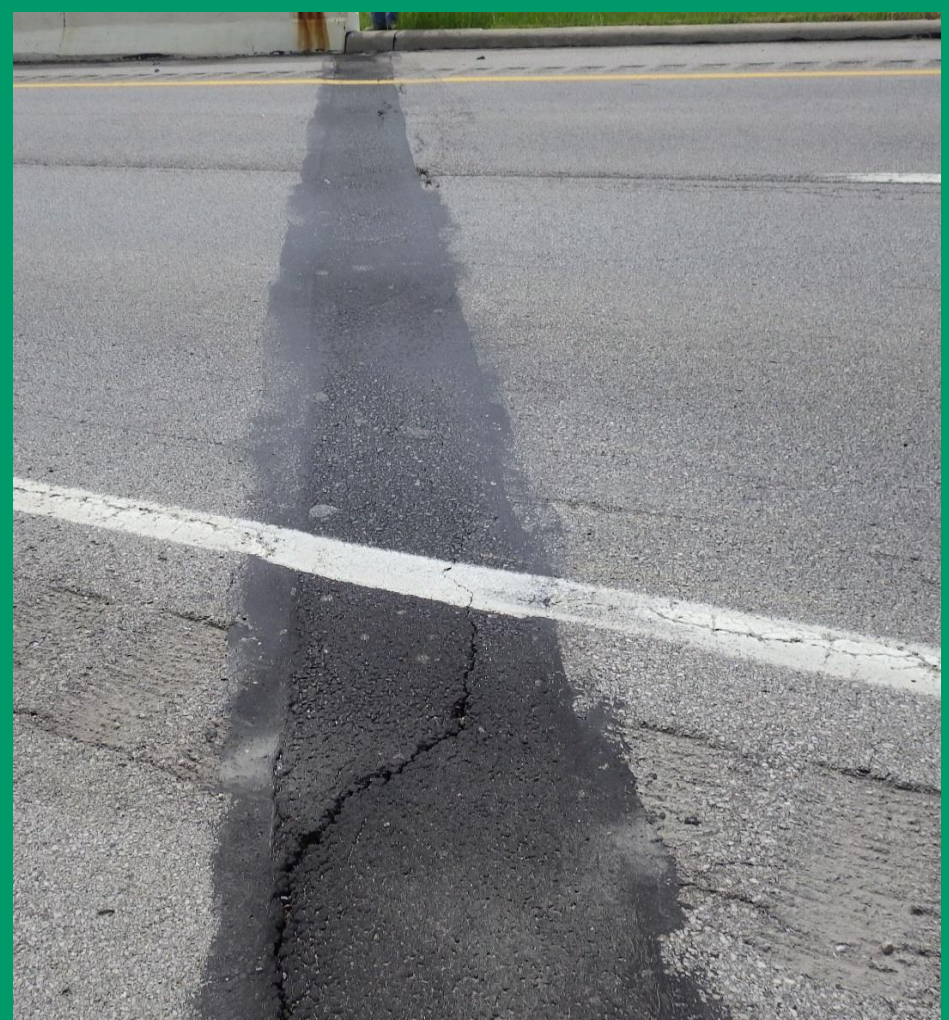
Fair to Poor

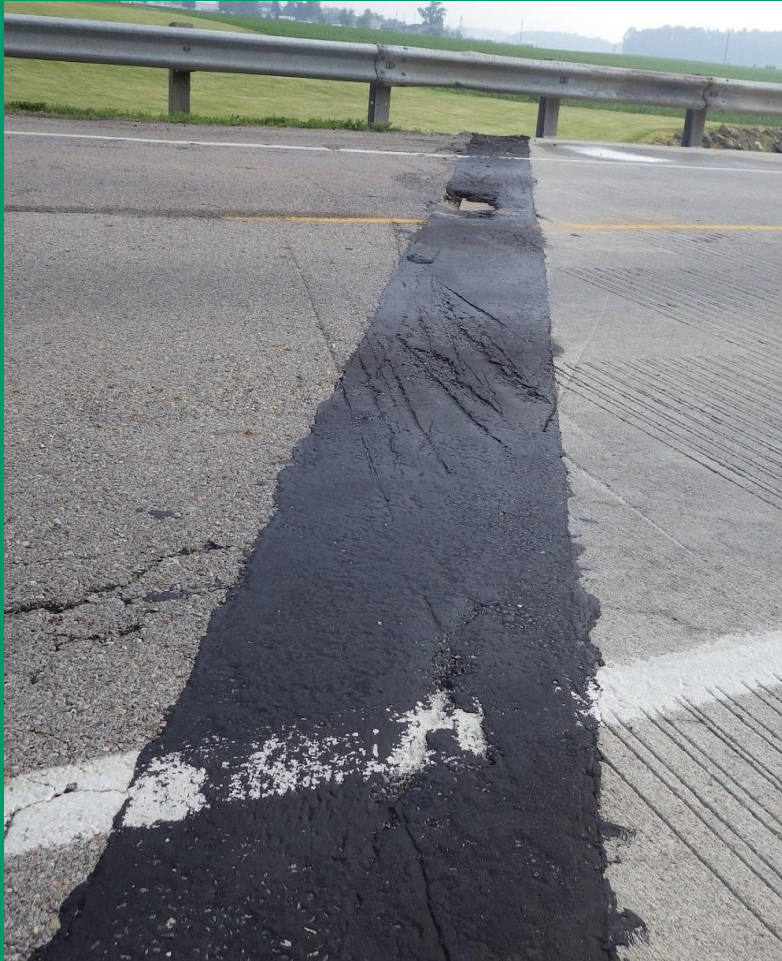
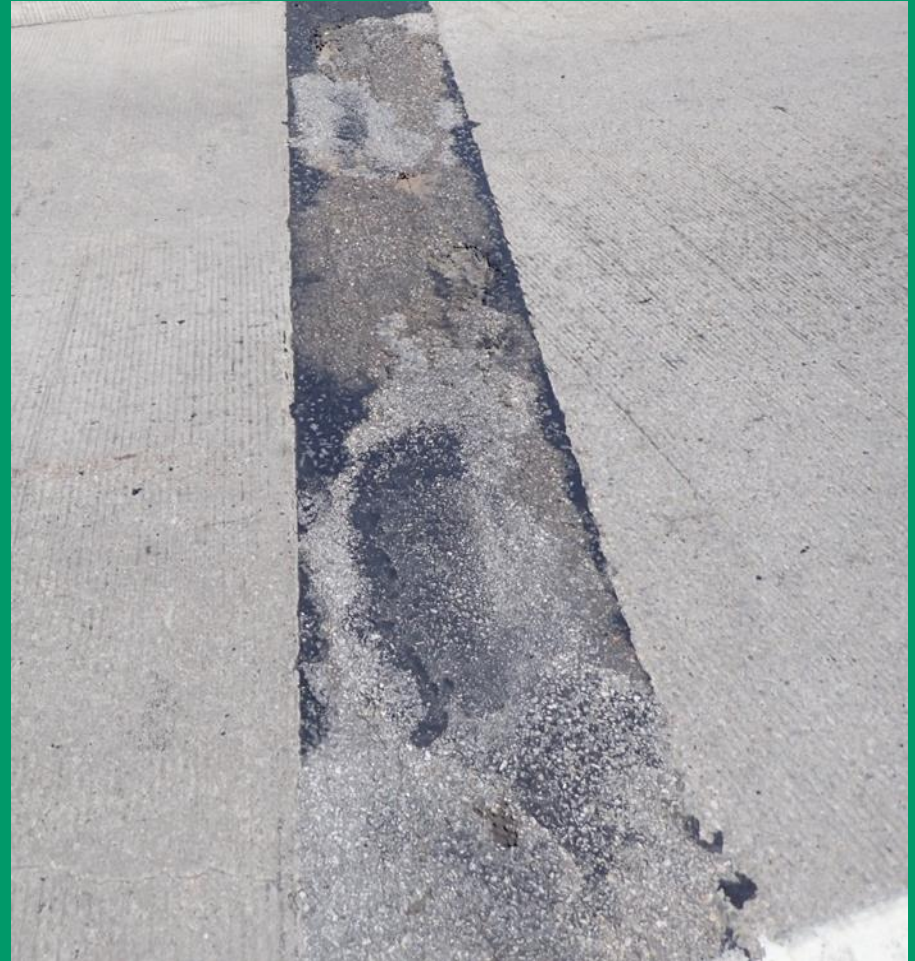
Poor to Critical

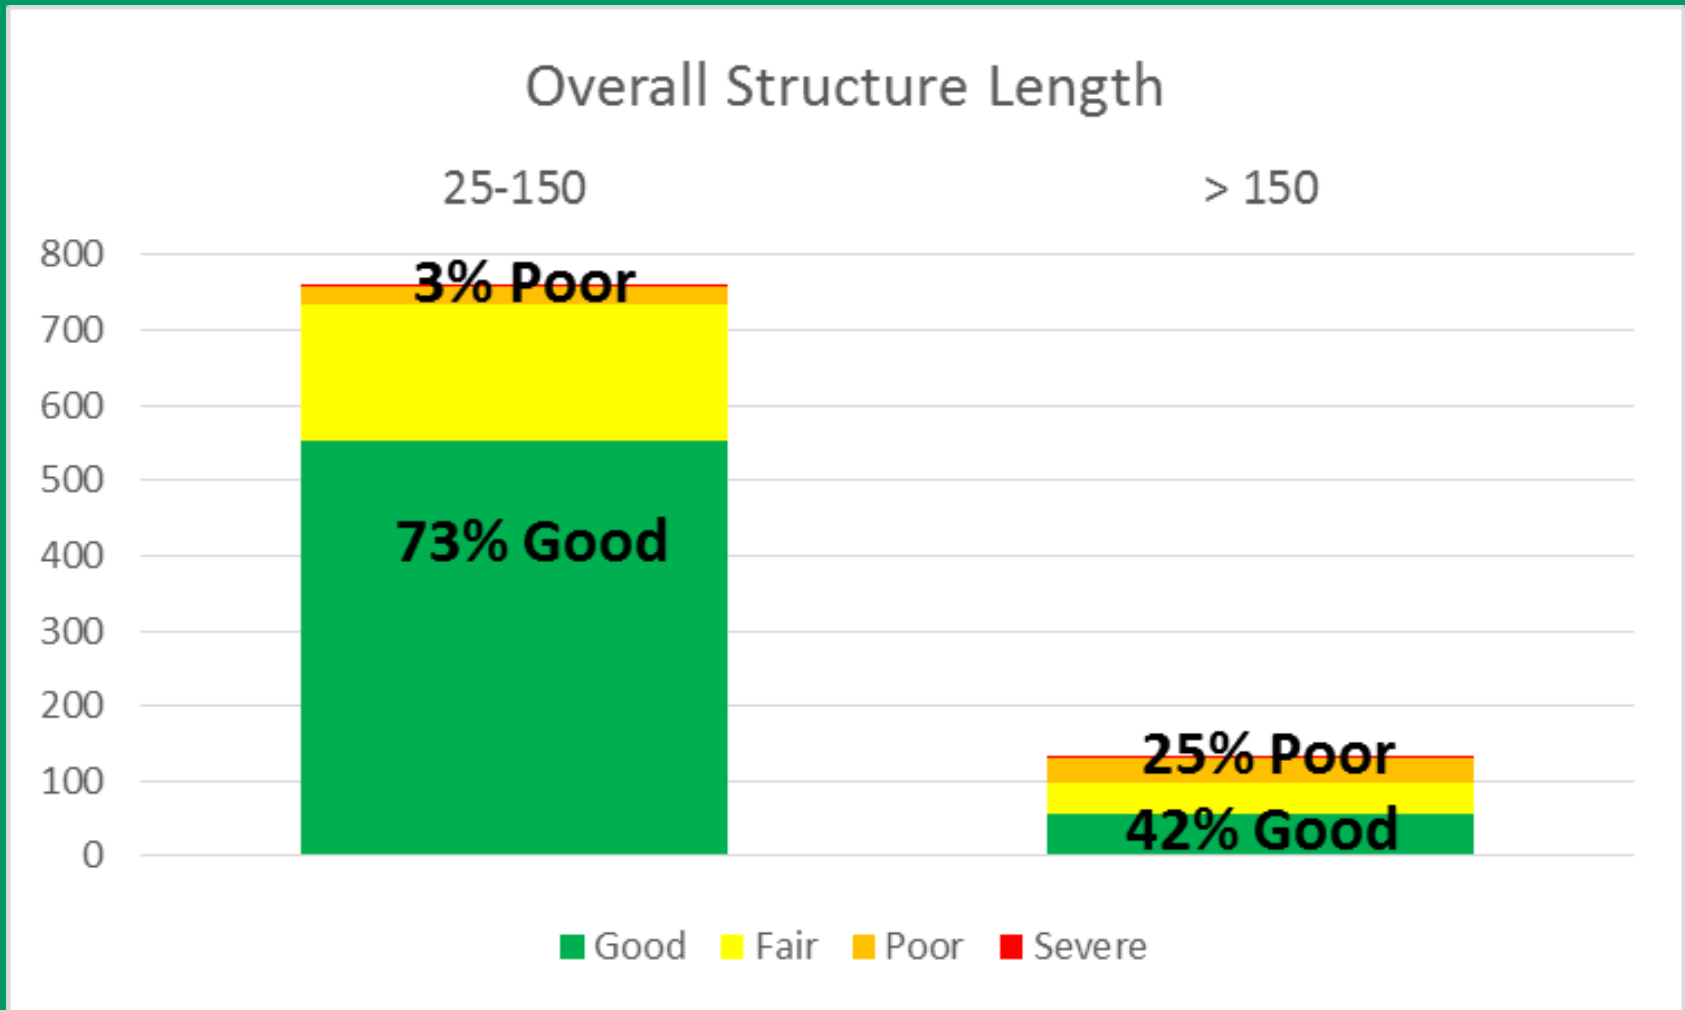
Overall Structure Length & PMJ Condition

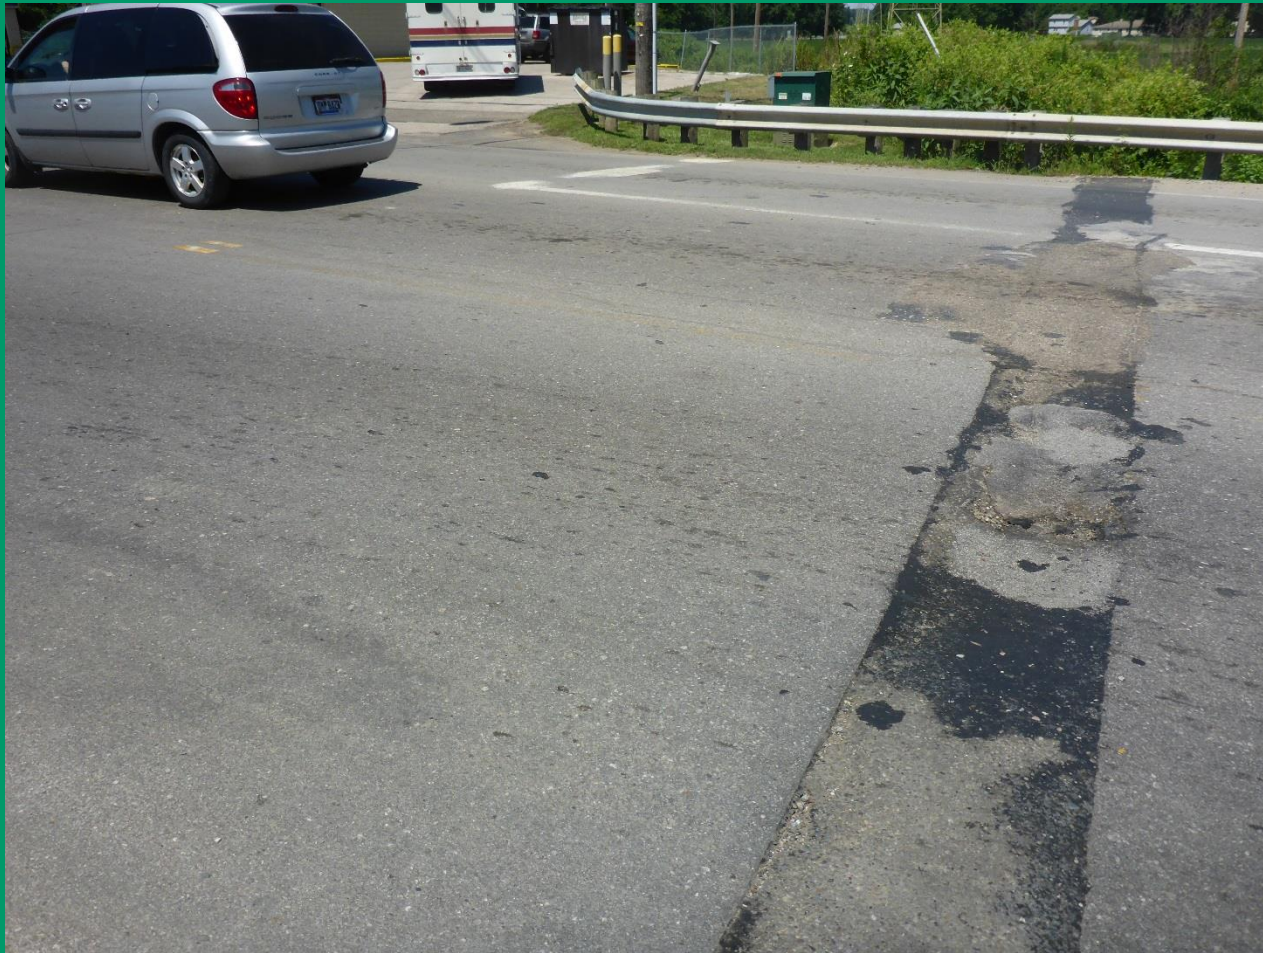
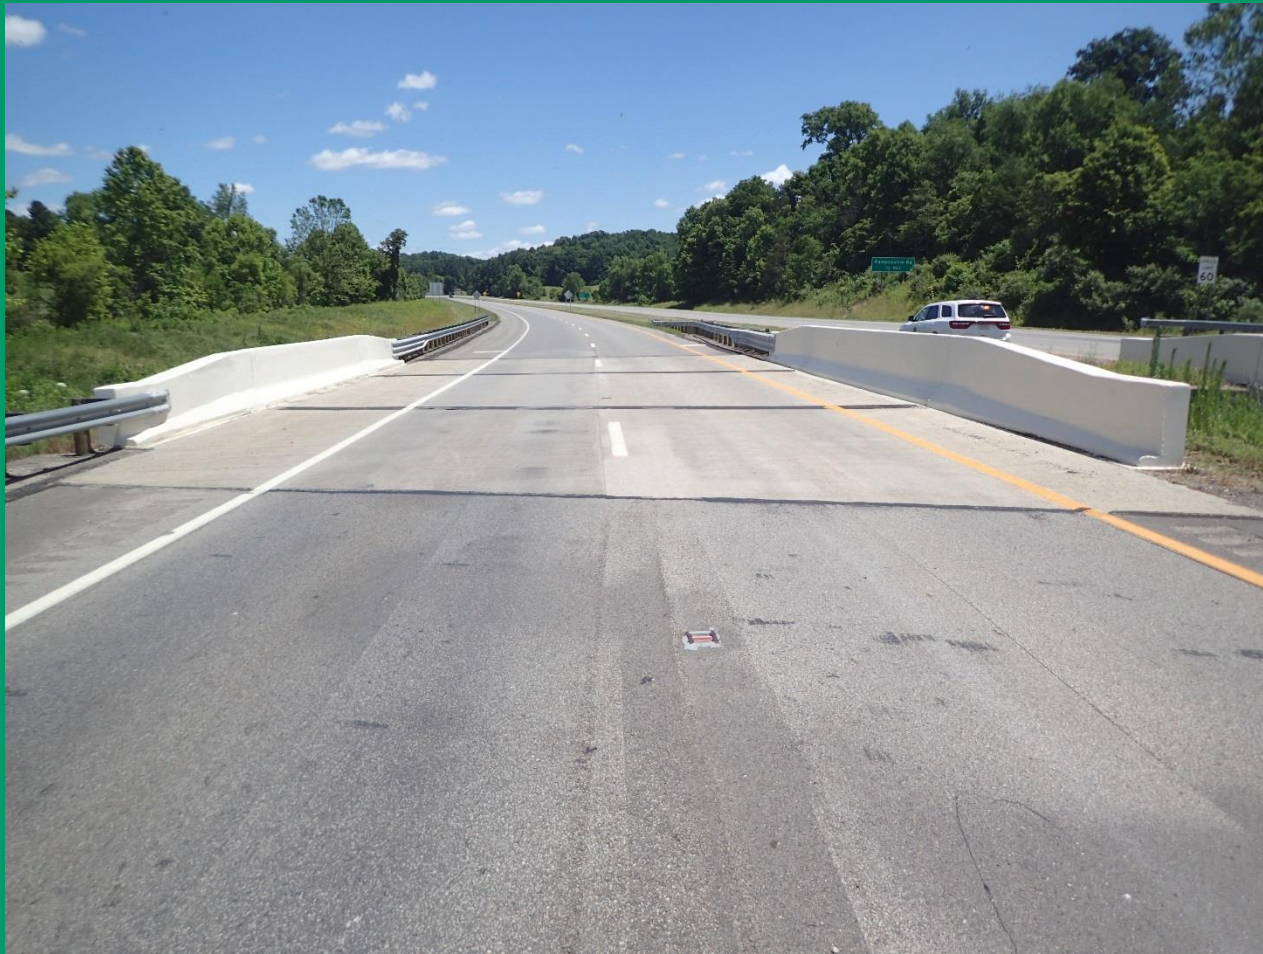
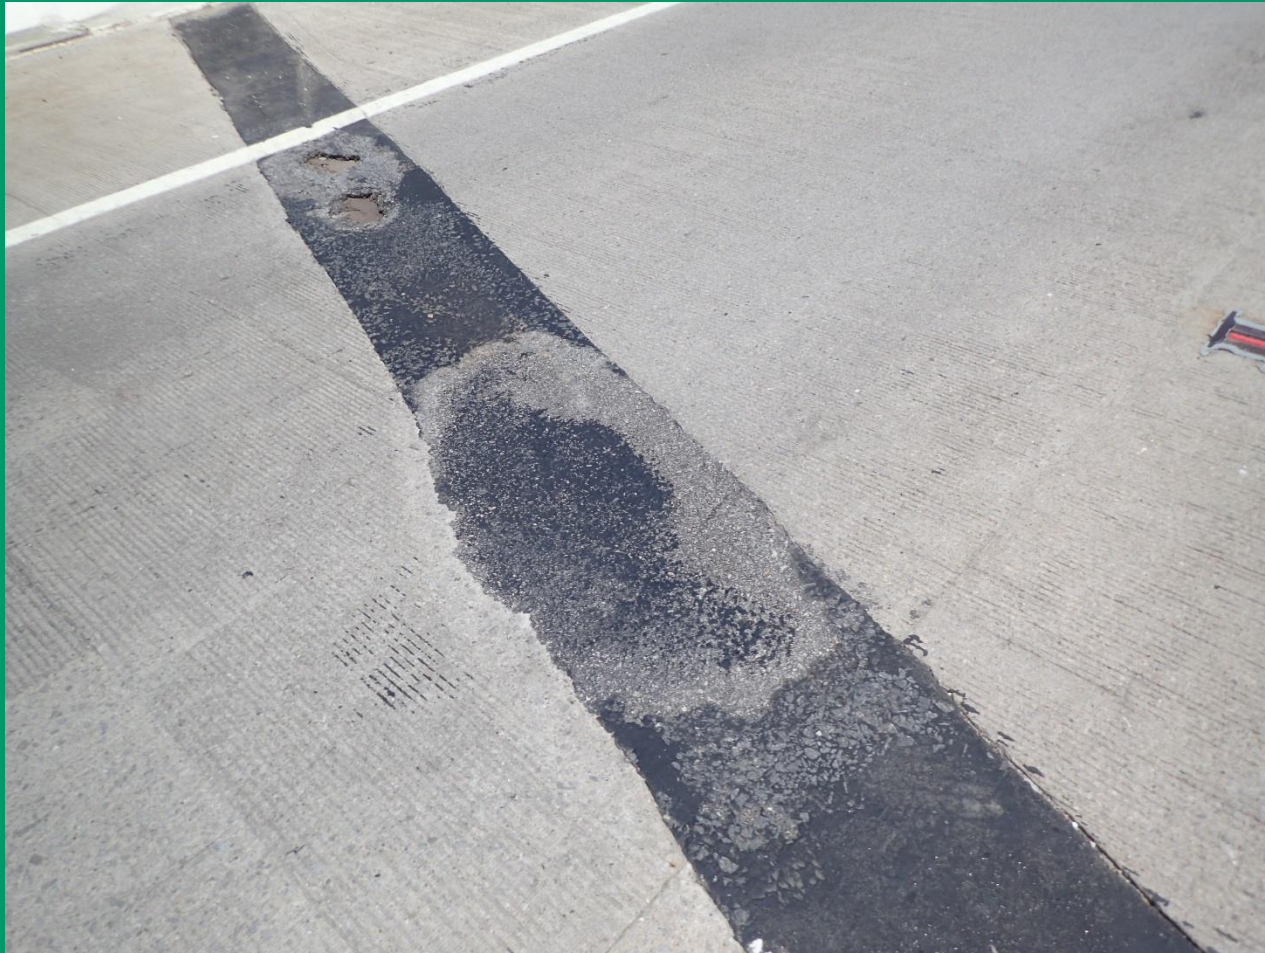
Outlier- JAC-32-1255L

🕒 Right Joint

🕒 17 Years Old

POURED JOINTS WERE INSTALLED IN 1999. BOTH JOINTS ARE RUTTING OUT IN THE LT LANE WITH THE REAR BEING WORSE. THERE ARE A FEW GAPS ALONG BERMS IN BOTH. THE RT LANE OF FWD HAS A 1' LONG TRANSVERSE CRACK. 5/12 THE JOINTS HAVE RUTTING OUT IN THE WHEEL TRACK. 7/14 REAR HAS TWO SPOTS IN JOINT THAT HAVE RUTTED OUT. CAN SEE THE METAL UNDER THE JOINT. THE METAL IS RUSTY AND BROKEN IN PLACES. 6/16 THESE AREAS

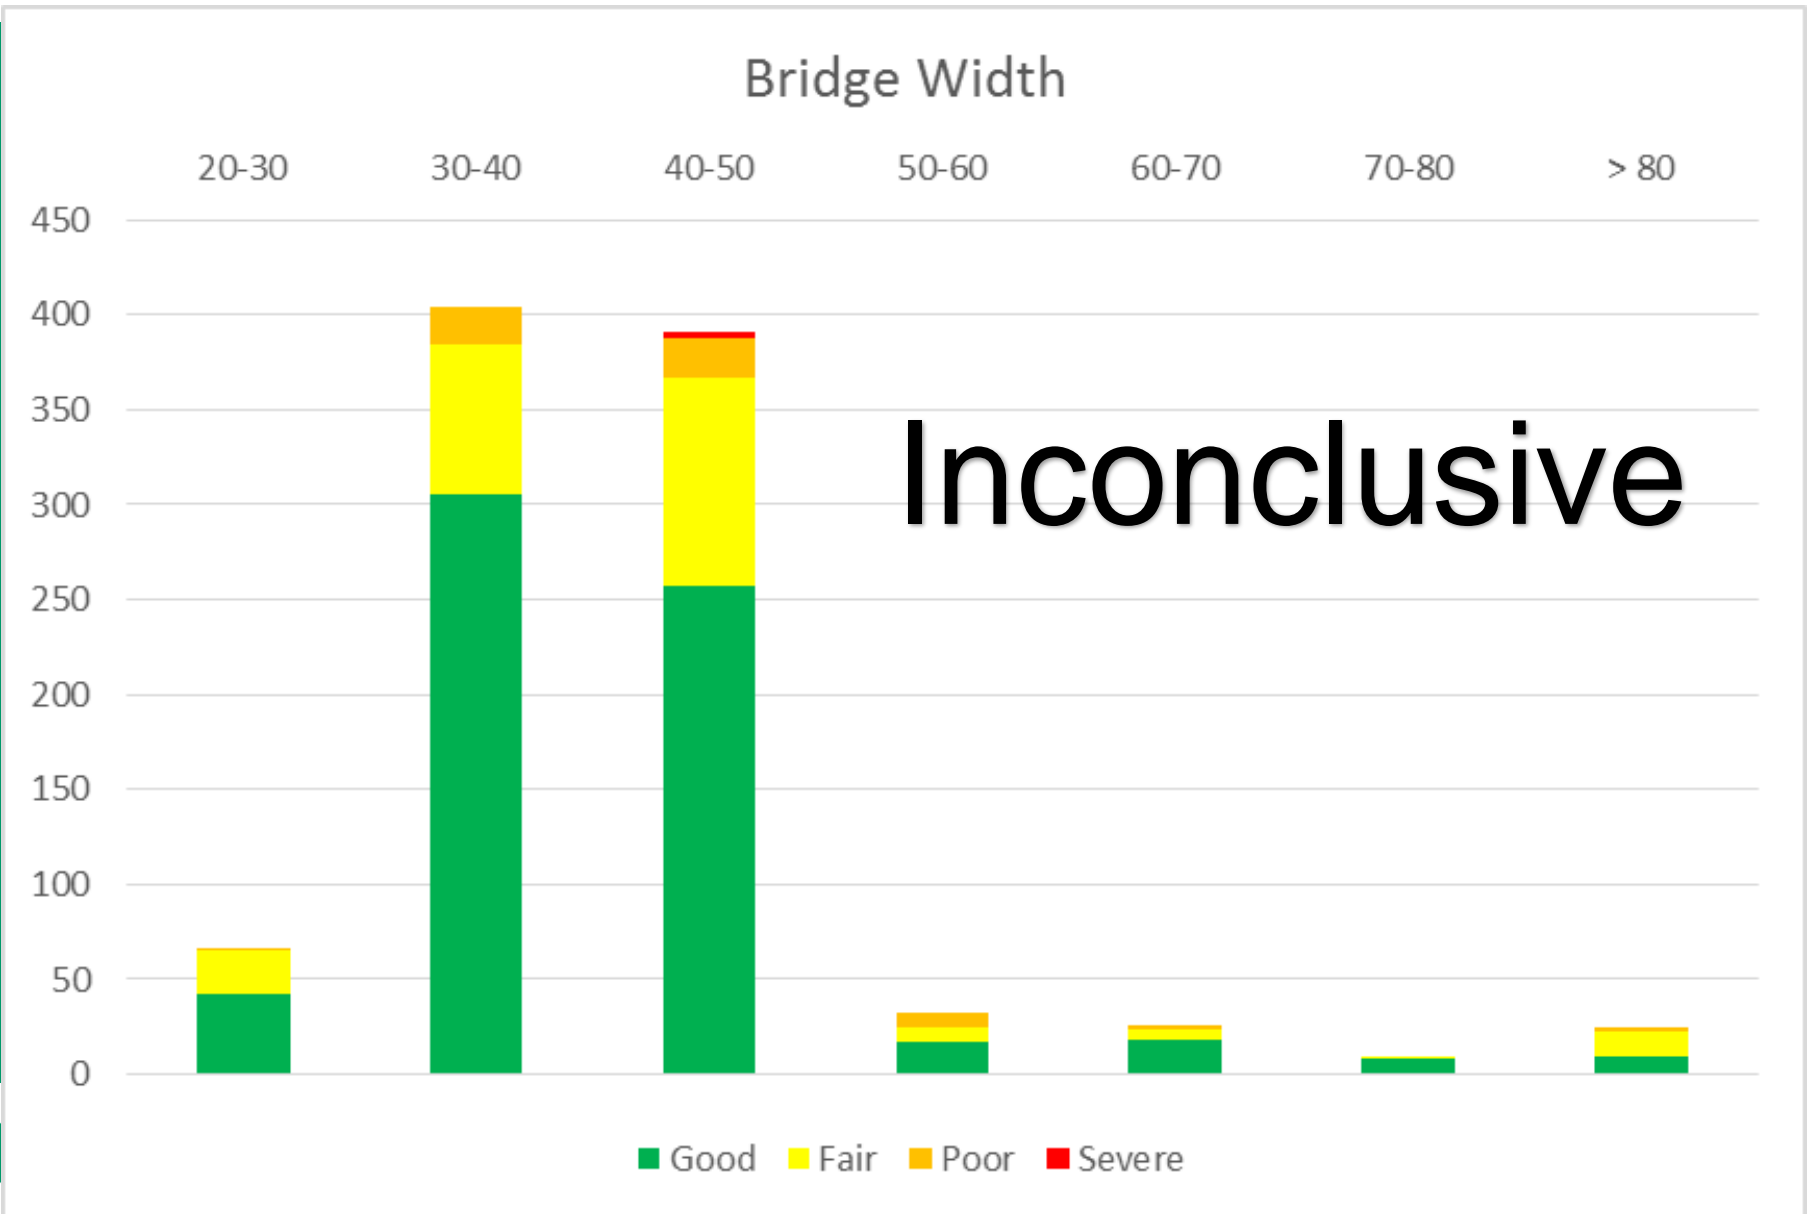
Bridge Width & PMJ Condition

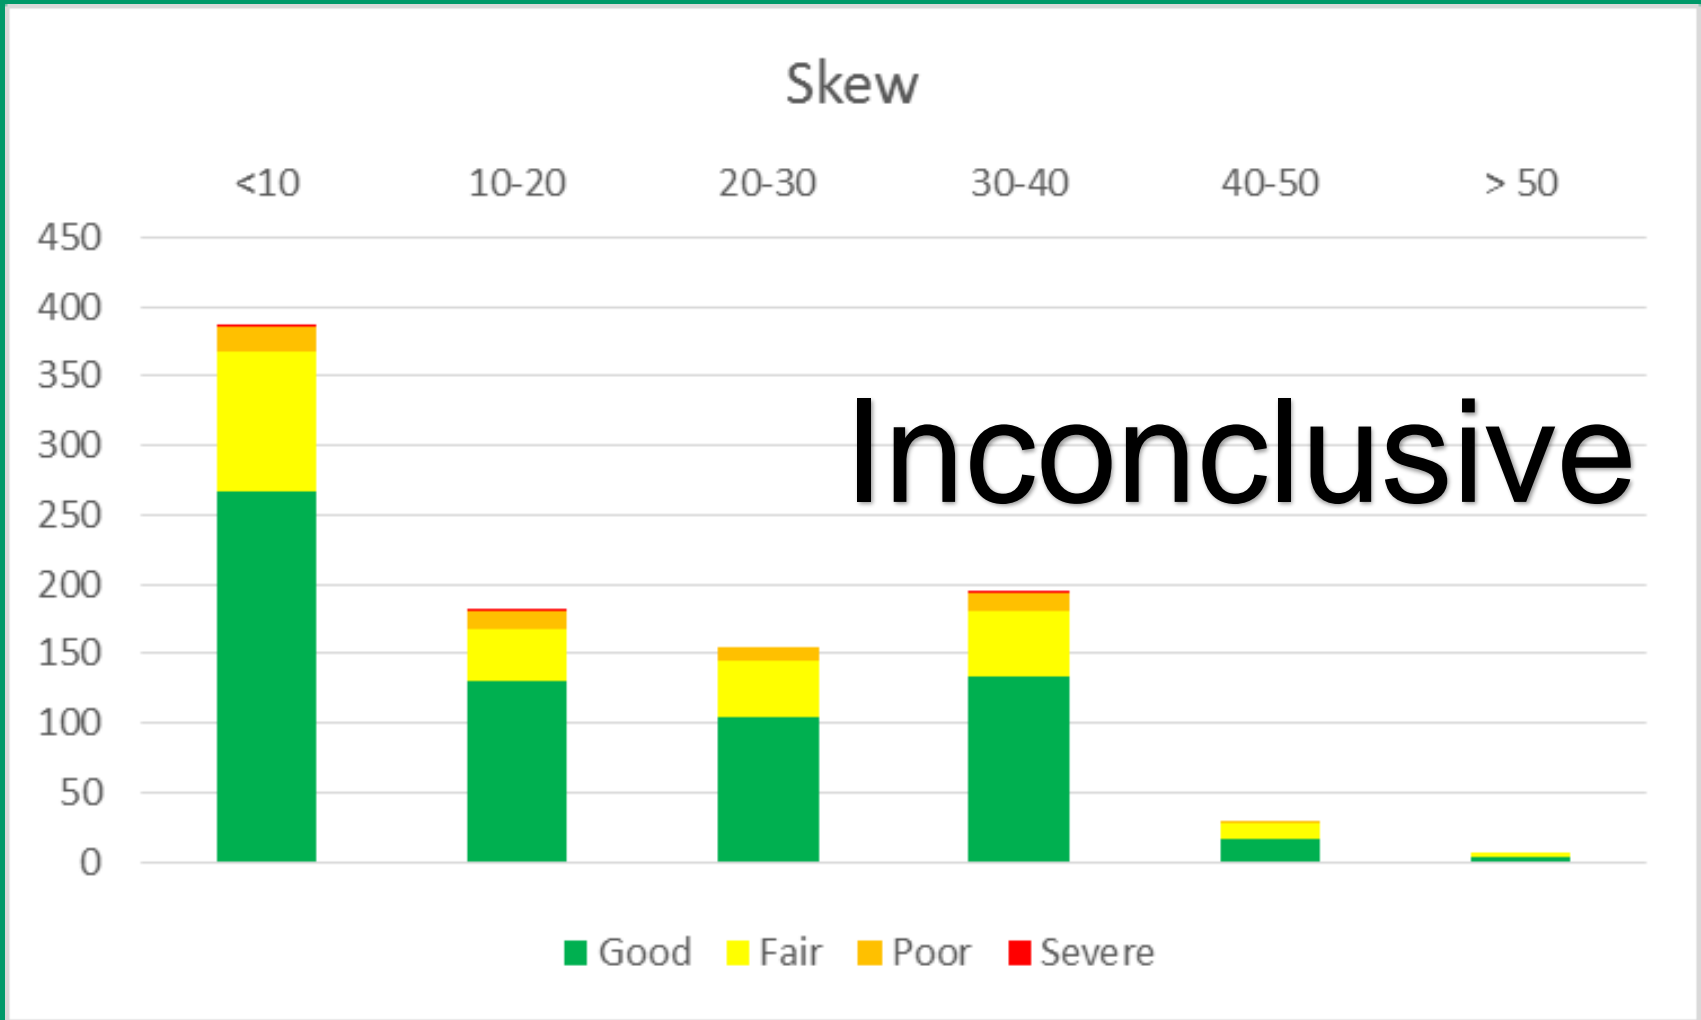
Bridge Skew & PMJ Condition
