Polymer Modified Joint (PMJ) Performance in Ohio

Mike Brokaw, P.E., Bridge Operations Engineer
MWBPP 2016 Annual Meeting, Milwaukee, WI

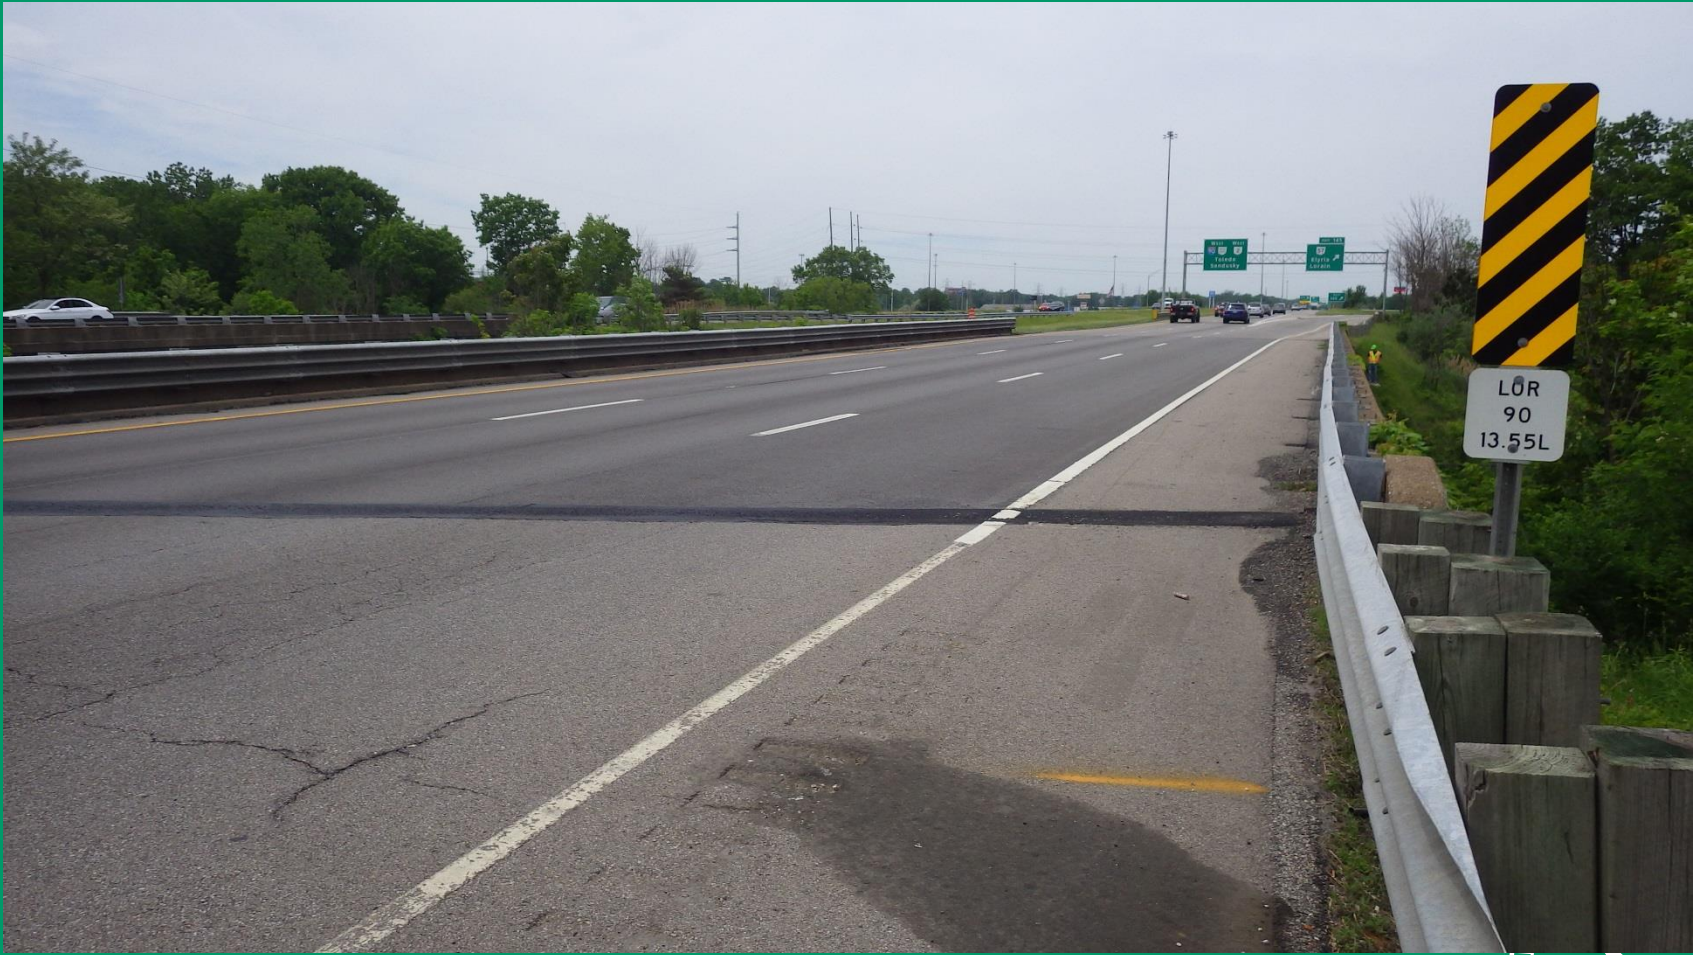
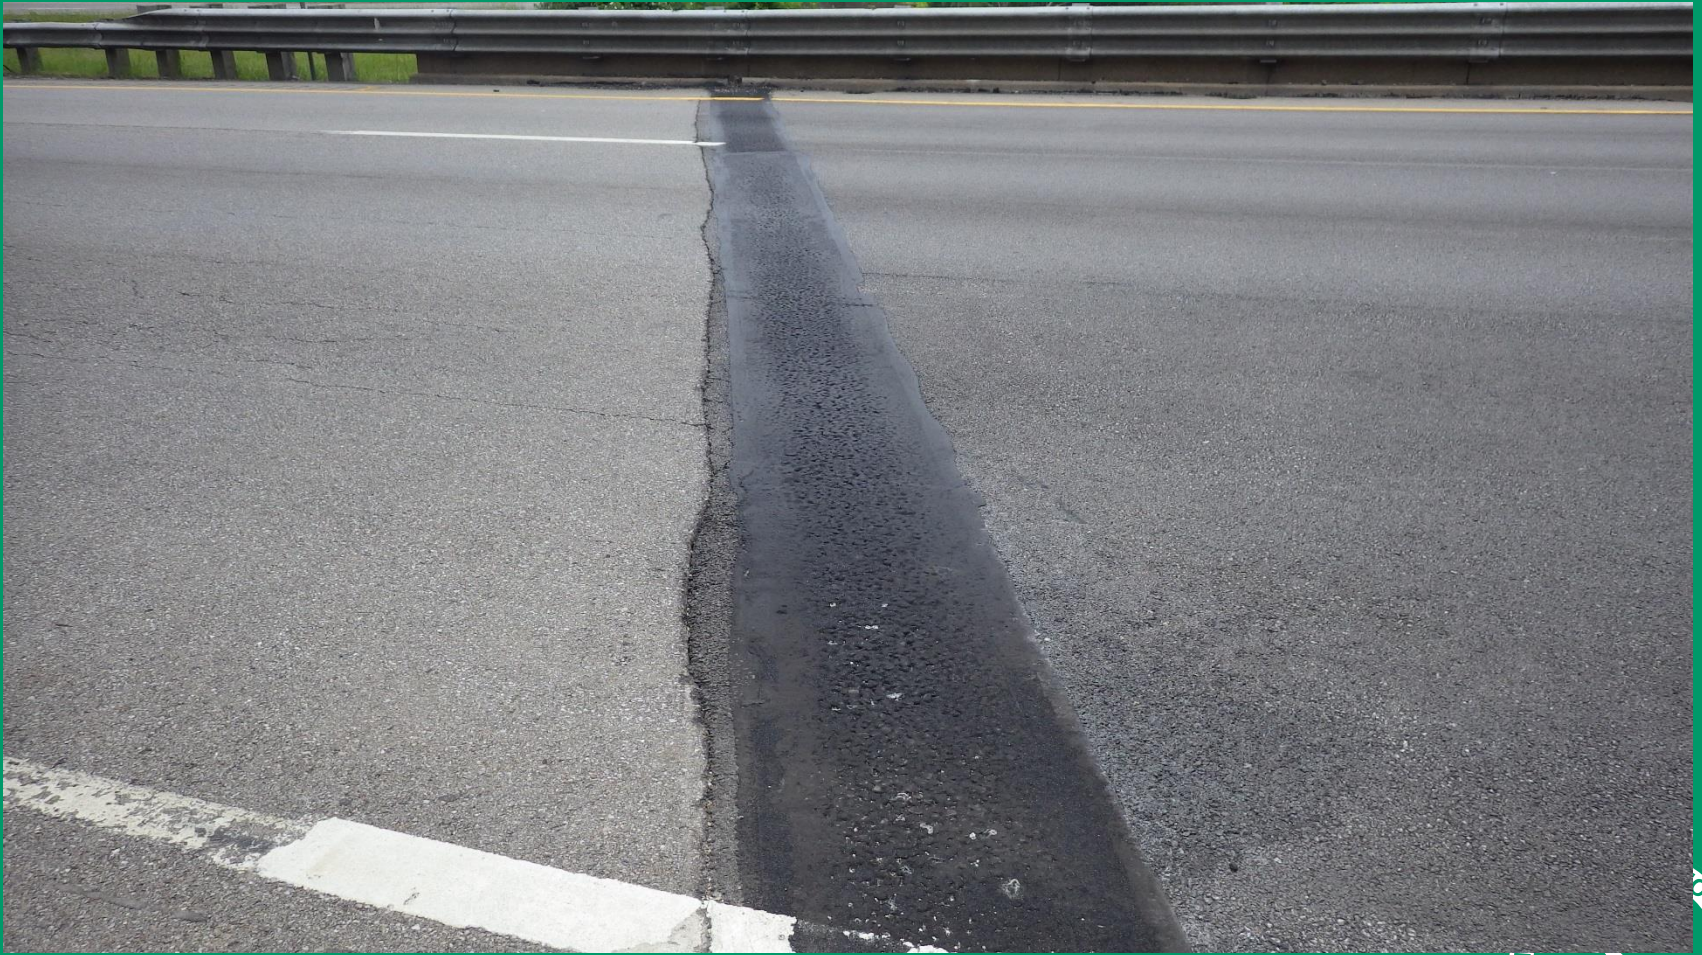
Outlier- LOR-90-1355L

- ☉ Good condition for High ADT, ADTT, Steel Beam, Longer Structure
- ☉ It is New

NEW POLY MOD JOINT SYSTEM. 2015.

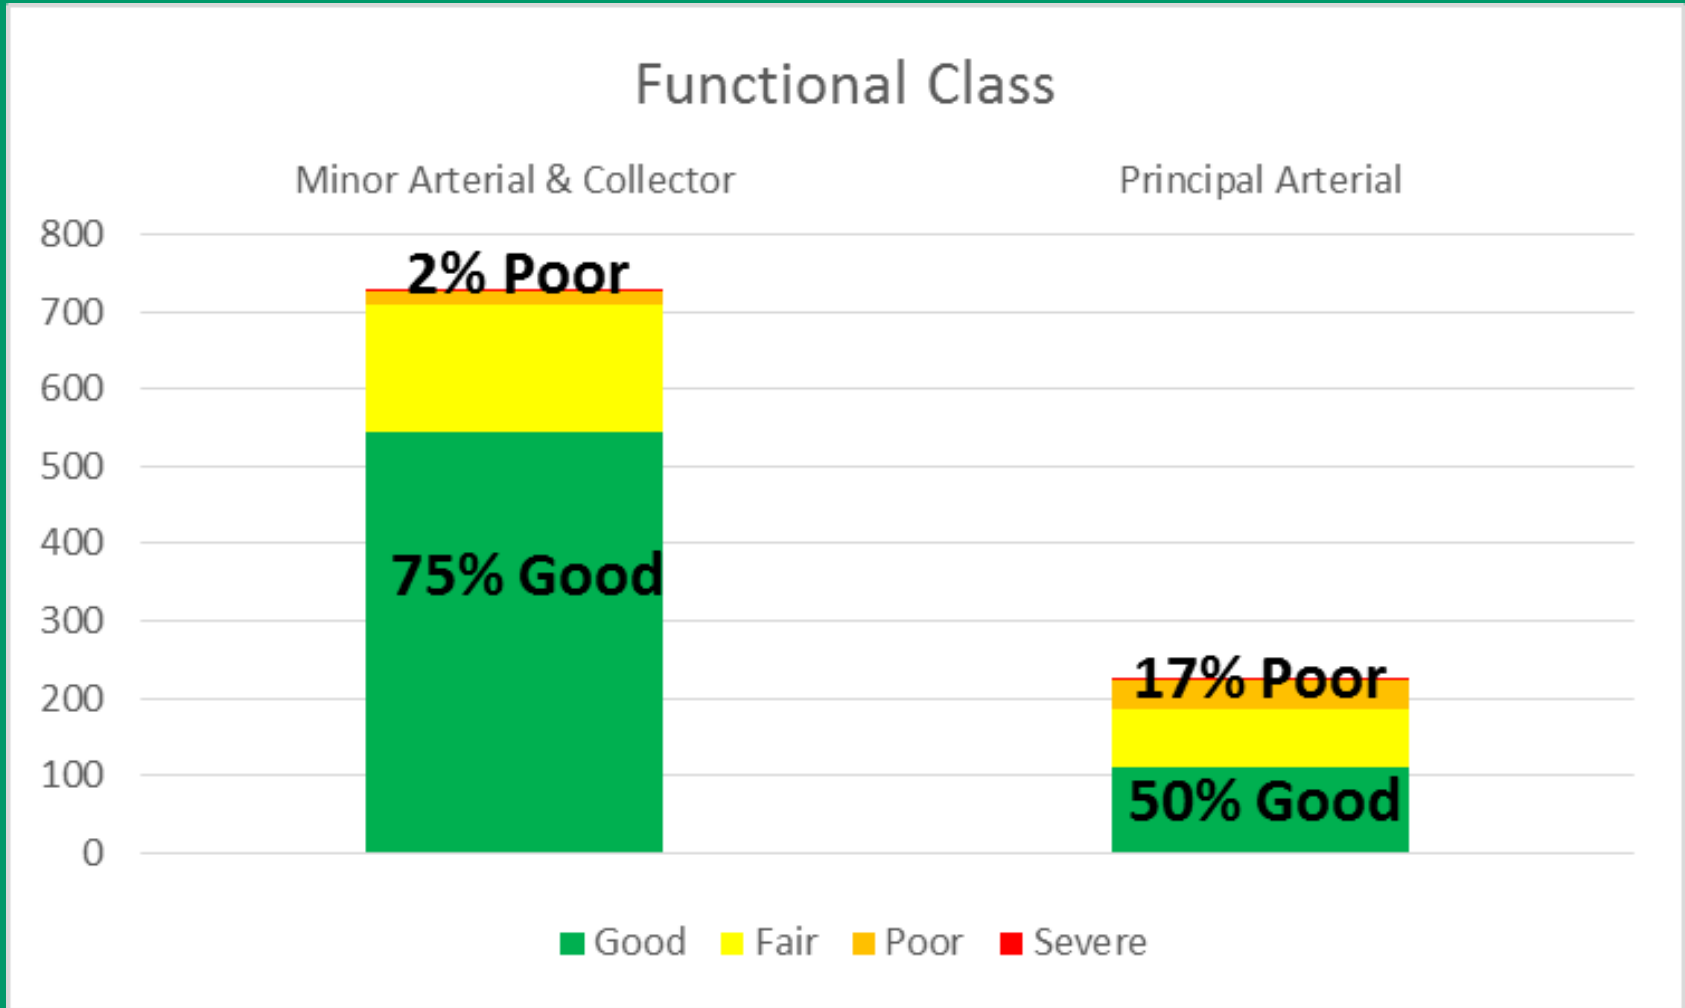
Functional Class & PMJ Condition

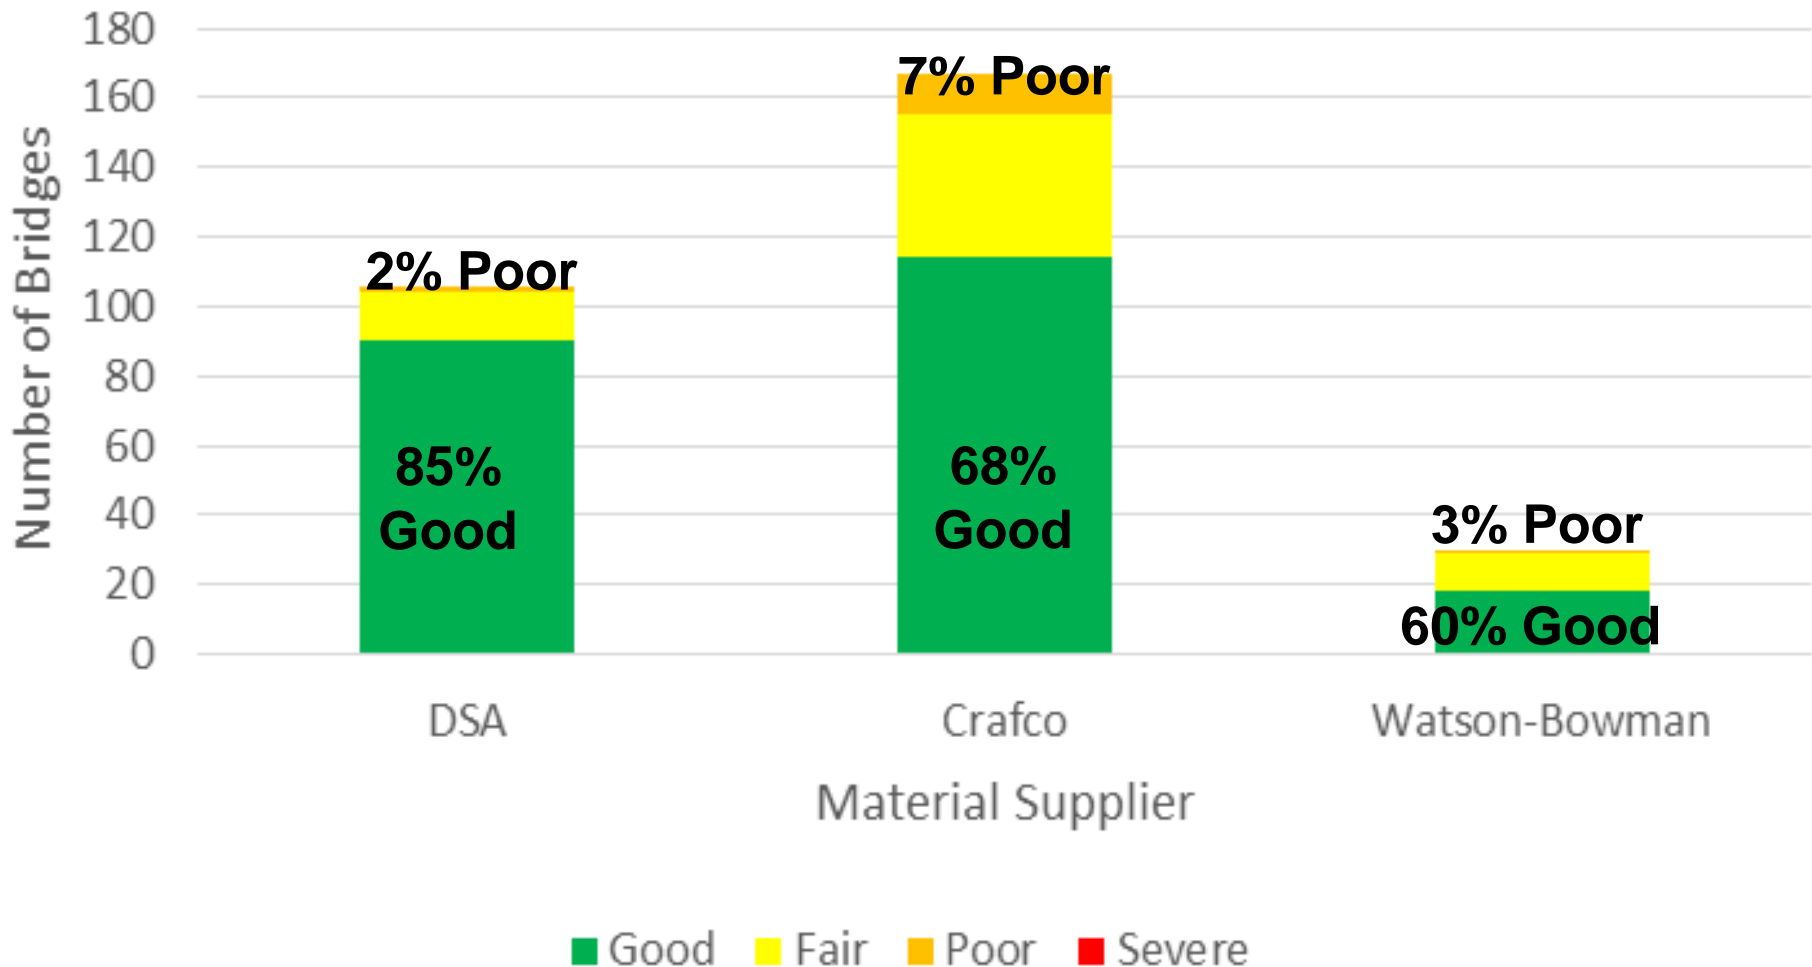
PMJ Condition Rating by Material Supplier

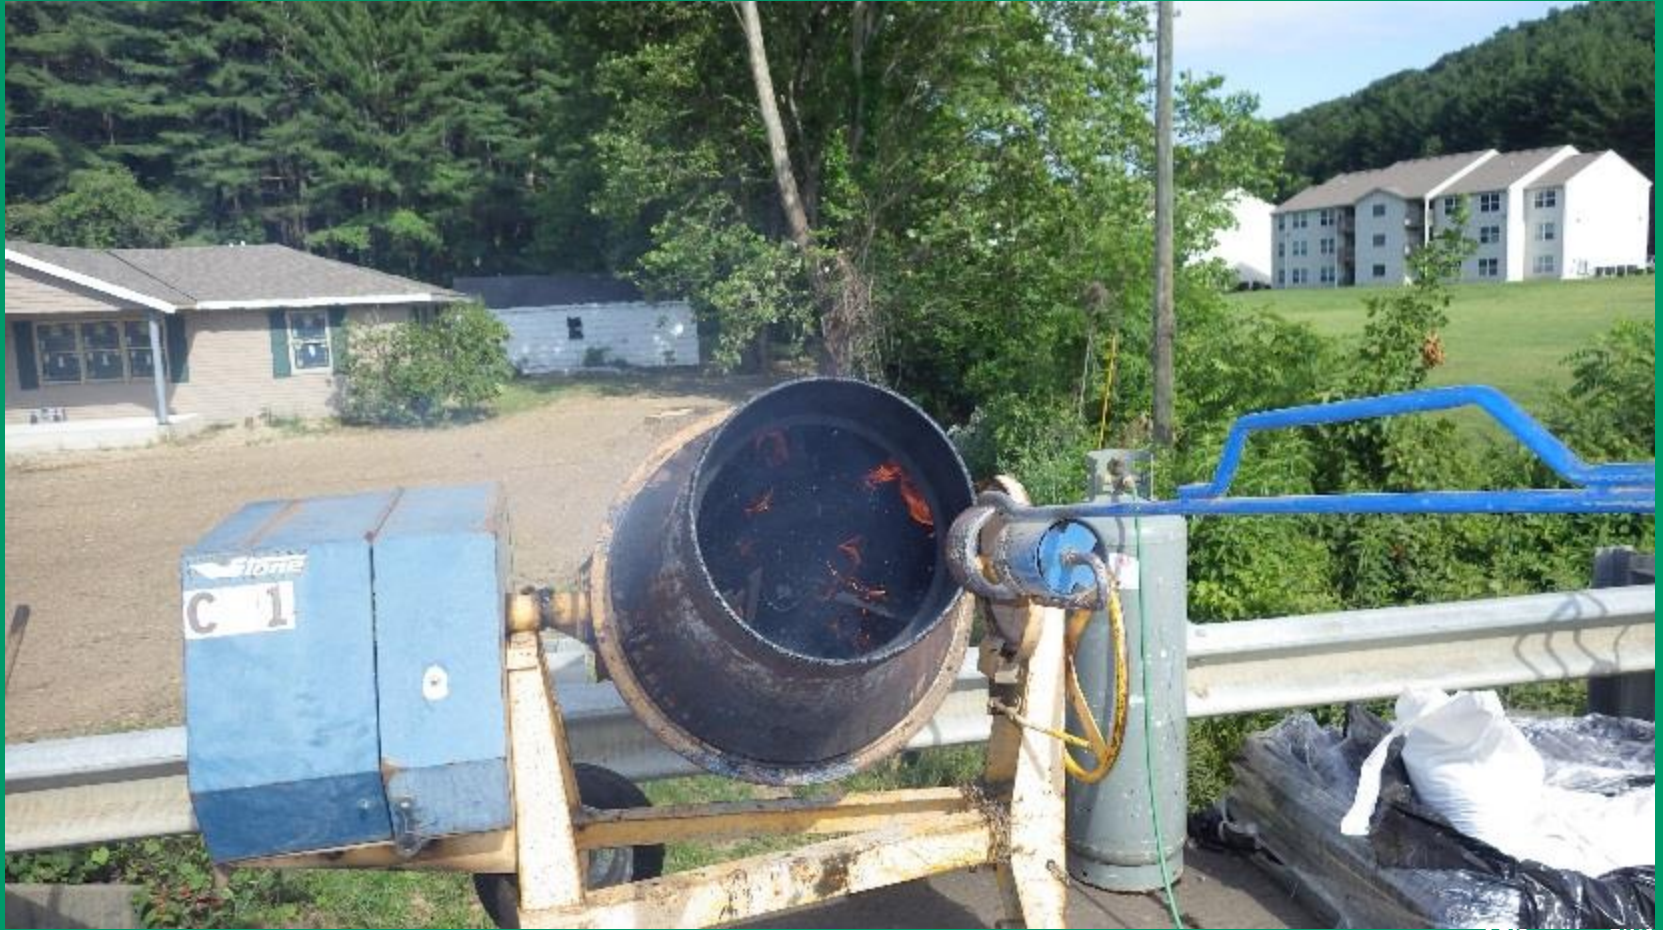
Aggregate Heating
