Beam End Treatments for Steel Bridges

**Bobby Meade
NEBPP Meeting
September 2016**

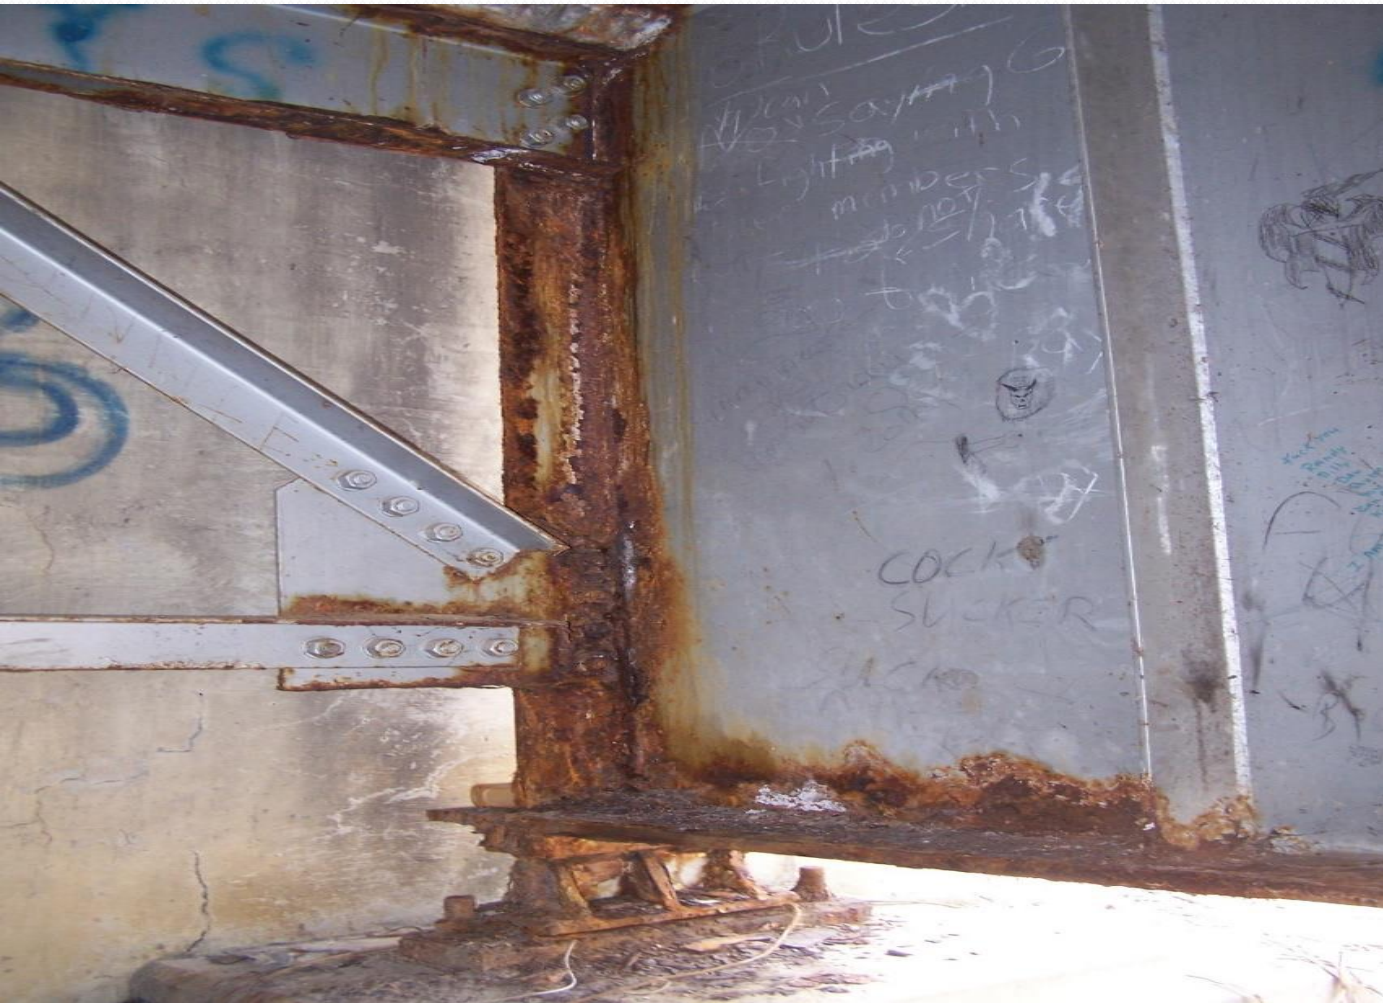
Typical Beam End Issues

- **Debris build-up**
 - **Attracts/retains moisture**
- **Leaking joints**
 - **Deck run-off falls onto beam ends, bearings, etc.**
 - **Extended time of wetness**
 - **Exposure to deicing salts**
- **Results**
 - **Localized premature coating failures**
 - **Significant corrosion**
 - **Loss of section on steel members**

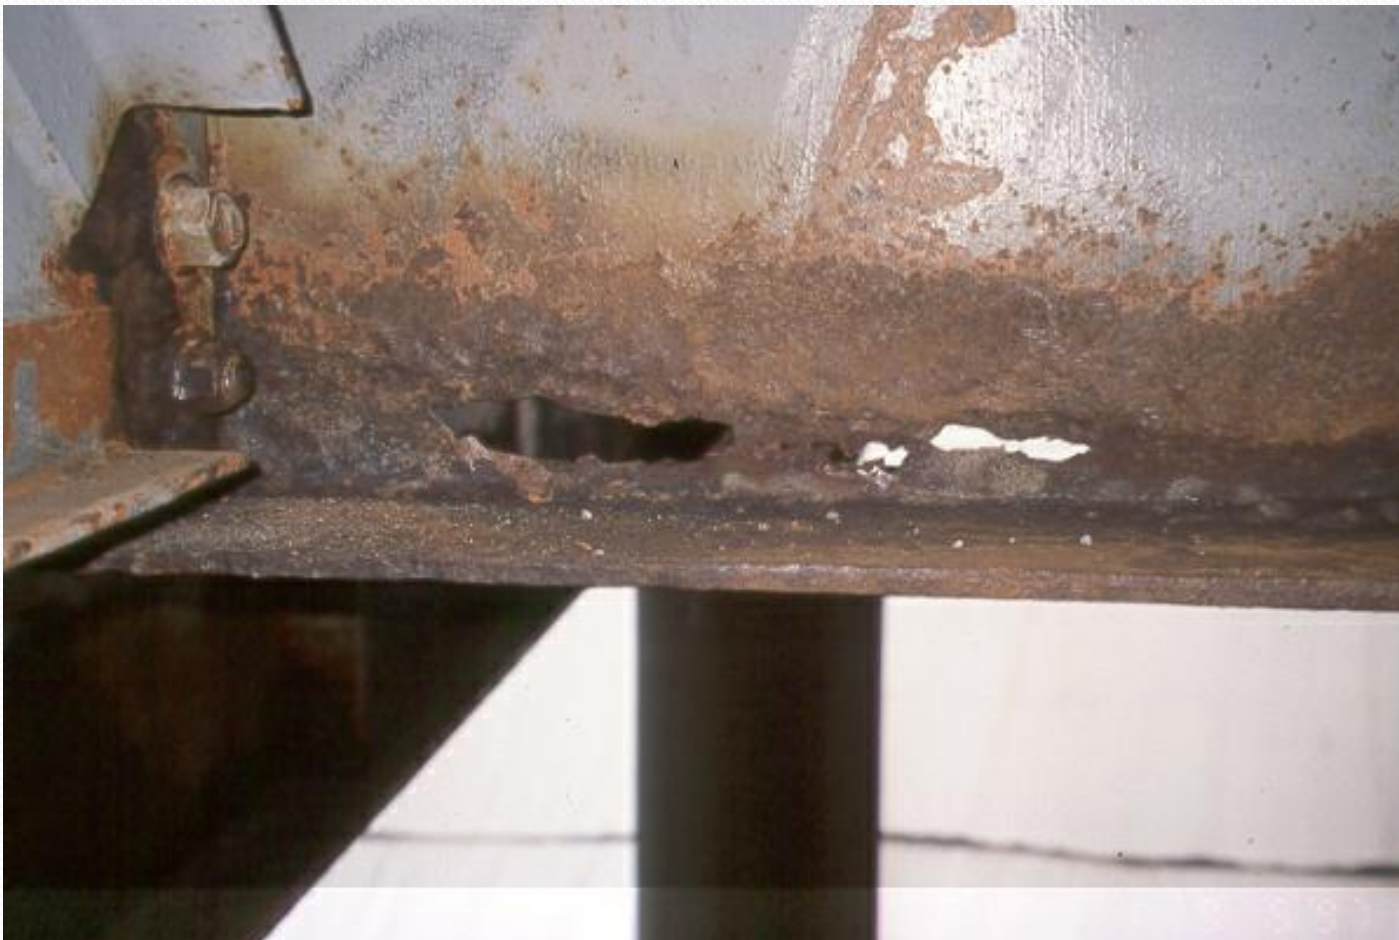
Typical Beam End Issues

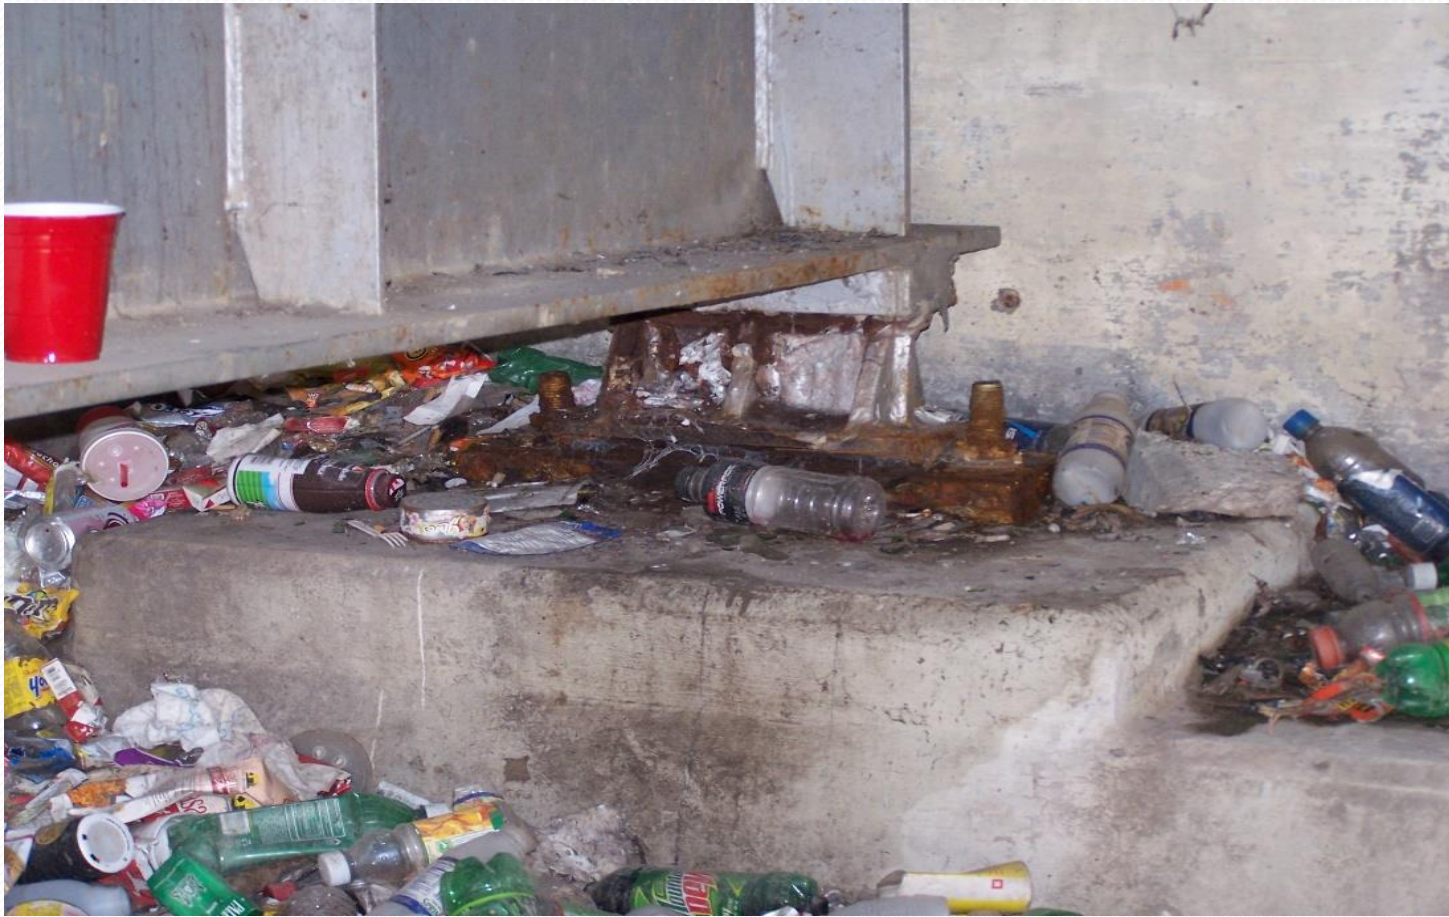
Typical Beam End Issues

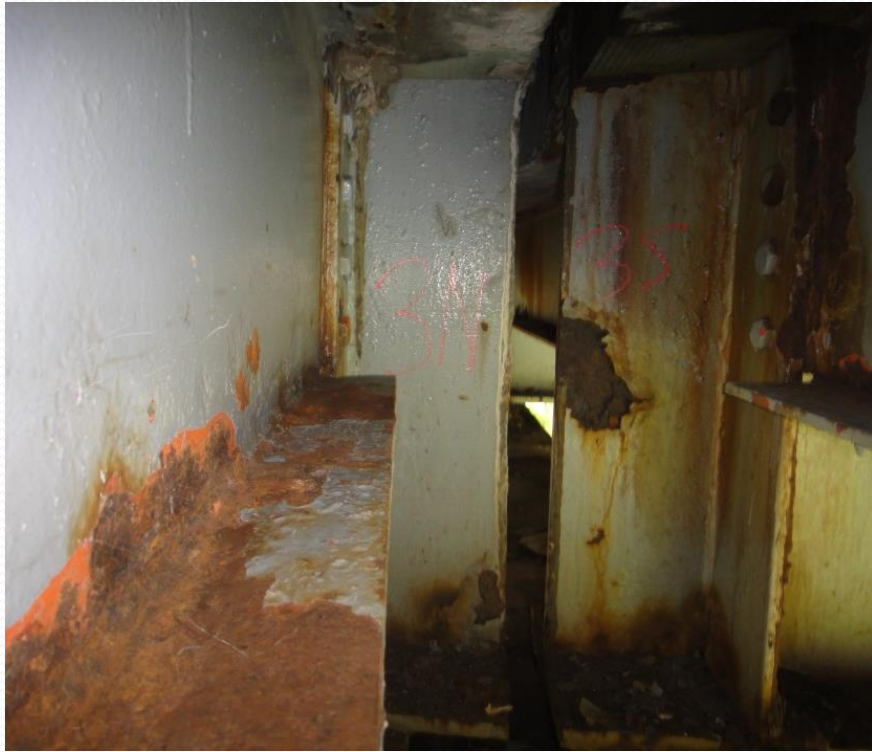
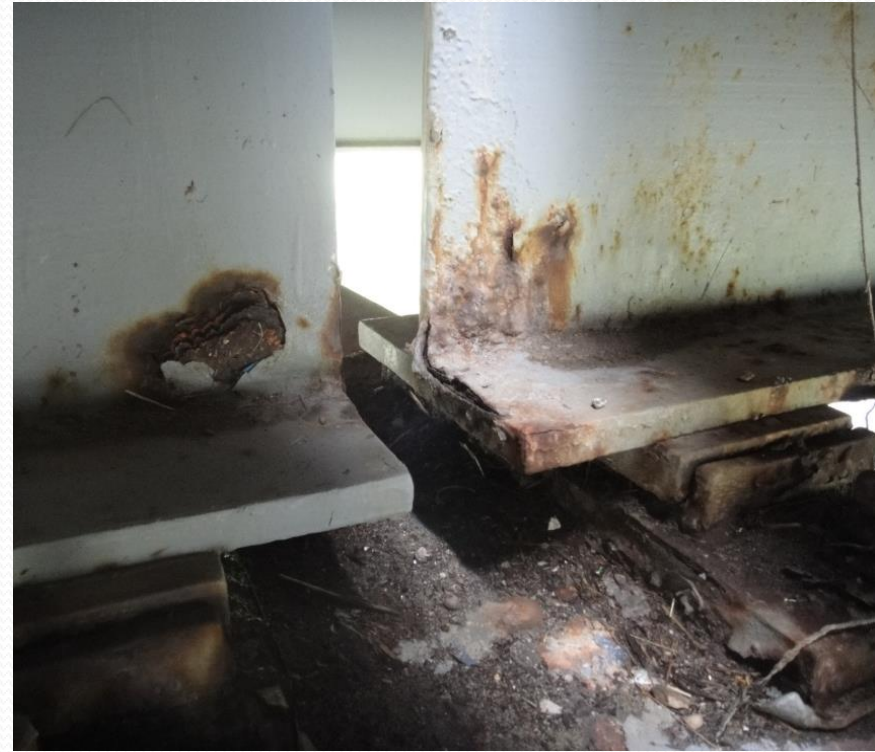
Steel Condition

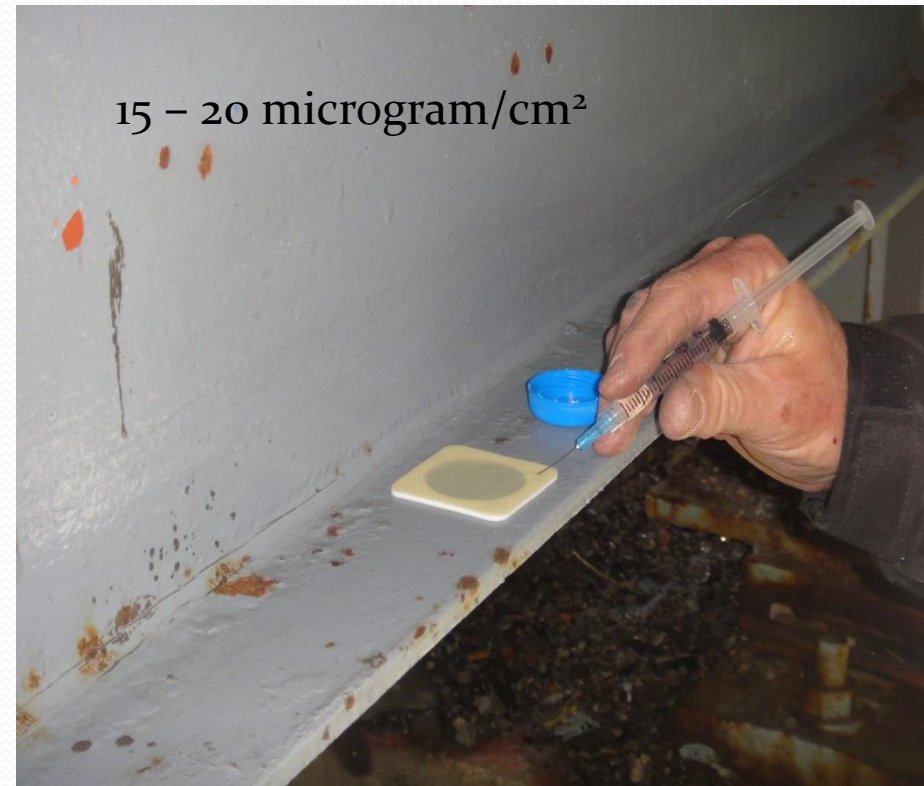
Steel Coating Condition

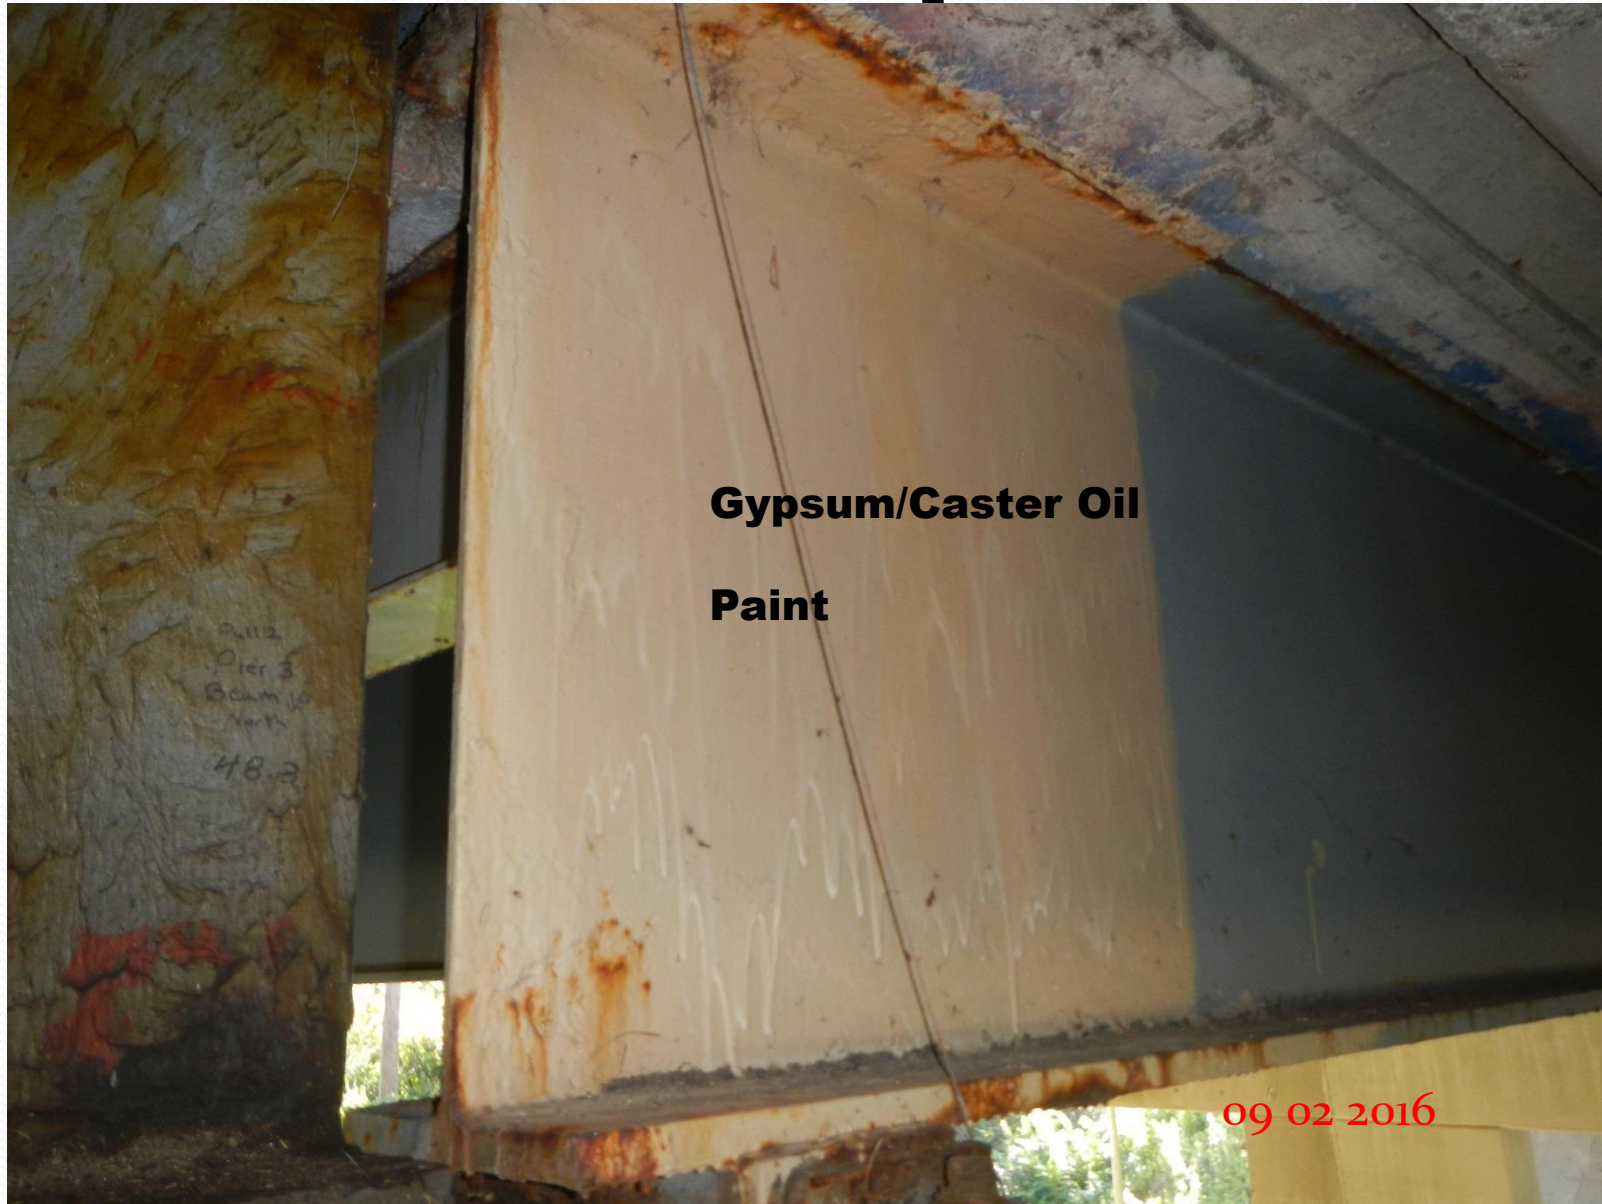
Gypsum/Caster Oil

Paint

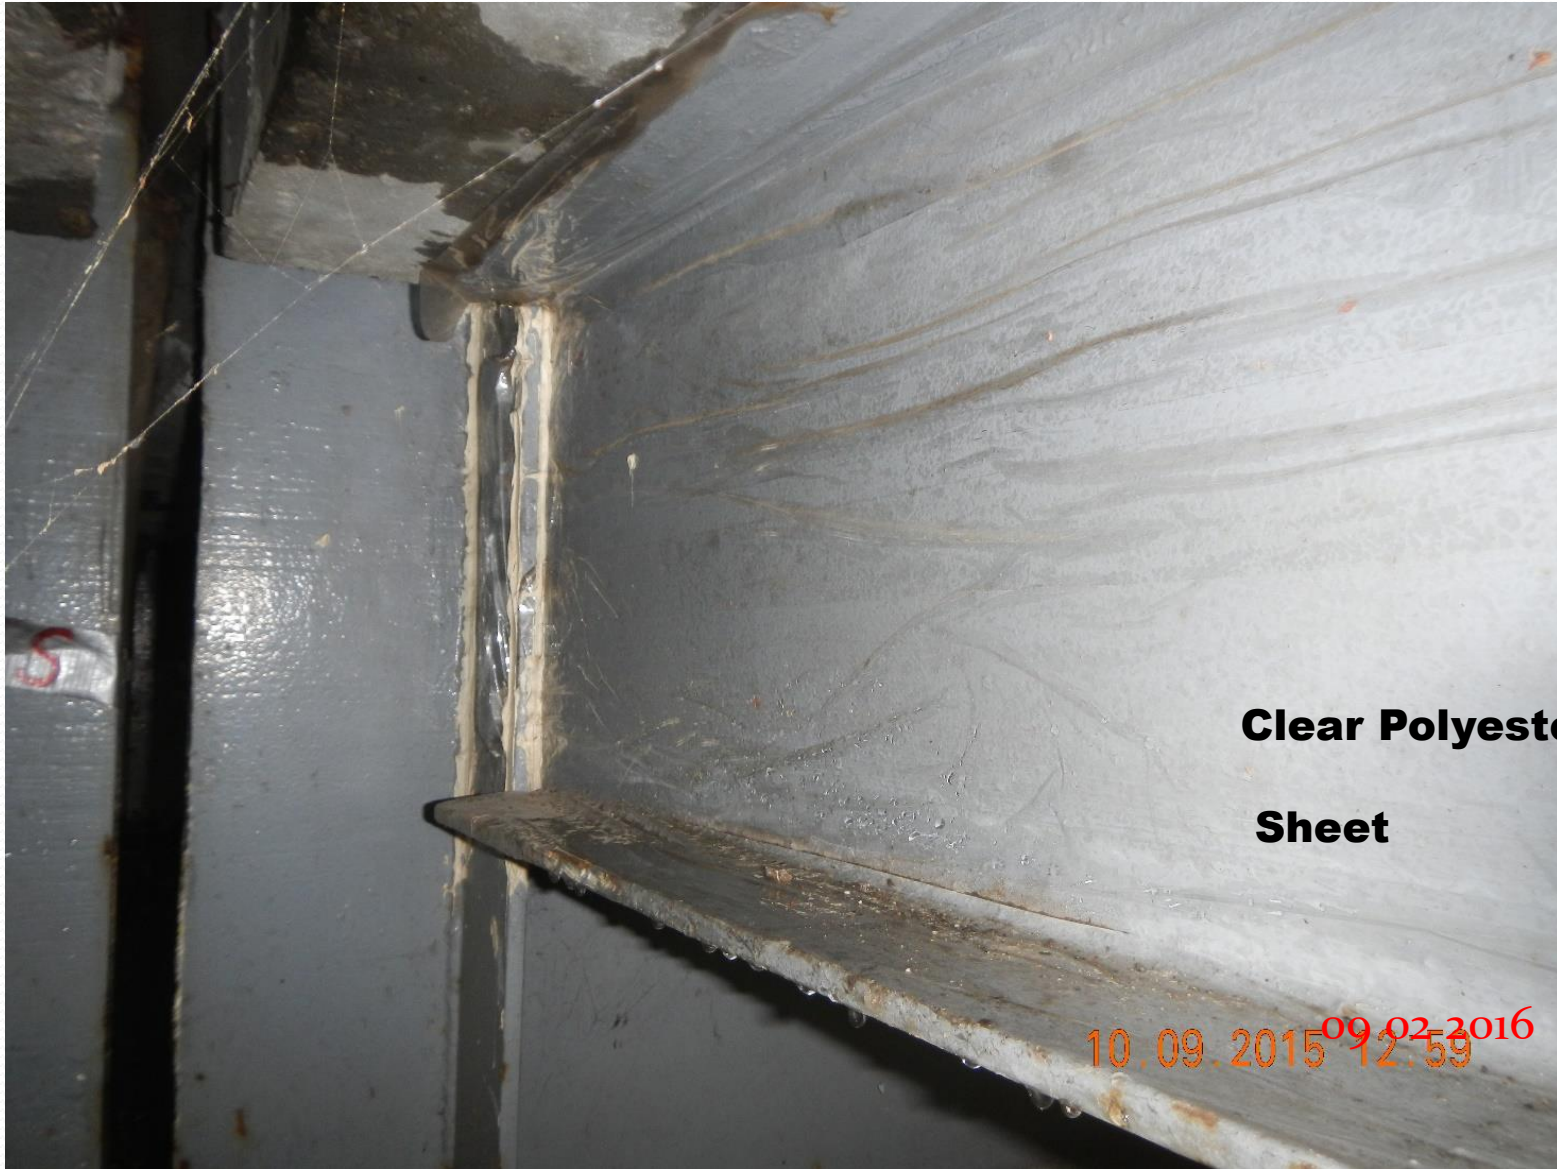
**Clear Polyester
Sheet**

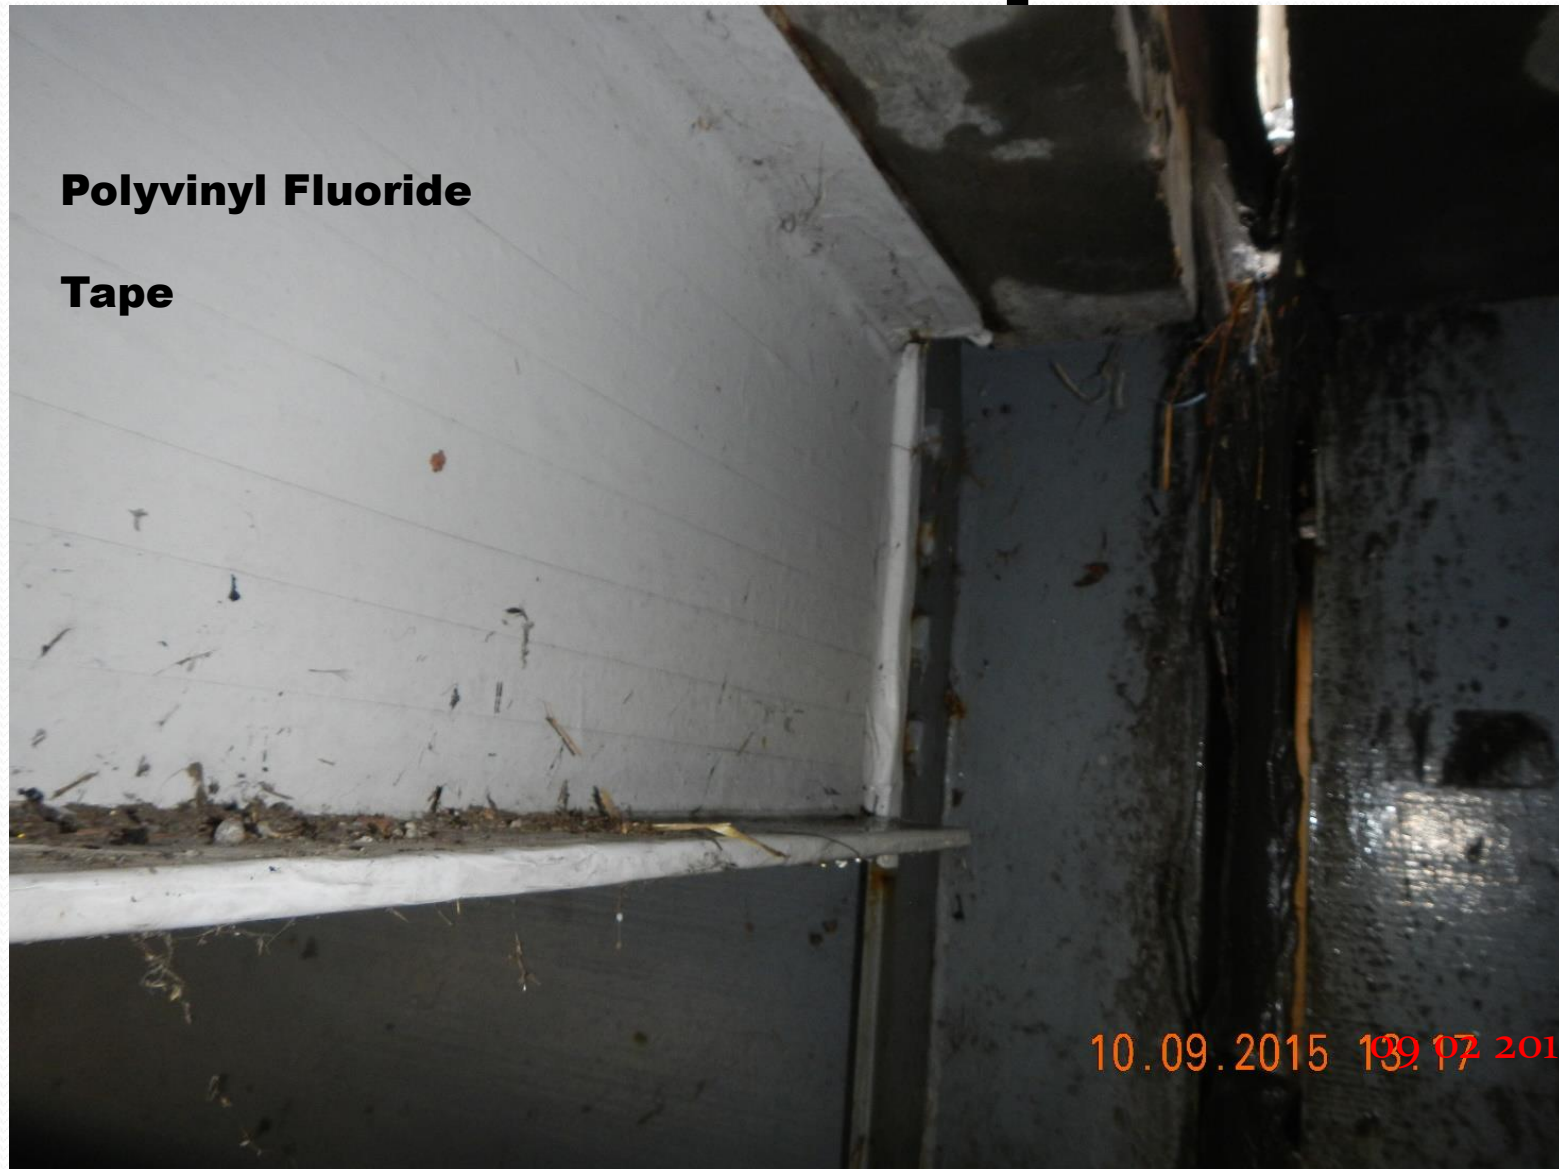
Polyvinyl Fluoride

Tape

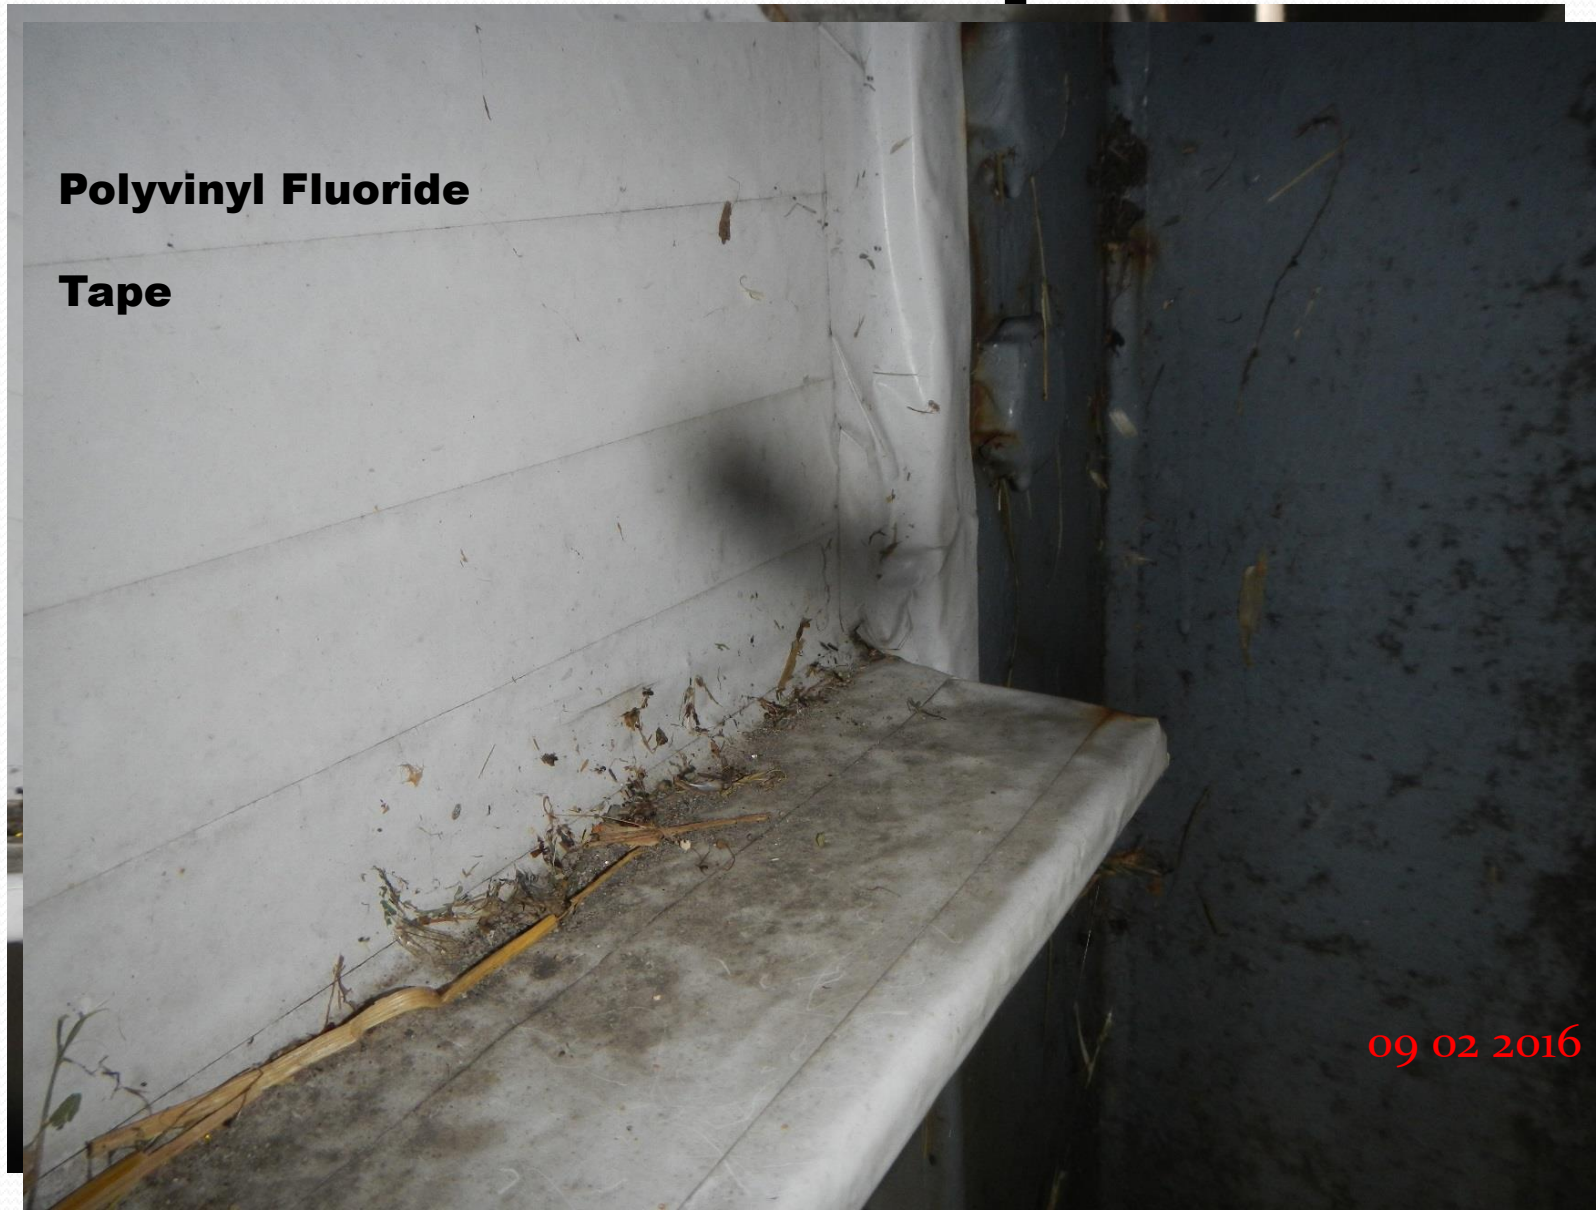
**Polyvinyl Fluoride
Tape**

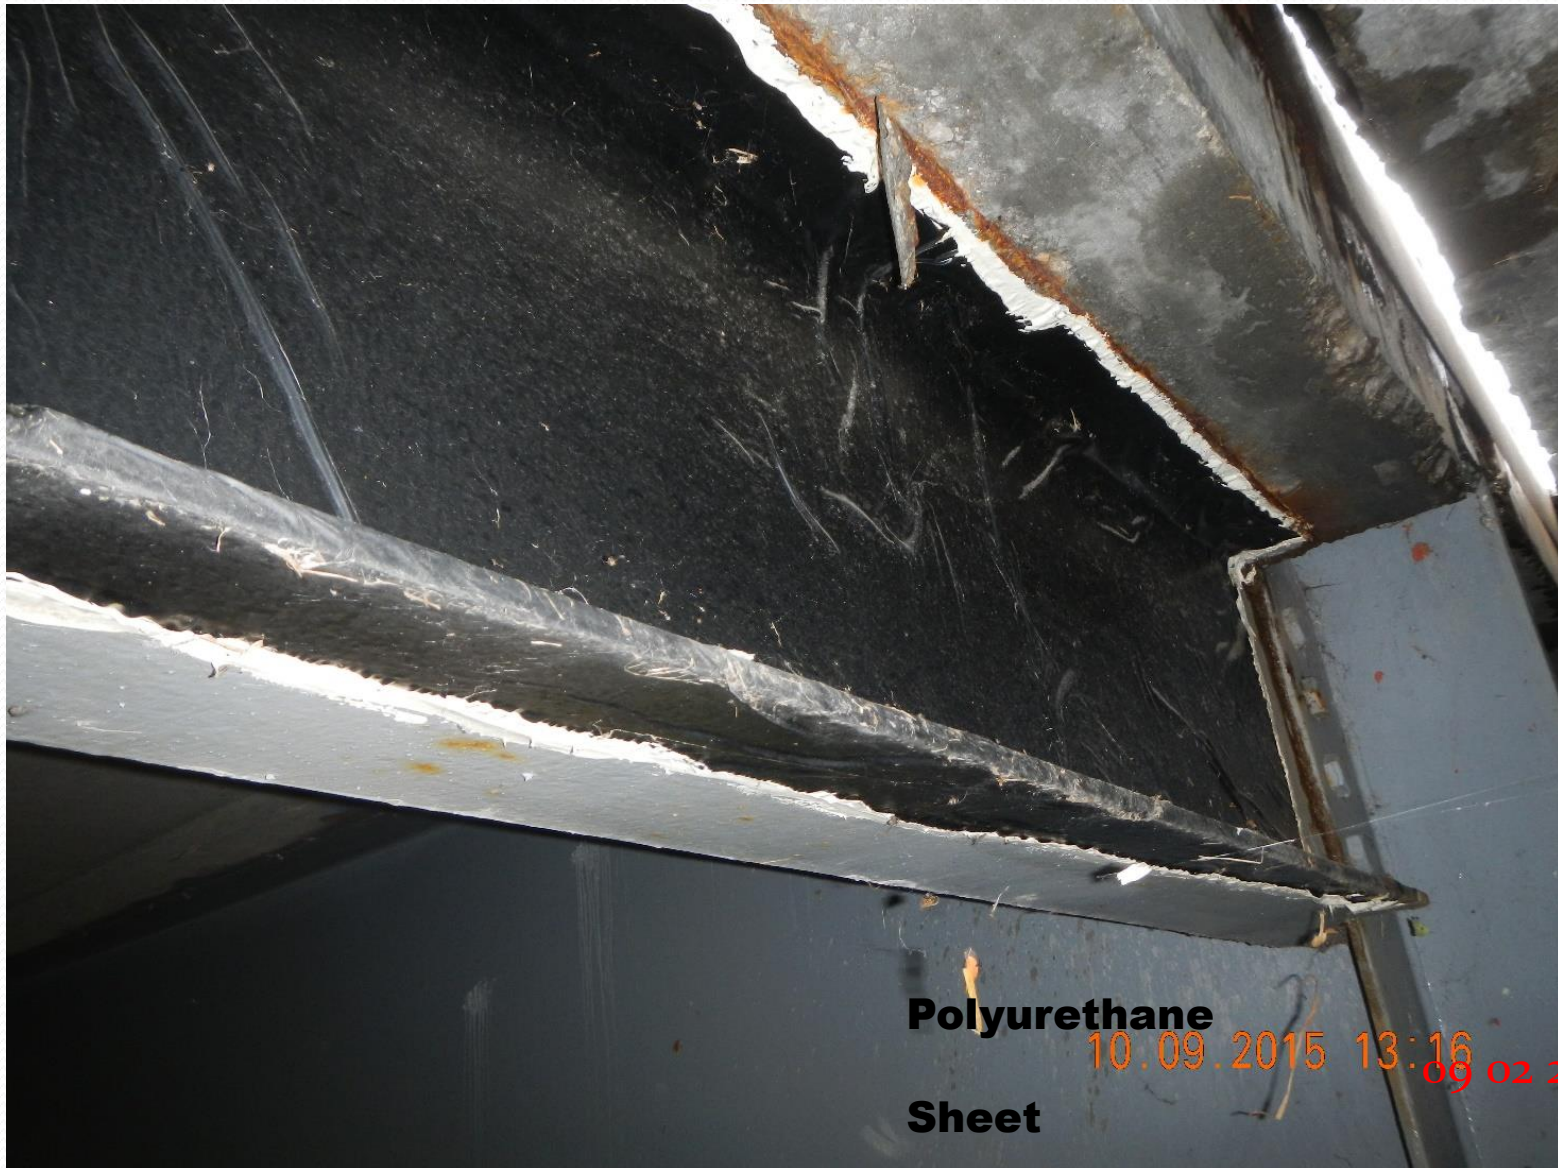
Polyurethane

Sheet

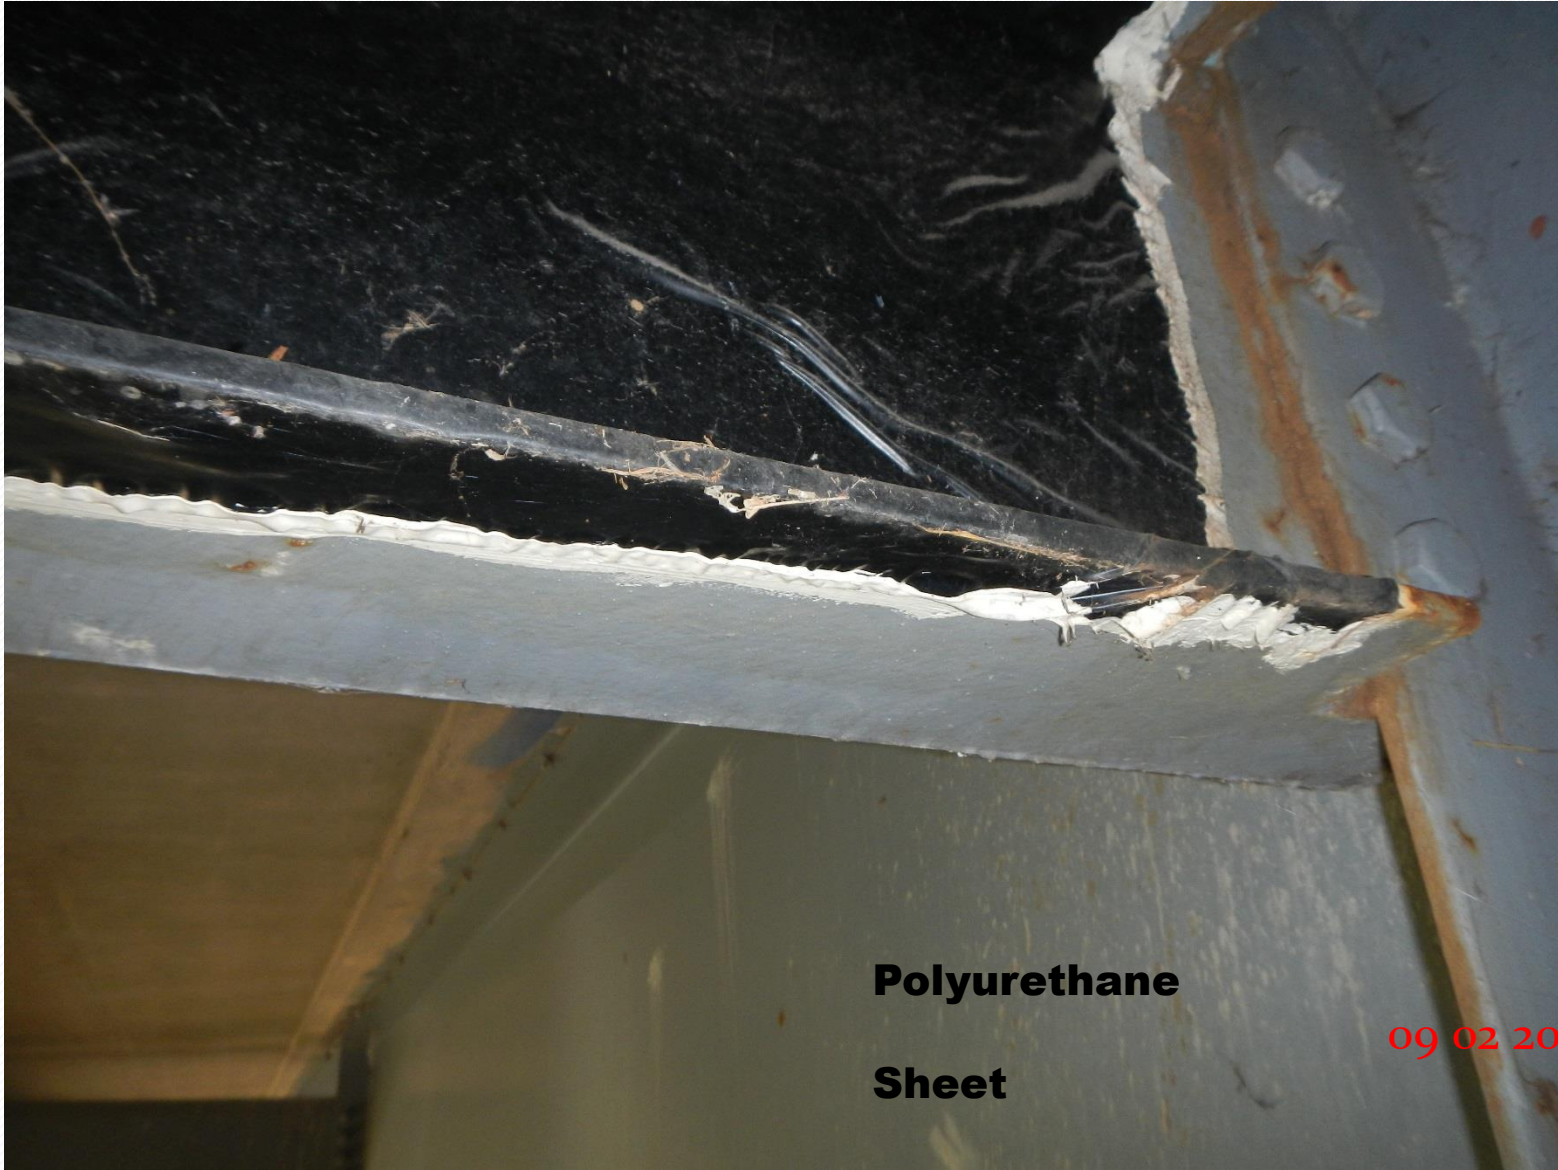
Polyurethane

Sheet

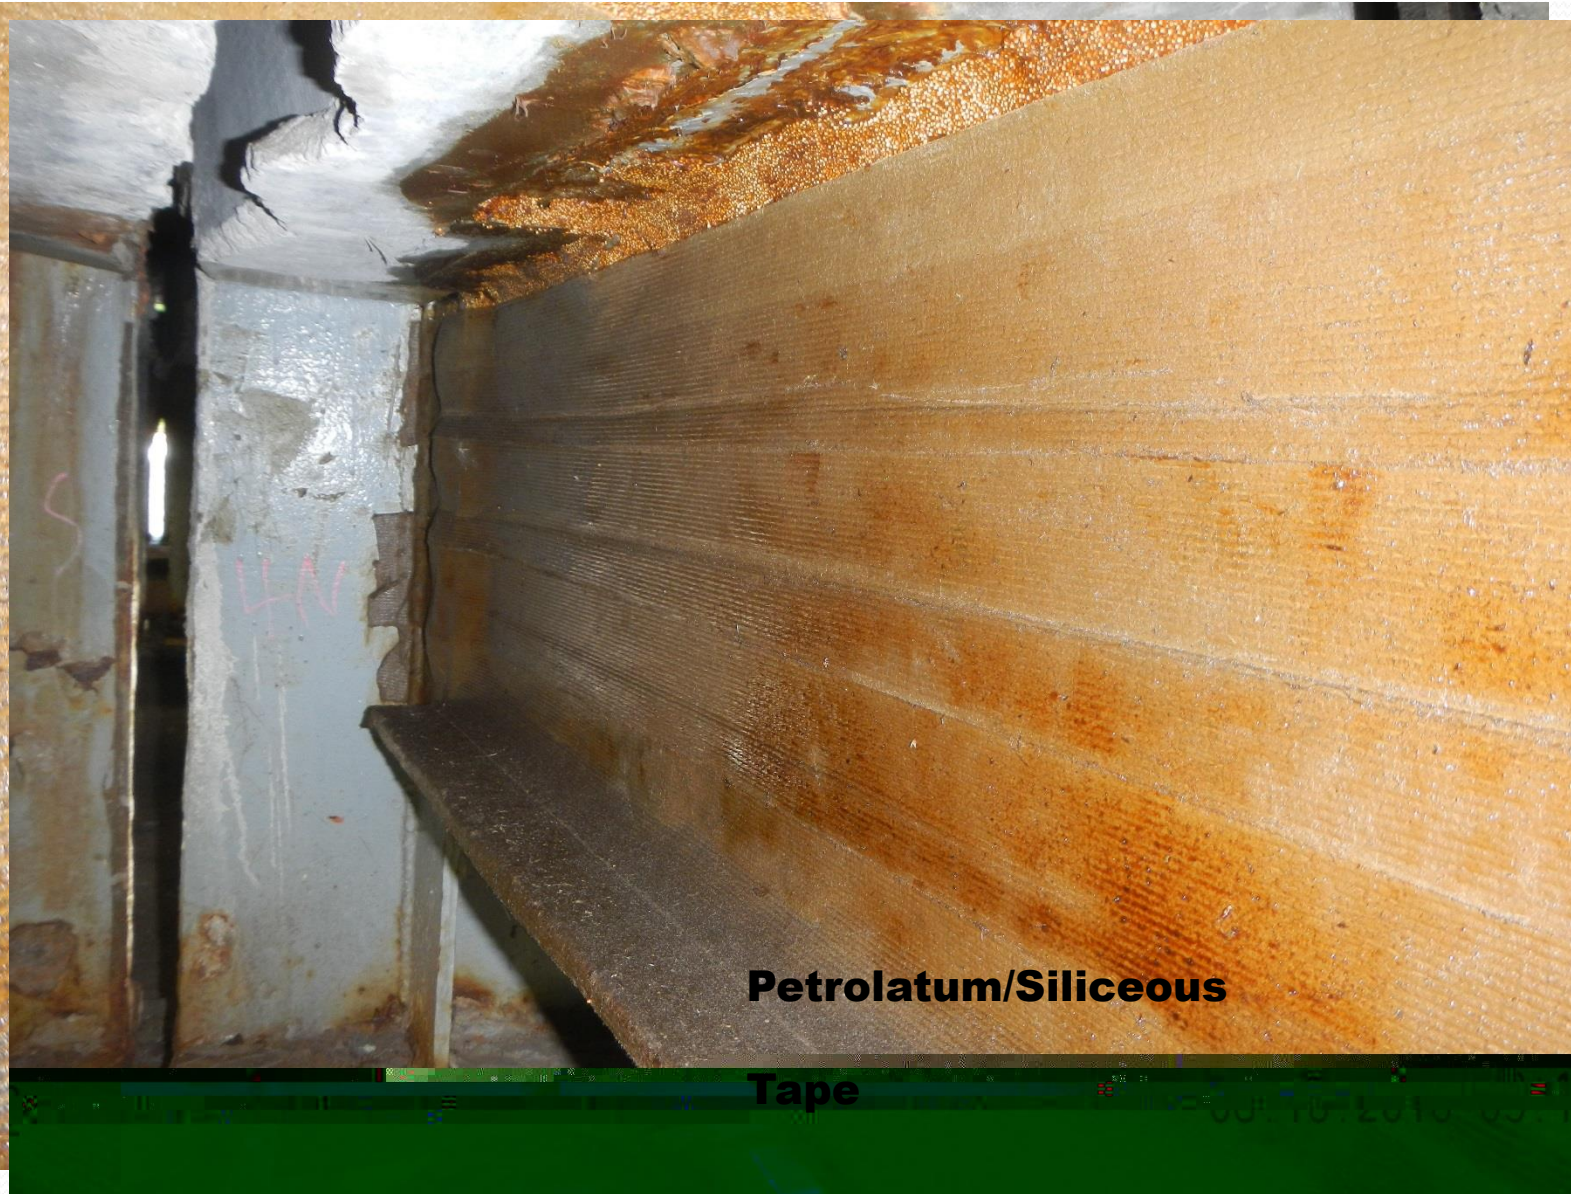
Petrolatum/Siliceous

Tape

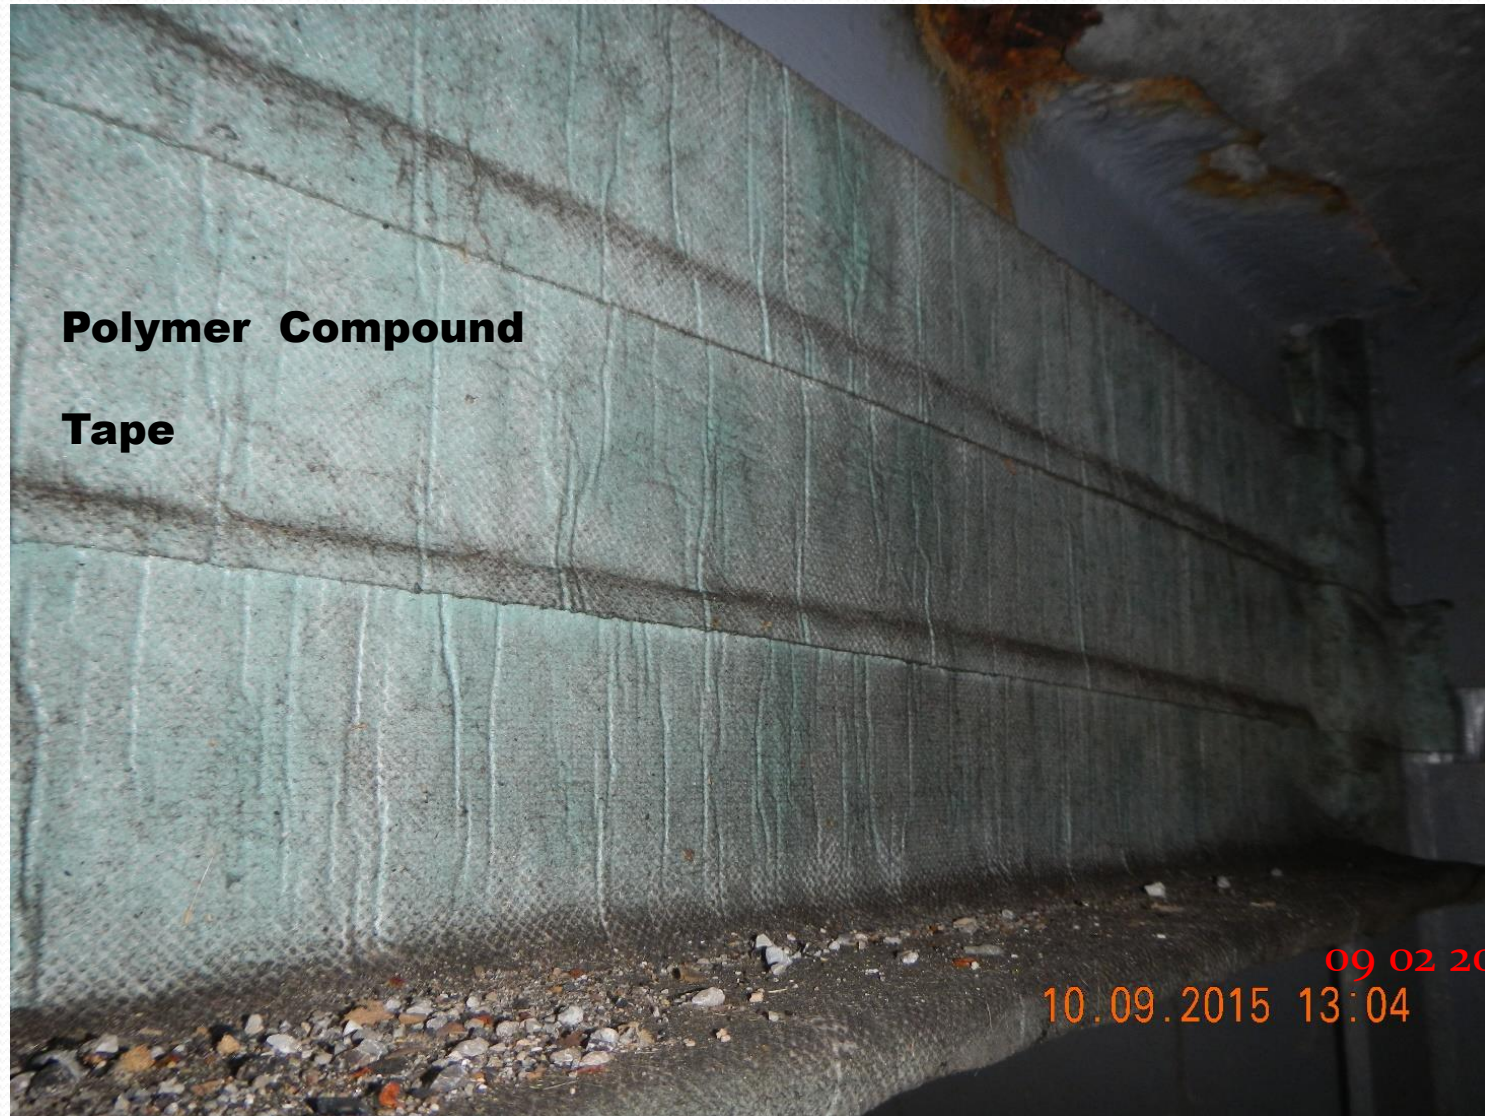
Polymer Compound

Tape

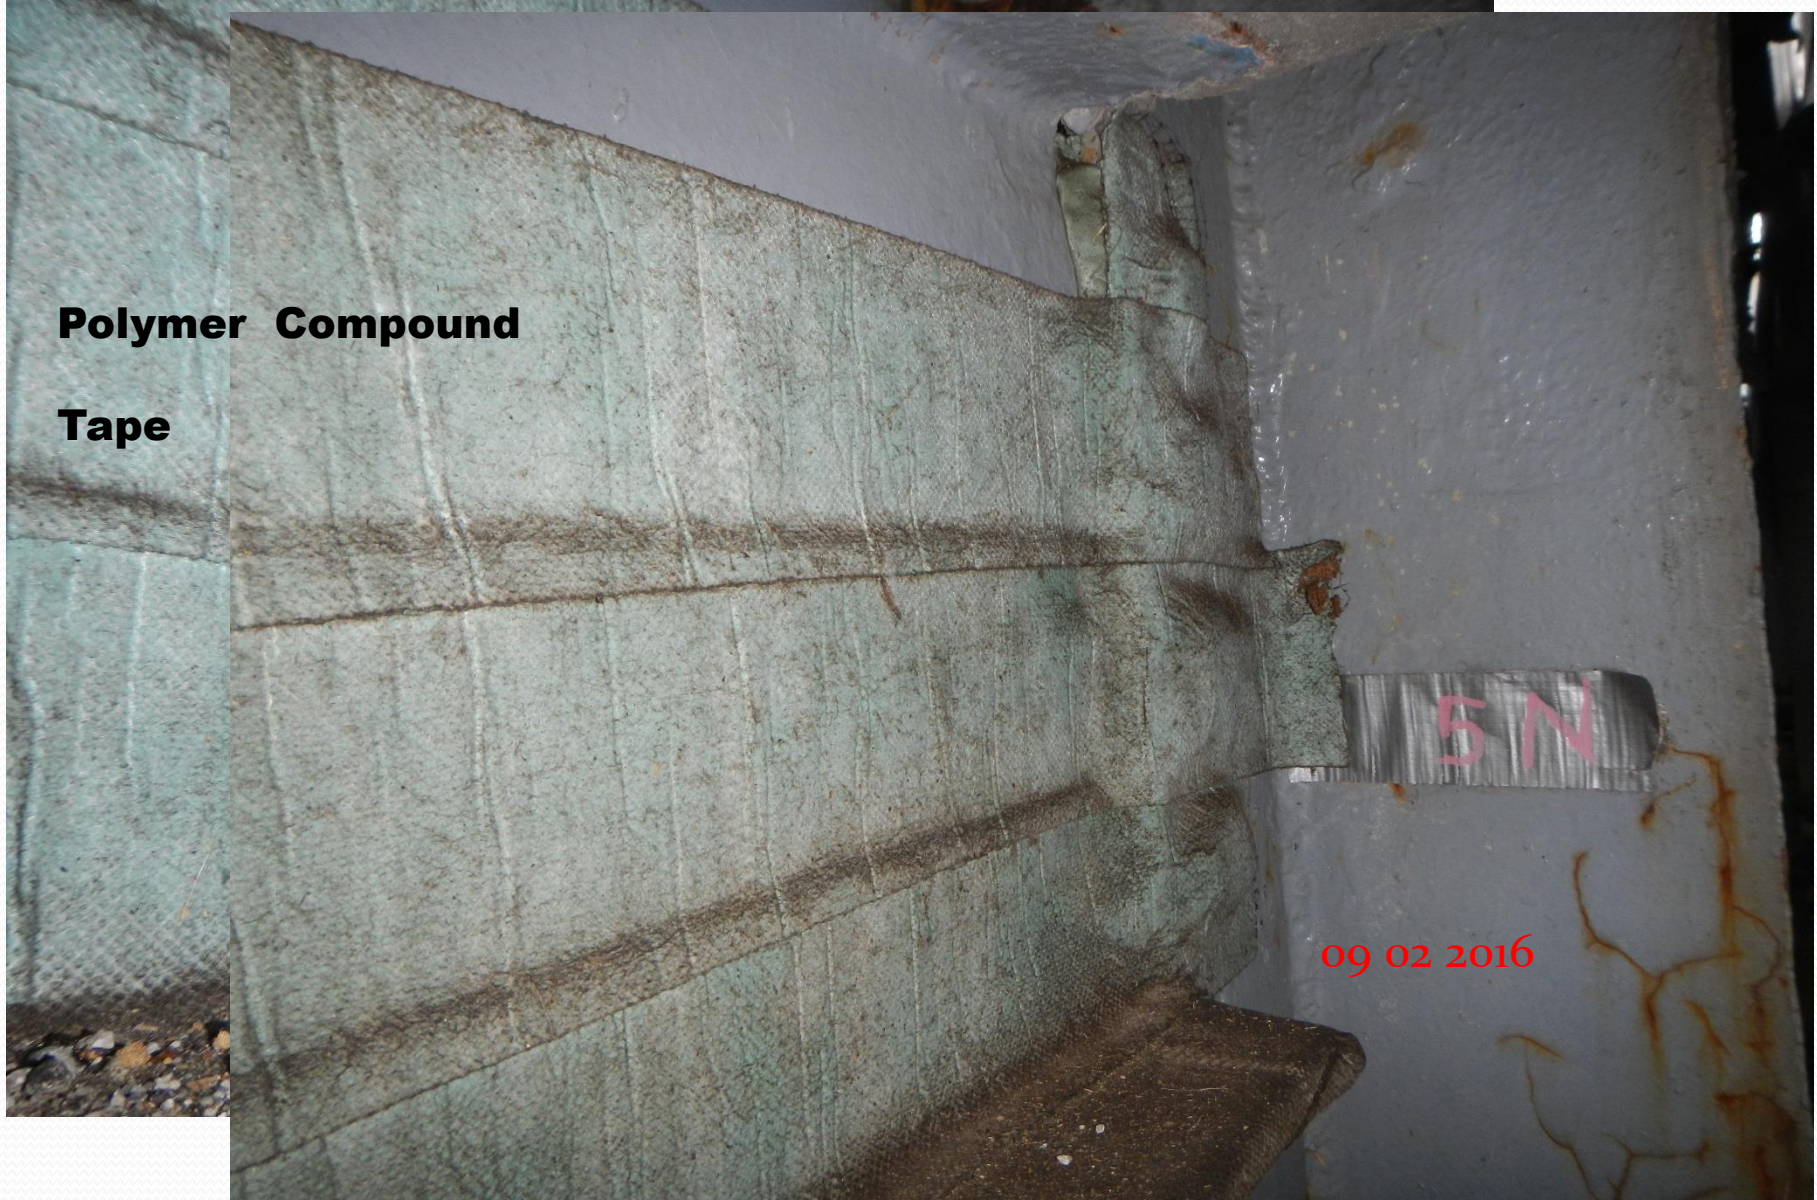
Polymer Compound

Tape
