Repair of Corroded Steel Beam/Girder Ends with Ultra High Strength Concrete

Northeast Bridge Preservation Partnership (NEBPP)
Sept. 19–21, 2016 | Baltimore, Maryland

Problem Statement

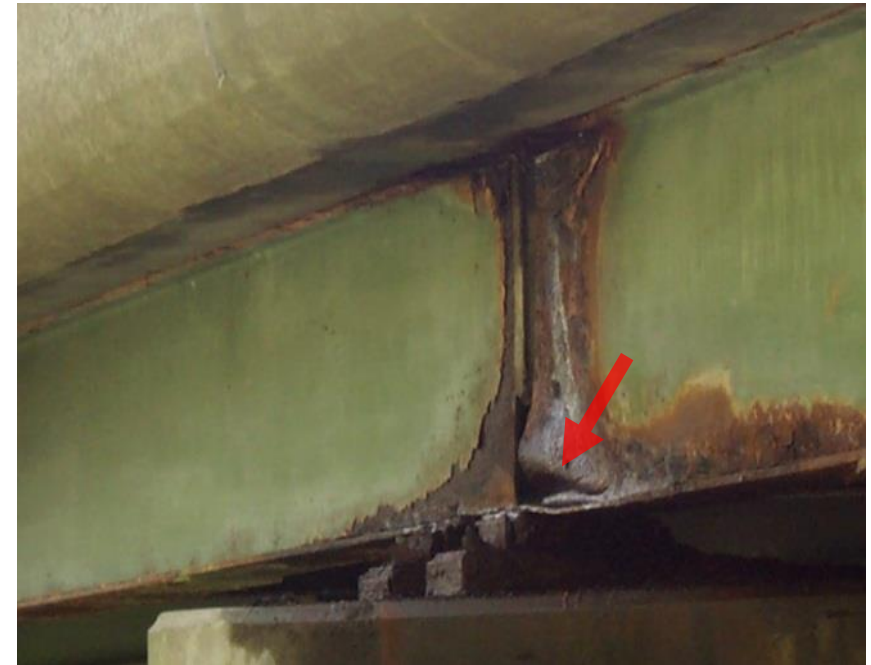
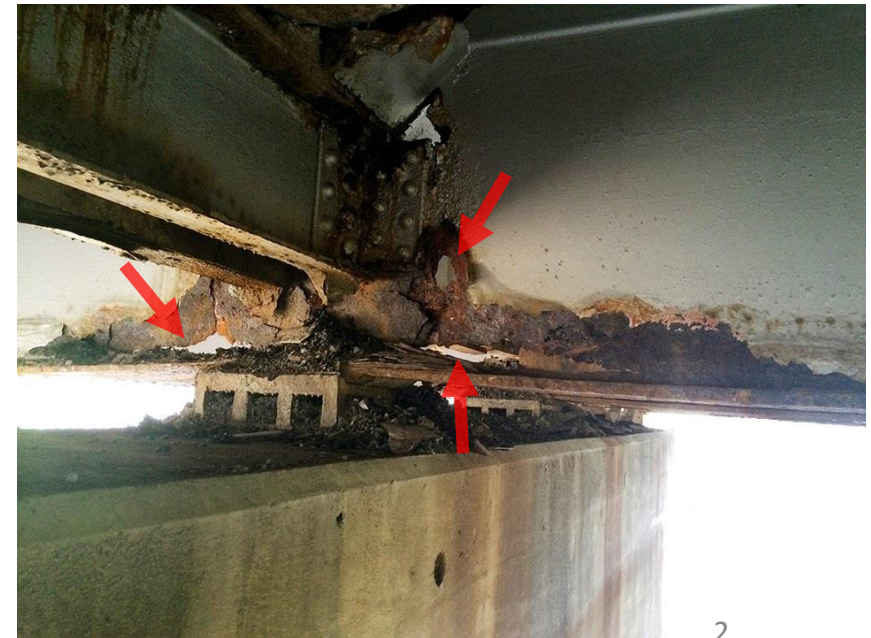
- Extensive corrosion of bridge girders occur beneath deck expansion joints due to leaking joints.
- Corrosion damage is the cause of approximately 15% of bridges receiving a structurally deficient rating.
- The United States spends *\$8.3 billion* annually to repair and replace corrosion damaged highway bridges.
- Corrosion at girder ends may significantly reduce the bearing capacity.

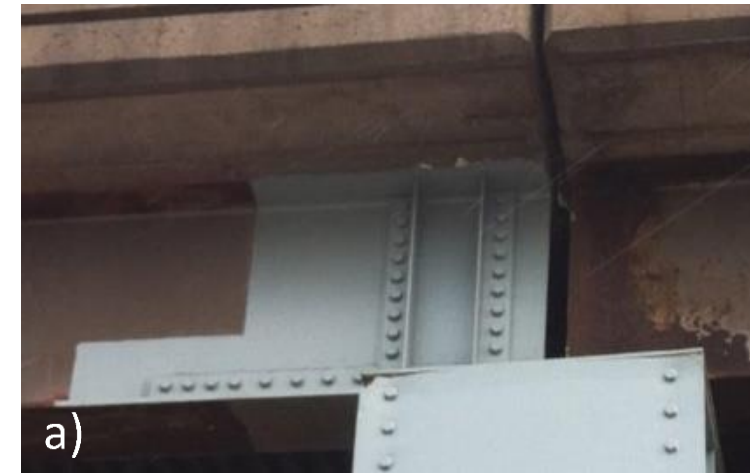
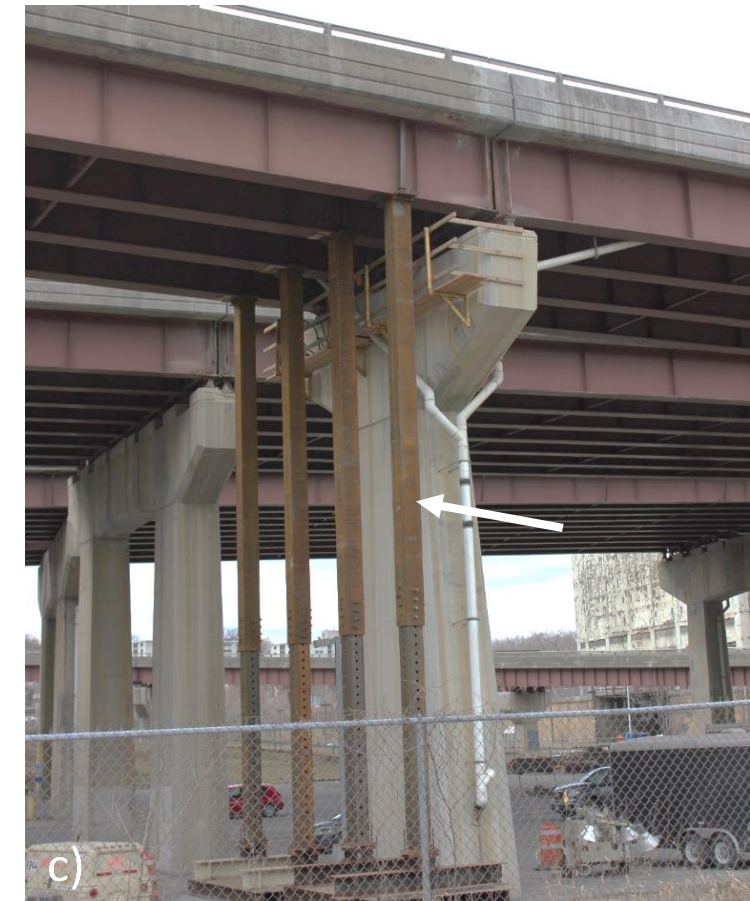
Standard procedures to repair corroded steel girder ends:

- 1) jacking the structure to relieve the loads
 - 2) cutting out the corroded section of steel
 - 3) welding a new steel section into place
 - 4) lowering the span and removing the jacks
- This process is expensive and time consuming
 - It may require lane closure and **lead paint** removal
 - Continued corrosion remains an issue

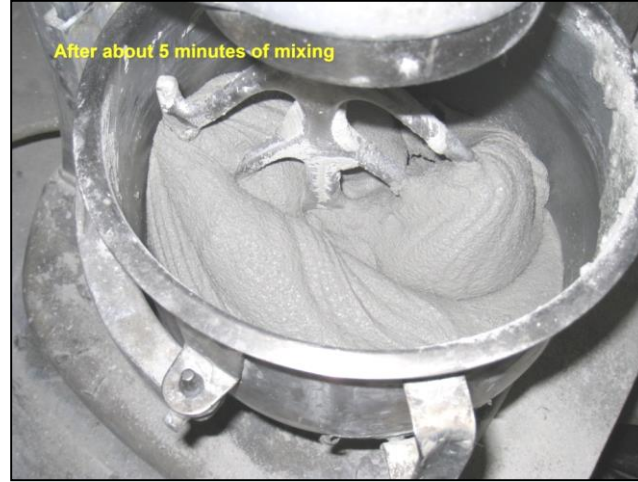
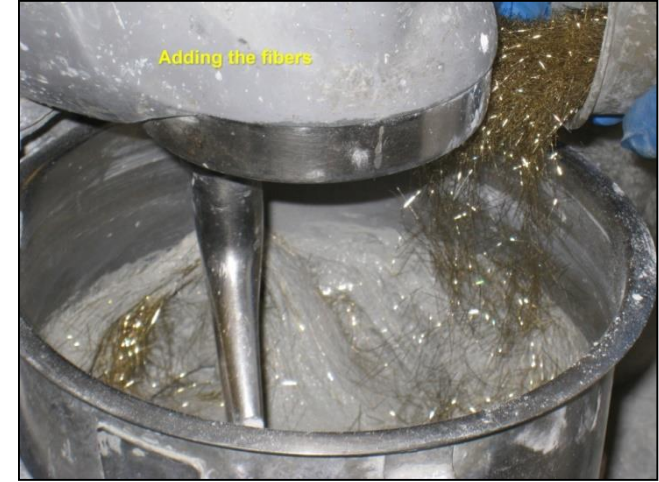
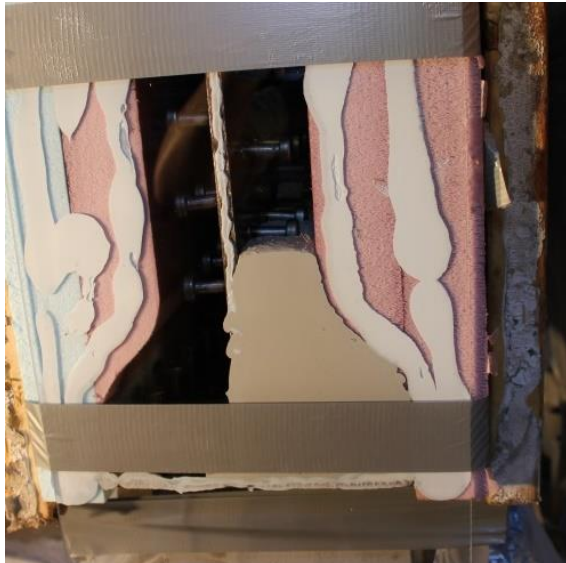
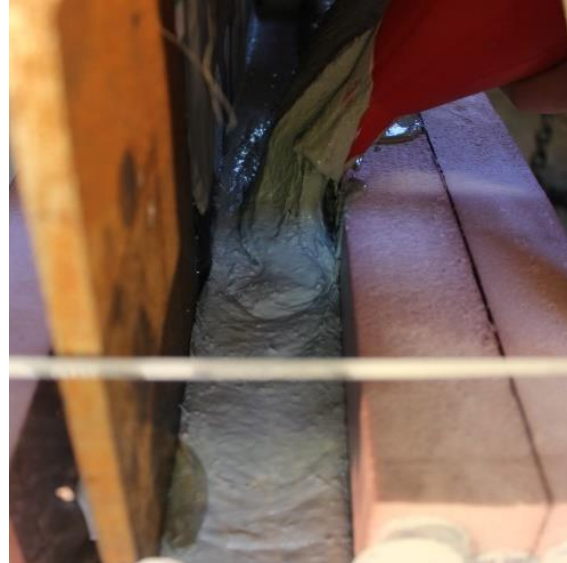
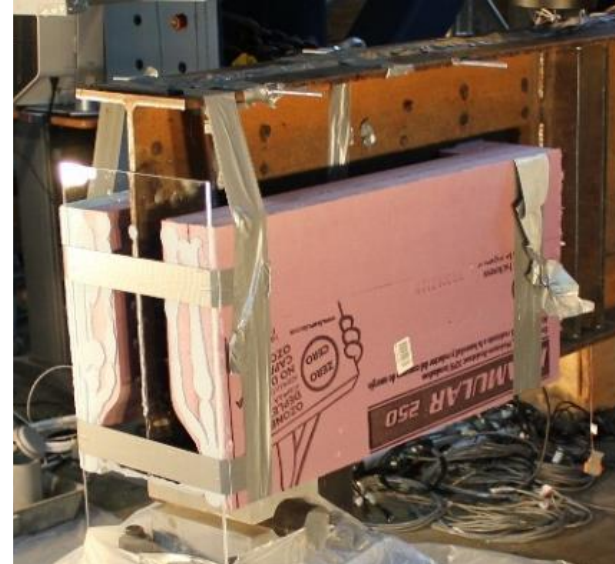
Ultra High Performance Concrete and Casting

- Proprietary mix design by Lafarge
- Gain 12ksi in 12hrs (JS1212)
- Significant, flowability and workability
- May be pumped or cast from the top

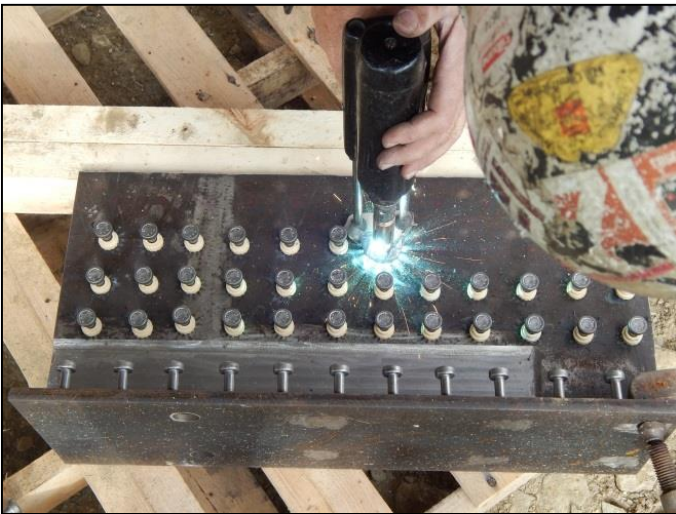
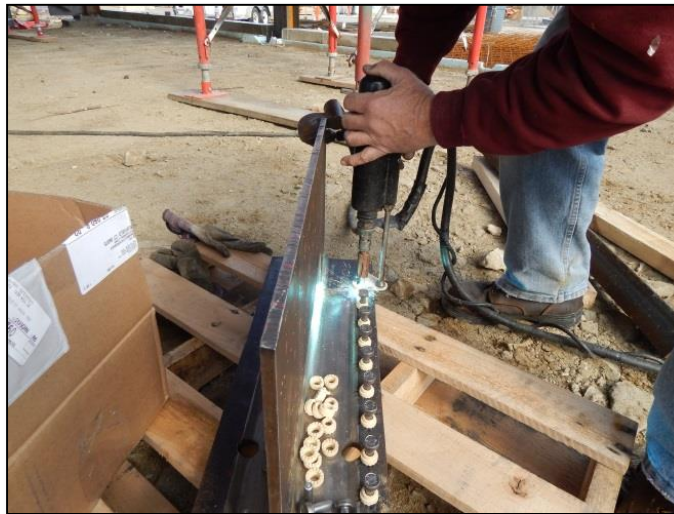
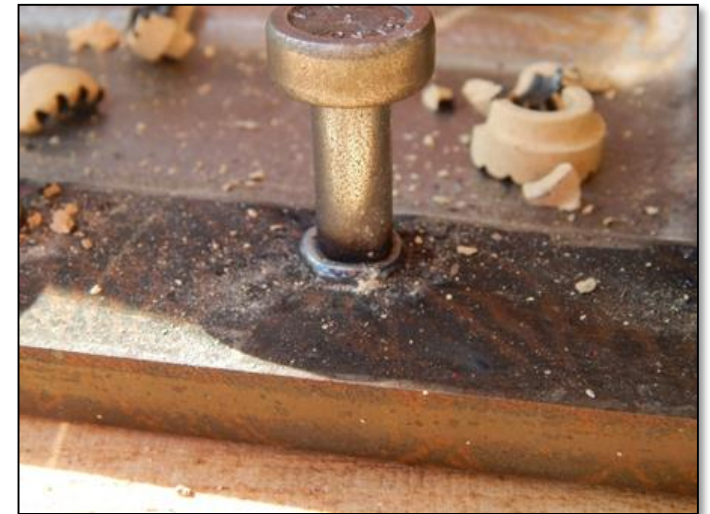
Welding of Shear Studs on the Beam

- Stud welding can be performed using a stud gun
- Studs can be welded in tight spaces, like between stiffeners
- Minimal surface preparation
- They provide a new load path!

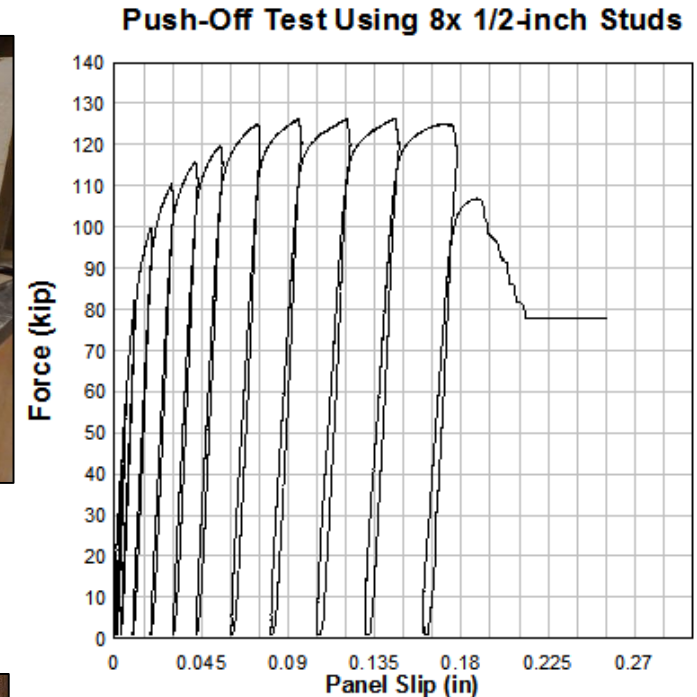
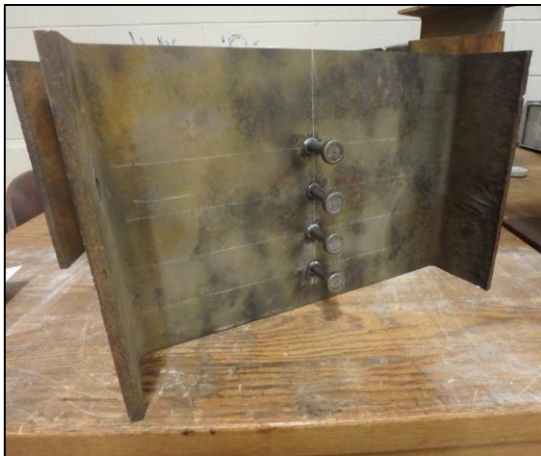
- Experiments performed to study:
 - the stud's shear strength in UHPC
 - Effects of welding on old steel (A7 Steel)
 - Layout, minimum spacing, length
- Observations
 - Capacities are larger than regular concrete
 - Studs shank shear-off after the weld collar
 - Failure is ductile

Stud Capacity, 1/2" Diameter (kip)	
AASHTO LRFD 6.10	12.8
Eurocode 4	10.2
Hegger et al. (2006)	15.0
Luo et al. (2015)	14.7
UConn Experimental	15.8

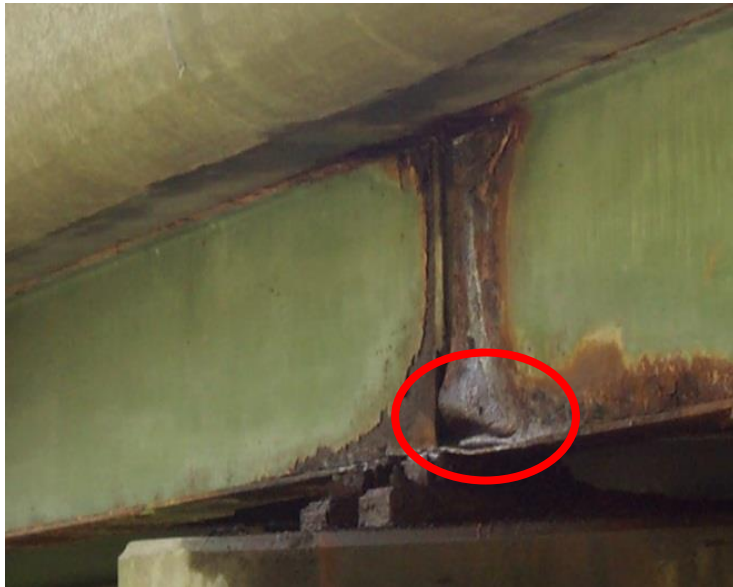
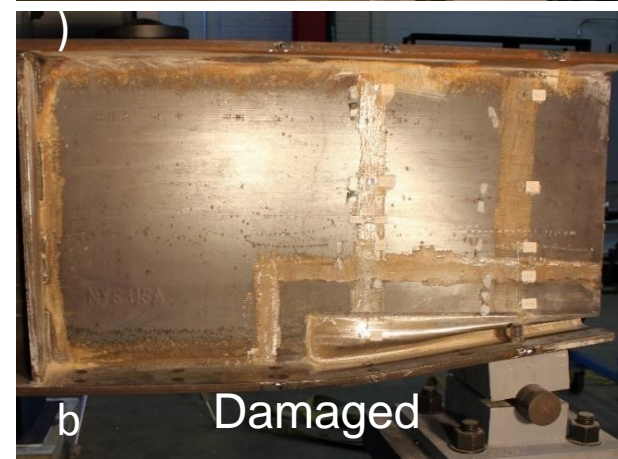
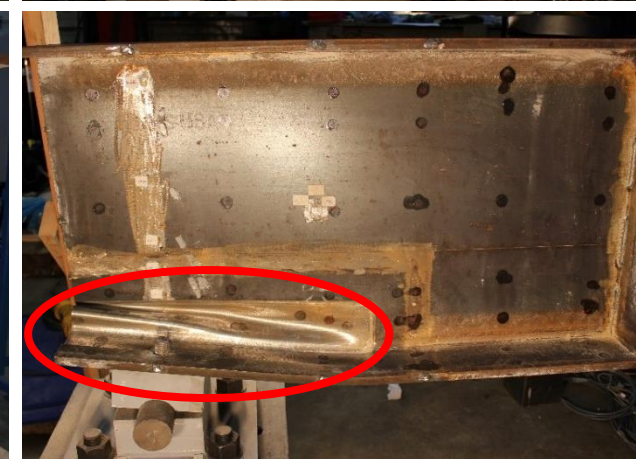
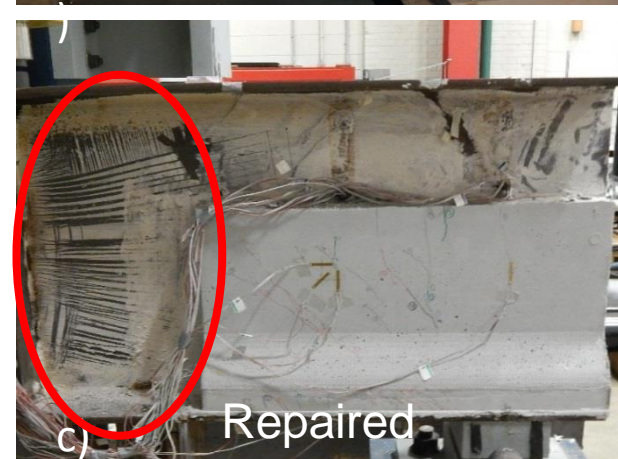
Failure Modes of Rolled Girder

- The undamaged girder failed due to global web buckling
- The damaged girder failed with local buckling of the reduced web section
- The repaired girder did not fail. Flexural yielding controlled the capacity.

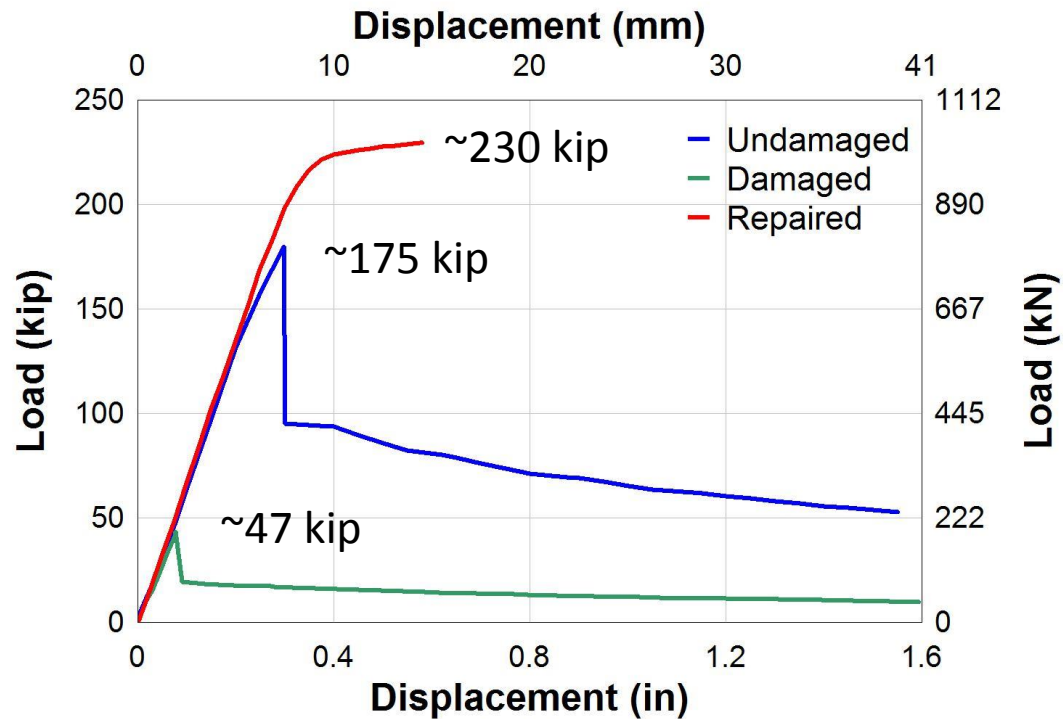
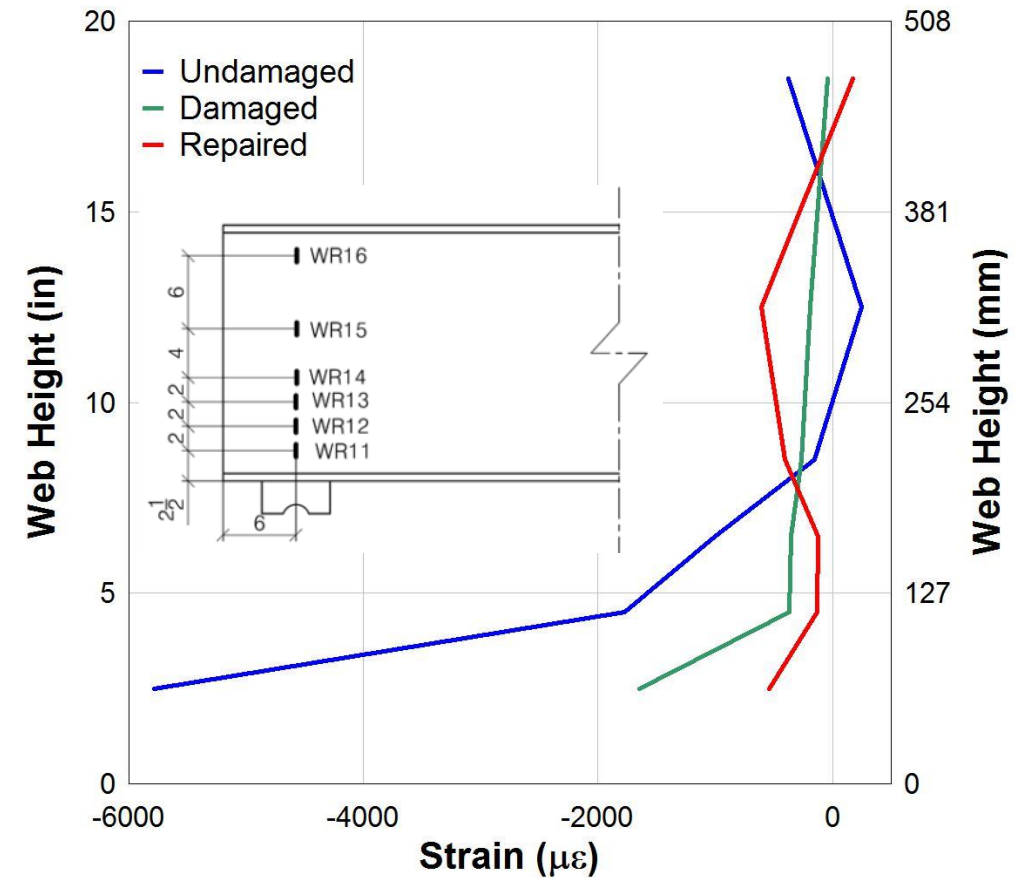
- 70% loss in cross-section \rightarrow 75% reduction of capacity
- The repaired girder capacity was **25% higher** than undamaged

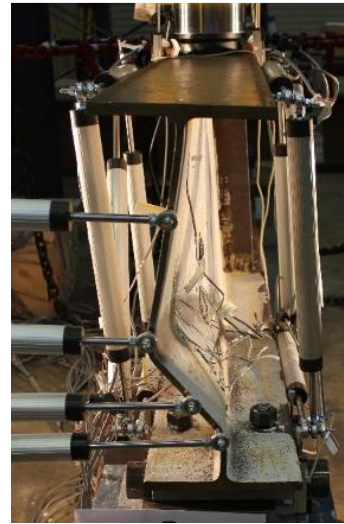
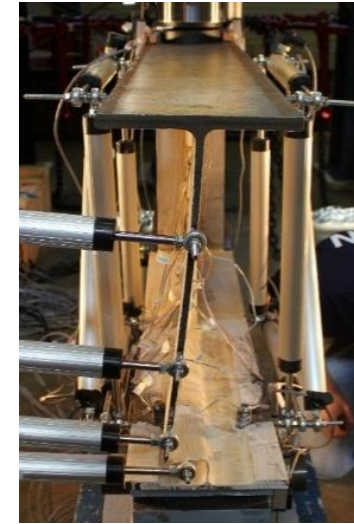
Deformed Shapes of (a) Experimental Undamaged, (b) Experimental Damaged, (c) Experimental Repaired, (d) FE Undamaged, (e) FE Damaged, and (f) FE Repaired Girders.

- LS-Dyna was used for FE simulations
- Good agreement found between the experimental and analytical results
 - Modes of failure
 - Load-displacement relationships
- The modeling methodology will be used to study different geometries
- It enables development of standard details or customized designs

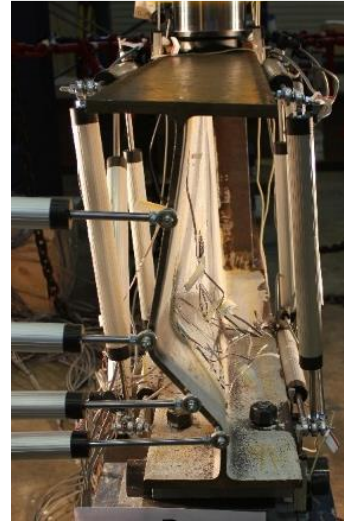
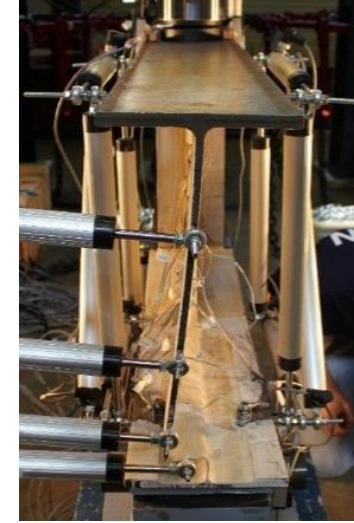
Deformed Shapes of (a) Experimental Undamaged, (b) Experimental Damaged, (c) Experimental Repaired, (d) FE Undamaged, (e) FE Damaged, and (f) FE Repaired Girders.
