# Swift Island Historic Arch Bridge Rehabilitation and Widening Feasibility Study

John Sloan, PE

**AECOM**

April 2018

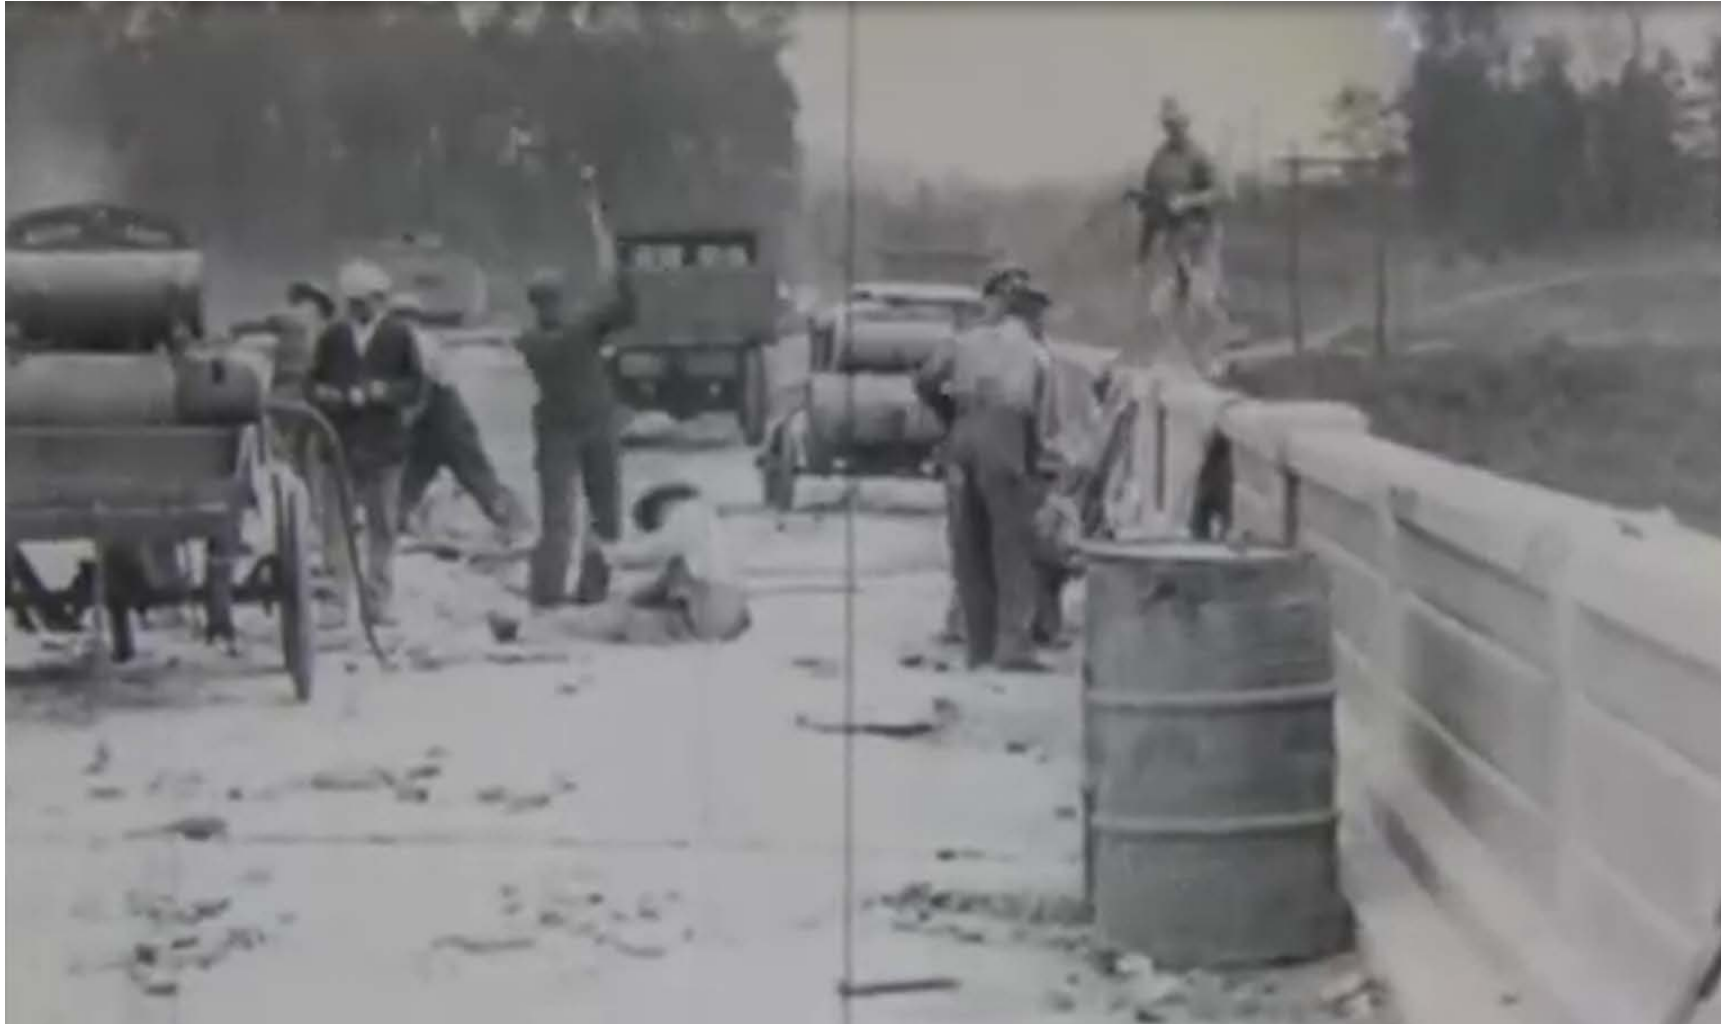
“In the second phase the floor was cut through so that the action of the free arch could be studied”

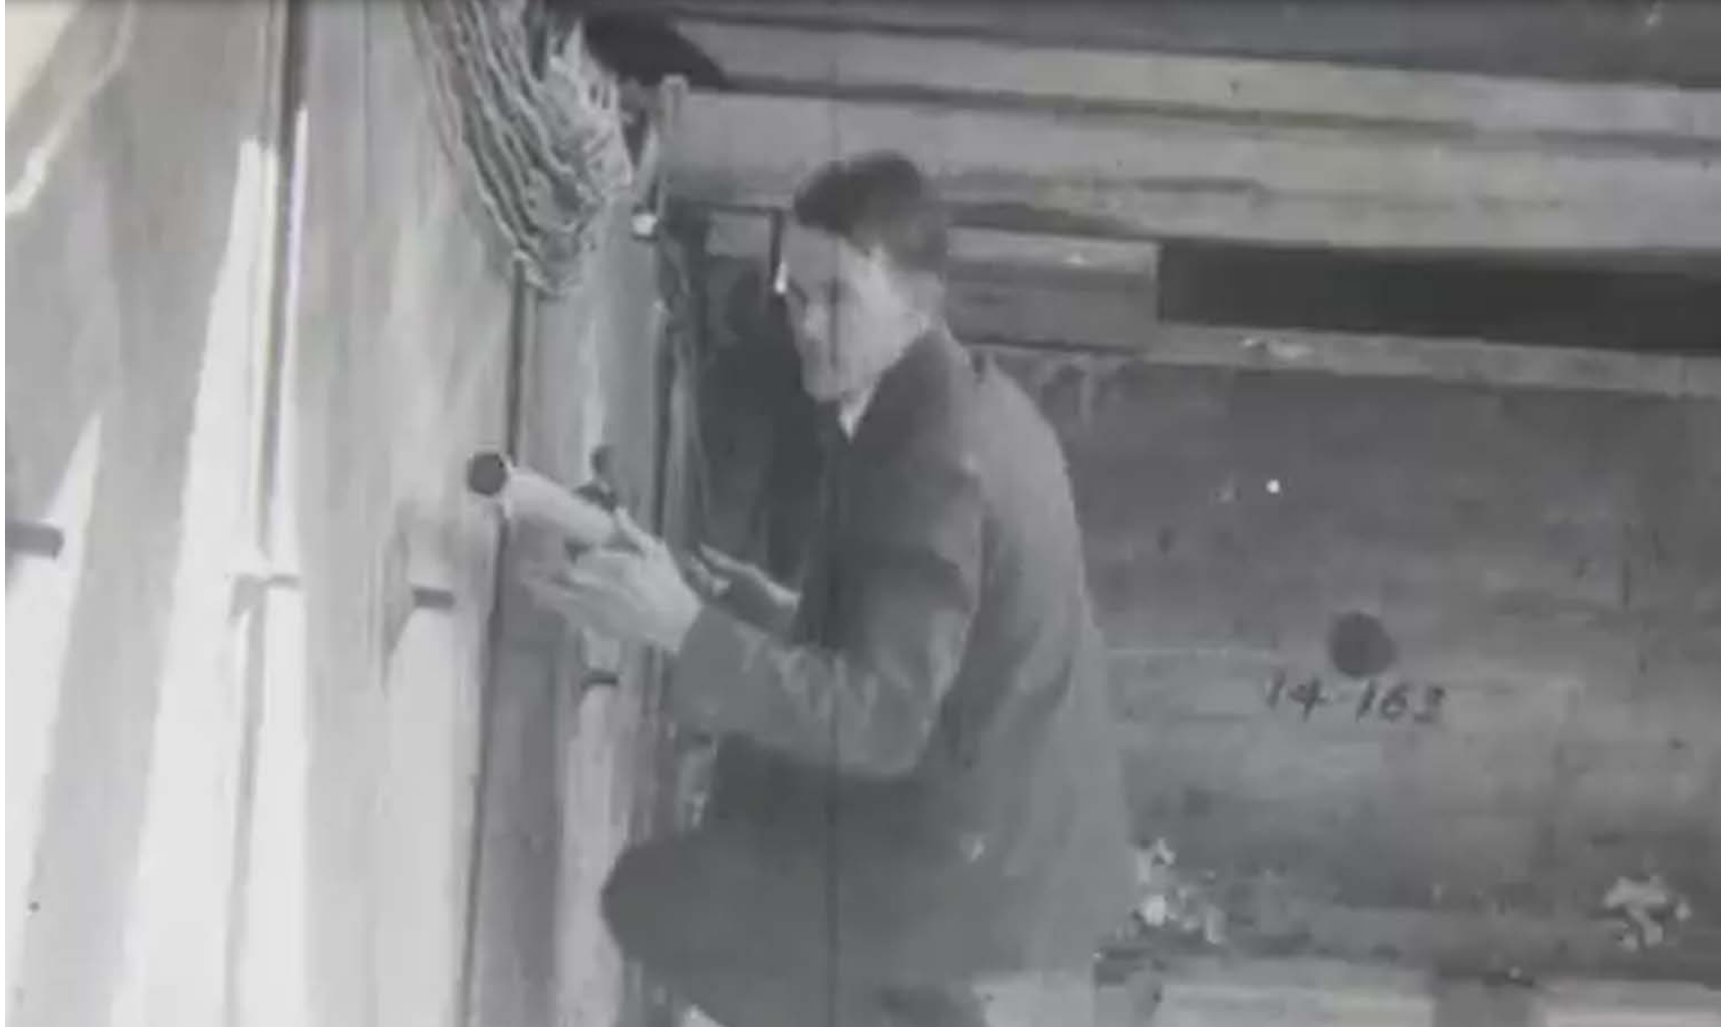
“changes in the shape of the arch rib were measured with a radius meter”

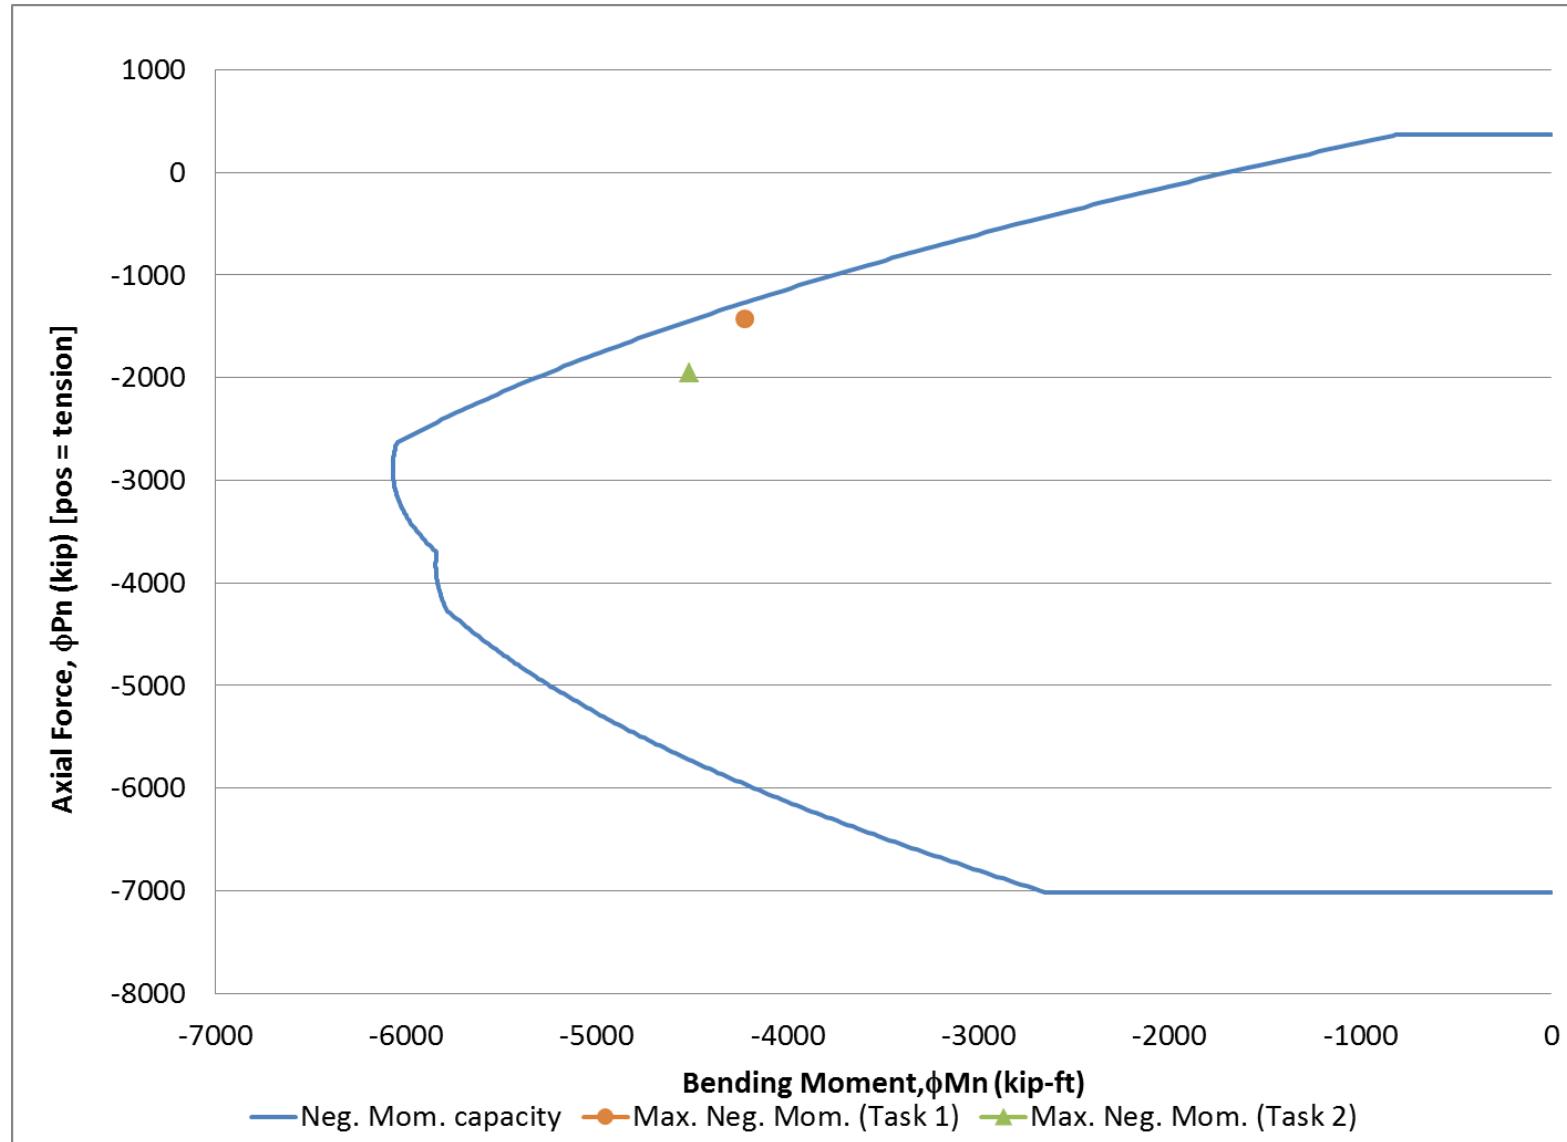
# Arch Rib Interaction Diagram at the Springline

- The proposed superstructure has a significantly higher inertia over the existing. In combination with relatively soft bearings, this helps relieve demands on the arch ribs.
- The dead load of the proposed superstructure is also significantly higher than the existing. This can be beneficial if the load is applied without inducing flexural demands since the arch rib is a compression member.
- Expansion joints at 1/3 points within each arch span were eliminated, which provided significant benefit for positive bending of the arches in these locations.
- Temperature fall causes significant negative moments at the arch rib springlines.

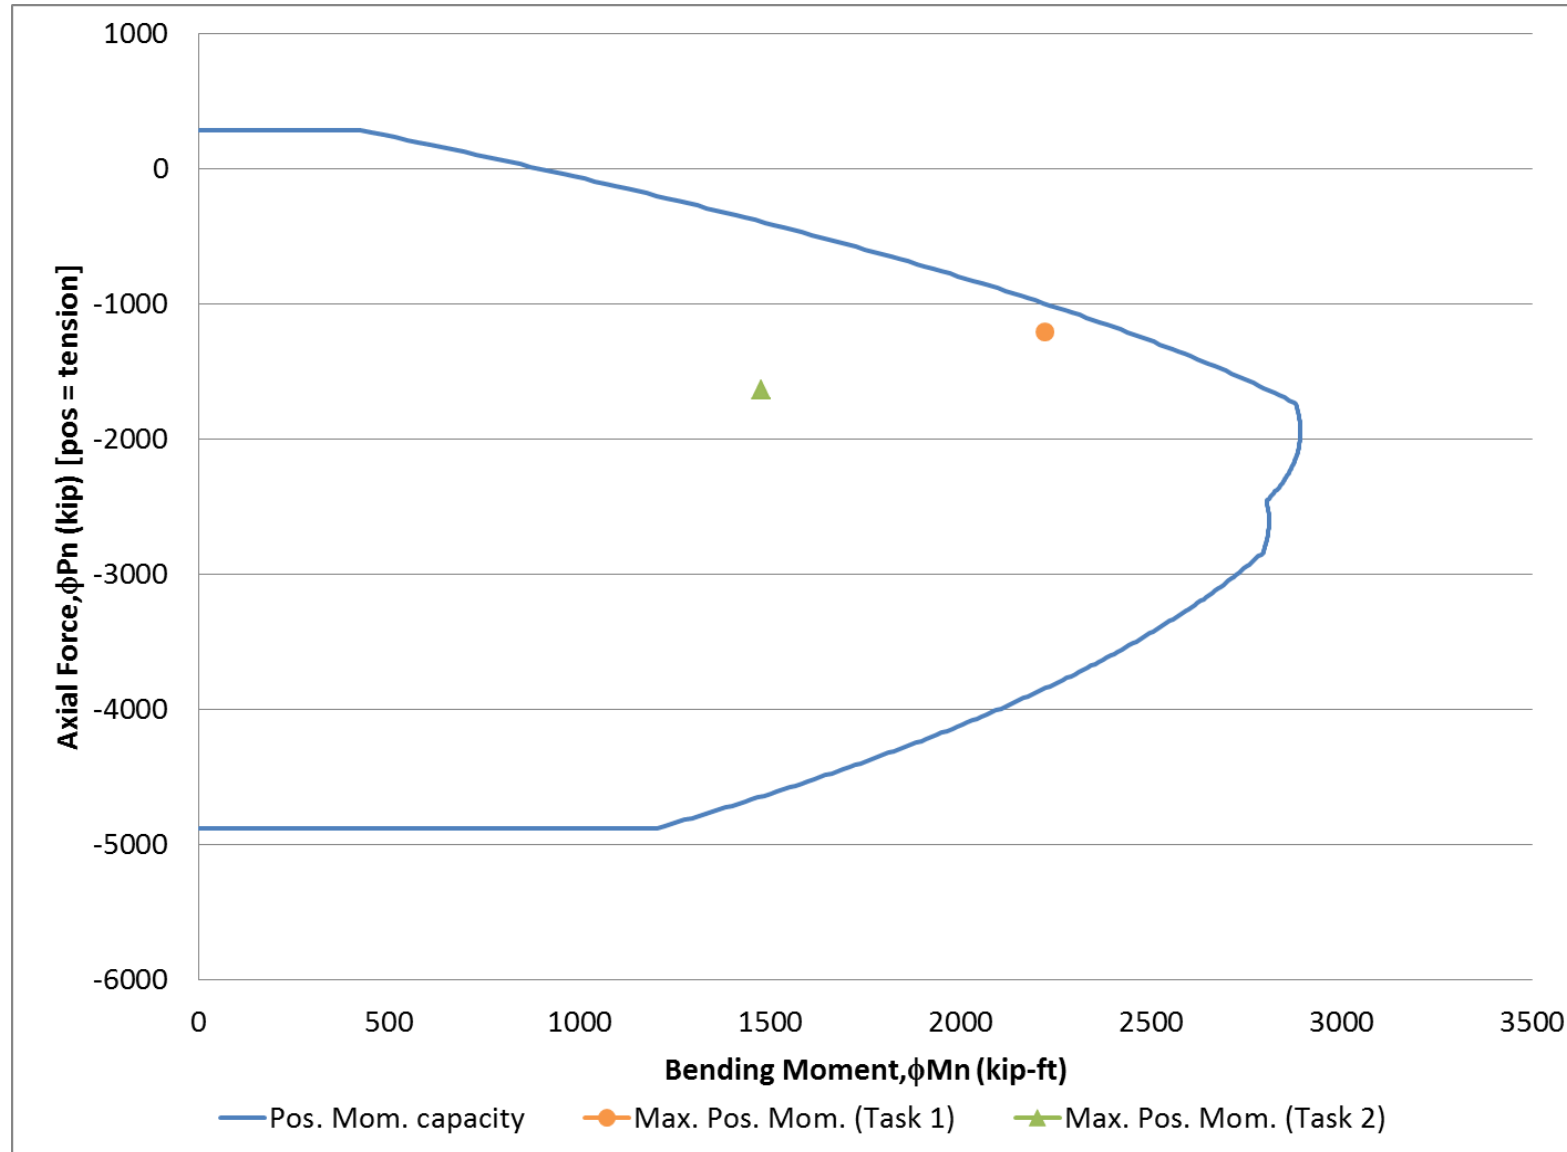
# Arch Rib Interaction Diagram at 1/3 Span Exp. Joint

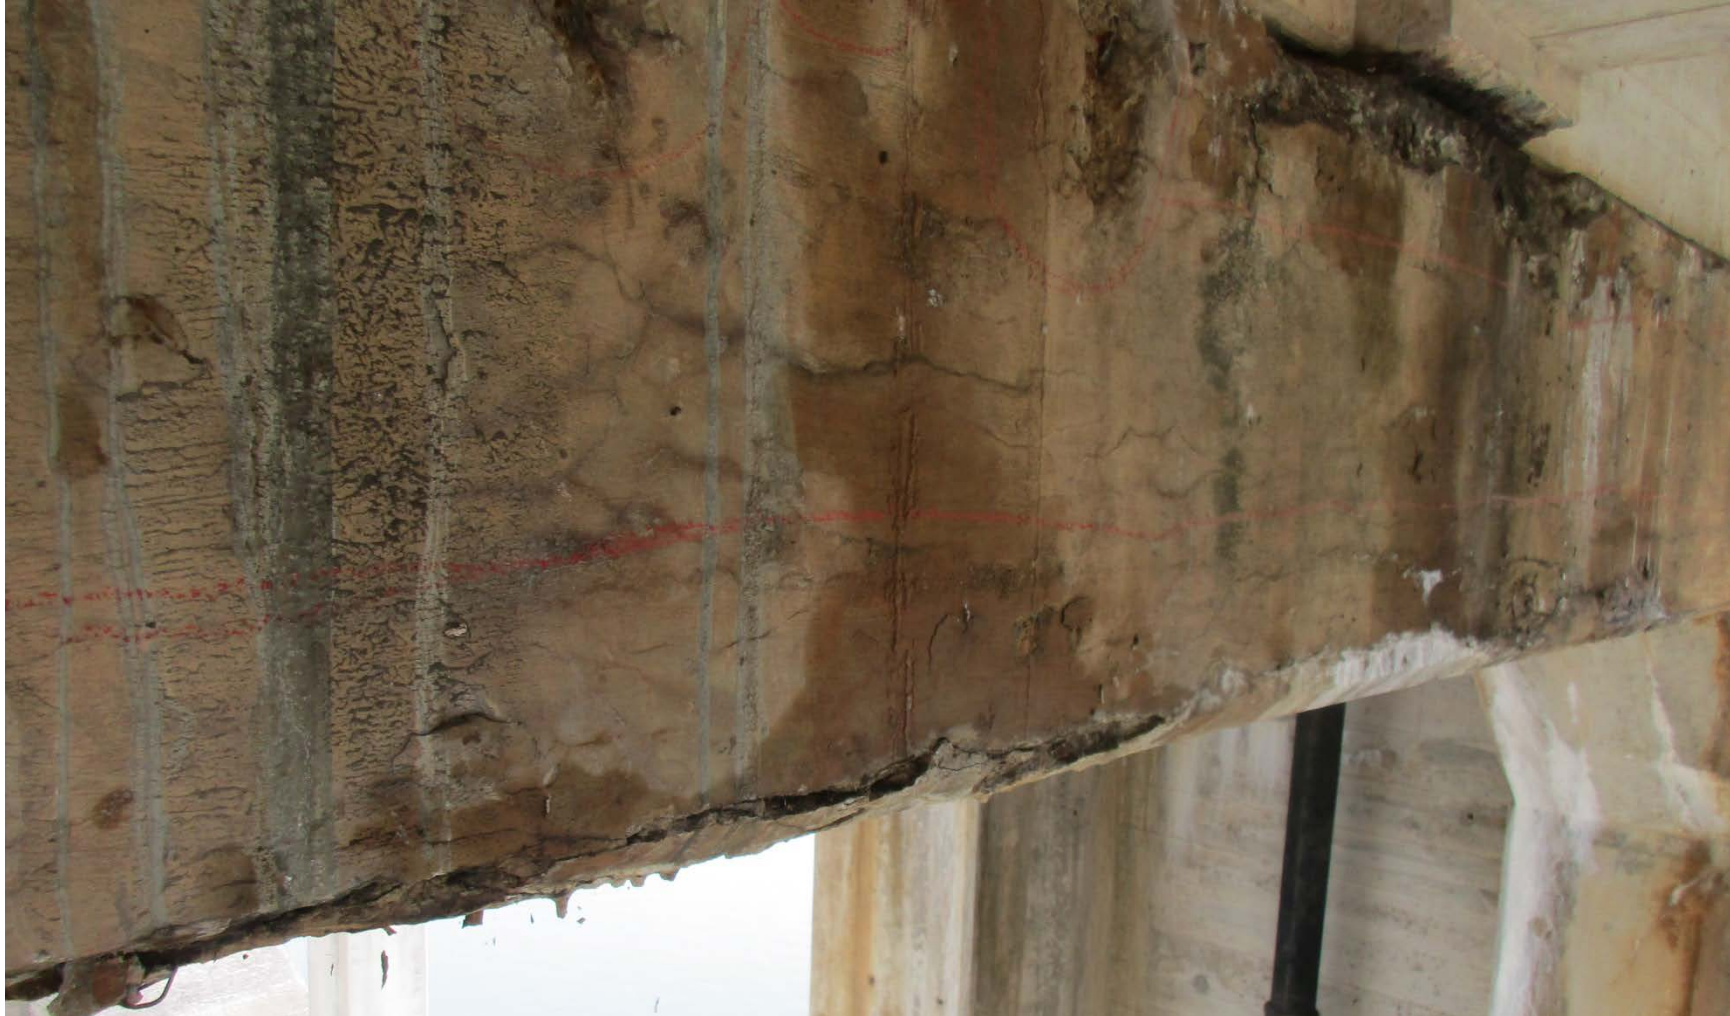
## Inspection Results – Arch Piers

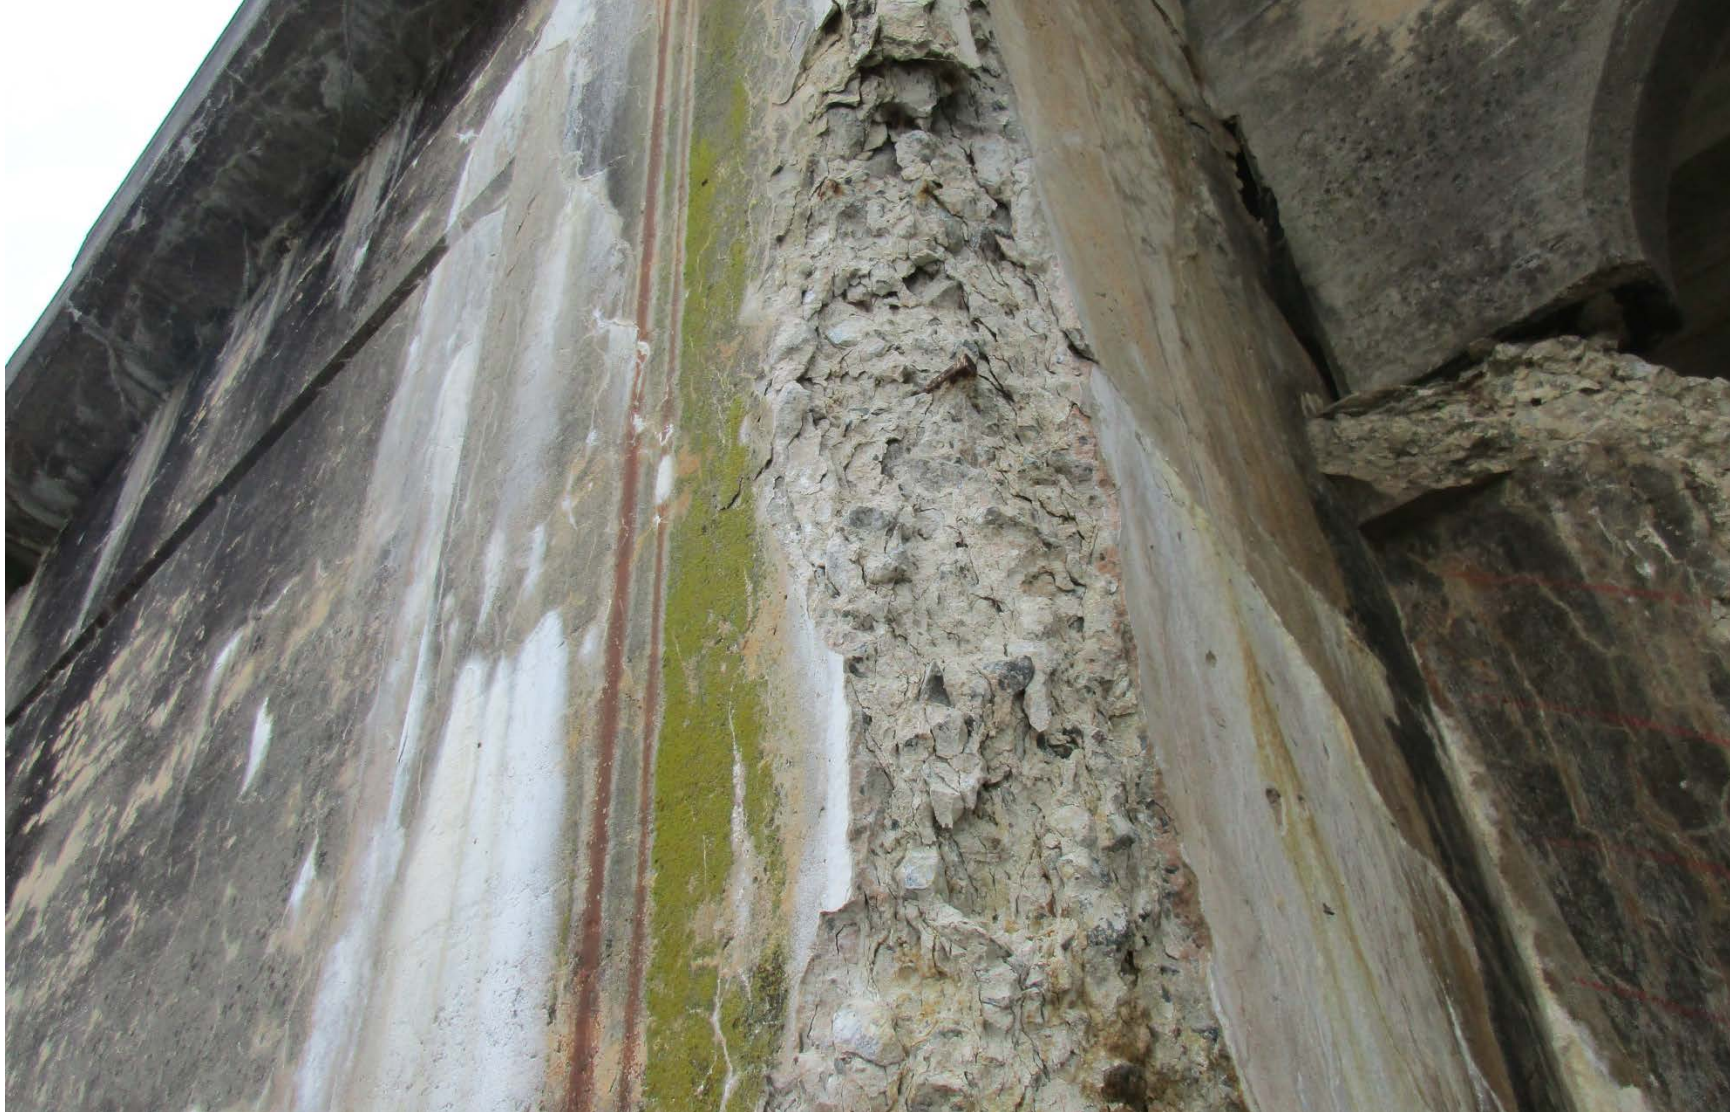
## Inspection Results – Arch Piers

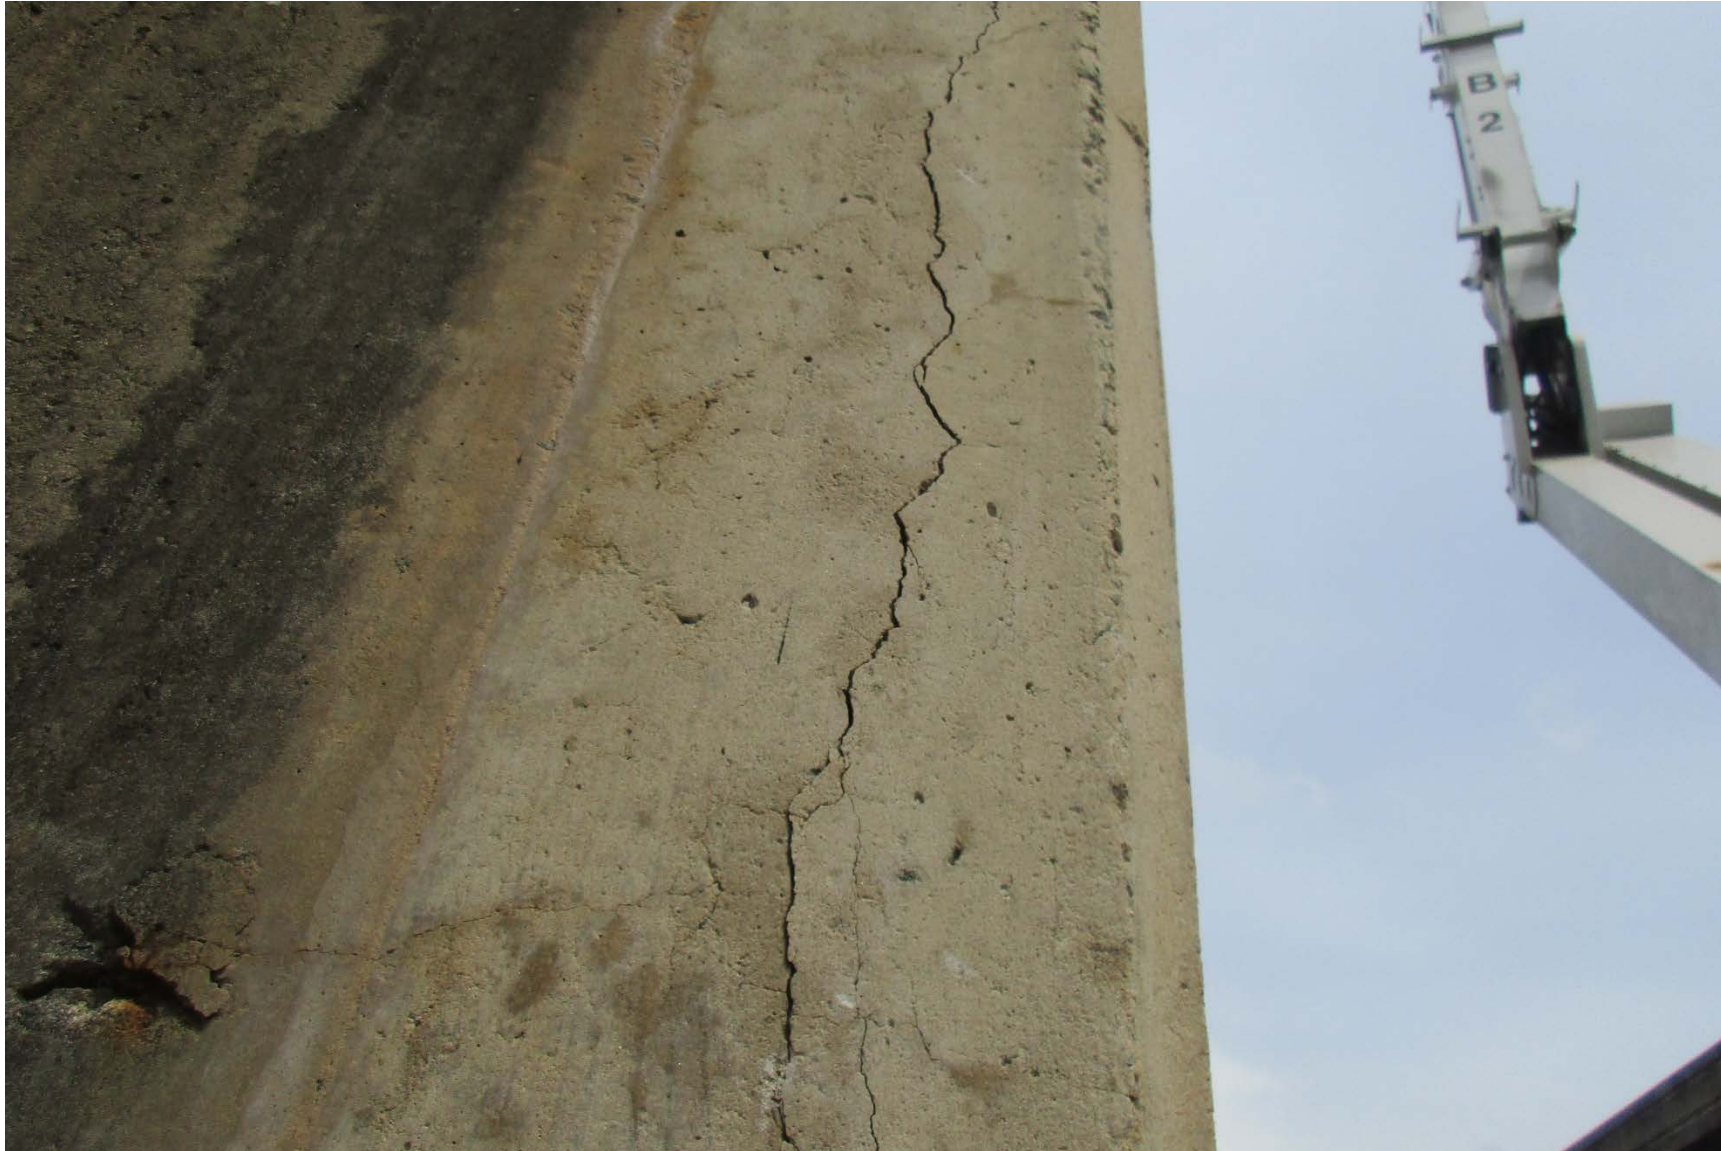
## Progression of Deterioration – Crack

- Eliminate as many joints as reasonably possible. Maintain & replace joints regularly if they can't be eliminated.
- Document every defect with a photo and a sketch during inspection. This benefits quantity calculations for repair material and service life analysis.
- Cracks parallel to a corner indicate corrosion has initiated in the longitudinal reinforcement. Crack injection is not the appropriate repair methodology.
- Concrete Jacket repair at the waterline.
- Replace piers down to the arch rib springline.

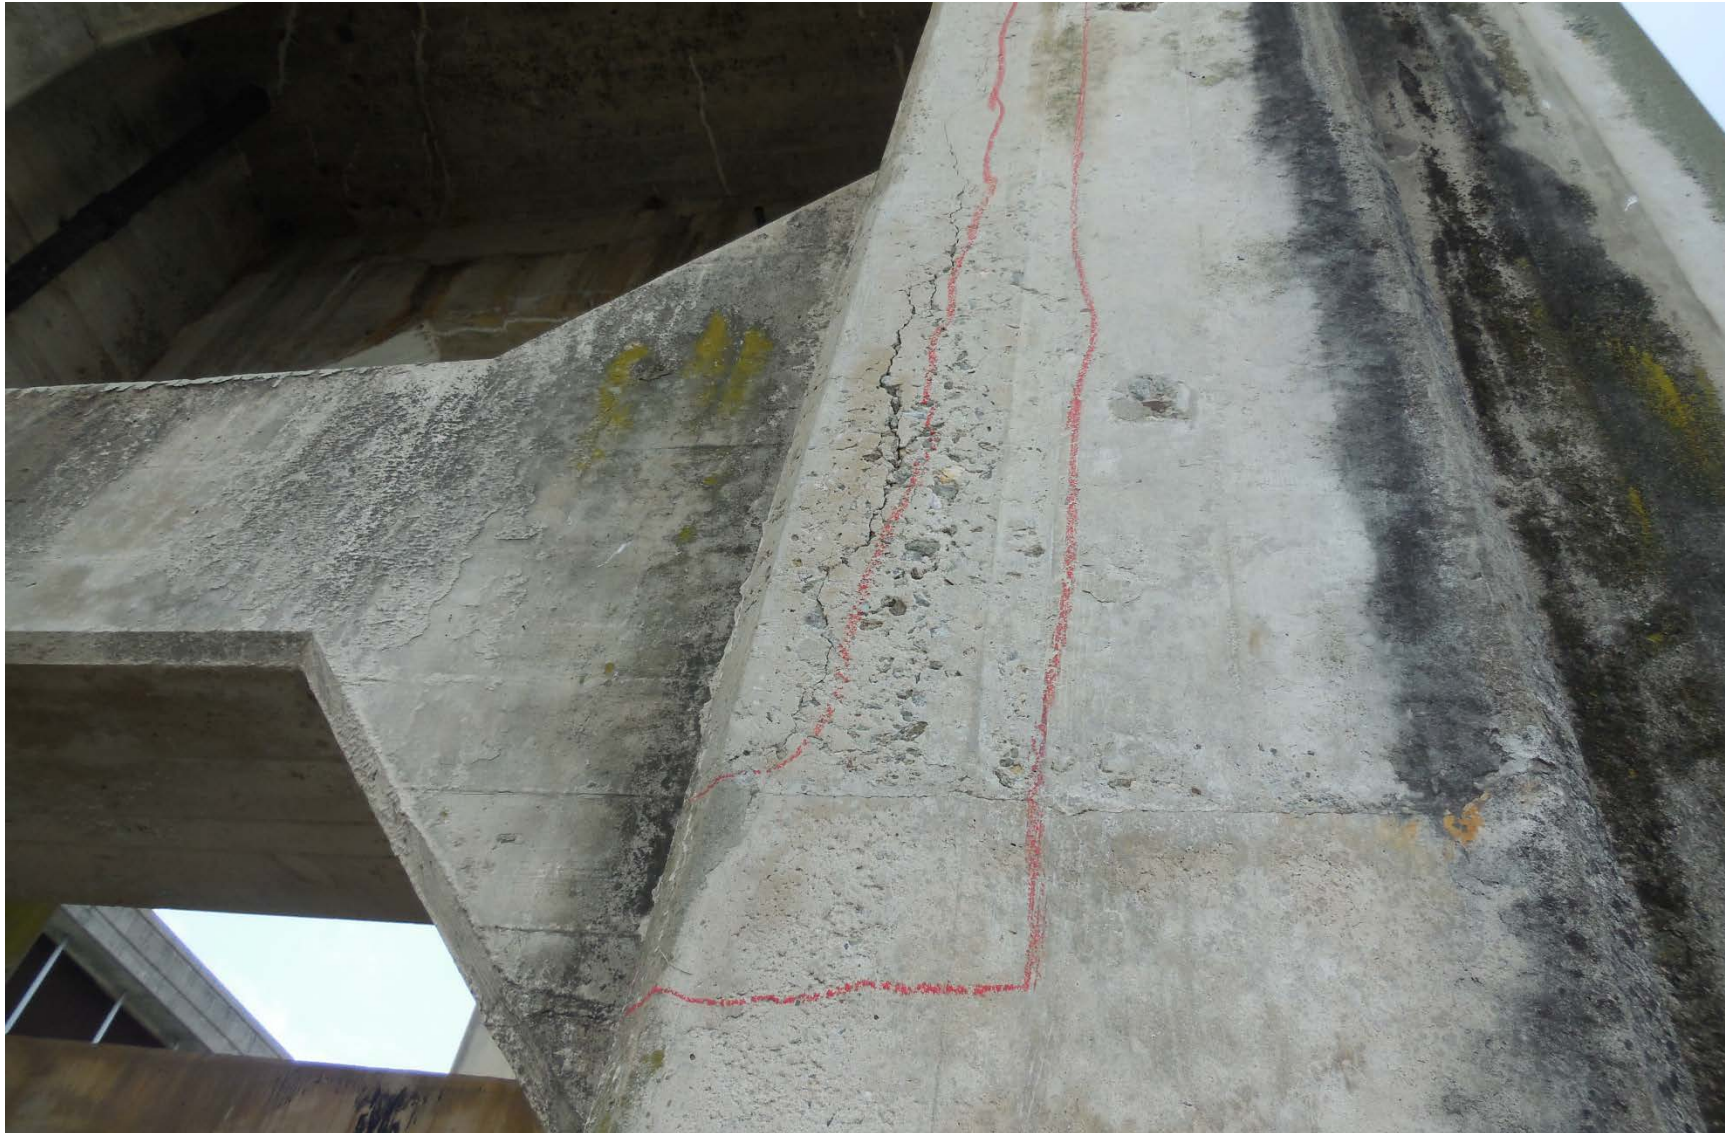
## Progression of Deterioration – Delamination

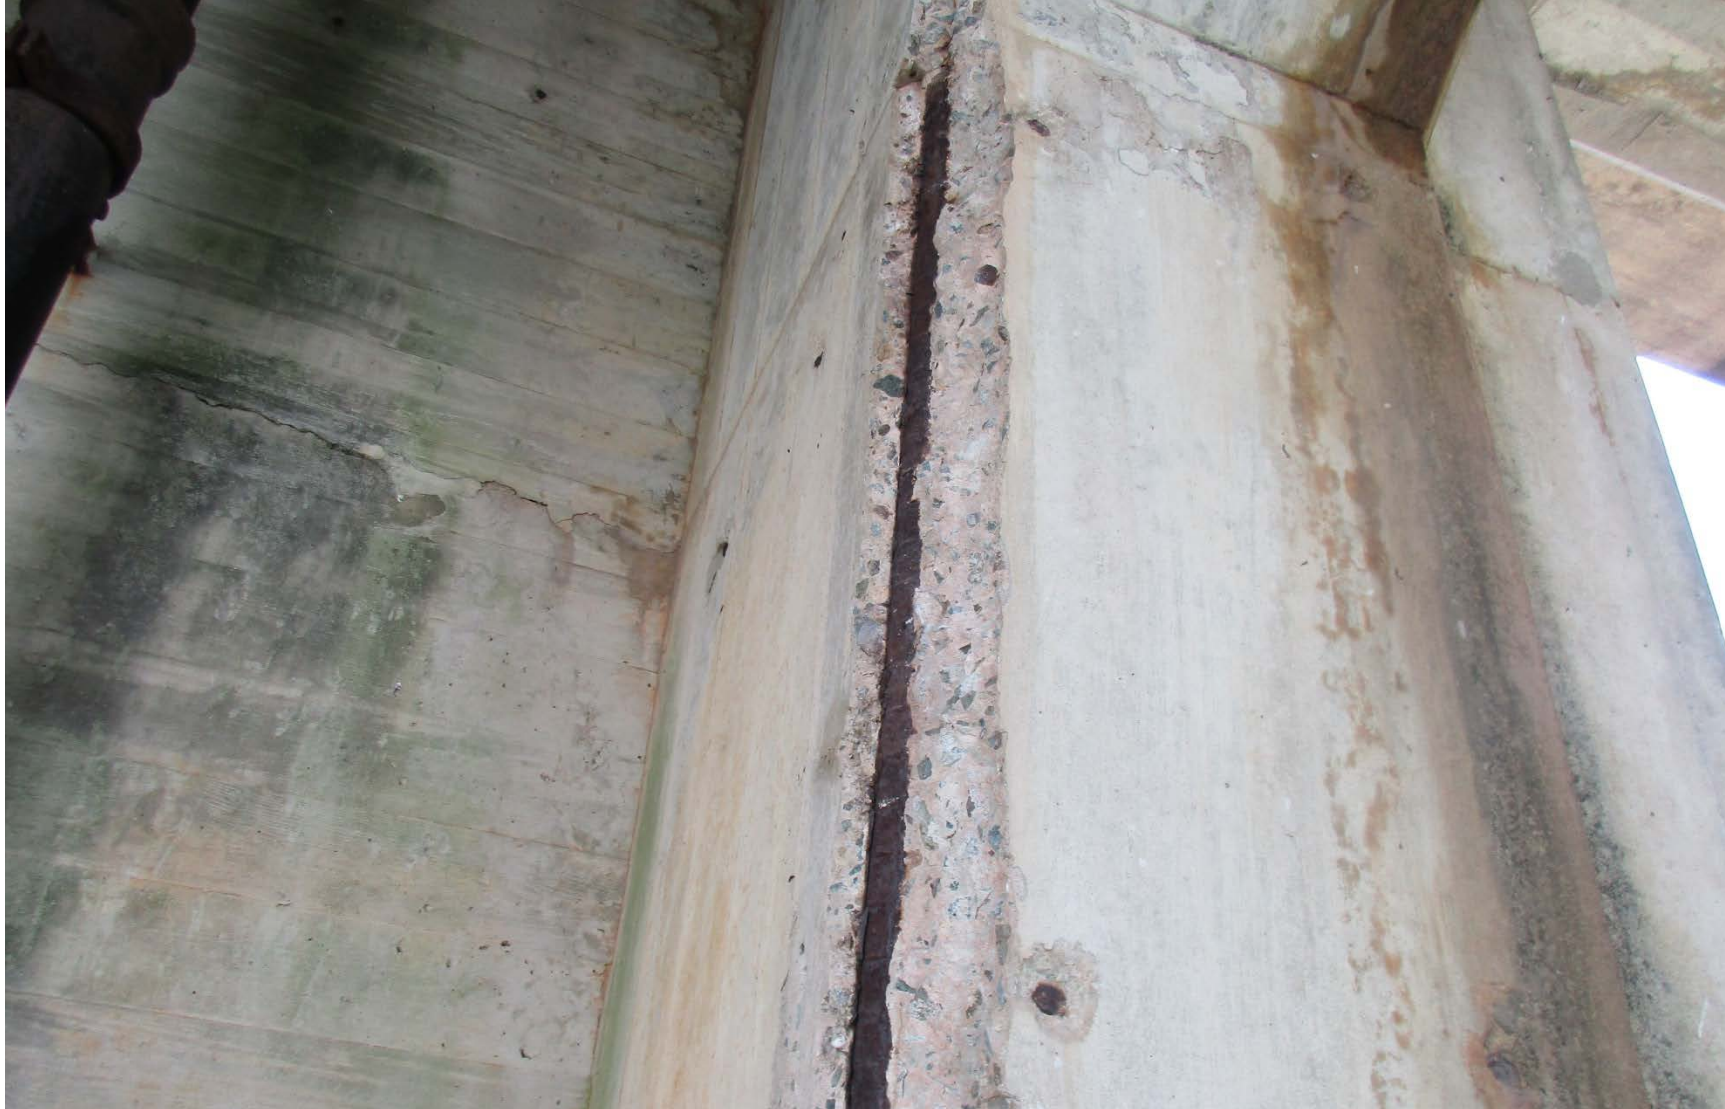
## Progression of Deterioration – Spall

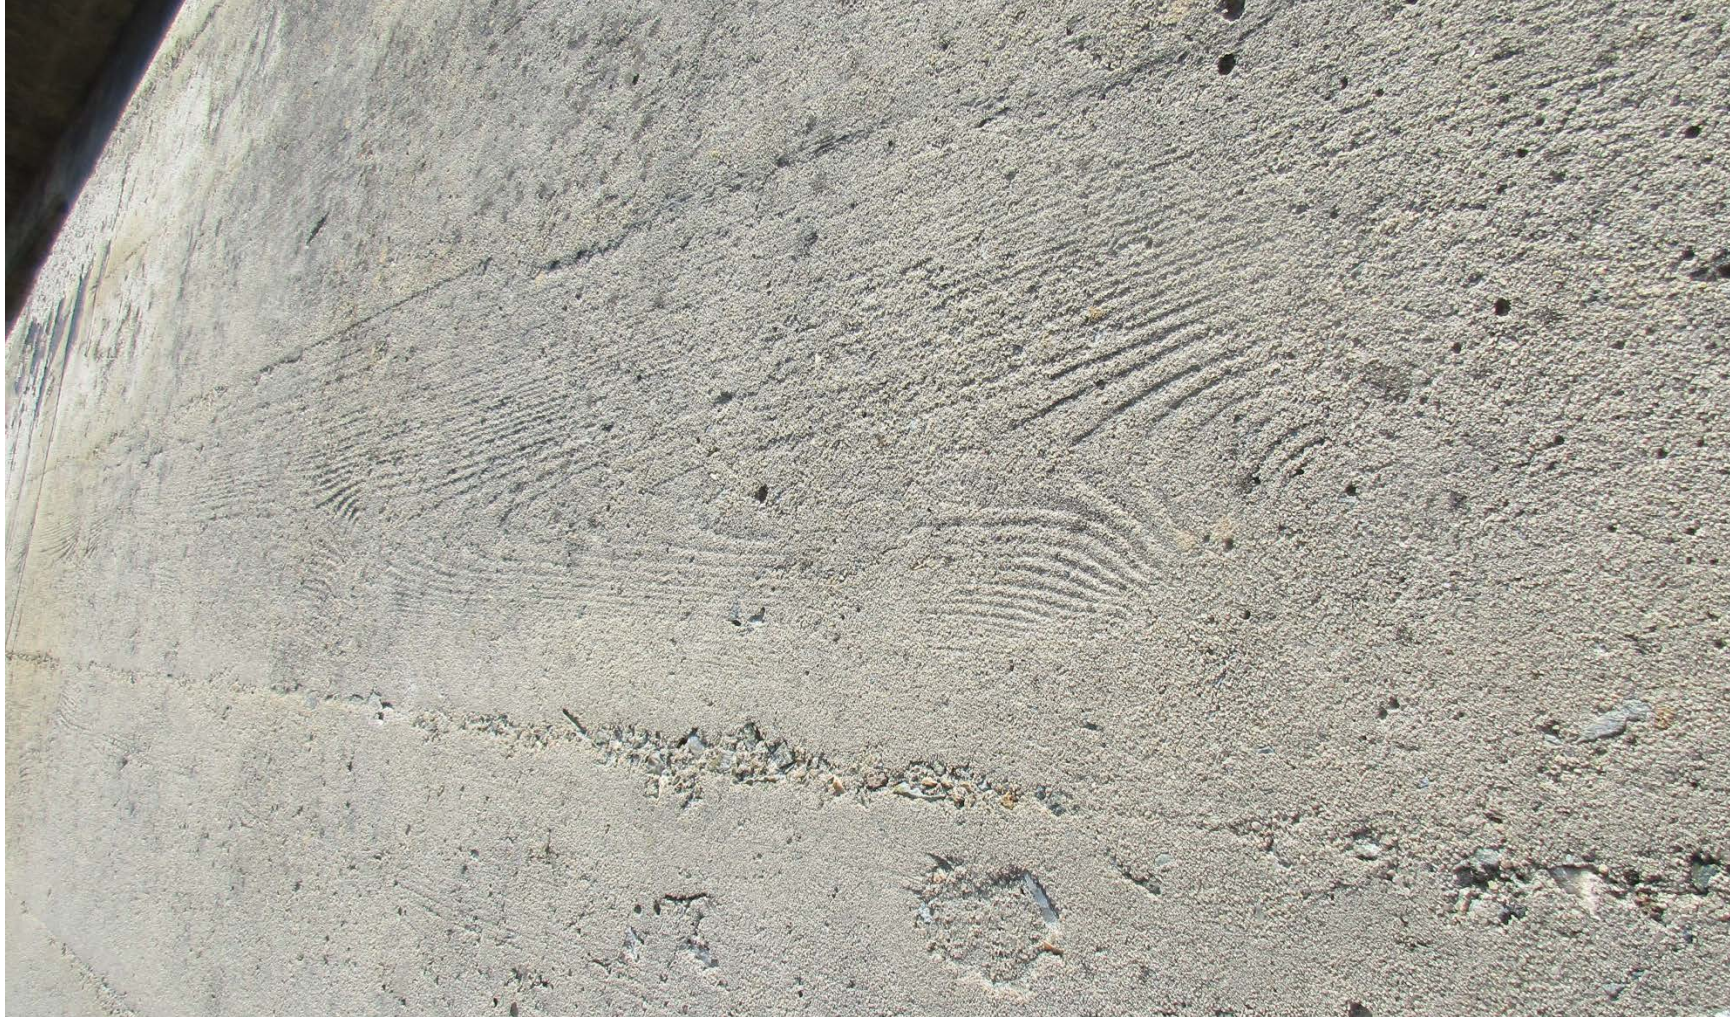
# Inspection Results – Arch Ribs

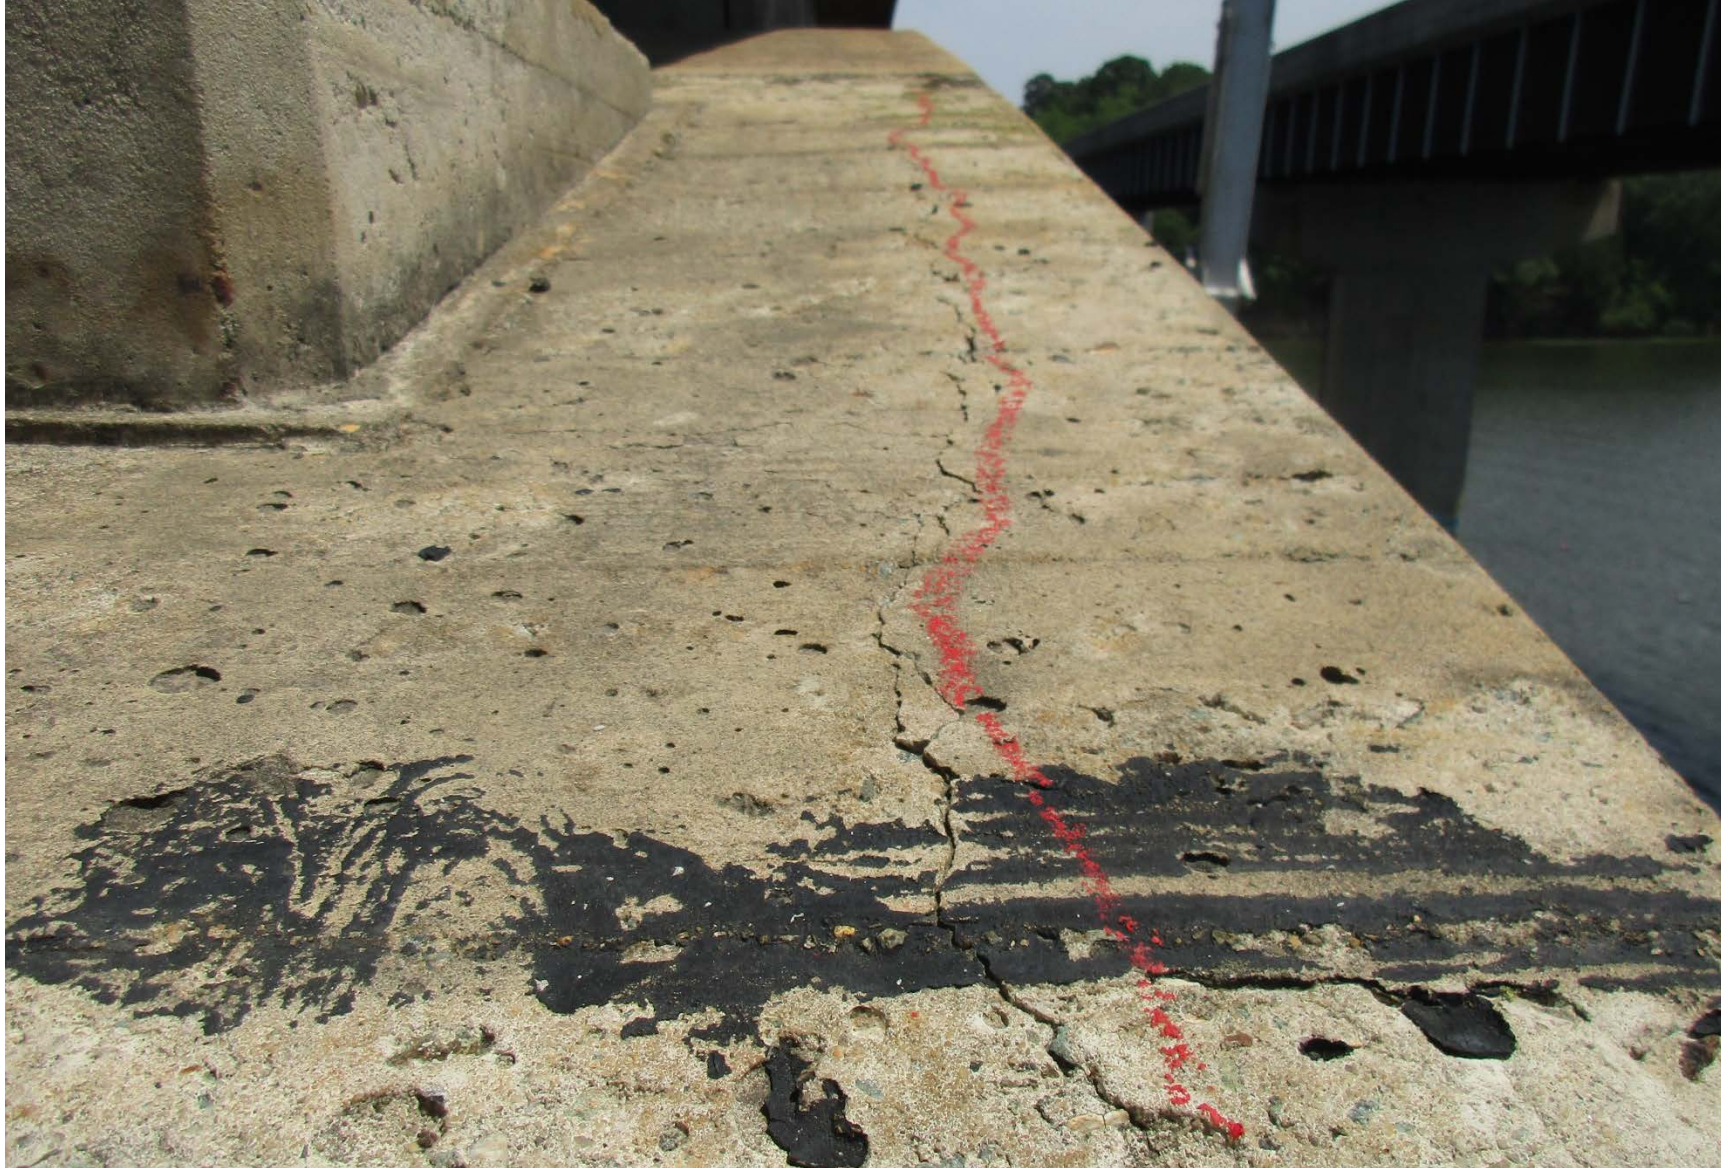
## Deck Expansion Joints at 1/3 of the Arch Span

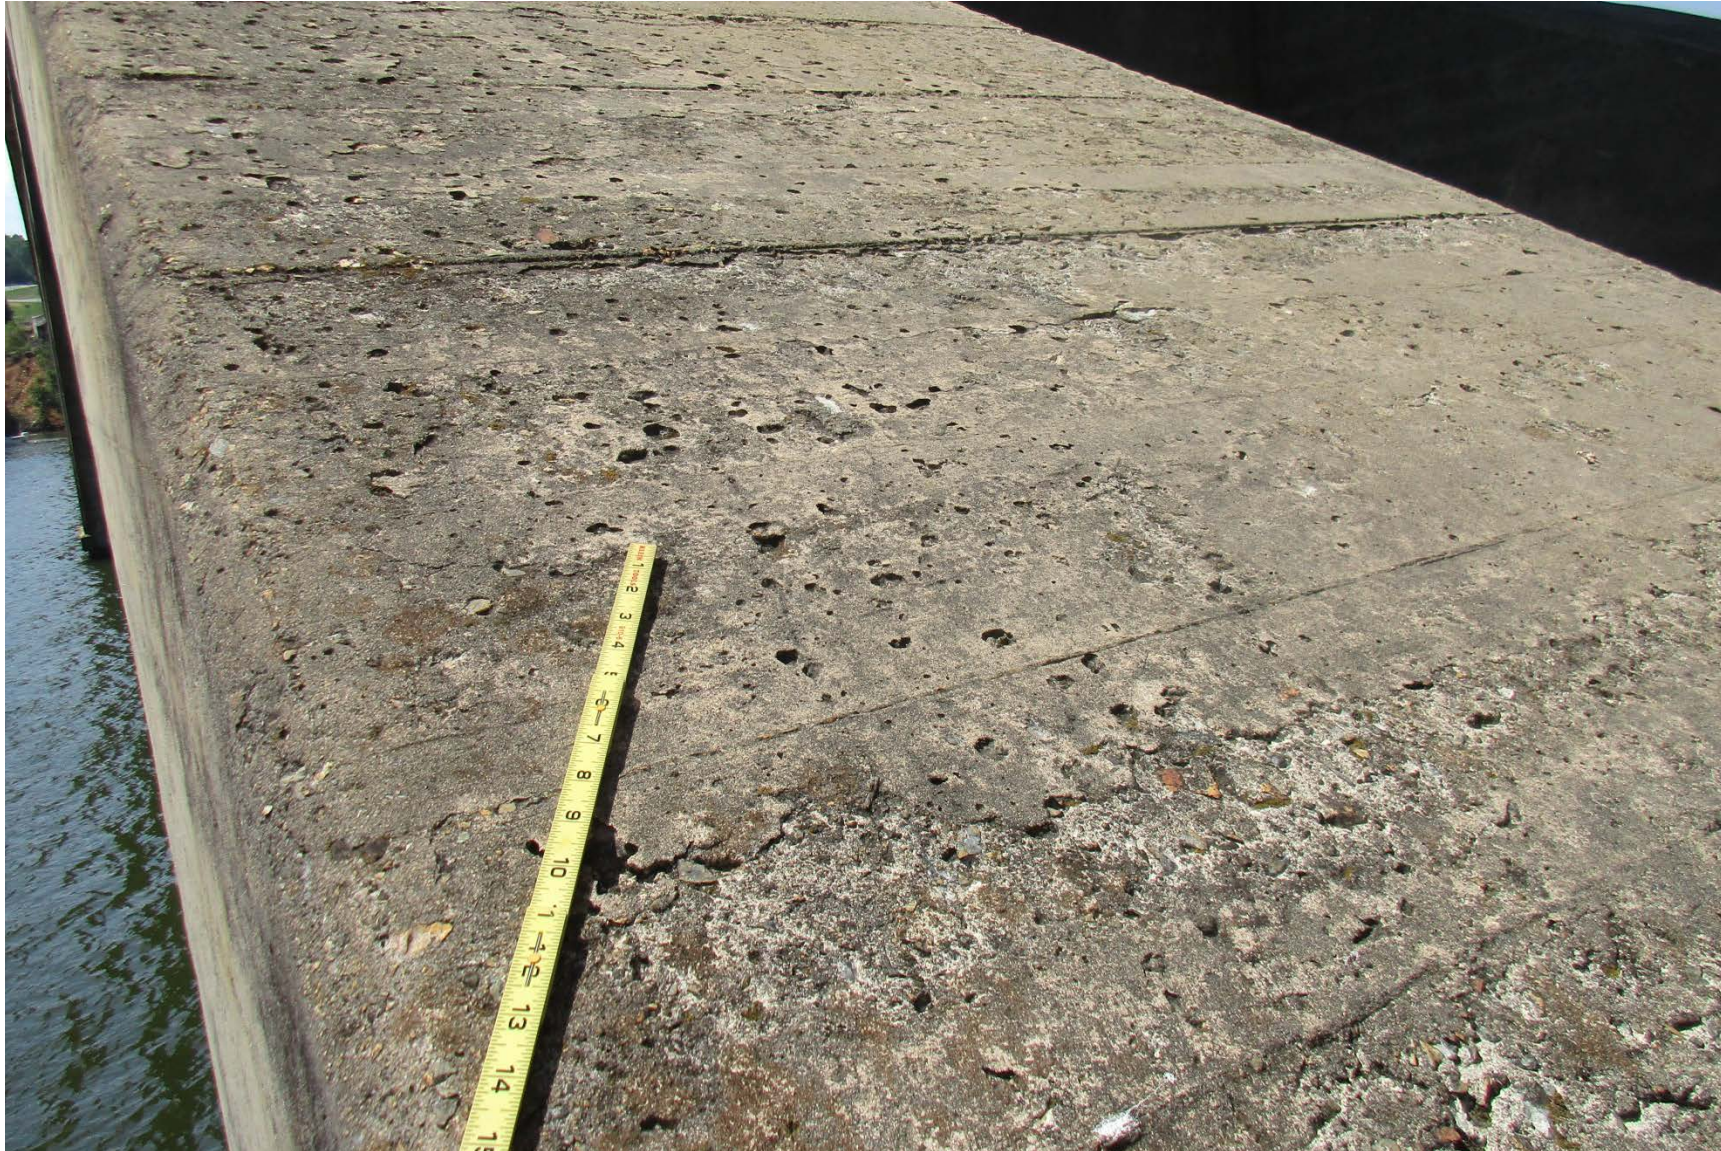
## Scaling at the Top of the Arch Rib near the Springline
