WALLOPS ISLAND CAUSEWAY BRIDGE OVER CAT CREEK

NASA 1(3)
Edward Kluckowski – Freyssinet, Inc.
April 9, 2018

Project Description

NATIONAL BRIDGE PRESERVATION PARTNERSHIP CONFERENCE 2018

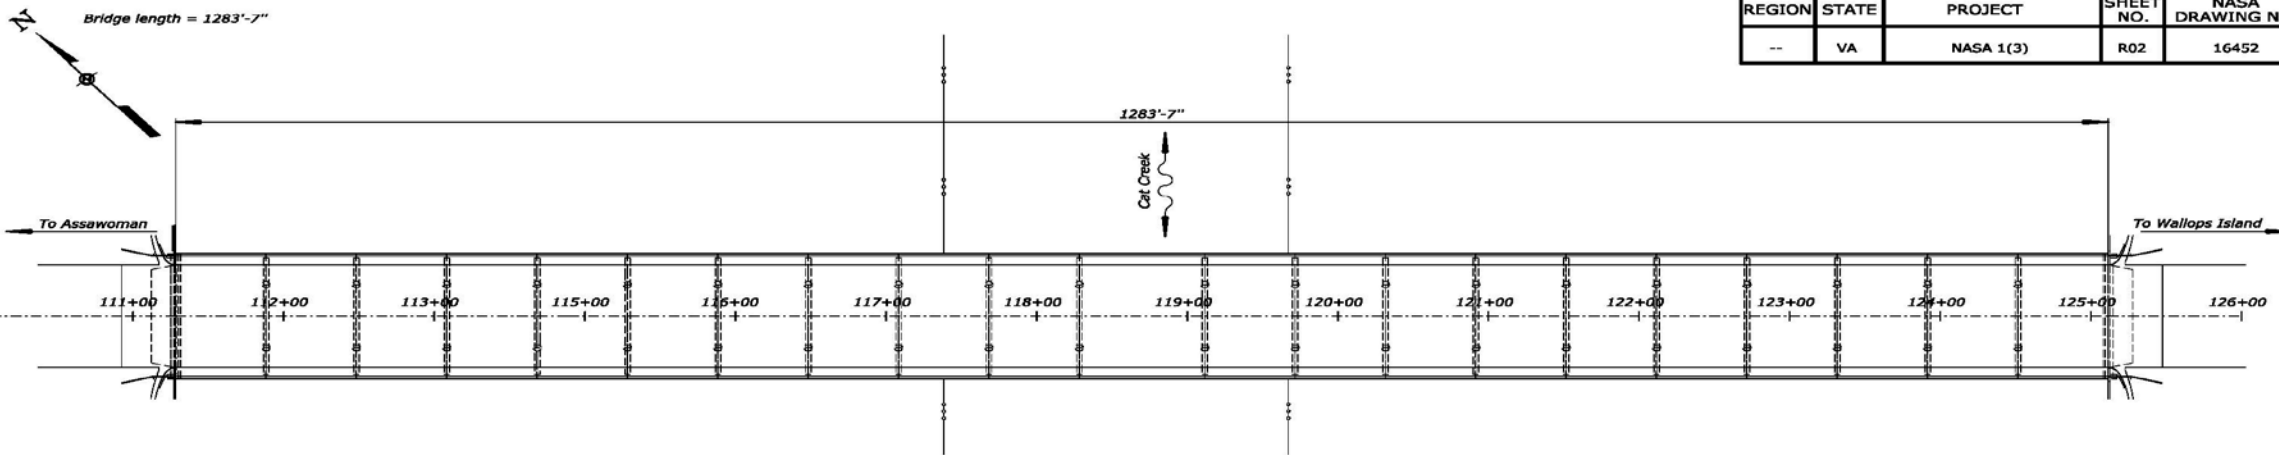
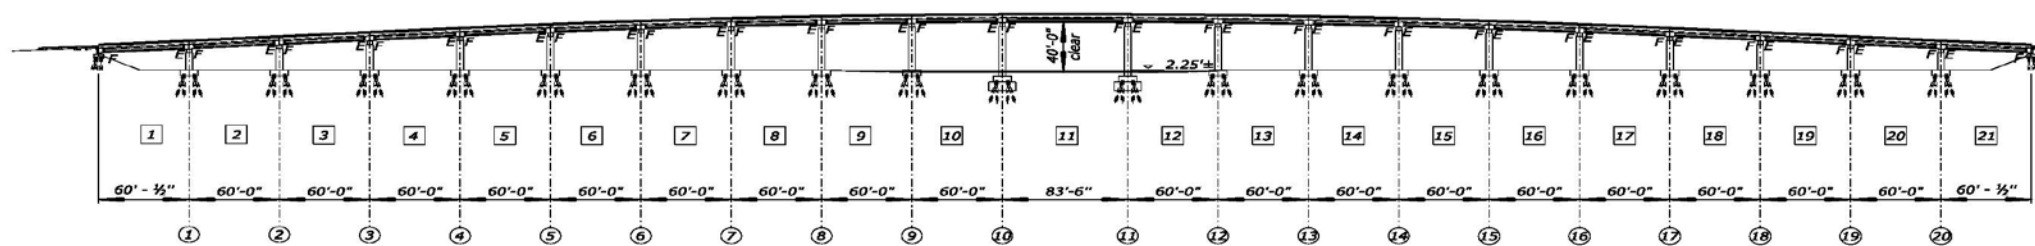
PLAN AND ELEVATION

PLAN

ELEVATION

KEY
 E = Expansion
 F = Fixed
 ⊕ = Ⓞ Pier #
 # = Span number

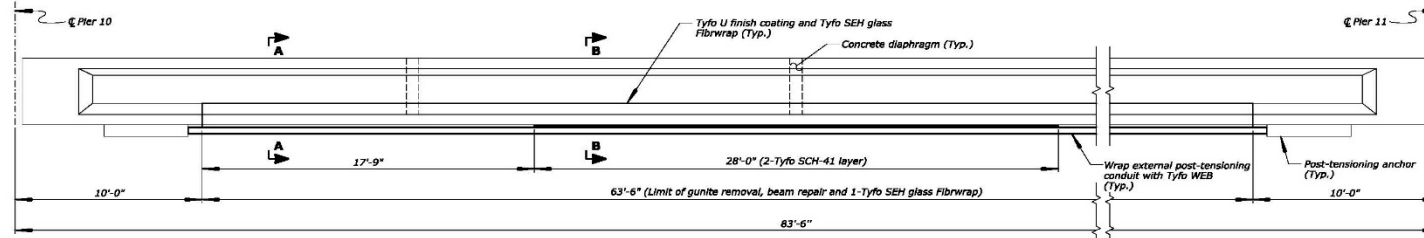
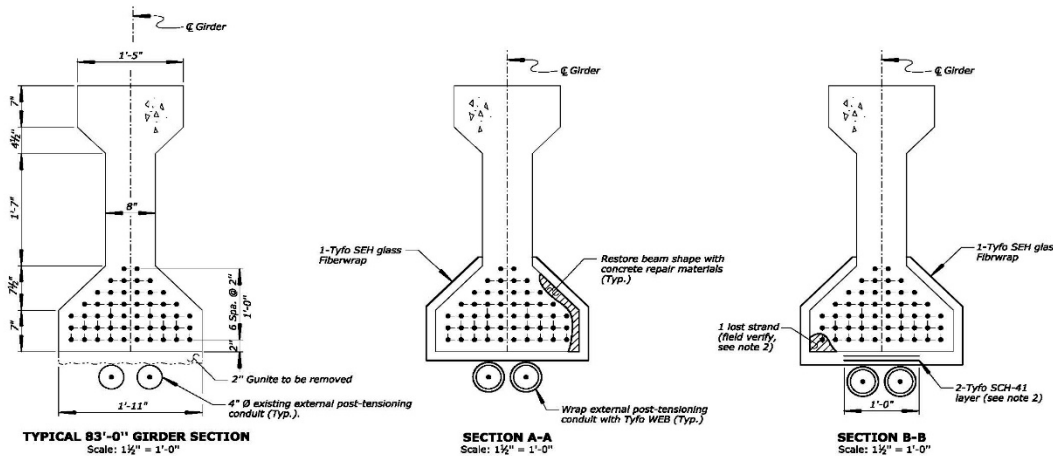
**SPAN 11 - PRESTRESSED BEAM
 REPAIR DETAILS**

SPAN 11 - GIRDER ELEVATION
Not to scale

TYPICAL 83'-0" GIRDER SECTION
Scale: 1 1/2" = 1'-0"

SECTION A-A
Scale: 1 1/2" = 1'-0"

SECTION B-B
Scale: 1 1/2" = 1'-0"

- All beams in Span 11 are to be repaired.
- Manufacturer to verify number of Tyfo SCH-41 layers. If additional strands are deteriorated, notify the CO. When determining Tyfo SCH-41 layers, external post-tensioned strands are not considered in the calculation.
- Existing prestressed concrete compressive strength $f_c = 5,000$ psi.
- Existing prestressing strand is $\frac{7}{8}$ " \emptyset , seven wire, stress relieved, $f_{pu} = 250$ ksi.
- Existing reinforcing steel is Grade 40.
- Existing external post-tensioning strands are 2-0.6" \emptyset , seven wire, low relaxation, $f_{pu} = 270$ ksi.

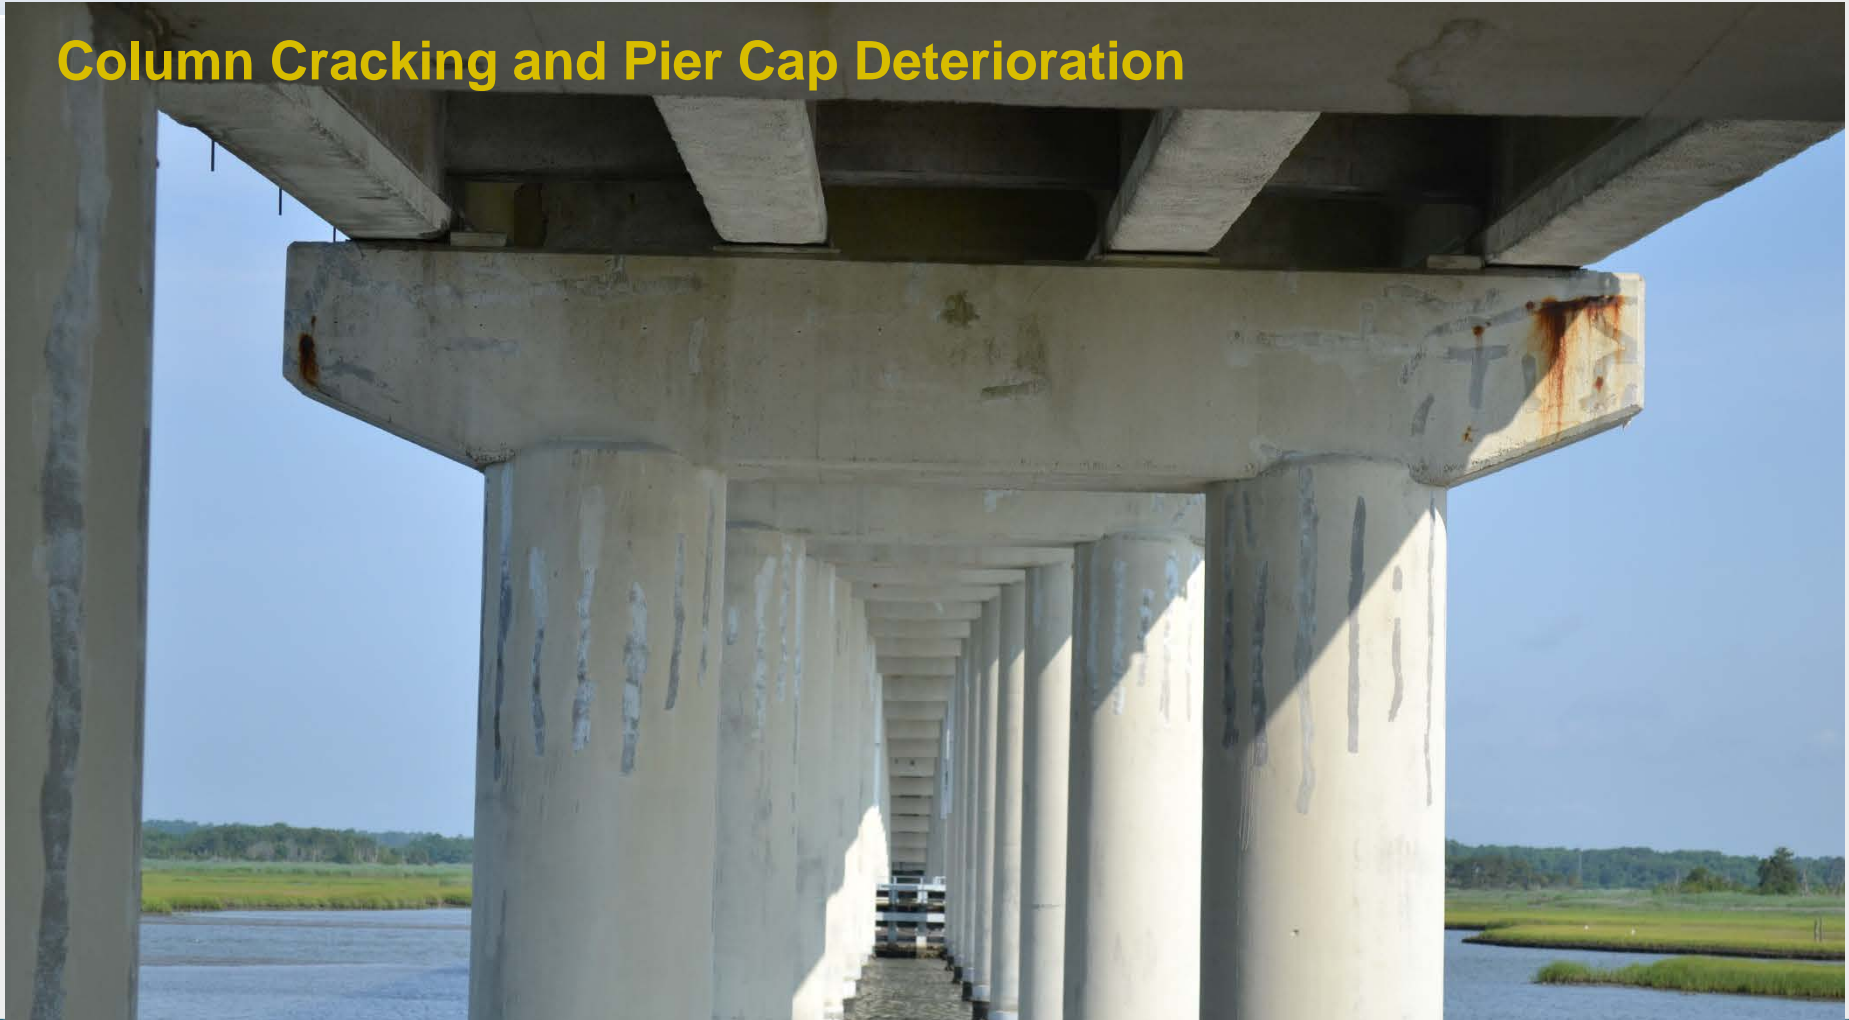
Typical Area Requiring Repair

Column Cracking and Pier Cap Deterioration

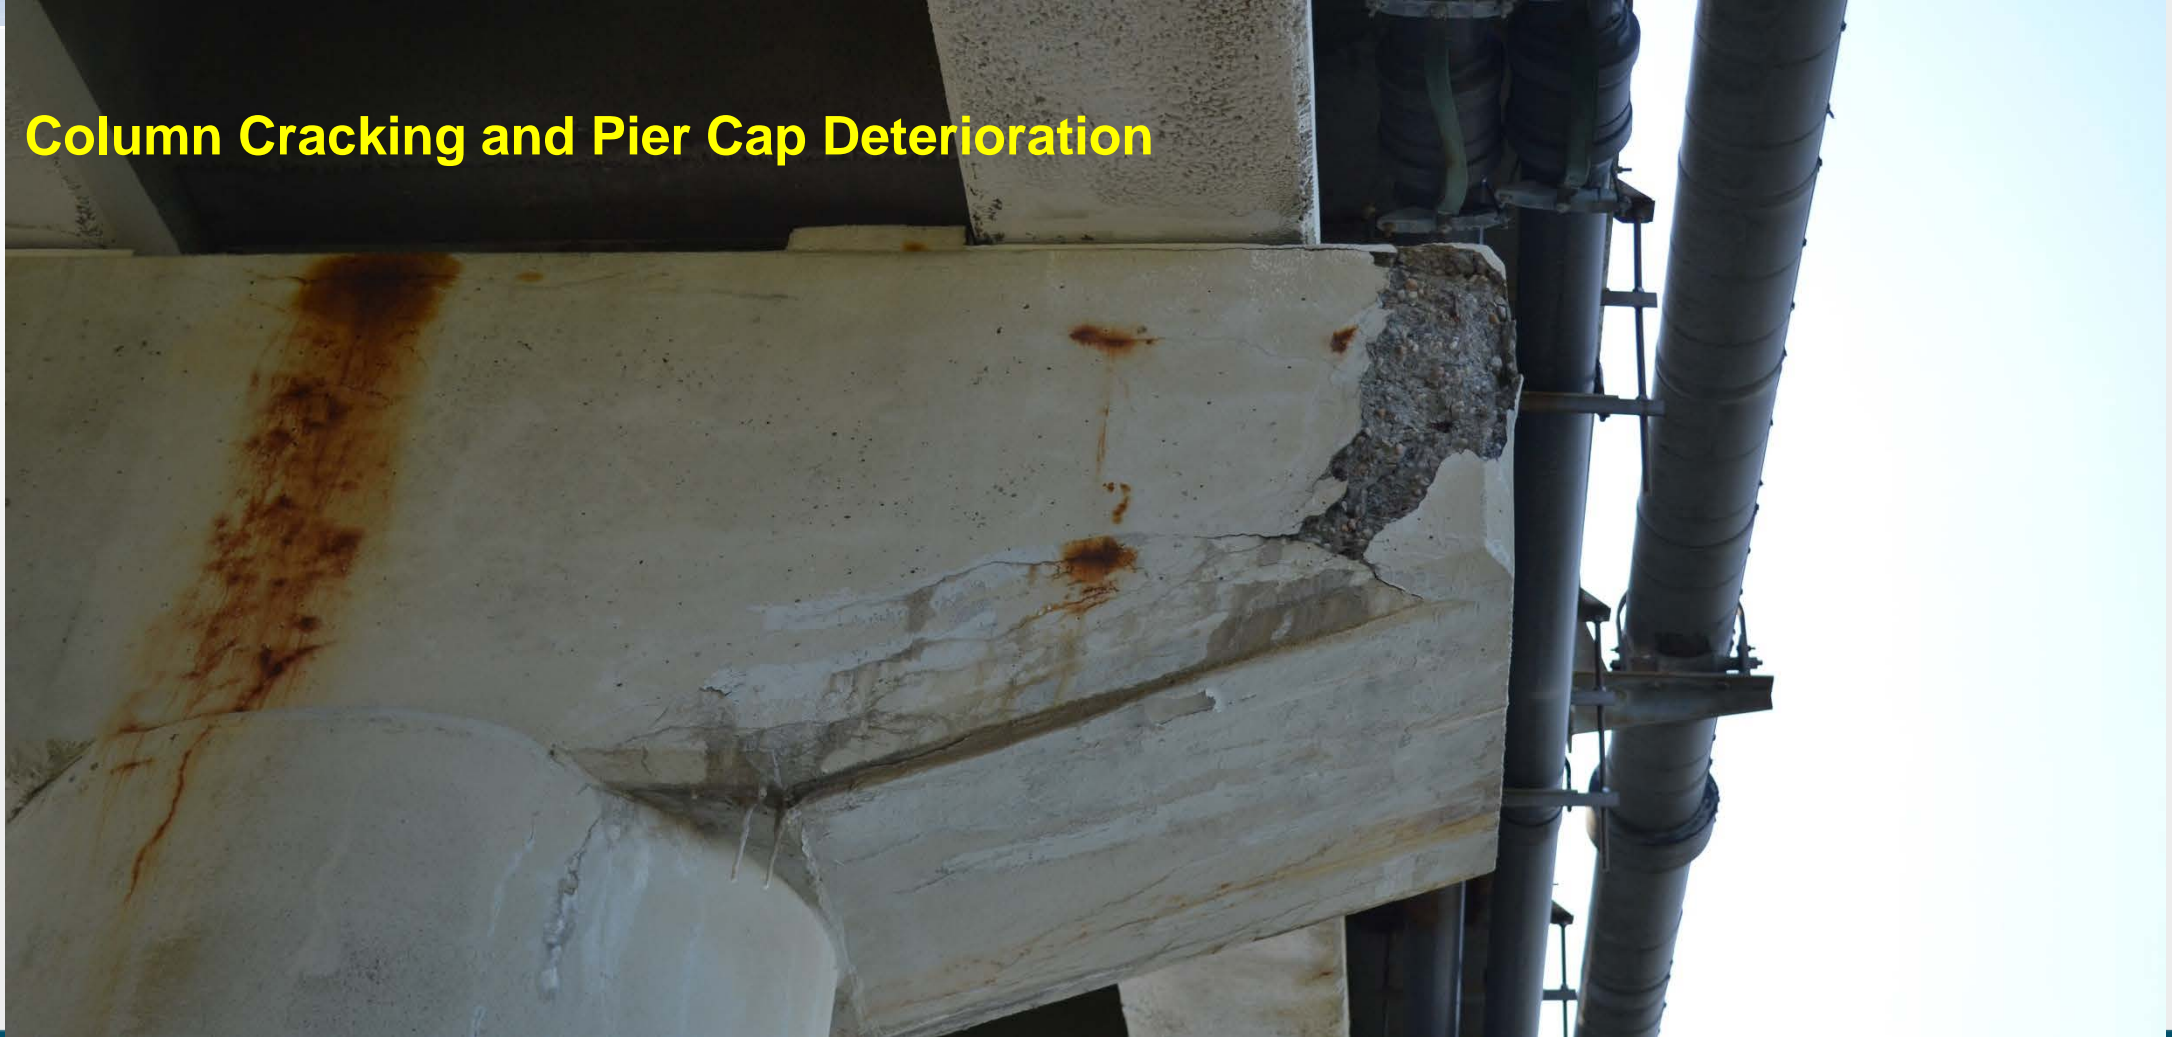
Typical Area Requiring Repair

Column Cracking and Pier Cap Deterioration

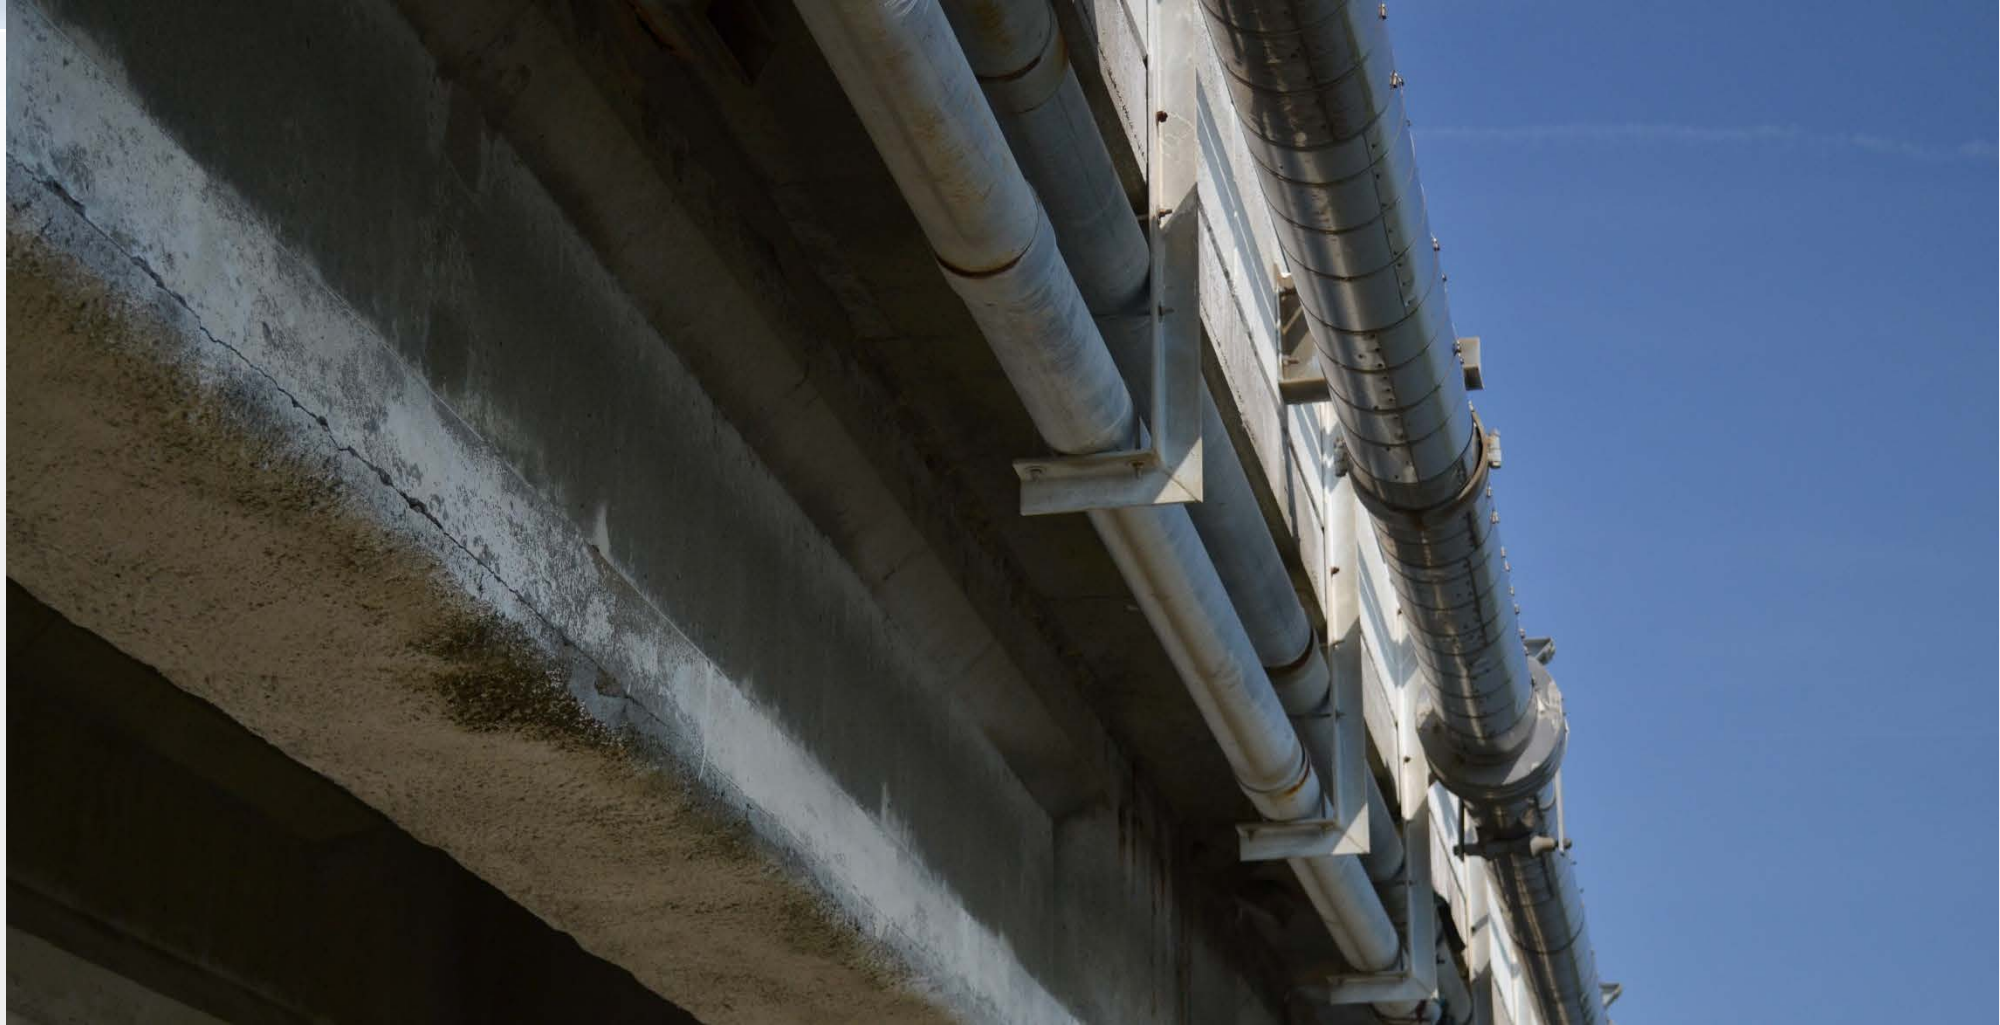
Typical Area Requiring Repair

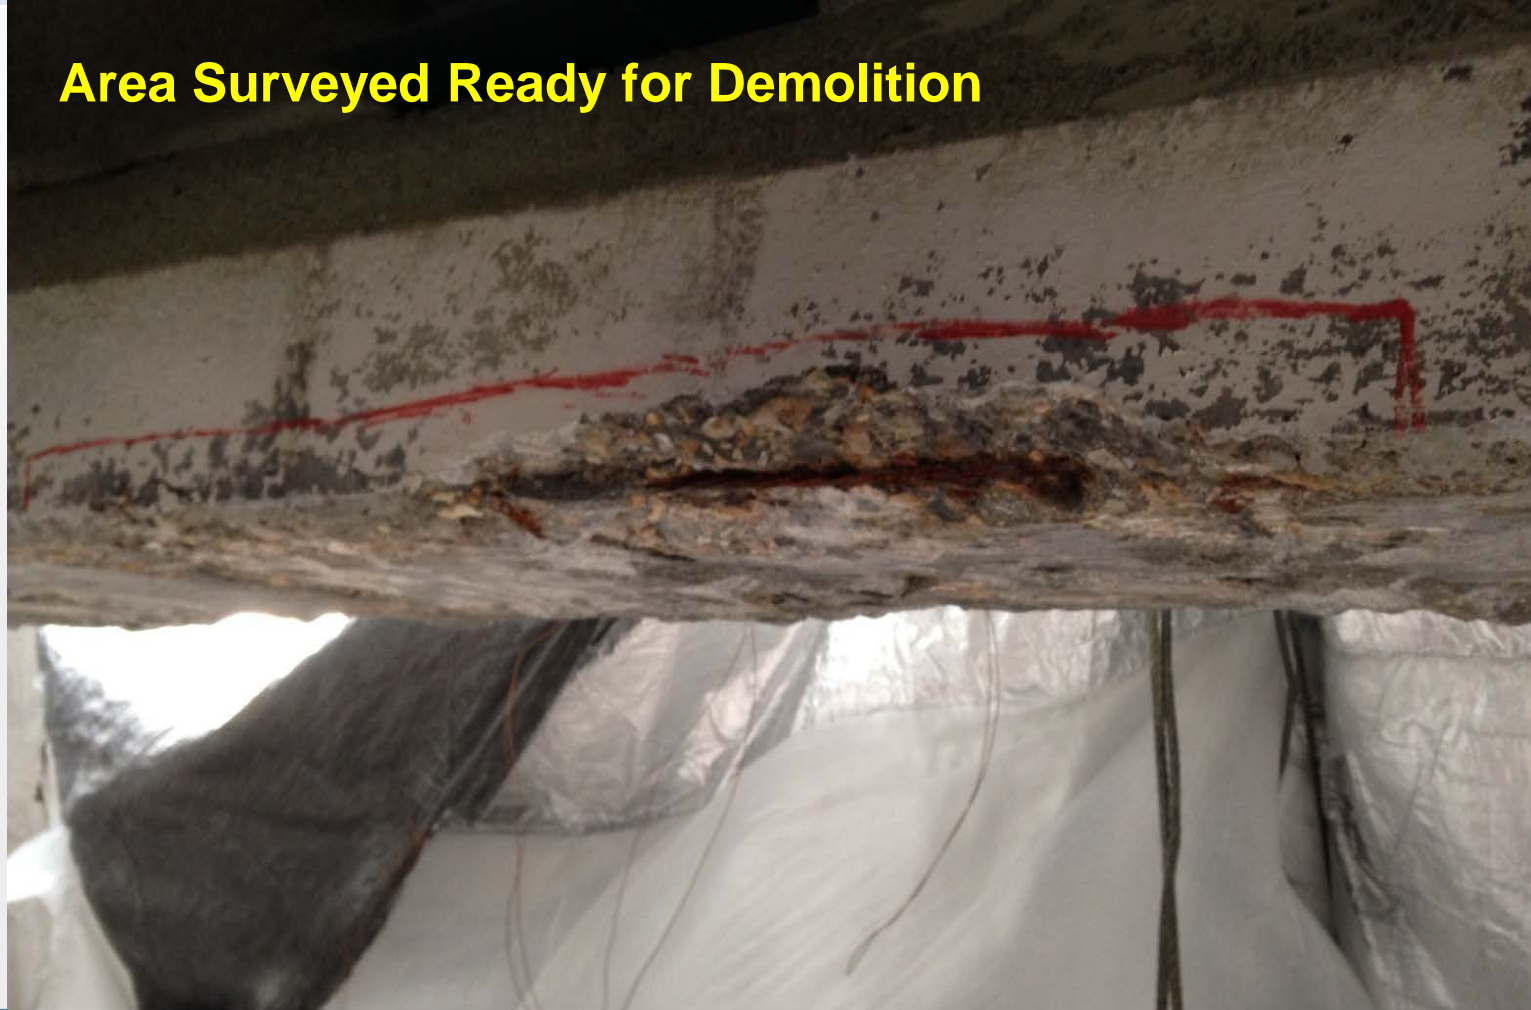
Typical Area Requiring Repair

Area Surveyed Ready for Demolition

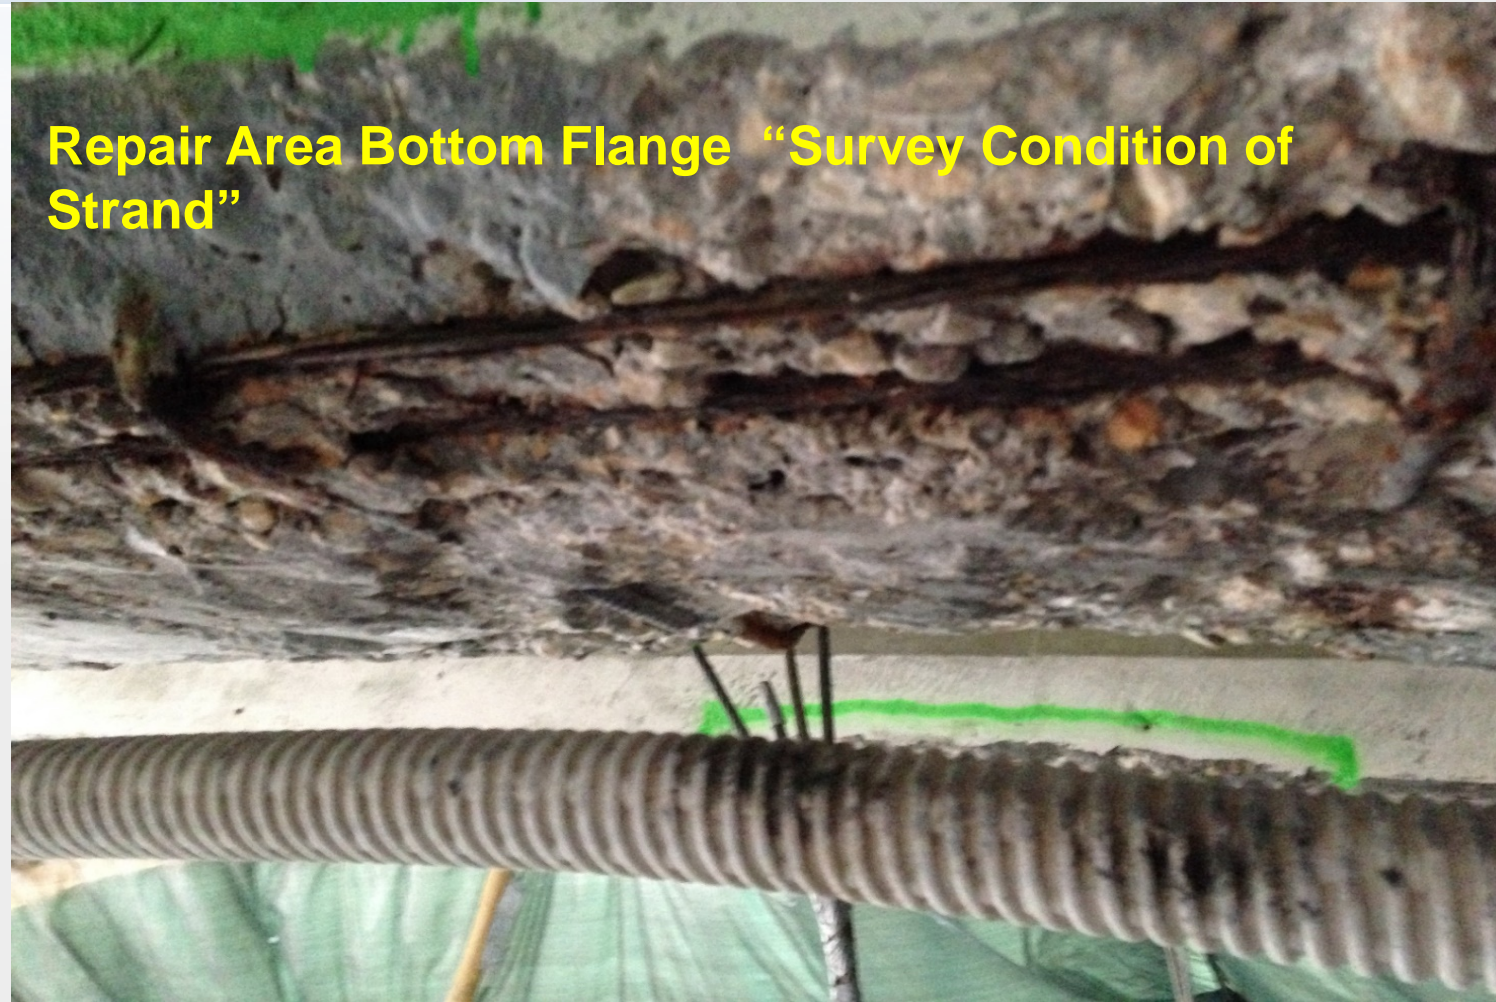
Typical Area Requiring Repair
