THE BRIDGE AUTHORITY
 In conjunction with
 THE MINISTRY OF PUBLIC WORKS

A Bridge To Paradise

Refurbishment Of East Paradise Island Bridge, Nassau, Bahamas

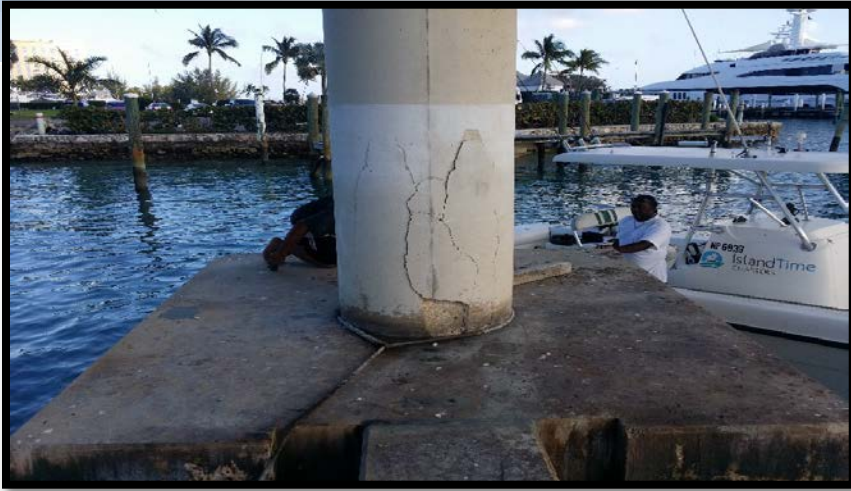
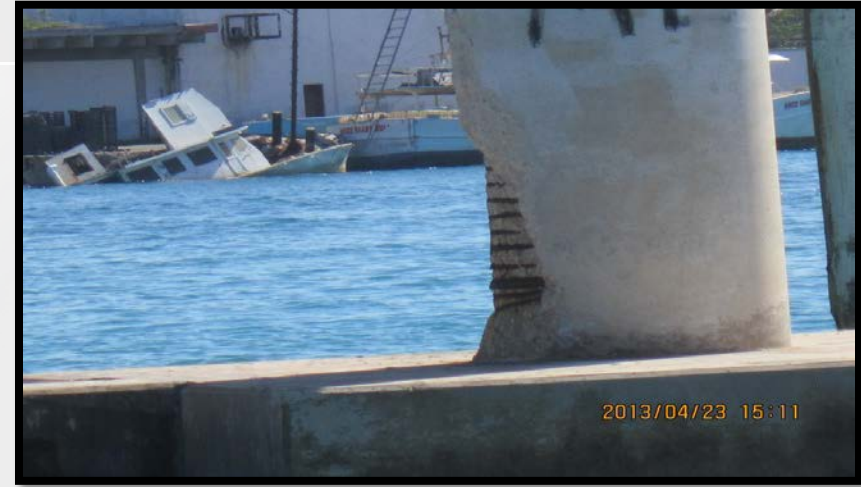
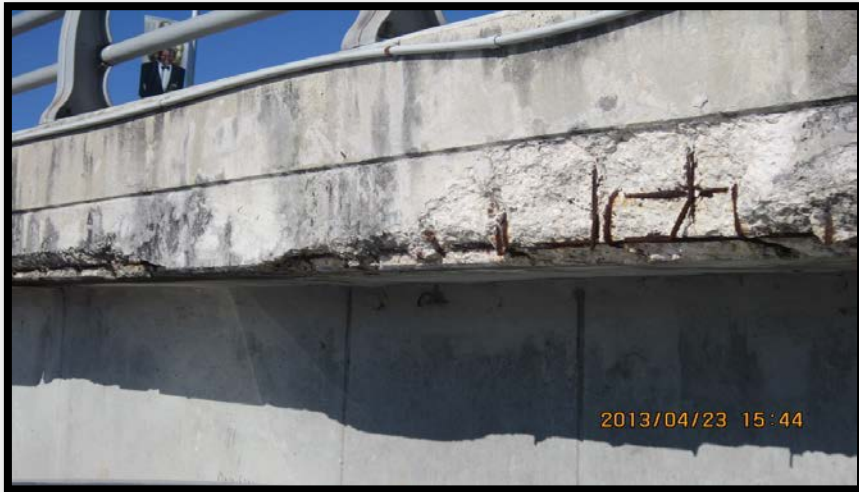
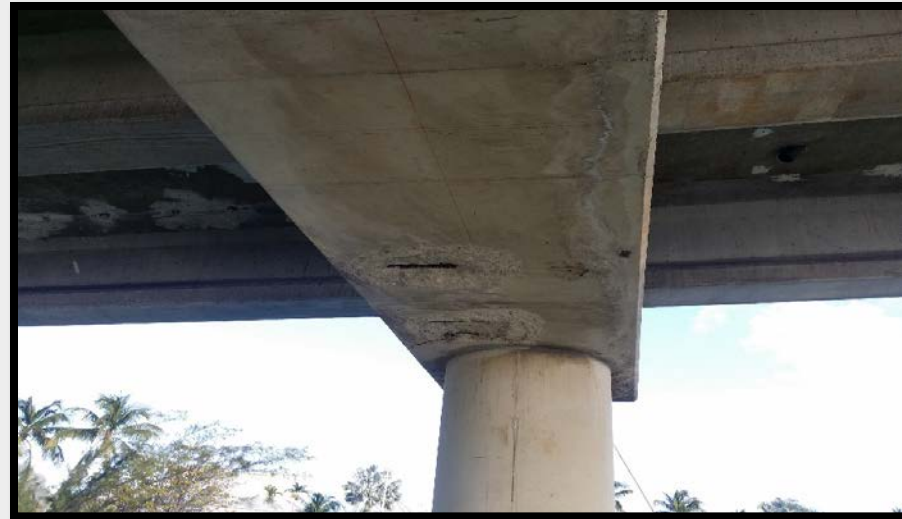
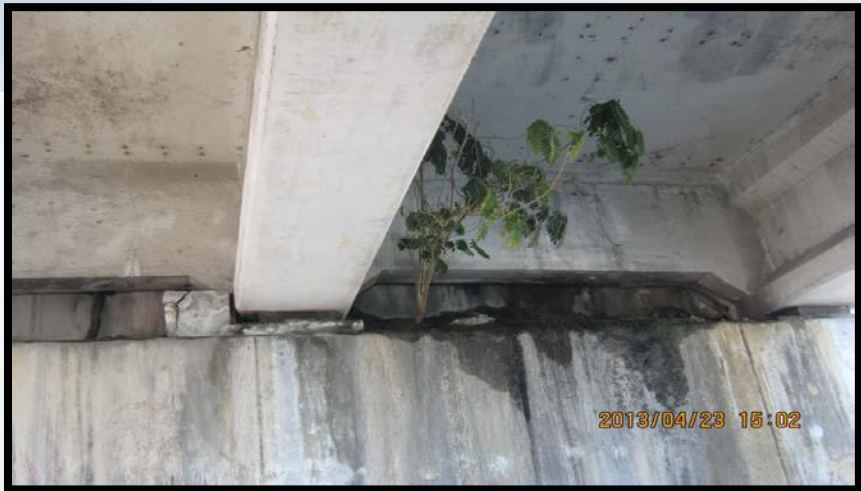
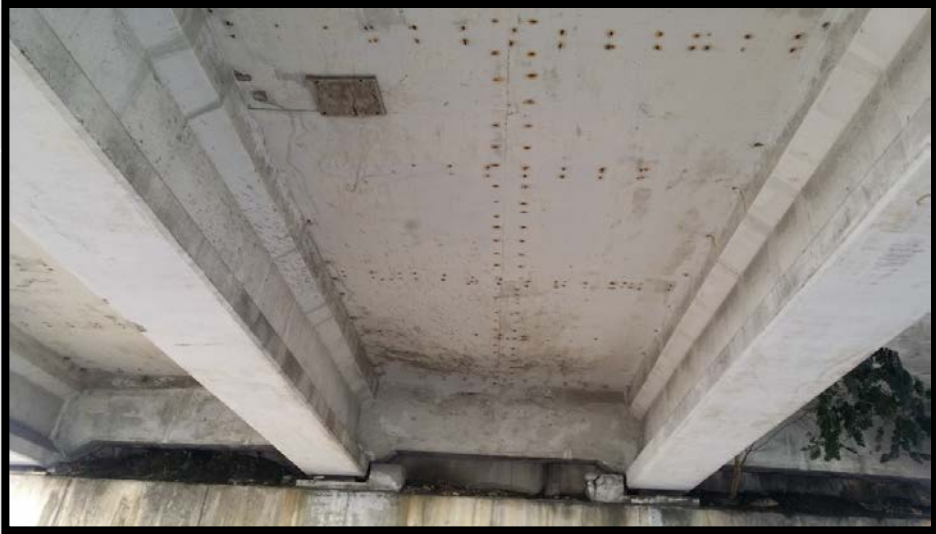
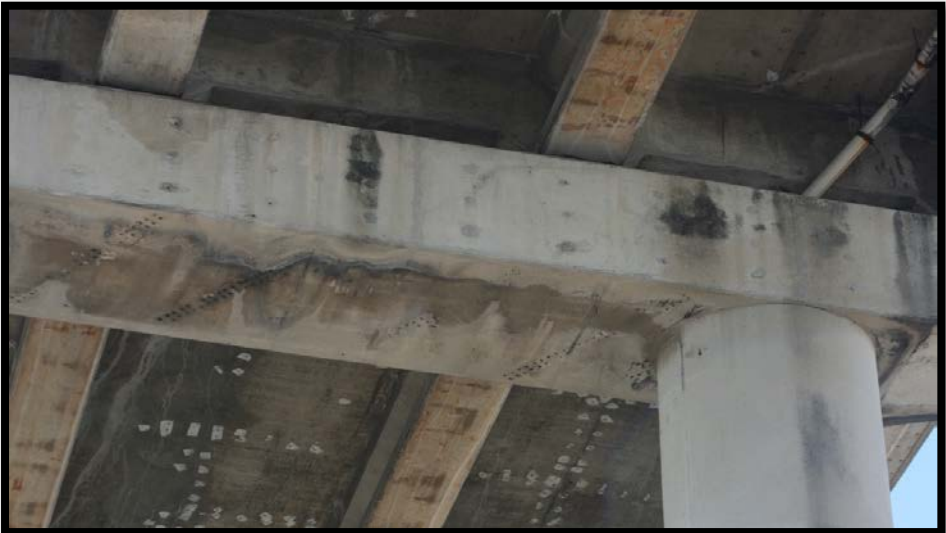
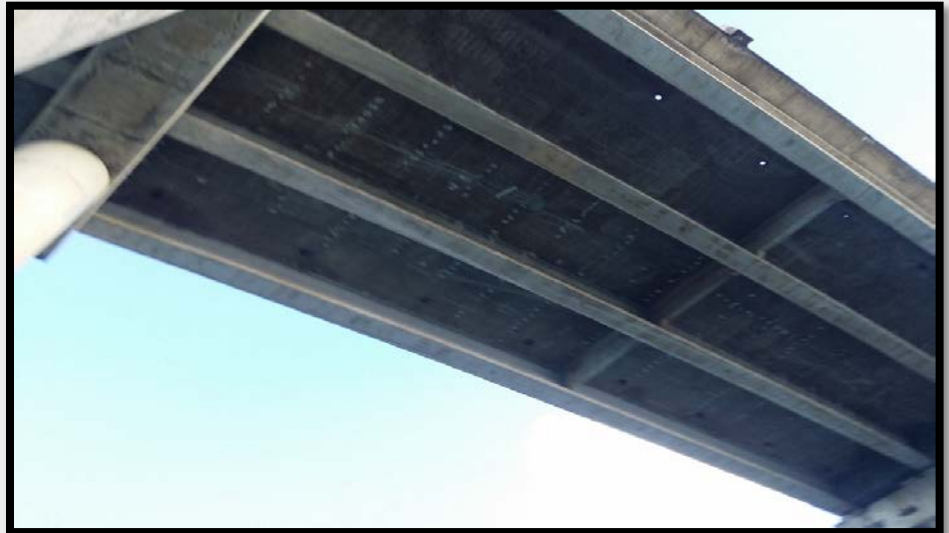
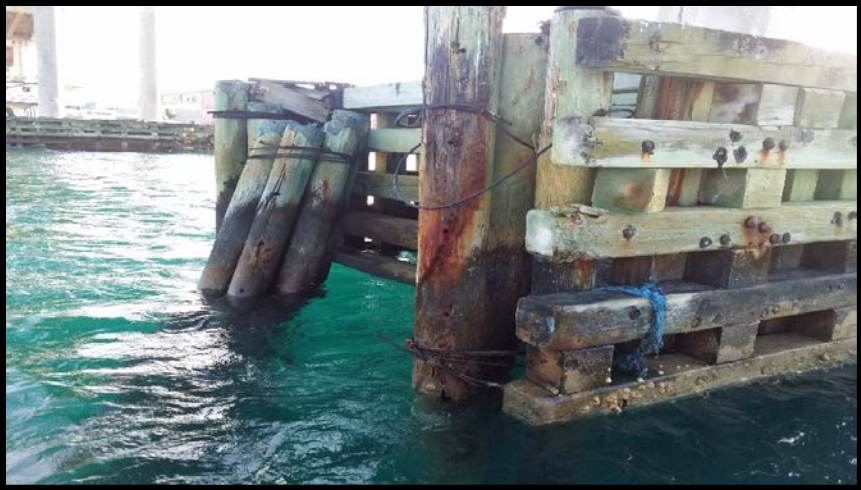
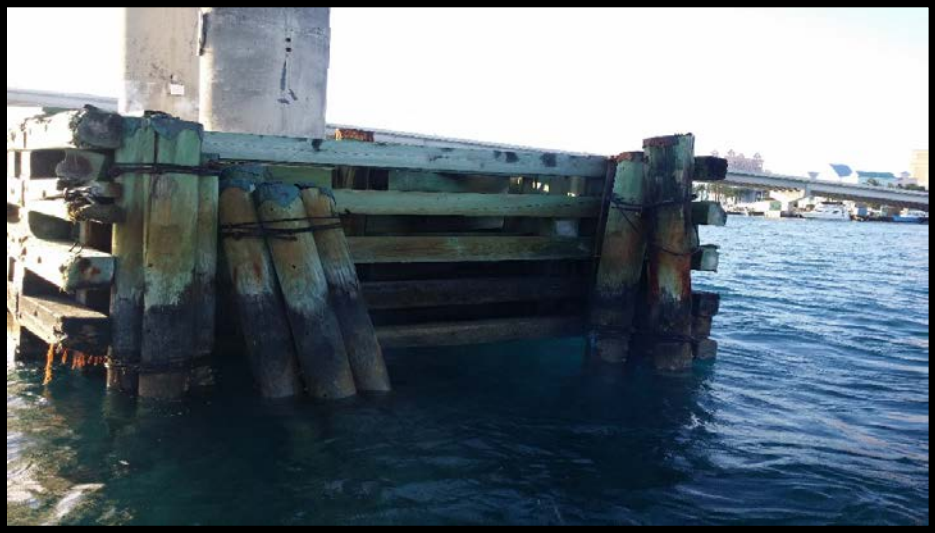
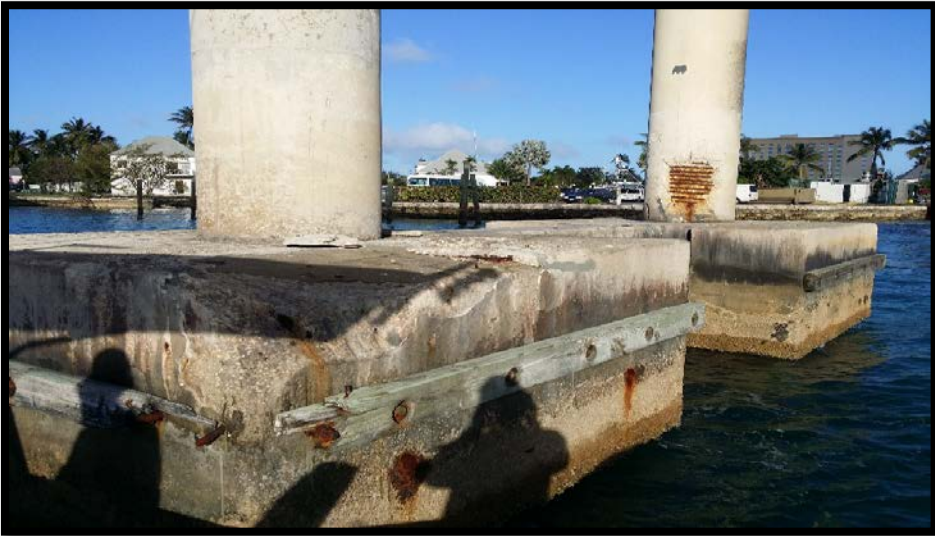
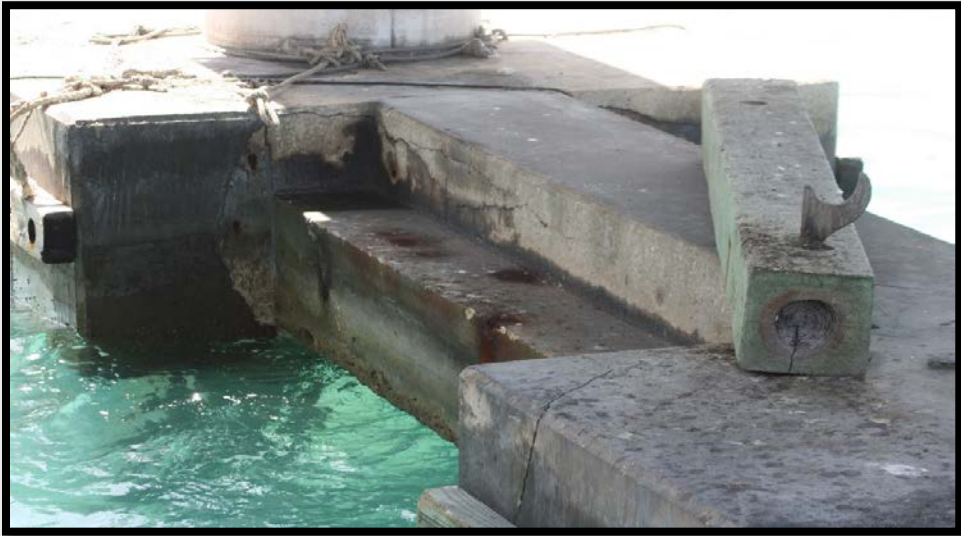
- Engineering Technical Services /Parsons engaged by the Ministry of Works to undertake:-
 - Bridge Inspection,
 - Load Evaluation,
 - and Life Cycle Analysis.
- The inspection found that the structure was in generally good condition.
- However, several of the bridge components exhibit varying levels of deterioration which require some localized rehabilitation.
- This includes localized areas of concrete deterioration mainly due to reinforcement corrosion.
- The “current” condition was evaluated in 2015 before the finalization of the repair contract.

Refurbishment Of East Paradise Island Bridge – Condition of Bridge before Contract

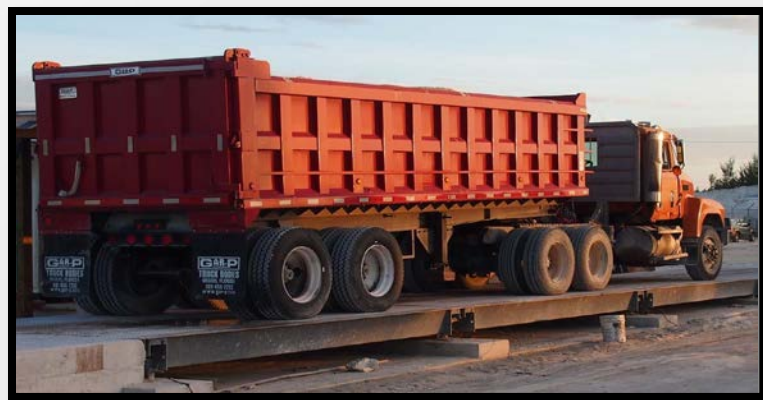
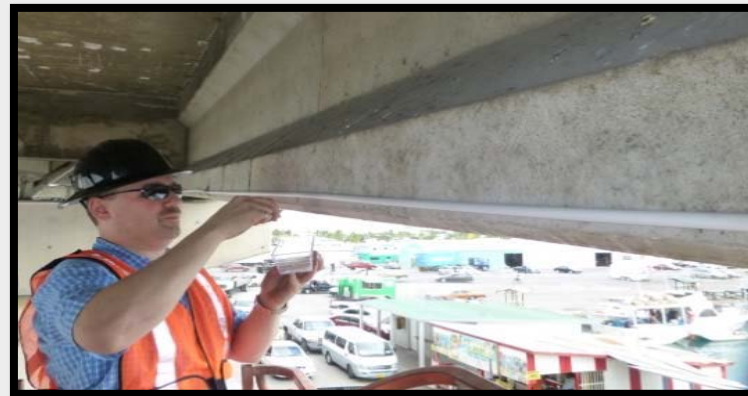
- Unable to undertake complete Load Evaluation due to the original drawings not being available.
- For this reason, a detailed member by member capacity check could not be fully completed.
- This means that areas of specific concern, such as the dapped ends, could not be verified due to insufficient information.
- While no signs of any distress have yet to have been reported it was decided to undertake a load test on the structure.
- In 2014 a load test was undertaken on the bridge to determine the capacity.
- The load test proved that there was adequate capacity in the bridge for vehicles that use the bridge

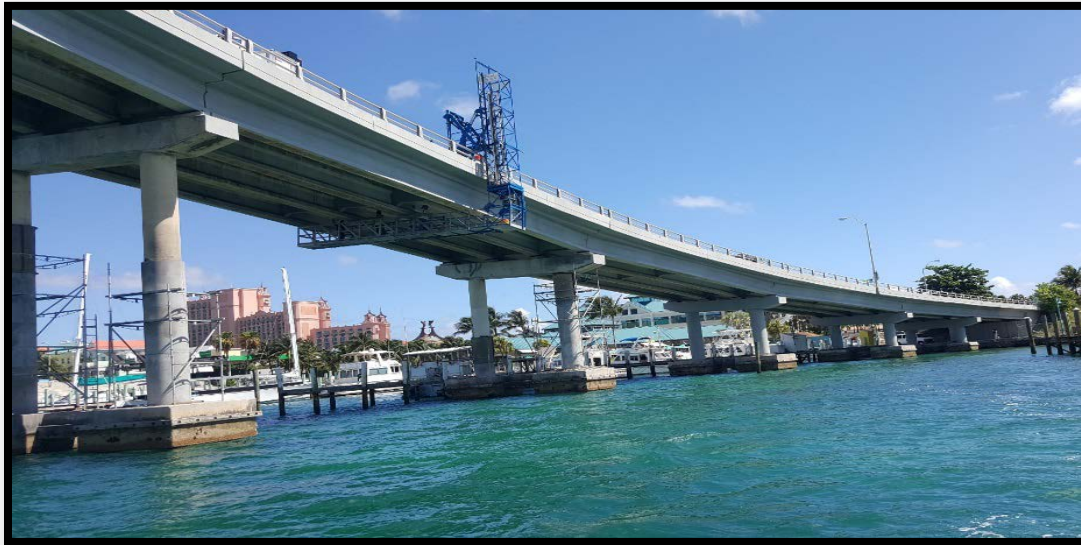
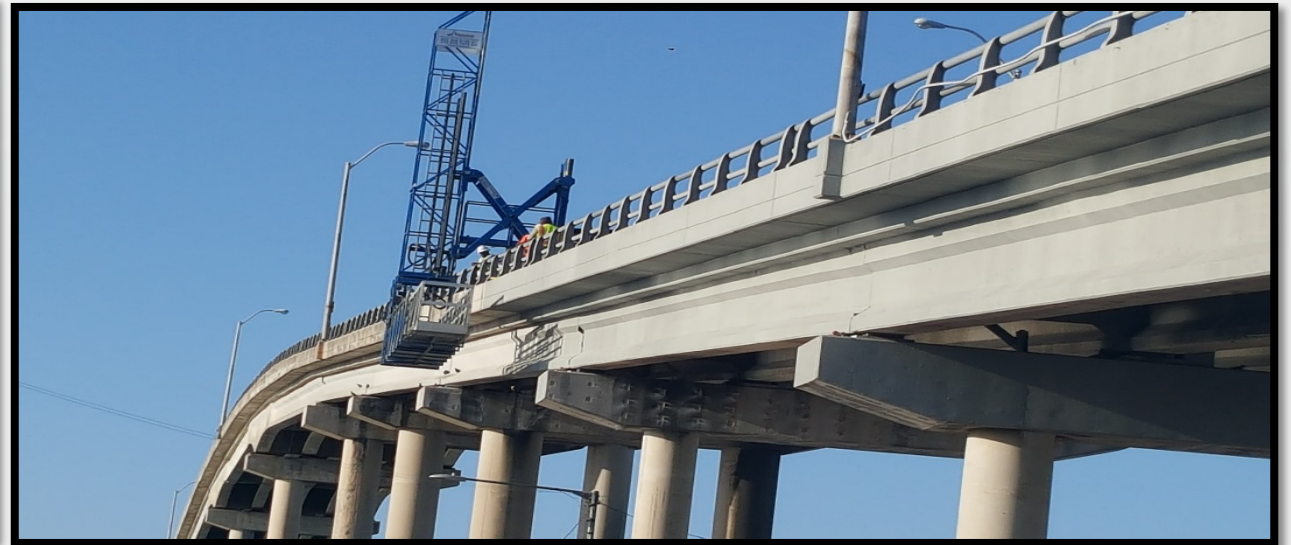
Procure and supply an aluminum bridge access platform

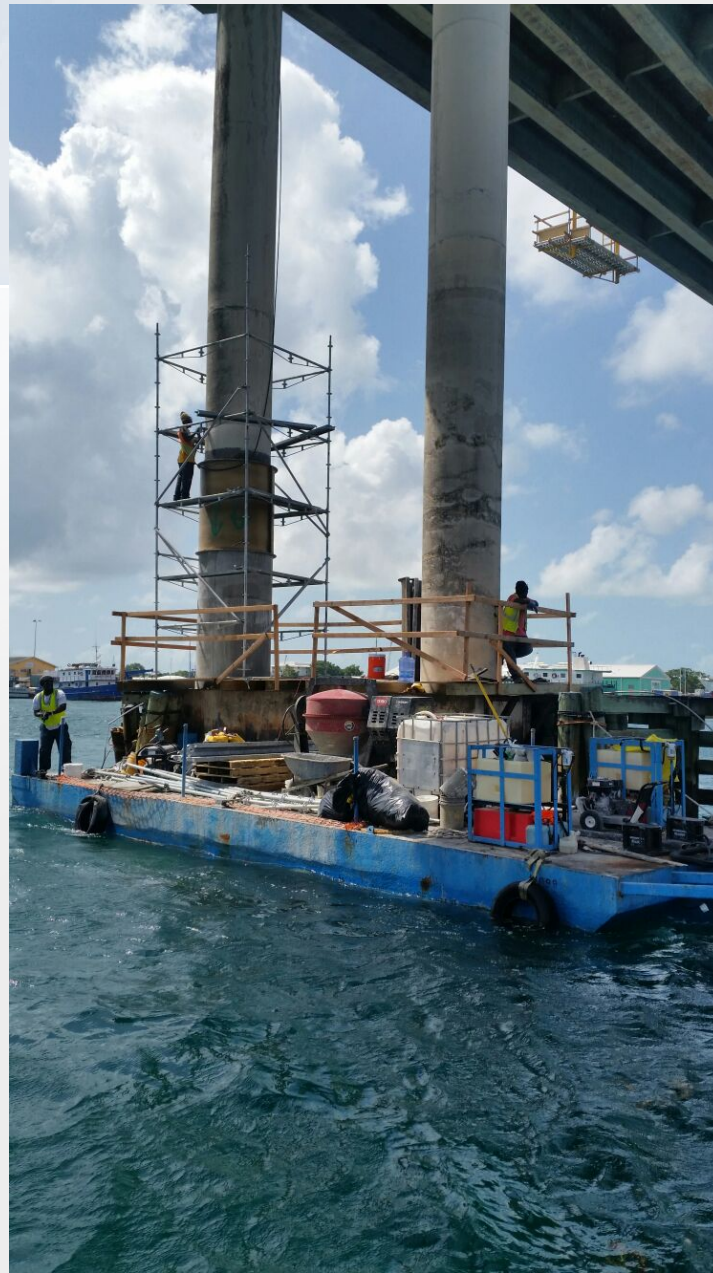
Floating work platform
for column repairs

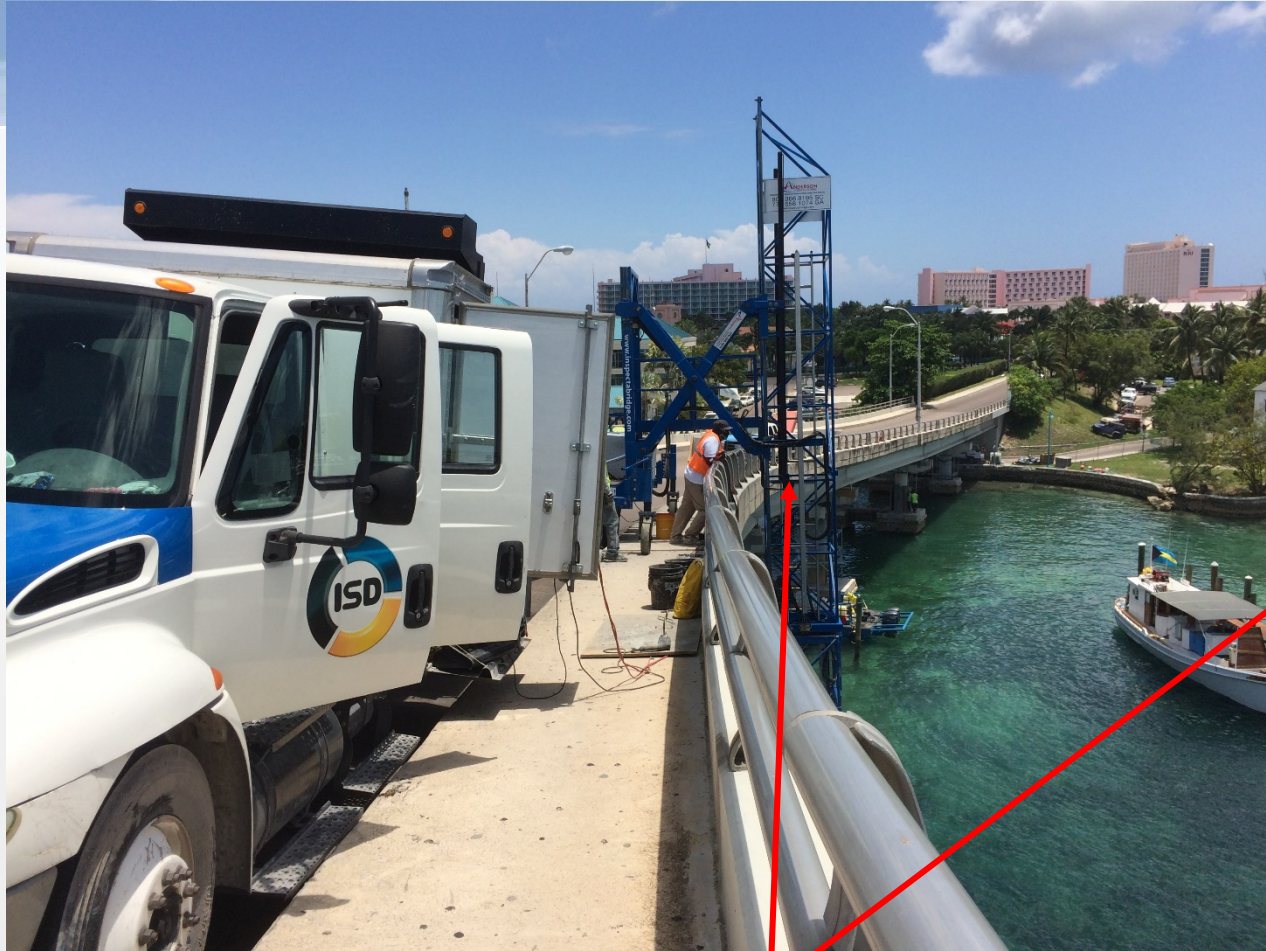
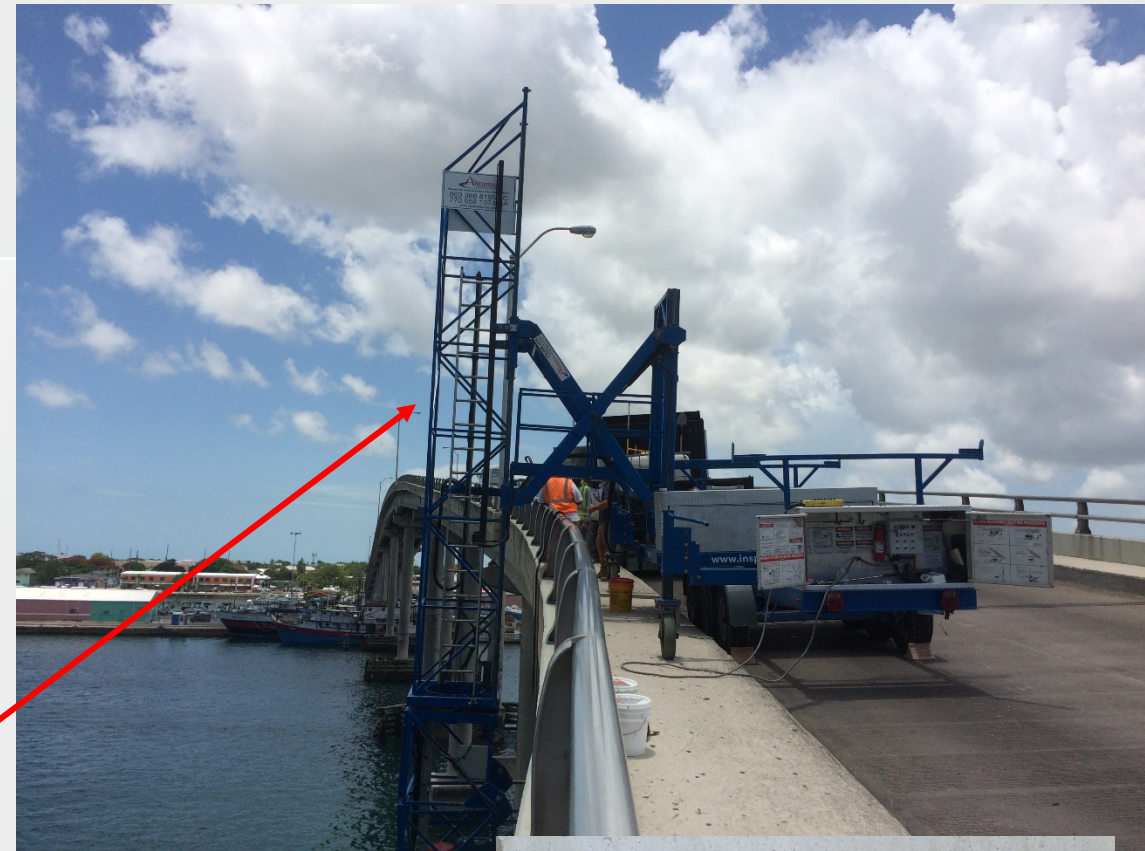
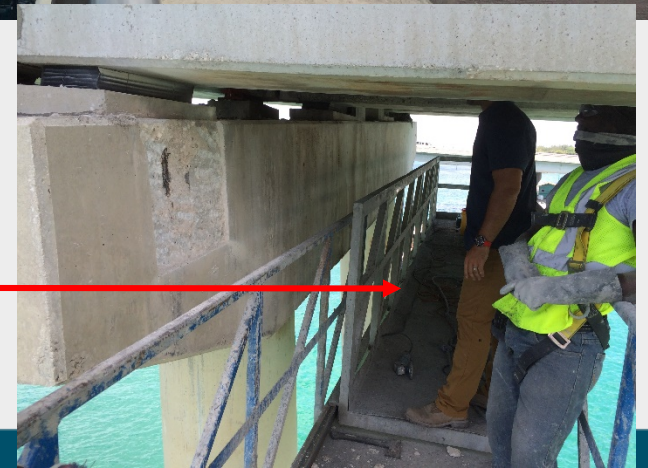
Hydra Platform for beam repairs under deck

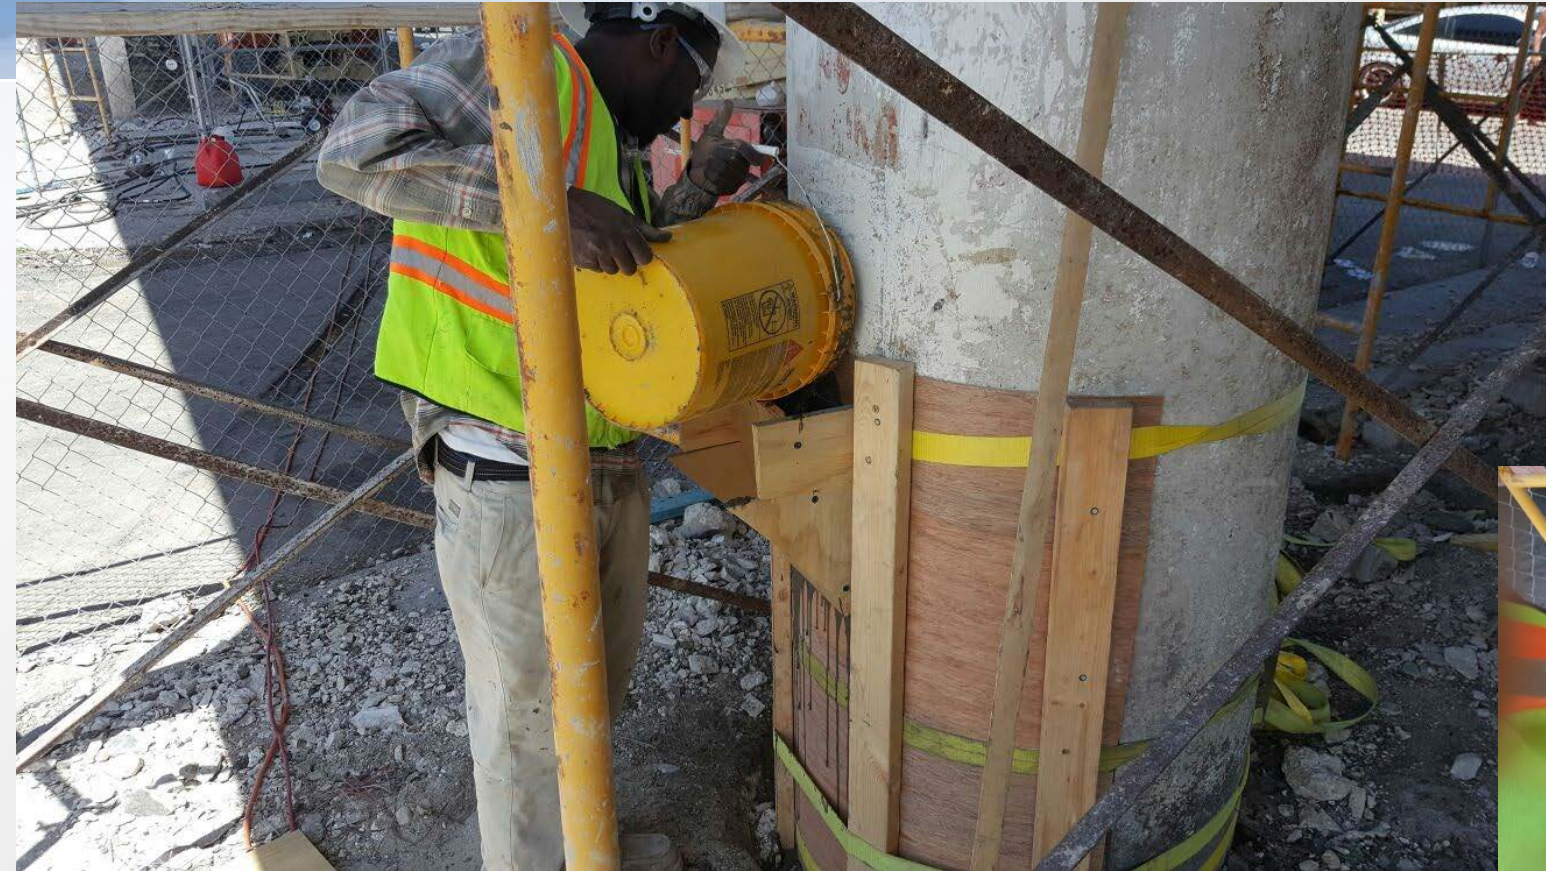
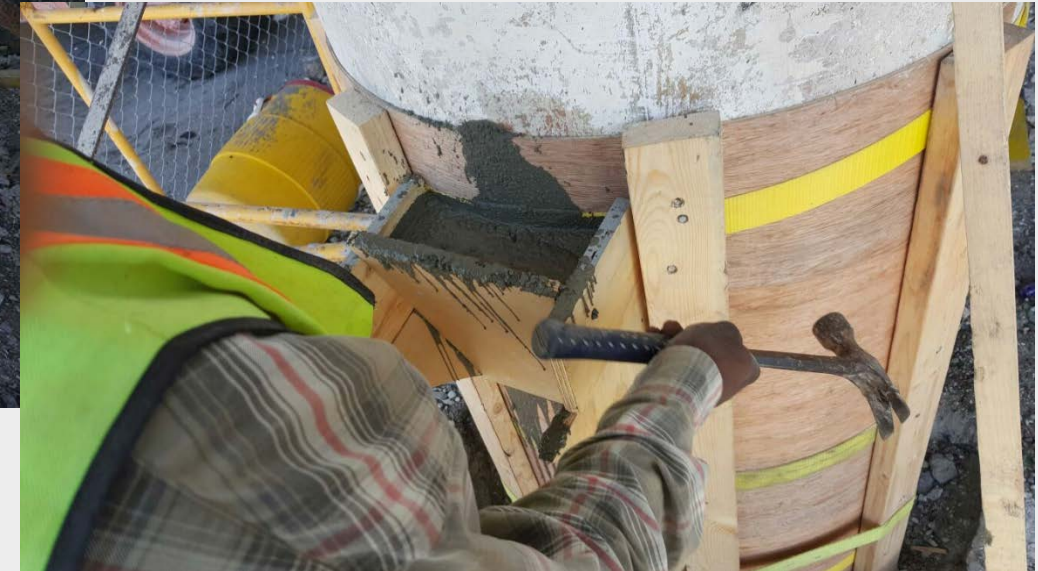
Column Repair – Isolated Form & Pour Repairs

Using self-consolidating concrete (SCC) with integral corrosion inhibitor and polymer modification.

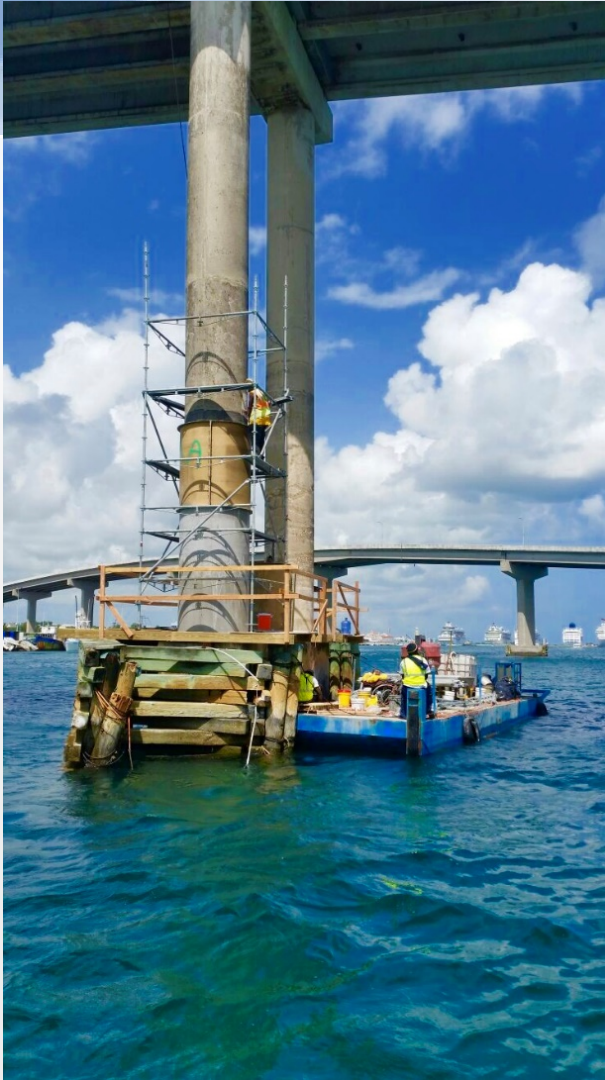
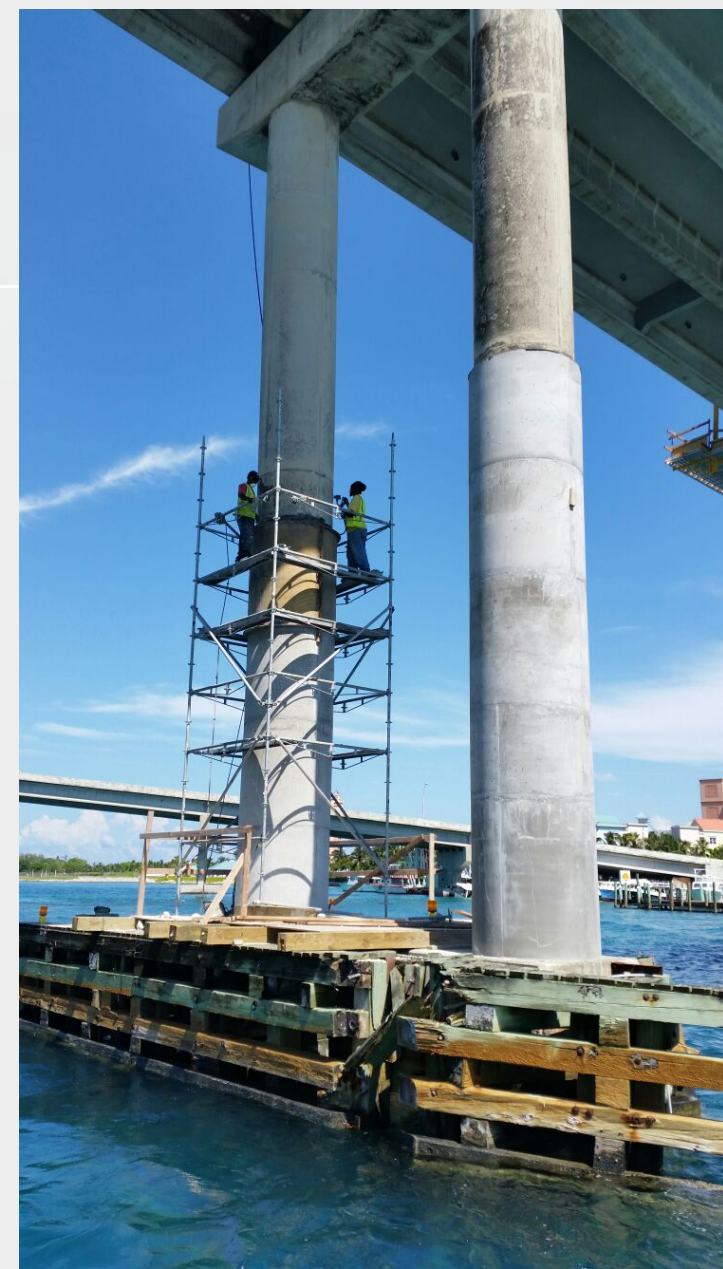
Column Repair – Column Encapsulation

6" of Self-Consolidating Concrete (SCC) with integral corrosion inhibitor creates increased cover for rebar.

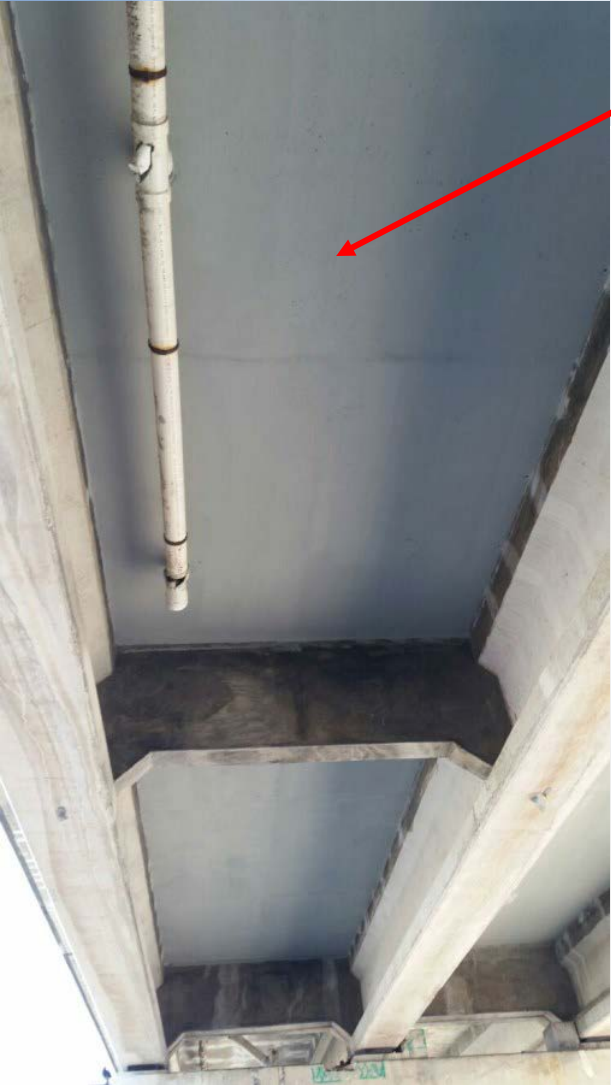
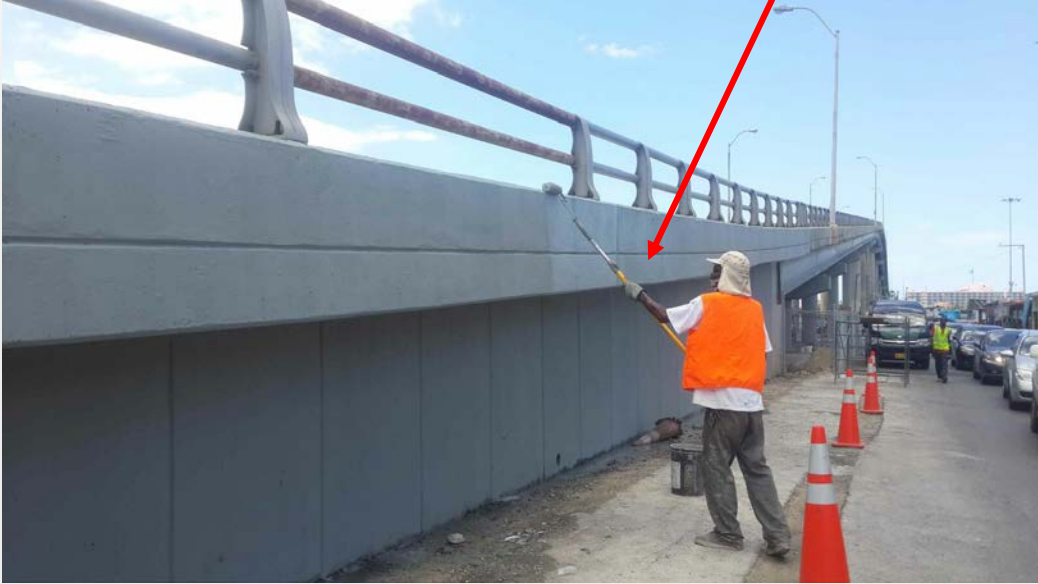
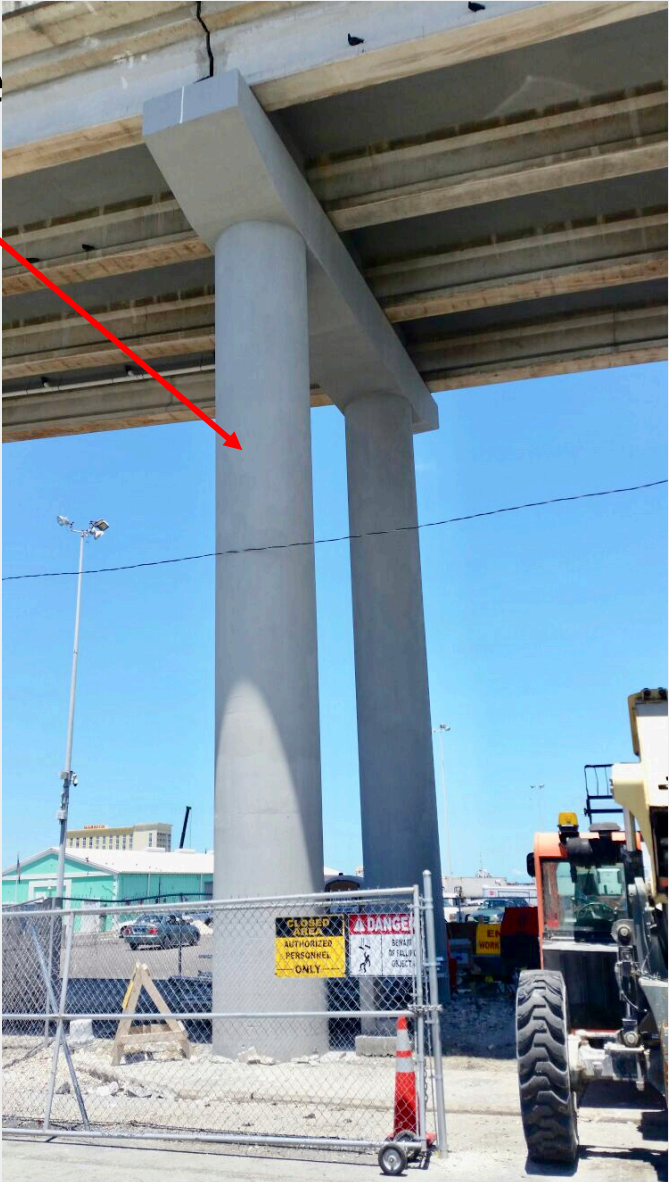
Protect

Polymer-modified cementitious protective coating to reduce salt and water penetration into concrete elements.

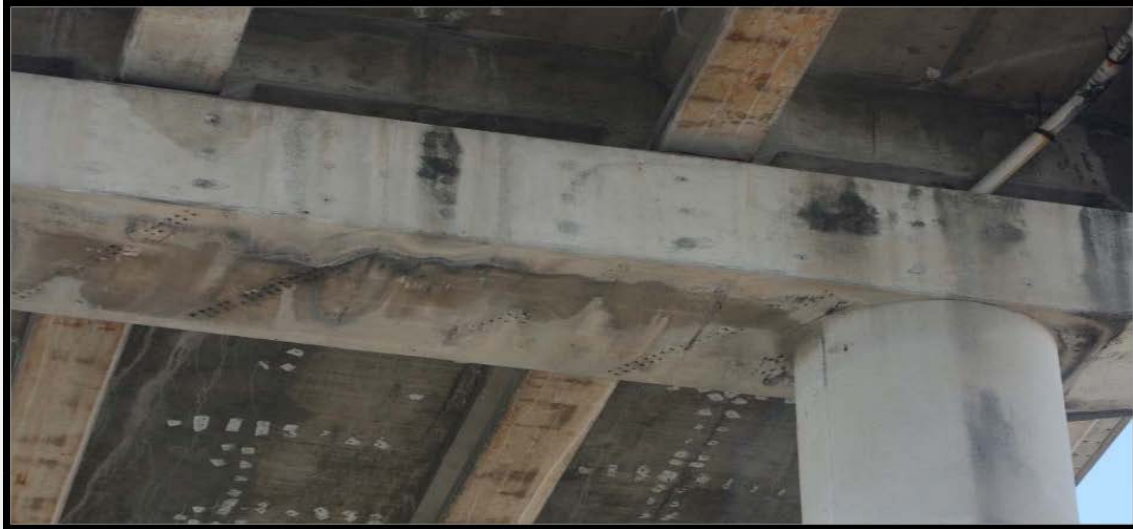
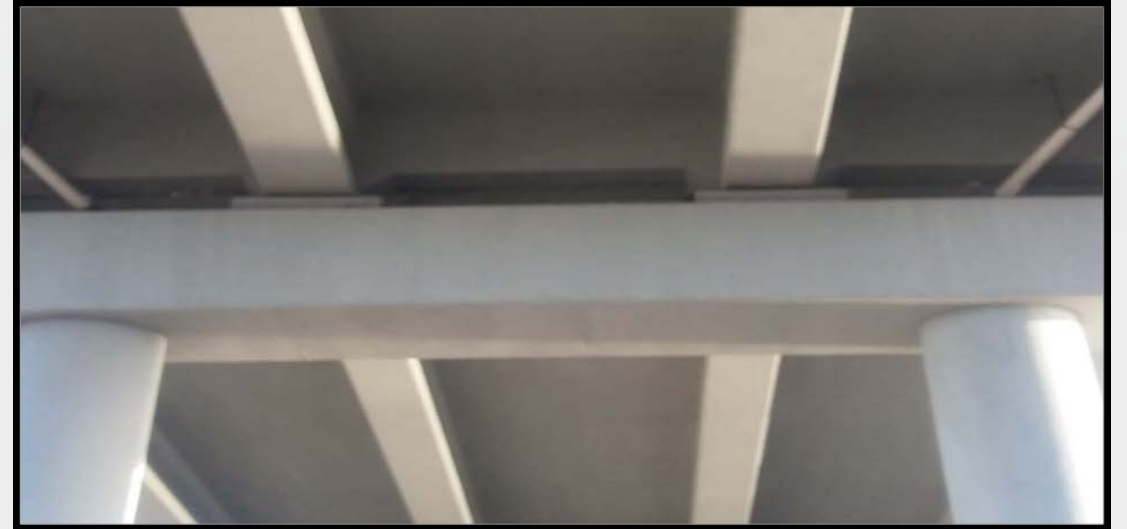
Pier Cap Repairs

BEFORE

AFTER

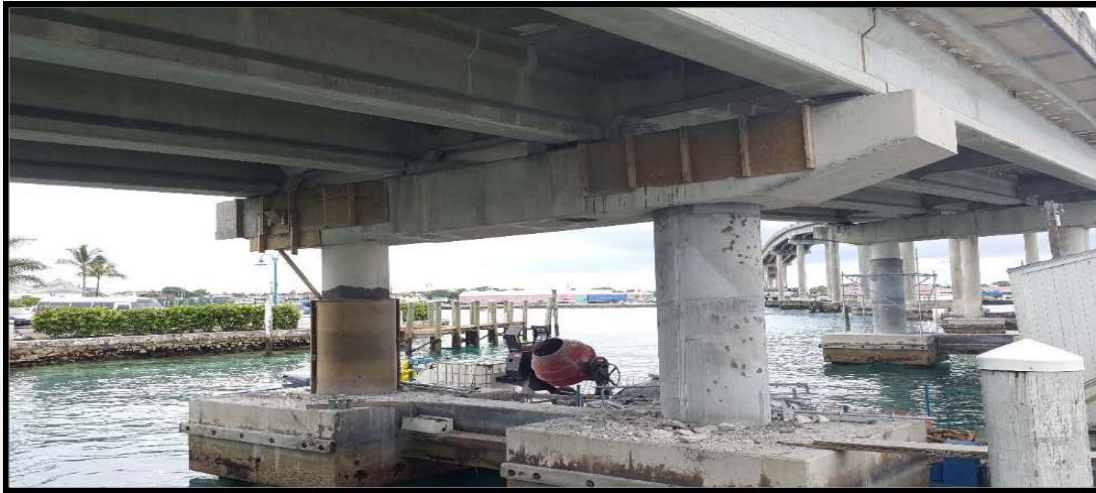
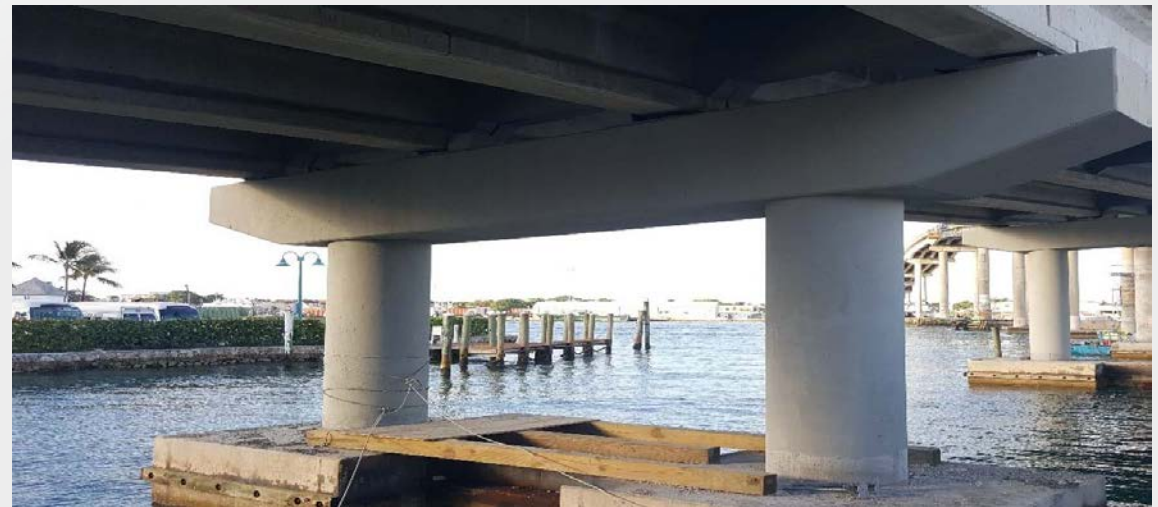
Column Repairs

BEFORE

AFTER

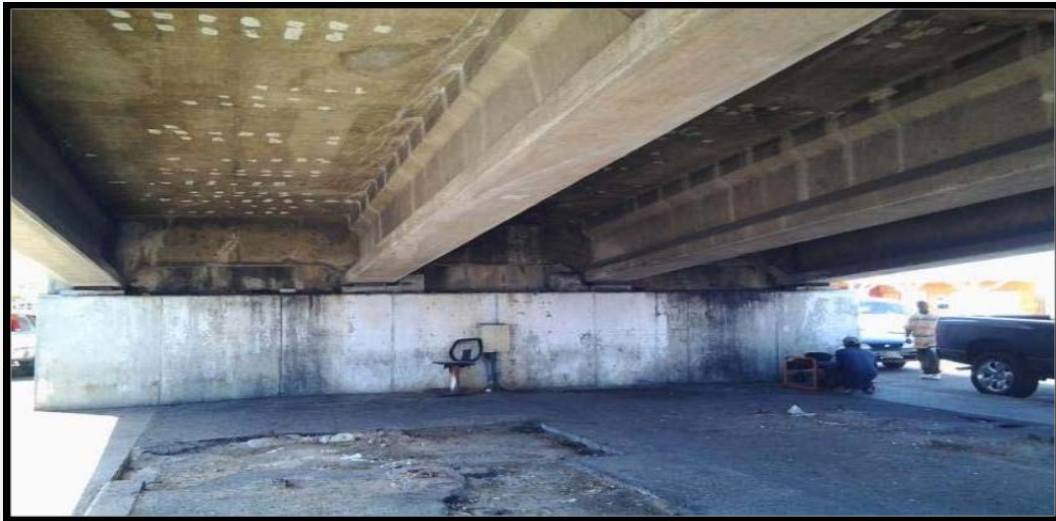
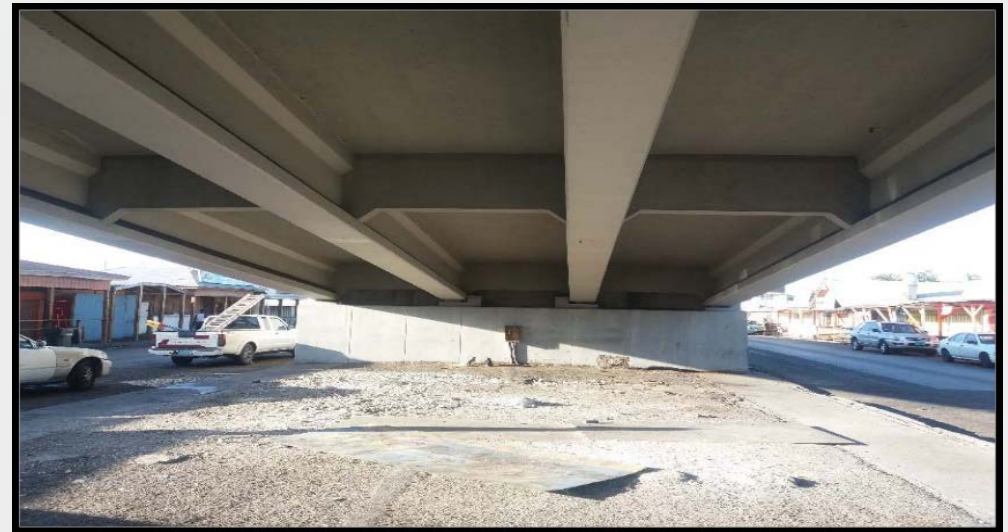
Underside of Deck

BEFORE

AFTER

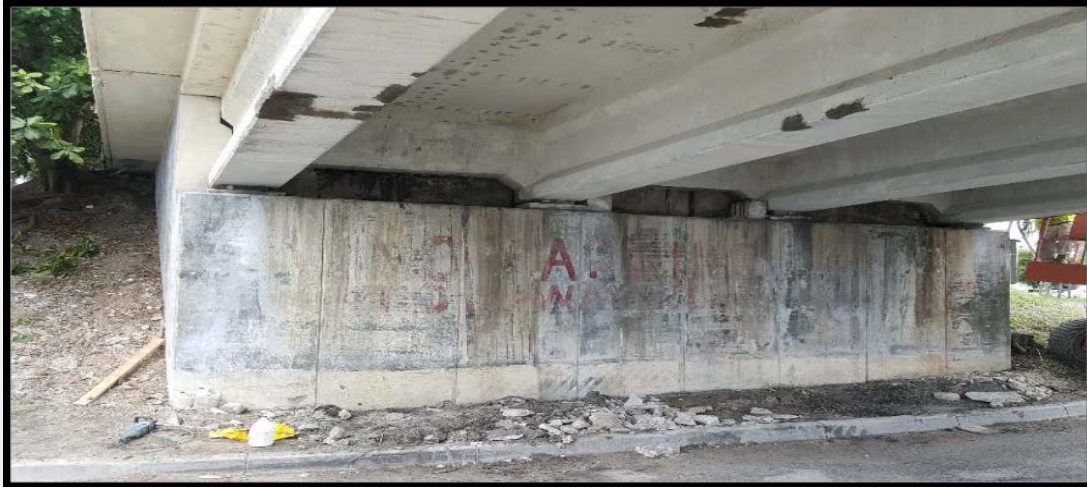
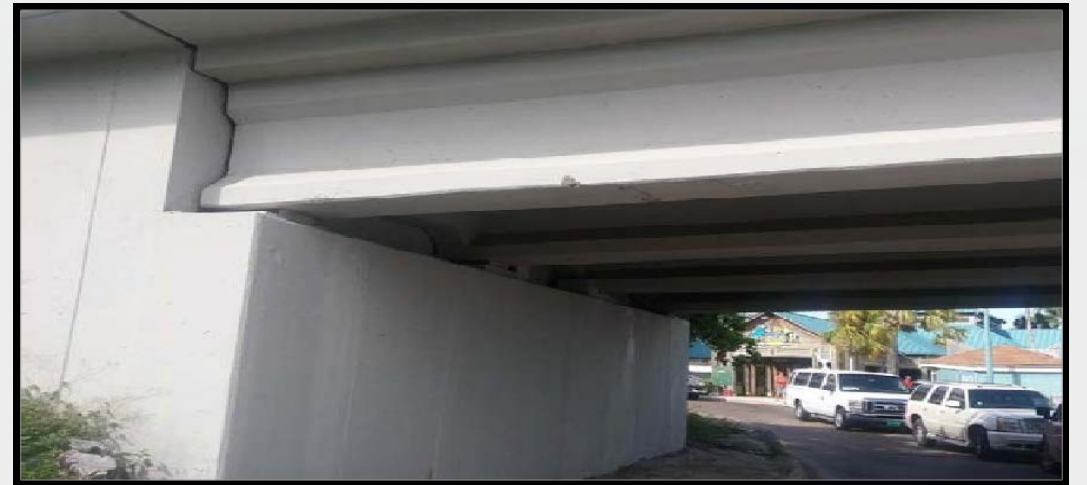
Abutment Repairs

BEFORE

AFTER

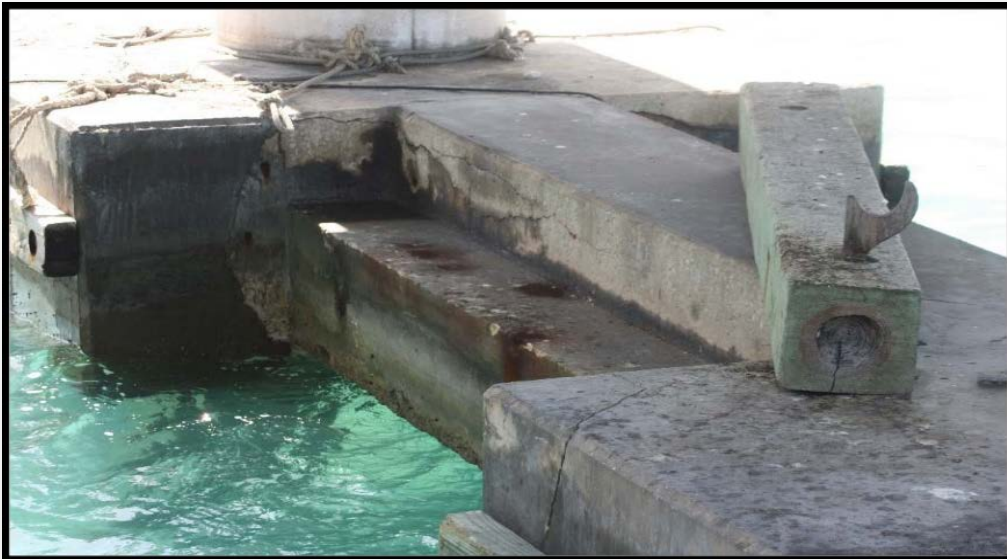
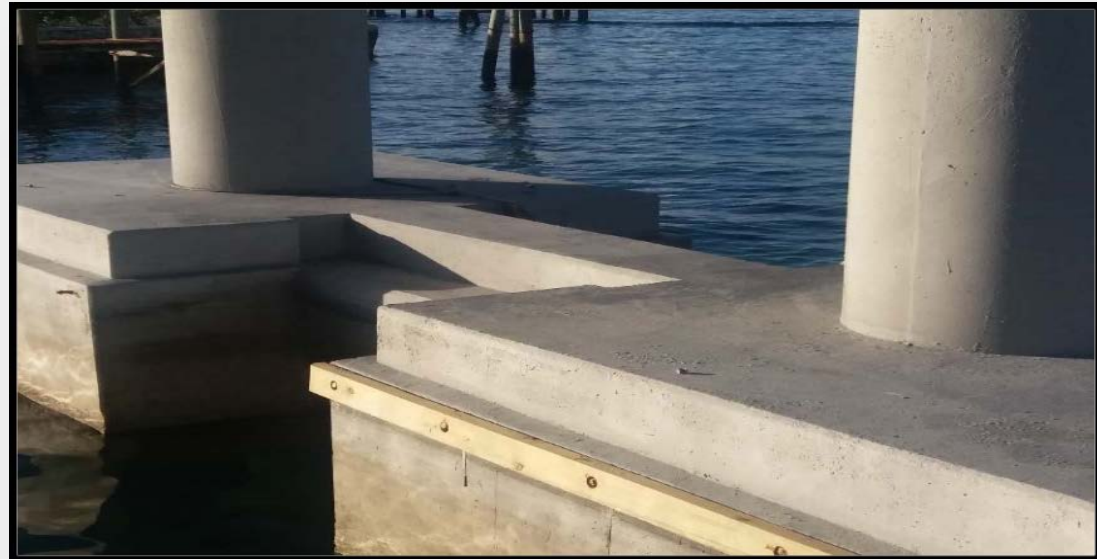
Pile Cap Repairs

BEFORE

AFTER
